# MEMORANDUM

TO: File DATE: November 5, 2003

SUBJECT: Kennecott Greens Creek Site  
Visit  
August 21, 2003

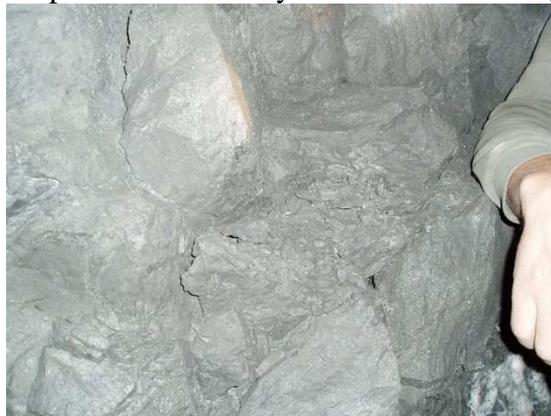
- A. KGCMC demonstrated how their geologists visually classify waste rock for acid generation potential. The annual report showed visual classification has a 96% success rate when compared to laboratory acid base accounting methods.

*Classification of waste rock underground*

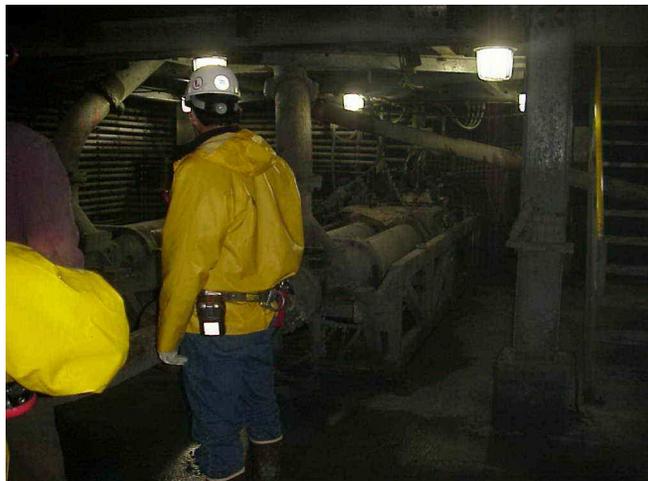
- C. The paste backfill pump area was also visited. Tailings are hauled from the mill to an underground hopper, where they are mixed with water and cement to form a paste. Hydraulic rams pump the paste through 6" steel pipes to various locations within the mine. Approximately 50% of all tailings are returned underground.

*Paste backfill pump underground*

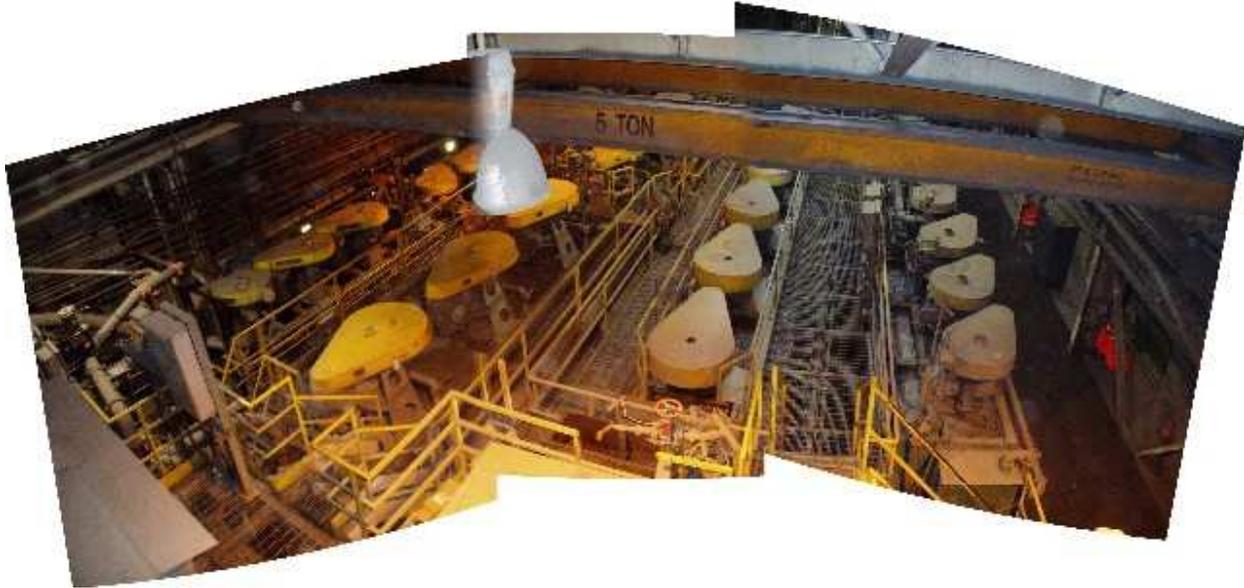
*Mill Flotation tanks*

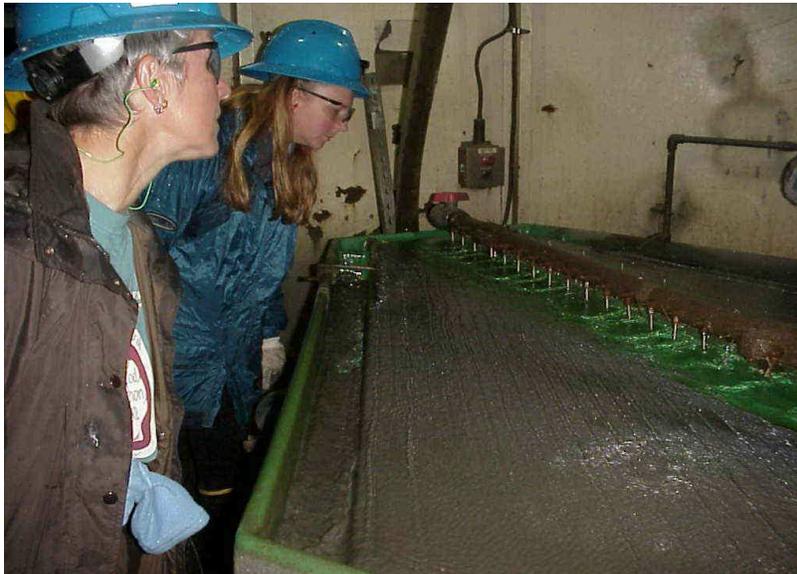
*Gold recovery table*

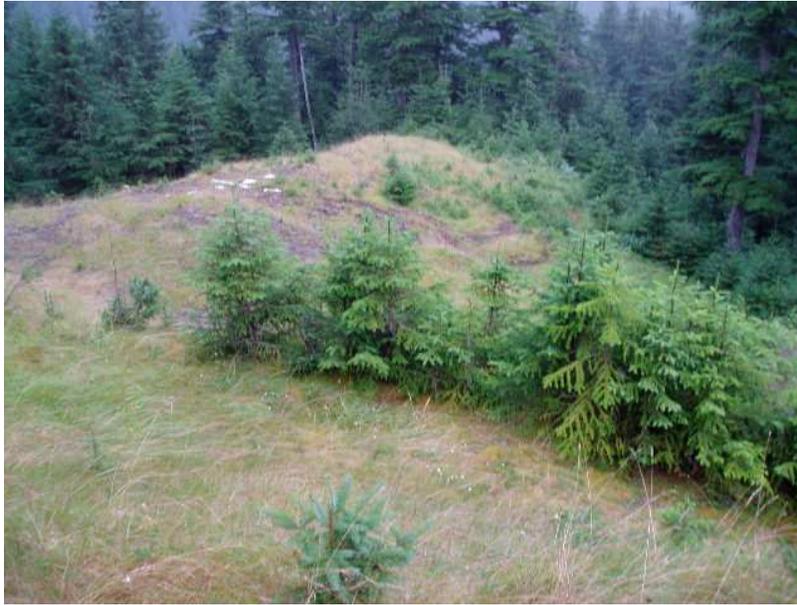
*Site 1350*

The site was observed to be densely revegetated with grass. Spruce, and a few western hemlock trees were noted to have naturally seeded from the surrounding forest into the planted grass cover. The surface was uneven and side slopes were very steep (approximately 1(H):1(V)).

This site is to be backhauled into the 1350 adit at the end of mine life.

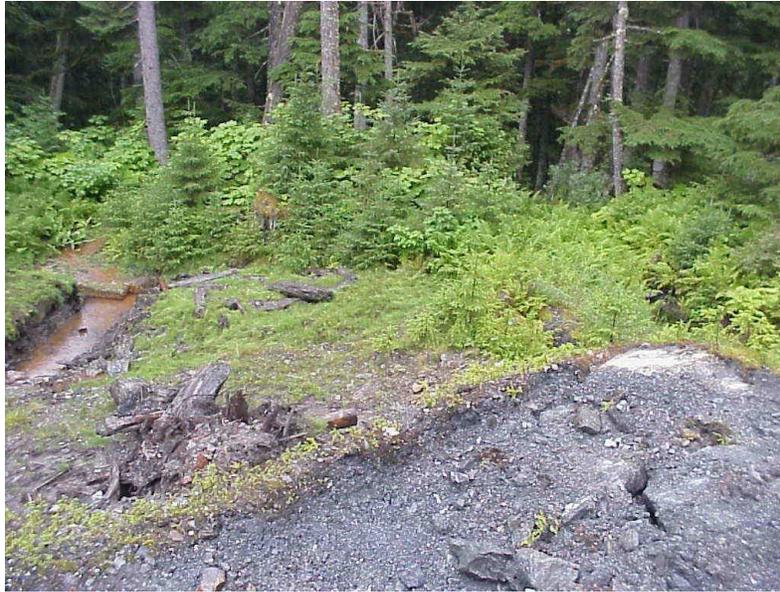
- B. Site 960. It was noted that approximately 50% of Site 960 rock had been excavated from the site and hauled underground. Greens Creek intends to remove the remainder of the material in 2003. There were two small seeps at the site, one with reddish brown precipitates and a pH near neutral, the second clear with a pH near 3.0. It was reported that some upgradient groundwater may enter site 960. This water appears to pick up pyritic byproducts and metal sulfides as it passes through the site, adding to the contaminant load in the discharge. These low-flow groundwater seep's characteristics will be better determined once all the 960 material has been removed.

*Site 960, iron-rich seep to the left, clear, low pH seep to the right.*

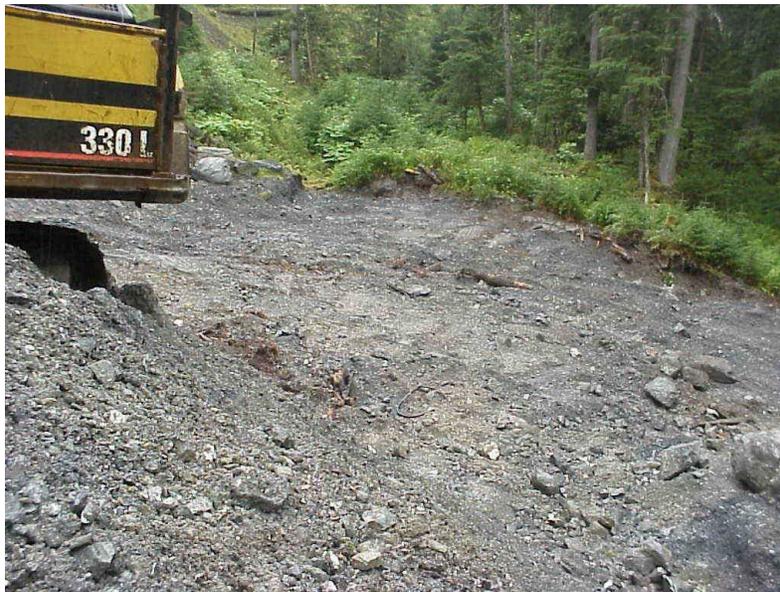
*Excavation of Site 960 material*

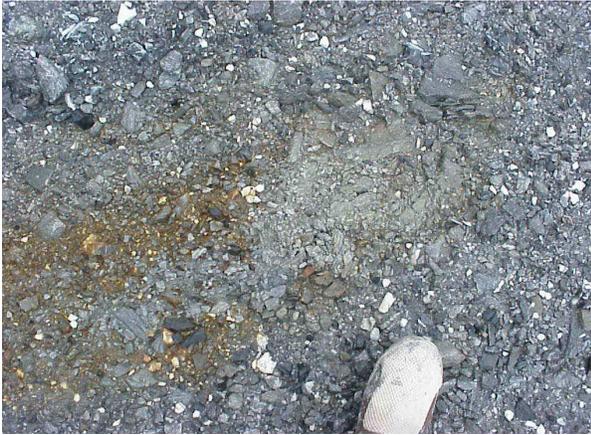
*Site 23 1-year old waste rock at site 23  
Note iron staining (approximately 1/4" deep)*

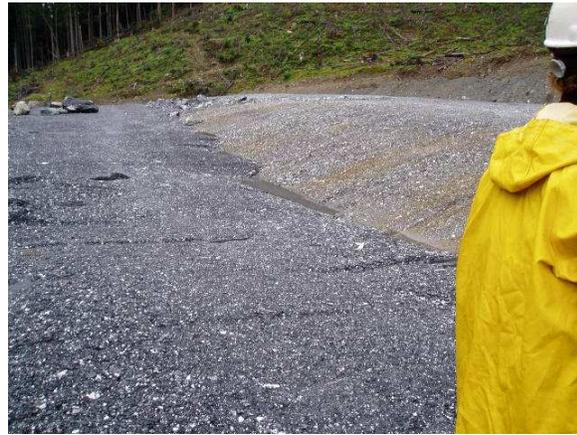
*Class I argillite (left), Class II phyllite (right)*

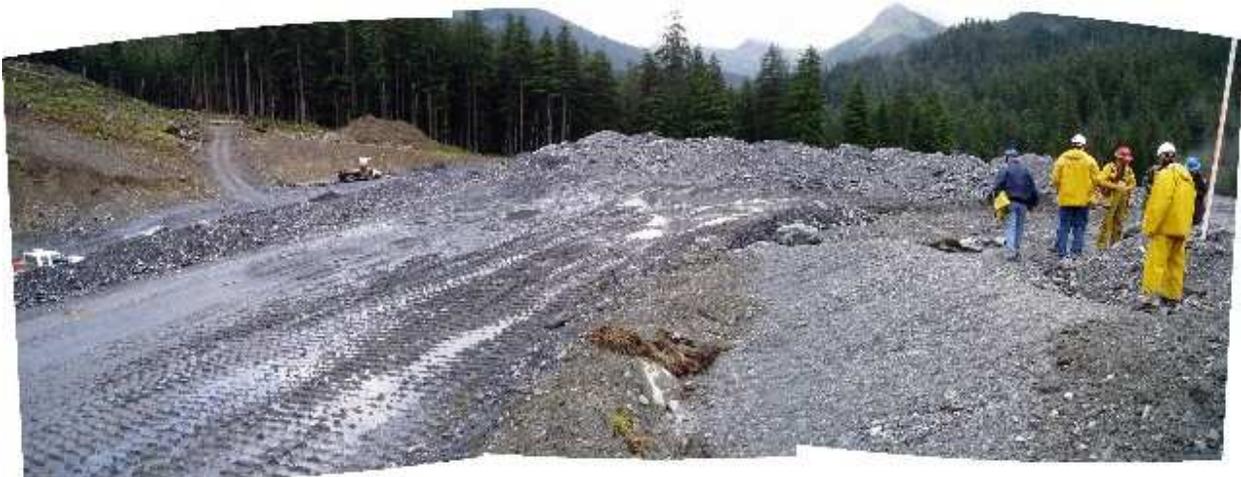
Site 23 was visited. Greens Creek officials pointed out the zones where various classification of waste rock have been placed in accordance with the plan of operations. Additional items noted were water collection appurtenances, finger drains, and the 1-acre engineered cover system that is being monitored to document how it performs relative to the design assumptions.

*Differentiation of Class II and Class III waste rock placement zones at Site 23*

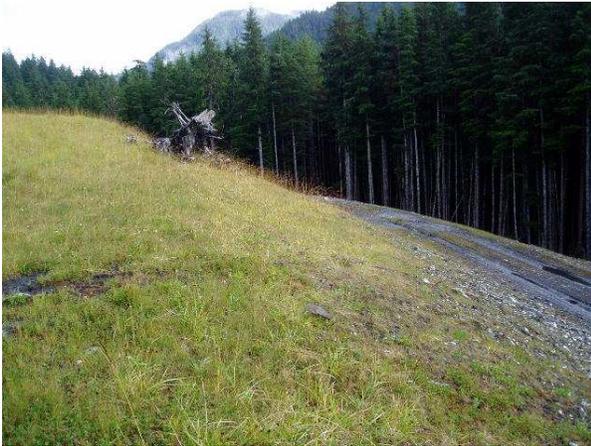
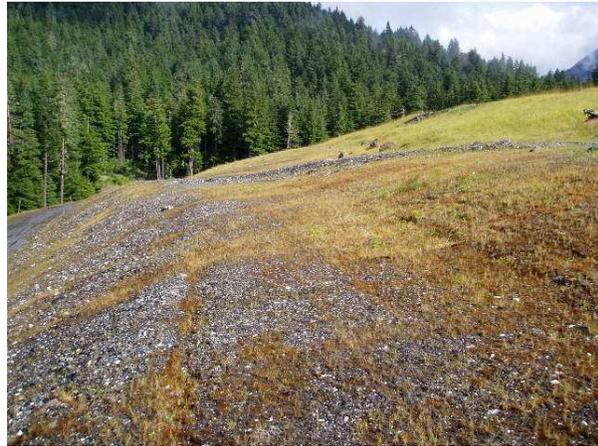
- D. Site E. There were no remarkable changes at Site E since DEC's visit in November 2002. One reclamation alternative being considered for this site is to backhaul the production rock to the tailings disposal site after the stage II tailings expansion is permitted. This would alleviate the need to supply a cover system at Site E. It was reported the cost to do this would be competitive with supplying a reclamation cover system and regarding the existing pile to a 3:1 slope. There are also stability concerns related to native sands under the pile. A geo-technical assessment is currently in progress for Site E to address some of the above issues preparatory to site closure.

*Site E, Southeastern Aspect*

*Site E, Northeastern Aspect*

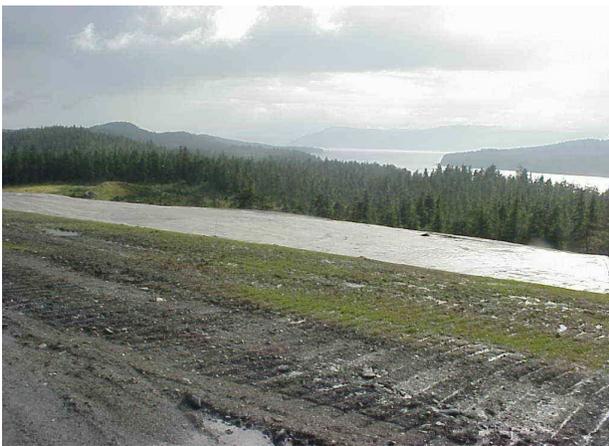
*Buttress on the west side of the tailings pile*

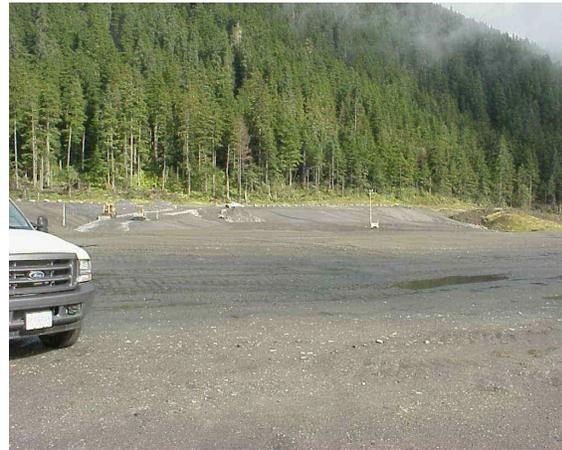
3. Tailings Disposal Site. The tailings site was visited. Portions of the tailings pile are at its presently permitted maximum height and tailings were being placed on the eastern side in the lined quarry area.

*Tailings placement in the lined quarry area*
