MEMORANDUM

State of Alaska

SUBJECT: Kennecott Greens Creek Site
Visit, May 26, 2004

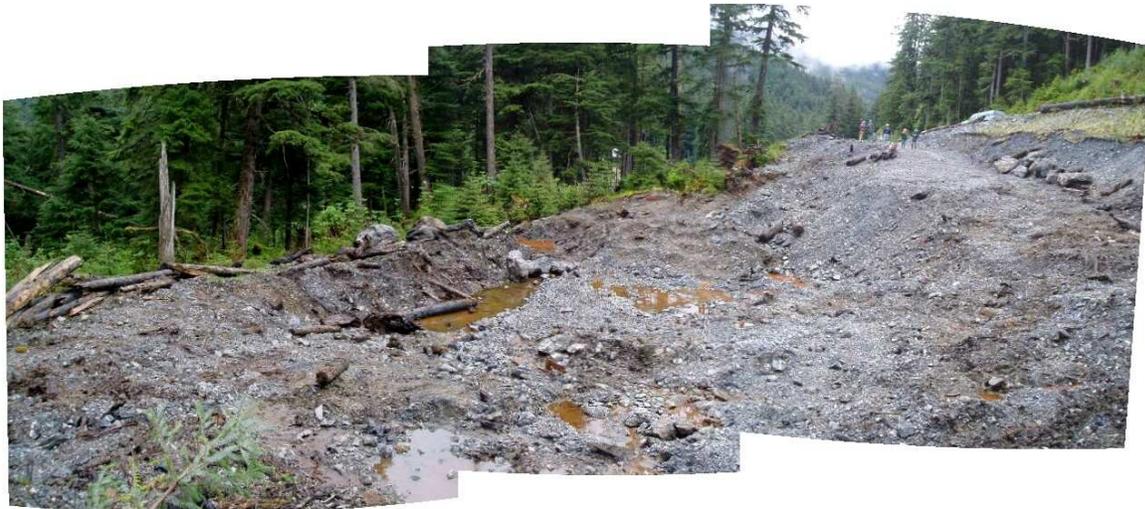
1. Site 960

Approximately 2/3 of the material has been removed. Much of the site has been excavated to original ground. KGCMC plans to remove the remainder of the material within the next few months when they have a safe place to deposit it back underground. The site will then be left as-is for a year or two to monitor the effects of the cleanup effort, then it will be reclaimed. There will continue to be some production rock under the 1350 road in this area that will be removed and placed underground at reclamation. There were areas of orange staining that are presumed to be iron oxides from the oxidation of iron in the production rock and probably from upgradient natural anoxic groundwater. At the time of the inspection a small flow of approximately 2-3 gpm was leaving the site. This discharge continues to be monitored. Monitoring was reported to have high sulfates and zinc. pH continues to be neutral indicating sufficient neutralization capacity.

Site 960 showing excavation and iron staining

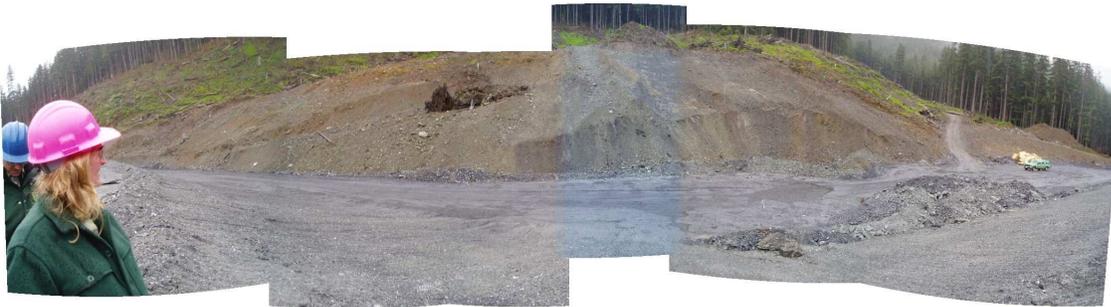
We observed the current Site 23 waste placement regime that includes a 5-foot layer of Class I rock at the outer periphery of the site. In the earlier referenced May 13, 2004 letter, the Department and the USDA/FS approved a revised waste placement regime. This change will reduce the requirement of 5 ft. of Class 1 production rock to 2 feet on the outer surface of the pile (with blended Class II/III allowed under the Class 1 rock layer, in the center of the pile, *see photo below*).

Site 23 – waste placement regime showing progressive placement of a 5-foot layer of Class I production rock at the lower aspect of the facility (upgradient FWMP well #57 in background near treeline)

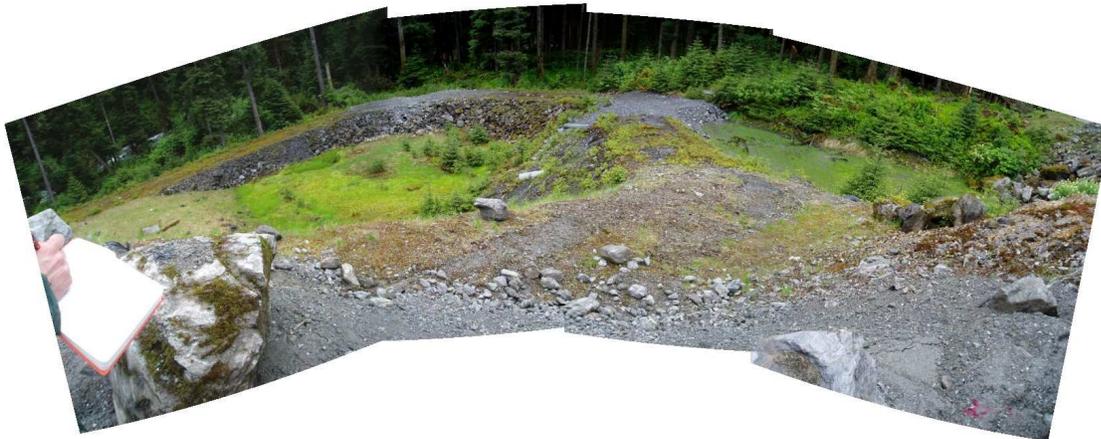
3. Site C

Both ponds used to have separate discharges. The upper catchment area was once lined (it no longer is lined). Both ponds contain sediment.

During a high rainfall event in January 2004 a sample of water from Greens Creek just below this site (FWMP Site 6) had a dissolved lead level of 0.915 mg/l, higher than the WQS of 0.905 mg/l. They noted another peak (about 2 years ago) at about 2 mg/l. In response to this KGCMC diverted the upper pond's water into the lower one to increase settling capacity.

Site C – upper and lower catchment areas

They are planning a way to remove sediments from these areas. KGCMC thinks the high lead is from the road runoff - tracked sediment off the mill site by trucks. KGCMC plans to create a catch basin in the ditch beside the road. They will then consider pumping most if not all storm water to the NPDES treatment plant. This may also involve diverting a ditch that flows at the back of the mill site. That flow has elevated zinc levels of between 300-400 ug/l. KGCMC will keep us apprised of their plans with these modifications and seek approval as needed to make the changes.

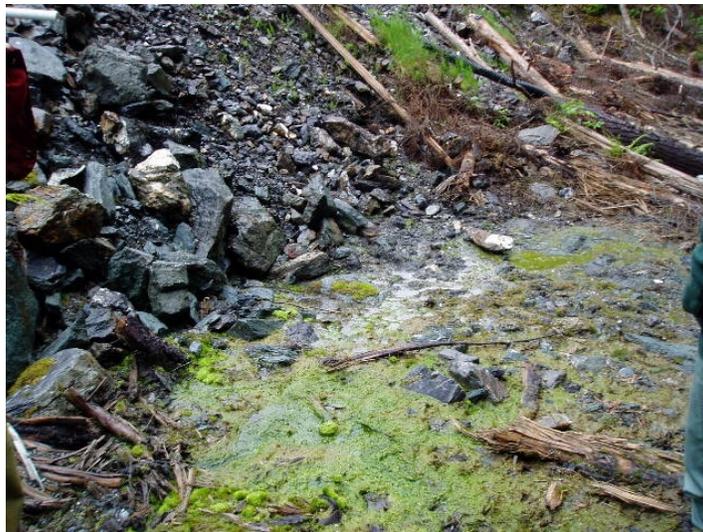
We were given a presentation of water sample results from wells and surface sites around Site E. This was a very comprehensive and useful presentation. It shows that most of the landfill associated water leaves the site near the toe of the pile at the outer perimeter. This flow pattern is due to a till aquitard that comprises most of the base of the pile (site development materials that will later be used for reclamation/capping of the tailings pile). The water then infiltrates into the natural sands & gravels and is expressed as seeps (in the 3 gullies associated with the southern aspect of the site) at an aquitard approximately 400-feet down-slope from the facility (about half way to Greens Creek). During the wet season water may also be transmitted by surficial flow into one of the 4 gullies that lead to Greens Creek. The seeps have been high in sulfate and exceeded the limits. Surficial flows have been high in zinc and have also exceeded

applicable limits. Historically zinc levels exiting the pile have remained near constant, but at some downgradient locations are now trending downwards. Both seeps and surface flows continue to show near-neutral water conditions. Water downgradient in Greens Creek has shown an increase over background, although the concentrations are well below water quality standard.

Site E – Sample Site #708, seep at southern aspect of the facility

KGCMC plans to remove the waste rock over the next 2 years to the tailings facility. There should be a reduction in metal concentrations and sulfate levels over the long term. Because this is an acceptable management practice DEC does not intend to incorporate this site into the Waste Management Permit. KGCMC will continue to closely monitor all seeps from the site and report the results in the annual report on waste sites.

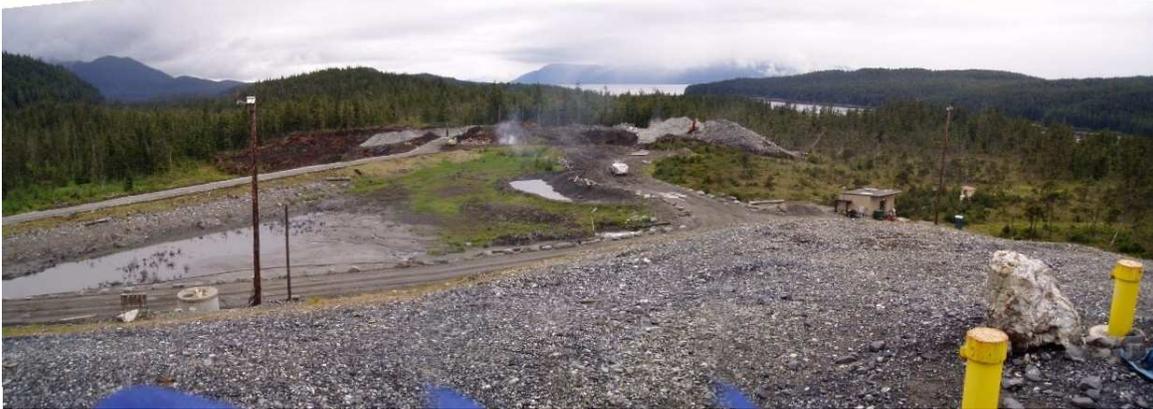
Blasting and rock removal was under way at Pond 7 under the 2004 expansion plans. Pond 7 will replace Pond 6 that is located at the toe of the tailings pile (head of Tributary Creek). Tank 6 that receives all water (storm + mill) will remain in place for at least the next year. A planned Pond 8 will be developed to the West of the site, with a planned Pond 9 developed to the North at a later date. These will be used for storm water retention in order to provide sufficient surge capacity to contain a 24-hour, 25-year storm. These ponds may be useful as constructed wetland treatment systems, post-closure. Rock from the blasted area for Pond 7 is reported to be very low in pyrite with some carbonate. Initial lab results are reported to be positive in NNP, all making for good quality construction material.

We observed the Duck Blind area and the NPDES 002 outfall pipe. Some small rock fragments from one Pond #7 blast made it to these structures but no damage was noted.

Tailings Site – southwestern aspect showing Pond #6 (left), newly blasted Pond #7 (center) and Duck Blind area (right)

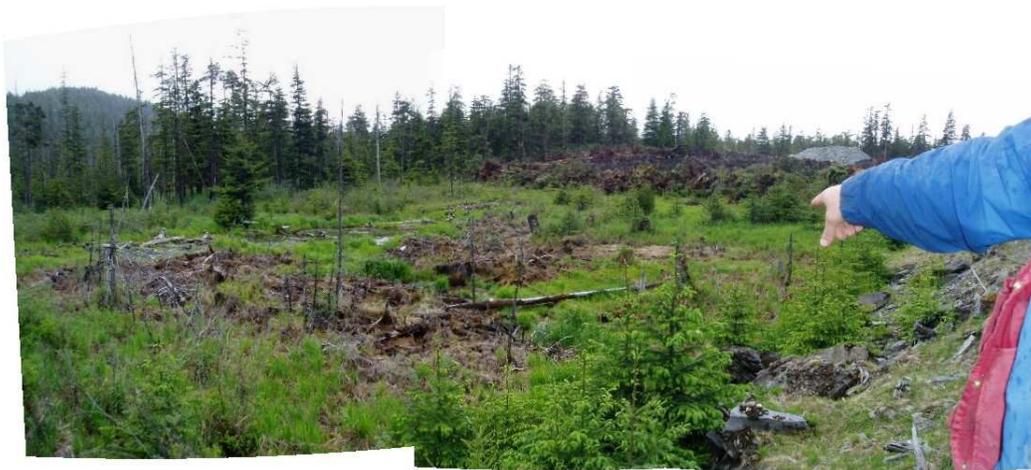
We observed the area where monitoring changes have been approved down-gradient of the saddle embankment at the southern aspect of the facility, at the head of Tributary Creek. In the earlier referenced letter dated May 7, 2004, the Department and the USDA/FS approved the discontinuation of FWMP Site 34. This site was in a pond below a road that contained pyretic rock. In 2002 the majority of the pyretic material in the road was removed. With the removal of the road the majority of the water previously retained in the pond now drains as diffuse surface flow through the natural muskeg. Results from internal monitoring between Site 34 and the containment structure indicate that recovery is occurring in this area.

Tailings Facility – Historic Site #34 area

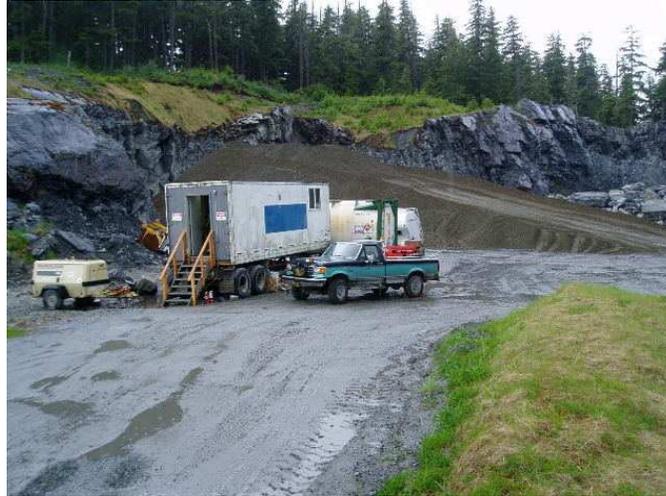
We went to Pit 5 and observed the relocated reclamation material/peat, as well as the stockpiled aggregate from Mile 1.4 of the A road. Volvo haul trucks were actively delivering screened aggregate to this site.

Pit #5 – stockpiling of aggregate for Pond #7

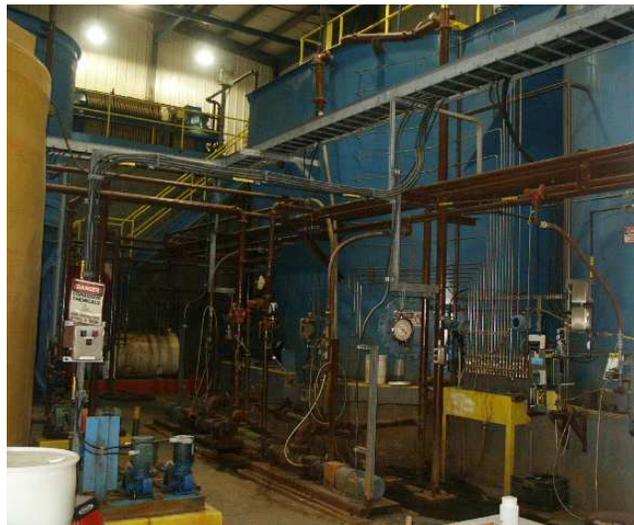
We had a brief tour of the Water Treatment Plant (WTP). We learned that the WTP treats 1.2 – 1.3 million gallons of water daily, with an increase during wet weather. The plant is reported to have performed very well, with metals levels some order of magnitude below the permit limit.

Pit #5 – Water Treatment Plant

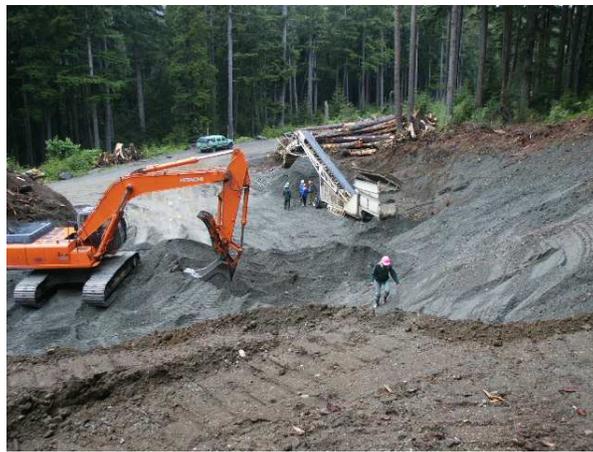
Sand Pit

We drove the A Road to Mile 1.4 to observe progress on aggregate removal. Aggregate found here is of high quality with very little to no fines, an excellent source of material for the tailings facility expansion construction material. Approximately one acre of land had been worked so far.

Trees had been cut, stumps grubbed out, overburden removed, the aggregate exposed, screened, then hauled to and stockpiled at Pit 5. A screening unit and excavator were on site but no operations were occurring at the late hour of the day.

A small fuel spill was noted as a result of a broken fuel filter from a backhoe. KGCMC was aware of this and corrective action was to take place.
