DEPARTMENT OF ENVIRONMENTAL CONSERVATION

FIELD INSPECTION REPORT HECLA GREENS CREEK MINING COMPANY

Inspection Date: May 28, 2008, 10:30 AM to 3 PM.
Report Date: June 5, 2008

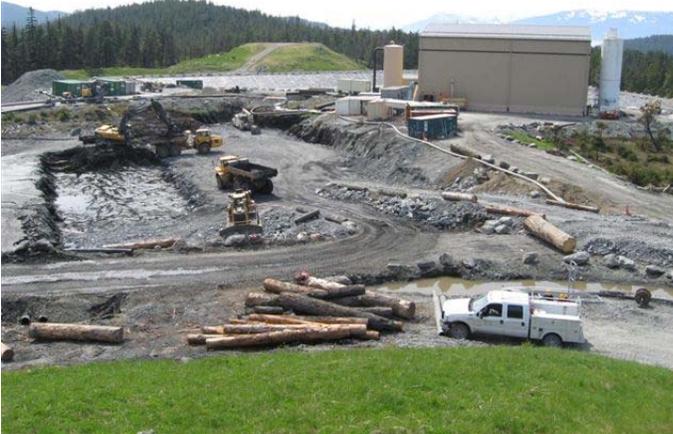
1. A new access road had been constructed to enable trucks with rock from Pit 5 to access the pond from the "clean" road without having to travel on a "dirty" road.
2. Trucks with sediment and organics do not now have to maneuver on "clean" roads.
3. The same trucks are used to move dirty and clean materials from/to Pond 6. Prior to changing from one mode to another (which occurs periodically rather than frequently) the trucks pass through the truck wash when exiting the tailings site prior to going to Pit 5.
4. Organics were being carefully removed from the underlying glacial till material with a bucket equipped with a flat blade.
5. If the weather cooperates, the remainder of the sediments and organics will be out of the pond within 2-3 weeks.

Pond 6 excavation showing the new access road constructed to the right of the photograph to bring rock in from the “clean” road.

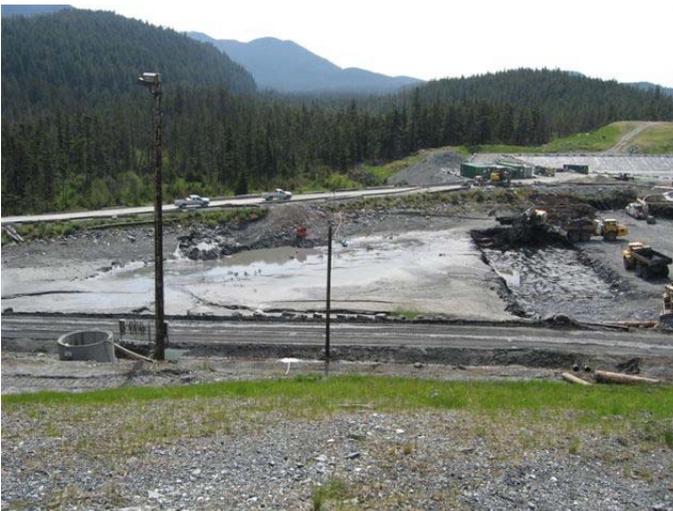
Pond 6 showing sediment and organics to be removed.

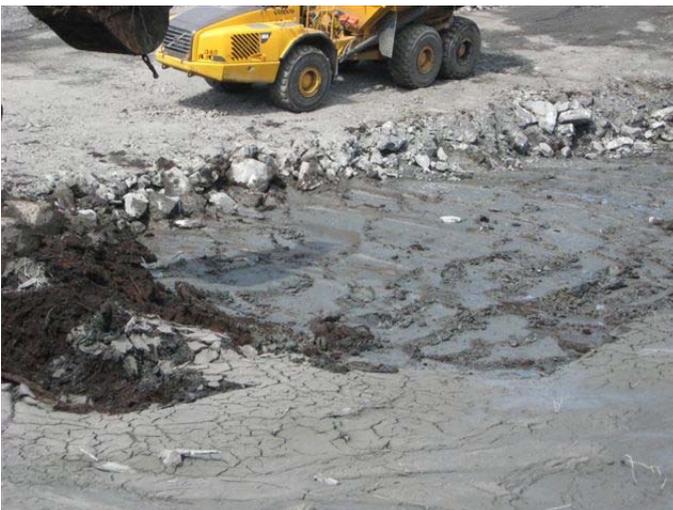
4. Sand will be placed over the glacial till to protect it from damage by the placing and compaction of tails. This may occur late in 2008 or in early 2009, as may an initial placement of tailings over the sand.

Pond 6 showing the clay glacial till layer with organics carefully scraped off.

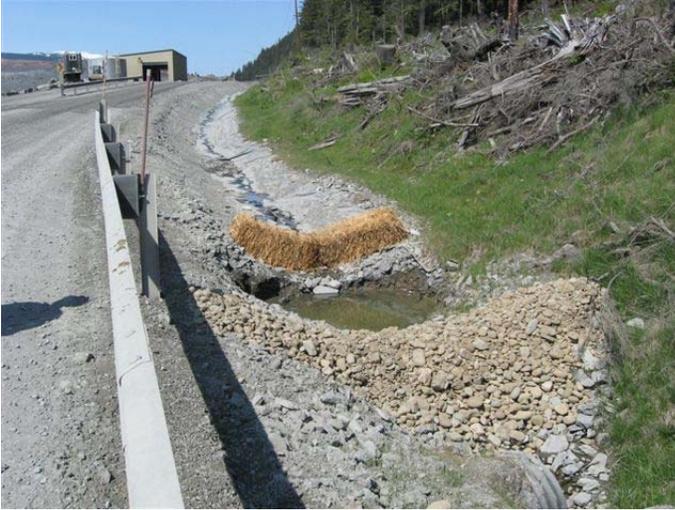
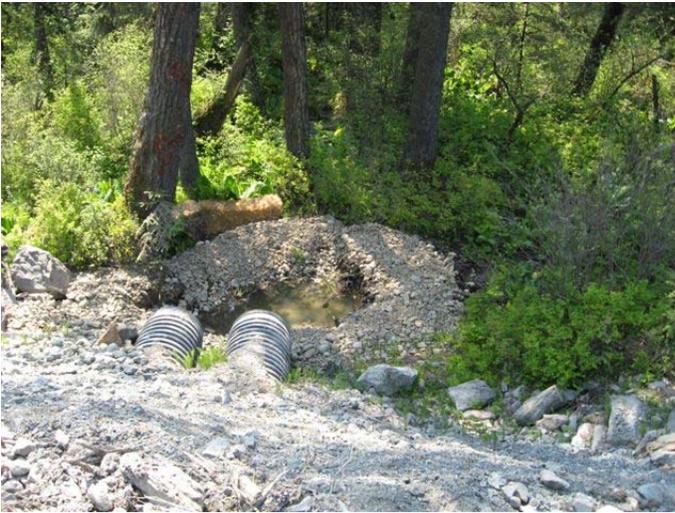
New bales had been placed in ditches alongside the road. In some locations rock berms were located ahead of the bales. This enhances settlement in certain locations. Ditch cleaning had been conducted; this was questioned since one of the BMP's is to allow sediment to remain in ditches until it is really necessary to remove it so that plants can grow in the ditches to help trap fine particles. Kerry said the ditch crew was still learning what was required with these recommendations.

New BMP's to capture sediments from the lined ditch at mile 1.2.

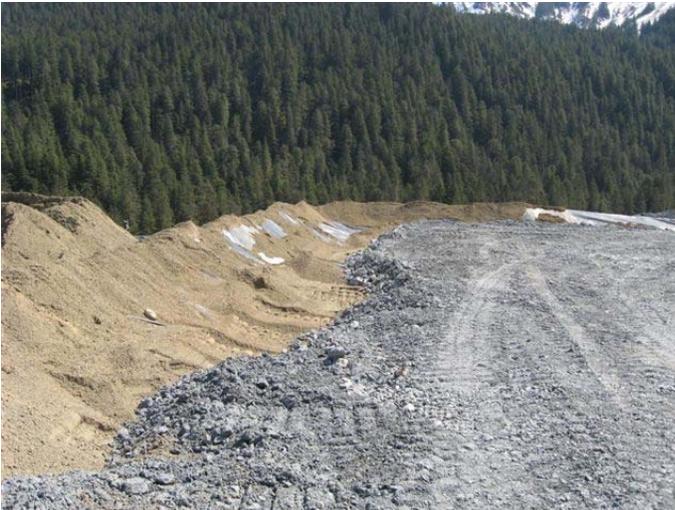
The new pad was briefly visited. Placement of the 3-foot thick layer of Class 3 rock above the liner was in progress. Kerry Lear said that the proposal is to raise waste rock levels on each side of the pile. This will allow access from the sides to enable removal of older material before more recently placed material. Covering the material was also discussed. This will only be done to control moisture content. It will not be necessary to cover the materials to neutralize oxidation products; there will be 1% lime added and this will retard acid generation during the short term that the materials will be located at site 23. An acceptable plan has been submitted and ADEC is preparing a modification of the WMP for this pad. As in Item #1 under Pond 6

above, approval of all plans of this nature is needed prior to construction activities. The original plan was submitted to ADEC on April 16, 2008. There was an insufficient amount of time between the submission of the original plan and HGCMC's construction of the pad. Again, ADEC asks that construction plans be delivered farther in advance of construction activities.

Site 23 pad with sand and class 3 rock over synthetic liner.

4. Submit Engineered plans well in advance of construction work to allow ADEC sufficient time to review the plans and discuss aspects of the design with HGCMC, if necessary.
