# MEMORANDUM State of Alaska

TO:	Distribution List	DATE:	January 28, 2003
		SUBJECT:	Solid Waste Permit
			Number 0111-BA001
			Kennecott Greens Creek
FROM:	Kenwyn George		Mining Company
	ADEC, Water Quality Section		November 4, 2002 Inspection
			of Potential ARD Sites
	Ed Emswiler		Not Covered By Permit
	ADEC, Solid Waste Section

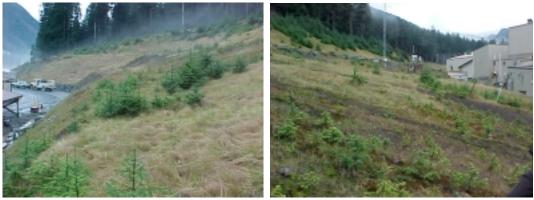
Site 920 Millsite Backslope

An approximately 5-acre area of the mill back slope was initially excavated and contoured. Approximately 100 horizontal slope drains and 11 collection manifolds were placed to collect run-on water from the up-slope area. Approximately 1-10 feet (6,000-10,000 tons) of waste rock were placed over the drains. Generally the depth of fill is 1-3 feet. This was done to control erosion, and to assure stability of the area behind the mill during the operational period. The area has been hydro-seeded and has limited growth (in some areas this was marginal), with some areas supporting stands of waist-high "volunteer" spruce trees naturally seeded from the surrounding forest.

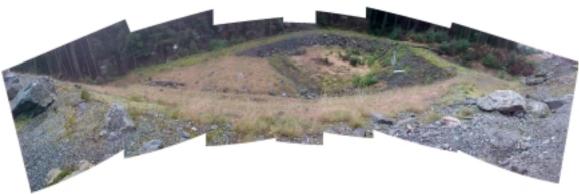
Site "C" Panorama of Downgradient Aspect – Note Proximity of Greens Creek

This 2-acre site is located approximately 100 yards down the B-Road from the mill where the mine safety building and laboratory are situated. Waste rock was placed here over 10 years ago. Approximately 28,400 cubic yards of production rock and fill have been placed at this site. The slopes were rather steep at approximately 2(H):1(V). They were sparse to heavily revegetated. A sedimentation basin with decant overflow pipe was placed below the fill in order to manage flows and reduce sediments to Greens Creek located nearby. The basin is called "Pond C". A small flow of water was observed at the toe within the sedimentation basin area.

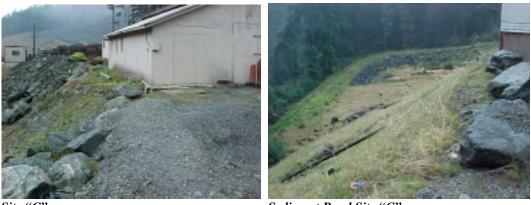
Site "C"

Sediment Pond Site "C"

According to the reclamation plan this area may be excavated and backfilled into the mine at the end of the mine life. The site is also bonded and being considered for the application of a closure cover system using a similar engineered soil cover system to that installed and being tested at Site 23. This final cover system utilizes profile #4 from the Unsaturated Soils Engineering Ltd. (USE), December 1998 report. The Department has approved the use of this profile in the waste disposal permit for the tailings and Site 23/D and it is incorporated into the reclamation plan. The bonded cost estimates for Production Rock Site "C" is \$193,430

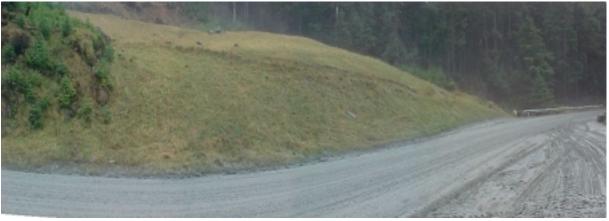
Pit 405 is a rock quarry that was developed to construct the B-Road. The site contains approximately 12,000 cubic yards of waste rock that was placed in 1988 during the initial construction of the mine. This material is assumed to be similar in character to that placed at Site D during the same time. Site D material has been characterized to be potentially acid generating.

The site was covered with soil by 1994, seeded and revegetated. The site was noted to be mostly revegetated. However, revegetation has not occurred on the newer, seeded material placed in 2000. The site was contoured appropriately with gentle slopes. Any water that did manage to enter the fill at the back of the pit likely drains to the ditch on the B-road. Visual inspection of the drainage ditch was unremarkable.

KGCMC intends to use the colluvial material and the till material from the mill in the reclamation of roads at the end of the mine. The waste rock placed in 1988 will be either excavated and placed either back in the mine or in Site 23 or a final cover system will be placed over it. The reclamation bond amount for this site is \$20,696. This is for topsoil and contouring but does not include costs for a final cover system or for ARD mitigation.

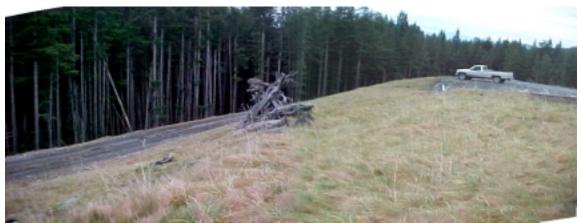
Waste Site E Southwestern Aspect

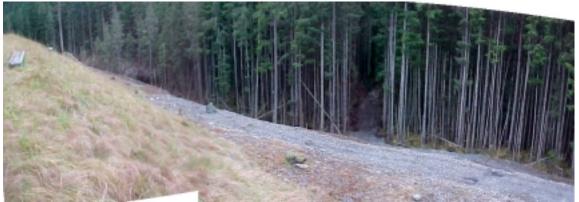
Waste Site E Southeastern Aspect: Looking into the access clearing for Well DH-02-09

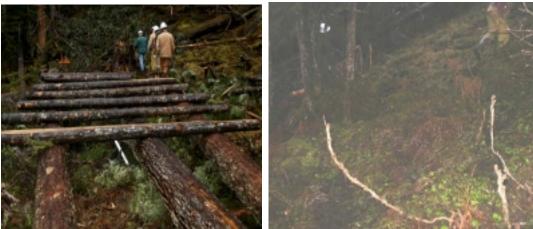
Well DH-02-03

waters down-slope from the site. A spring was observed some 70-80 feet downslope from the waste pile, near well DH-02-03. Apparently at springtime there is a band of wetter soil at this elevation and location that supports ferns and other vegetation more lush than that in the surrounding forest area. During periods of high rainfall, an incised gully near DH-02-09 drains runoff that collects at the base of the pile's southeast side, an area soon to be covered during recontouring and cap placement.

Wet area near well DH-02-03 where fern growth indicated a band of increased groundwater flow

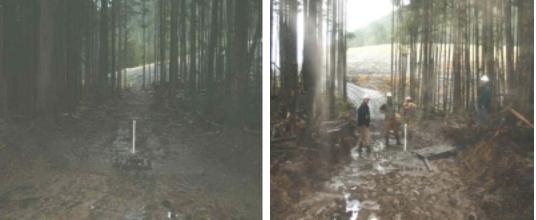
Well DH-02-12

Well DH-02-09

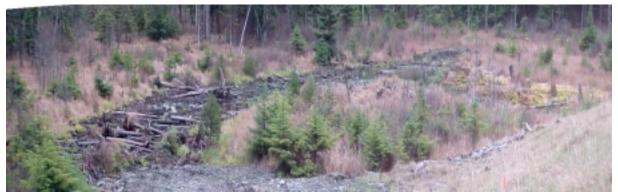
Old Road Downgradient of the South Main Embankment Slurry Wall – Photo Taken From Embankment

This old road to the tailings disposal site was located immediately down-gradient of the original effluent treatment area and the embankment to the storm water storage pond to the south of the tailings facility. It is located at the head of the Tributary Creek drainage. The road contained pyritic rock. In late-June 2002 the road material was removed according to the action plan prepared and submitted by KGCMC in January 2002.
