BEST MANAGEMENT PRACTICES PLAN
2020 ANNUAL REPORT

Hecla Greens Creek Mining Company

1 March 2021

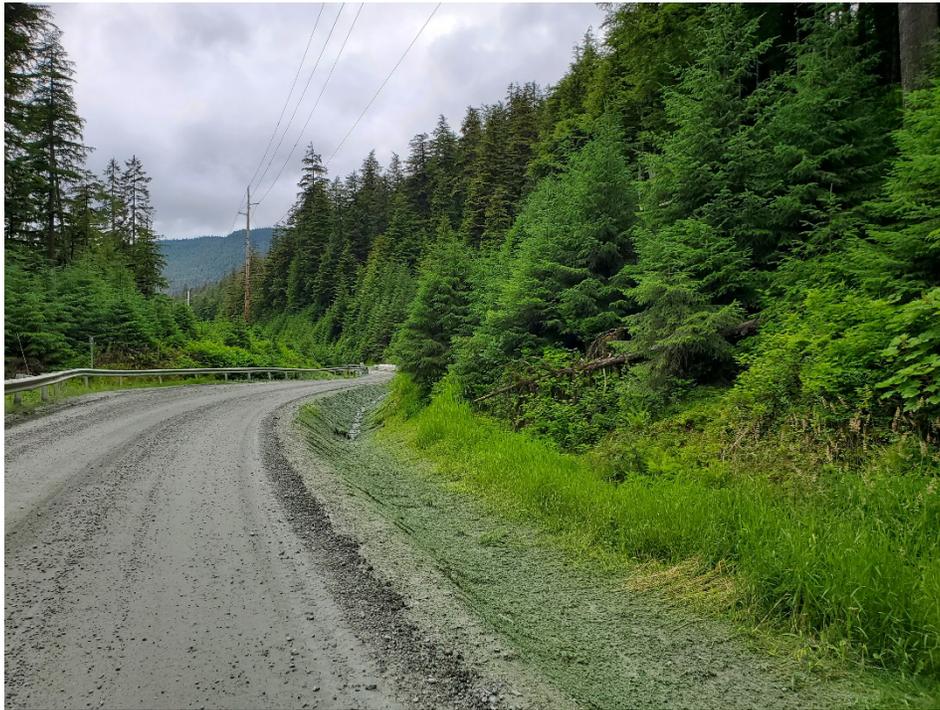
PHOTO 1. Ditch maintenance above 7.4-mile bridge.

Ditch maintenance and stabilization activities began in April as soon as snowmelt and ground thaw allowed. By July, the entire ditch had been cleaned and hydroseeded to establish vegetation for stabilization. In some areas where the buried pipelines hinder the excavation of the roadside ditch, the

material was placed to raise the road surface elevation to establish the ditch. Photos 1 and 2 illustrate the ditch maintenance activities performed in 2020.

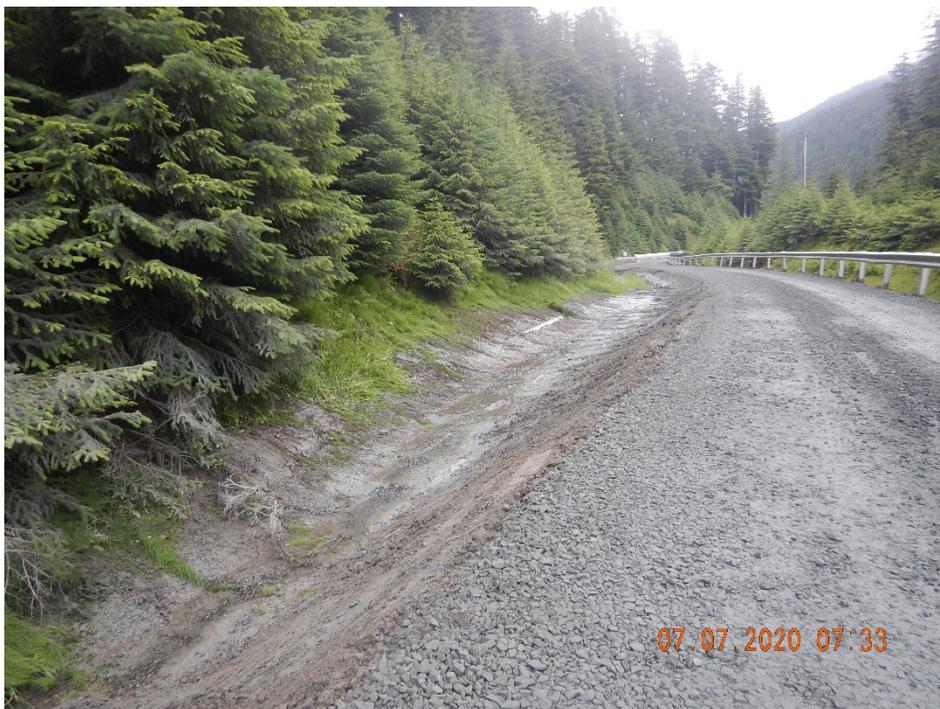
PHOTO 2. Road surface raised to establish a larger conveyance ditch for runoff.

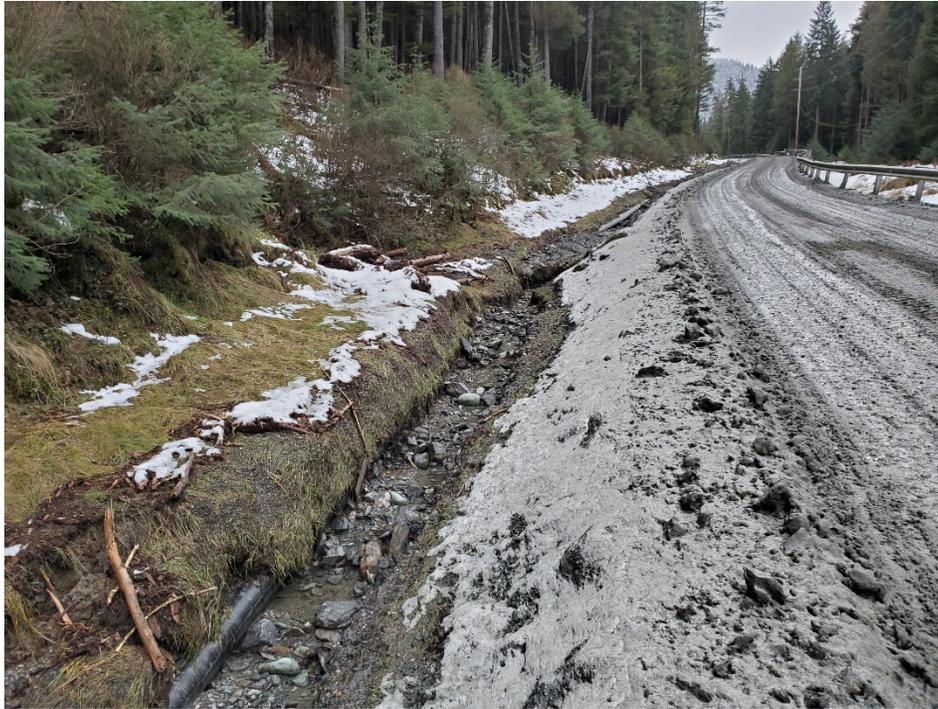
From 30 November through 2 December, there was an extreme storm event with portions of the site receiving over six inches of rain on top of the snow. The runoff from this event caused mudslides and severe erosion of some sections of the B-Road. Following the event, Surface Operations personnel re-established culvert drainages and began repair of sections of the roadside ditch. However, full repair of the ditch will not occur until the summer of 2021. Photos 3 and 4 show the condition of the ditch above the 3.4-mile bridge.

PHOTO 3. Erosion below 3.7-mile of B-Road during 1 December storm.

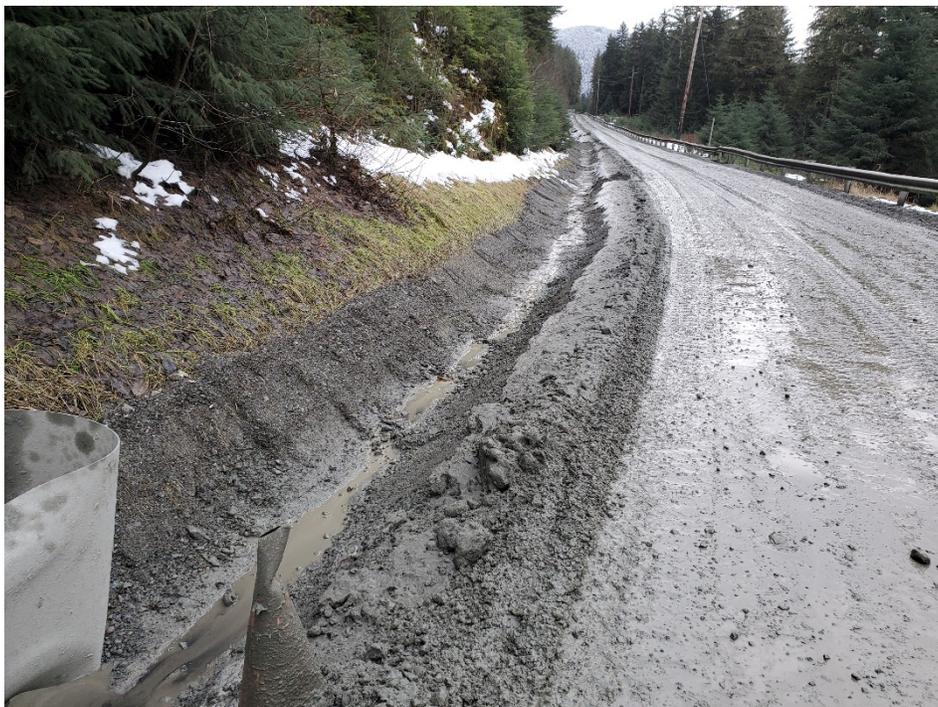
PHOTO 4. Repair of ditch above 3.4-mile bridge following 1 December storm.

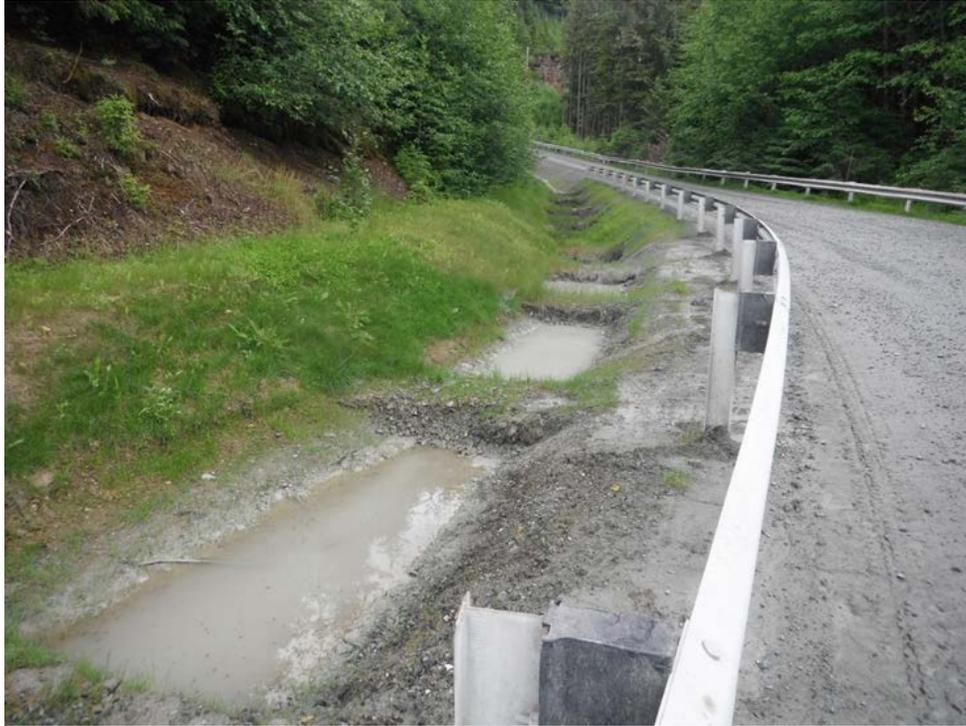
PHOTO 5. Sediment sumps above 3-mile bridge.

Sediment sumps and culverts along the B-Road were cleaned multiple times throughout 2020. Photos 5 and 6 show the condition of select sumps after cleaning.

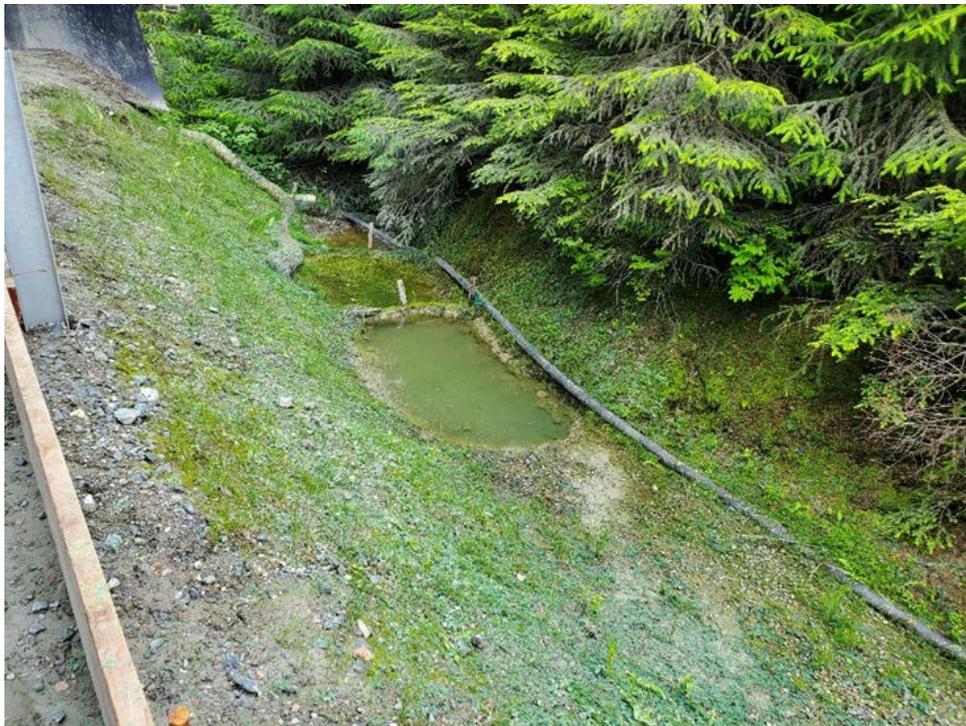
PHOTO 6. Sediment control at the 7.4-mile bridge.

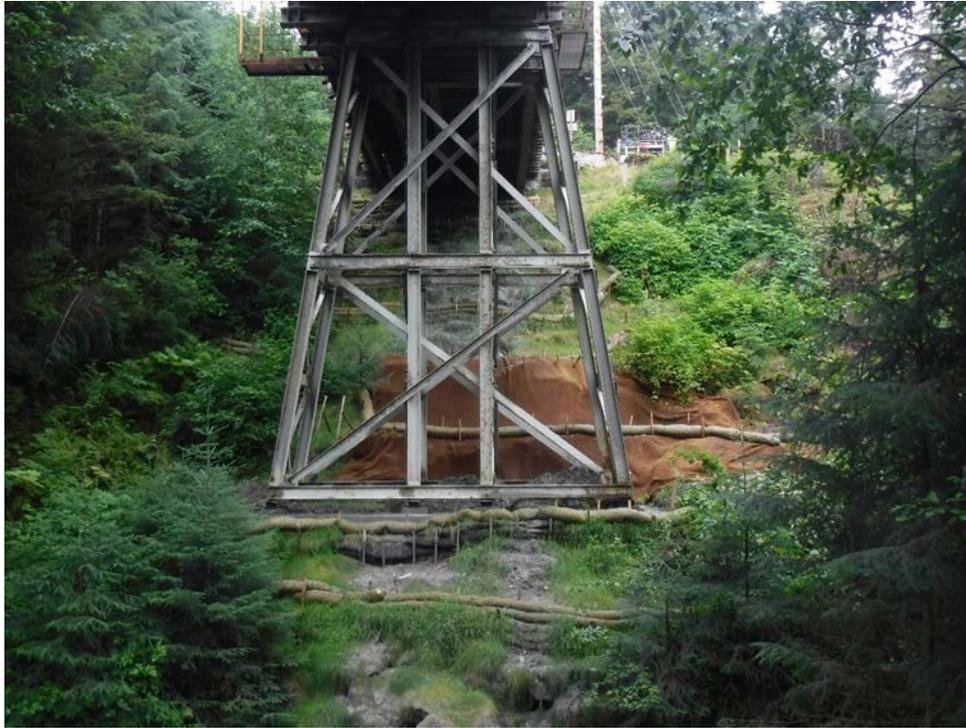
PHOTO 7. New straw wattles on south abutment of Zinc Creek bridge.

Maintenance and enhancement of the BMPs beneath the Zinc Creek bridge located at 3-mile on the B-Road was completed in early August. Approximately 35 cubic yards of sediment was removed and hauled to the TDF. New straw wattles were added to the existing compost filter socks to restore the sediment containment volume. The area was then hydroseeded to establish vegetation. Photos 7 and 8 show the enhanced BMPs.

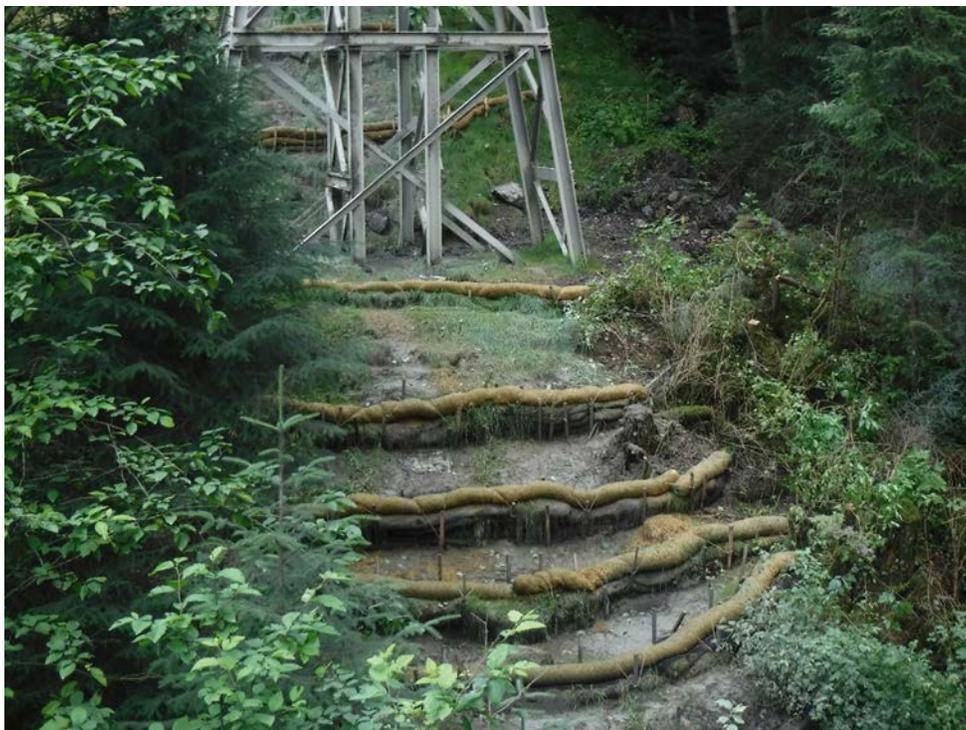
PHOTO 8. New straw wattles on north abutment of Zinc Creek bridge.

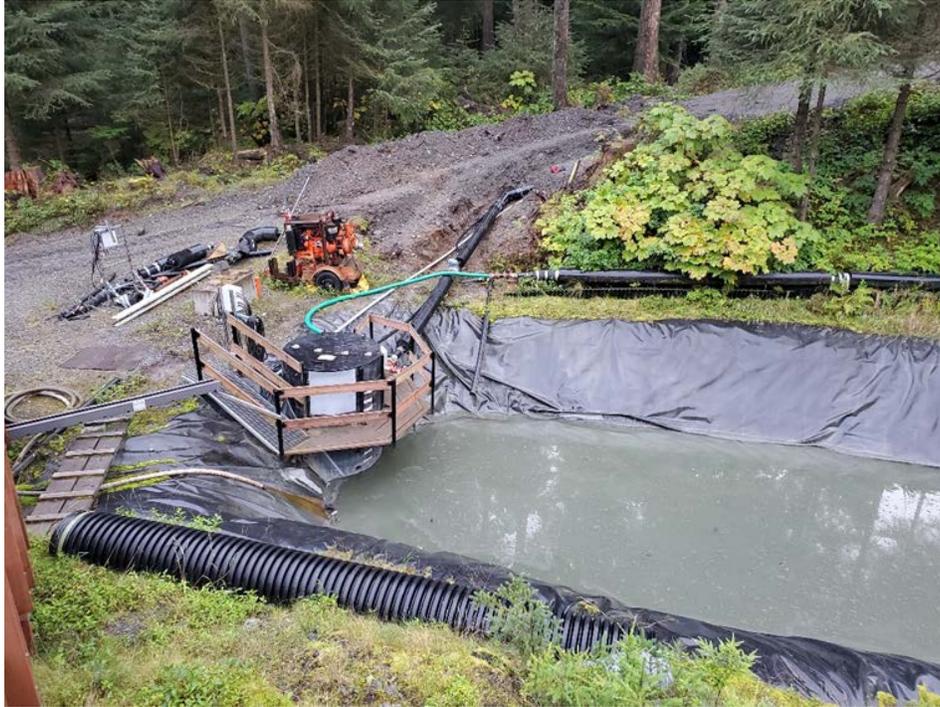
PHOTO 9. New discharge line from upper Pond C. Old piping remains in place as a backup.

New piping was installed for pumping storm water from upper Pond C to Pond 23. The HDPE arctic piping is buried, graded to drain completely, and has an electric heat trace to prevent freezing during cold periods when minimal pumping occurs. Photos 9 and 10 show the new piping being installed.

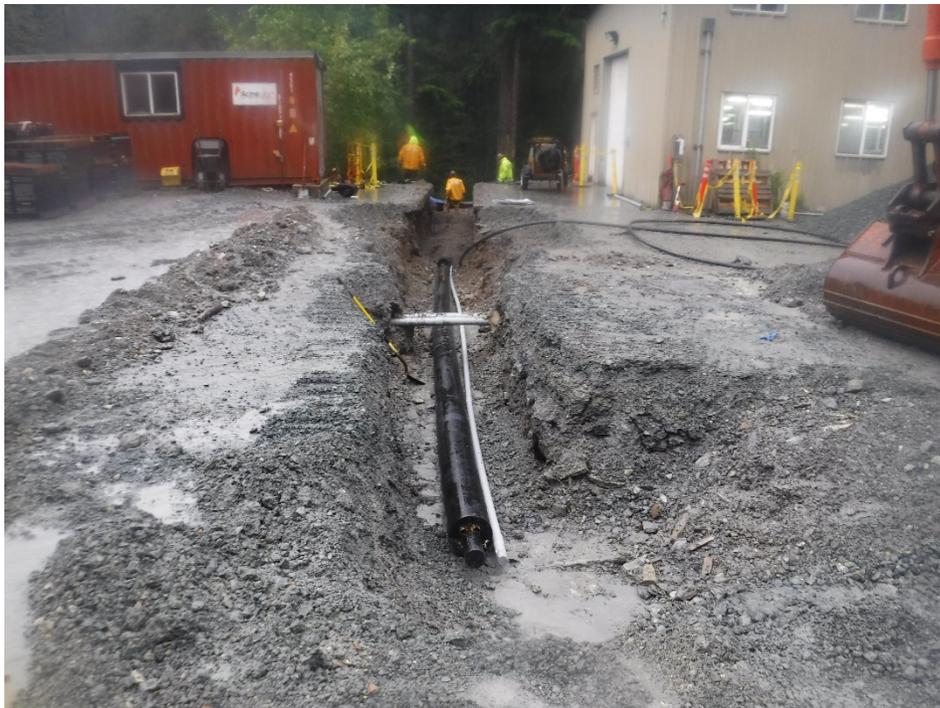
PHOTO 10. New discharge pipe being installed from upper Pond C.
