# STATE OF ALASKA

DAM SAFETY AND CONSTRUCTION UNIT

## FIELD INSPECTION REPORT GREENS CREEK MINE

**Inspection Date:** June 27, 2005  
**Report Date:** July 21, 2005  
**Weather:** Fair. Temperatures around 60°F.  
**Inspection Objectives:** Observation of tailings water storage facilities  
**Operator Contact:** Eric Sundberg, Kennecott Greens Creek Mining Co. (KGCMC)  
**State Personnel:** Ed Emswiler, DEC; Charlie Cobb, DNR,  
**Other Personnel:** Tom Zimmer, KGCMC; Keith Everard, Klohn-Crippen  
**Documentation:** Photos were taken and are available for inspection at DNR in Anchorage and DEC in Juneau.

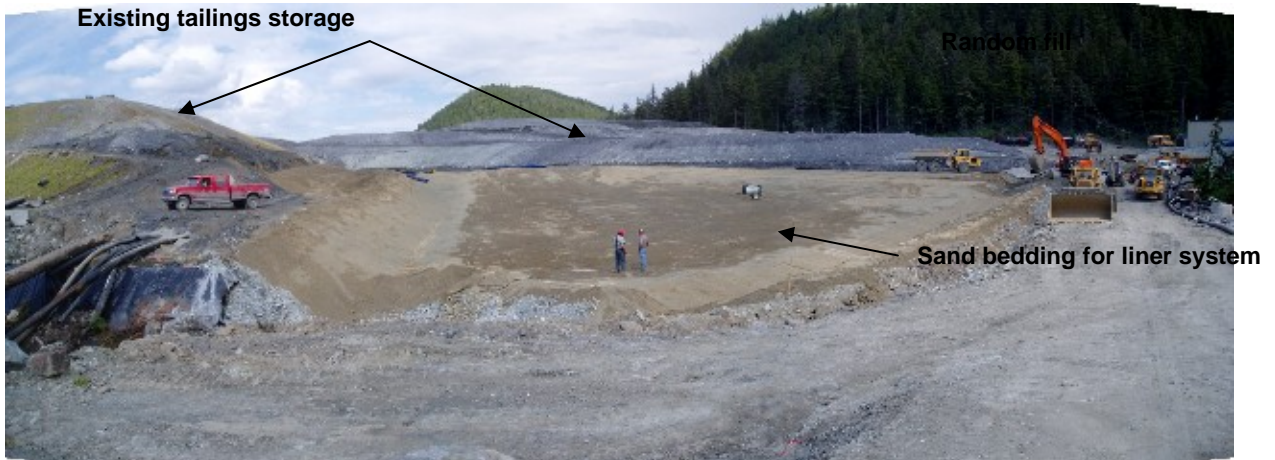
**Figure 1. Tailings Disposal Site – Southeast Expansion Area 2 (looking northeast from Pond 6)**

At the Southeast Expansion Area 2, Tank No. 6 and the truck wash had been removed and the area had been prepared with a sand bedding layer and monitoring equipment (lysimeters and/or piezometers). The work appeared to be contiguous with the specifications in the 2005 work summary. The sand bedding layer was installed and the contractor was beginning to install a geotextile cushion and the 80 mil thick textured (both sides) HDPE geomembrane.

The supplemental geotechnical stability report for the Stage 2 expansion is pending. No additional tailings should be placed above the level of the service layer in the southeast expansion area without ADEC approval. Demonstration of the stability of this critical cross section should be submitted as soon as possible.

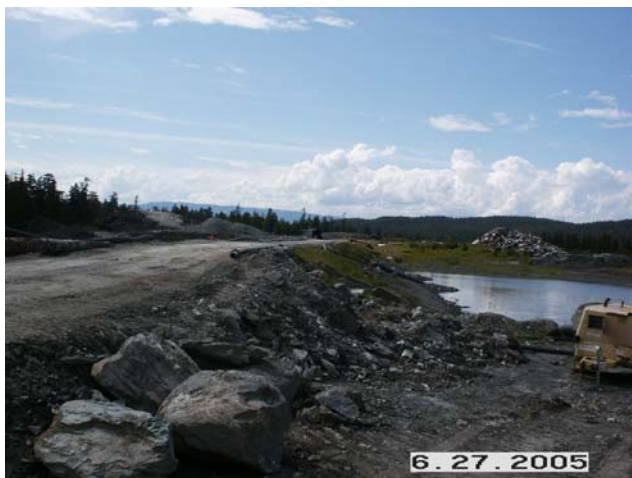
Pond 6 was observed including the Upper Cannery Tailings Dam (National Inventory of Dams number AK00203) which is under jurisdiction of the Alaska Dam Safety Program, as seen in Figures 2 and 3. The water level in the pond was low, and water was observed entering the system from the tailings pile underdrains. The dam and spillway appeared to be in good condition. Pond 6 is scheduled to be removed from service and used for tailings storage as part of the Stage 2 expansion.

**Figure 2. Upper Cannery Tailings Dam.**

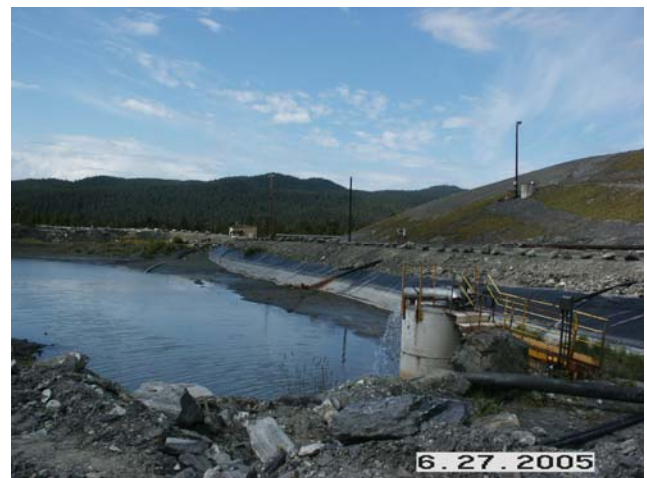
**Figure 3. Pond 6**

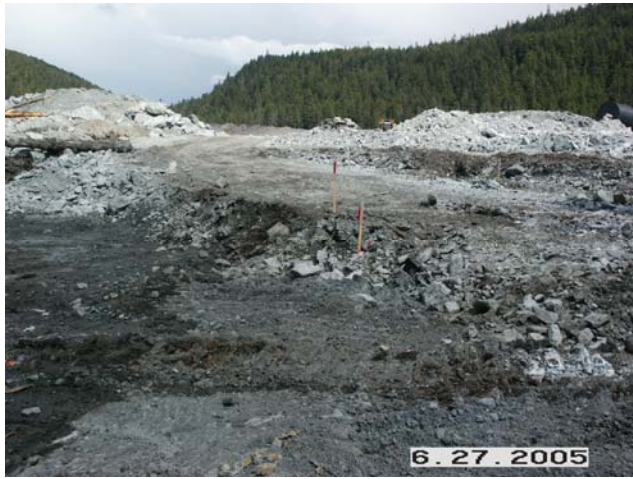
**Figure 4. Pond 7 Dam Excavation and Fill**

We then proceeded to the Pond 7 area that was being excavated and prepared as a stormwater retention pond according to the 2005 work summary. We observed the HDPE components and foundation for a wet well that will be installed in Pond 7, and the portions of exposed foundation and fill placement for the Pond 7 Dam (National Inventory of Dams number AK00307). This dam will be under the jurisdiction of the Alaska Dam Safety Program and a *Certificate of Approval to Construct a Dam* has been issued by ADNR. The area of the spillway was also observed, but a substantial amount of excavation still needed to occur. Some oversized rock was observed in an area of fill. The foundation excavation and construction of the dam and liner system for Pond 7 will be completed over the 2005 construction season. Pond 6 will continue to operate until Pond 7 is commissioned, and will be used for additional operational storage until it is to be used for tailings disposal.

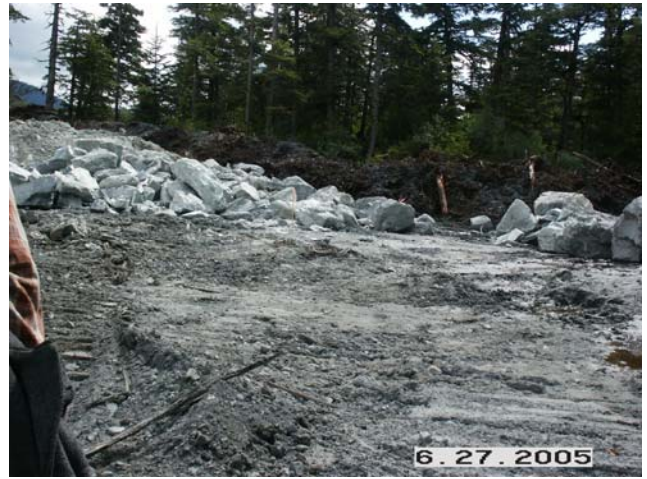
**Figure 5. Oversized rock in fill at Pond 7 Dam**

Oversized rock in fill at Pond 7 Dam should be removed and replaced with fill that meets project specifications.

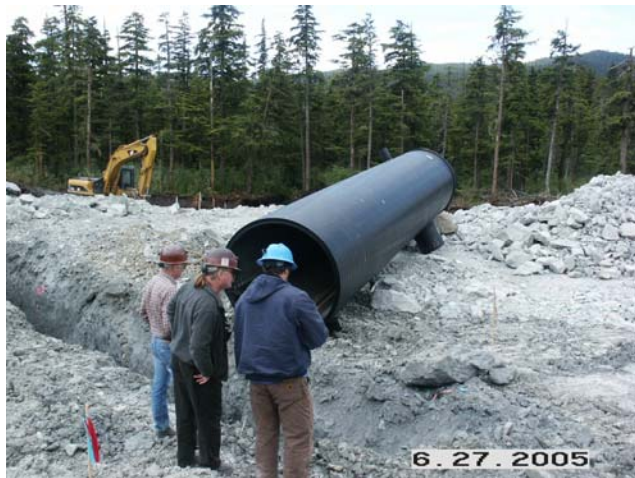
**Figure 6. Pond 7 Wet Well**

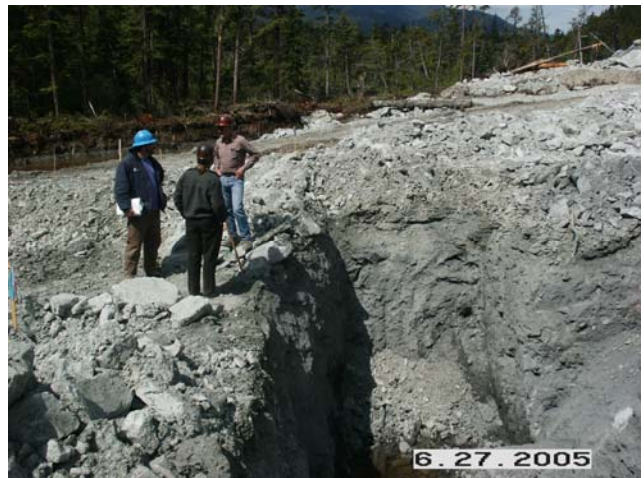
**Figure 7. Pond 7 Wet Well Excavation**

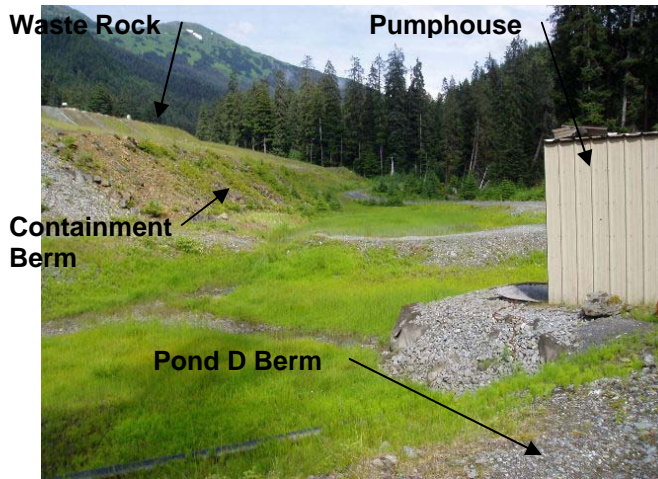
**Figure 8. Site D and Pond D**

At Site D, placement of native glacial till excavated from the mill during site development is overlain by waste rock, as seen in Figure 8. Recent investigative field work and data analysis associated with hydrology, geochemistry and geotechnical stability suggest that there may be long term advantages to relocating the production rock placed at Site D. Field work and data analysis is continuing to identify potential risks and benefits with either leaving the site at the current location or moving the material elsewhere. We observed red staining of the rock in the outer buttress that is most likely due to lichen growth, as seen in Figure 9.

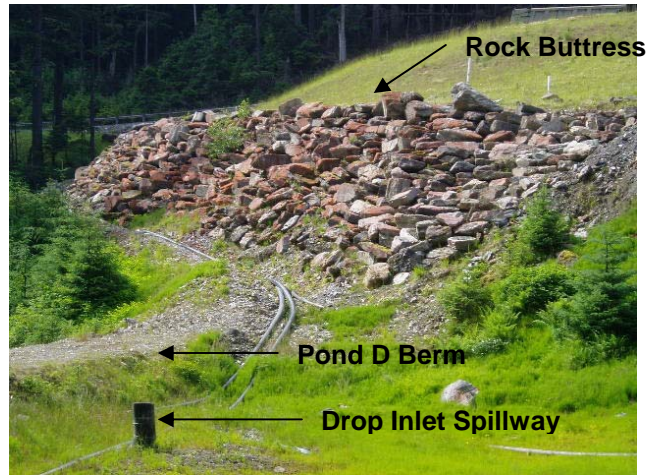
**Figure 9. Site D Buttress and Pond D Berm**

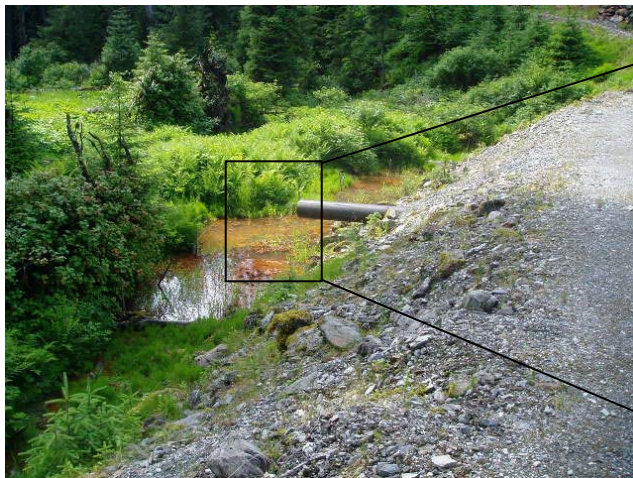
**Figure 10. Pond D Spillway Outlet**

An orange colored precipitate/staining was observed in the water below the Pond D berm at the discharge of the drop inlet spillway, as seen in Figure 10 and 11. The berm at the lower aspect of Site D was constructed to contain the surface and groundwater runoff from Site 23/D and to provide sedimentation control. The berm contains some pyritic quarry rock from the development Pit 405 in 1988. The water was clear. The orange color appeared to result from the sediment and biological growth that settled on the bottom of the pool. Efforts are taken to drain down Pond D to the maximum extent possible. At this visit a minimal amount of water storage was observed in the upper compartment. At the time of this site visit there was no apparent evidence of seeps through the berm, as active pumping maintains the pond empty or very low other than during major storm events.

KGCMC measured field parameters of the pool outside of the Pond D berm (Figure 10) in June 2002. This monitoring produced a pH of 6.9 and conductivity of 620 uS/cm. This represents a low to moderate soluble load and low acidity. A likely explanation for this is that oxidation of pyrite rock in the berm produces soluble iron that precipitates upon reaction with the atmosphere as the water daylights from the toe of the berm. Iron oxidizing bacteria usually promote these reactions. It is also common in disturbed areas to have changes in the water table, or redox-boundary, mobilizing iron and manganese from the original, undisturbed soil. This may contribute to the staining observed at the base of the site. Examples of such natural redox reactions exist at several sites beyond the KGCMC facilities. Water flows intermittently from the Pond D berm into a vegetated boggy area (Figure 10; upper-left) prior to reaching Greens Creek.

The remediation plan for the Pond D berm will result in its being removed within a few years, following completion of other priorities, such as a pumped water return system from Pond C. Plans include reconstructing the berm with inert material; a possible source is material recovered from the continuing development of the upslope of Site 23.

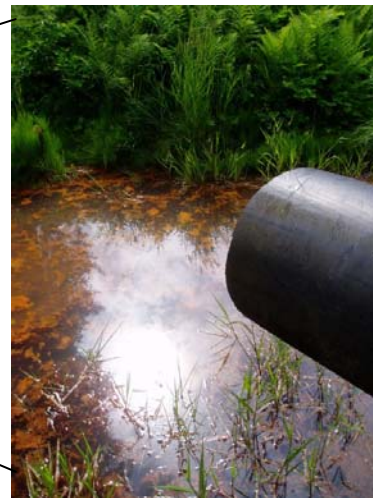
**Figure 11. Pond D Outlet. Note orange color of water.**

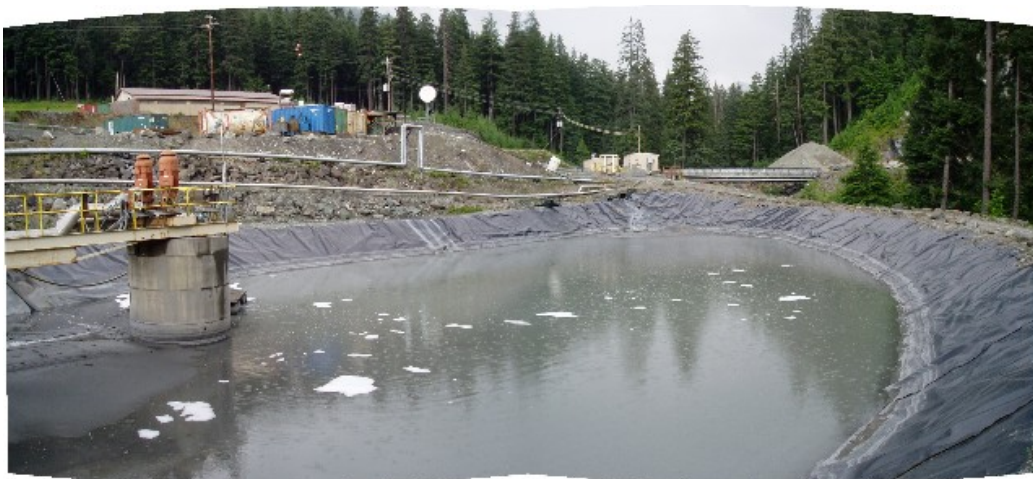
**Figure 12. Pond A. Note proximity to bridge over Greens Creek to portal.**

At about 3:30pm we visited Pond A at the mill area. Pond A is part of the “closed” system that captures waters which contain sediments from the mill area. Runon into Pond A is limited by diversion ditches above the mill. Water captured in Pond A is transmitted to treatment at Pit 5. When sediments build within the pond and other containment structures in this area they are collected and taken back to the mill or taken to the tailings disposal site. Pond A is formed by an embankment adjacent to Greens Creek, as seen in Figure 12.

A review should be conducted of Pond A to determine if the embankment meets the statutory definition of a dam under AS 46.17.900(3). If so, it would be under the jurisdiction of the Alaska Dam Safety Program. A Hazard Potential Classification and Jurisdictional Review form (available from the Dam Safety and Construction Unit) should be completed by an engineer qualified under 11 AAC 93.193.

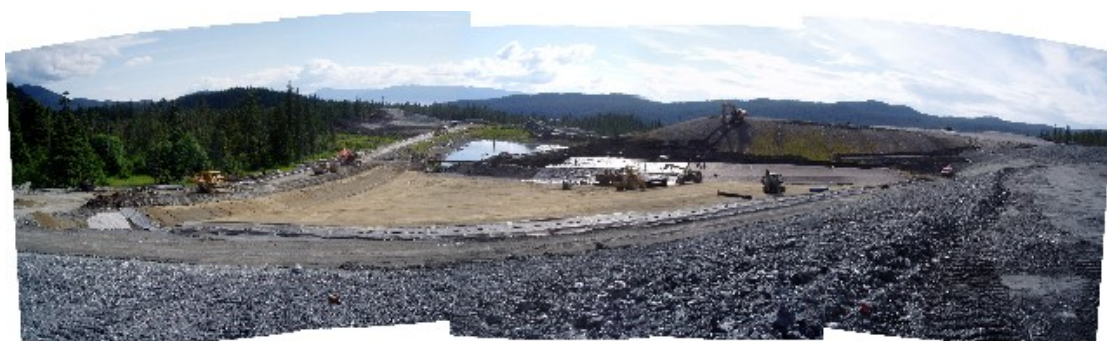
**Figure 13. Liner installation at Southeast Expansion Area #2 of Tailings Storage Facility**

At approximately 4:30pm we traveled back to the cannery area where we turned in our protective gear and caught transportation back to Juneau. On the way we stopped at the tailings site where we observed the geosynthetic liner system being installed at the southeast expansion area 2, as seen in Figure 13.
