INSPECTION REPORT: GREENS CREEK MINE

Tongass National Forest Minerals Group
8510 Mendenhall Loop Rd
Juneau, AK 99801
(907) 789-6276 – office
(907) 586-8808 – fax

Date of Inspection: Monday January 25, 2021
Date of Report: 02/08/2021
USDA Forest Service Inspector: Casey Loofbourrow

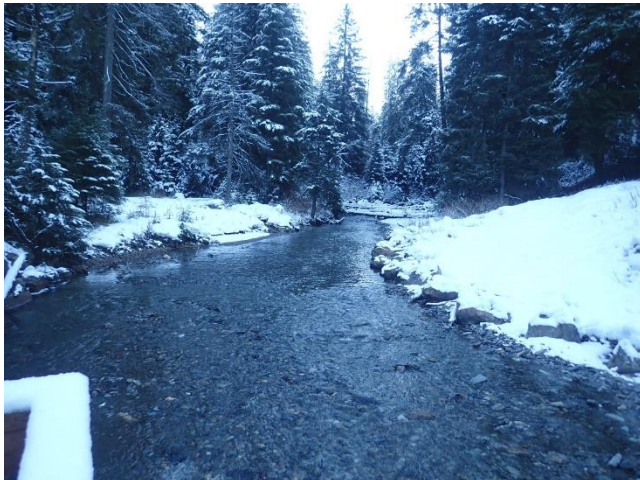
The recorded flow rate for Greens Creek (Photos 1-3) was 13 cubic feet per second (cfs). The 920-area water withdrawal rate from Greens Creek was approximately 1.5-cfs.

Photo 1. Greens Creek at the 920 weir looking upstream.

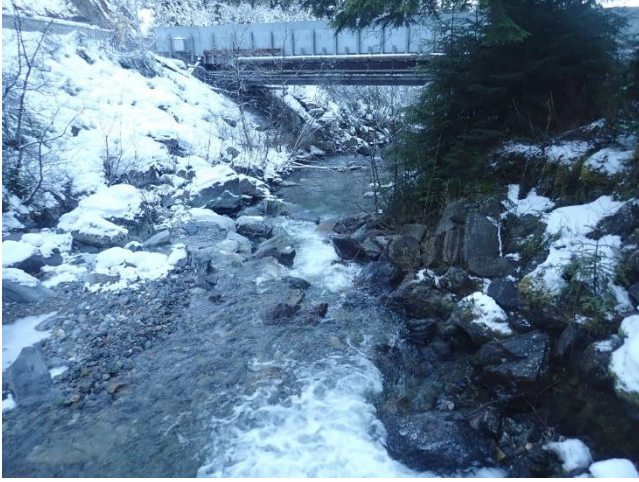
Photo 2. Greens Creek at the 920 weir looking downstream at Greens Creek bridge.

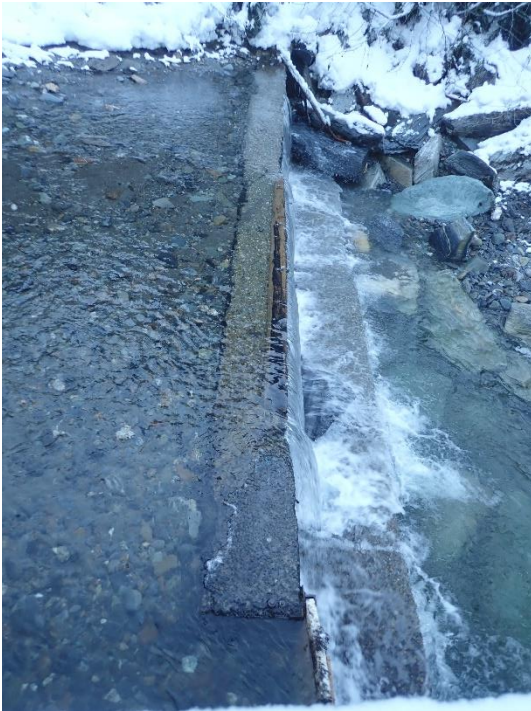
Photo 3. The 920 Greens Creek weir.

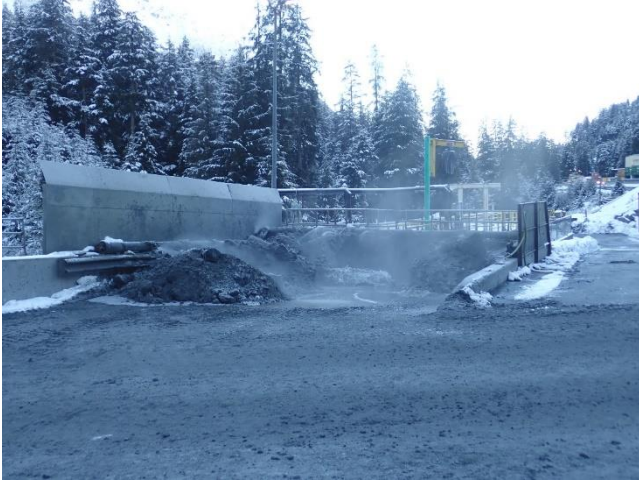
Degrit basin DB01 was operating (Photo 4).

Photo 4. Degrit basin DB01.

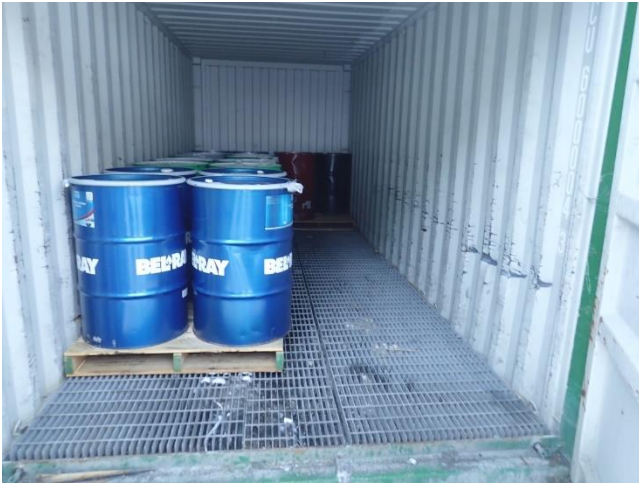
Good housekeeping practices were observed at the 920 warehouse (Appendix 5 BMP Plan page 39). All petroleum/chemicals observed were properly stored within appropriate secondary containment (Photos 5-6). Ore was being placed on ore pad adjacent to the mill (Photo 7). A powder absorbent used to clean an apparent fluid spill was observed in parking area (Photo 8)

Photo 5. 920 warehouse storage container with appropriate secondary containment.

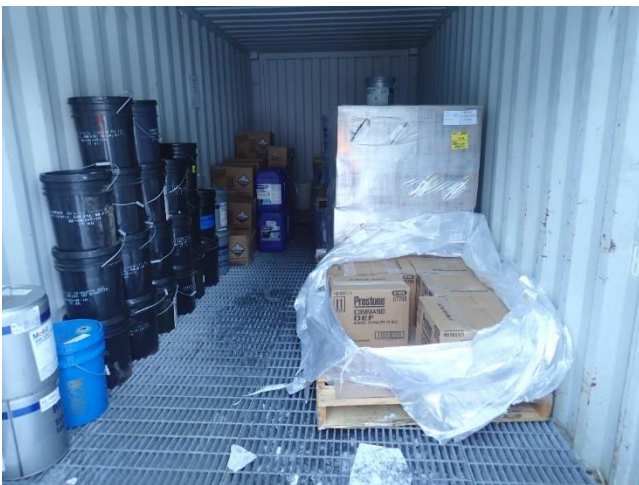
Photo 6. 920 warehouse storage container.

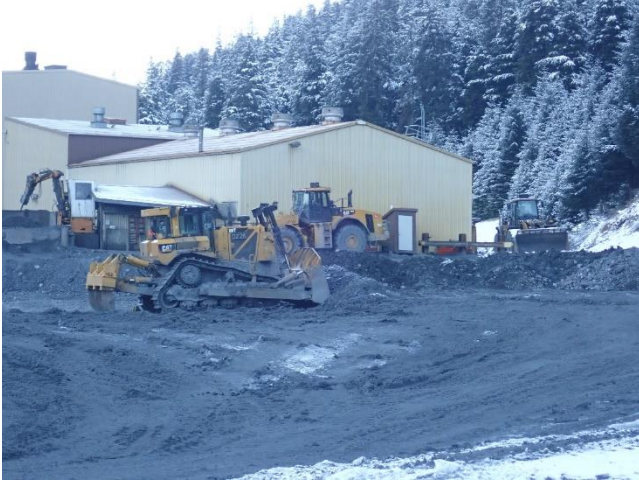
Photo 1. 920 ore pad and mill exterior.

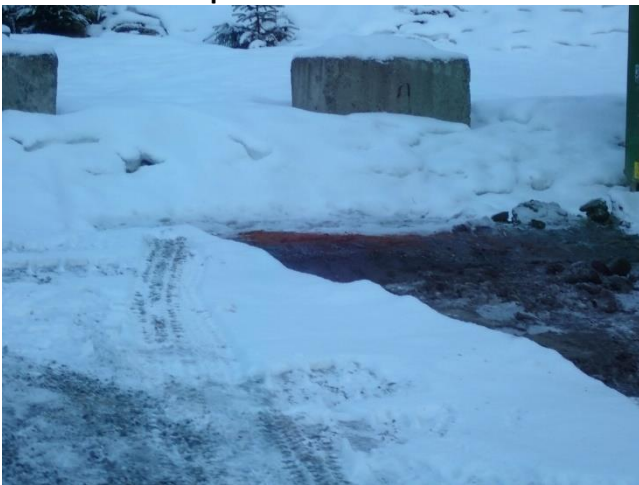
Photo 8. Red sawdust that appears to have been used to clean up small spill at 920 parking area.

- **Verify cleanup of small spill visible in 920 parking area (photo 8).**

**Monitor status of repairs to B-road ditch erosion, 7.5 mile landslide, and downed cables.
Ensure small spill site at 920 parking area is properly mitigated by the following inspection.**

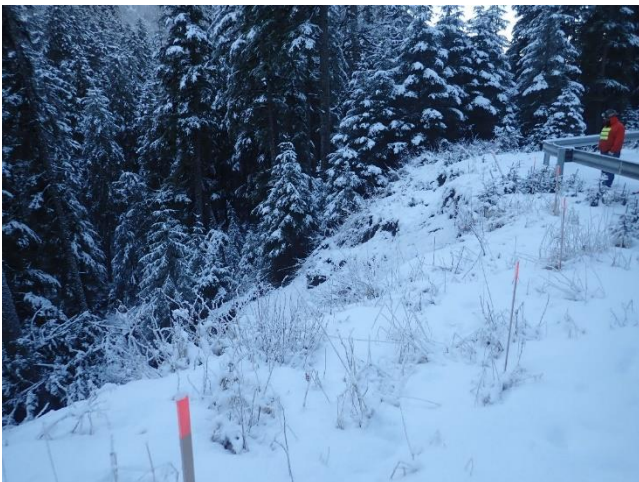
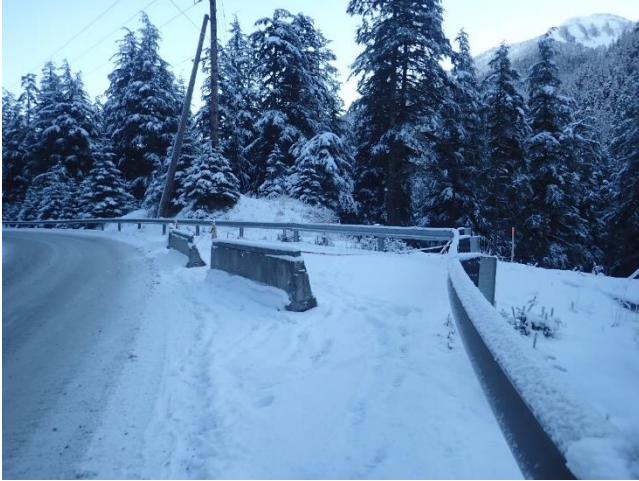
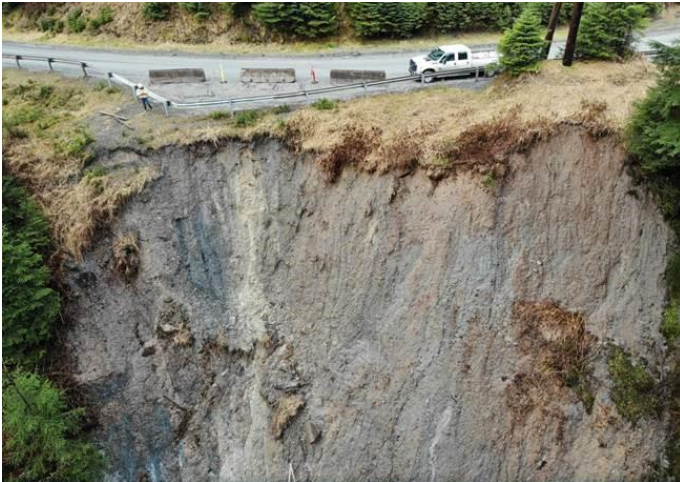
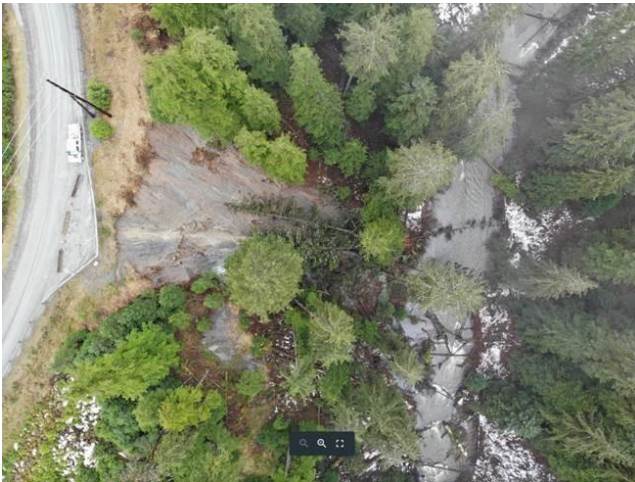
- **Impacts from the early December rain event include a landslide that occurred below 7.5 mile B-road (photos 9-12), a landslide that crossed the B-road at 3.7 mile (Photos 17-18), and erosion throughout the B-road ditch that exposed water pipes (Photos 19-20). Surface operations is planning to cover the pipes. Mitigations may be required to ensure the safety and continued operation of the B-road at the 7.5 mile landslide.**

Impacts from an early November ice storm, as well as an early December rain event, were present at several locations along the B-road. These include a landslide below 7.5 mile B-road (Photos 9-12), downed cables and fiber optic lines (Photo 13), numerous downed trees (Photos 14-16), a landslide that crossed 3.7 mile B-road (photos 17-18), and erosion throughout the B-road ditch that exposed water pipes (Photos 19-20). HGCMC plans to re-hang cables and cover the exposed pipes. They are also discussing possible mitigations measures for the B-road at the 7.5 mile landslide such as road realignment, and may need to remove additional hazard trees that could obstruct the road.

Photo 9. Crown (upper edge) of 7.5 mile landslide.

Photo 10. B-road adjacent to 7.5 mile landslide.

Photo 11. Photo provided by HGCMC on December 9, 2020. 7.5 mile landslide below B-road.

Photo 12. Photo provided by HGCMC on December 9, 2020. 7.5 mile landslide, B-road, and Greens Creek.

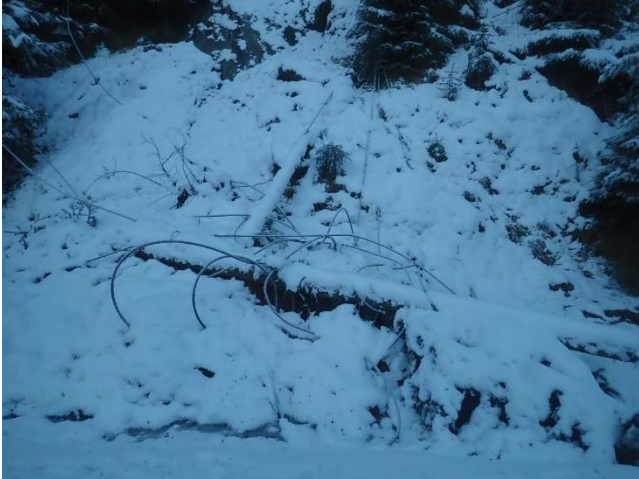
- **Impacts from an early November ice storm include downed transmission/fiber optic lines (Photo 13) and numerous downed trees (Photos 14-16). Surface Operations is working to re-hang fiber optic lines and may need to remove additional hazard trees.**

Photo 13. Cables on the ground adjacent to the B-road due to storm impacts.

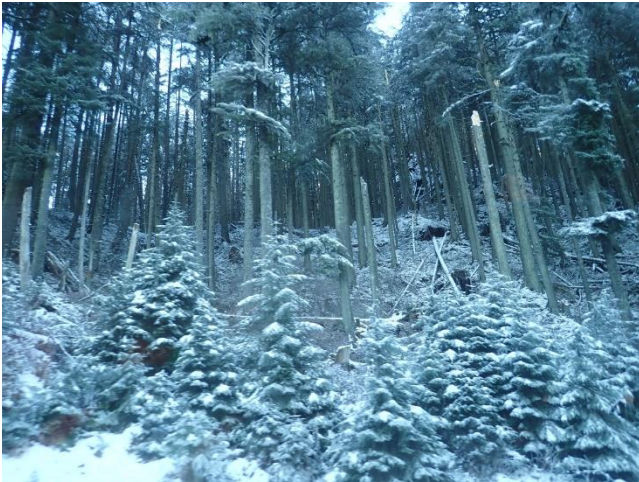
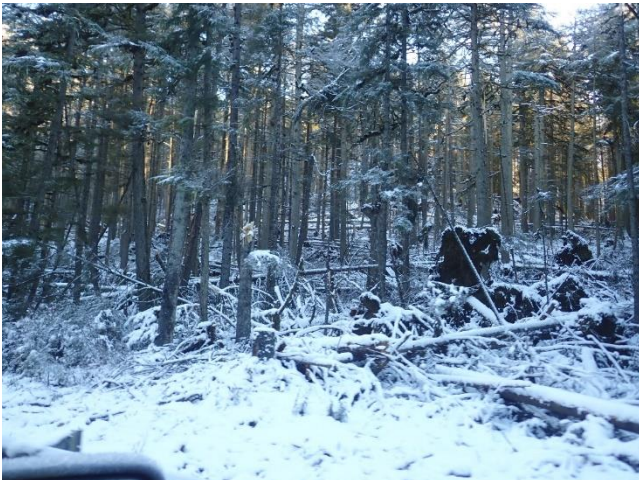
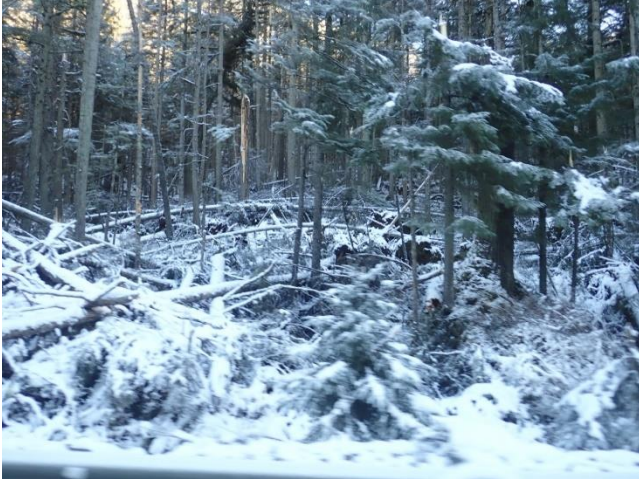
Photo 14. Area of snapped and uprooted trees near 4.7 mile B-road from November ice storm.

Photo 15. Area of snapped and uprooted trees near 4.7 mile B-road from November ice storm.

Photo 16. Area of snapped and uprooted trees near 4.7 mile B-road from November ice storm.

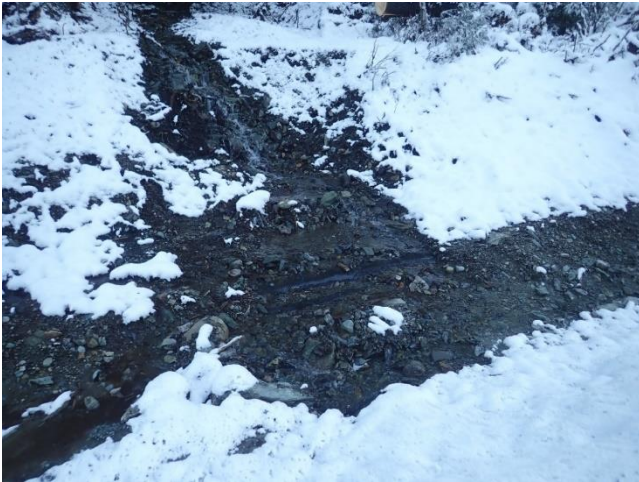
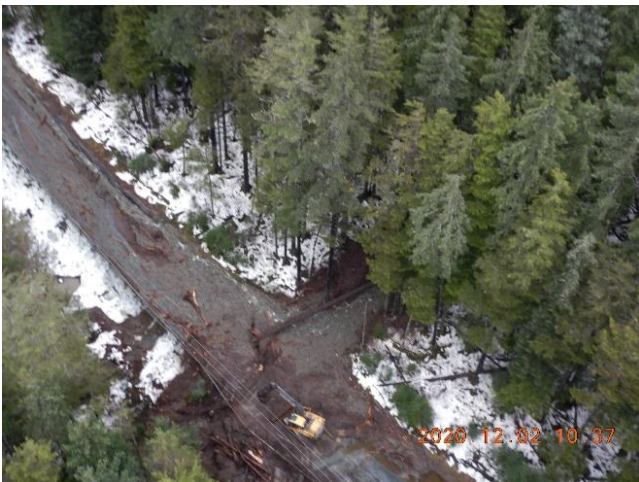
Photo 17. Site of 3.7 mile B-road landslide from December storm.

Photo 18. Photo provided by HGCMC showing 3.7 mile B-road landslide being cleared on December 2, 2020.

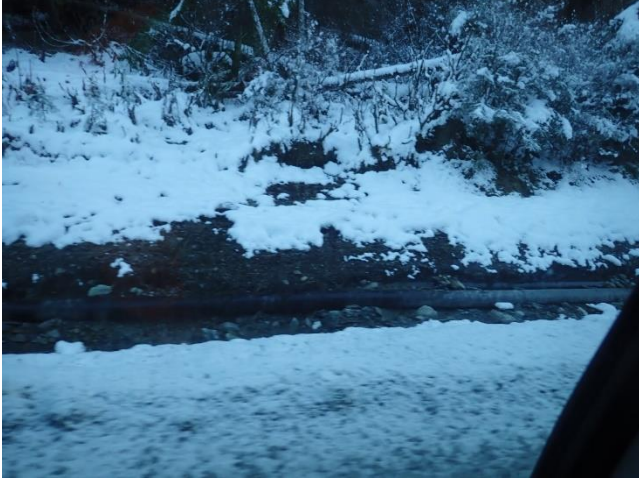
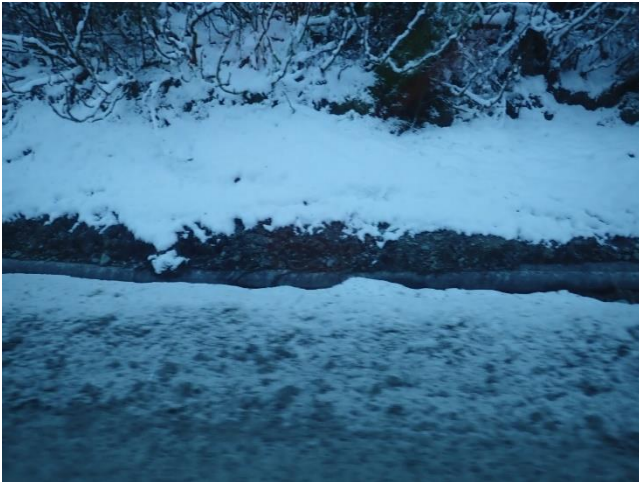
The B-road was in adequate condition. The adjacent ditch experienced erosion during the December storm and exposed pipes that will be covered at a later date by Surface Operations (see above section “Storm Impacts”). A-road was not travelled on during this inspection.

Photo 19. Pipes exposed in B-road ditch due to December storm erosion.

Photo 20. Pipes exposed in B-road ditch due to December storm erosion.

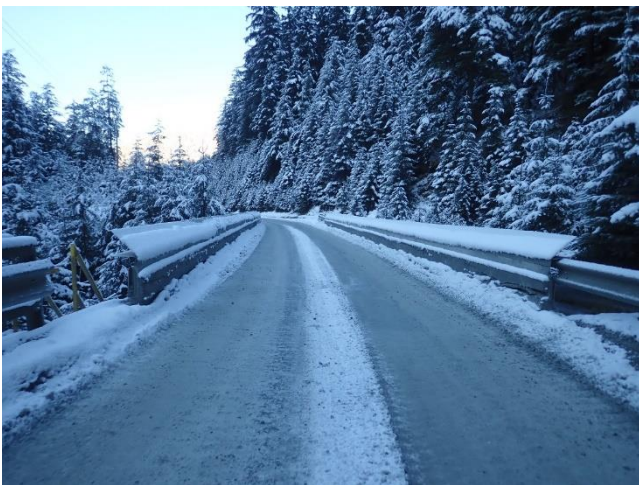
The bridge's splashguards are functioning as designed preventing sediment splash-over from vehicular traffic (Photo 21).

Photo 21. 7.4 Mile B Road Bridge (Killer Creek Bridge).

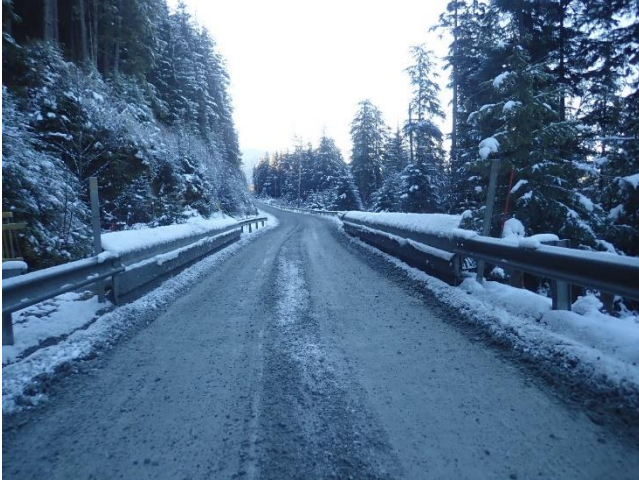
The bridge's splashguards are working as intended by preventing sediment splash-over from traffic (Photo 22).

Photo 22. The 3.4 Mile B-road Bridge (Falls Creek Bridge).

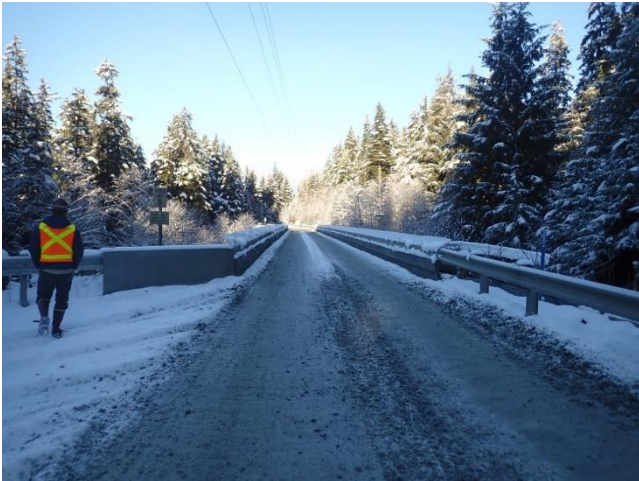
The bridge’s splashguards are functioning as designed, preventing sediment splash over from vehicular traffic (Photo 23). The uphill side abutment BMPs are frozen and not currently receiving surface water (Photo 24).

Photo 23. The 3.0 mile B-road bridge (Zinc Creek bridge).

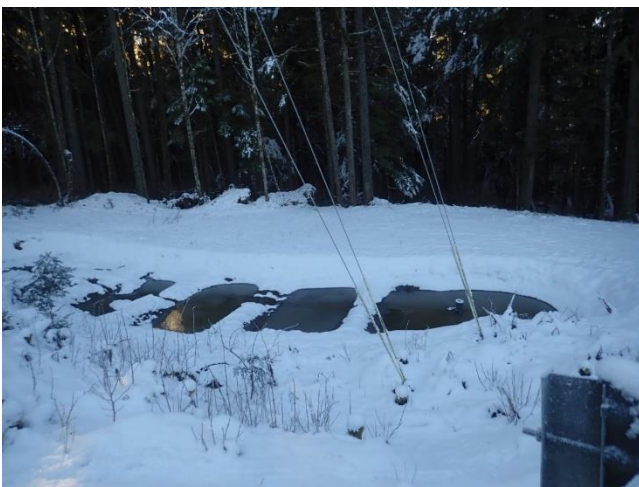
Photo 24. 3.0 mile B-road uphill abutment BMP's.

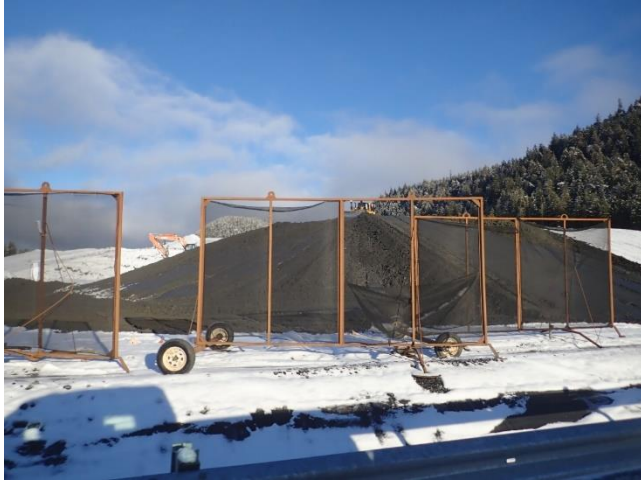
During the inspection, atmospheric conditions were consistent with previous dusting events from the tailings facility. Dust screens were present at the toe of the active placement area (Photo 25).

Photo 25. Tailings being placed in S3P1 area with fugitive dust control screens in place.

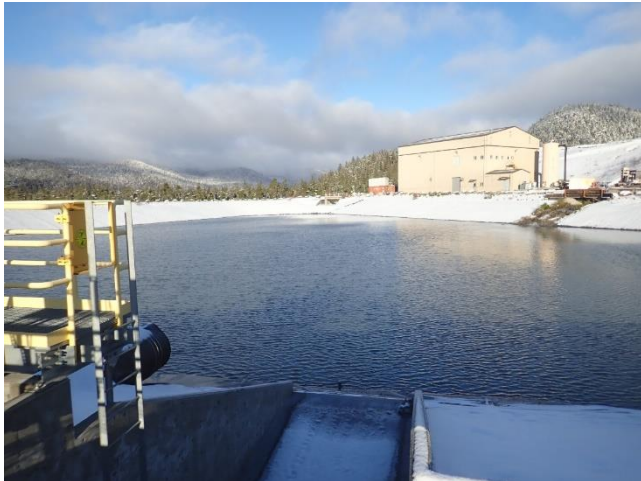
At the time of the inspection, Pond 7 (Photo 26) was collecting contact water, and Pond 10 (Photo 27) was collecting direct precipitation.

Photo 26. Pond 7 receiving mine site contact water.

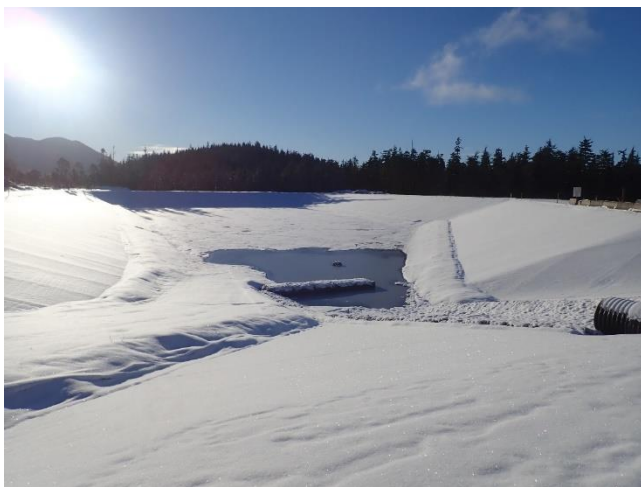
Photo 27. Pond 10 with snow and meltwater.

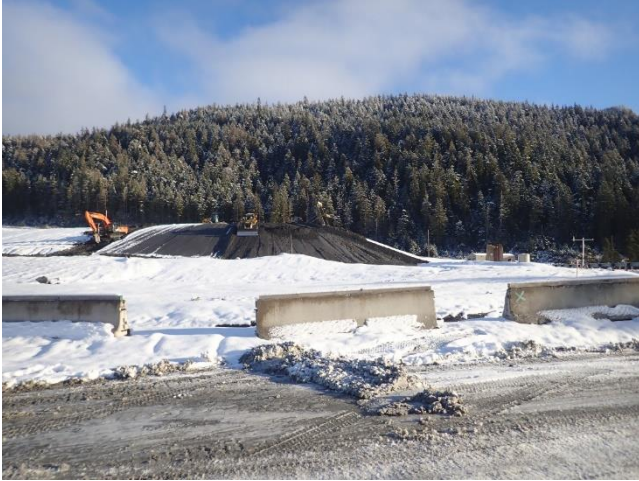
Surface Operations continue to deposit tailings in the S3P1 expansion area (Photo 28).

Photo 28. TDF S3P1 area. Personnel were actively placing tailings during the inspection.
