INSPECTION REPORT: GREENS CREEK MINE

Date of Inspection: Thursday, July 28, 2022
Date of Report: Monday, August 15, 2022
USDA Forest Service Inspector: Casey Loofbourrow

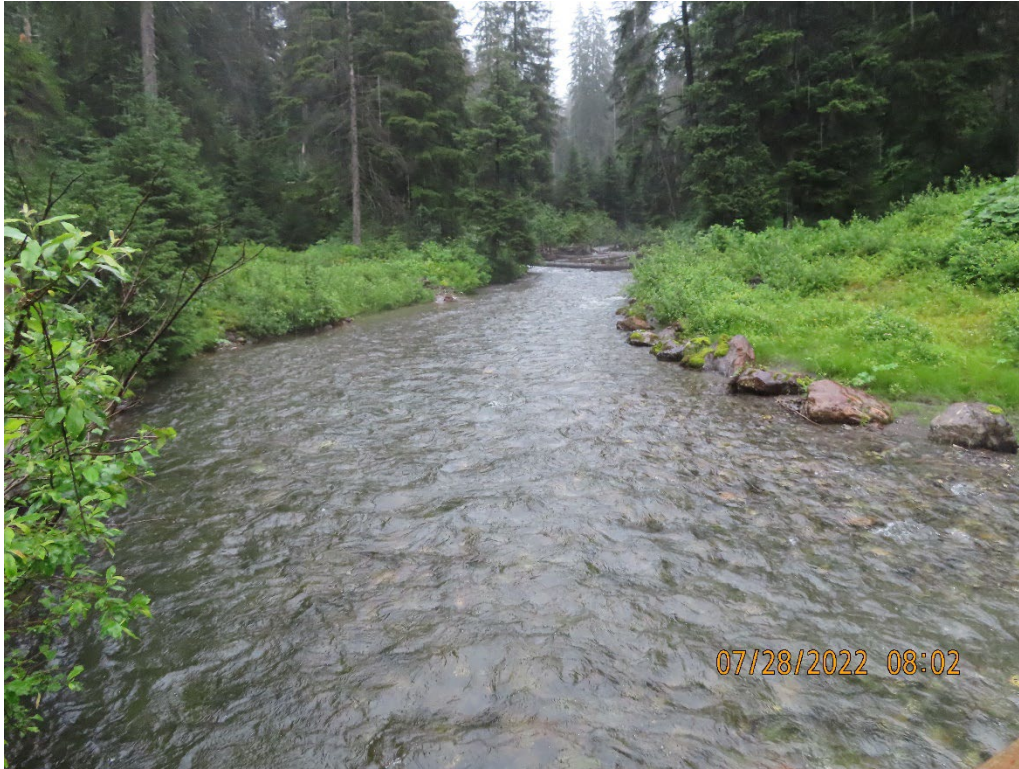
The Greens Creek discharge was 88 cfs (Photos 1-2), and 1.34 cfs was being withdrawn for operational use.

Photo 1. Greens Creek looking upstream from the 920 weir.

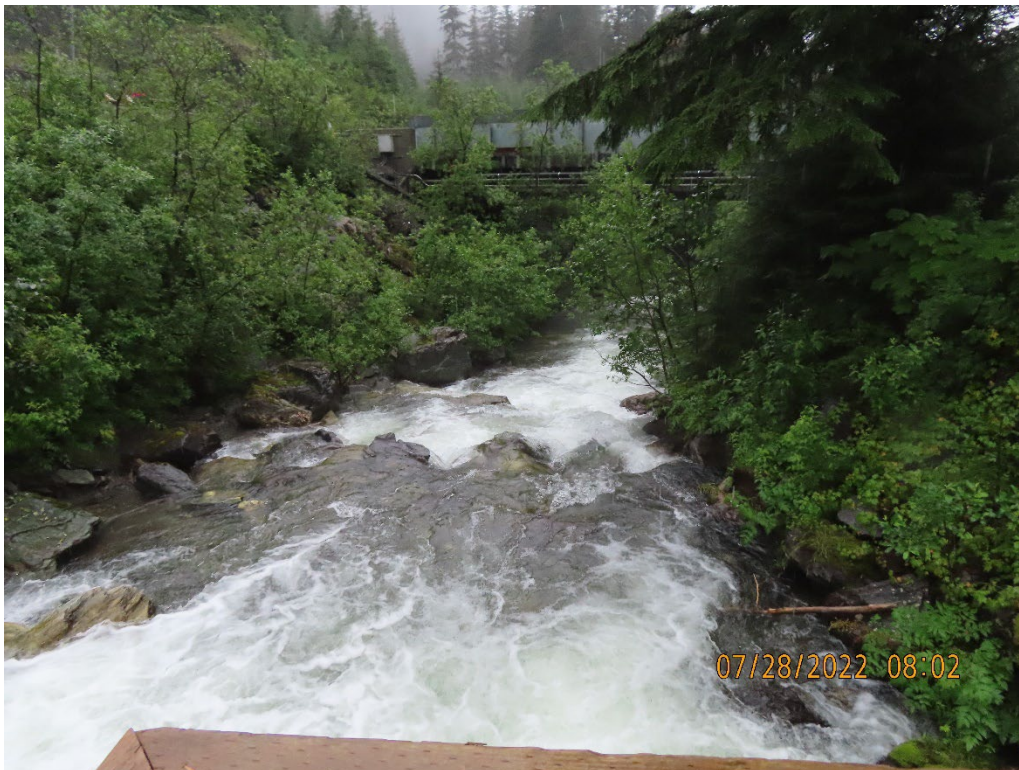
Photo 2. Greens Creek looking downstream from the 920 weir.

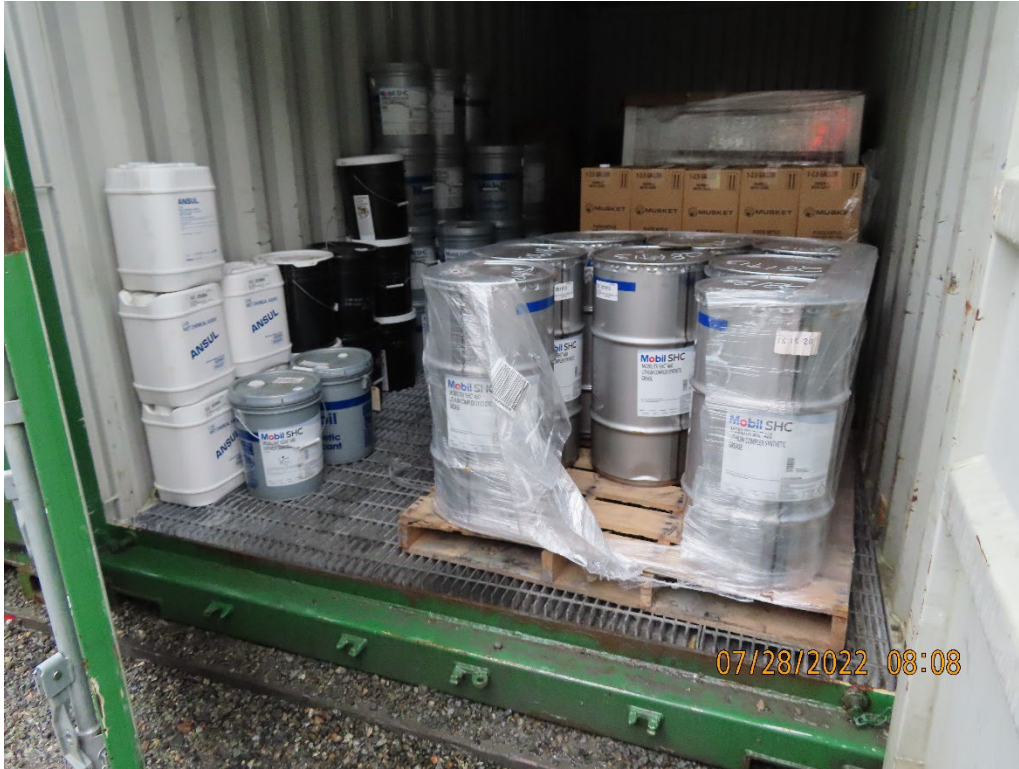
Good housekeeping practices were observed at the 920 warehouse (GPO, Appendix 5 BMP Plan, page 39). All petroleum/chemicals observed were properly stored within secondary containment (Photo 3).

Photo 3. Chemicals stored in appropriate secondary containment at the 920 warehouse.

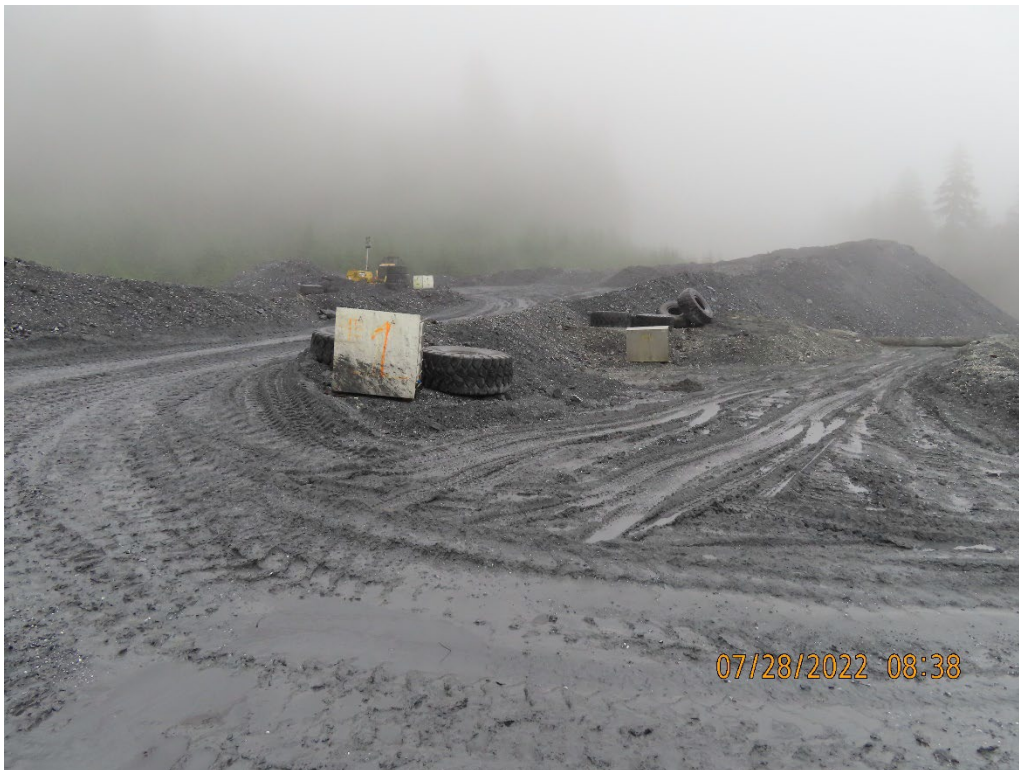
Class 1/2/3 waste rock continues to be placed at this location (Photo 4).

Photo 4. Site 23 active waste rock placement area.

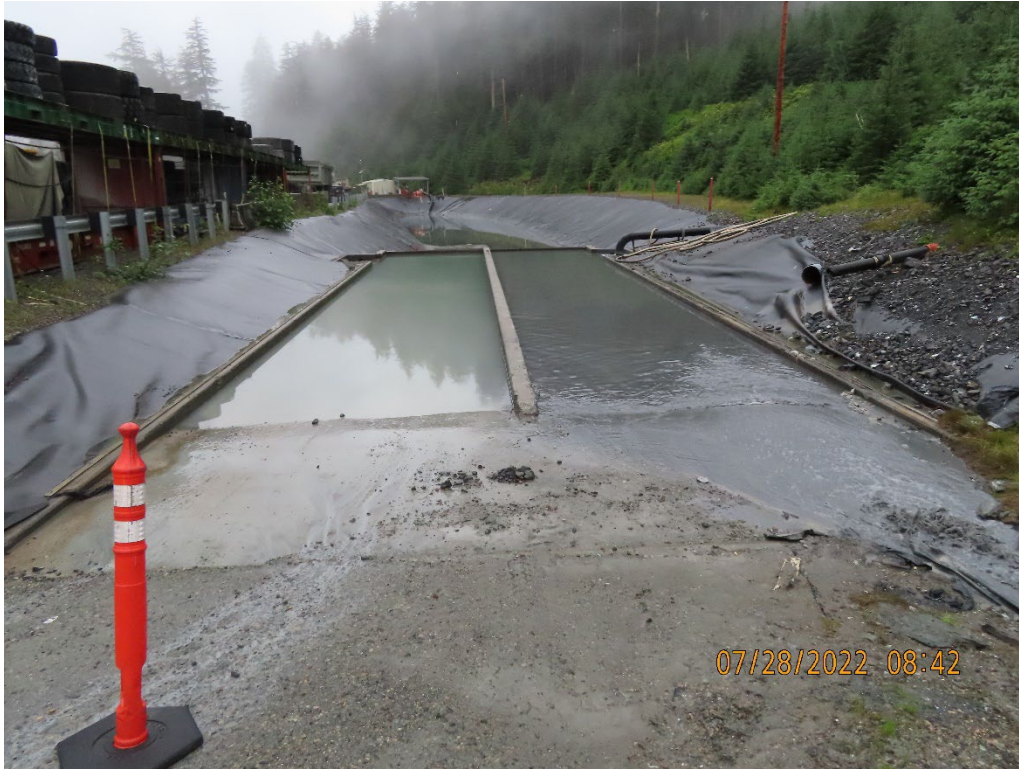
Pond 23 appeared in good condition with substantial surge capacity (Photo 5).

Photo 5. Pond 23 showing substantial surge capacity.

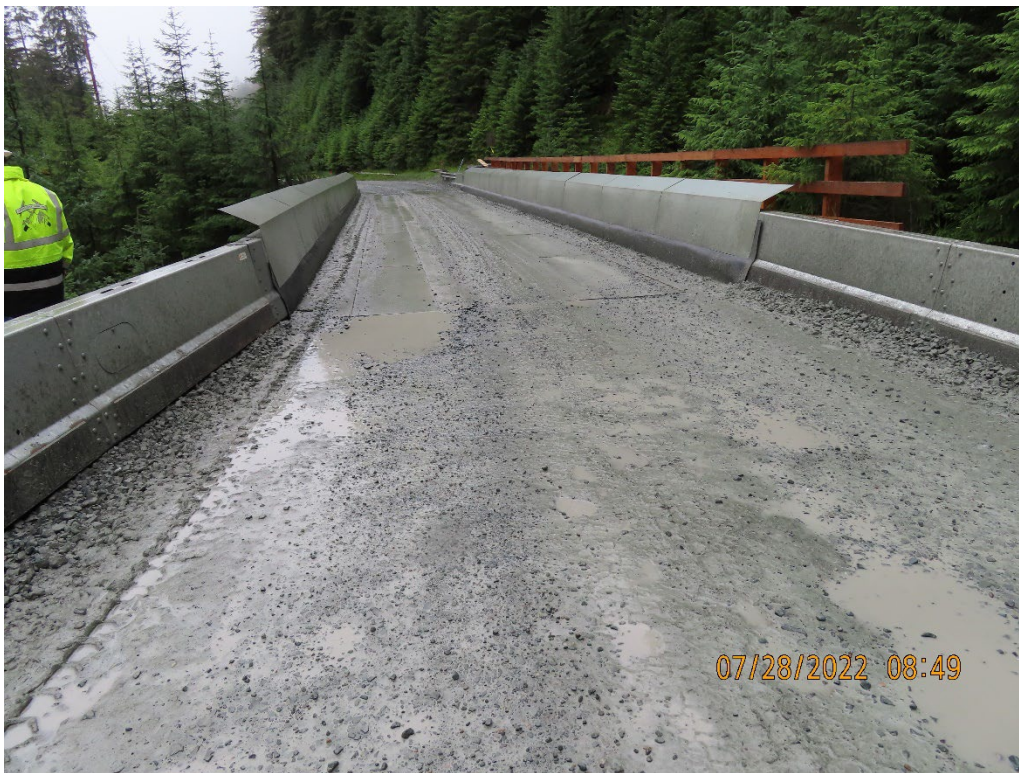
The recently overhauled Killer Creek Bridge appeared in good condition, with sediment deflection concrete barriers effectively preventing sediment from reaching bridge abutments (Photo 6).

Photo 6. Killer Creek Bridge, showing effective sediment deflection barriers at the uphill end.

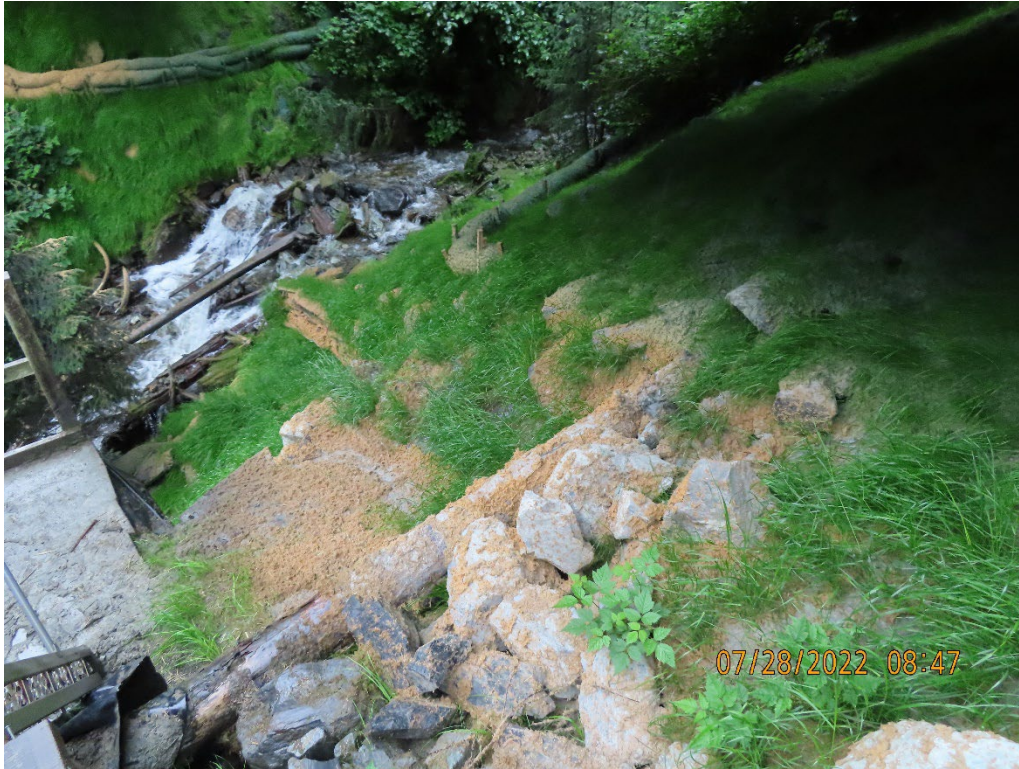
Recently replaced sediment BMPs on the bridge abutments appear in good condition, and the hydroseeded surface is showing dense vegetation growth and coverage (Photos 7-8).

Photo 7. Uphill side BMPs at Killer Creek Bridge, showing new wattles and successful revegetation efforts.

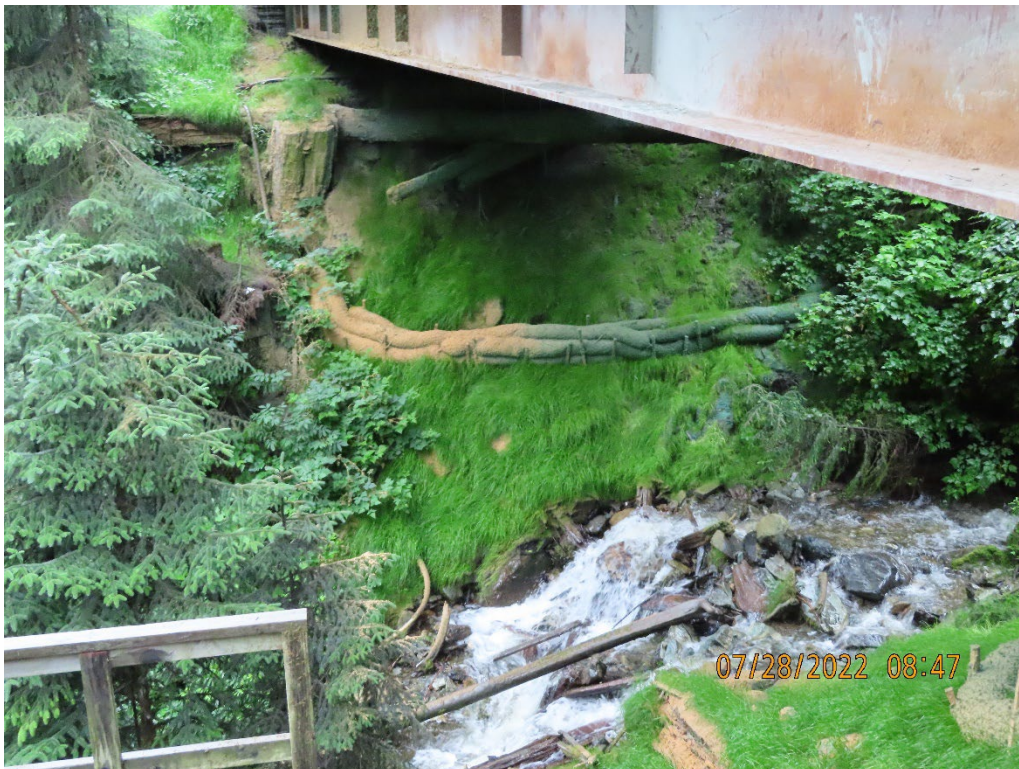
Photo 8. Downhill side abutment BMPs at Killer Creek Bridge, showing new wattles and successful revegetation efforts.

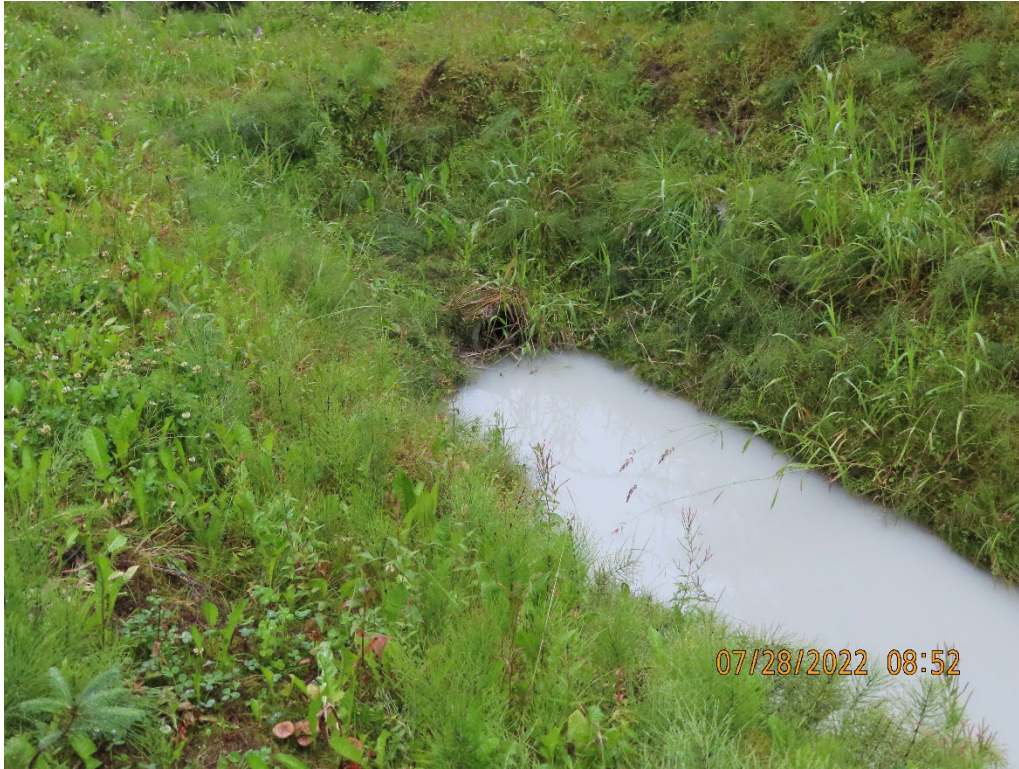
5/12/2022; 421-1	A stormwater BMP adjacent to the B-Road located above the Killer Creek Bridge has accumulated sediment that requires removal.	Resolved. Accumulated sediment has been removed.
---------------------	---	---

RESOLVED ACTION ITEM 421-1: A stormwater sump BMP adjacent to the B-Road located above the Killer Creek Bridge had accumulated excess sediment that has been removed (Photo 9).

Photo 9. Stormwater BMP at the uphill end of Killer Creek Bridge from which sediment has been removed to restore sediment settling function.

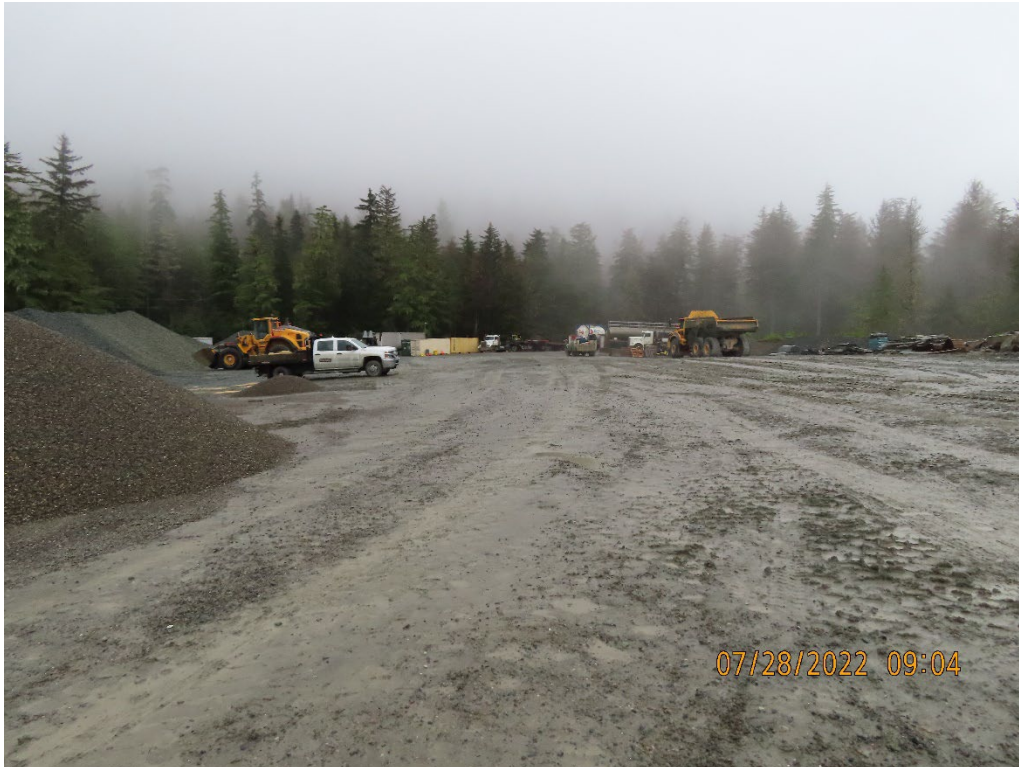
Site E continues to be used as a laydown area for storing road surface rock, equipment, explosives, and materials excavated and/or used for projects including bridge replacement and repair, and the 5.6 B-Road slope stabilization project (Photos 10-11). The settling pond appeared in good condition with substantial surge capacity (Photo 12).

Photo 10. South end of Site E, used for equipment laydown and material storage.

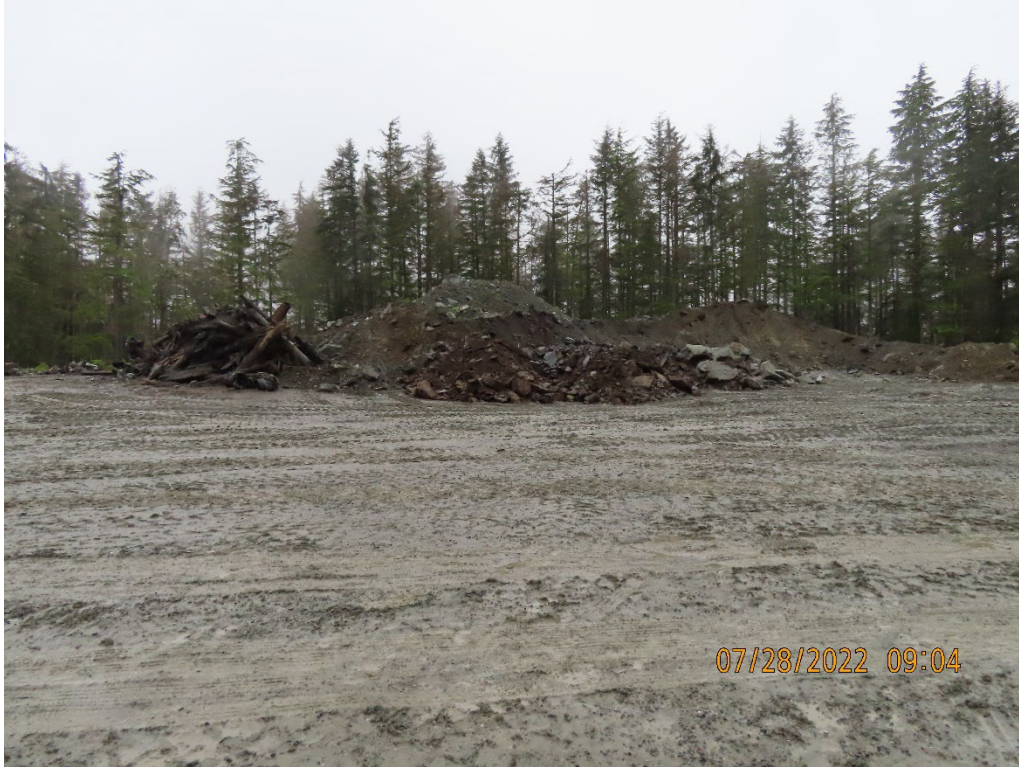
Photo 11. Site E, debris and fill stockpiled from the recently completed slope stabilization work at 5.6-mile B-Road.

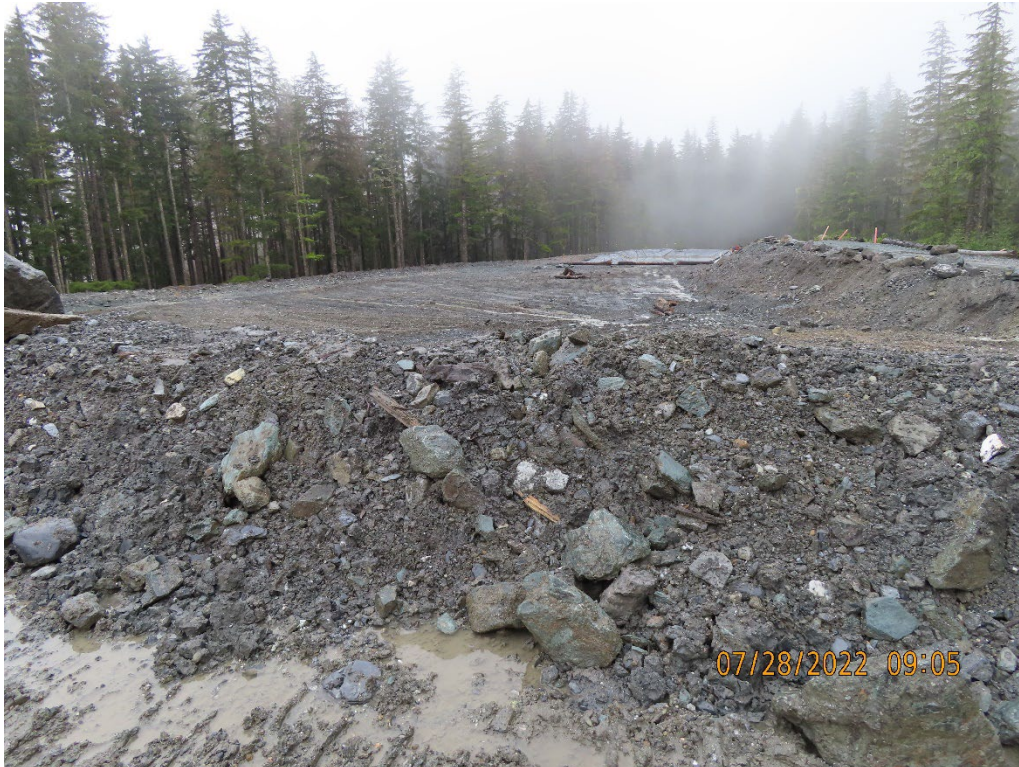
Photo 12. North end of Site E, pond E visible in background.

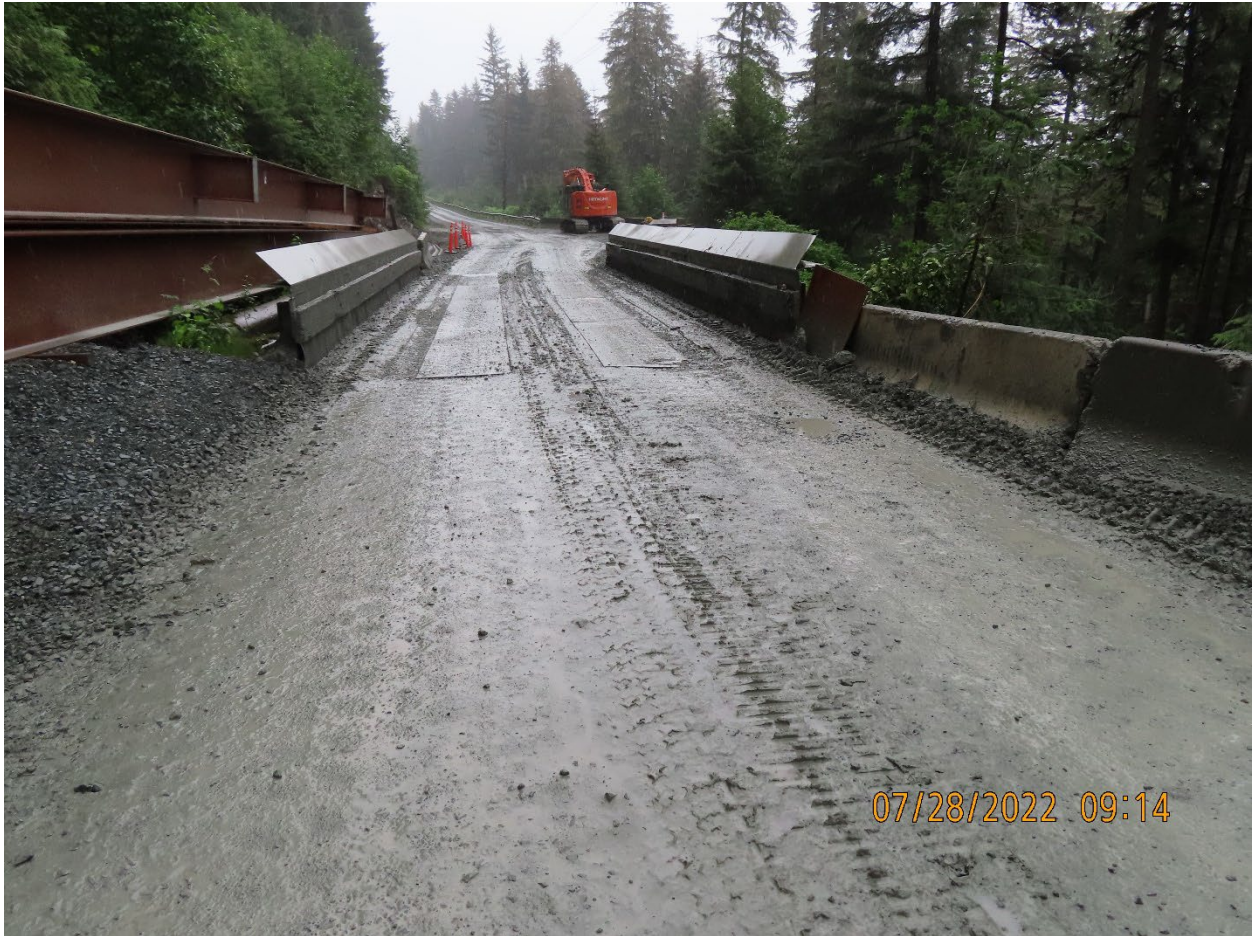
Date/Item No.	Item Description	Status
3/16/2022; 419-1	Sediment deflection boards at the uphill bridge end of Falls Creek Bridge are damaged and require replacement (GPO, Appendix 5 BMP Plan, page 10).	Resolved. Temporary sediment deflection measures have been installed. Permanent barriers will be installed concurrent with bridge replacement scheduled for August 2022.

RESOLVED ACTION ITEM 419-1: Sediment deflection barriers have been temporarily modified with plywood, wattles, and jersey barriers, and will be replaced with more permanent barriers during bridge replacement, scheduled to commence August 10, 2022 (Photos 13-14, requirements at GPO, Appendix 5 BMP Plan, pages 10 and 98).

Photo 13. Downhill side of the Falls Creek Bridge. Plywood used on the right of the photo, and a coarse-grained fill berm on the left of the photo, preventing sediment from reaching the abutment from the roadway. These features will be improved with bridge replacement scheduled to begin August 10, 2022.

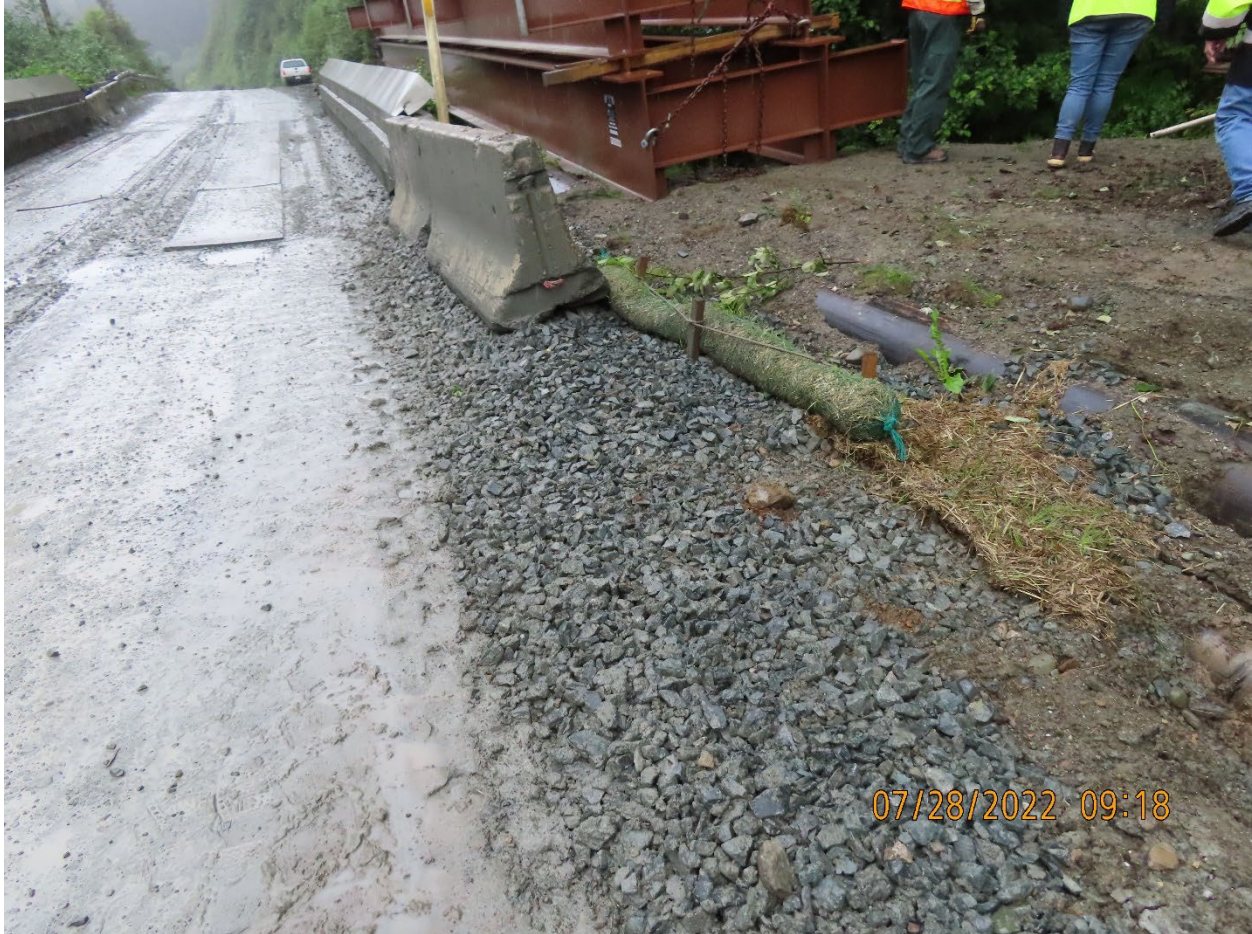
Photo 14. Temporary sediment deflection wattles and concrete barrier on the uphill side of the Falls Creek Bridge. Steel girders to be used in bridge replacement scheduled to begin August 10, 2022, are visible to the right of the bridge.

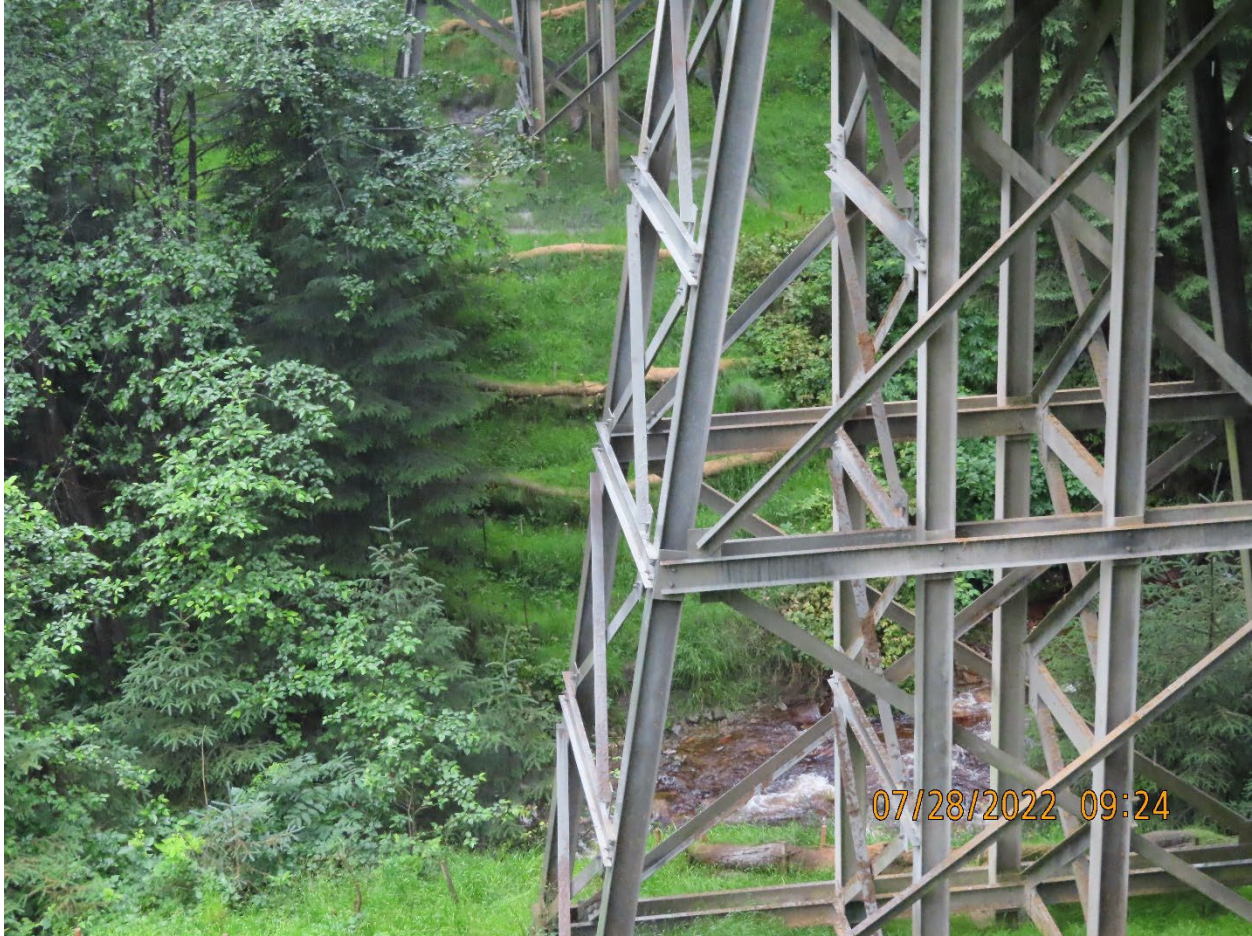
The recently replaced and improved sediment BMPs at the Zinc Creek Bridge abutment are in good condition and functioning as intended. Vegetation was established by hydroseeding and is showing dense growth and coverage, which should improve resistance to erosion (Photos 15-16).

Photo 15. Downhill side Zinc Creek Bridge abutment showing recently replaced wattles and substantial vegetation growth.

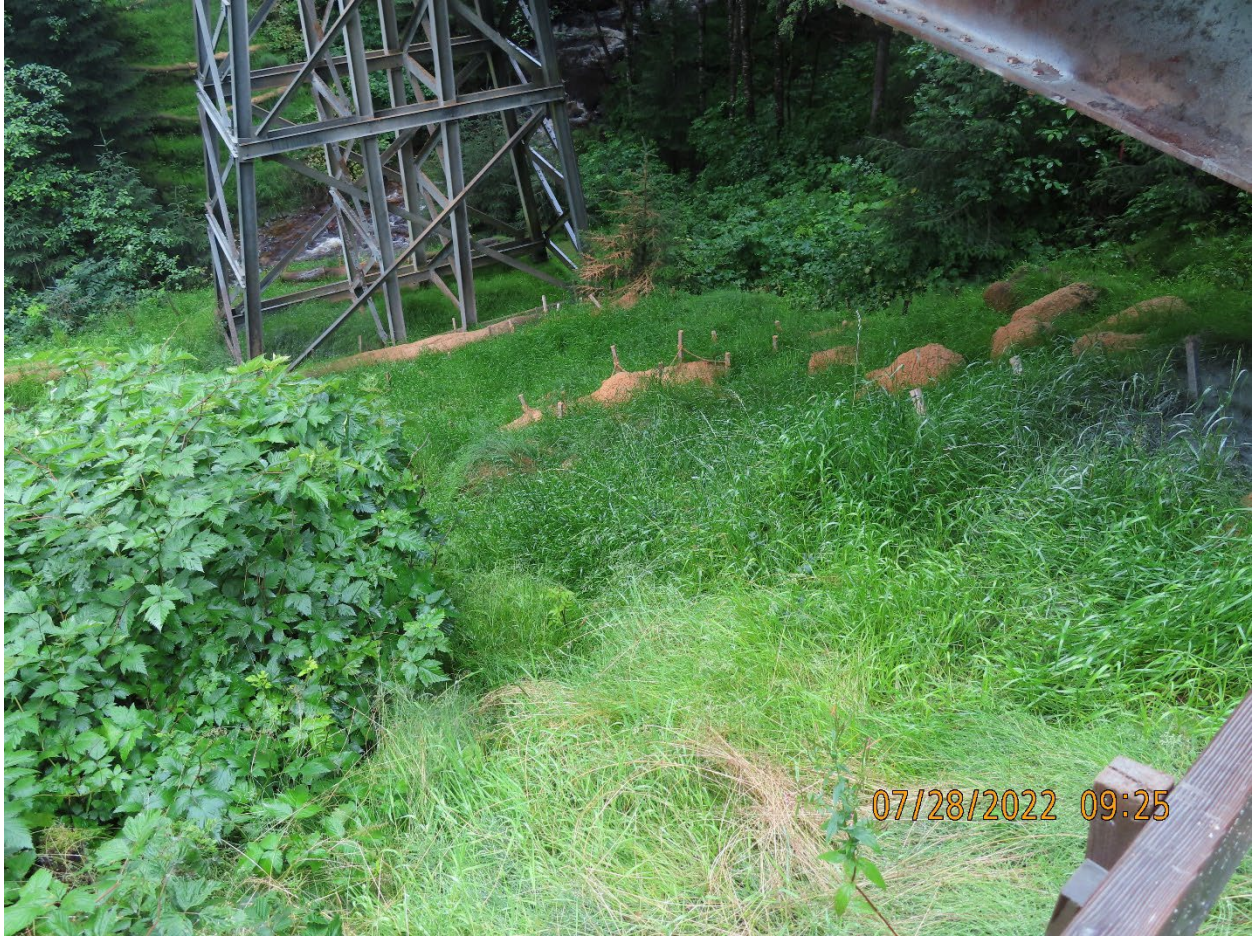
Photo 16. Uphill side Zinc Creek Bridge abutment showing recently replaced wattles and substantial vegetation growth.

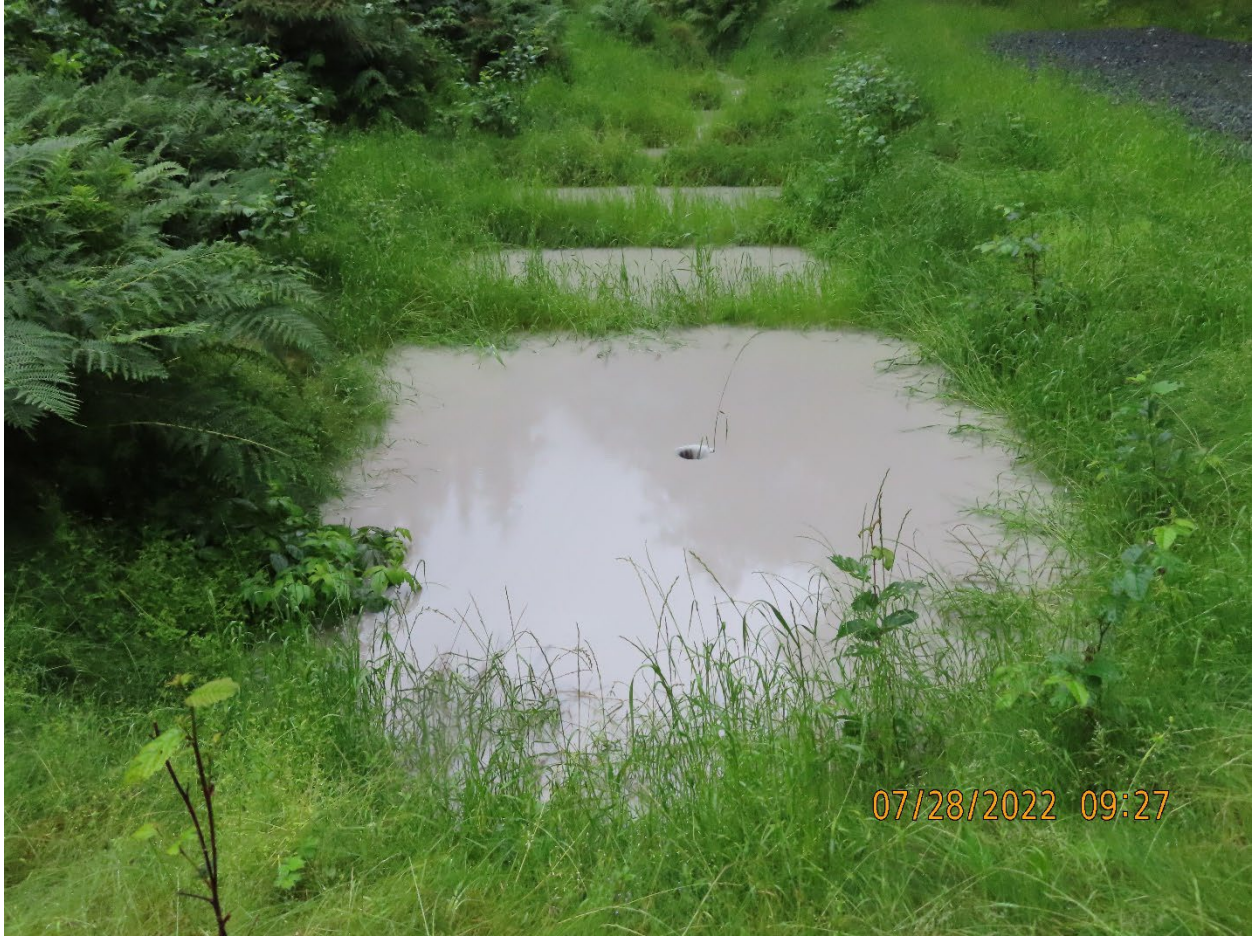
NEW ACTION ITEM 423-1: The stormwater BMPs located at the uphill side of Zinc Creek Bridge, commonly known as the “Gnome Ponds” (Photo 17), were observed discharging water with increased turbidity to the forest floor (Photos 18-19). During this inspection, the extent of the turbid flow was not able to be traced to its terminus or confluence with a stream but continued for at least 100 yards beyond the discharge point. The presence of fine grained sediments below the turbid flow suggests fine sediment deposition from repeated increased turbidity events. In the following inspection, the full flow path from this BMP discharge will be documented to evaluate the potential for adverse impacts to surface waters, and if BMP effectiveness requires improvement.

Photo 17. B-Road Stormwater BMP located uphill from the Zinc Creek Bridge. Downpipe that leads to discharge pipe visible at center of lower sump.

423-1: Increased turbidity of surface water runoff was observed at the 3.0 mile B-Road Zinc Creek Bridge uphill side stormwater BMPs. During the next inspection, the flow path of this water will be traced to its terminus or confluence with surface water to determine the potential for impact to surface waters, and if BMP performance needs to be improved.

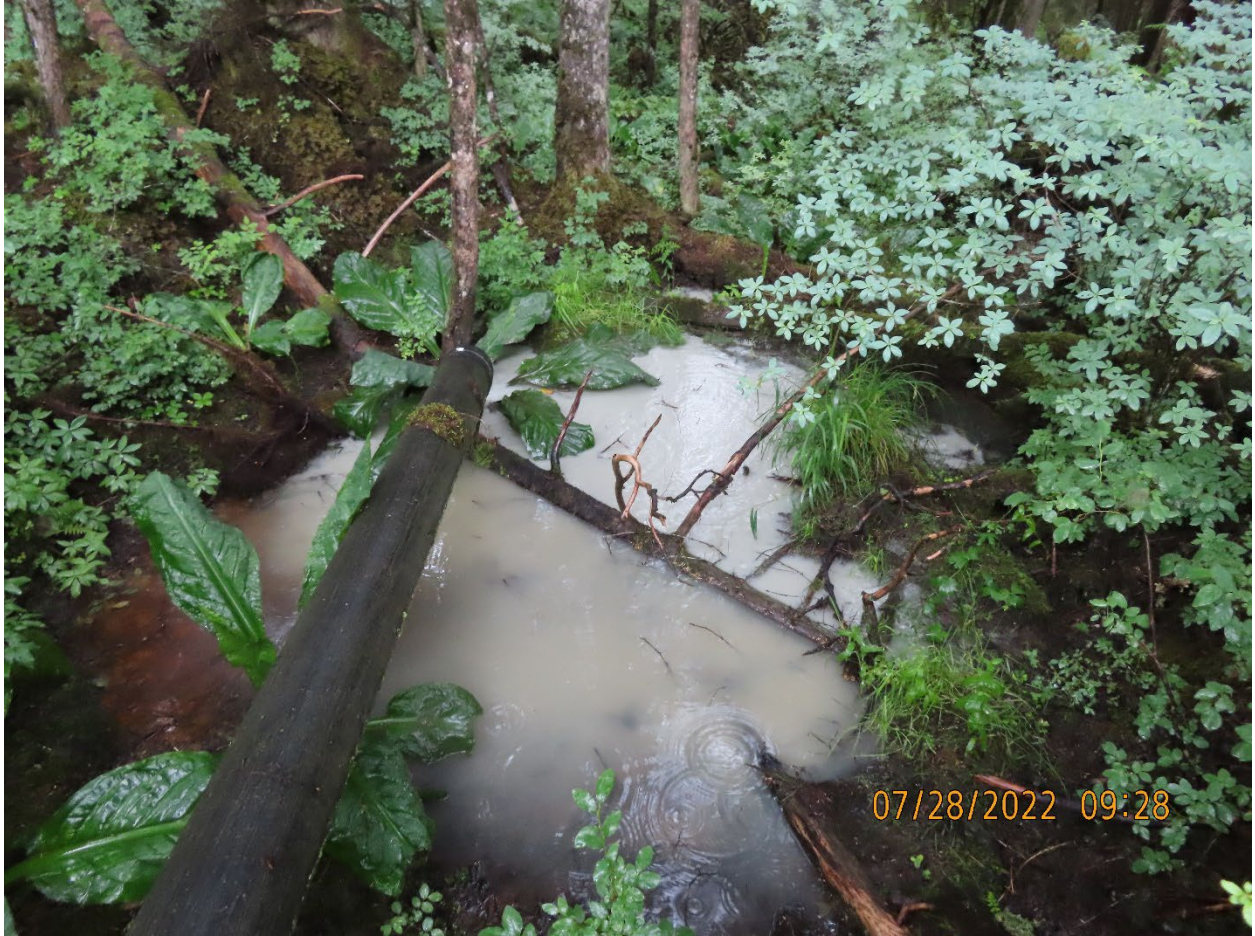
Photo 18. Discharge point of the B-Road Stormwater BMP located uphill from the Zinc Creek Bridge.

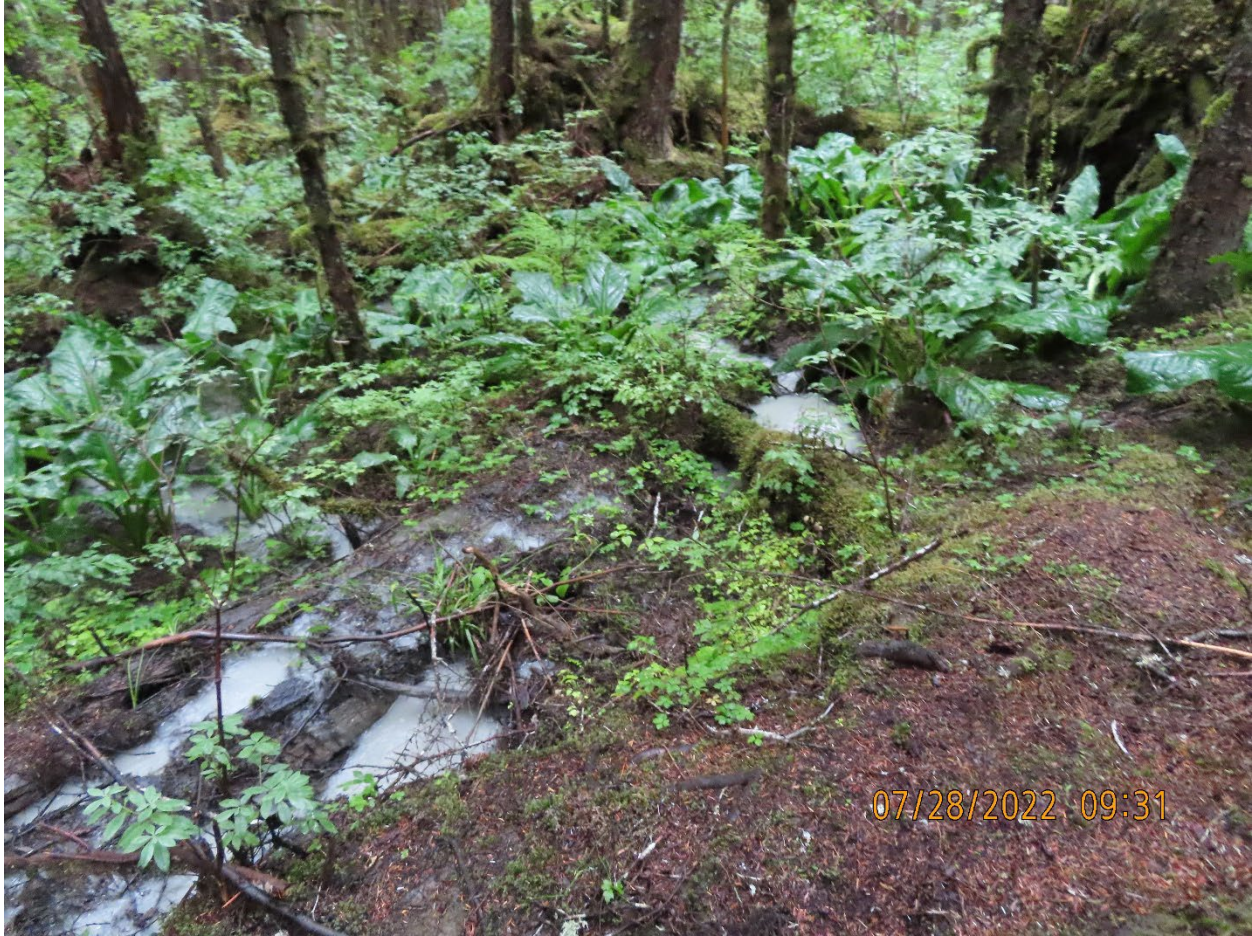
Photo 19. Turbid water flowing over the forest floor downgradient from the B-Road stormwater BMP located uphill from Zinc Creek Bridge.

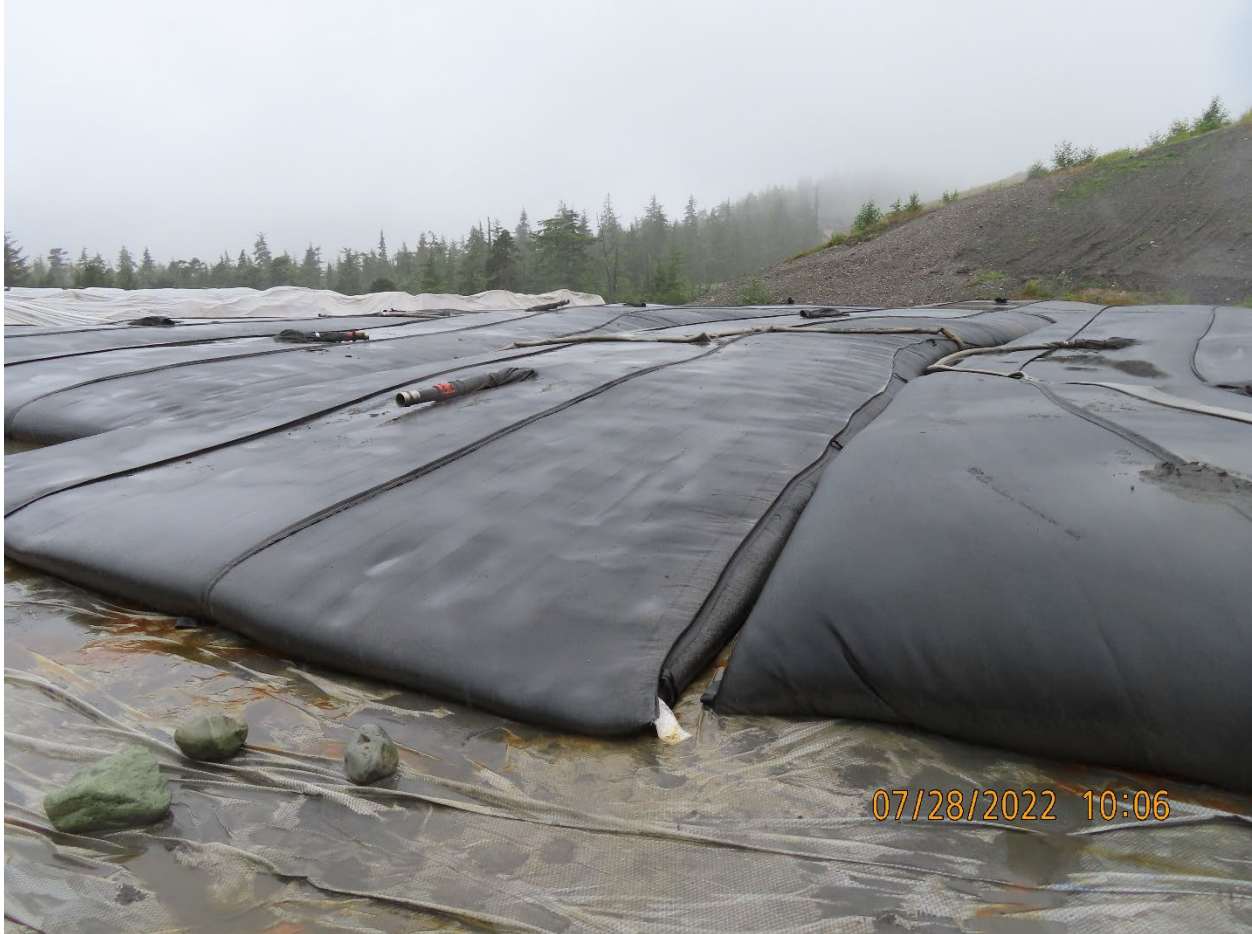
HGCMC was not actively dredging sediment from Pond 7 due to staff availability, but the dredge was still in place in Pond 7. Three dewatering bags within the TDF adjacent to the water treatment plant had been filled with sediment from Pond 7 at the time of inspection (Photo 20). Dewatered sediment will be disposed within the TDF.

Photo 20. Dewatering bags containing sediment dredged from Pond 7. Located in the TDF east of the water treatment plant.

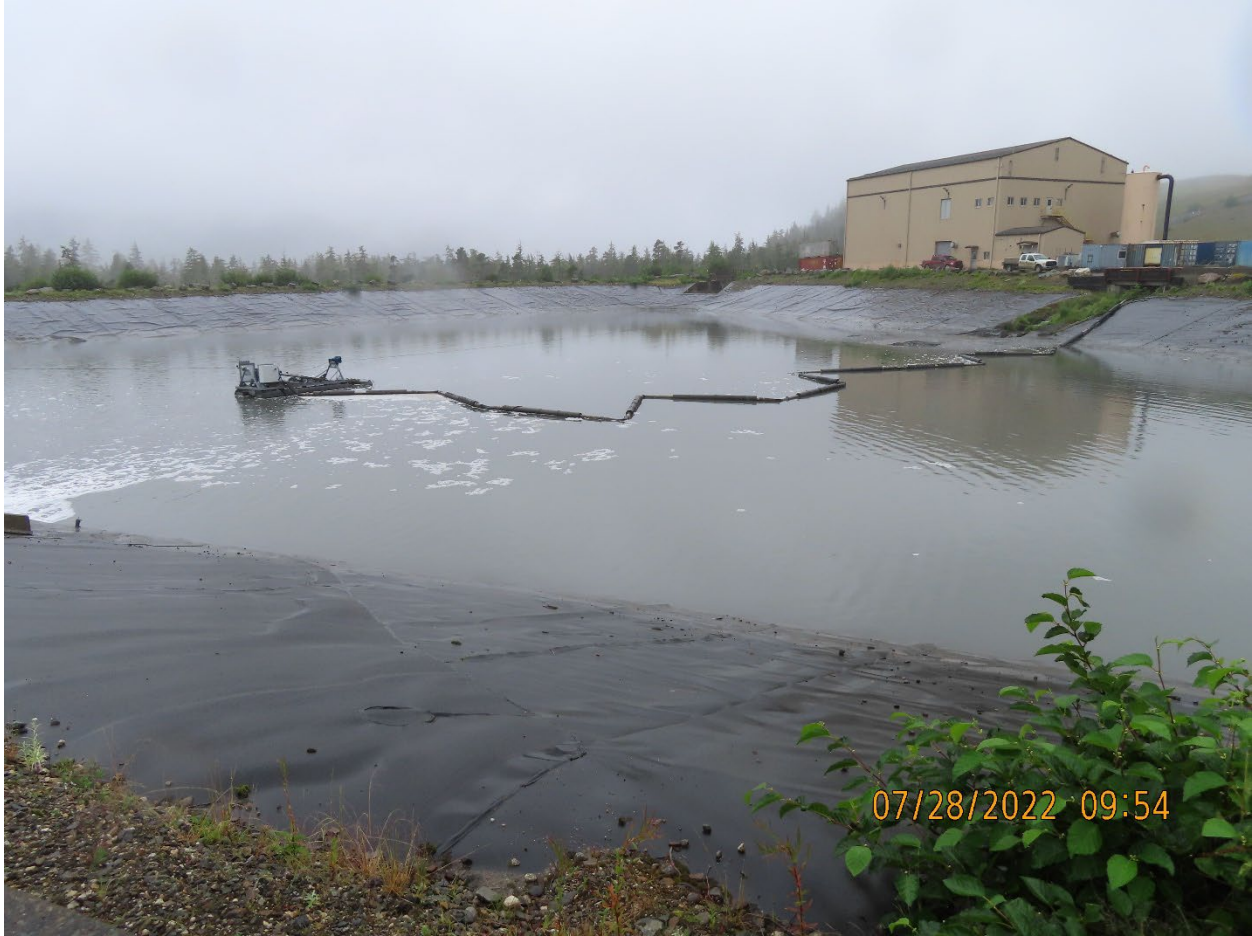
At the time of the inspection, Pond 7 (Photo 21) was collecting contact and process water, and Pond 10 (Photo 22) was not receiving water but contained a small amount from precipitation and its previous use to control water levels in Pond 7 to facilitate dredging activities.

Photo 21. Pond 7 receiving contact and process water. Dredge in photograph was not actively operating.

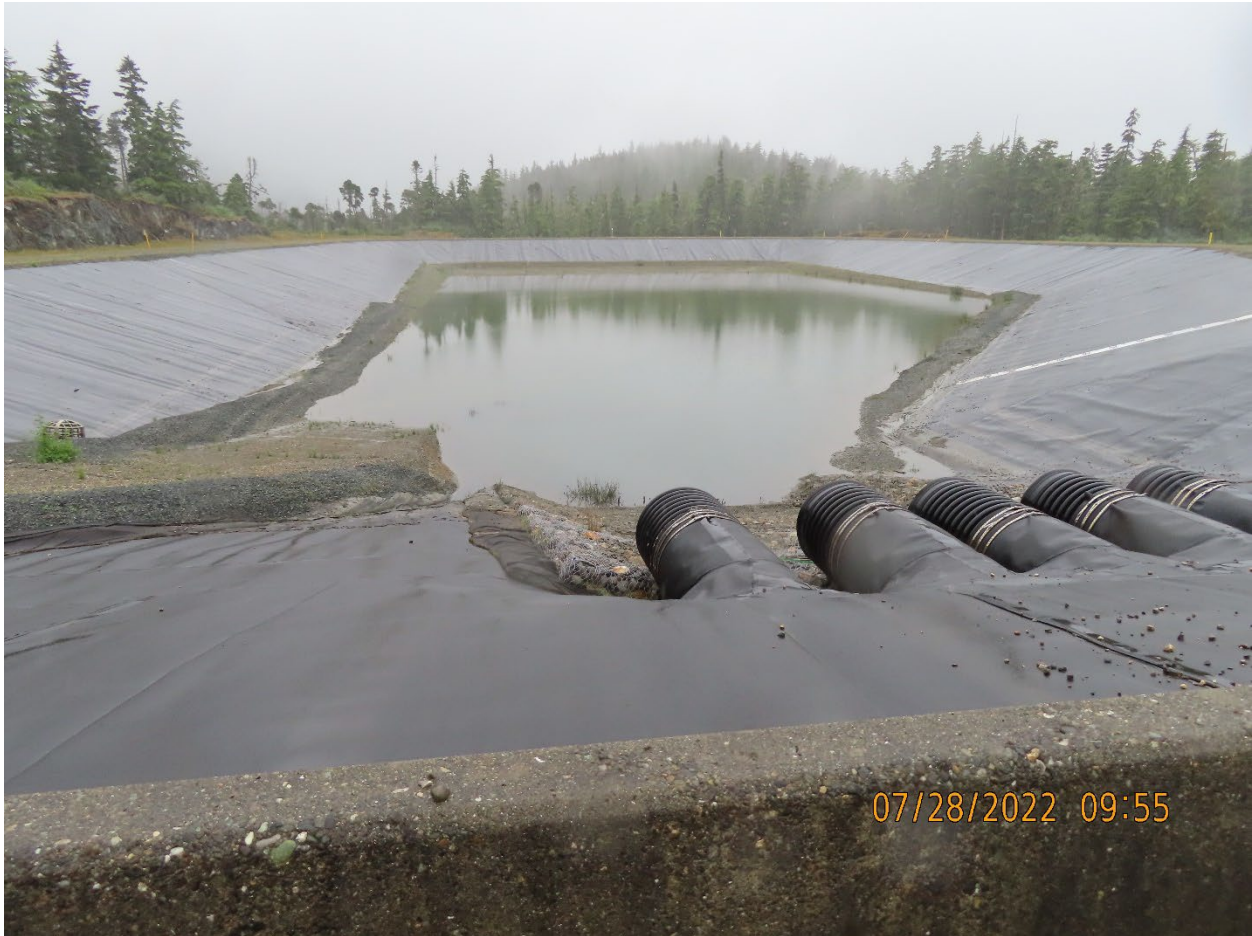
Photo 22. Pond 10 storing a small amount of water.
