INSPECTION REPORT: GREENS CREEK MINE

Date of Inspection: Wednesday, August 30, 2023
Date of Report: Monday, September 25, 2023.
USDA Forest Service Inspector: Richard Dudek

Ranger District: Admiralty National Monument, Juneau Ranger District
Weather Conditions: Partly cloudy and light rain. Temperature: Low 60's (°F).

The site inspection included the B access road, 920 area, 7.4-mile B-Road Bridge (Killer Creek Bridge), Site E, 3.4-mile B-Road bridge (Falls Creek Bridge), 3.0-mile B-Road bridge (Zinc Creek Bridge), and the Tailings Disposal Facility (TDF).

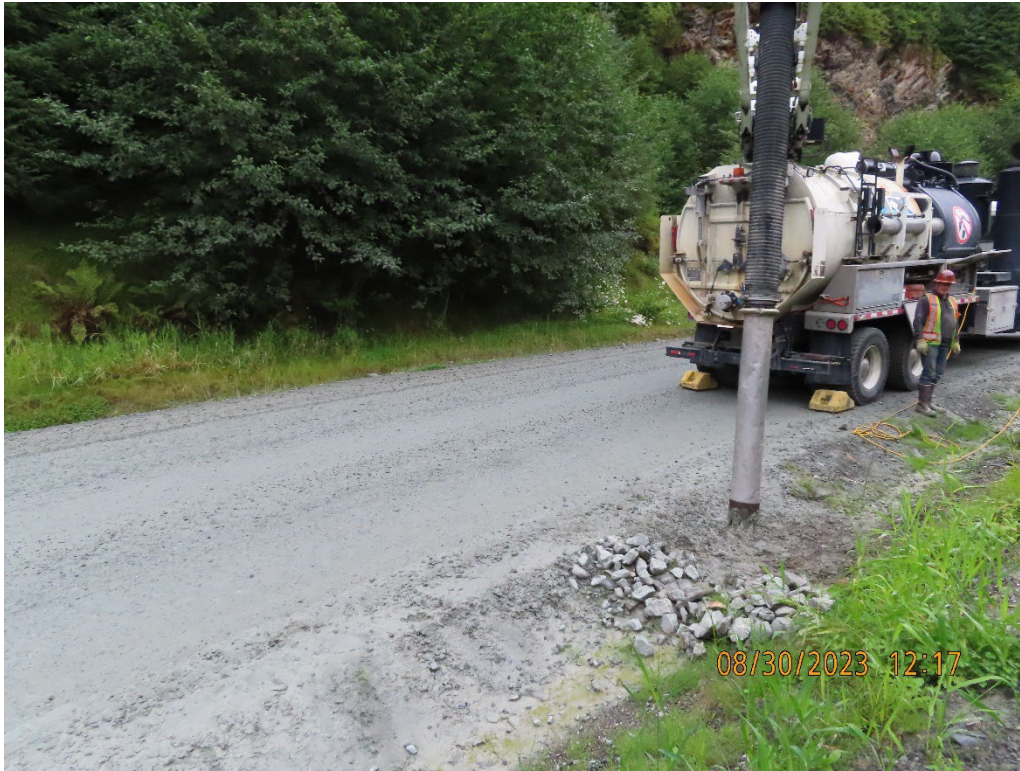
The B access road appeared to be in adequate condition. HGCMC Surface Operations personnel operated the vacuum truck to clean out the sediment sumps along the 3.3-mile marker B Road (Photo 1).

Photo 1. Surface Operations personnel cleaning sumps at the 3.3 Mile B Road.

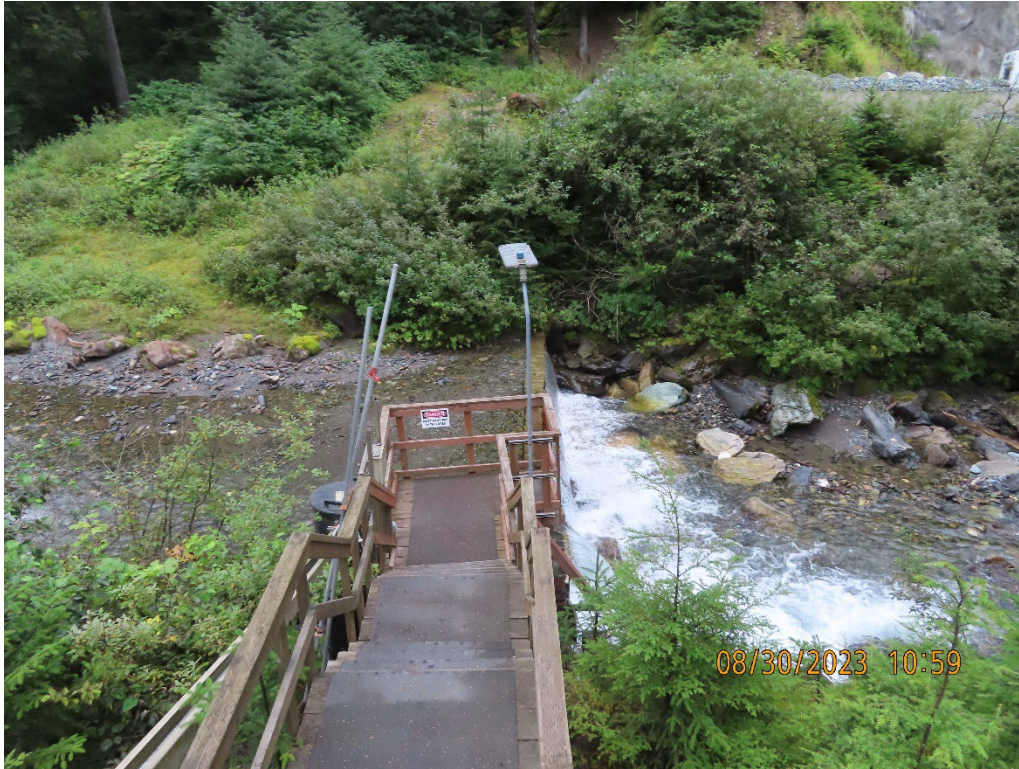
The Greens Creek weir discharge was 41 cfs (Photo 2), and 1.5 cfs was being withdrawn for the 920 facilities.

Photo 2. 920 Greens Creek Wier.

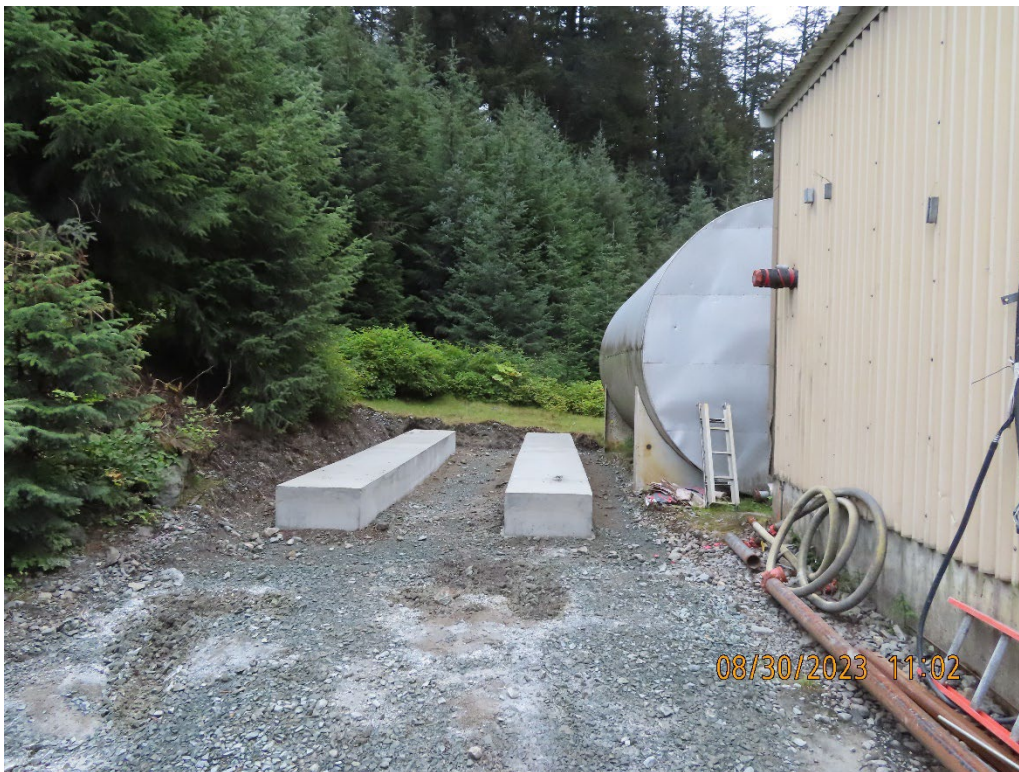
HGCMC will be installing an active carbon filter system next to the 920 pump house to help improve potable water quality for the 920 area (Photo 3).

Photo 3. The foundation blocks for the active carbon filtration system.

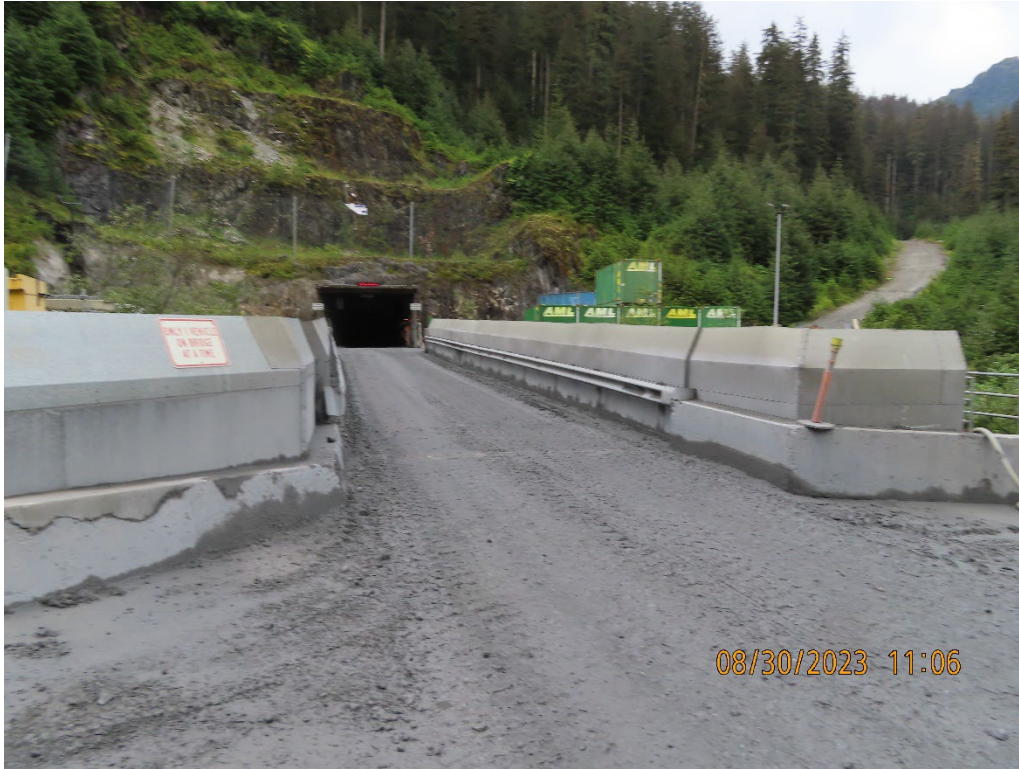
The 920 bridge was in good condition, and the splash guards functioned as designed (Photo 4).

Photo 4. The 920 Bridge.

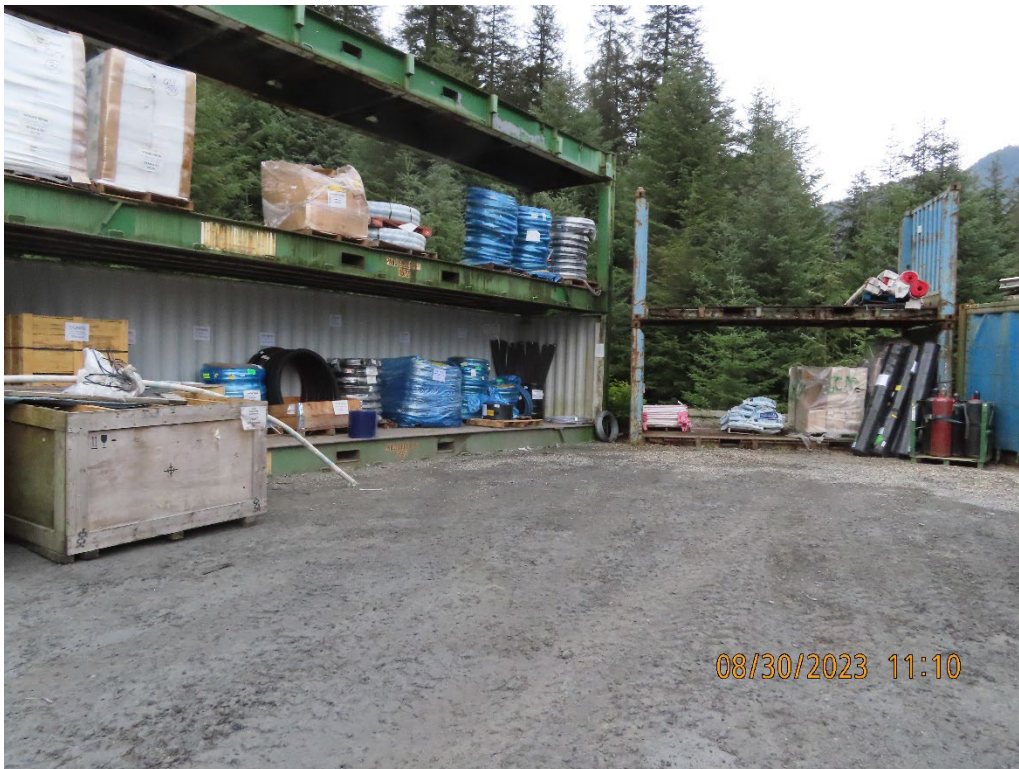
Good housekeeping practices were observed at the 920 warehouse (Appendix 5 BMP Plan, page 39). All petroleum/chemicals were stored adequately within secondary containment (Photo 5).

Photo 5. The 920 warehouse.

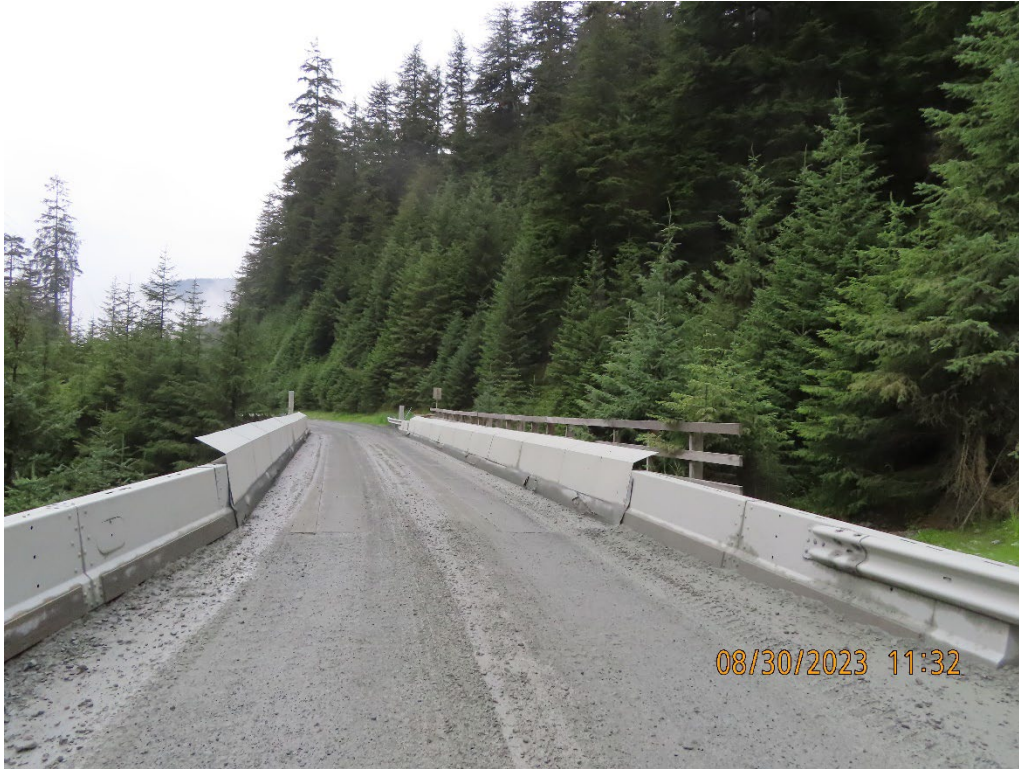
The Killer Creek Bridge decking was in good condition, and the associated BMPs were functioning as intended (Photo 5).

Photo 5. 7.4 B-Road Bridge (Killer Creek Bridge).

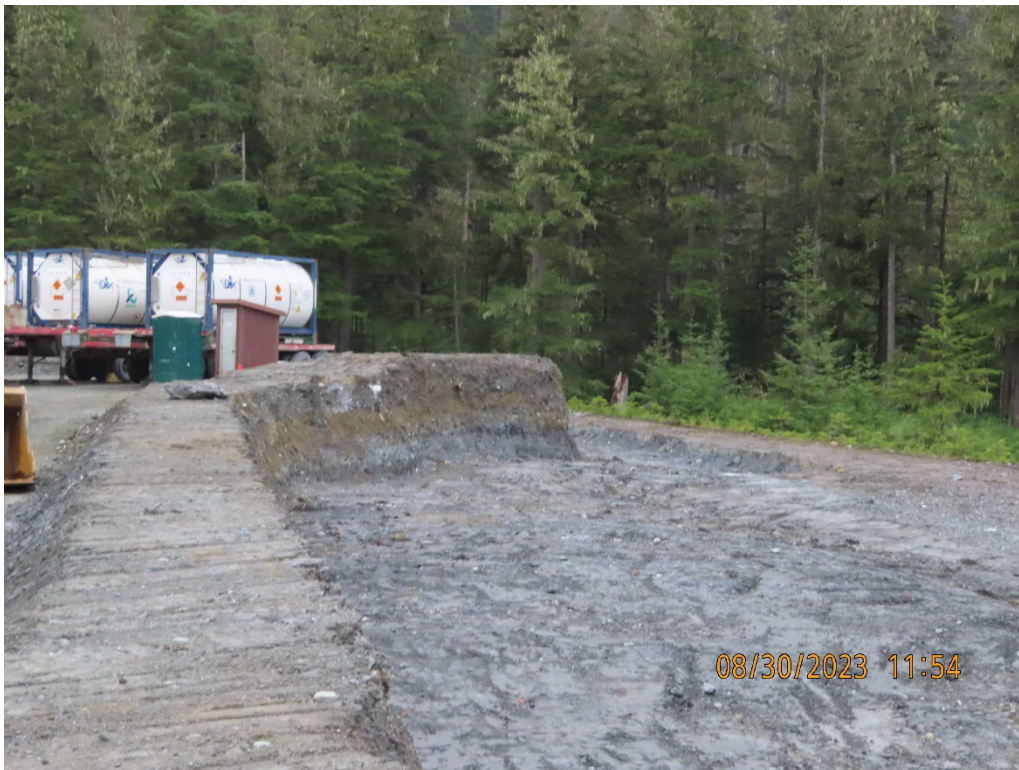
FY 2023, HGCMC has removed 32,695 tons (24,399 CY) of waste rock from this location and disposed of it in the TDF (Photo 6).

Photo 6. Waste Site E (4.7 mile B-road).

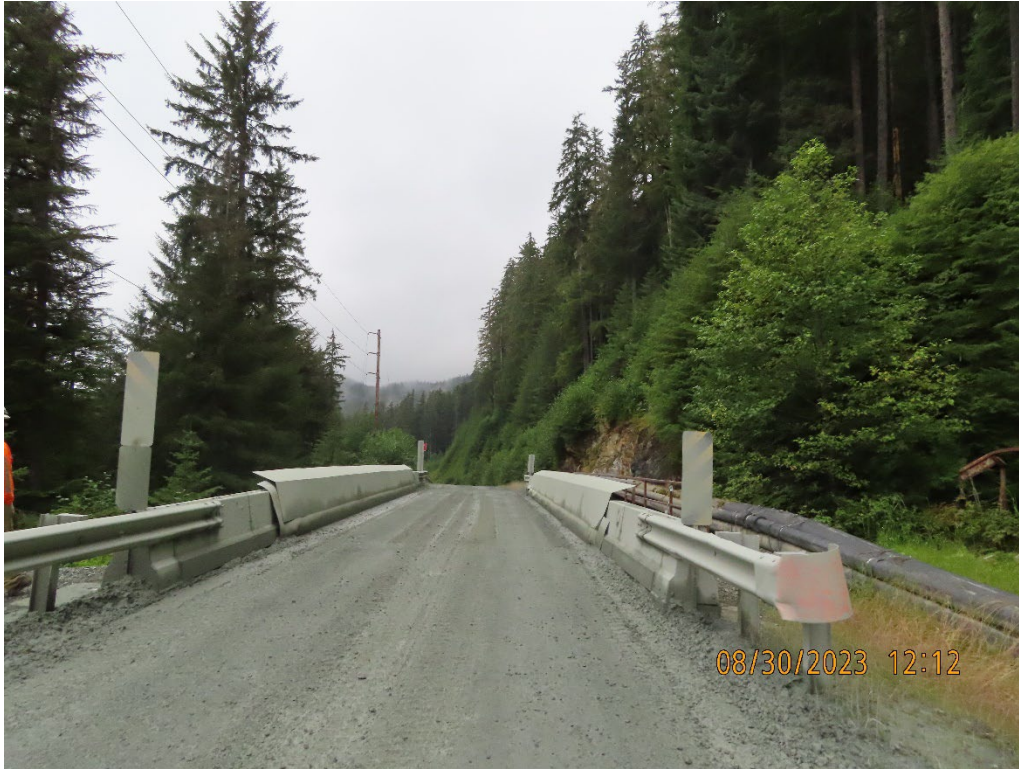
The bridge surface or wear layer was in good condition, and the splash guards worked as intended (Photo 7). The associated BMPs for the bridge were working as designed.

Photo 7. 3.4 B-Road Bridge (Falls Creek Bridge).

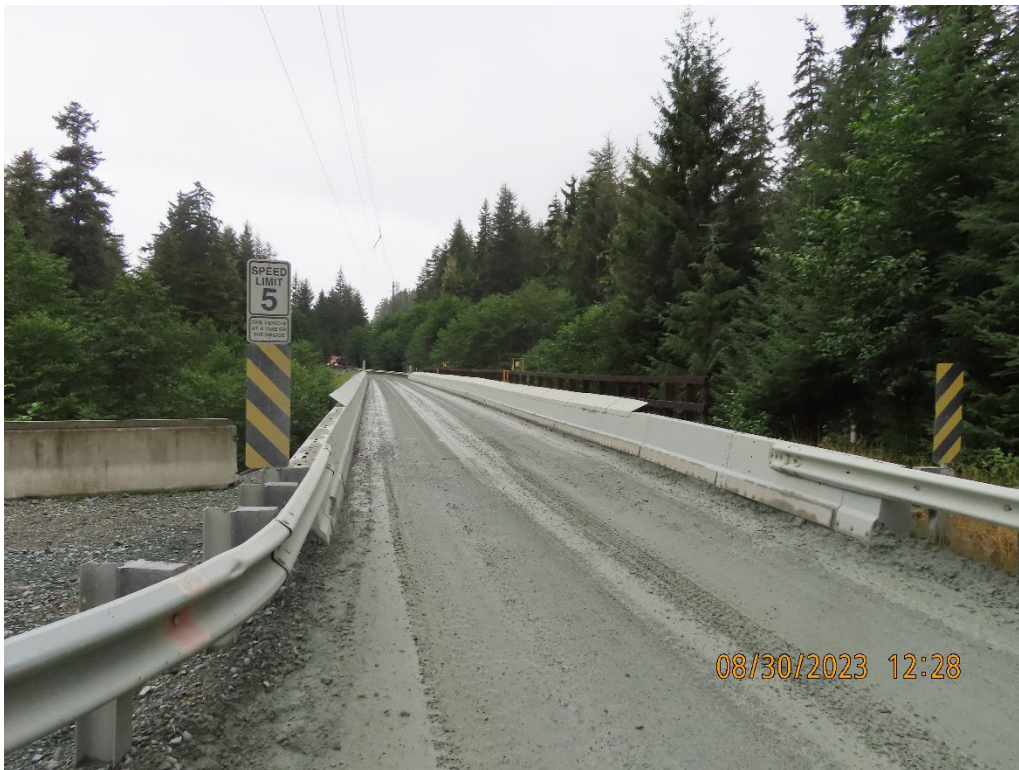
The Zinc Creek bridge was in good condition (Photo 8).

Photo 8. 3.0 B-Road Bridge (Zinc Creek Bridge).

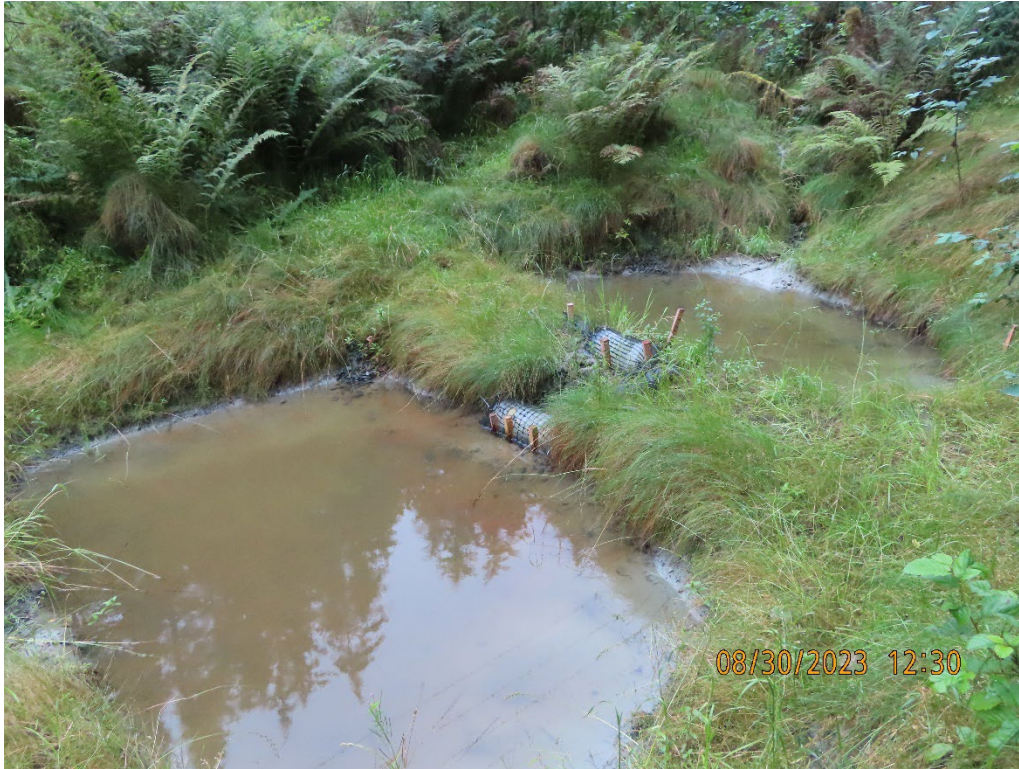
Over the summer, HGCMC installed several flocculant logs at the inlet of the Gnome pond. Since then, HGCMC personnel have observed that turbidity and sediment accumulation have decreased in the other connected ponds, including the Gnome Pond (Photo 9).

Photo 9. Zinc Creek Bridge abutment sediment ponds with Flocculant logs stage at the inlet of the first pond.

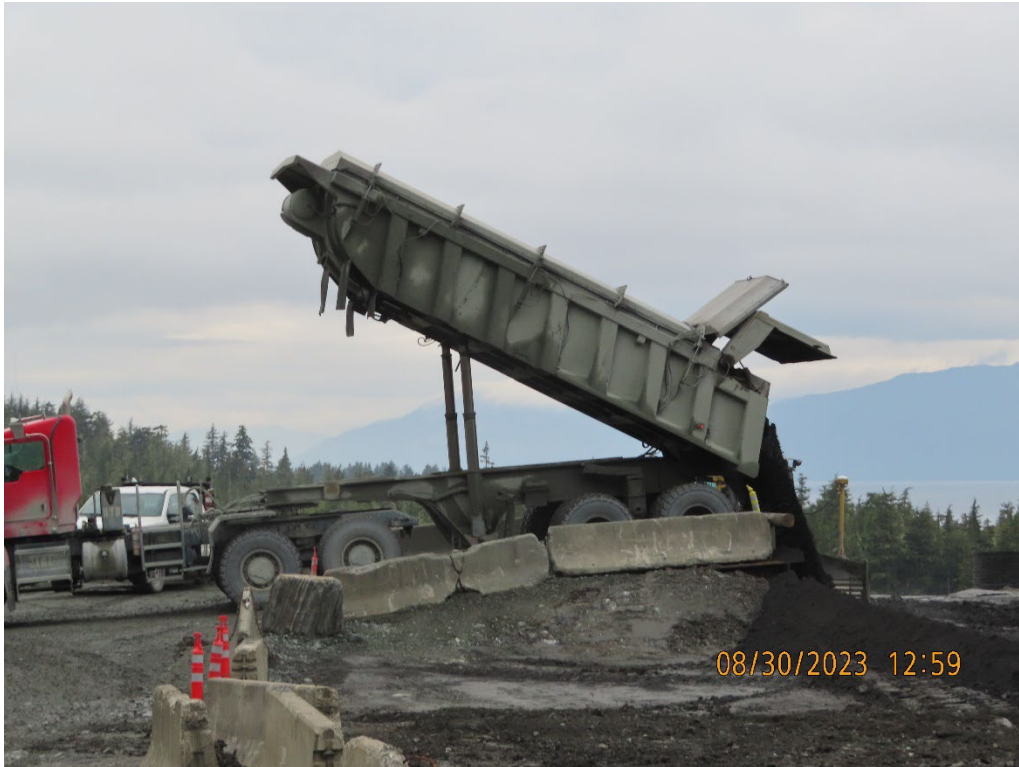
The current active tailings placement location was in the western section of the TDF's S3P1 area (Photo 10). HGCMC personnel plans to install new portable/adjustable dust screens at the TDF.

Photo 10. Max haul depositing tailings in the western section of the S3P1 TDF.

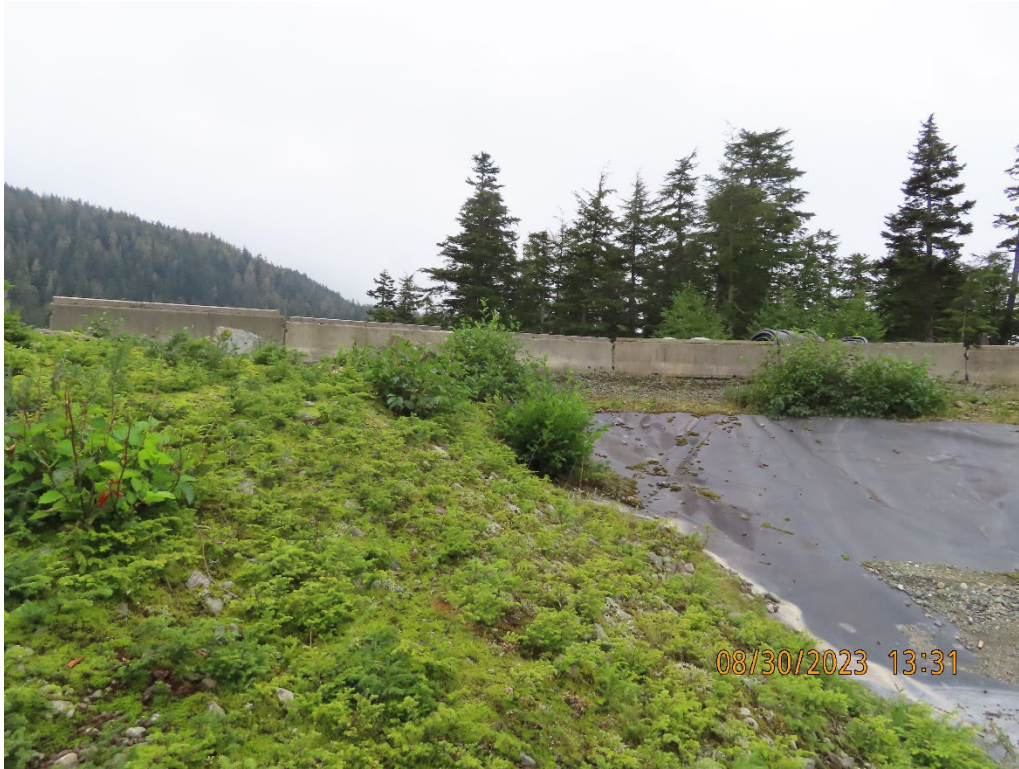
Pond 7 was receiving mine site water, and the dredge was not operating during the site visit. The perimeter of the pond's liner was also inspected to ensure vegetation was not growing through the 80 mm HDPE liner (Photos 11-12). Some small alders and small conifers are growing on top of the liner. However, their roots were not penetrating through the liner. HGCMC will contact the Forest Service to discuss ways to remove the vegetation safely.

Photo 11. The vegetation is seen growing around the perimeter of Pond 7, has a shallow root system, and is not growing through the liner.

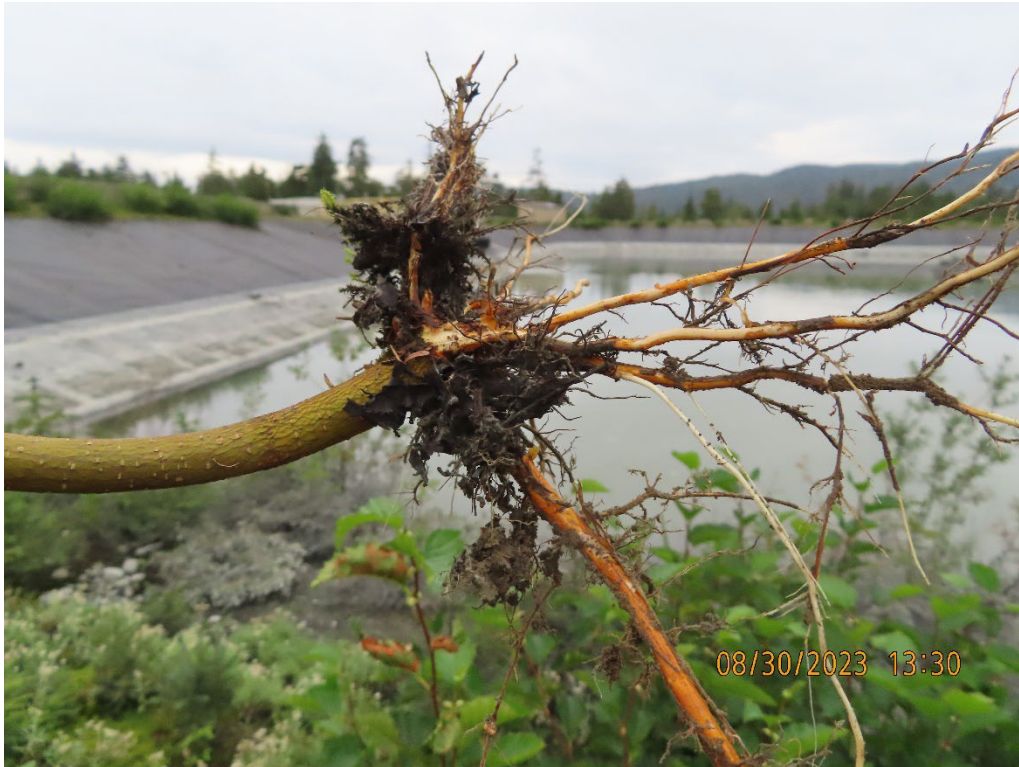
Photo 12. A pulled alder from the soil on top of the Pond 7 liner.

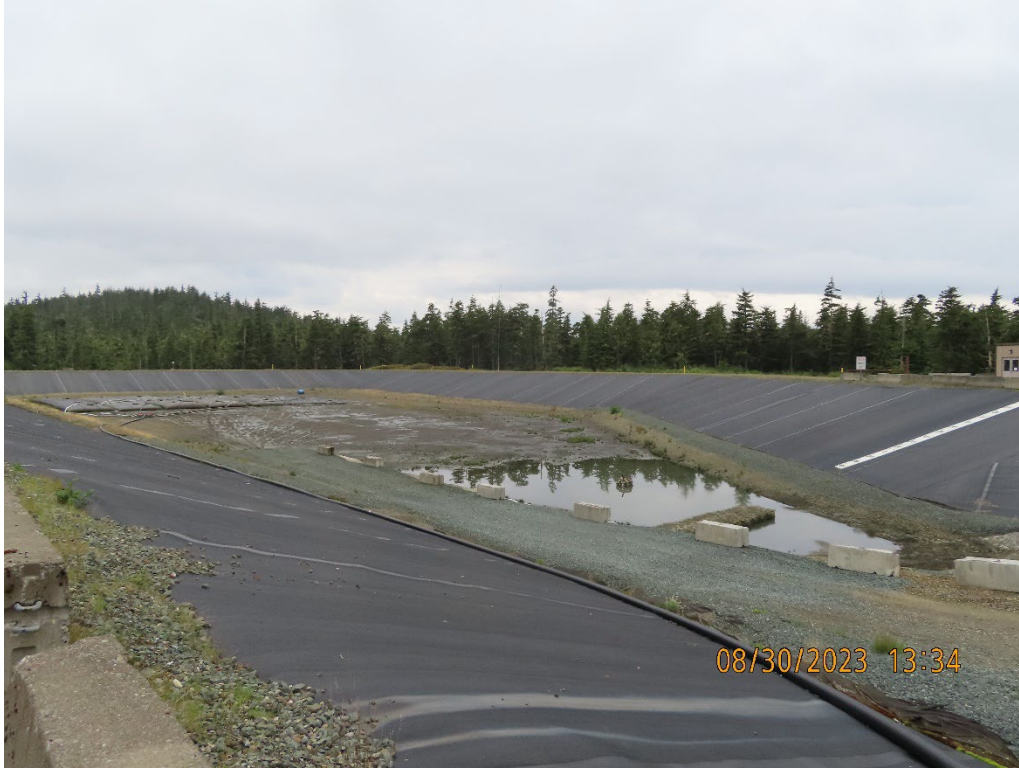
Photo 13. Pond 10.

Seven dewatering bags are staged in Pond 10 (Photo 13). Two of the seven bags are currently collecting sediments from the Pond 7 dredging activities. Once the 2023 dredging operations have ceased, a contractor will be on-site to dispose of the sediments in the TDF.

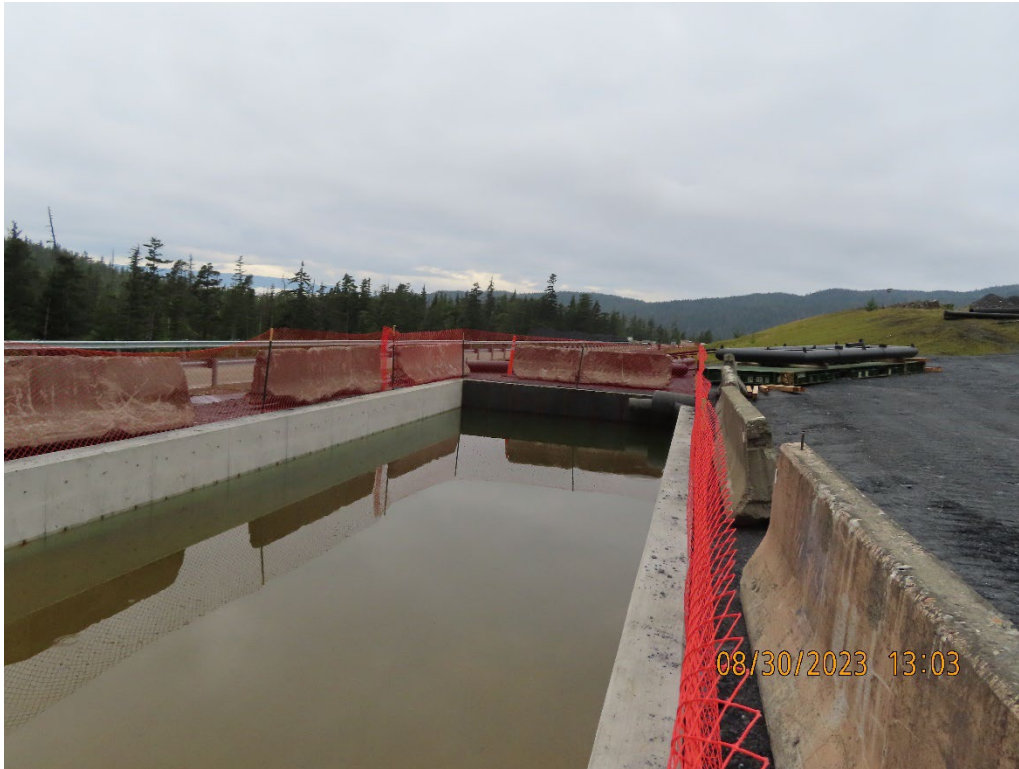
The new degrit basin in the TDF's S3P1 southwest area was collecting sediment-laden water from the tailings pile (Photo 14).

Photo 14. TDF de grit basin.
