DEPARTMENT OF ENVIRONMENTAL CONSERVATION

FIELD INSPECTION REPORT HECLA GREENS CREEK MINING COMPANY

Inspection Date: July 31, 2012, 8:00 AM – 3:45 PM

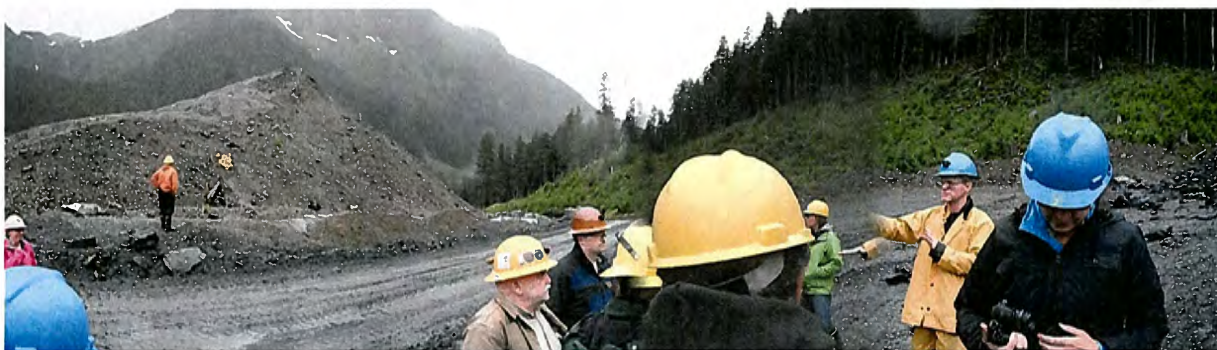
A pile of waste rock from the 1350 area is staged within lined containment at Site 23. This waste contains some Class IV acid producing and metals leaching rock. It has been mixed with lime prior to placement onto the lined pad at Site 23. The staging area is at full capacity. The current plan is to dispose this waste underground when space becomes available. Space at both tailings and underground sites is limited for the disposal of anything other than tailings. Work to extract waste rock from all of the inactive sites is curtailed because of this.

Site 23. Note contained stockpile of Site 1350 waste rock on left

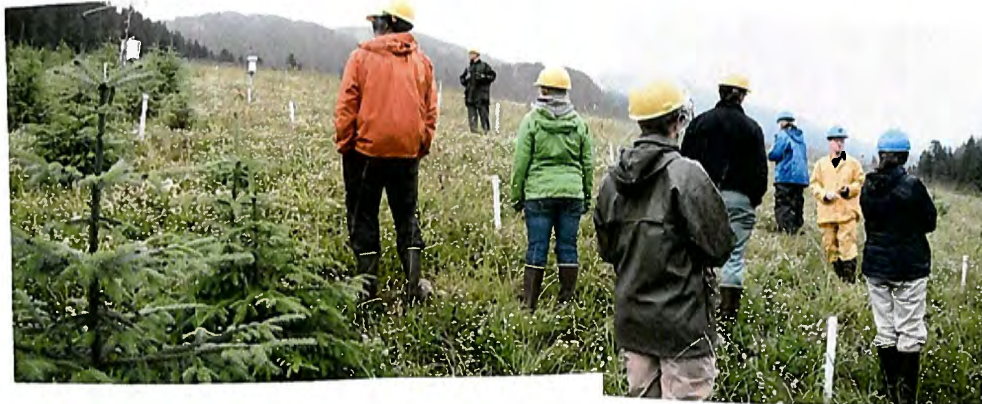
We stopped briefly at the Site 23 test plot at the lower end of Site 23 where the cover system was explained. The barrier layer continues to remain saturated at greater than 85% for the monitoring period. This implies the oxygen diffusion coefficient was minimized thus minimizing ingress of atmospheric oxygen through the barrier layer. However, water continues to flow through the barrier layer at a higher rate than modeled and would have the effect of producing an increased volume of leachate in the final closure configuration for both Site 23 and the Tailings Disposal Facility. The current design modified with a barrier layer with a lower hydraulic conductivity could result in a more effective design. Increasing the growth medium thickness from 2 feet to 1 meter may further protect the underlying capillary break and barrier layer from exposure by windthrow (blow down or uprooting of large, mature trees). This should be included.

The studies of the cover system conducted to date indicate the cover system will function to prevent the effects of freeze/thaw or windthrow. However, HGCMC has not provided details or considered the design of the cover system at the periphery of the landfill. Tree blow-down may be more of a concern at the leading edges of the fill where uprooting of trees may more likely occur and where the cover system is most sensitive to oxygen entry. The toe of the fill is where springs and run-off control devices will be located and where the cover system will also be required to limit the entry of air. Therefore special importance should be placed on how the cover system is designed, constructed and monitored at the toe of the fill. HGCMC is complimented in this inspection report with the work that has been accomplished to study cover system performance. Since there is a lack of experience with these cover systems there continues to be a lack of information with regard to conifer growth and blow-down. Unfortunately, the Oregon and O'Kane work did not bring attention to the lack of information having to do with how to construct the final configuration at the leading edges.

Several opportunities exist for imperfection of the cover system during installation (i.e. construction methods, variations in materials, etc) and afterwards (e.g. tree blow-down, erosion, freeze/thaw, etc) that could allow oxygen to enter. A cover system with an incomplete seal can allow airflow into the pile through convection or diffusion. The piles are also especially vulnerable to an incomplete seal at the toe of the fill because of tree blow down and erosion as mentioned above. Various other ways for air to enter or leave the pile exist by advection due to thermal gradient, wind pressure and barometric pumping. Temperature differences between the pile and outside air can also influence the direction of air flow as mentioned above. The installation of monitoring devices below the cover system that measure oxygen concentration profiles at selected locations within the tailings and waste rock landfills would be useful. The measurement of net neutralization potential (NNP) and pH would also be useful if an oxygen front was found to be moving through the pile (by way of regular analysis of oxygen as mentioned above). HGCMC is considering the development of a modified test plot on the tailings disposal facility that will likely include but not be limited to a

Test Cover System at Site 23. Note volunteer conifer growth and monitoring probes. Also note clover and grass growth on the cap. Deer and bear are excluded by an electric fence that surrounds this test plot

thicker growth layer and barrier layer with a lower hydraulic conductivity. Monitoring for oxygen, NNP and pH beneath the barrier layer would be useful and is recommended.

7. Provide details of the cover system at the periphery of the landfill in the final cover design.
8. HGCMC is considering the development of a modified test plot on the tailings disposal facility that will likely include but not be limited to a thicker growth layer, and a barrier layer with a lower hydraulic conductivity. Monitoring for oxygen, NNP and pH beneath the barrier layer is needed in the design.

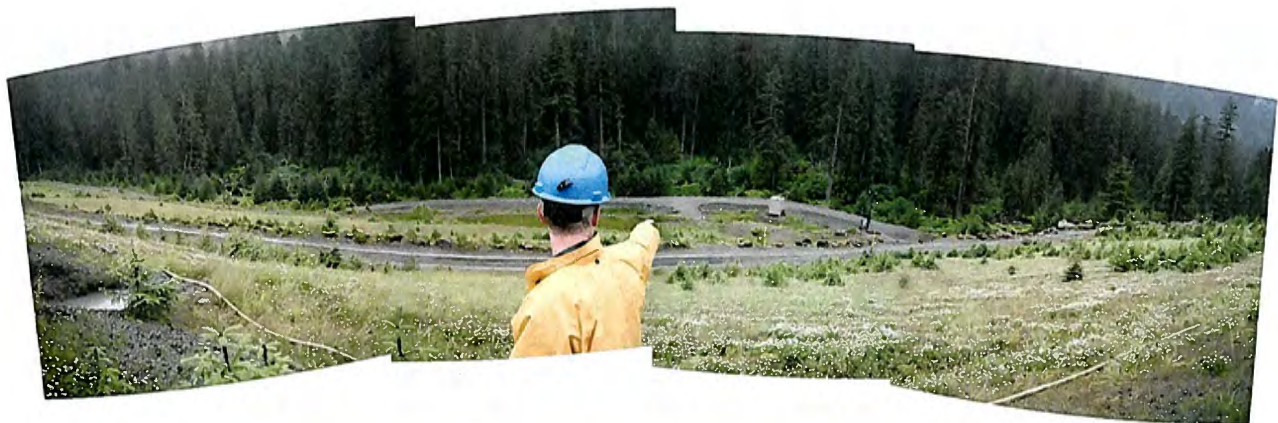
HGCMC has requested, and ADEC would like to see a new compliance monitoring station downstream of Site 54 below the confluence of Gallagher Creek. This station is needed to identify the highest concentration of hazardous constituents migrating from the facility and whether or not contamination from Site 23/D has any effects on the down-gradient surface water environment. The station should be carefully selected and approved by ADEC in order to ensure that it is effective in catching seepage from both Sites 23 and D. The results of a 3-part survey started in the summer of 2011 to identify a new station have been completed and were presented at the annual meeting. ADEC, the USDA Forest Service and HGCMC will meet soon to discuss the new information and to identify the new monitoring station.

Site D. Note the area to the right near Greens Creek will be a potential location of a new surface water monitoring station

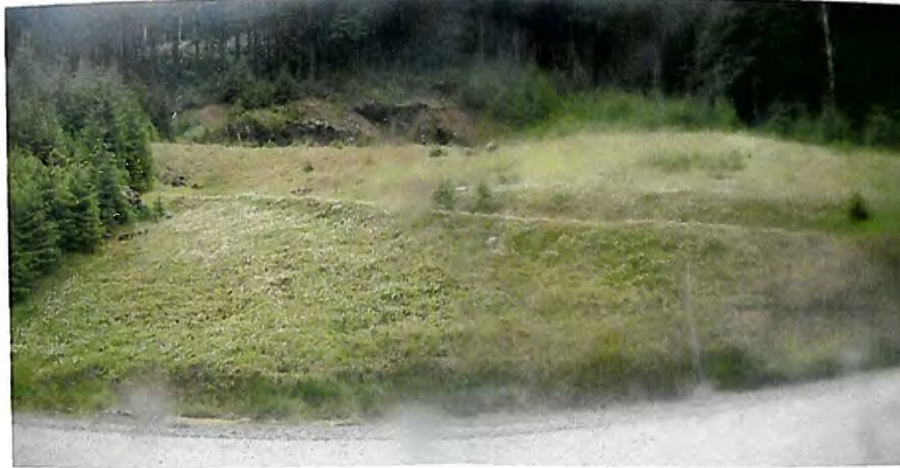
We stopped briefly at Pit 405 which is located at 7.6 mile on the B Road. The rock from this quarry was used for construction of the B Road and other mine infrastructure. Mine records indicate that approximately 13,000 cubic yards of production rock were backfilled into the quarry in 1988. The

quarry received reclamation materials (colluvium and glacial till) in 1994, 1995 and 1998 for use in future reclamation projects. The waste in Pit 405 is pyritic although monitoring of drainage downgradient of the quarry demonstrates that influences from the site are negligible. According to the annual report the production rock in the quarry is suggested to be either removed or covered in-situ. This is yet to be determined. Removal of the rock could be problematic as this would increase exposure of the now covered pyritic quarry wall. Reclamation costs should include the cost to remove waste from this site.

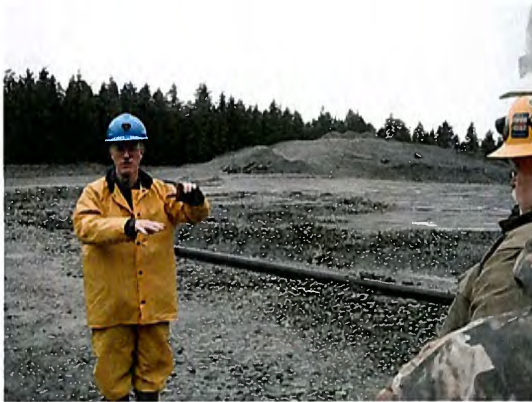
Site E: We stopped briefly at Site E. Approximately 365,000 cy of waste rock was disposed at this site of which about 200,000 cy was acid generating and metals leaching. This will eventually be moved to the tailings facility. Approximately 85,000 cy have been removed so far at around 40,000 cy a year. Until there is an approval for the tailings expansion the amount of material removed from the site will be minimal in order to give preference to tailings from mill operations. The contact water sump was approximately half full and appeared to be functional.

Site E: Approximately 85,000 cy removed

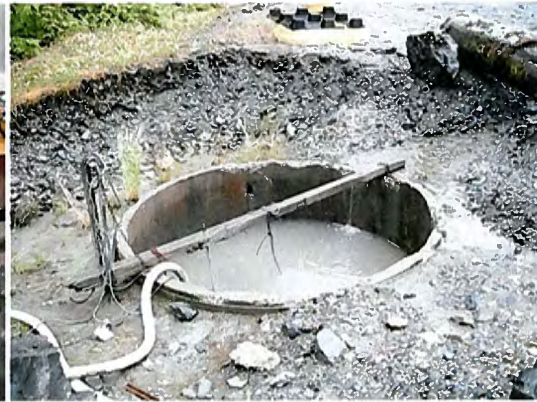
Contact water sump

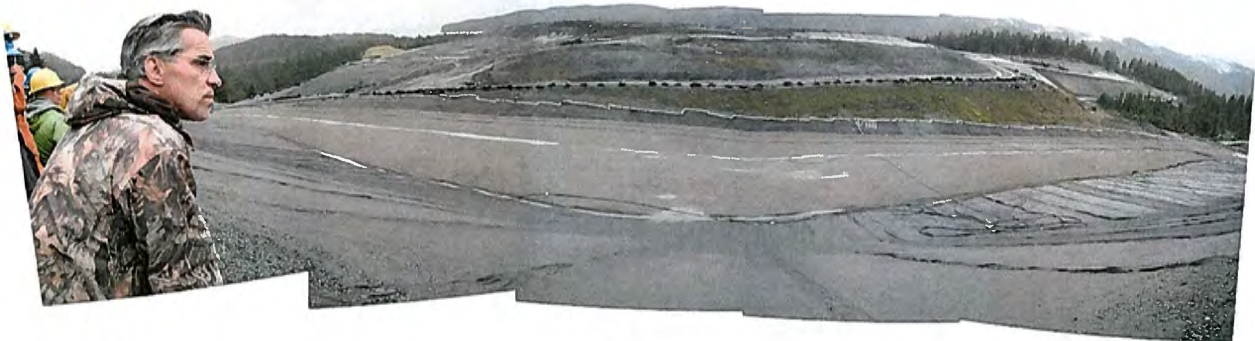
The East Ridge Expansion Area has not yet been used for tailings disposal. HGCMC is waiting for drier weather conditions (i.e., spring) for disposal. Since the shape of the East Ridge area is currently concave, HGCMC would like to place tailings during the driest time of year so that water does not pond. The goal would be to fill it as quickly as possible up to the point that it can more easily shed water, not to its full capacity. A drain in the east expansion area that conducts contact water to Pond 9 was not operational. This will need to be repaired prior to placing tailings in this area.

Tailings Disposal Facility: East Ridge Expansion Area

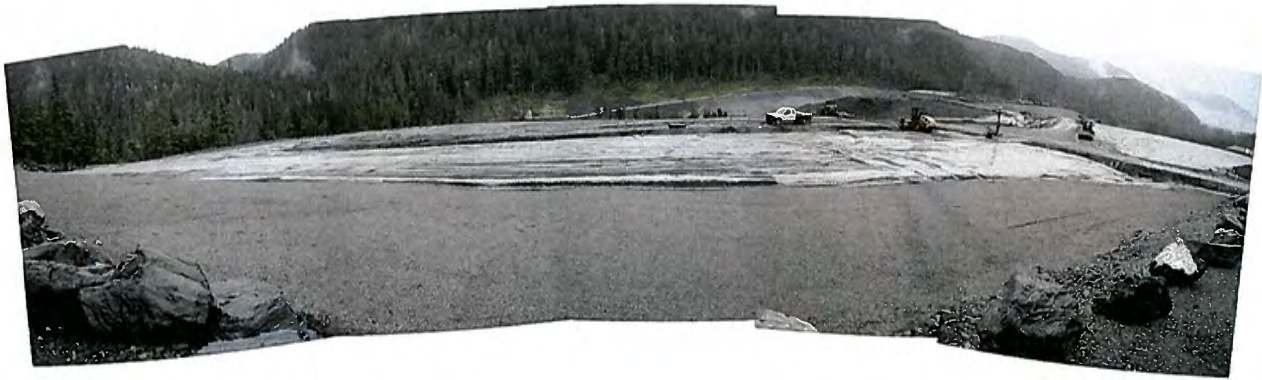
Currently tailings are being placed in the Northwest Pit 5 expansion area. HGCMC placed tailings using the specific criteria established by Klohn Crippen Engineering in 1999 using cellular configurations and compaction standards.

Tailings Disposal Facility: Northwest Expansion area- active placement taking place
