## I. Introduction

This 2010 Best Management Practices (BMP) and Storm Water Report is submitted by Hecla Greens Creek Mining Company (HGCMC) pursuant to Sections II.F.1 and II.F.2 of NPDES Permit AK-004320-6, effective 1 July 2005. Authority over the federal permitting, compliance and enforcement NPDES program transferred to the State (ADEC) in November of 2010 for the mining industry. The Report summarizes the scope and dates of the comprehensive site compliance inspections/evaluations, major observations related to implementation of the BMP Plan, corrective actions taken as a result of the inspections/evaluations, identification of potential incidents of noncompliance as they pertain to the BMP Plan, description of the quantity and quality of the storm water discharged, and BMP Plan modifications made during the year. The final section of this report contains the required annual certification under Section II.F.2.

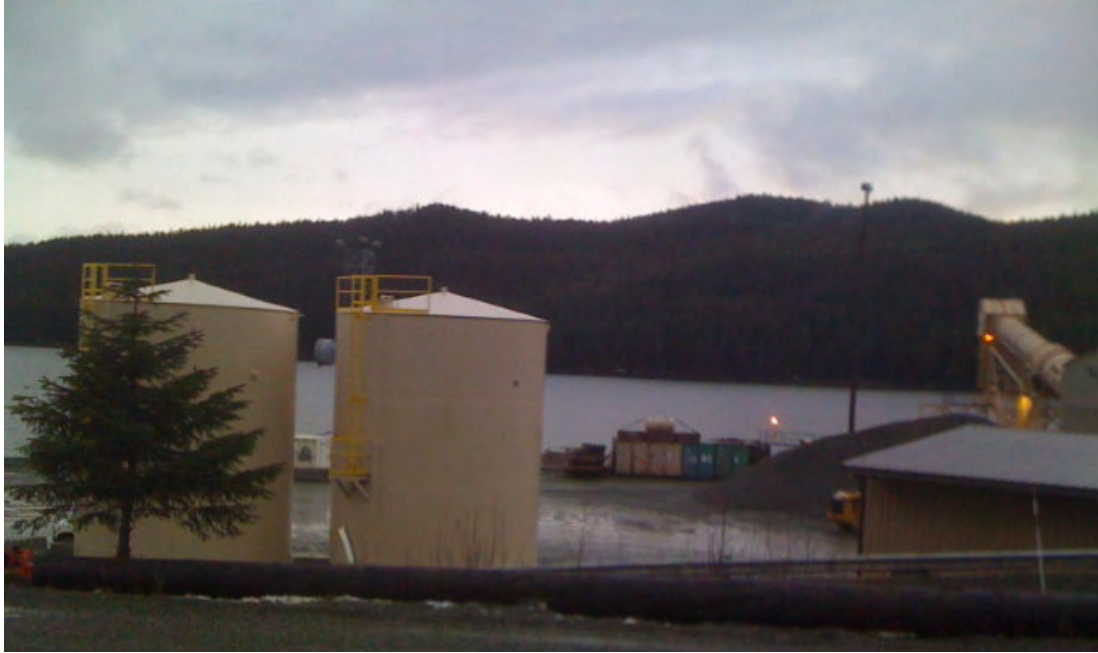
Additional sampling of contributing flows to this outfall in 2009 had found a number of small seeps with elevated metal concentrations from waste rock foundation areas. Investigations into capturing these small seeps and rerouting them to containment led to a storm water containment improvement project at Hawk Inlet. It was determined that in order to capture the seeps and the water reporting to Outfall 003, the storm water collection capacity at Hawk Inlet needed to be expanded. In 2010, two 93,000 gallon water storage tanks were installed adjacent to the existing degritting basin (DB04) at Hawk Inlet. Tanks in this location are meant to disturb the least amount of useable space (vertical tanks minimize footprint). The tanks will also provide storm surge storage capacity. Water will be pumped from these tanks to the water treatment plant.

In 2010, primary construction elements for this project included subgrade excavation, grading, concrete forming and pour, placing the tanks onto the pad, and mechanical connections for filling and draining the tanks. See Photo 1 of the two new tanks at Hawk Inlet. In 2011, minor piping and mechanical work on the tanks will be completed, and a network of small seepage collection sumps with pumps will report to a runoff diversion collection system to collect the seepage and the Outfall 003 waters, and route these flows to the tanks.

PHOTO 1. Hawk Inlet Storm Water Collection Tanks; Fall, 2010

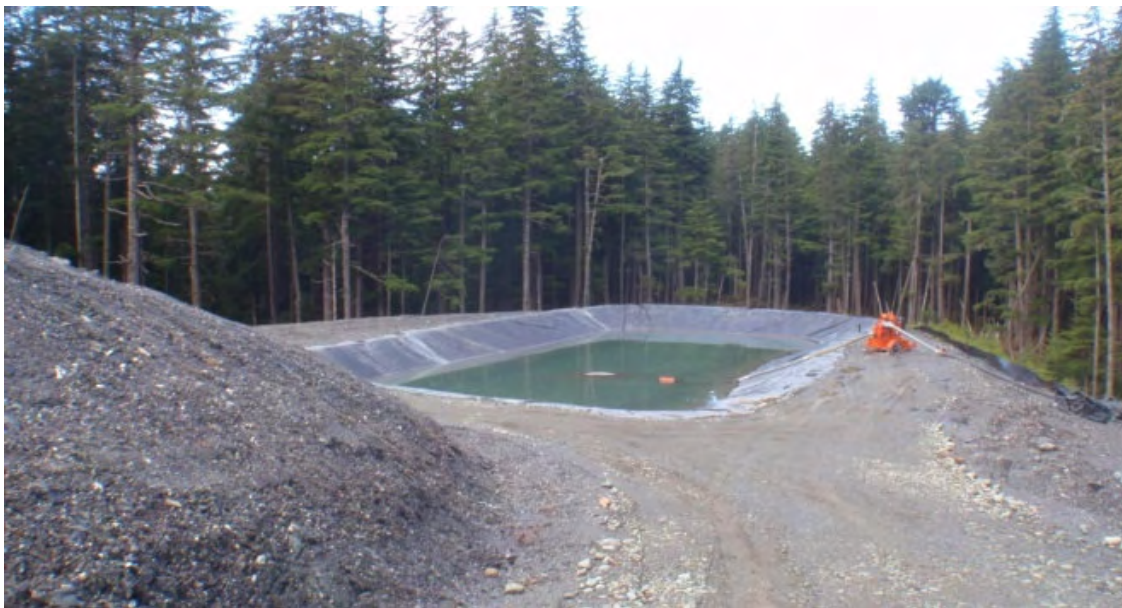
Approximately 40,000 cubic yards of waste rock was removed from Site E in 2010. The waste rock from Site E was hauled to the tailings facility area, and codisposed of with tailings. A 0.9 ac-ft water collection pond was constructed in June 2010 at the north end of the site (see Photo 2). The pond collection area is about 3.6 acres and was designed to collect flow for a 3-inch/24-hr rain event. The pond is lined with 36-mil RPP liner bedded with approximately 6 inches of sand cushion. A 4-inch Godwin diesel pump is located at the pond and operates with manual on/off control when active removal is occurring to route collected water through a 6-inch HDPE pipe to the existing storm pipe system along B-Road, which then flows to the water treatment plant. The plan for Site E in 2011 is continued removal of waste rock for codisposal with tailings.

PHOTO 2. Site E Water Collection Pond, Completed and in use; October 2010

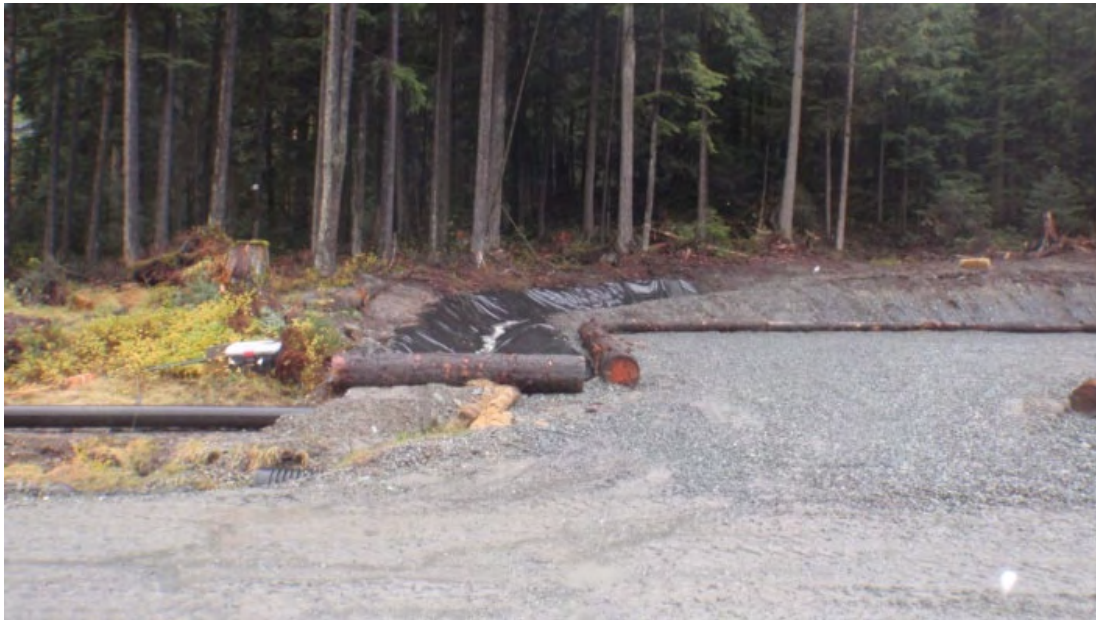
HGCMC constructed a diversion ditch to divert clean, upgradient noncontact water from entering Pond C. This will minimize the volume of water routed to treatment, as well as decrease the chance for storm water discharge from this area during large storm events. A parking pad was constructed, with the installation of a lined diversion drainage channel on the upgradient side of the pad to convey the western portion of the backslope surface diversion directly into Bruin Creek while avoiding any mixing with contact waters from the 920 area (see Photo 3).

PHOTO 3. Pond C Noncontact Water Diversion Ditch and Parking Pad, September 2010

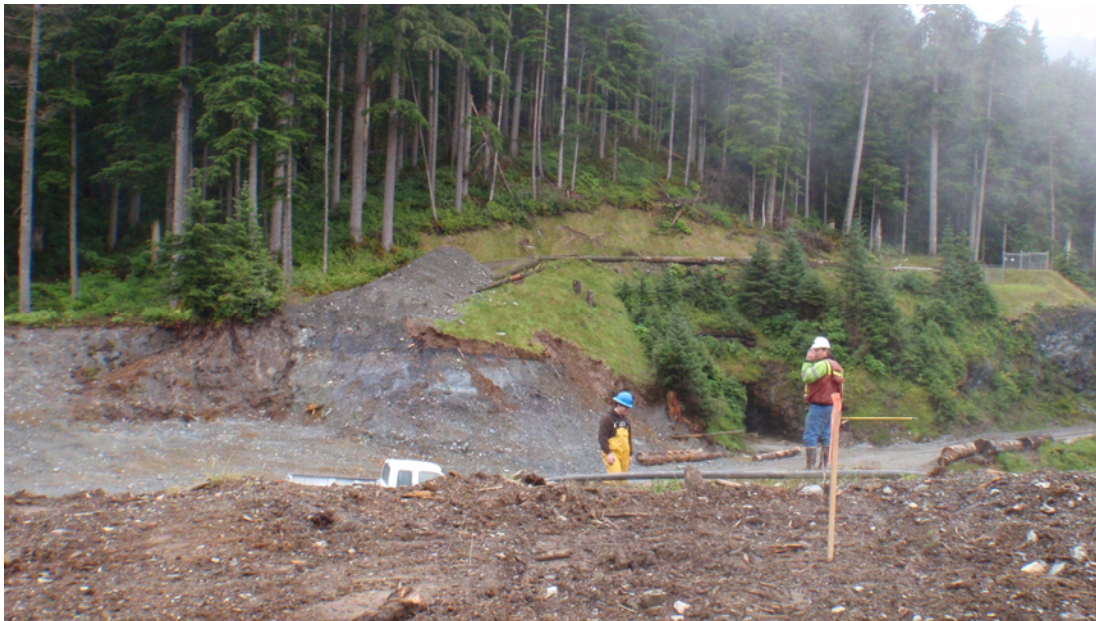
Approximately 9,000 cubic yards of waste rock was removed from the 1350 site in 2010 (See Photo 4). Proposed haulage for 2011 is 25,000 cubic yards. Along with removal activities, there will be continued grading efforts to ensure that contact water from this area is routed to collection at the 1350 portal. Material from this site is transported to the temporary holding pad at Site 23, and taken underground for permanent disposal when void space becomes available.

PHOTO 4. Site 1350 Removal Area Near Portal; August, 2010
