I. Introduction

This 2012 Best Management Practices (BMP) and Storm Water Report is submitted by Hecla Greens Creek Mining Company (HGCMC) pursuant to Sections II.F.1 and II.F.2 of NPDES Permit AK-004320-6, effective 1 July 2005. Authority over the federal permitting, compliance and enforcement NPDES program transferred to the State (ADEC) in November of 2010 for the mining industry. The Report summarizes the scope and dates of the comprehensive site compliance inspections/evaluations, major observations related to implementation of the BMP Plan, corrective actions taken as a result of the inspections/evaluations, identification of potential incidents of noncompliance as they pertain to the BMP Plan, description of the quantity and quality of the storm water discharged, and BMP Plan modifications made during the year. The final section of this report contains the required annual certification under Section II.F.2.

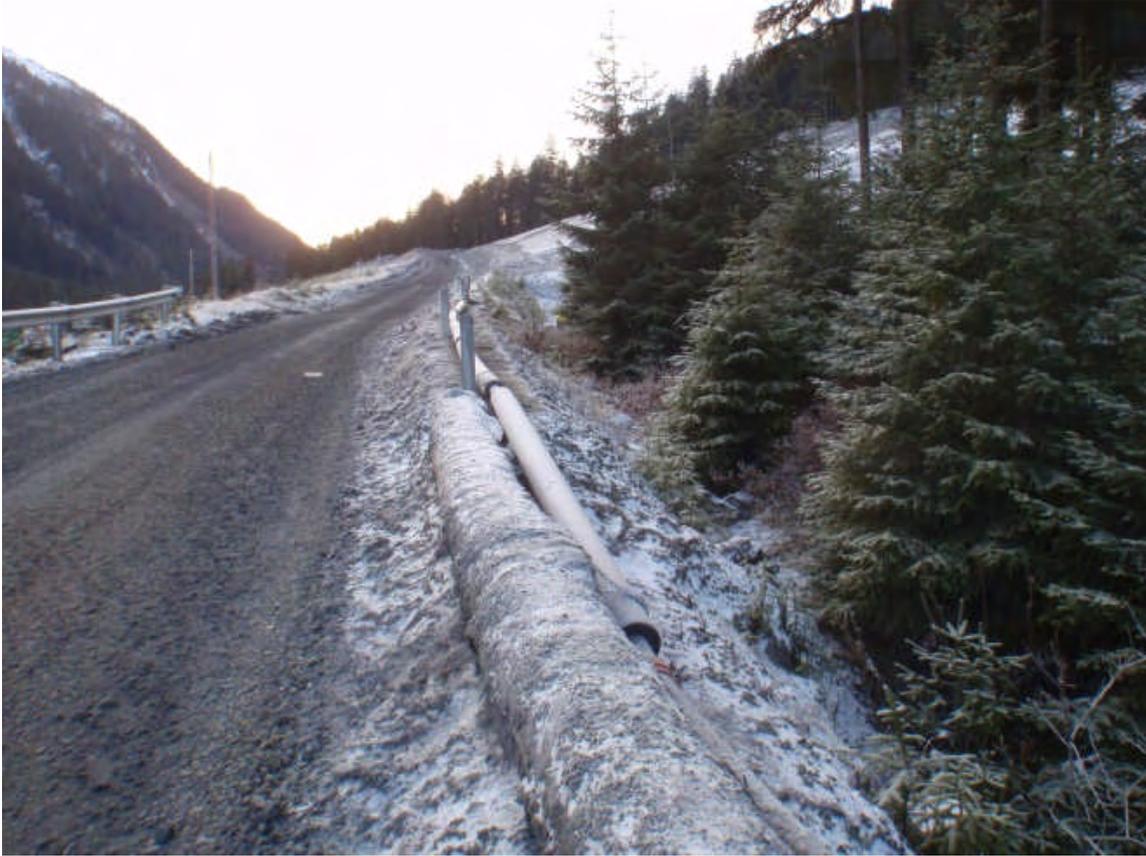
During 2012, arctic pipe and heat trace were installed on the upper Pond C discharge line that transmits water to the Site 23 ditch (see Photo 1). The headwall for the discharge pipe that collects the noncontact water flows above the 860 Pad was also installed during 2012. Flows are being tracked from the upper Pond C discharge; however, due to the backflow valve release for freeze protection (which discharges the line back up to upper Pond C during the pump's off cycles), accurate tracking of total volume pumped does not exist.

PHOTO 1. Insulation for C Pond Pipeline above B Road, in progress, November 2012

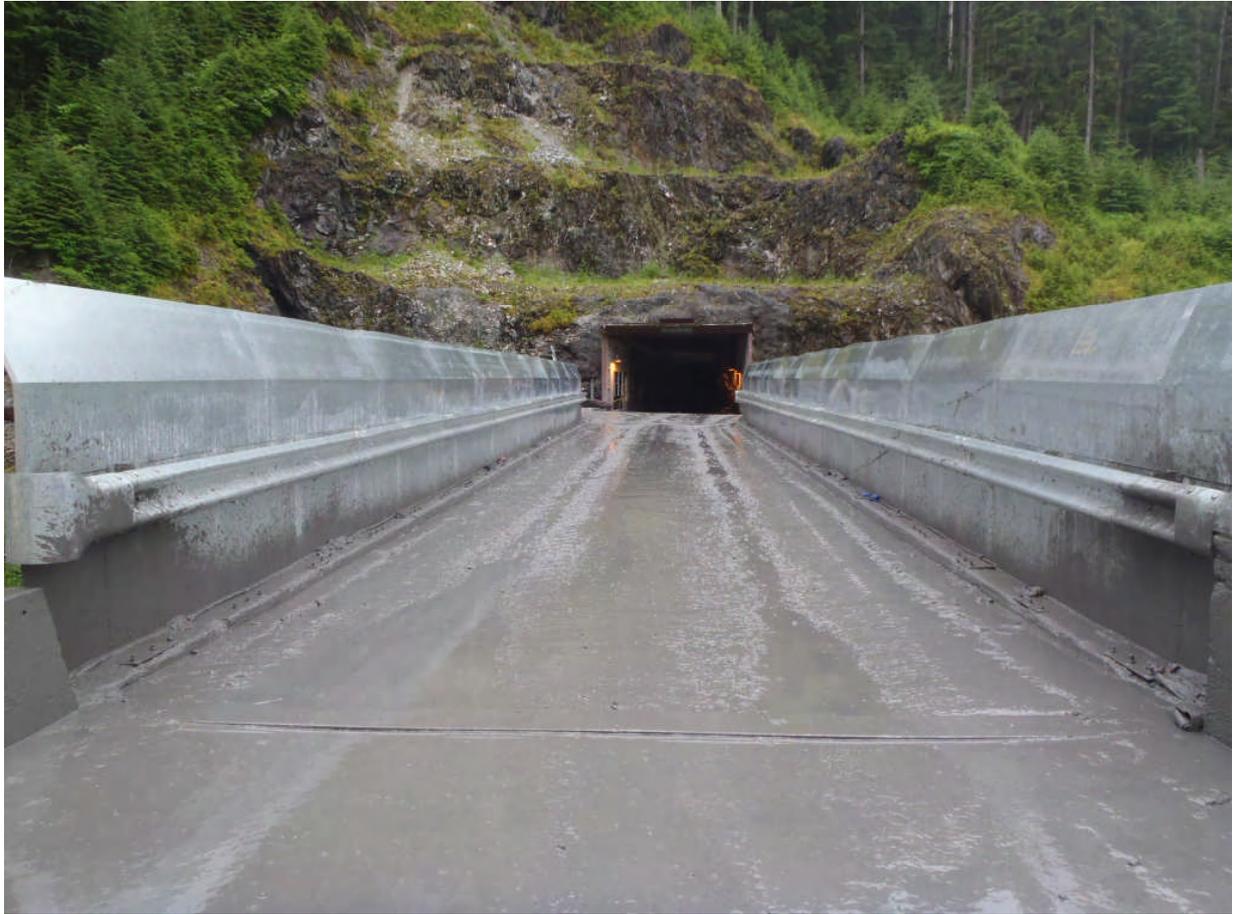
- In 2010, the roadway and drainage issues at the Batch Plant were repaired.
- In 2011, repaved the road from the bridge entrance to the tie-in area of the 2010 project, paved a previously unpaved freight pad, improved road drainage issues at Degrit Basin 01 (DB01), paved a previously unpaved tractor parking area and overlaid the road behind the 920 Administration building.
- In 2012, activities included paving both sides of the portal for capturing surface water and pumping it to the mine's main sump and providing containment at the edge of the Creek, which will direct drainage into the portal. Also installed higher splash guards on the Greens Creek Bridge (see Photo 2). Continued paving at the 920 Admin building site in front of the new Light

PHOTO 2. New Splash Guards on Greens Creek Bridge, 2012
