INSPECTION REPORT: GREENS CREEK MINE

Date of Inspection: Friday August 12, 2016
Date of Report: Friday August 26, 2016
USDA Forest Service Inspector: Richard Dudek

This inspection included A/B access roads, 1350 area, 920 area, 7.4 Mile B-road Bridge, Falls Creek Bridge, Zinc Creek Bridge, TDF area, Pit 7, and the Sand Pit.

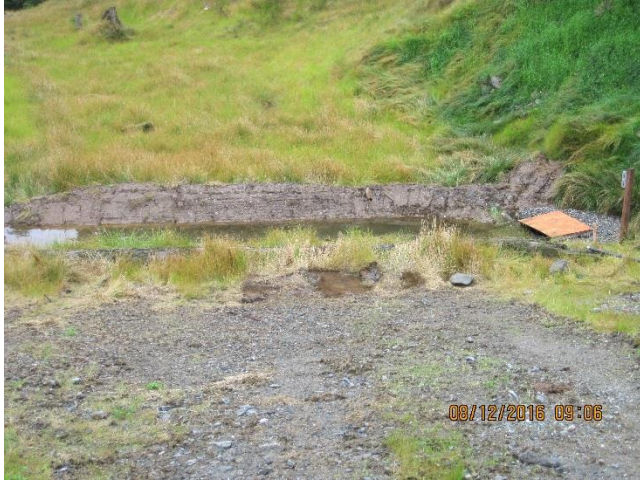
A trench and caisson (Photo 1) have been installed to capture stormwater runoff from a waste rock stockpile in an attempt to mitigate zinc exceedances detected down gradient at FWMP site 13. A pump and pipeline (Photo 2) have been installed to convey water from the caisson to the 1350 adit. Parts are still needed before the pump and pipeline can be fully functional. Once the pump and pipeline are completed, the water will be transferred from the caisson to the 1350 adit. From there, the water will be routed to the water treatment facility and discharged under the APDES permit. The 1350 adit (Photo 3) appeared in order and well maintained by HGCMC's Surface Operations.

Photo 1. 1350 area trench and caisson for stormwater runoff from an old waste rock stockpile.

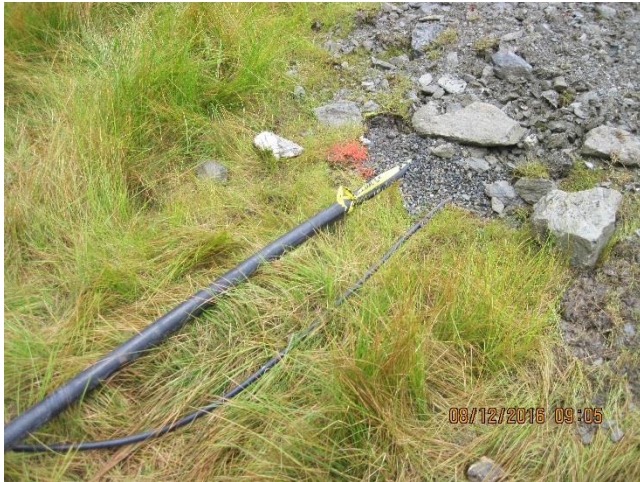
Photo 2. Pipeline for the 1350 caisson to the 1350 adit.

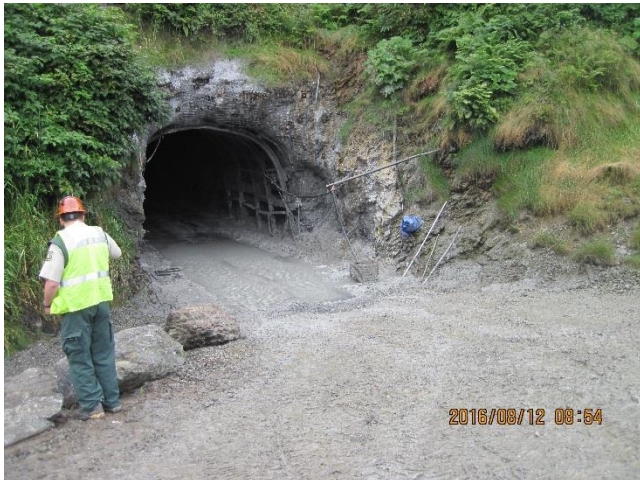
Photo 3. 1350 Adit.

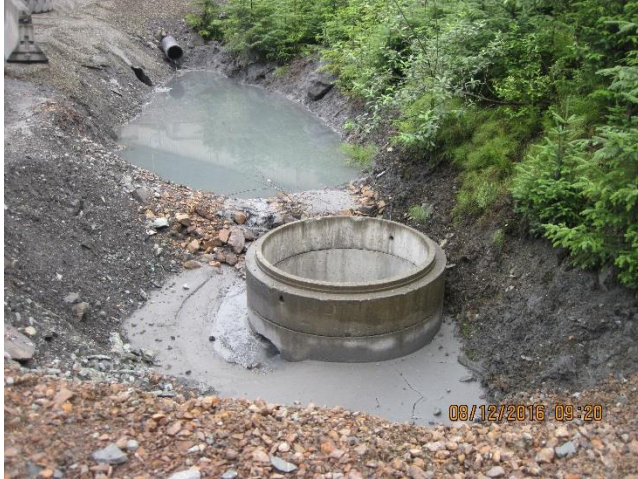
The sump and rock check dam (Photo 4) across from DB-01 appeared to be in good working order. The 920 bridge's splashguards (Photo 5) are effectively working to prevent sediments from entering Greens Creek. At the 920-pump house, Surface Operations installed a steel walkway for safety so personnel can cross over waterlines (Photo 6) during operations. In the fall of 2016, HGCMC's Surface Operations has plans to reconstruct a water diversion ditch (Photo 7) to improve drainage behind the ore pad and warehouse. The construction of the diversion ditch will improve the drainage on the back slopes of the ore pad and warehouse. During the construction for the diversion ditch, a culvert that runs under the ore pad will also be replaced. This culvert diverts water to DB-01/Pond-A prior to water treatment. During this inspection, HGCMC personnel were unloading shipping containers and placing supplies into appropriate storage containers (Photo 8). The 920 warehouse storage containers were clean with all liquid and petroleum products properly stored within secondary containment (Photo 9).

Photo 4. 920 sump across from DB-01.

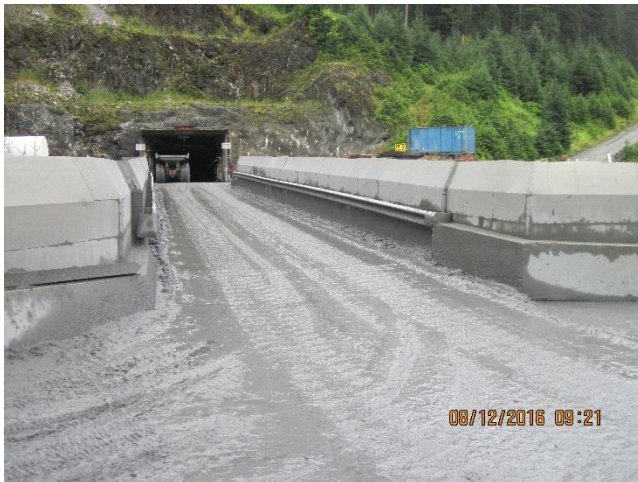
Photo 5. 920 bridge.

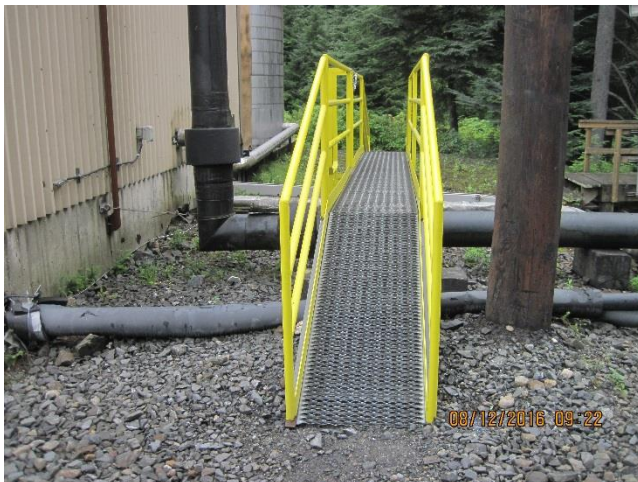
Photo 6. 920 Pump house safety improvement.

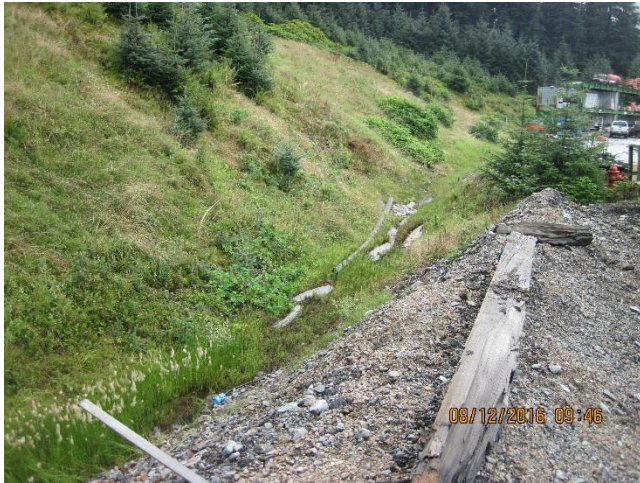
Photo 7. Water diversion ditch behind the 920 ore pad and warehouse.

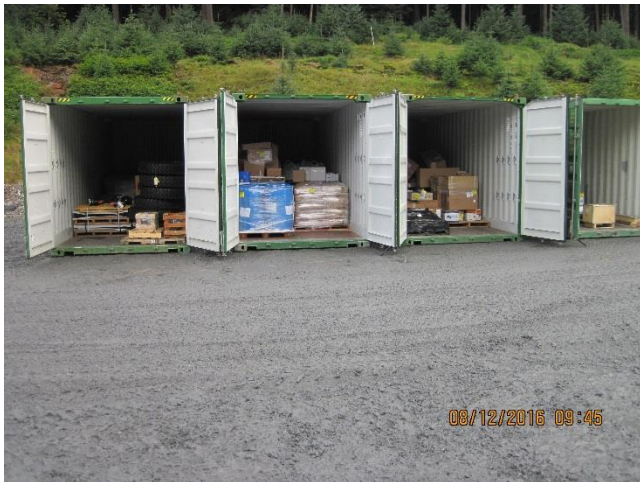
Photo 8. Shipping containers staged for unloading supplies at the 920 warehouse.

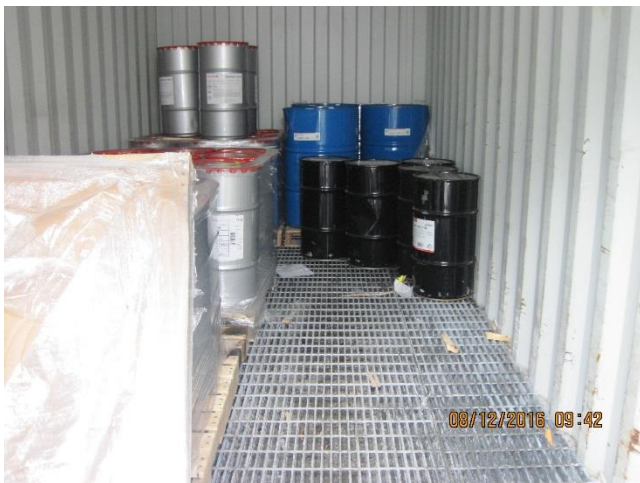
Photo 9. 920 warehouse storage container with secondary containment.

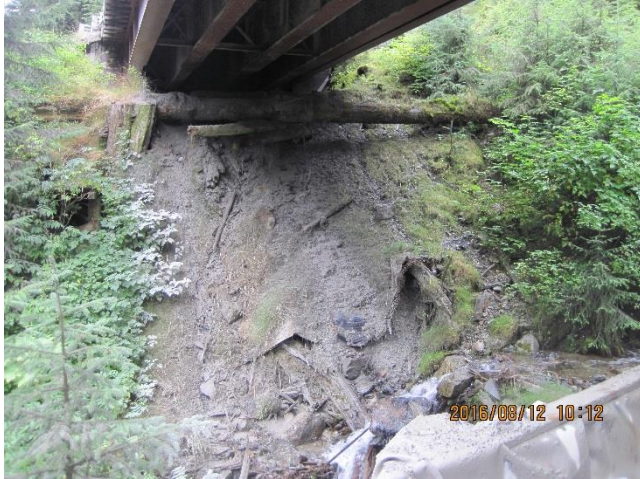
Currently, stormwater is transporting sediments from the road to the banks at both ends of the bridge. This has potential to impact water quality. A protective liner was observed on the camp side of the bridge (Photo 10). However, the liner appears to be allowing sediment to flow freely into Killer Creek. The liner needs to be improved to capture sediments from stormwater runoff. Approximately 1 to 3 centimeters of sediments has accumulated along the splashguard rails (Photo 11). HGCMC personnel should continue to monitor sediment accumulation on the splashguard rails and clean the rails when deemed necessary.

Photo 10. A liner (camp side of bridge) is not effectively preventing sediments from entering Killer Creek.

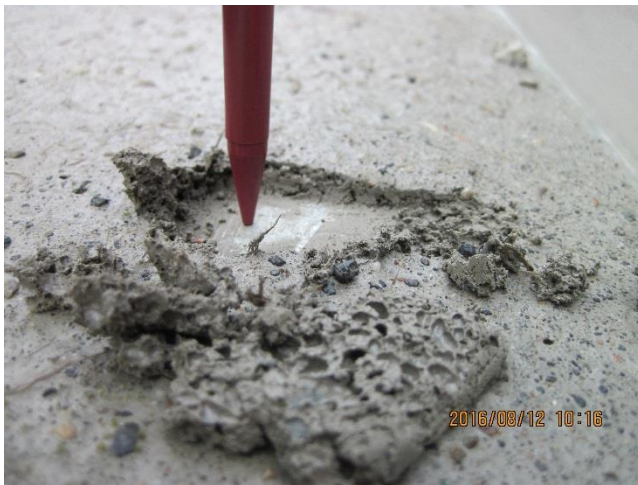
Photo 11. Sediment accumulation on the Killer Creek bridge's rails.

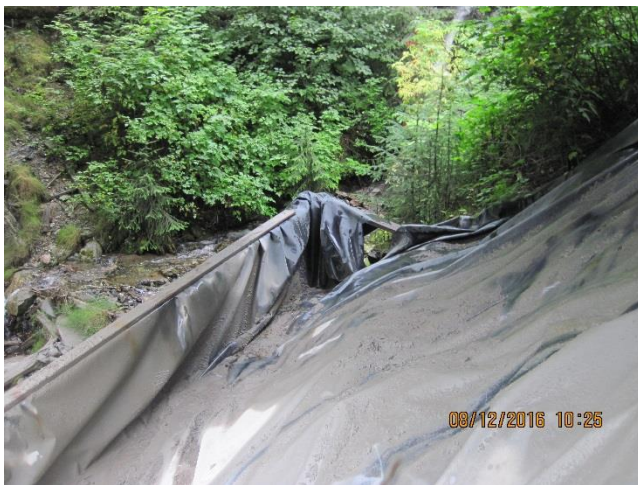
On the Mill side of the bridge, a liner was in place and effectively preventing sediment from entering the creek (Photo 12).

Photo 12. A liner underneath the Killer Creek Bridge (Mill side).

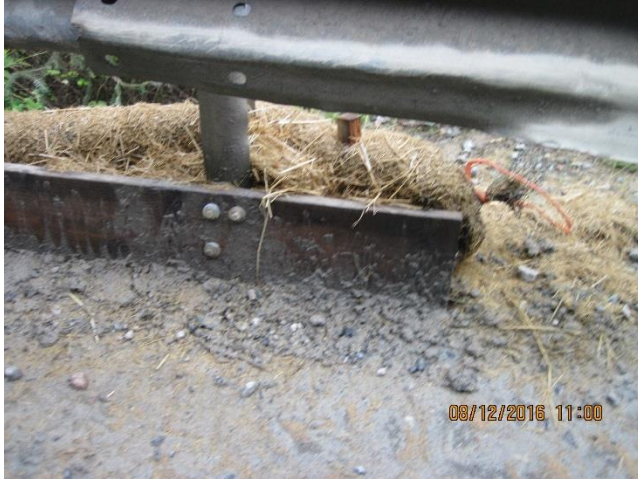
HGCMC's Surface operations have installed a temporary barrier (Photo 13) on the downstream side of the bridge to prevent sediment runoff from the road. A long-term BMP strategy is required to capture the stormwater runoff and to prevent sediment from flowing into the creek (Photo 14). The sumps and rock check dams need to be improved to capture stormwater runoff from the B-road (Photo 15).

Photo 13. One temporary barrier was installed to monitor sediments accumulating on the downstream (camp side) of the Killer Creek bridge.

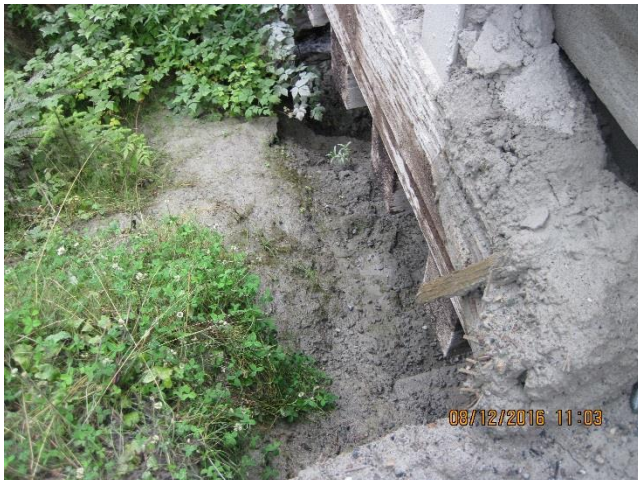
Photo 14. A barrier is needed to prevent sediment deposition on the downstream (Mill side) of the Falls Creek bridge.

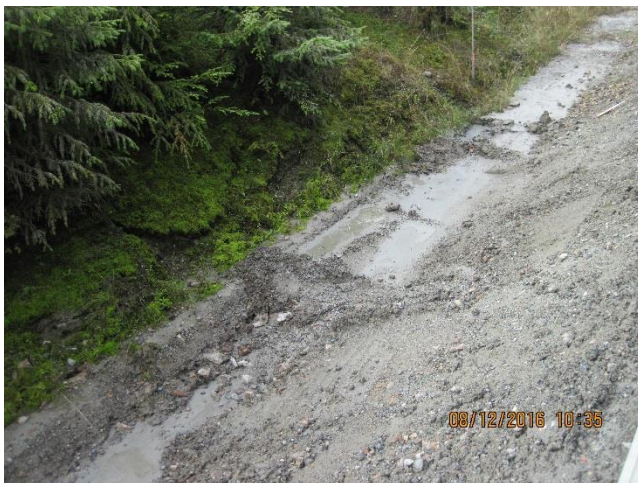
Photo 15. Rock check dams and sumps need improvements.

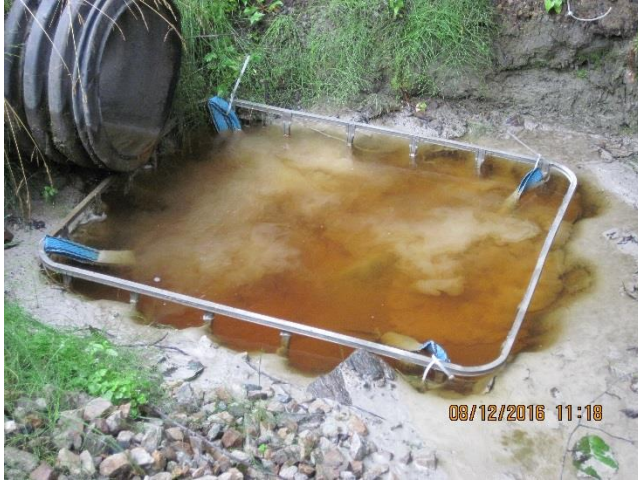
The 3.1 mile B-road removable sediment screen is near capacity and needs to be cleaned (Photo 16). A sediment sump (Photo 17) located on the south abutment needs to be mucked for better functional operations. The sumps and rock check dams need to be frequently monitored and maintained to prevent sediment from making its way through the BMP's and entering into the forest (Photos 18-19). The observed sediment buildup level for a dam or settling pond should not exceed one-third of its height (2015 General Plan of Operations Appendix 5 page BMP-7).

Photo 16. 3.1 mile B-road removable sediment screen.

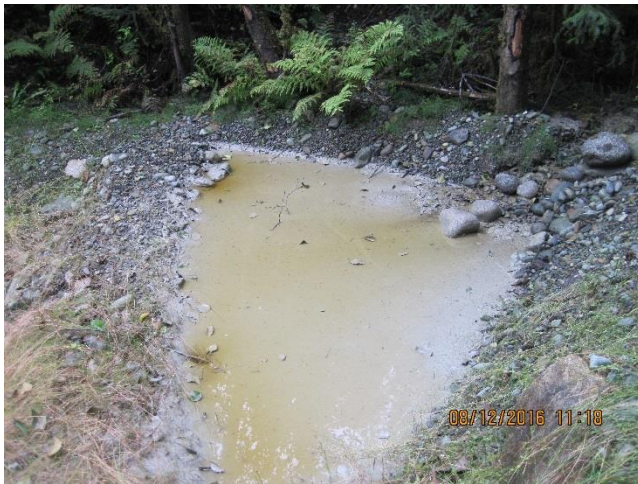
Photo 17. Settling sump near capacity.

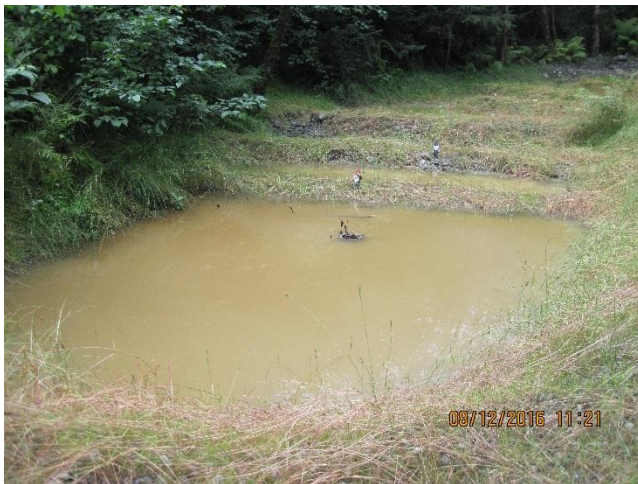
Photo 18. Some sediment is working its way through the sumps and rock check dams.

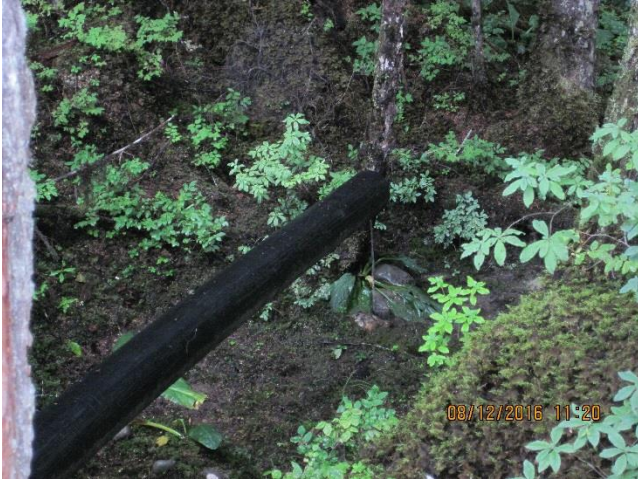
Photo 19. Standpipe drain.

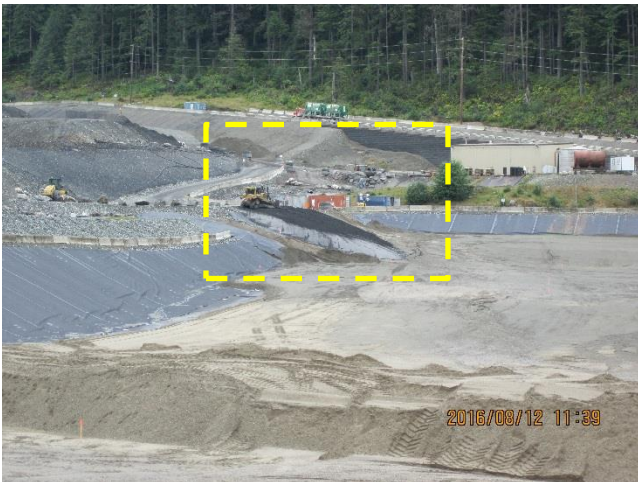
HGCMC has started depositing tailings within the new TDF expansion area (Photo 20). Additional Class 1 waste rock (Photo 21) and organic material has been placed on the outer slopes of the TDF.

Photo 20. Highlighted within the dashed lines, tailings are now being deposited at the TDF expansion.

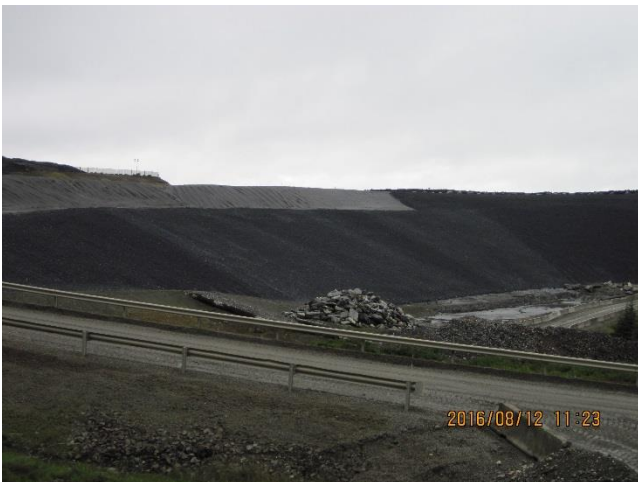
Photo 21. Class-1 waste rock deposited on the outer slopes.

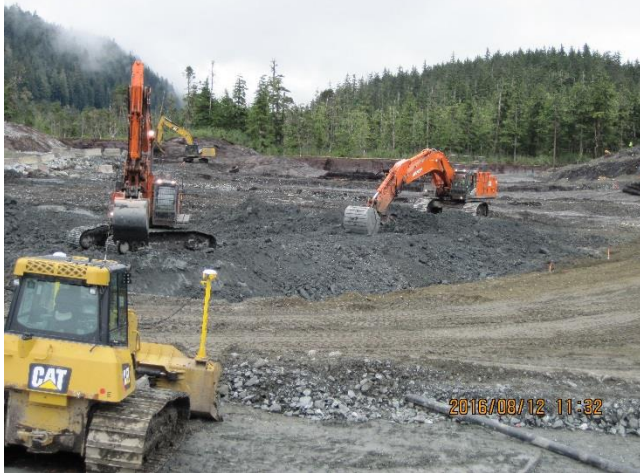
The majority of the organic layer has been excavated from the Pond-10 construction. Currently a blue/gray clay material (Photo 22) is being excavated and deposited at the Sand Pit. HGCMC is currently blasting the bedrock to ensure the planned capacity is met. The blasted bedrock will be tested to determine if the rock can be used for construction material.

Photo 22. Gray/blue clay excavated from Pond 10 is stockpiled at the Sand Pit.

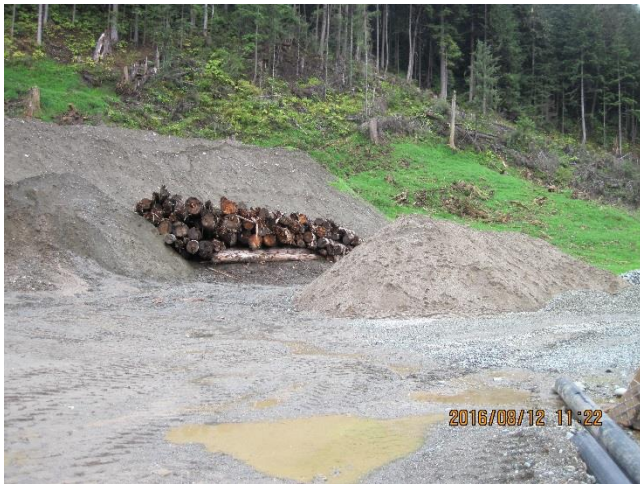
Material stockpiled at this location is the excavated material from the 1.4 mile A-road Sand Pit. The stockpiled material will be used for the TDF expansion project (Photo 23). Rock check dams and straw wattles are in place (Photos 24-25). Due to recent heavy rains, a flow path was observed along the access road that leads to the stockpile pad. The TDF Expansion contractors have been informed and will address the issue.

Photo 23. 0.9 mile sand stockpiles.

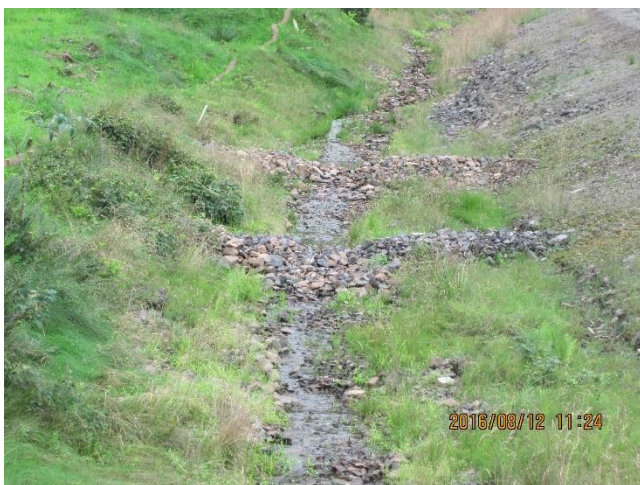
Photo 24. Rock check dam.

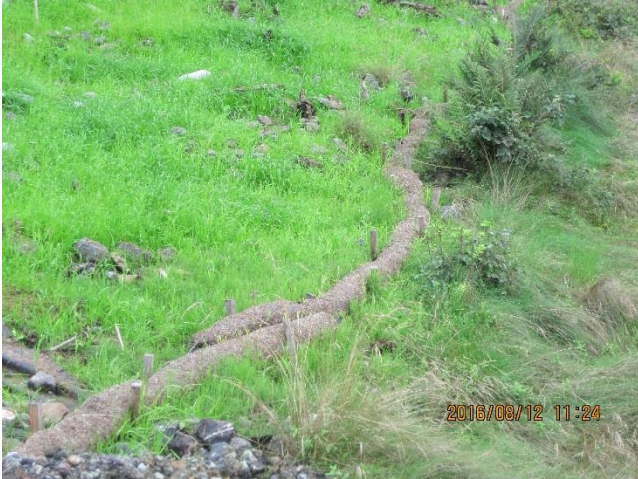
Photo 25. Straw wattles.

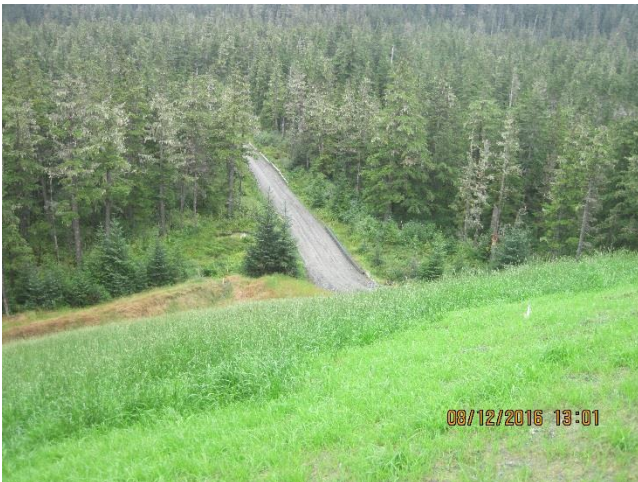
The hydroseeded slope is showing grass is growing well (Photo 26). HGCMC has installed prism monitors to observe any soil slumping along the slope (Photo 27).

Photo 26. Pit 7 slope.

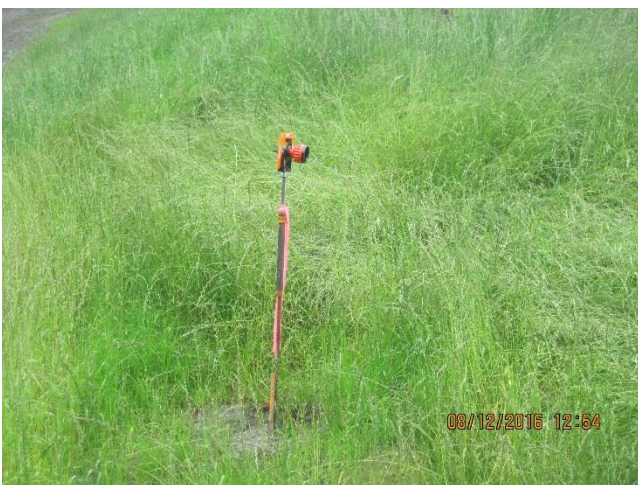
Photo 27. A prism monitoring system for monitoring slope movement.

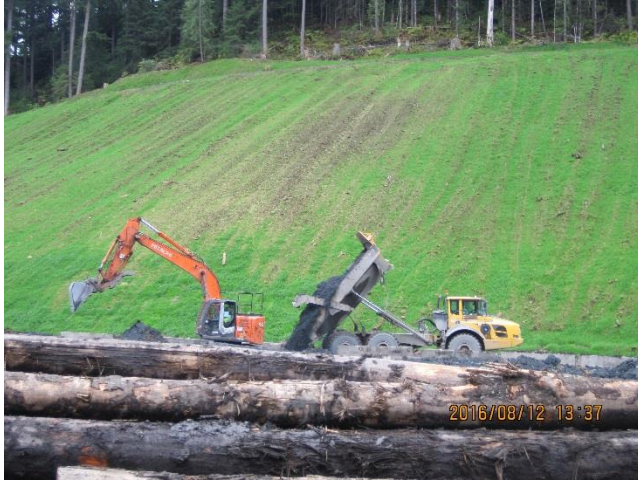
The gray/blue clay material is currently being stockpiled around the perimeter of the pit (Photo 28). Approximately one-fifth of the pit is filled from top to bottom (Photo 29). The slopes and berms that were hydroseeded have established grass (Photo 30) to help reduce stormwater erosion (HGCMC's BMP plan Appendix 5 page 13).

Photo 28. Blue/gray clay deposited on the perimeter of the pit.

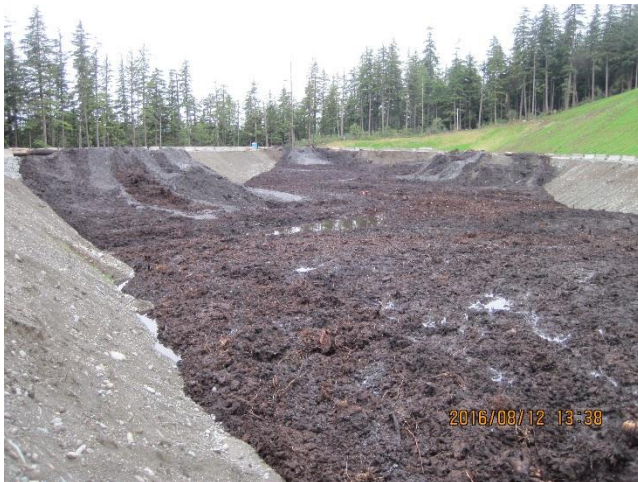
Photo 29. Organic material stockpiled. Approximately 1/5 of the pit is full of organics.

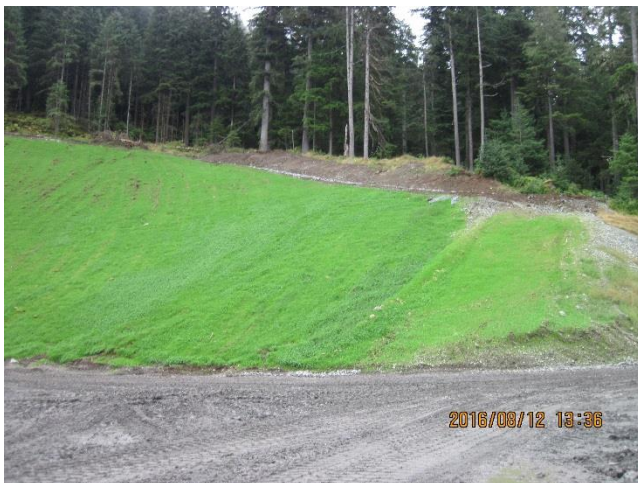
Photo 30. Grass has established on the berms and slopes.
