INSPECTION REPORT: GREENS CREEK MINE

Date of Inspection: Thursday, April 20, 2017
Date of Report: Monday, May 1, 2017
USDA Forest Service Inspector: Curtis Caton

Ranger District: Admiralty National Monument, Juneau Ranger District
Weather Conditions: Overcast. Temperature: 40-50's (°F).

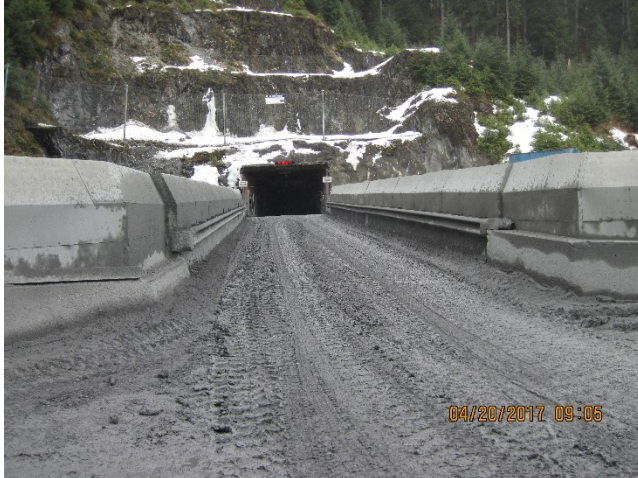
The 920 portal bridge was in adequate condition; minimal mucking of accumulated sediment along the base of the bridge splashguards should occur once spring like conditions persist (Photo 01).

Photo 01. 920 Portal and Bridge.

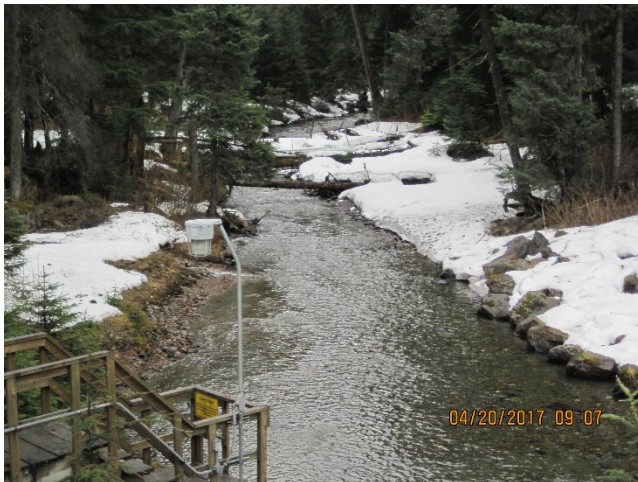
Greens Creek flow appears normal for the season (Photo 02).

Photo 02. Greens Creek.

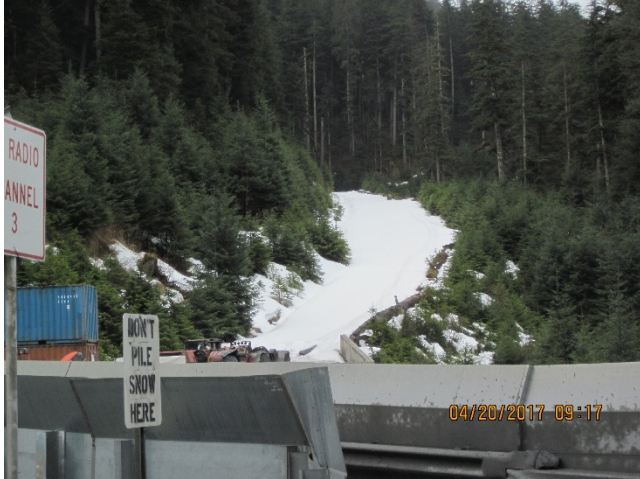
Until surface conditions allow safe access, the 1350 access road remains closed (Photo 03).

Photo 03. 1350 access road.

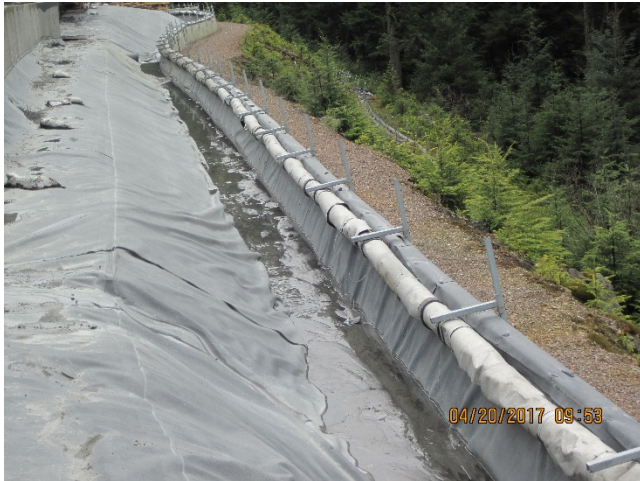
The 920 lined ditch that captures contact water from the mill area and routes to Pond A for treatment was operational (Photo 04). The 920 ditch was repaired as approved in the surface operations 2014 work plan. The 920 ditch is a gravity controlled lined ditch that leads to a concrete settling basin (degrit basin) then drains to a lined retention pond. The ditch is located along the improved edge of the 920 footprint and runs from the administration building to Pond A. Surface runoff at the mine/mill site from all process areas, including areas where chemicals are stored, drain across concrete surfaces to the lined 920 ditch (Appendix 5, Figure 4; Appendix 6, section 5.2). The 920 ditch serves as secondary containment barrier by reporting all liquid draining from the improved surface to Pond A. The repairs to the 920 ditch decreased sediment loading within the ditch, which has minimized reoccurring surface maintenance.

Photo 04. 920 ditch.

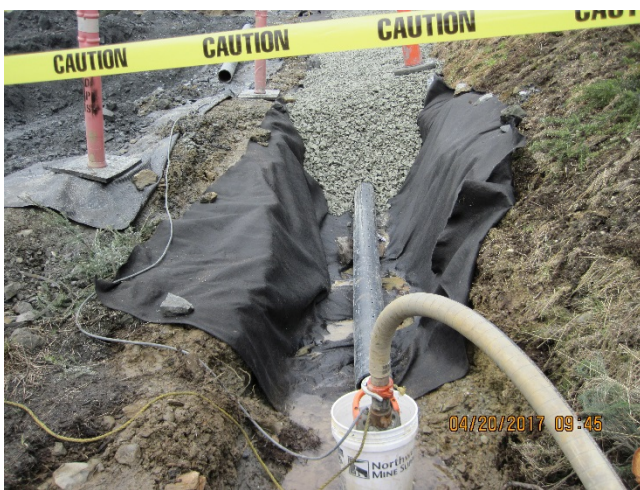
HGCMC has begun repairs to the ore pad diversion ditch and culvert (See Appendix 5, Figure 4 for reference). The upslope ditch adjacent to the ore pad is designed to divert stormwater before infiltration onto the ore pad can occur. A series of HDPE culverts, pipes, and lined ditches convey the influent stormwater to A Pond for treatment (Photo 05).

Photo 05. Diversion ditch upslope of the Ore Pad.

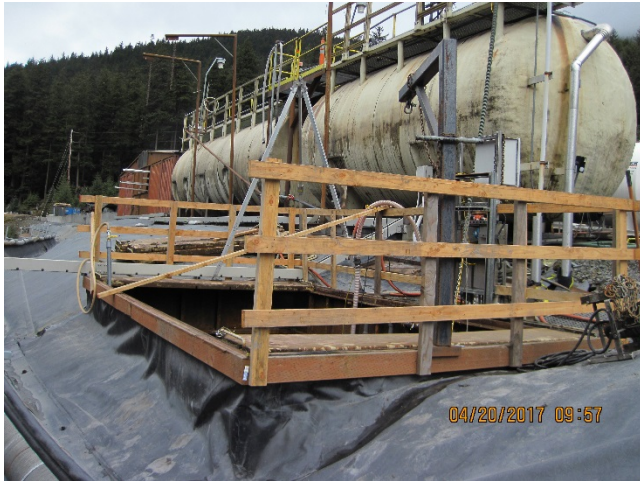
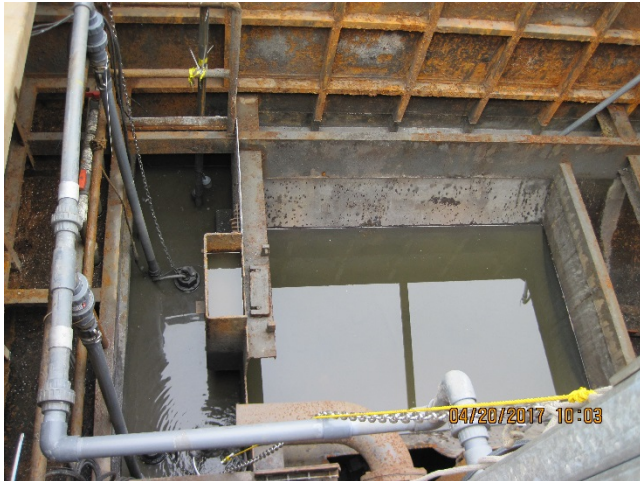
HGCMC is preparing to improve the 920 sewer lift station this summer (Photos 06-07). The text in italics below was extracted from the HGCMC 920 Sewer Lift Station Improvements memorandum dated February 27, 2017.

Photo 06. 920 sewage lift station.

Photo 07. 920 sewage lift station.

The purpose of this project is to replace the existing 10-foot x 18-foot x 12-foot deep vault used as a lift station for sewer influent with a 48-inch diameter HDPE caisson. Currently, a small portion of the existing vault is used to collect sewer influent for the 920 mill and admin buildings. This project will include the following:

- *Removal of the steel structure inside the vault.*
- *Installation of a 48-inch diameter caisson with two rail pumps.*
- *Filling of vault outside of the caisson with a low-strength concrete and/or gravel fill.*
- *Capping the fill with normal strength concrete.*

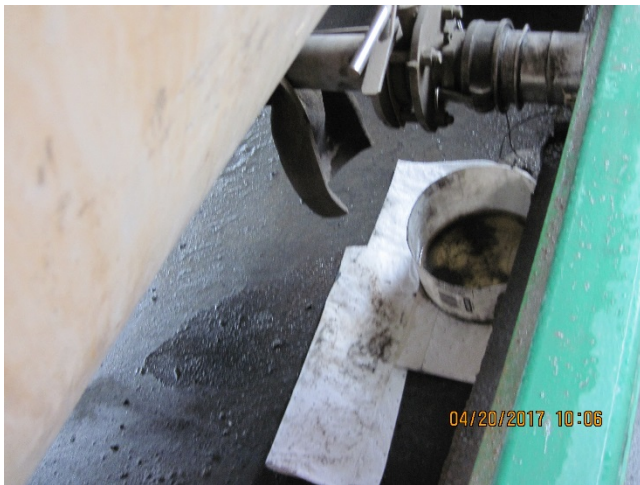
An isotainer transferred hydraulic oil to the double walled day tank located adjacent to the shop on the improved concrete pad. As mandated in the SPCC inspection checklist for bulk oil containment, a drip pan is in place under the hose connection at the isotainer (Photo 08).

Photo 08. Drip pan under isotainer.

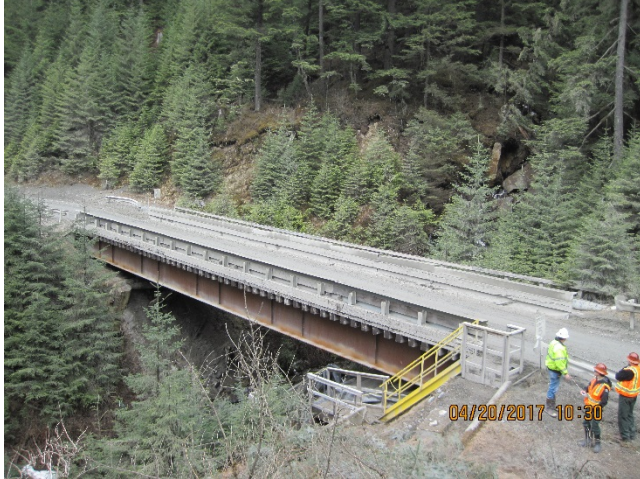
HGCMC discussed a number of ideas to reduce sedimentation in storm water runoff from the access roads at the three B-Road bridge locations: 7.4-mile Bridge (Photo 09); 3.0-mile Bridge (Photo 10); the 3.4-mile Bridge (*not inspected*). Planned work for 2017 includes regrading the road at the bridge approaches, replacing the 80-mil liner and wood decking, extension and inbound sloping of the existing splashguards, and the addition of wing walls at each end of the bridges. HGCMC will also apply a 'very hard' aggregate to the road surface near the bridges. HGCMC is currently investigating the feasibility of using a lighter weight, high strength polyester concrete to seal the surface of the 3-mile bridge, and may

Photo 09. 7.4-mile Bridge.

HGCMC is working on engineering design and cost analysis for options to replace the 3.4 and 7.4-mile bridges with culvert installations. HGCMC anticipates submitting a plan in 2017 for agency review. Replacing the bridges would likely be a multi-year project implemented in phases to minimize road closures. If approved, work may commence in 2018.

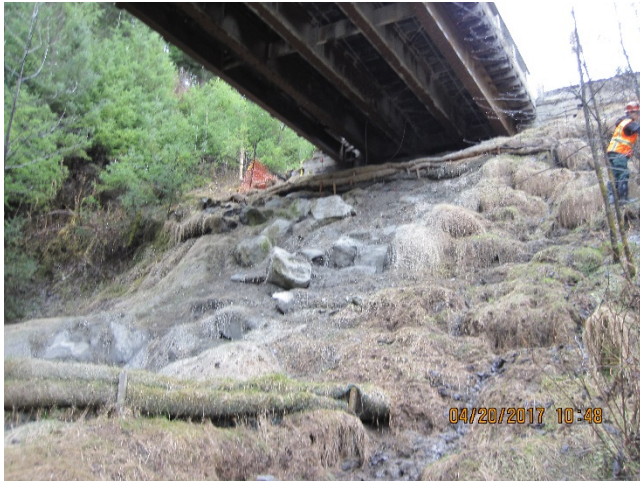
Photo 10. 3.0-mile Zinc Creek Bridge

apply it to a 20-ft test section at one end of the bridge in 2017. A plan would be submitted to the USFS for approval before proceeding with the test.

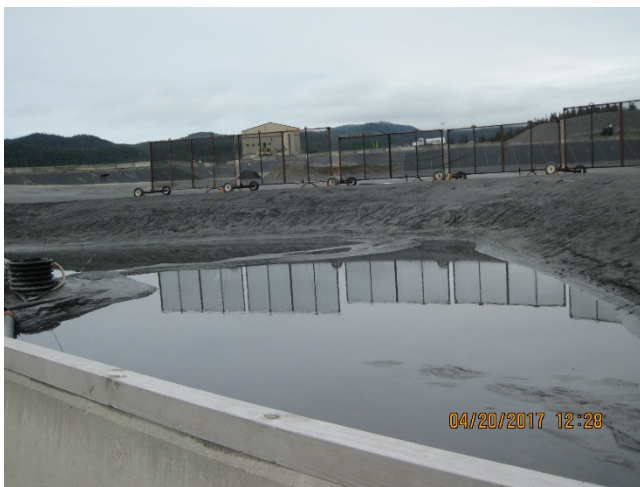
Windscreens are in place to mitigate fugitive dusting mandated in the 2013 Greens Creek Mine Tailings Disposal Facility Expansion FEIS/ROD (Photo 11).

Photo 11. TDF wind fencing.

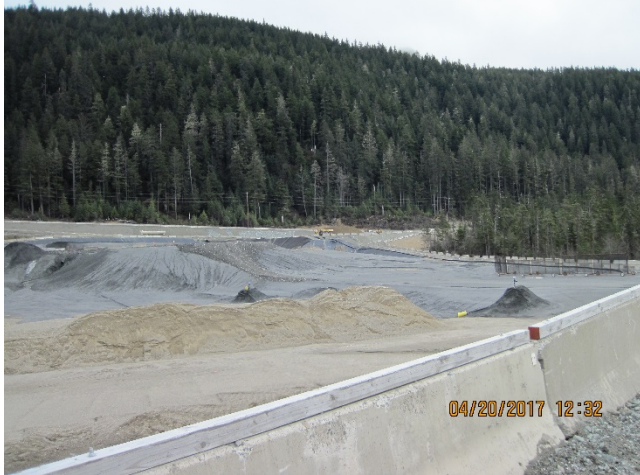
Depositions of tailings continue in the S3P1 tailings expansion area (Photo 12).

Photo 12. Southern expansion TDF (S3P1).

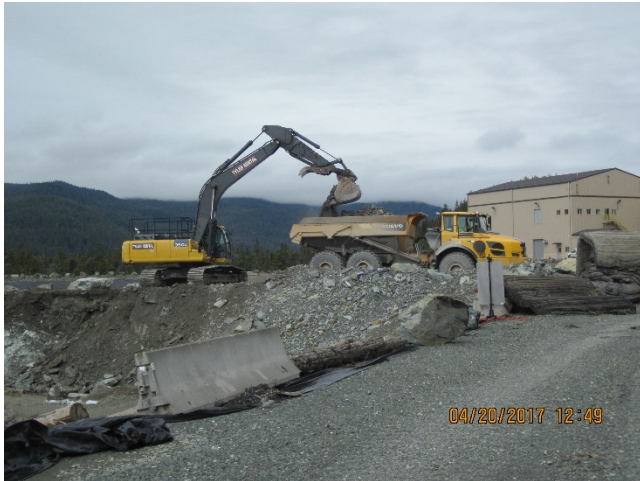
SECON mobilized to site on April 19 for continued construction at the TDF southern expansion area. Construction has just begun for a diversion weir that will connect Pond 10 to Pond 7. Currently, all TDF drainage is diverted to Pond 7 for containment and then treatment before discharge. After Pond 10 construction is completed and once tailings deposition in the southern expansion reaches the proper elevation to divert TDF drainage, the connecting piping will be installed so that effluent can be routed to both Pond 10 and Pond 7 for storage and eventual treatment (Photo 13).

Photo 13. Pond 10 construction.

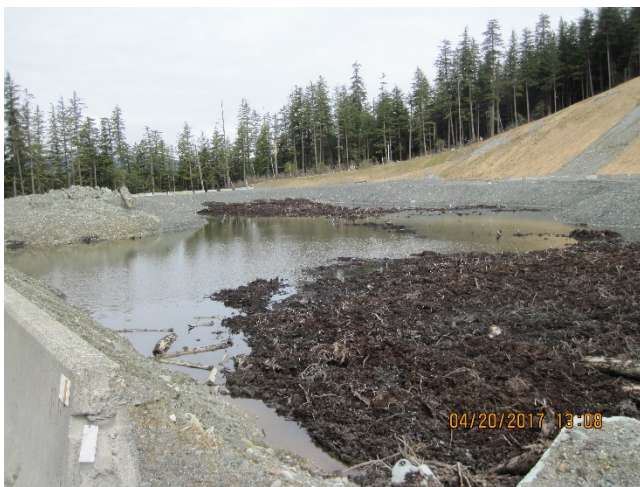
No recent activity noted at the A Road Sand Pit. The peat storage area was not filled to capacity in 2016, leaving a basin for storm water to accumulate. HGCMC will continue to monitor the area to see if the ponded water dries out naturally over the next few months. If not, measures will likely be implemented to minimize ponding of water. Options may include re-grading the stockpile or reducing the height of the perimeter berm (Photo 14).

Photo 14. A-road Sand pit.

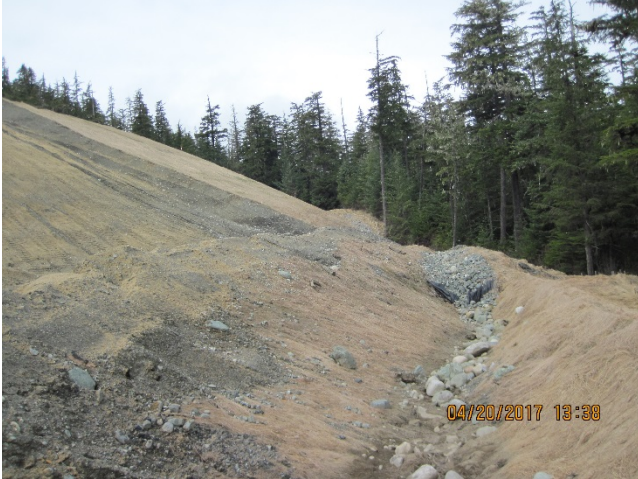
There is no recent activity to report at Pit 7 (Photo 15).

Photo 15. Pit 7.
