INSPECTION REPORT

Alaska Department of Environmental Conservation

Name and Location of Site/ Facility Inspected		Entry Time	Permit Effective Date												
Kensington Lower Slate Lake (LSL) Dam construction and Acid Rock Drainage area adjacent to LSL.	Loc: Lat: 58d 49' 58"N Long: 134d 57' 58"W	12:30	September 1, 2005												
	Source: NPDES permit	Exit Time 17:00	Permit Expiration Date August 31, 2010												
On-Site Representative Clyde Gillespie, Surface Operations Manager, Jeff Stacy, Construction Manager		Additional Participants: USFS: Chad Hood, Dave Barto & Ryan Kriner (Fisheries biologists). ADNR: Charlie Cobb													
Responsible Official(s): Clyde Gillespie, Surface Operations Manager x Contacted

PHOTO ADDENDUM – KENSINGTON TAILINGS DISPOSAL FACILITY –JANUARY 7, 2010

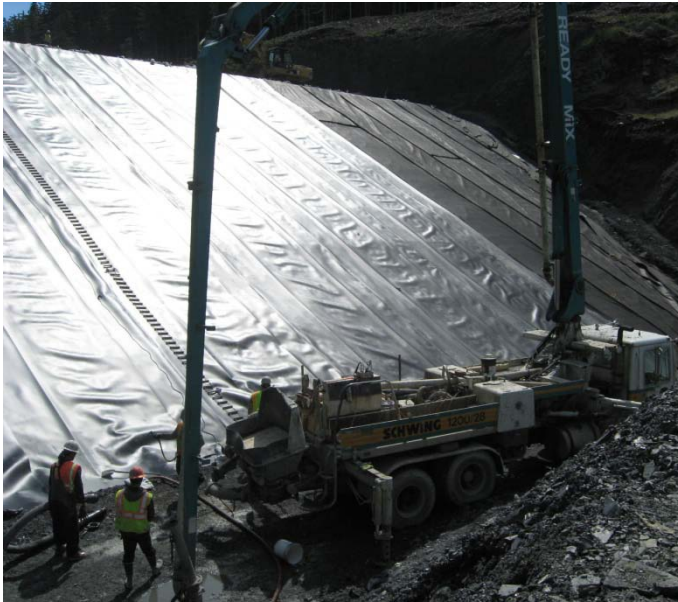
Dam: Installation of the geomembrane on the face of the dam was in process, as was placement of the 6" grout in the grout trench (to be overlain with bentonite and concrete within the trench).

PHOTO 1. DAM GEOTEXTILE & GROUT PUMP

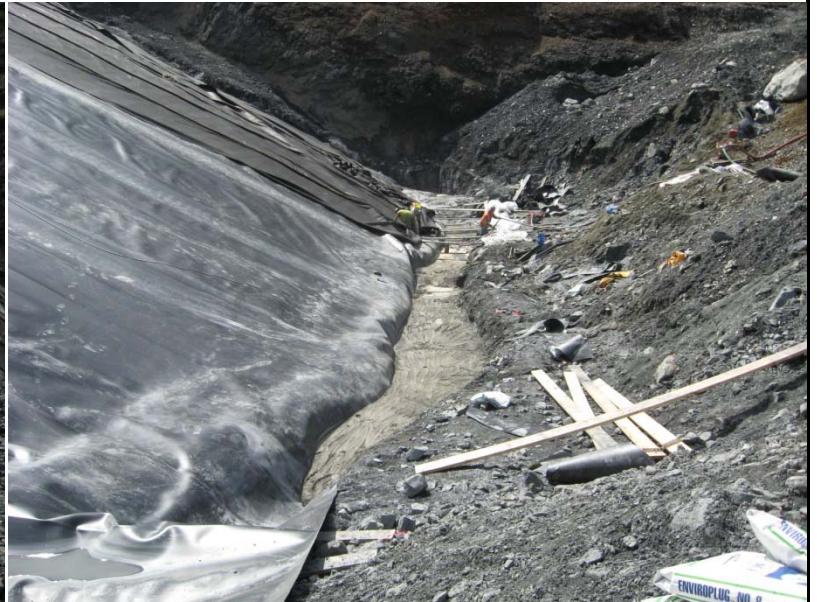
PHOTO 2. LINER AND GROUT TRENCH

Continuation with the installation of the geomembrane and concreting the grout trench. Completion of the liner installation is expected by Saturday 10th July.

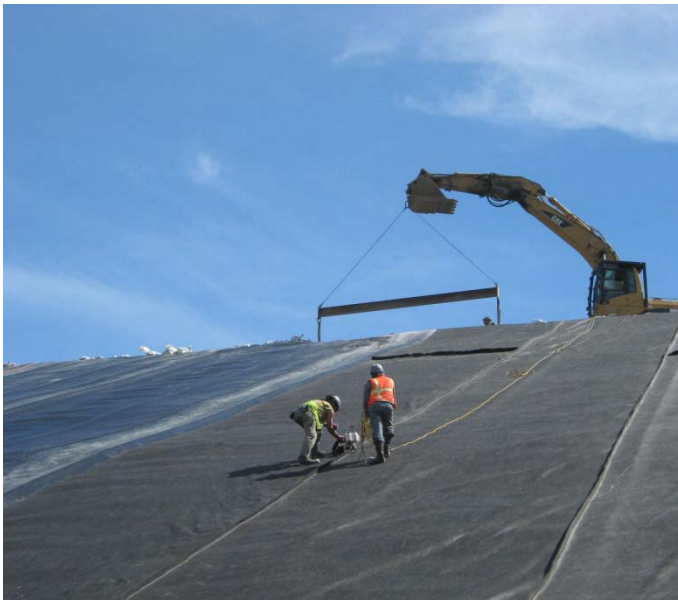
PHOTO 3. STITCHING GEOTEXTILE ON THE DAM FACE

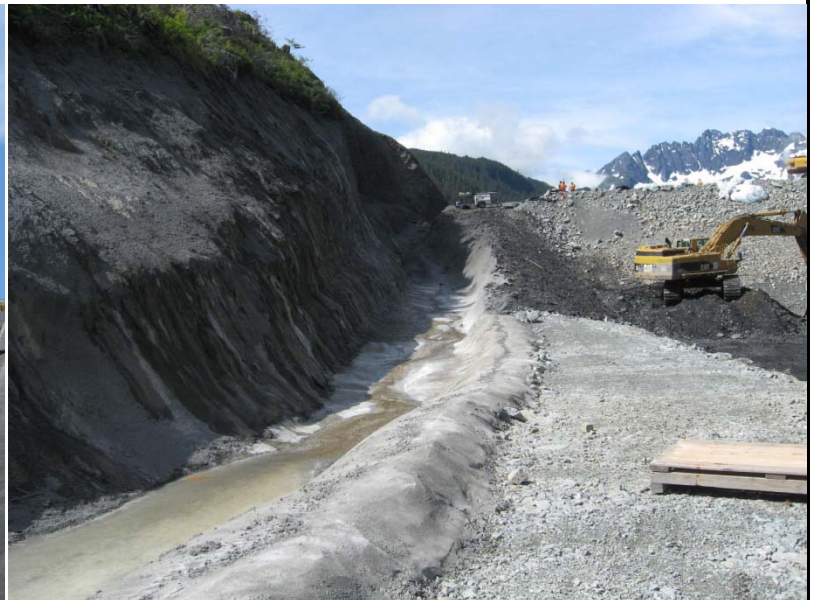
Spillway: The Phase I spillway had been concreted from the top of the dam. The lower horizontal portion and plunge pool were still to be completed.

PHOTO 4. CONCRETE LINED SPILLWAY

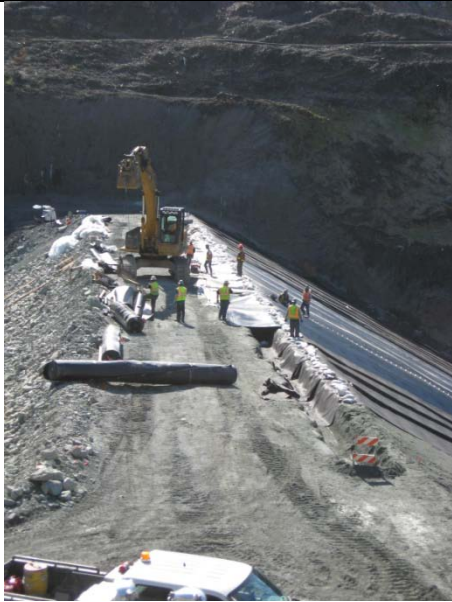
PHOTO 5. ANCHOR TRENCH AT TOP OF DAM

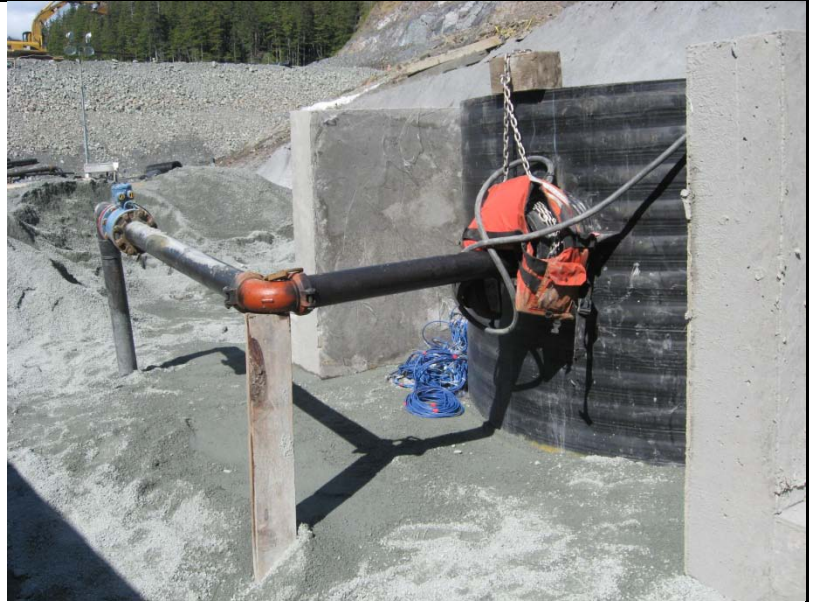
Sump: Protective concrete walls had been placed outside the 96" ID manhole. A meter was being installed to record the total amount of water pumped from the sump.

PHOTO 6. FLOW METER AT DAM SEEPAGE SUMP

Completion of the seepage sump flow meter.

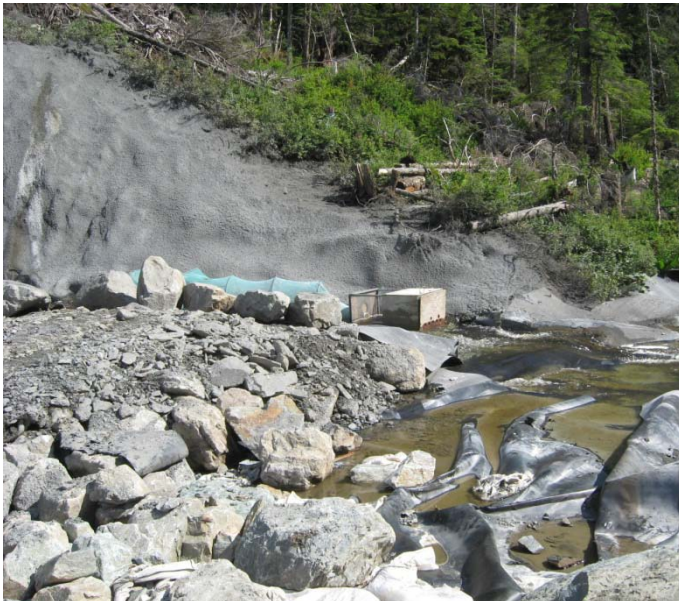
Bypass pipe: This had been connected to the Parshall flume and an automatic depth/flow recorder had been installed but was not operational yet. One more pipe will be installed into the head of the flume for the TTF run-on water diversion. Kate Kanouse from ADF&G was at the site to determine impacts to fish passing through the pipeline, flume and discharge into a plunge pool. At the time of the visit no fish had made it down the pipe; she was to return on the 8th to see if any fish had passed through the pipe and into a Fyke net installed in the outlet channel.

PHOTO 7. FYKE NET AT OUTLET OF USL BYPASS PIPE

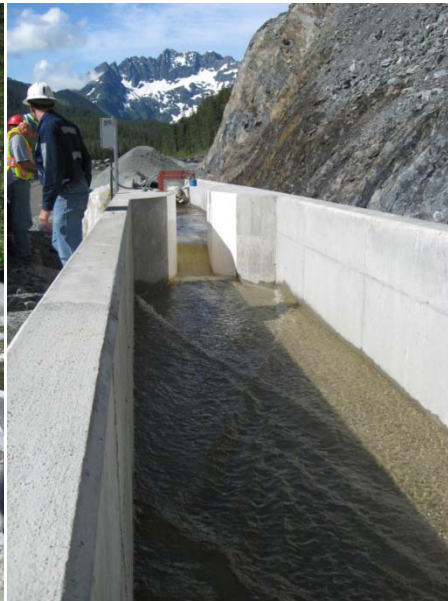
PHOTO 8. PARSHALL FLUME

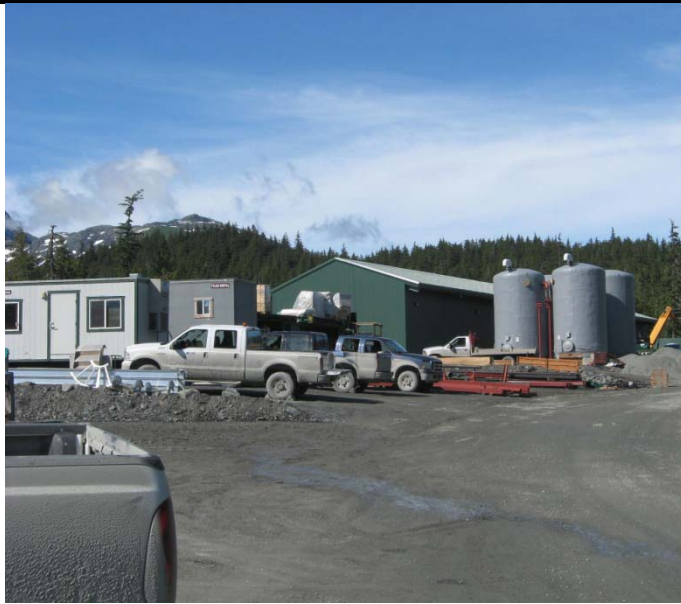
Water Treatment Plant: construction continues on this; a thickener tank outside the building was being assembled for welding at the time of the visit.

PHOTO 9. TTF WATER TREATMENT PLANT

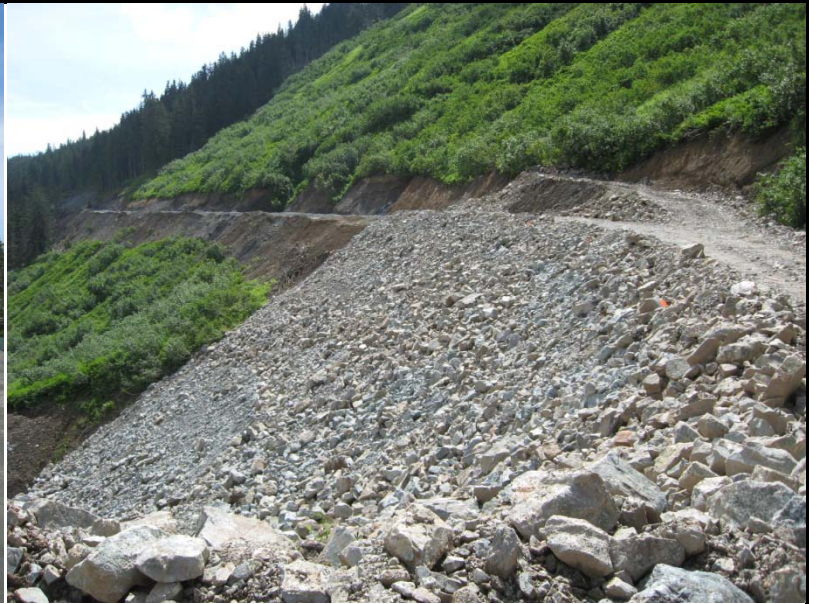
Snowslide Gulch was filled with rock; if the upper side is not leveled with rock this year, then snow will be brought down to fill behind the berm such that excess avalanche snow will be able to go over the top of the berm, road and pipeline. Further along the pipeline, where it is in an earthen fill on the steep hillside and still within the avalanche zone, fill material will be placed on the road to re-create the line of the hillside such that an avalanche will not dislodge the pipeline. There are moisture sensors within the double-walled pipe that will inform the person inspecting the pipeline should the pipeline be damaged.

PHOTO 10. PIPELINE – SNOWSLIDE GULCH AREA

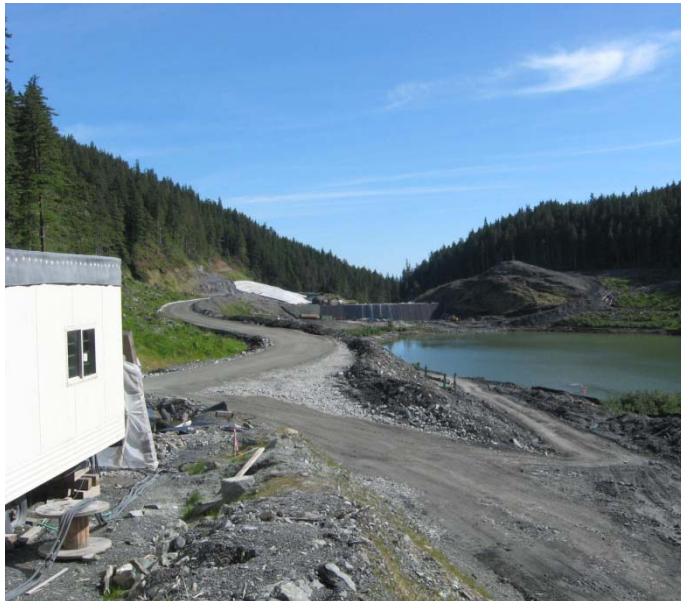
PHOTO 11. GENERAL VIEW OF TTF AND DAM

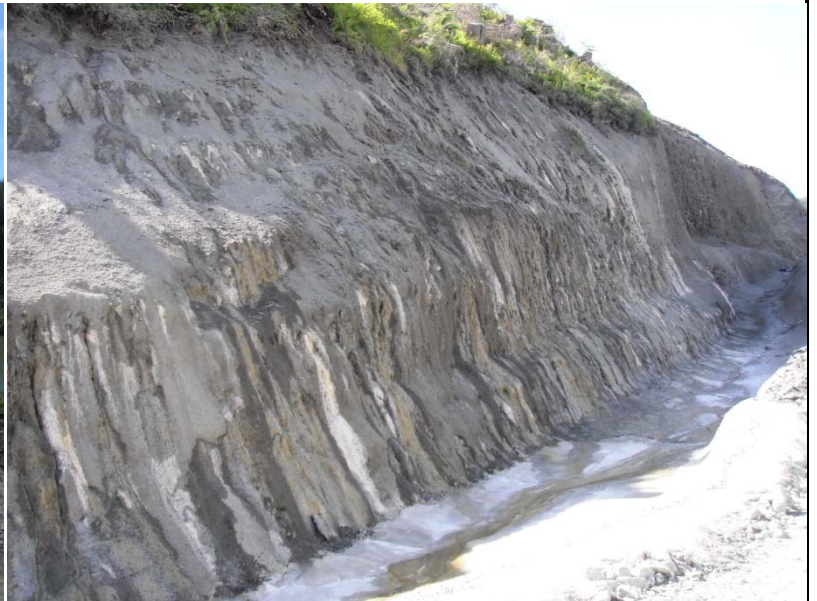
Seeps were noted at some locations along the shotcreted embankments where graphitic phyllite had been exposed during construction. The shotcrete was placed to isolate the graphitic phyllite from oxygen, however it would appear the barrier is not totally effective in all locations, and acid seeps have developed. Coeur is looking at ways to prevent oxygen from getting through this barrier.

PHOTO 12. SEEPS EMANATING FROM GRAPHITIC PHYLLITE WALL

1. Correct the malfunctioning water bar noted above.
2. Place a cover over the graphitic phyllite pile once all graphitic material has been located within the cell (except that which is covered in diorite below the dam).
3. A shotcrete expert will be coming to site to provide recommendations to improve the shotcrete on slopes containing sulfide material. Coeur must be diligent in assuring the sulfide material is stabilized where exposed in the slopes created during construction.
