## INSPECTION REPORT: KENSINGTON GOLD MINE

Date of Inspection: Wednesday October 18, 2017  
Date of Report: Monday November 13, 2017  
USDA Forest Service Inspector: Richard Dudek

This inspection included the Access roads, Comet Development Pile, Comet water treatment plant, Sherman Creek Outfall, Comet Beach Area, Kensington mill area, Pit 4, TTF area, and the Fuel Depot.

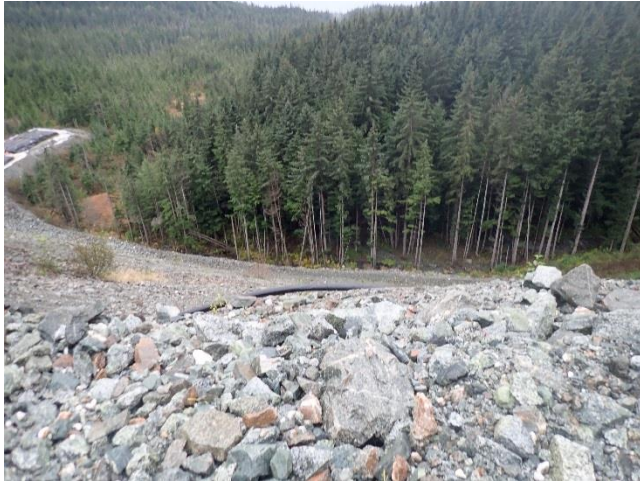
Coeur Alaska continues to stockpile waste rock from the Kensington mine workings at the southern end of the development pile (Photos 1).

**Photo 1. The Comet development pile.**

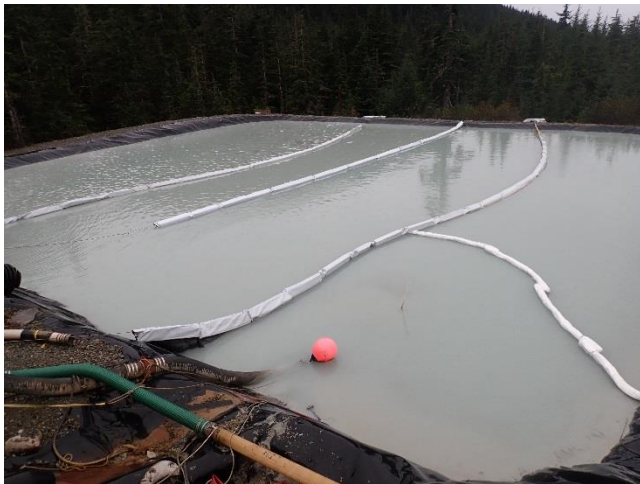
The day of the inspection, the CWTP was treating 1,638 gallons of water per minute (gpm), and the monthly average is 1,833 gpm. Pond-1 (Photo 2) was receiving mine site water and additional silt curtains were installed in the pond, which minimizes the sediment settling area. As a contingency for fuel spills, a hydrocarbon boom was installed near Pond 1's water transfer pump. Pond-2 (Photo 3) was inactive; Coeur Alaska personnel recently completed dredging of the pond, and were disassembling the dredger. Inside the CWTP, no white material was observed on the test rock (Photo 4) used for monitoring. Good housekeeping practices were observed at the CWTP (Photo 5).

**Photo 2. The CWTP's Pond 1.**

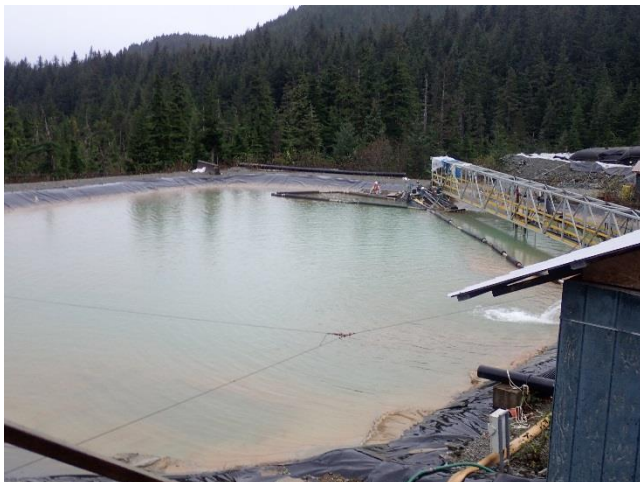
**Photo 3. The CWTP's Pond 2.**

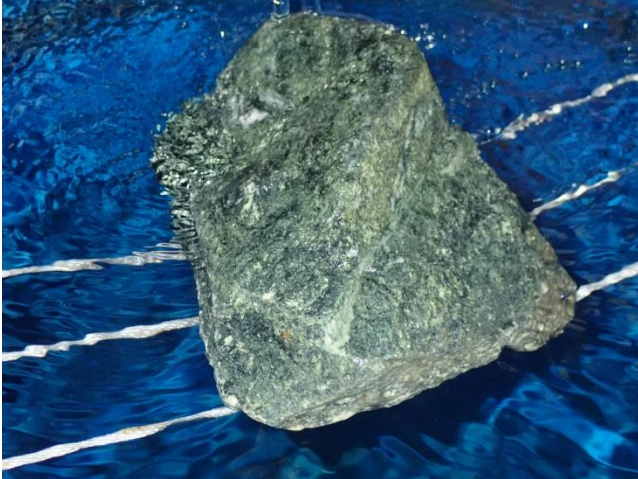
**Photo 4. The CWTP's test rock that is used for monitoring white material accumulation.**

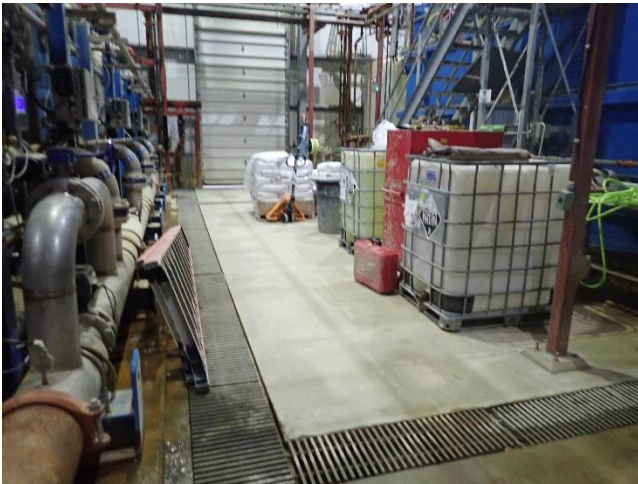
**Photo 5. Inside the CWTP.**

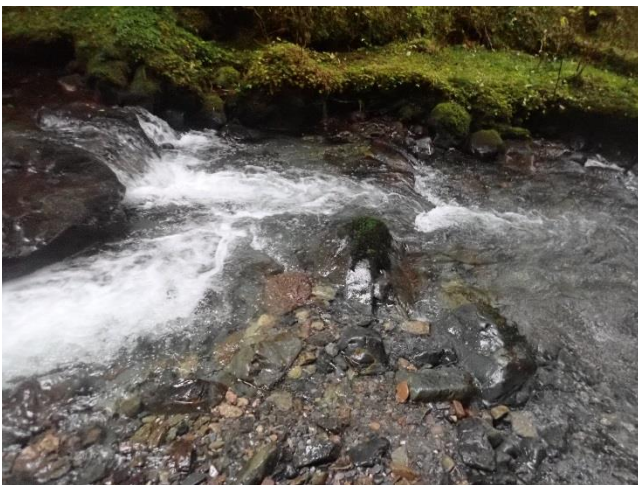
At the time of this inspection, no white material was observed in Sherman Creek (Photo 6).

**Photo 6. Sherman Creek Outfall 001.**

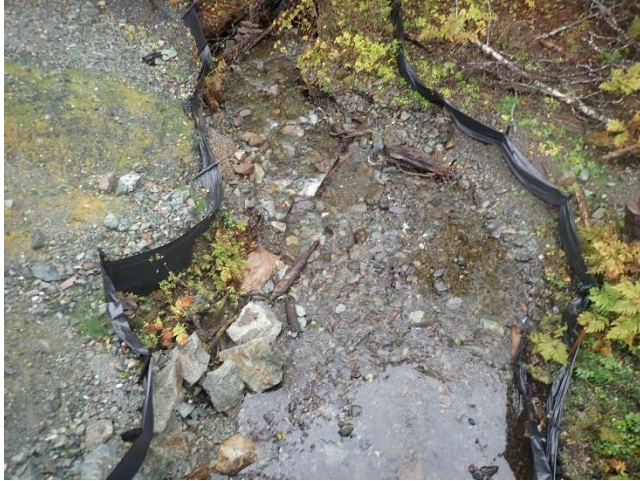
Both bridges (Photos 7-8) are being maintained by Surface operations, and the best management practices (BMPs) in place are in good condition and comply with Coeur Alaska's BMP plan Appendix 4; page C-11. In the summer of 2017, Coeur Alaska performed geotechnical drilling along the access road from the CWTP to Comet beach. The geotechnical drilling platforms and all ancillary equipment was removed, and the areas were reclaimed (Photos 9-11).

**Photo 7. The silt fencing staged along the abutments of the south fork Sherman Creek Bridge.**

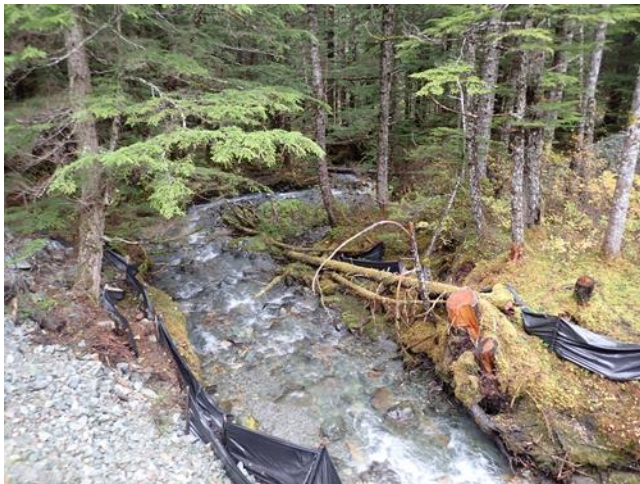
**Photo 8. Silt fencing staged along the abutments of the upper Sherman Creek Bridge.**

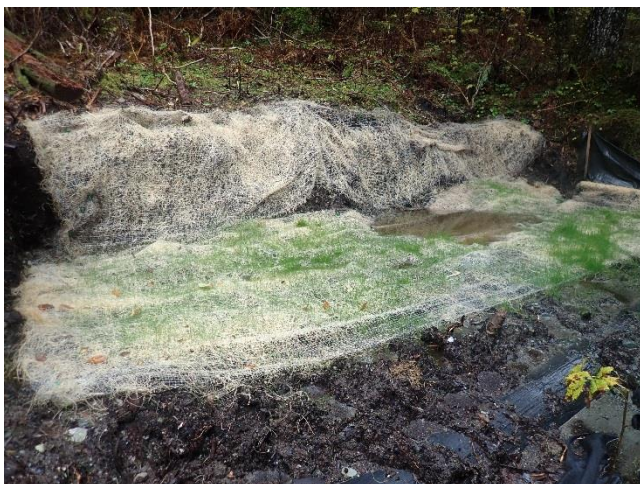
**Photo 9. A reclaimed area where a geotechnical drilling pad was staged.**

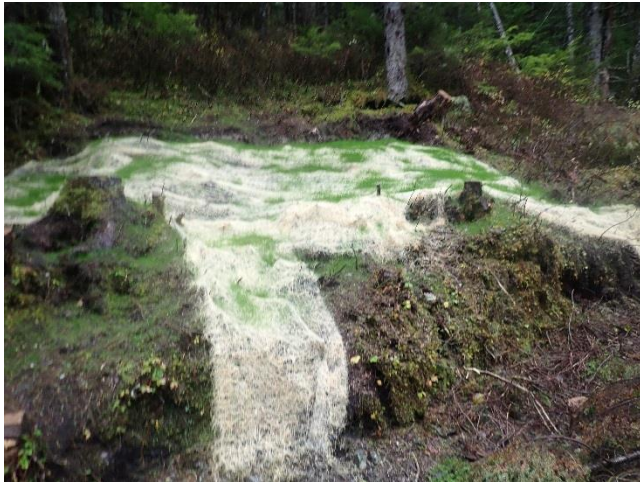
**Photo 10. A reclaimed geotechnical drilling site.**

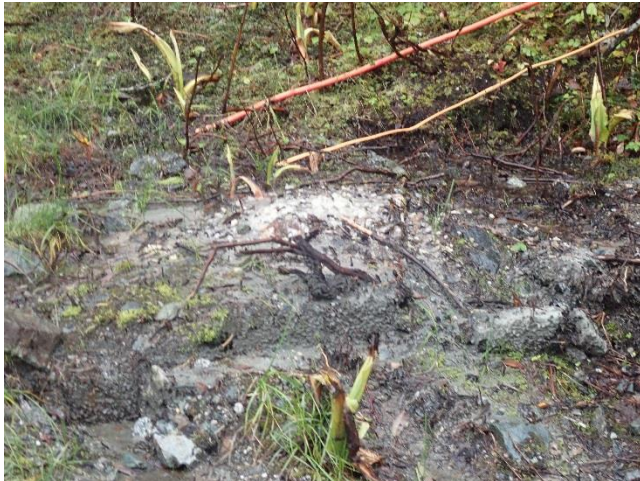
**Photo 11. A reclaimed or "plugged" borehole.**

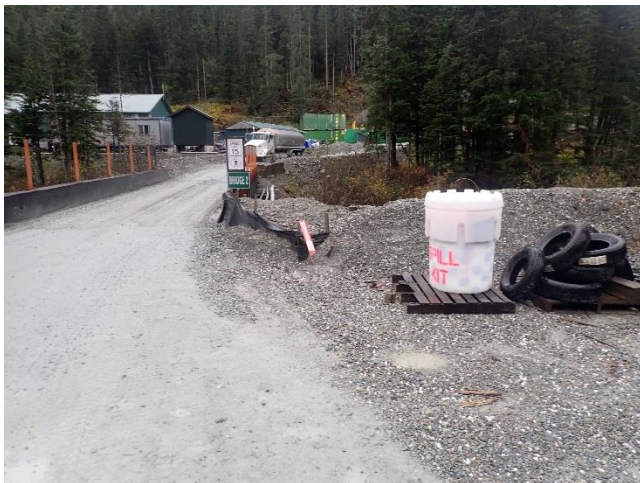
Both bridges are being maintained by Surface operations, and spill response kits are now staged near the bridge ends (Photos 12-13) as stated in Coeur Alaska's Plan of Operations (page 102). The previous response for mitigating spills near the bridges was to deploy the spill response trailer; Locating spill kits at the bridges is a better alternative of spill response.

**Photo 12. A portable spill kit staged near Bridge 2.**

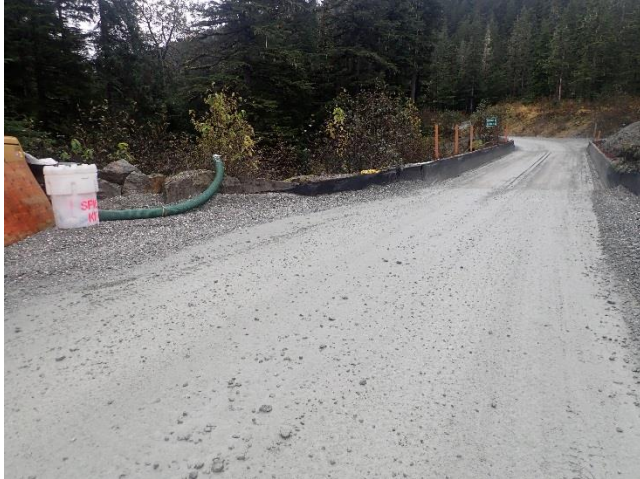
Photo 13. A portable spill kit staged near Bridge 1.

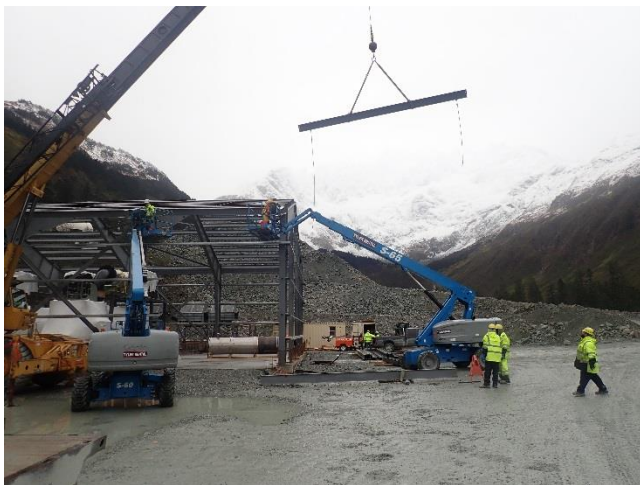
Contractors continue construction for the new powerhouse station that will contain four new 4-megawatt (MW) generators (Photo 14).

Photo 14. Contractors continue the construction of the new Powerhouse station.

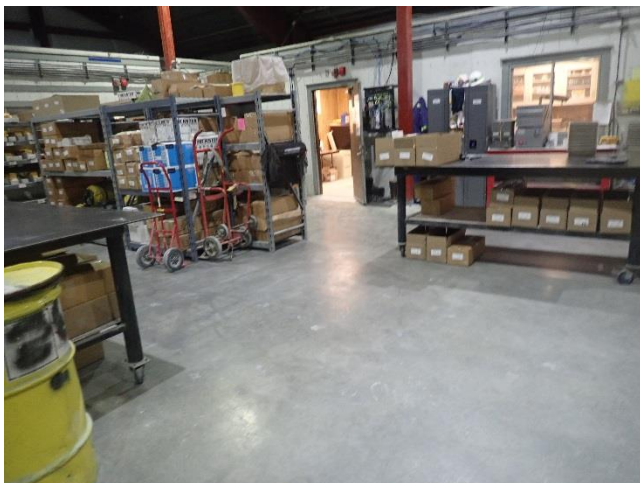
Good housekeeping practices were observed at the Assay laboratory, which complies with Appendix 4g BMP Plan Table 4-2.

Photo 15. The Assay Laboratory.

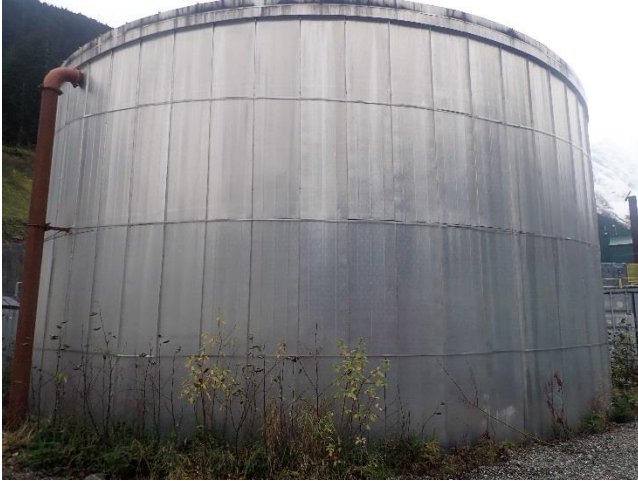
The fire suppression water tank (Photo 16) is properly maintained. The powerhouse for the backup generator for the tanks pump was tidy and in order.

**Photo 16. The firewater tank staged near the mill.**

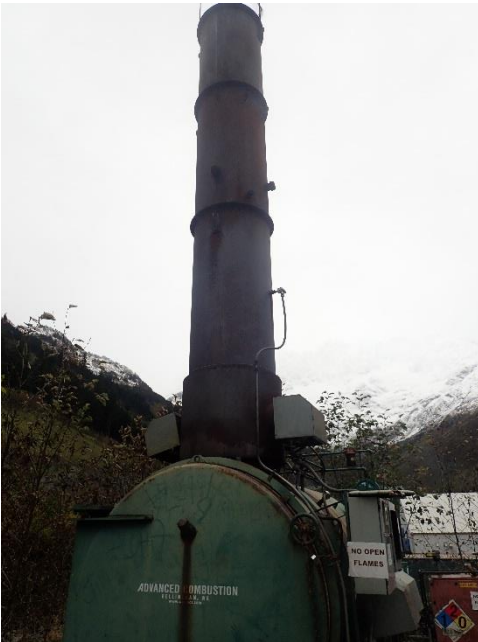
Incinerator that is used for combustible solid waste was locked (Photo 17) and being maintained by Coeur Alaska personnel.

**Photo 17. Coeur Alaska's solid waste incinerator.**

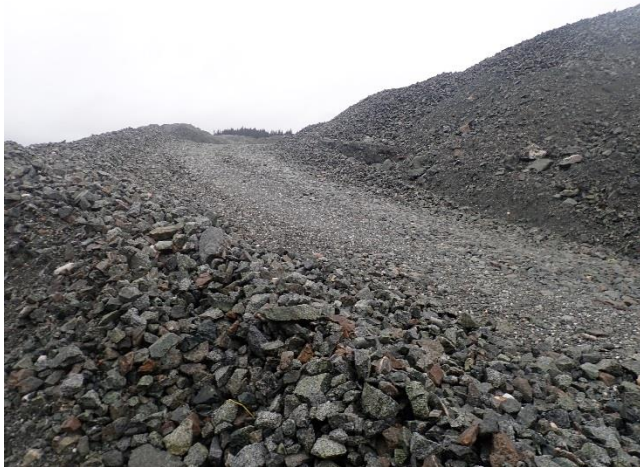
Approximately 50,000 tons of waste rock is staged at this location (Photo 18). During the site inspection, the Pug plant was not in operation (Photo 19). Coeur Alaska personnel continue to translocate pebble rock stockpiled from 4-mile to near the Pug plant.

**Photo 18. Pit 4. Approximately 50,000 tons of waste is currently stockpiled in this location.**

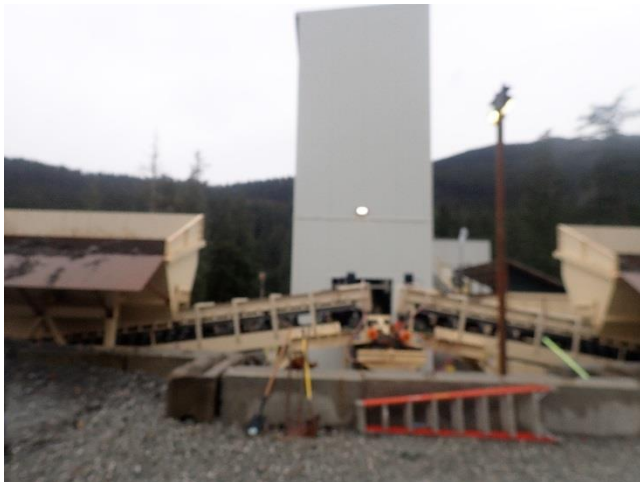
**Photo 19. The Pug plant located at Pit 4.**

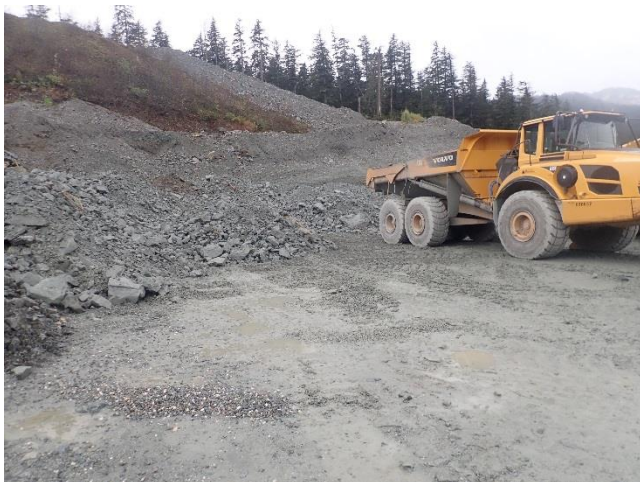
Coeur Alaska recently began replenishing a waste rock stockpile at this location using material from the Kensington development pile (Photo 20) in preparation for TTF dam construction. The stockpile's original size had been diminished when crews crushed and used the rock on access roads. The graphitic phyllite

**Photo 20. Waste rock stockpiled at Pit 7.**

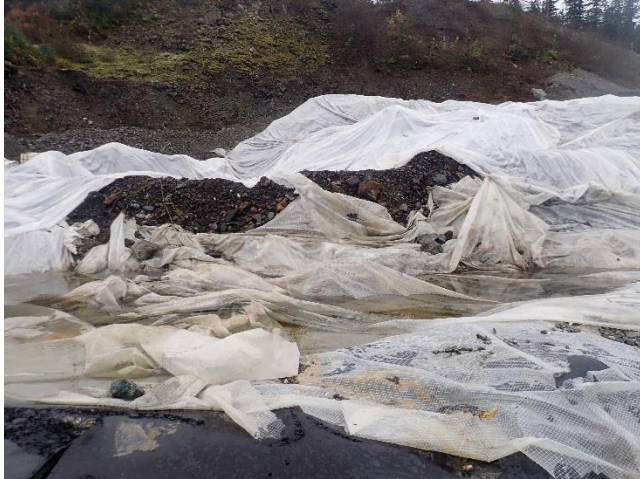
(GP) (Photo 21) stockpiled at this location is currently being utilized at the Pug plant, when in operation, for GP/cement underground backfill. When the GP stockpile is not being utilized, the pile will be completely covered to minimize acid rock drainage (ARD) generation.

**Photo 21. GP material stockpiled at Pit 7.**

**Ensure the logs were removed and the log barrier has been repaired.**  
**Inspection of the concrete applied on the TTF dam's southeast abutment.**  
**GP stockpiles are fully covered.**

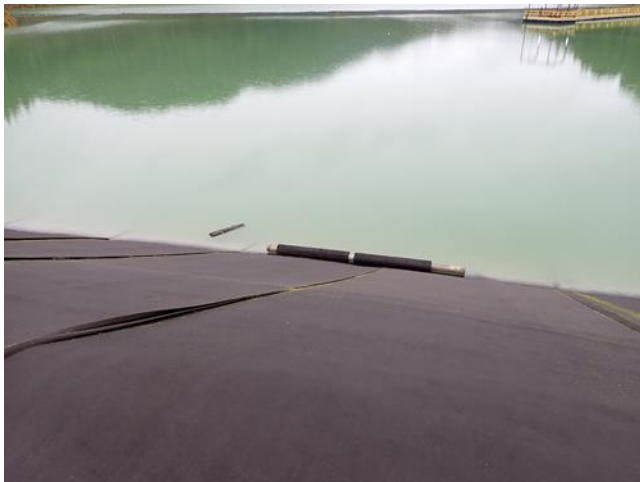
During observation of the TTF, it was documented that a section of insulated steel pipe and several logs have floated to the south end of the TTF (Photos 22-24). Coeur Alaska's Environmental Manager Kevin Eppers also documented this and reported this to Surface operations for immediate corrective action. On October 19, 2017, Surface operations removed the logs and pipe.

**Photo 22. A section of insulated steel pipe observed along the TTF dam.**

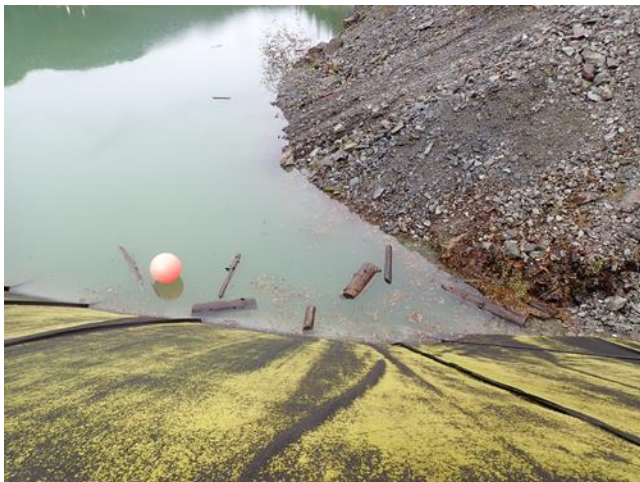
**Photo 23. Logs observed near the TTF's dam (southeast).**

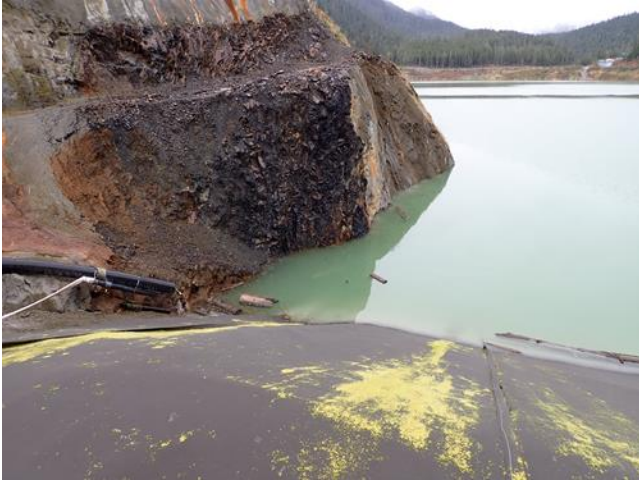
**Photo 24. Logs near the southwest end of the TTF dam.**

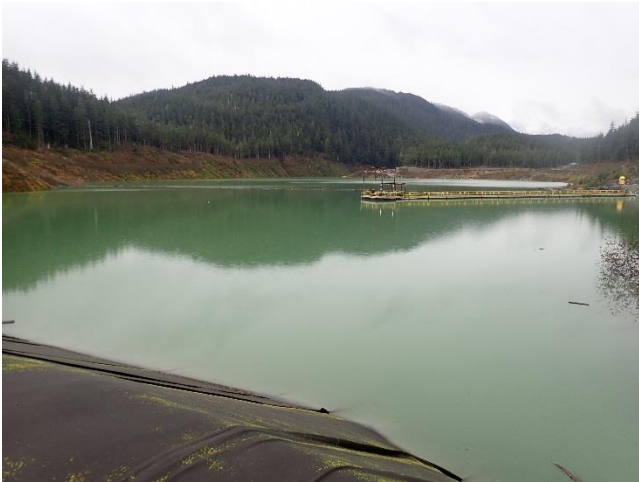
The recorded water level for the TTF on 10/18/2017 was 701 feet (Photo 25). The water treatment plant (Photo 26) was treating 580 gpm and the monthly average is 662 gpm. The water treatment plant was tidy and in order.

**Photo 25. The tailings treatment facility (TTF).**

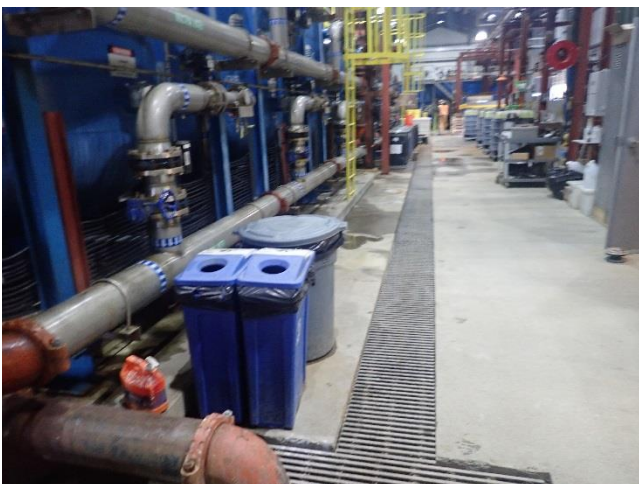
**Photo 26. The TTF water treatment plant.**

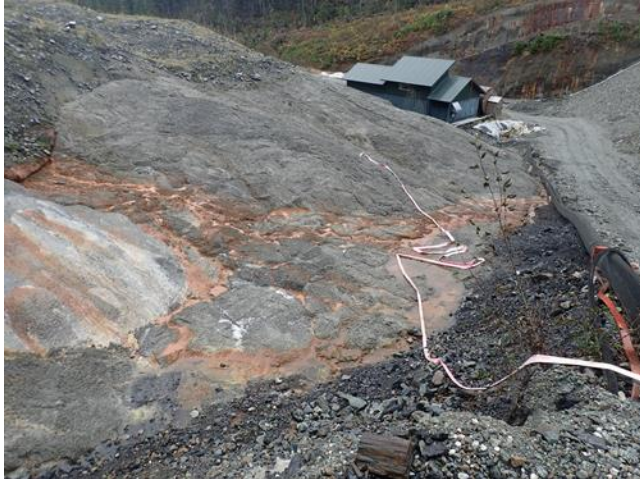
Along the southeast abutment for the TTF dam, ARD (Photo 27) continued to flow into a containment sump. Coeur Alaska has contacted the contractor, who applied the original concrete layer over the abutment, to reapply concrete over the area to minimize the ARD. On November 1, 2017, concrete was reapplied to the outcrop.

**Photo 27. Concrete will need to be reapplied to a section of a GP outcrop that is generating ARD.**

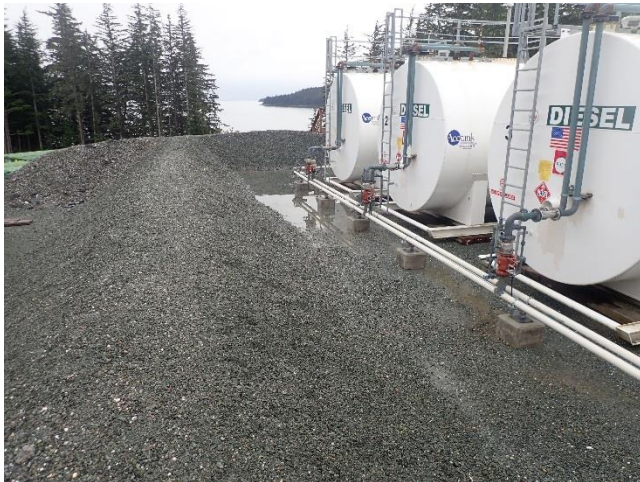
This site was tidy and in order (Photo 28).

**Photo 28. The fuel depot.**
