INSPECTION REPORT: KENSINGTON GOLD MINE

Date of Inspection: Tuesday March 6, 2018
Date of Report: Tuesday March 20, 2018
USDA Forest Service Inspector: Richard Dudek

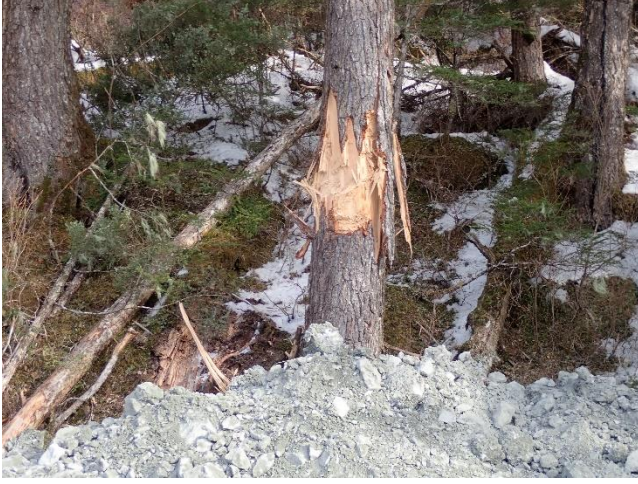
- During nighttime development of the new TTF east access road, a haul truck hit a tree. Removal will require approval from the Forest Service (Photo 1).

Photo 1. A tree was damaged during the construction of the new TTF access road.

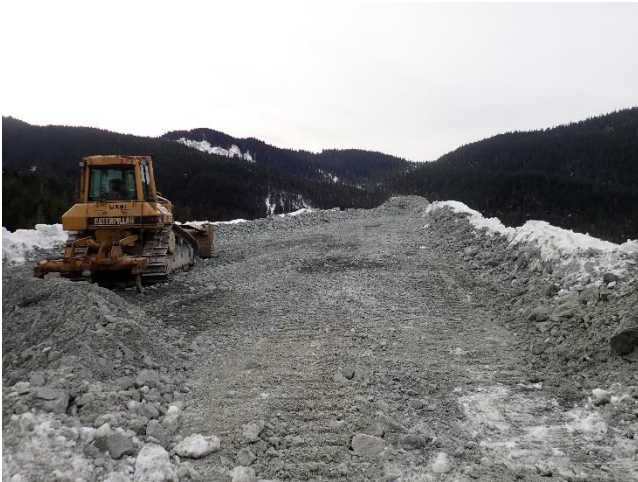
Waste rock from the Raven drift was recently deposited at this location (Photo 2).

Photo 2. The Comet development pile.

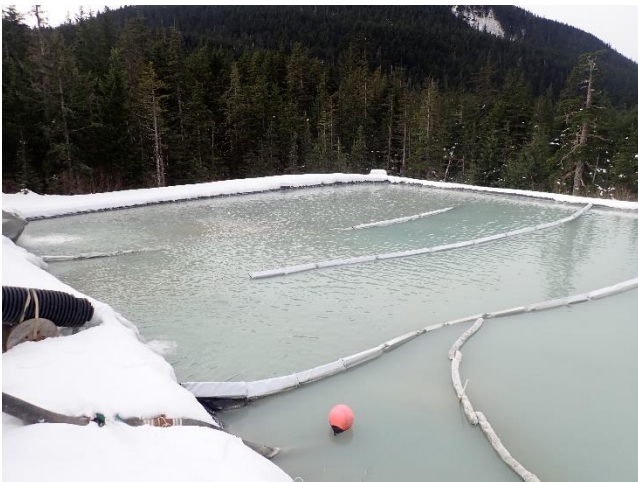
Photo 3. CWTP Pond-1.

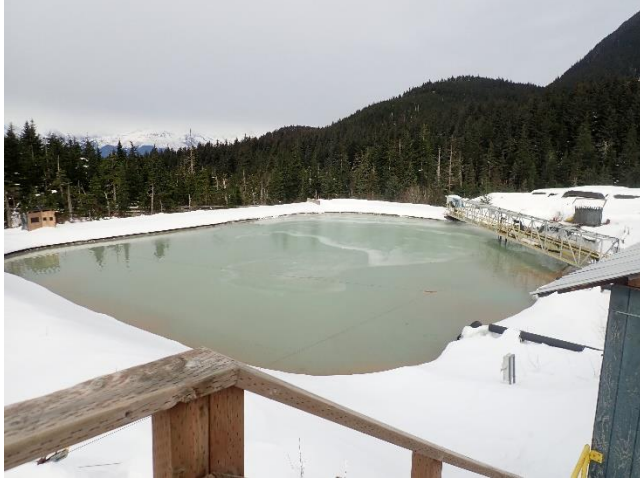
Photo 4. The CWTP's Pond-2.

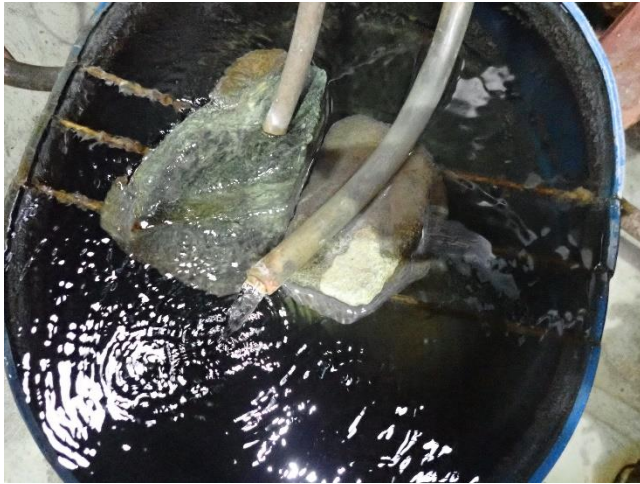
White material was not observed on the test rocks used for monitoring white material in treated mine site water (Photo 5). The permitted one-month trial test using calcium chloride (CaCl_2) appeared to be effective for precipitating white material out of solution. Coeur Alaska and the Alaska Department of Environmental Conservation (ADEC) are currently discussing the continued use of CaCl_2 .

Photo 5. The test rocks used for monitoring white material.

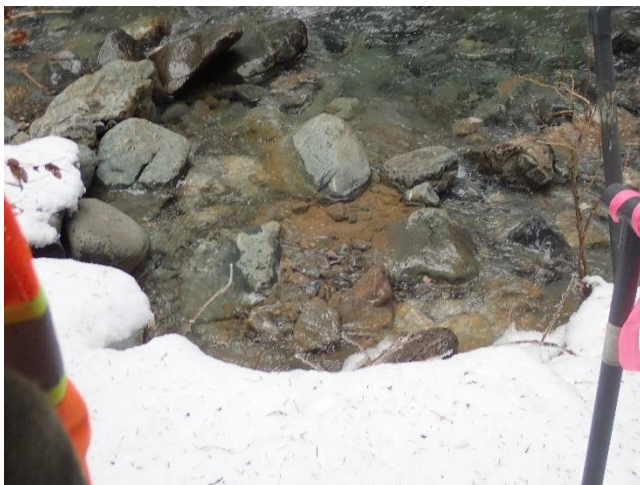
White material was not observed in Sherman Creek (Photos 6-7).

Photo 6. Sherman Creek Outfall 001. The brownish sediments seen here are fine sandy materials.

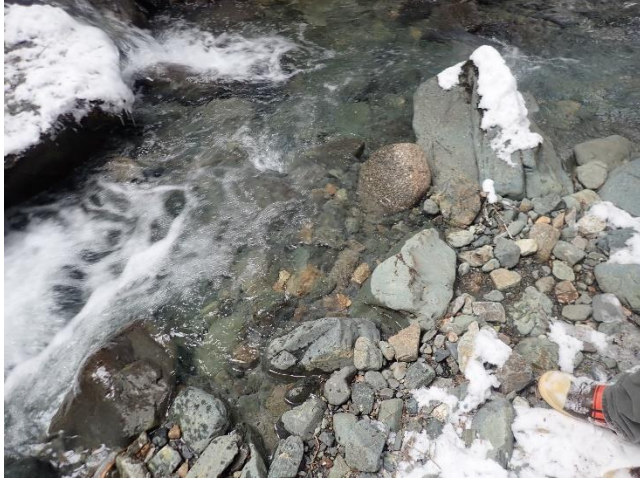
Photo 7. Sherman Creek.

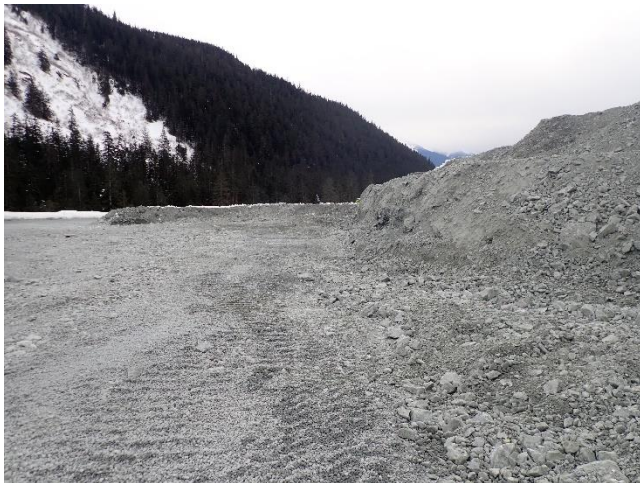
The waste rock (Photo 8) from this location is being temporarily staged at Pit 7, and then utilized as fill material for the new TTF east access road. Currently all pebble reject rock is being staged separately at this location (Photo 9).

Photo 8. Waste rock removed from the Kensington development pile.

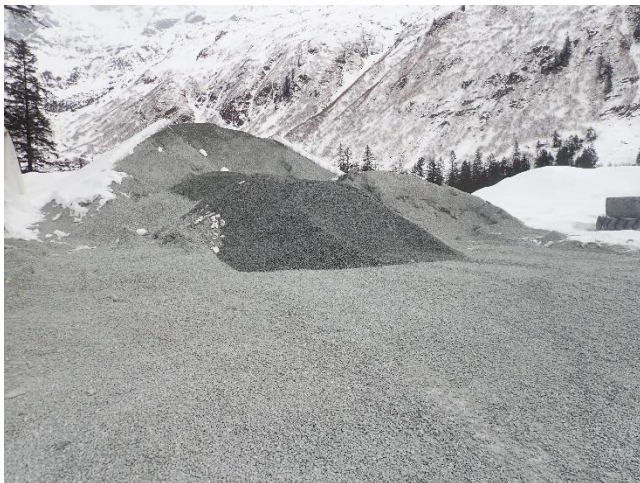
Photo 9. Pebble rock staged across from the Kensington development pile.

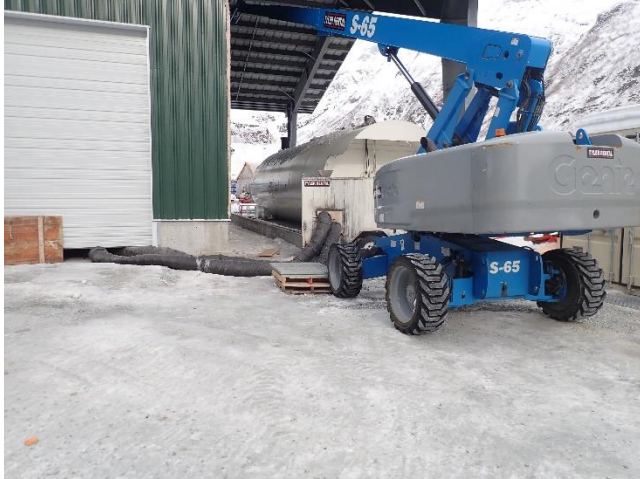
The 30,000-gallon day tank (Photos 10-11) was relocated and staged next to the new powerhouse. At the time of the inspection, the day tank was not in use due to the piping and connections were not in place. A 1,000-gallon tank was being used for refueling.

Photo 10. The 30,000-gallon day tank.

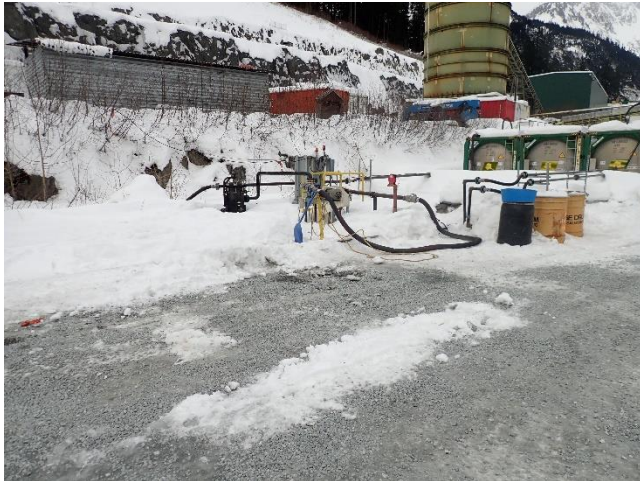
Photo 11. The previous location where the 30,000-gallon day tank was staged.

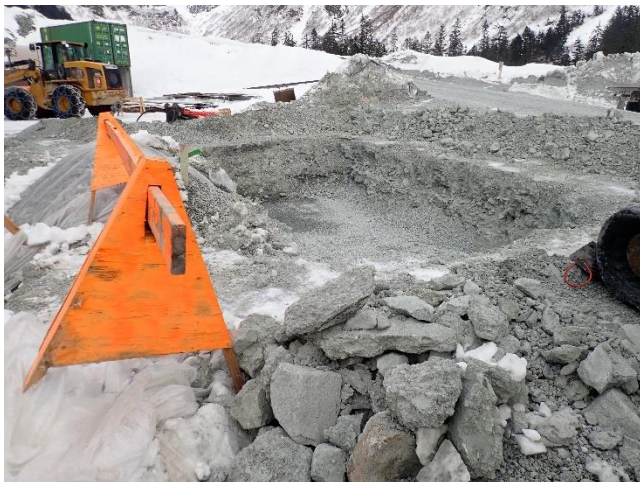
The new refueling pad near the powerhouse is under construction (Photos 12).

Photo 12. The location for the new refueling pad.

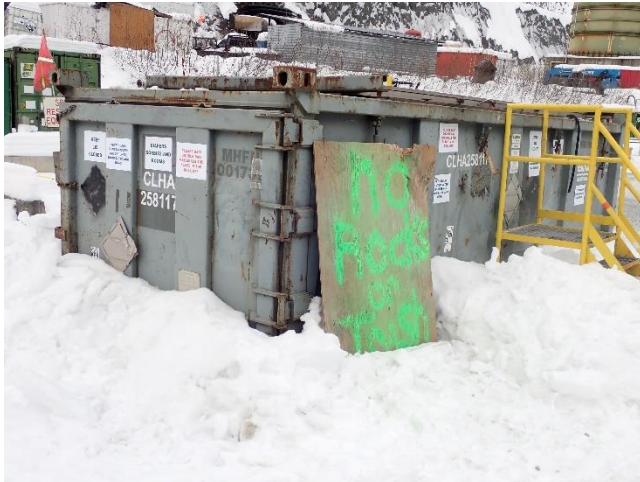
Coeur Alaska recently staged a storage container for used hydrocarbon absorbents (Photo 13). The used absorbents will be shipped offsite to an appropriate disposal facility.

Photo 13. The storage container for used hydrocarbon absorbents.

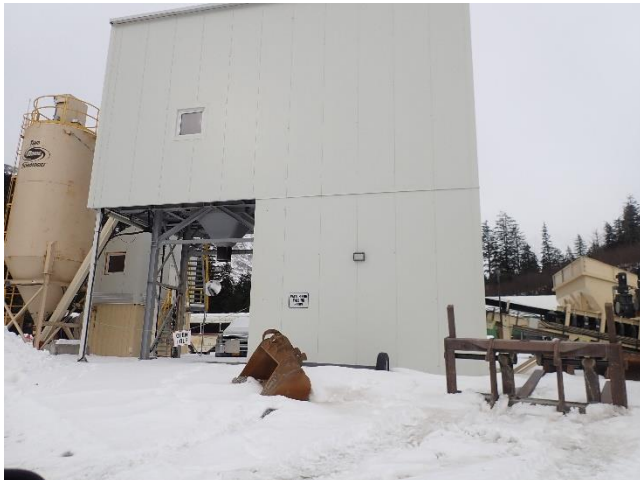
The pug plant is currently inactive during the winter months (Photo 14).

Photo 14. The Pug plant at Pit 4.

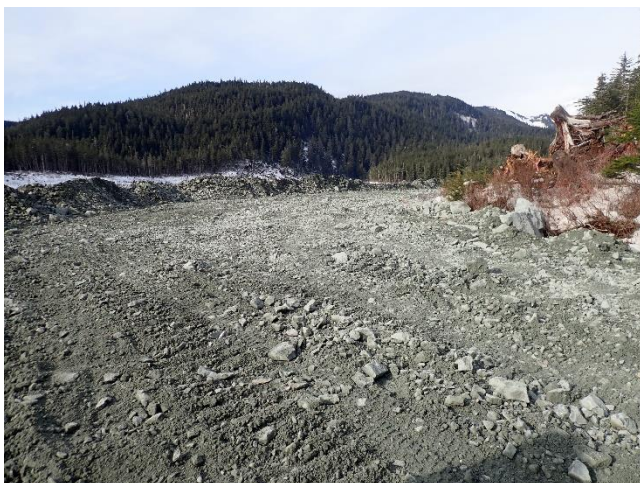
Coeur Alaska has begun construction of the new TTF east access road. Approximately 8,000 tons of waste rock was utilized as fill material to raise the access road due to the future increase of the water level (Photo 15).

Photo 15. The new TTF access road.

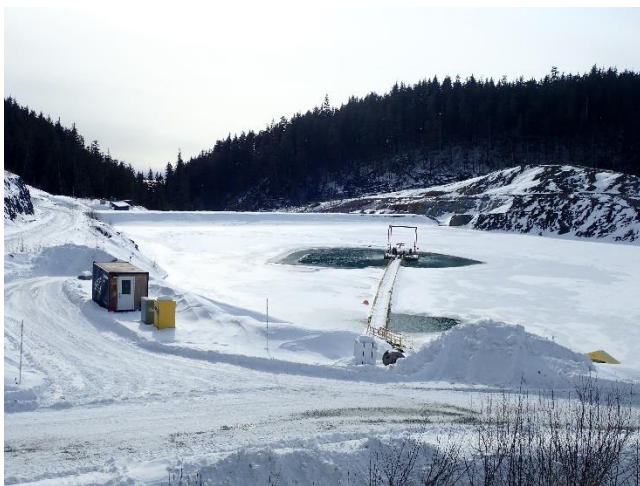
The TTF was mostly frozen over and the recorded water level on 03/06/2018 was 703.1 feet (Photo 16). During the site visit, TTF personnel were in process of breaking ice for a path to the tailings barge (Photo 17). The warm temperature from the tailings being deposited keeps ice from forming around the barge; however, TTF personnel require an ice-free path from shore to the tailings barge.

Photo 16. The TTF.

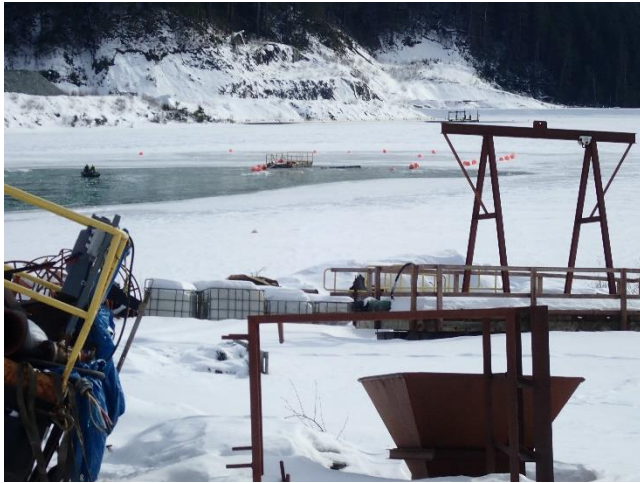
Photo 17. TTF personnel were in the process of breaking ice.

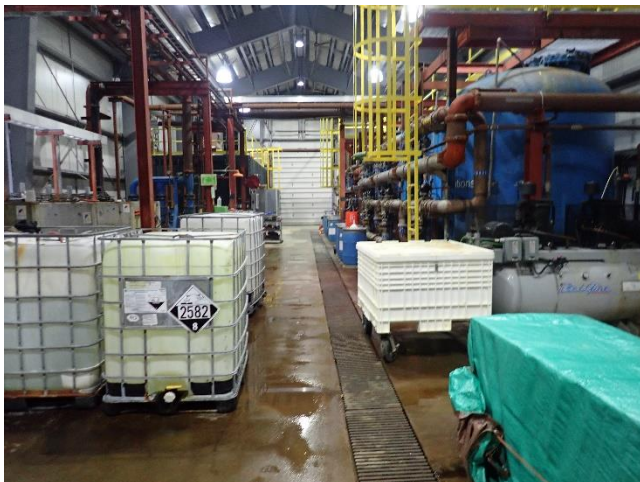
Good housekeeping practices (BMP plan Table 4-1) were observed inside the water treatment plant (Photo 18).

Photo 17. The TTF water treatment plant.

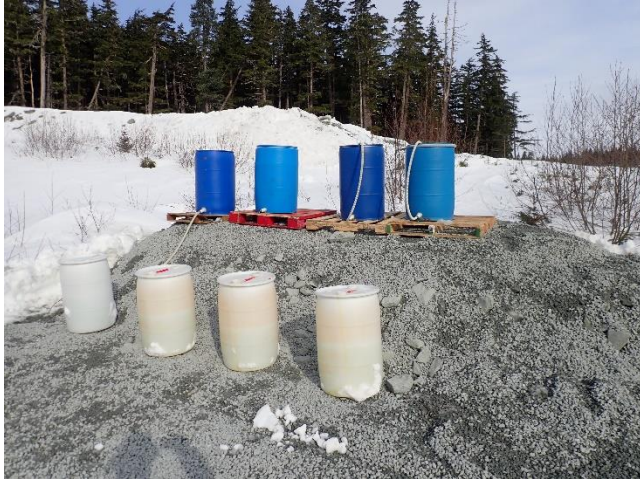
The Graphitic Phyllite (GP) cells (ARD test barrels) in the northern TTF area were relocated closer to the TTF laydown yard (Photo 19).

Photo 18. The GP material leachate test barrels.

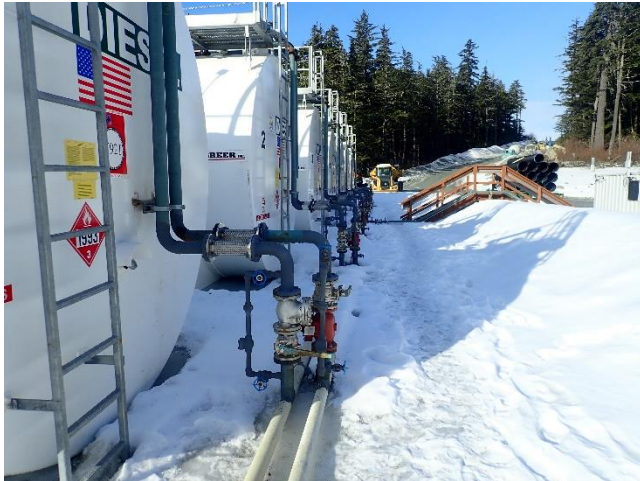
Photo 19. The fuel depot.

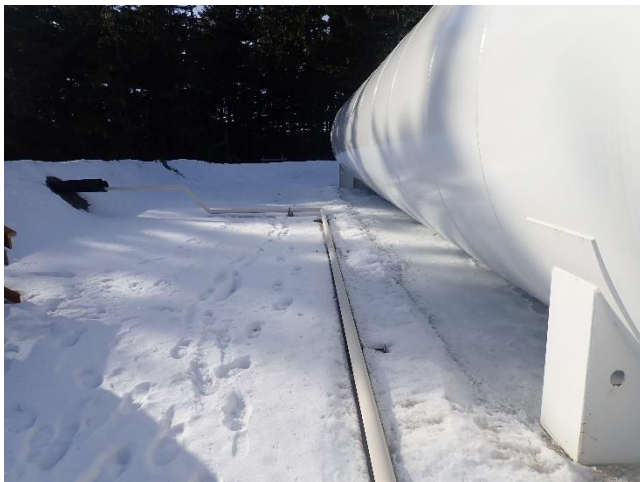
The fuel tank's structural gravel pad was covered in snow and ice (Photos 20-21). The structural gravel pad is regularly monitored for water, snow and ice accumulation. Fuel depot operators will remove the accumulation if it is impacting the capacity to store 110% of the volume from a single tank.

Photo 20. Snow and ice covering the tanks farms structural gravel pad.
