Inspection Date: February 8, 2017
Weather: Cloudy, light snow showers at times, upper 20's F
Time of Inspection: 9:30 am to 2:30 pm
Operator Contact: Kevin Eppers – Coeur Alaska
Agency Personnel: David Wilfong – ADNR; Richard Dudek, Edward Gazzetti - USFS
Inspection Objectives: General Inspection

This report covers the February 8, 2016 inspection of the Kensington Gold Mine. Transportation to and from the mine was provided by a United States Forest Service (USFS) chartered DeHavilland Beaver floatplane operated by Ward Air. The inspection team (inspectors or team) consisted of David Wilfong – Alaska Department of Natural Resources (ADNR), Richard Dudek and Eddie Gazzetti – (USFS). The team was accompanied for the duration of the inspection by Kevin Eppers (Kevin) from Coeur Alaska's (Coeur) Environmental Department.

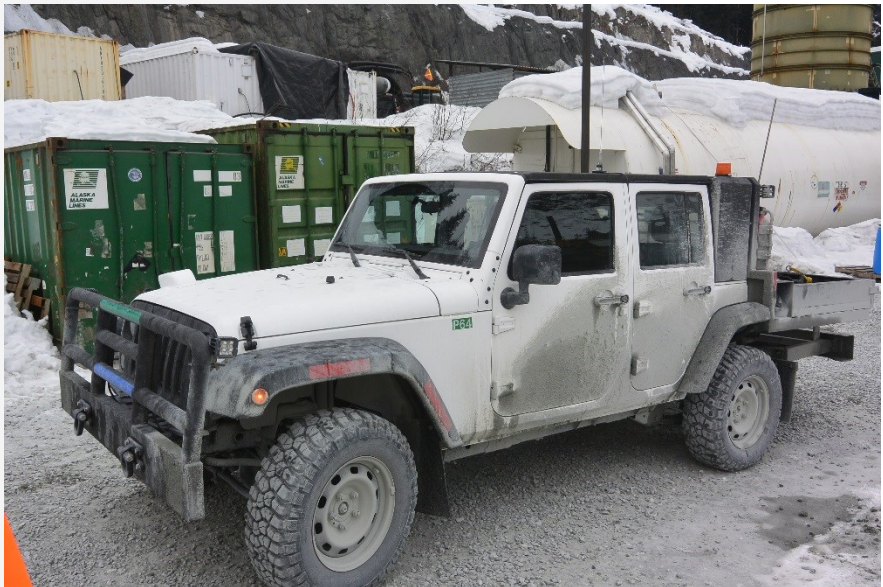
Kevin met the team at the Marine Terminal in one of Coeur's new Jeep style vehicles. The Jeeps are replacing the old Dodge pickups that are well worn. The Jeeps have had diesel engines retrofitted into them as very little gasoline is kept on the mine site (5-10 gallons for chainsaws and other small power tools). The team traveled to the Camp area where Personal Protective Equipment (PPE) was donned, and then traveled to the Mill Building where the extra equipment needed to travel underground was

Figure 1 The diesel powered Jeeps are replacing the old Dodge pickups.

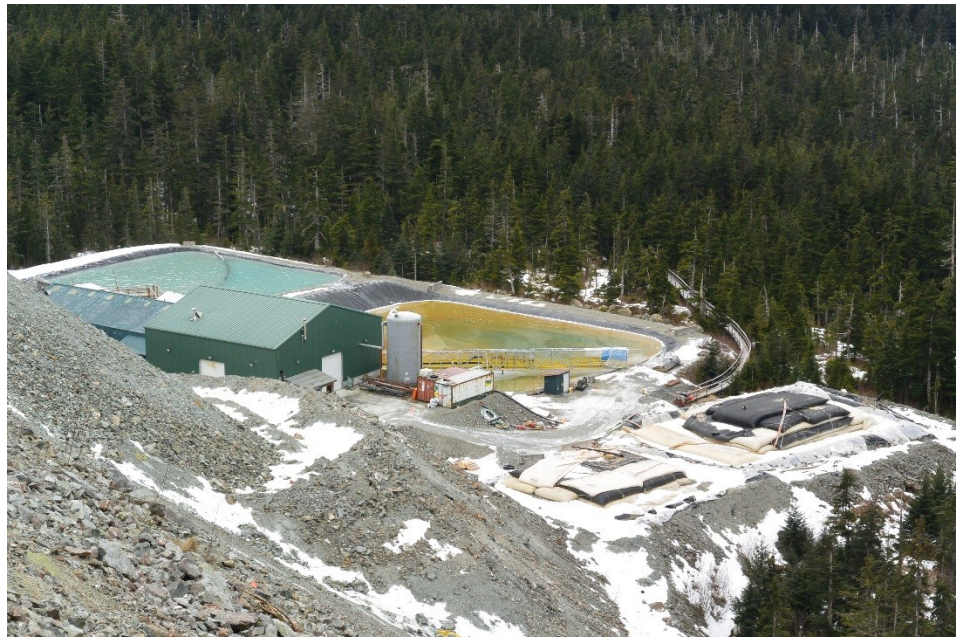
pile's footprint will grow when it is reclaimed due to flatter slopes. The Comet Water Treatment Plant (WTP) sits near the base of the pile, and Coeur has stated that the plant and ponds will need to be removed prior to reclamation of the waste rock pile. According to the Reclamation Plan, during and after closure, the WTP ponds are to be reclaimed as wetlands that will provide a receiving area for water draining from the closed mine. The Reclamation Plan should be updated to reflect the removal of the ponds.

Figure 2 The Comet WTP as viewed from the top of the waste rock pile.

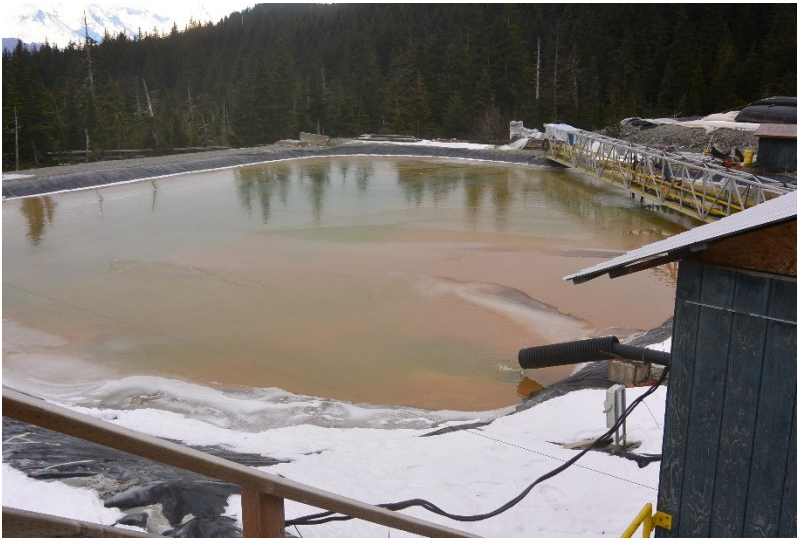
Figure 3 Pond 2 at the Comet WTP.

the dredge pump, it can expand and result in a broken pump case.

The team traveled down to the WTP at the base of the pile and walked over to the ponds. Mine water was flowing into Pond 1, and Pond 2 was sitting idle. Kevin stated that dewatering flows from the mine were averaging about 900 gallons per minute (gpm). 900 gpm is relatively low for the mine which can peak around 3000 gpm during the spring breakup, but flows typically drop off through the winter months when much of the water is locked up as snow and ice, and cannot infiltrate into the mine. The dredge that normally works the ponds had been pulled from the water and sat at the edge of Pond 2, wrapped in plastic. If water freezes in

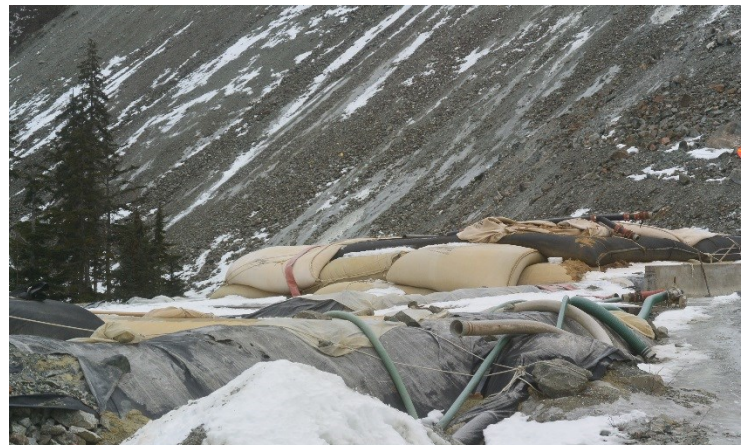
As the team traveled down to Sherman Creek, it passed by the dewatering bags filled with sediment dredged from the ponds. The bags were stacked high as the added weights helps the bottom bags to drain water from the pore space in the sediment, which can take several months. After walking down the trail,

Figure 4 Dewatering bags filled with sediment dredged from the ponds.

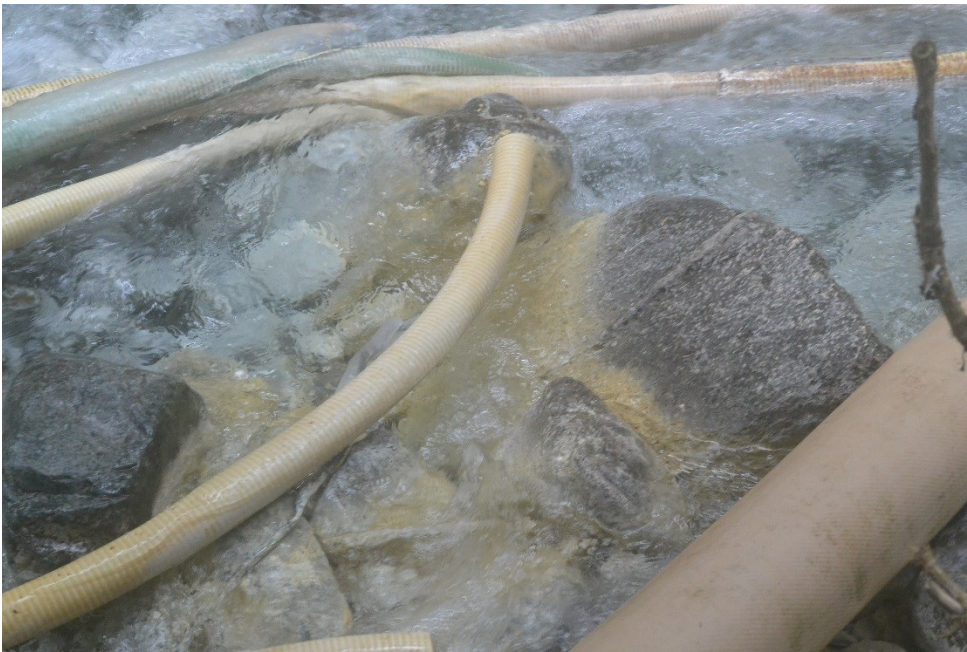
Figure 5 White material covering rocks in Sherman Creek.

the team arrived at the partially frozen Sherman Creek. The white precipitate persists in the creek, and shows no signs of abating.

The white material has coated the rock intermittently for about 2 years. Coeur has used X-ray fluorescence and diffraction, spectrography, deoxyribonucleic acid (DNA) and other tests to determine the type and source of the white material. The testing shows that it is most likely bentonite. Bentonite is a type of clay that is used for many purposes including drilling mud,

adsorbents and sealing agents. Because bentonite swells when it comes in contact with water, Coeur used it in the past as a drill hole sealant in an attempt to slow the infiltration of water into the mine. However, Coeur no longer uses bentonite in the mine and none is stored on site. Due to bentonite's very small grain size, it can be difficult to settle out in water treatment plants. Although the mine water is the source of the bentonite, at the time of the inspection, Coeur was meeting the water quality permit limits set by the Alaska Department of Environmental Conservation.

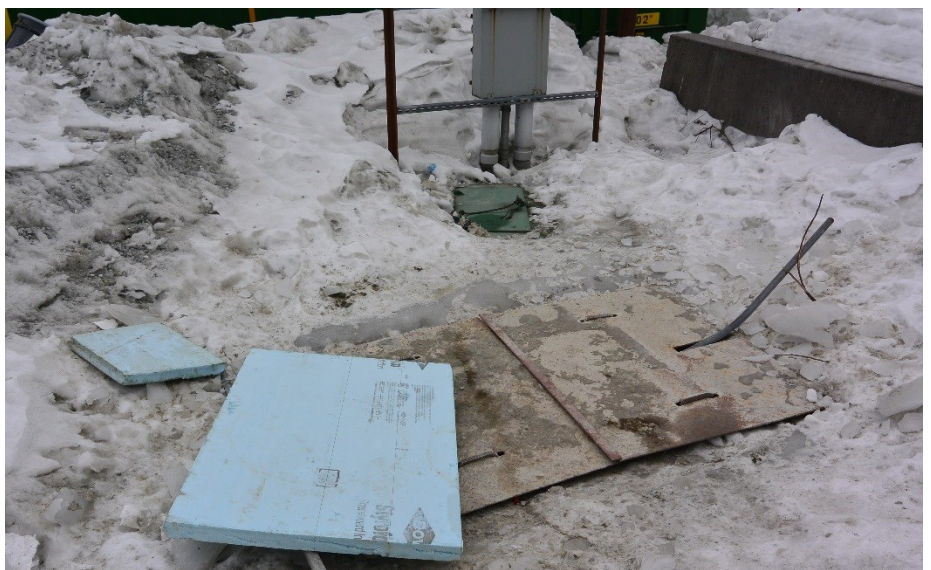
Figure 6 Secondary containment sump and lift station.

The Assay Building may be repurposed as the above-ground maintenance shop, as the old shop near Pit 4 needs to be moved to accommodate the waste rock pile that has been proposed for the area. The secondary containment sump/lift station that froze a few weeks prior to the inspection and caused the unintentional release of diesel fuel into the Mill's water treatment system was free of ice. However, the Styrofoam board meant to insulate the sump was not properly placed.

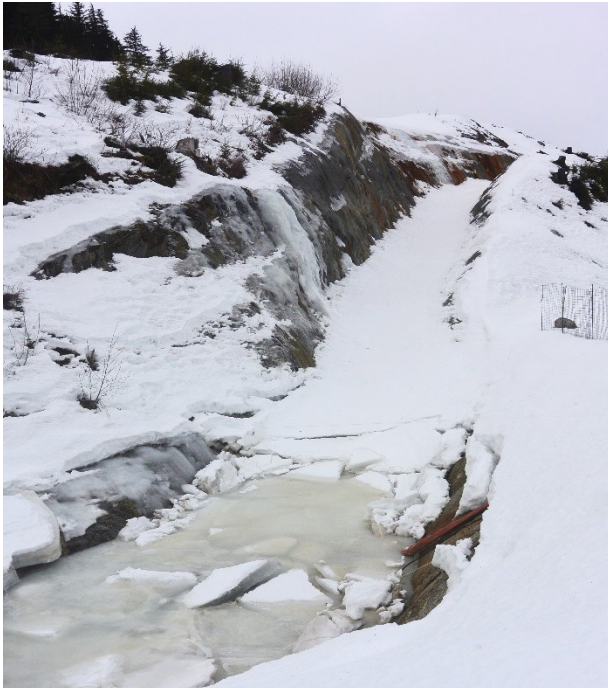
Figure 7 Emergency spillway and plunge pool.

The emergency spillway plunge pool was full of solid ice and no water was exfiltrating from the shotcrete that lines the spillway due to the cold weather. The shotcrete wall was covered with formations of ice that resembled frozen waterfalls, and it appeared that no water had flowed down the slope for at least several days. The Lower Slate Lake bypass outlet was flowing freely, and no major ice buildup was observed near the end of the pipe.

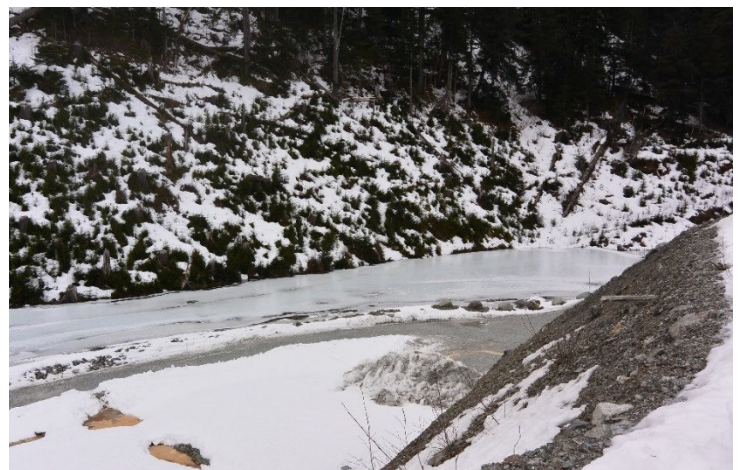
The team moved north to the barrel test area. The barrel tests were frozen, and no water has been collected for several months due to the cold weather. Water with high levels of metals continues to flow from the toe of the area where

graphitic phyllite was accidentally dumped. The water was still flowing in the sub-freezing temperatures, likely due to impurities, and was collected in the nearby sump. The team traveled to the WTP and walked through. The plant and nearby containers were clean and tidy.

Figure 8 The area where water flows from the toe of the pile where acid-generating graphitic phyllite was dumped.

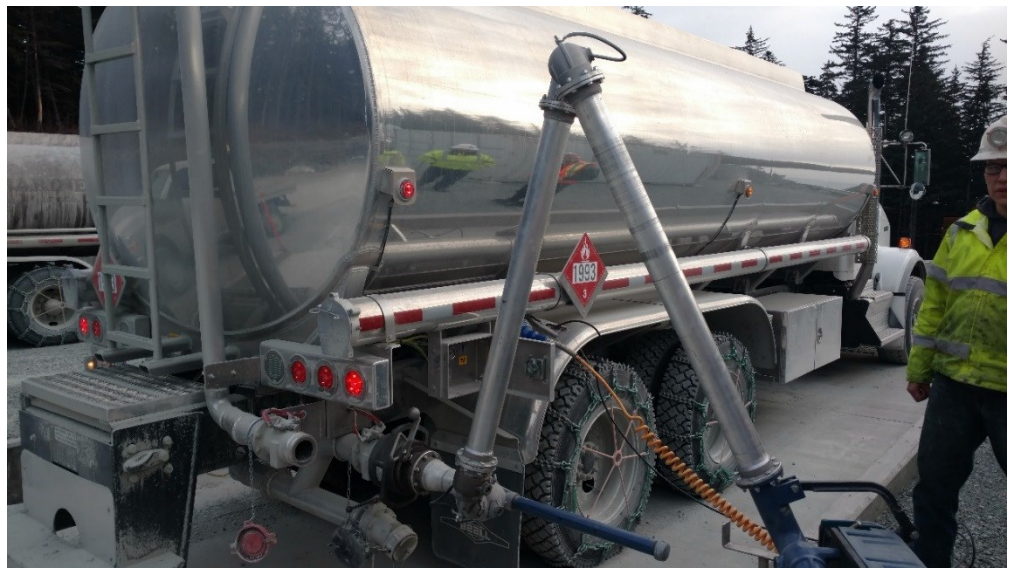
ISO Containers to transfer fuel. A fuel truck was being filled at the time we arrived, and we took a moment to watch the process. The truck pulls into a concrete secondary containment filling area which ensures that no fuel is released into the environment in the event of a leak or spill. The driver connects a ground cable and wire harness from the pump shack to the truck, and attaches a hard line which carries the fuel. When the truck's tank is full, the system automatically shuts off and drains the fuel pipe. When the pipe was disconnected, not a drop of fuel spilled into the secondary containment. The entire process was very easy and efficient.

Figure 9 A fuel truck being filled at the tank farm.
