Kensington Mine 2017 Environmental Audit

Coeur Alaska, Inc.

January 19, 2018

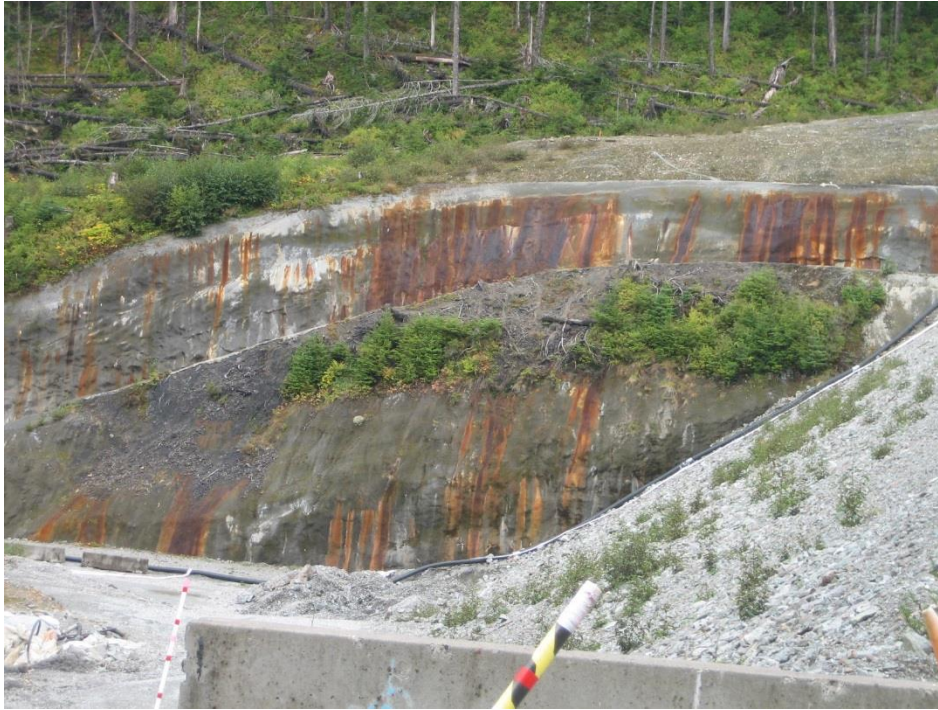
Photo Q Stage 2 Interim Spillway west wall and west abutment wall below spillway and downstream of Stage 2 Dam toe, shotcrete spillway walls with ARD seepage staining on spillway & abutment walls, looking west.

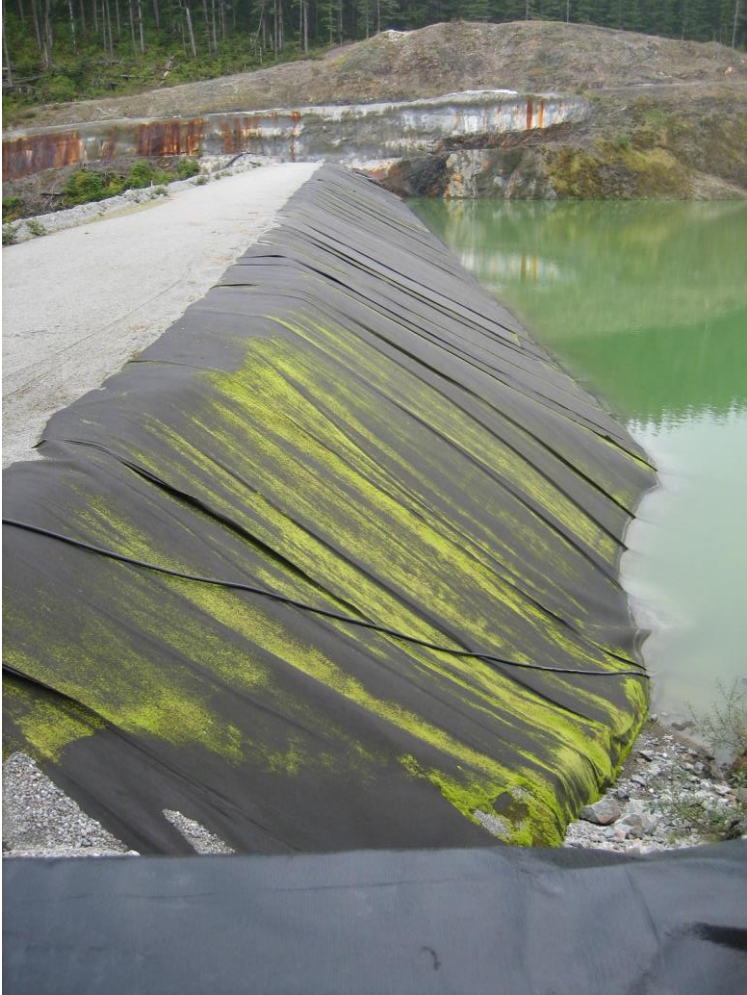
Photo R Lower Slate Lake Dam Stage 2 upstream slope with exposed geotextile, looking west.

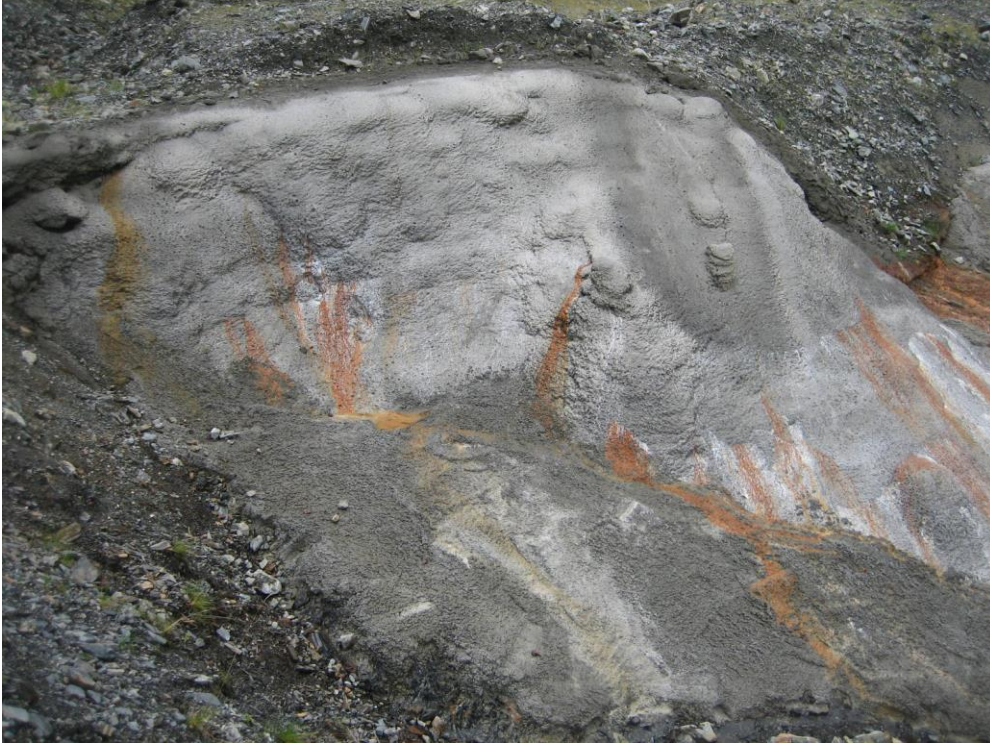
The observed condition by the Audit Team of the temporary graphitic phyllite cover on the eastern side of the downstream end of the dam is inadequate to ensure seepage and runoff does not escape containment (WMP Section 1.3.3). The Audit Team's recommendation is to add a crushed diorite cover to the exposed graphitic phyllite surfaces or a similar alternative because the shotcrete/dental concrete application does not appear to function as needed to contain seepage.

Photo T Lower Slate Lake Dam area downstream of east (left) abutment, shotcreted slopes (understood to have been excavated to rock) with staining from ARD seepage and collected seepage at toe of slope.

would be a release from containment. It is the Audit Team's recommendation that while surface water seepage from this east side of the dam abutment is potentially reporting to the dam seepage sump, that the dam seepage sump water goes to the GPPTP rather than back to the TTF.

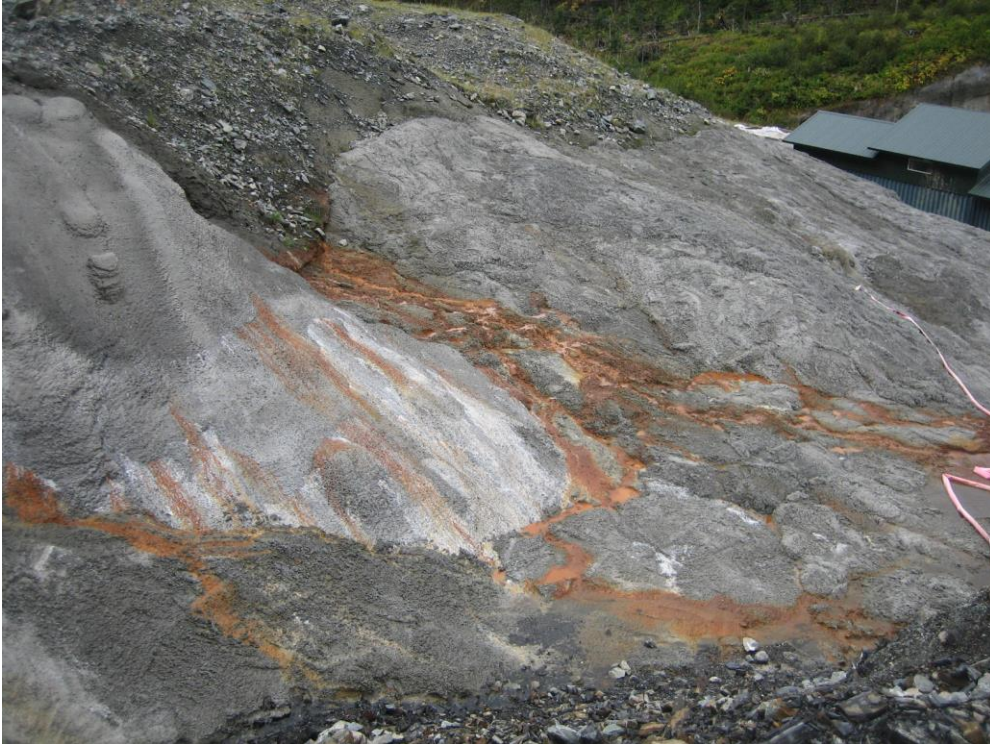
Photo U Lower Slate Lake Dam area downstream of east (left) abutment, shotcreted slopes (understood to have been excavated to rock) with staining from ARD seepage and collected seepage at toe of slope.

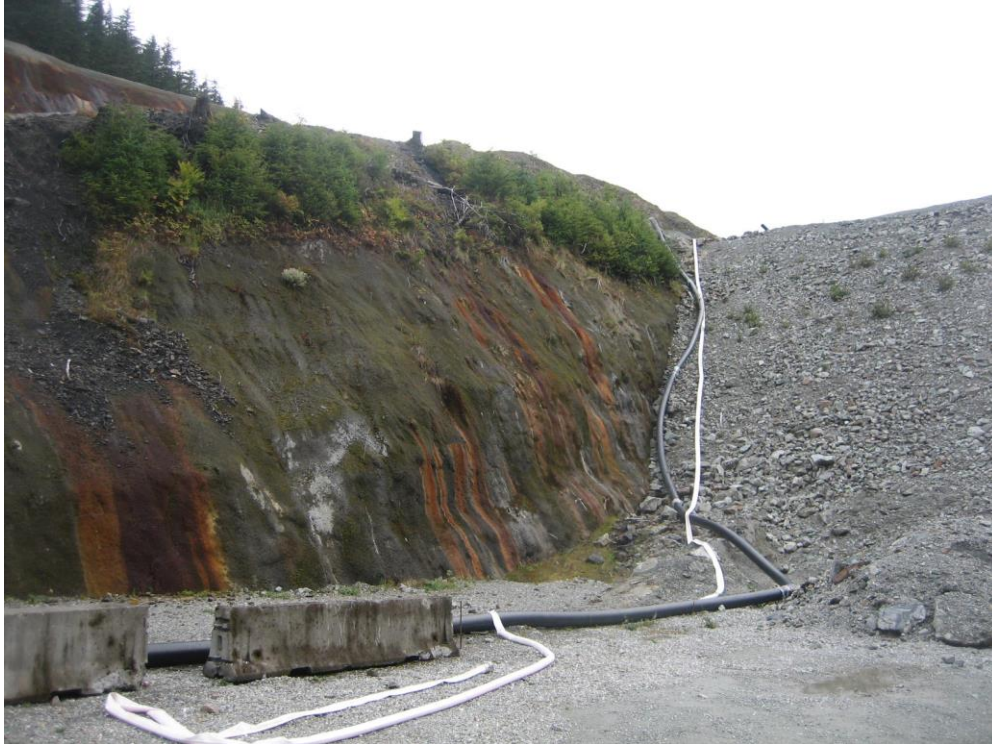
Photo W Lower Slate Lake Dam Stage 2 downstream slope. Seepage Collection Sump return pipeline along west groin of dam. Shotcrete west abutment wall with staining from ARD seepage.

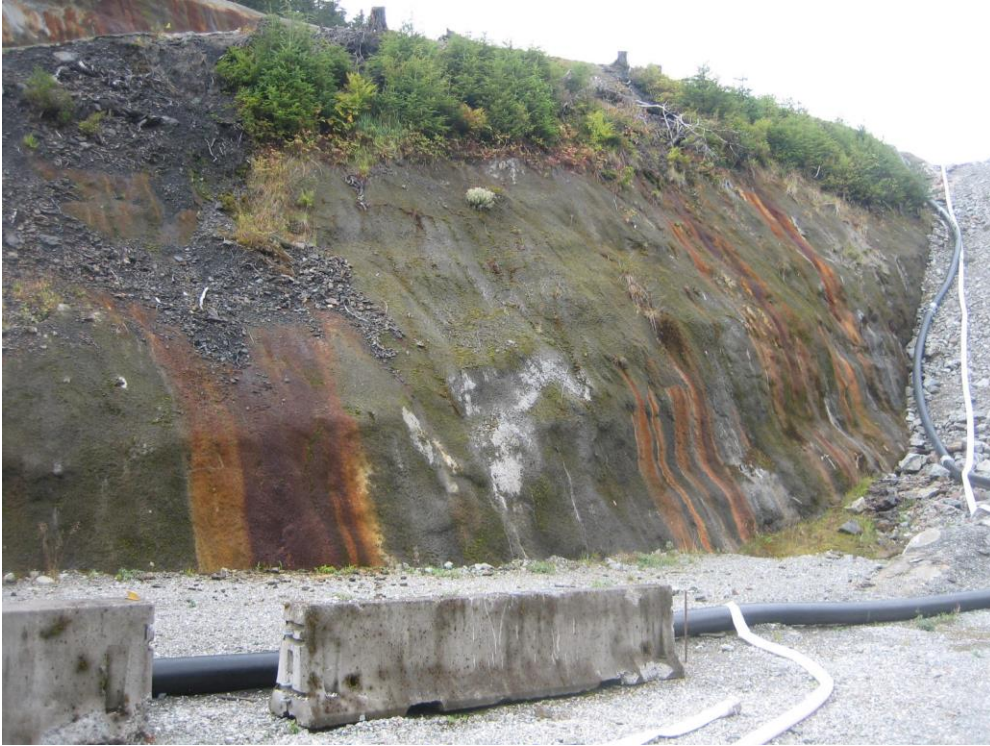
Photo CC Lower Slate Lake Dam Seepage Collection Sump return pipeline along west groin of dam. Shotcreted west abutment wall with staining from ARD seepage.

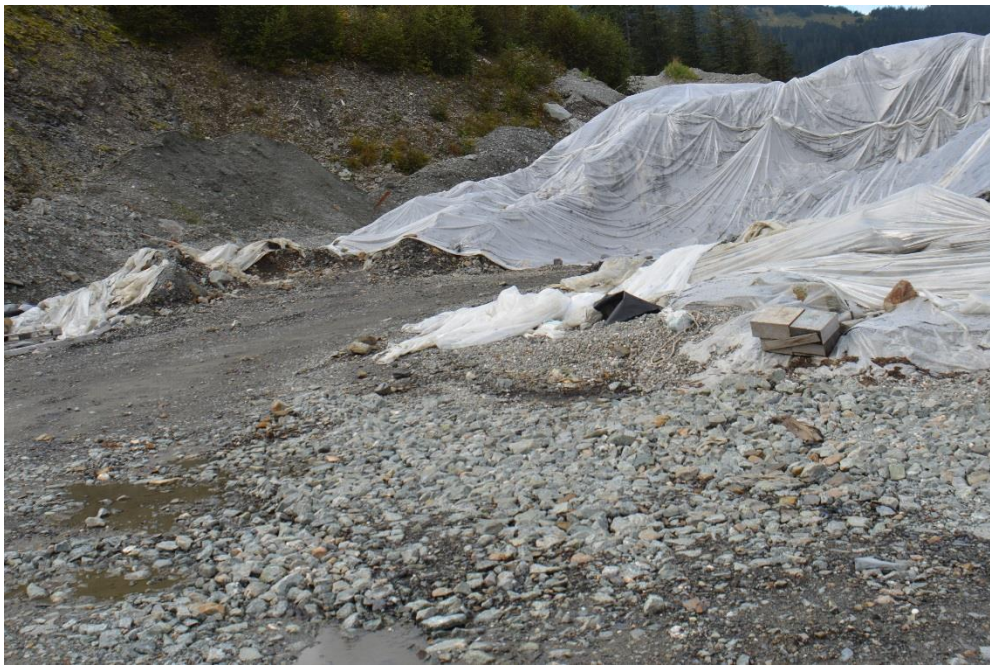
All of these sites are authorized in the WMP Section 1.3. Graphitic phyllite is temporarily stockpiled until it can be mixed with cement and diorite (development rock) and is then placed in underground stopes for permanent disposal. The Audit Team observed all of the containment areas and liners were functioning. The Audit Team observed that Pit 7 had exposed graphitic phyllite (because it was actively being transported) and was missing runoff controls (e.g., berms) such that runoff in contact with graphitic phyllite had the potential to flow away from Pit 7 (Appendix A Photo JJ). The Audit Team recommended to the Environmental Manager during the Audit Site visit that berms or similar runoff controls be established at the site to contain stormwater in contact with the graphitic phyllite.

Photo JJ Pit 7 graphitic phyllite storage, missing a berm to capture runoff.

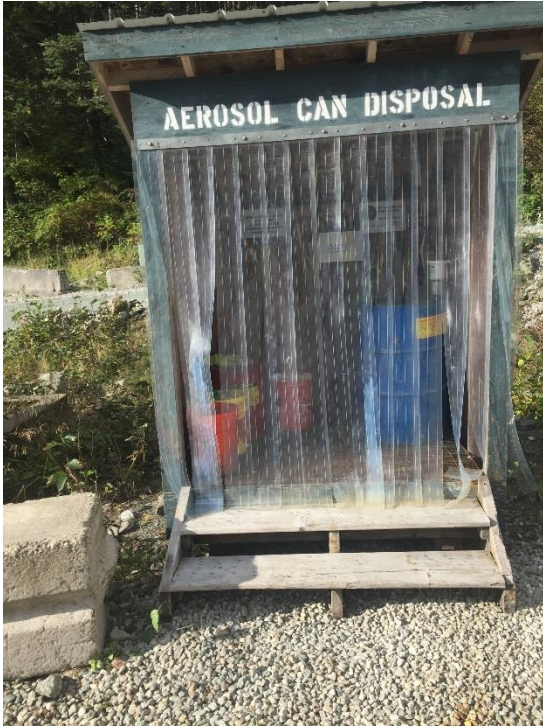
Photo MM showing an aerosol can disposal station, cans are punctured and discharged directly in to a 55 gallon drum containing a Hazardous Waste Label.
