MEMORANDUM

State of Alaska

SUBJECT: Niblack meeting & site visit,
August 24, 2006

LMPT Photos from the Niblack Inspection on August 24, 2006

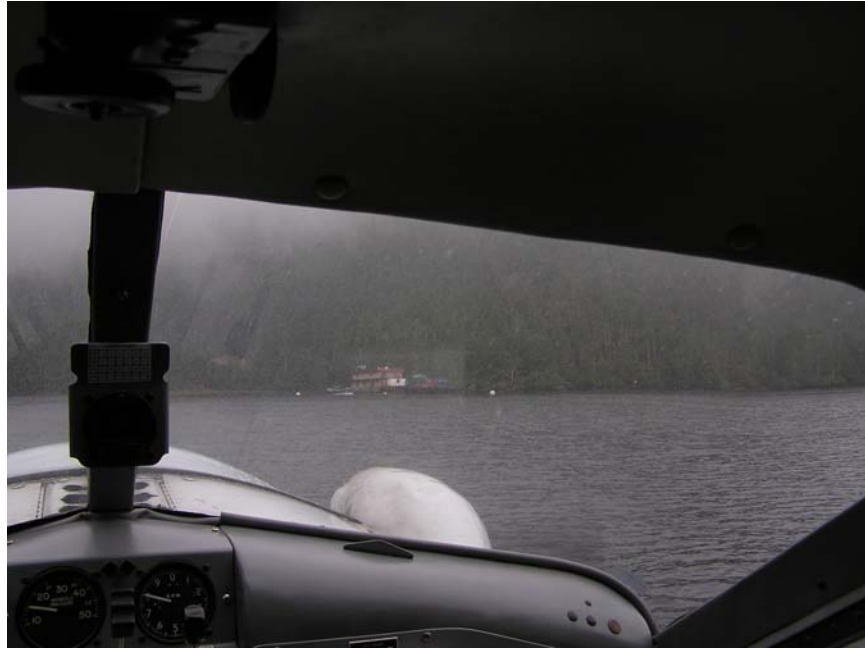
Landing near barge camp

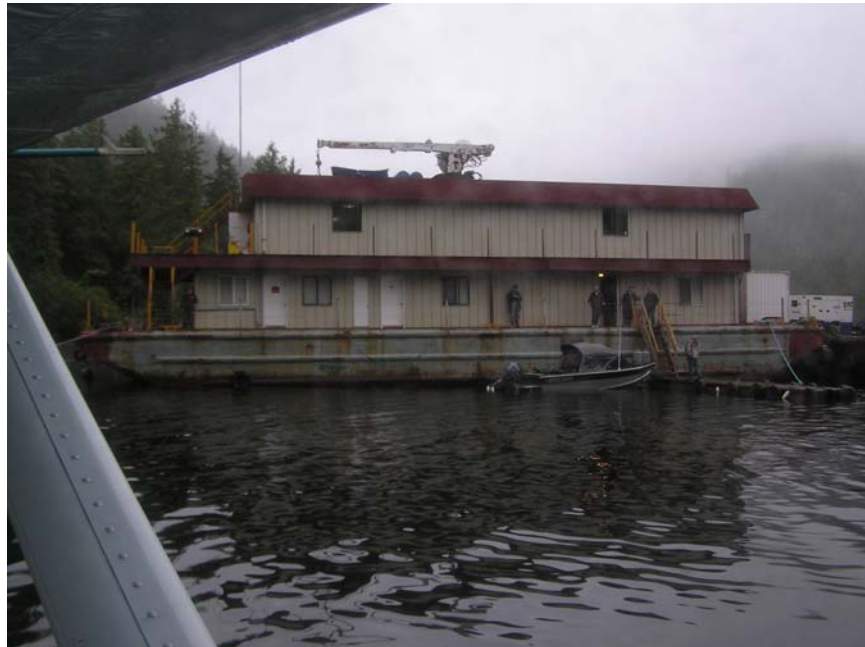
8. The barge camp and the barge used to store drilling equipment and as a helicopter landing pad appeared neat and orderly. The barge camp has all necessary permits including an ADEC wastewater discharge permit and drinking water plan approval.

Barge camp

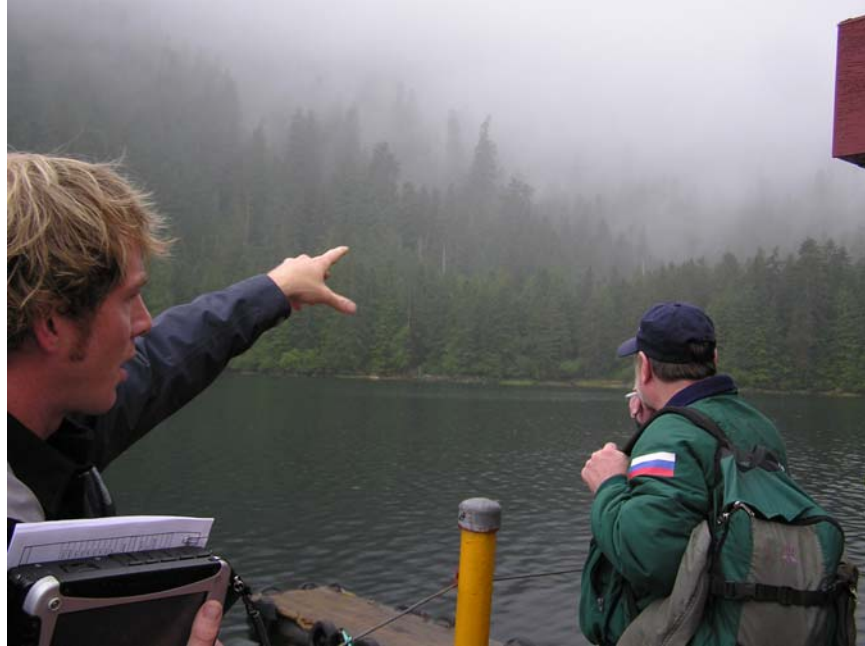
“The portal will be up there.”
(Use your imagination)

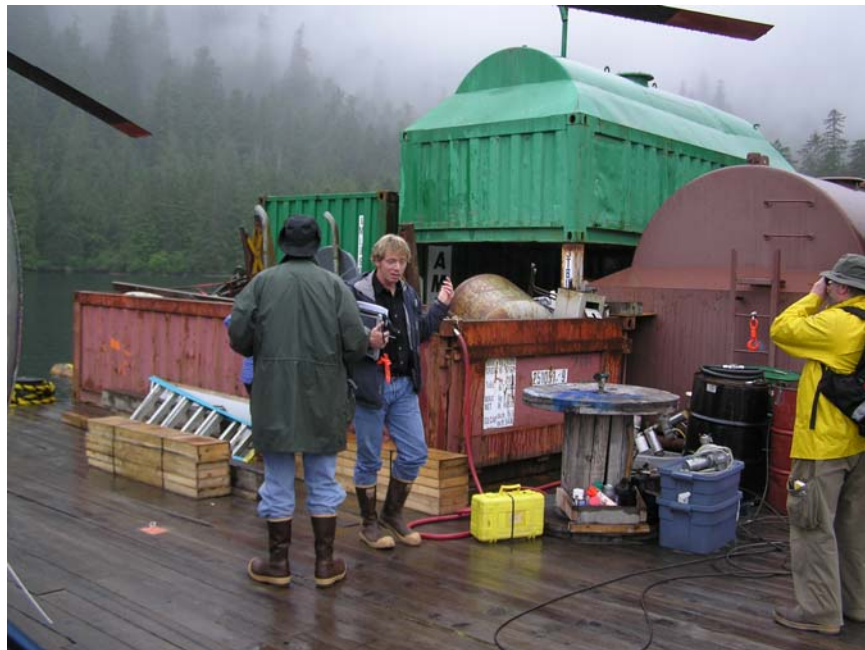
Scrap metal recycling bin and double-walled fuel tanks
(Helicopter is parked behind photographer)

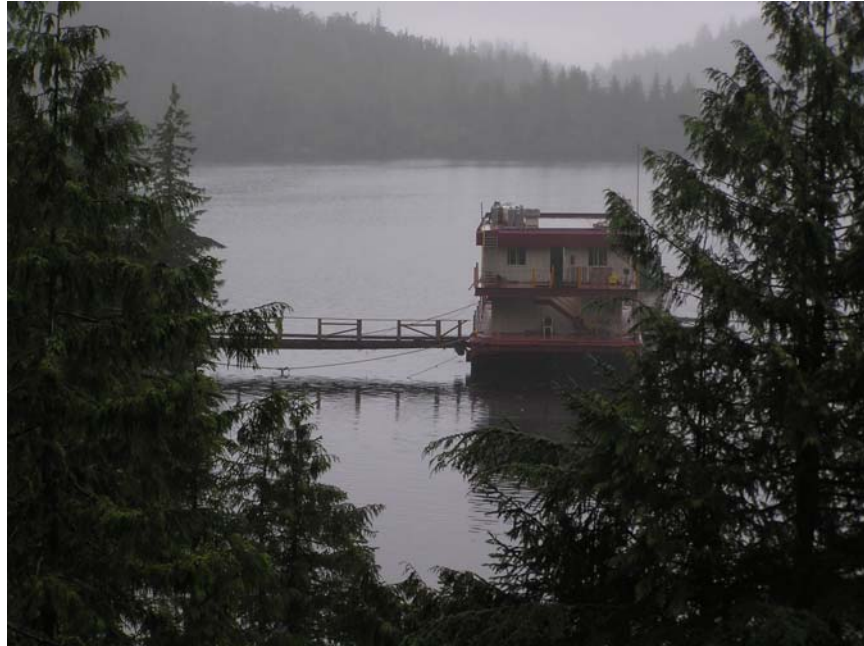
Barge camp at temporary location

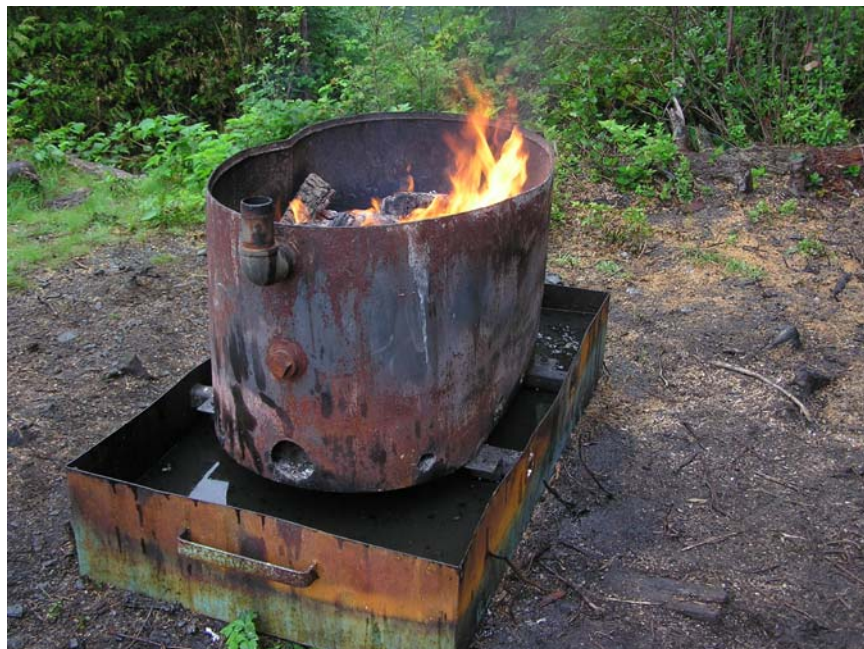
9. The “burn-barrel” for the burnable camp wastes appears to be well operated in that bears and other animals are not attracted to the burned portion of the waste. In this operation, food waste is not burned. A fire is made with wood and an efficient operating temperature is reached before incorporating waste to be burned. Metals from the burned remains are sorted and recycled. Only ash is disposed. A general permit from the ADEC Solid Waste Program is required for this operation.

Incinerator (burn barrel) with secondary containment/fire safety tank

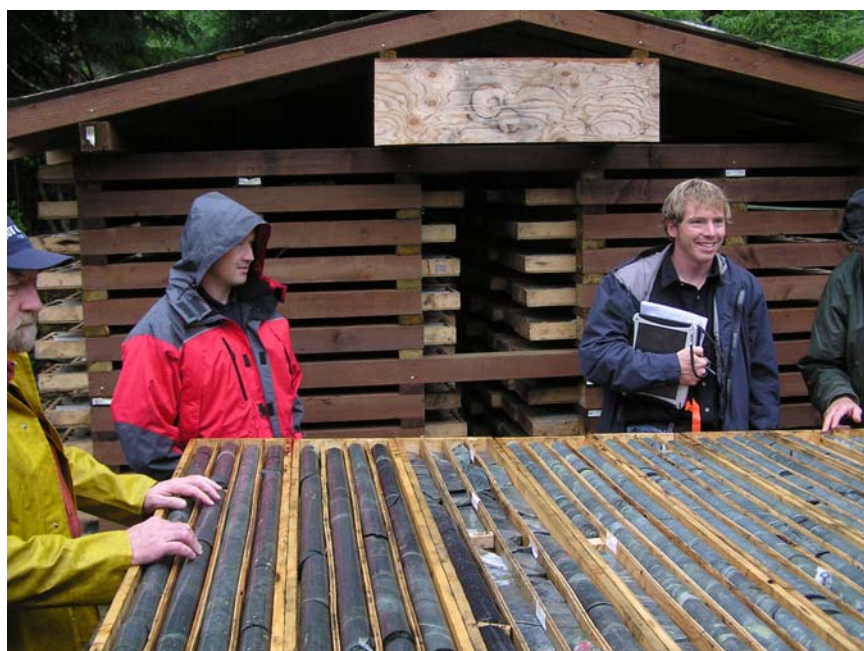
11. Eight-year old drill core shows evidence of the oxidation of sulfide mineralization.
12. The core we saw appeared to have a fairly high RQD (“Rock Quality Designation”) which suggests fairly competent rock that might have relatively low permeability except in fracture zones.

Core set out for our examination
(Core is stored under cover as behind)

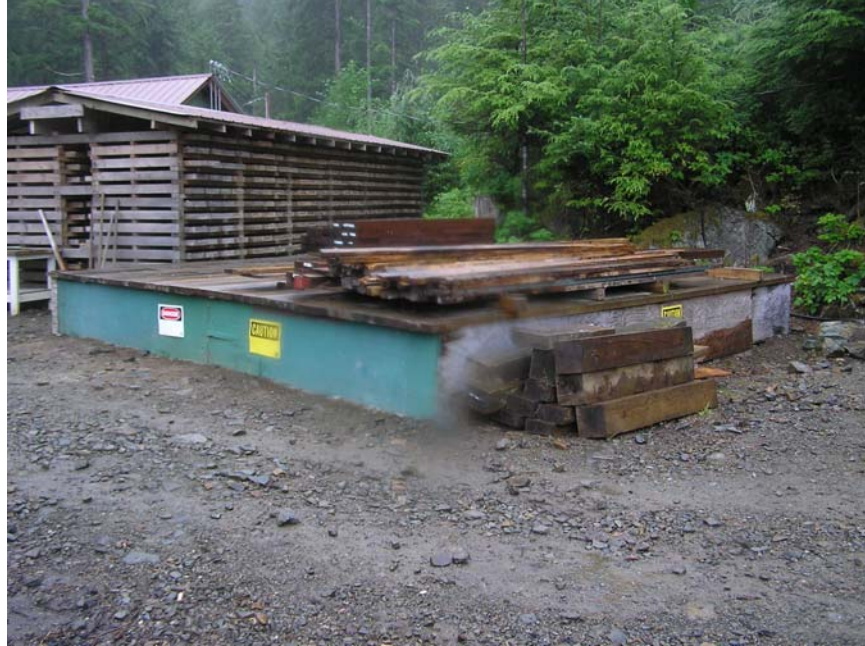
Boarded-up decline from the early 1900s

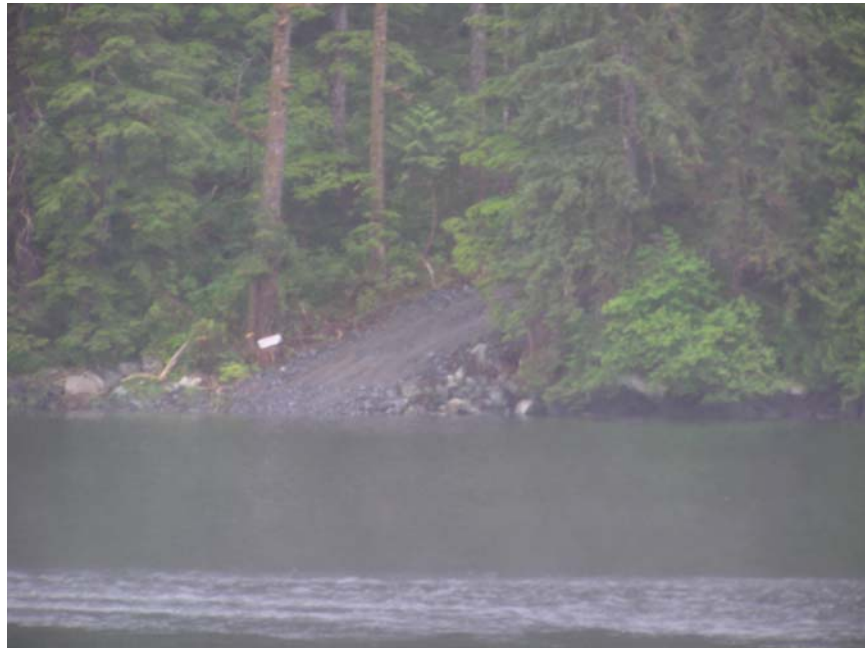
New barge landing (very inconspicuous)

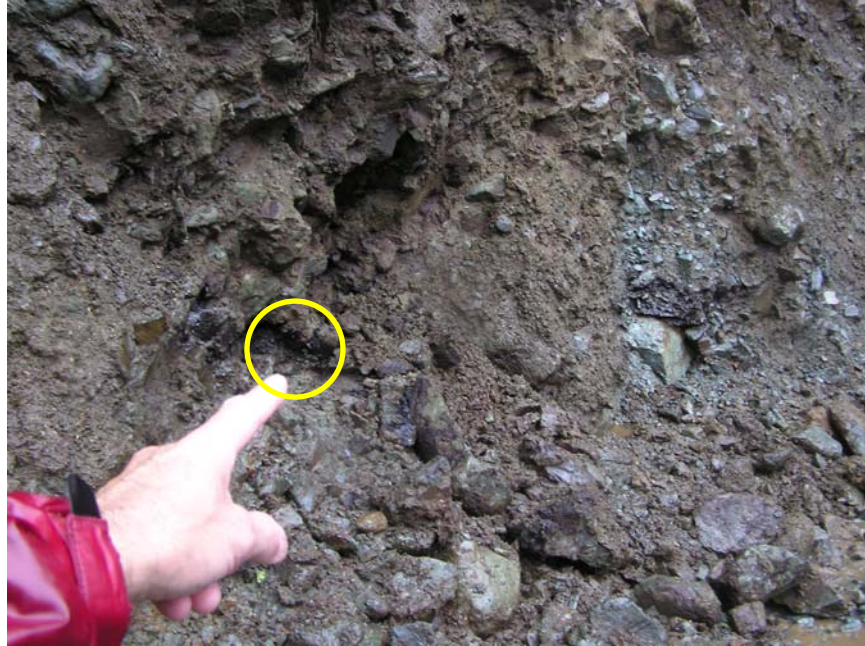
16. Road cuts exposed a mixture of rubble or talus mixed with fine grained materials. At places, surface water flows disappear underground and reemerge some distance down the slope. There does not appear to be a clearly defined shallow groundwater system on the steeper slope and the shallow sub-surface flows appear to be highly chanelized into “conduits” of groundwater flow through well-washed rocks. This groundwater regime may make the establishment of groundwater monitoring locations challenging.

Seep in a "conduit" through the colluvium

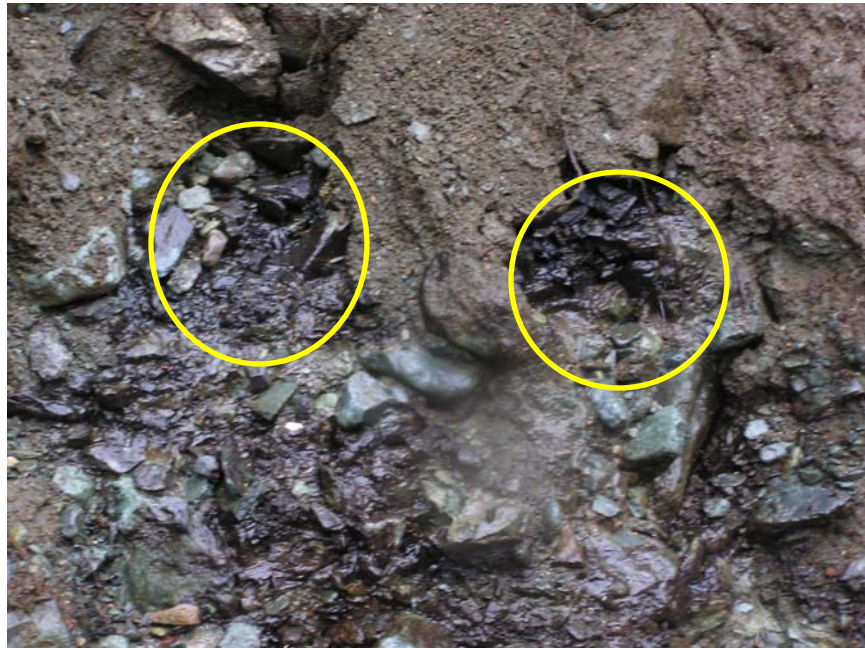
Seeps

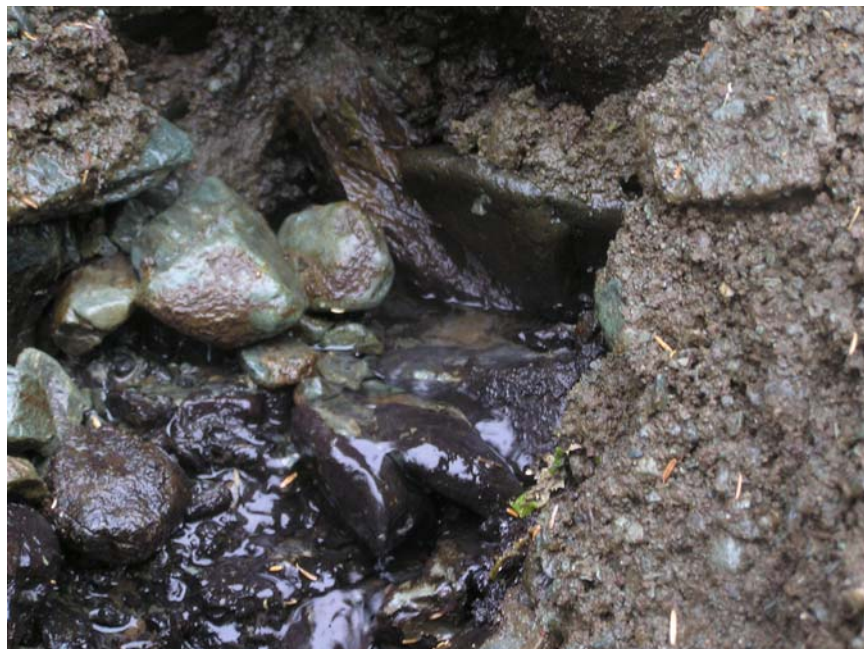
Close up of a seep

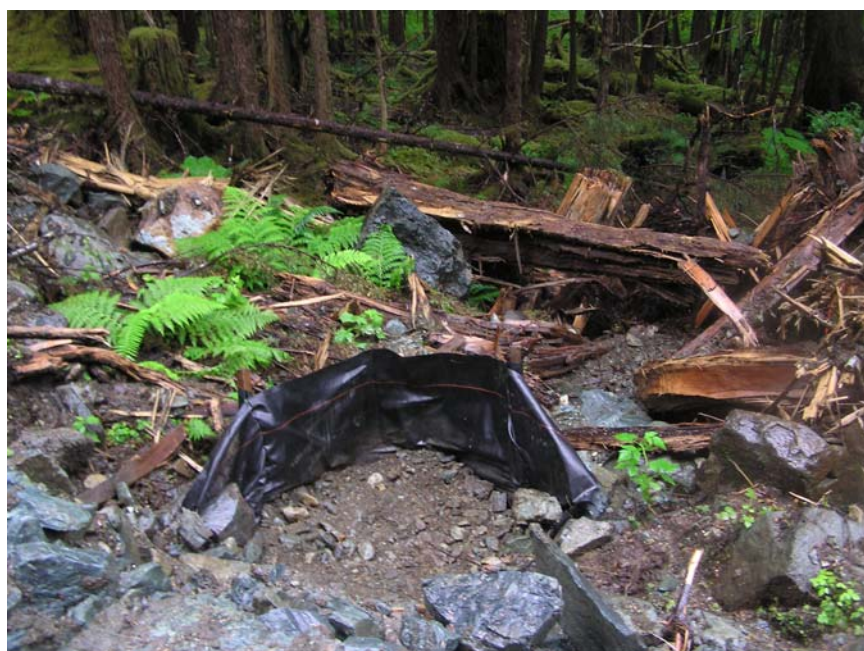
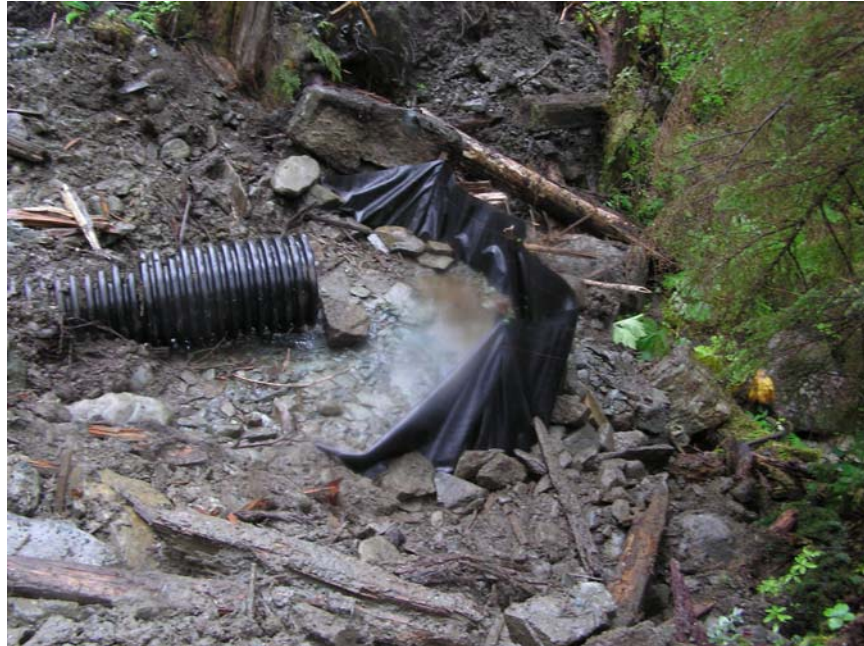
- e. Standard silt-fences have been installed below the road where culverts are located. Some of the silt-fences need to have the sediment removed.
 - f. Deep “sediment traps” have been excavated in the drainage ditch at the up-slope end of most culverts. Some of these need to be cleaned out.

Sediment trap along road

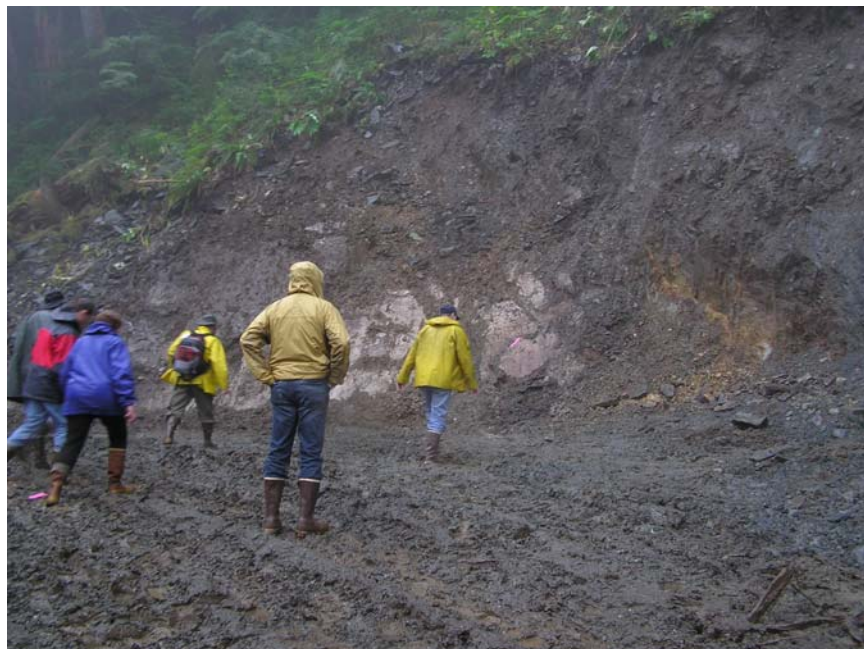
17. The proposed portal has been raised to a higher elevation in order to reduce the volume of AG material that will be excavated from the exploration adit. The new location puts the adit predominantly in the Hanging Wall Unit (NAG), however rock from the first blast round will be from the Lookout Unit (AG). Since this rock is at the surface and is probably weathered, it may be oxidized (and therefore NAG), but plans must be in place before the first blast to characterize this rock and handle it appropriately.

New location of proposed portal

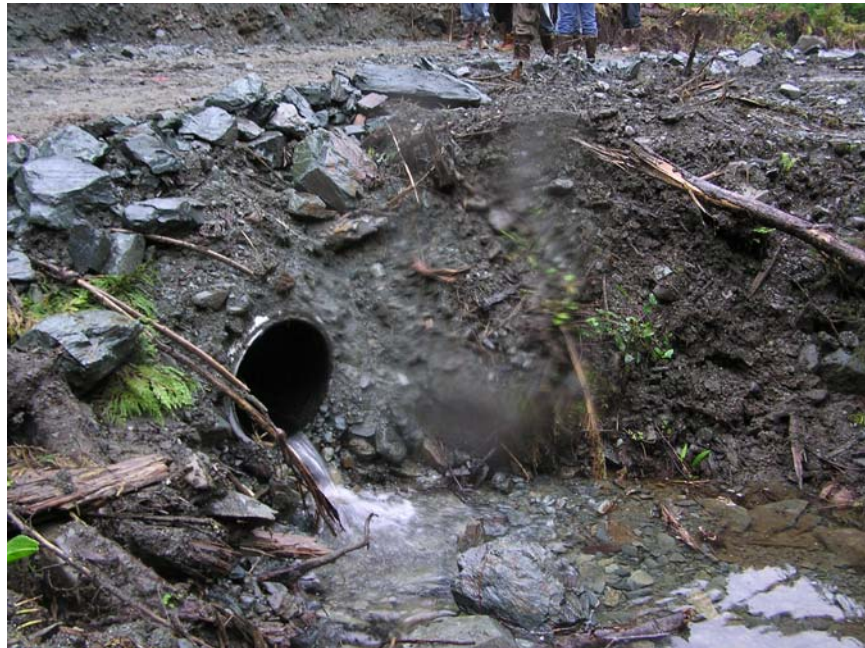
- c. There is a well defined ditch on the up-slope side of the road.
 - d. The company has installed culverts at appropriate locations to transfer water down-slope.

Culvert along road to quarry

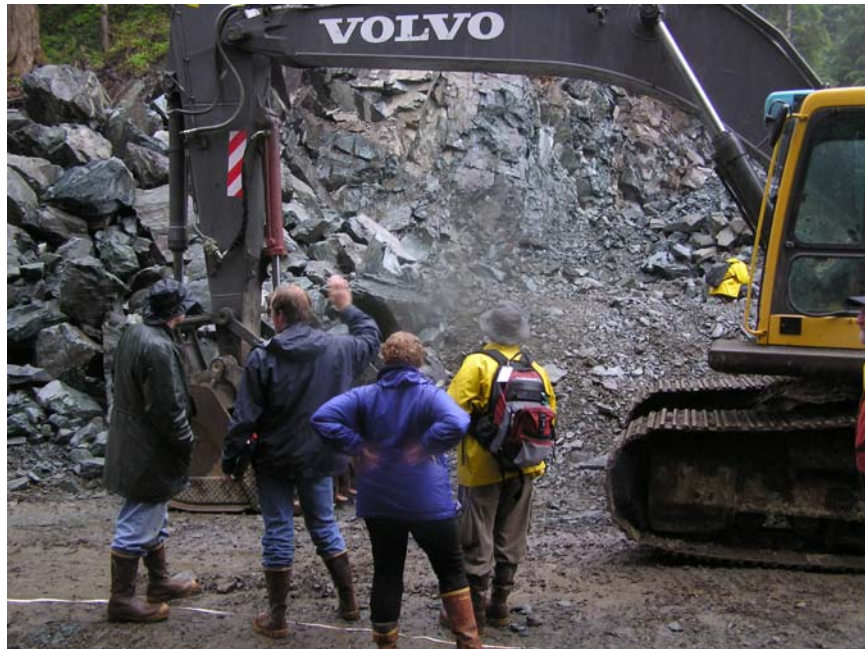
- j. Examination of the rock from the construction rock quarry indicated minimal sulfides. We suggested that some representative samples be run for ABA so that the company has a record of the character of the rock utilized on the road.

Quarry

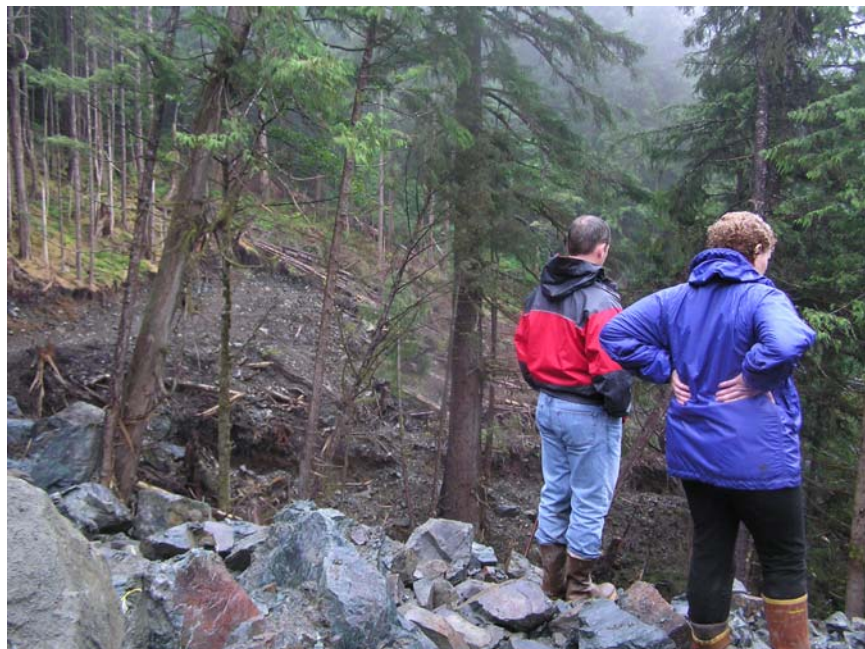
- c. The AG storage/disposal site must meet the requirements of Title 18, Chapter 60 of the Alaska Administrative Code (18 AAC 60.410(a)), which prohibits a monofill from being constructed on slopes greater than 10 percent grade or on unstable soils that might cause the waste to slide or settle excessively. Under 18 AAC 60.410(c) a monofill must be designed to protect its integrity from damage caused by natural events that could be reasonably anticipated to occur at the facility such as floods, earthquakes and the effects of freezing and thawing.

Proposed location of AG rock storage pile as viewed from quarry

- d. A geosynthetic liner will be placed under the AG site. Rain/seepage water will flow by gravity (preferred) or be pumped to the treatment facility.

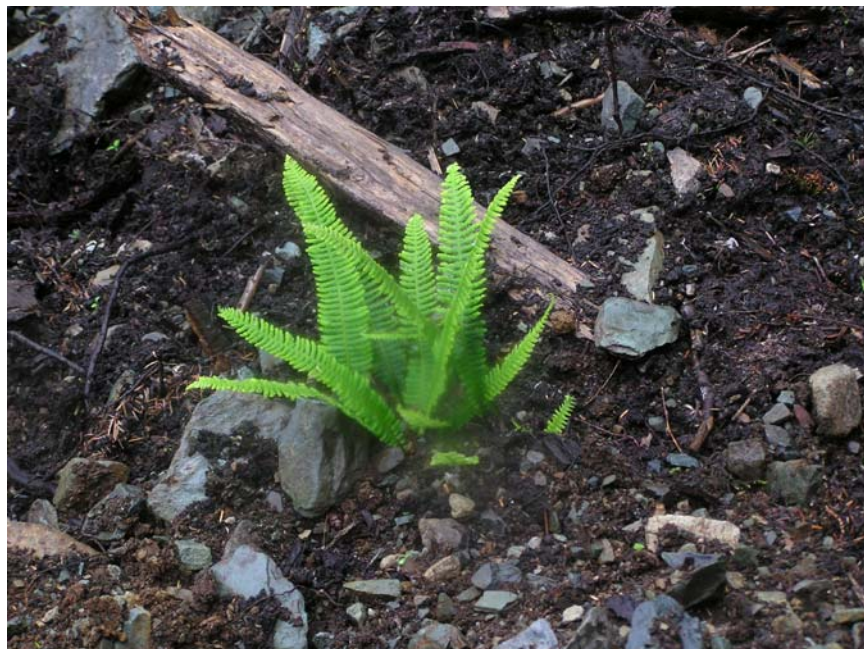
Evidence of rapid regrowth in a disturbed area near proposed AG rock pile
