## Field Monitoring Report -- Pebble Copper/Gold Exploration Project --

Personnel:	Inspection Date: 6/15/2010 and 6/16/2010
Kate Malloy, Ron Benkert - DF&G	Site Contact: Gary Deschutter
Jim Vohden, Stephanie Lovell - DNR	APMA #: A20106118
Gay Harpole, Kara Kusche - DEC	
<b>■ Inspection Type:</b> <input type="radio"/> Complete: Inspected one active drill rig and 11 abandoned sites (2 were abandoned the day of, or day prior, to site inspection). <input type="radio"/> Partial: <input type="radio"/> Follow-up: <input type="radio"/> Response to Public Complaint:	<b>■ Wildlife Observed:</b> <input type="radio"/> Bear: One brown bear during fly over between drill holes <input type="radio"/> Caribou: None <input type="radio"/> Moose: None <input type="radio"/> Waterfowl: Waterfowl observed at only the largest ponds; seems smaller ponds aren't being utilized <input type="radio"/> Fish: None <input type="radio"/> Other: None
<b>■ Weather Conditions:</b> <input type="radio"/> Temperature: Approximately 45F <input type="radio"/> Wind: Beaufort Scale 4 (approx. 15 mph) <input type="radio"/> Precipitation: Light rain on and off all day <input type="radio"/> Visibility: Moderate, 2-3 miles <inpu

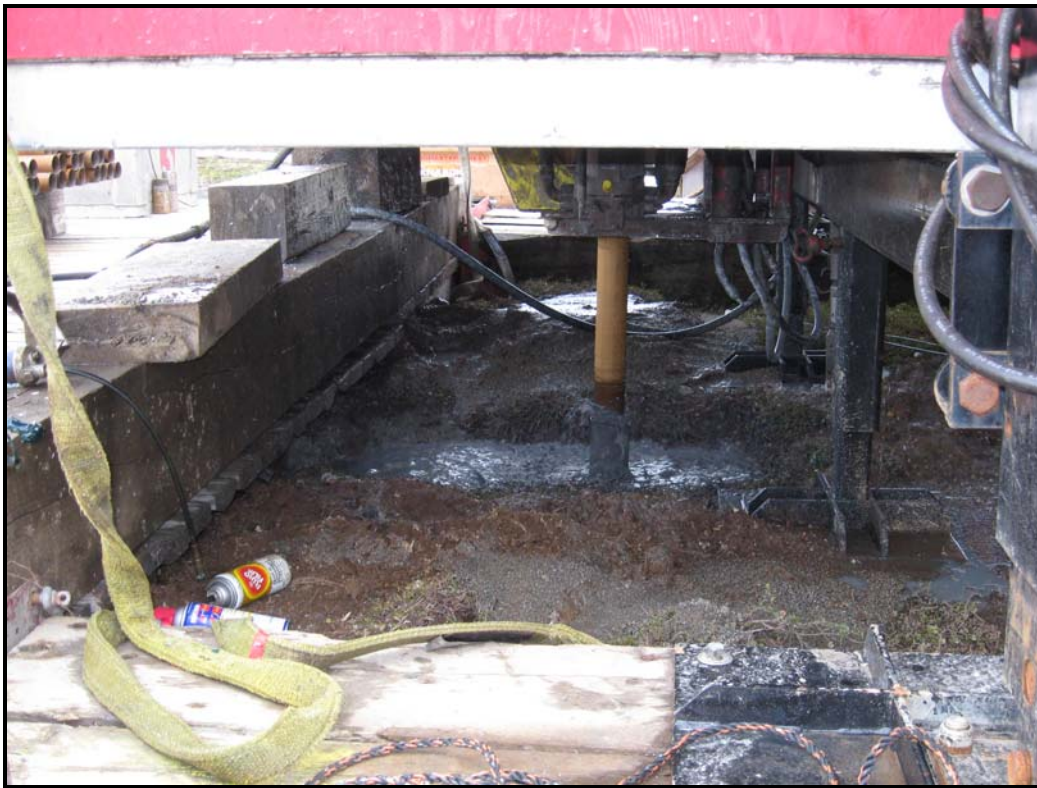
Figure 2. Active drill currently at a depth of 928 feet, going to 1200 feet.

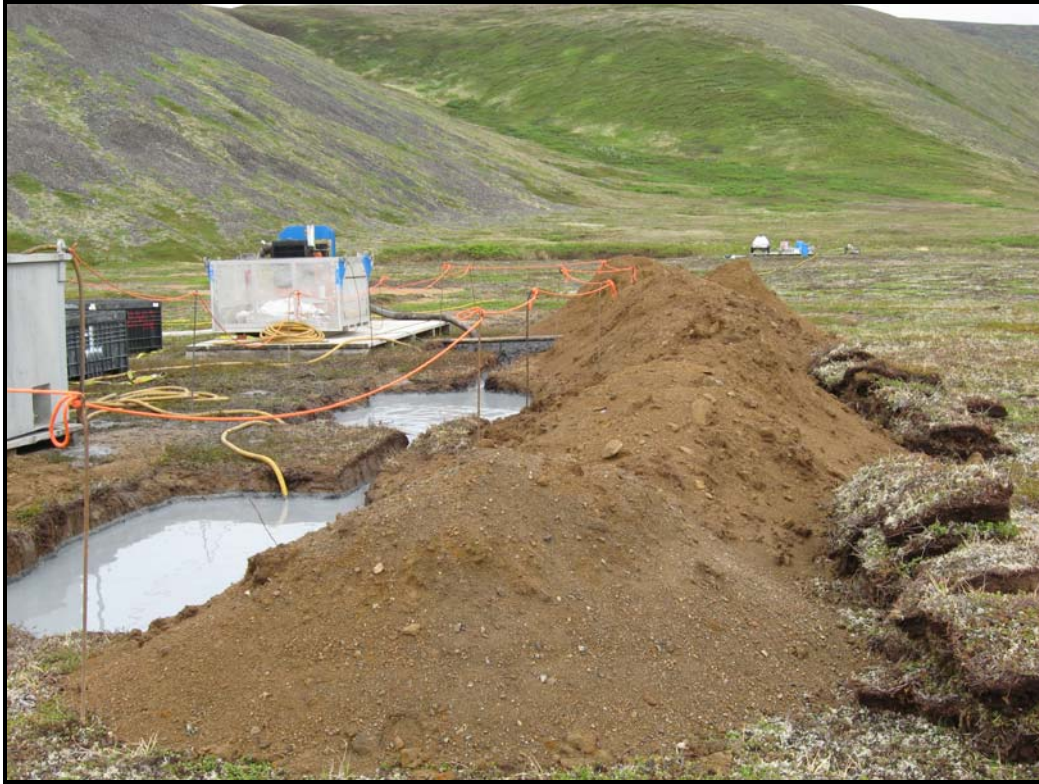
Figure 3. Sump pits (on left) and tundra stock pile being saved for reclamation (on right).

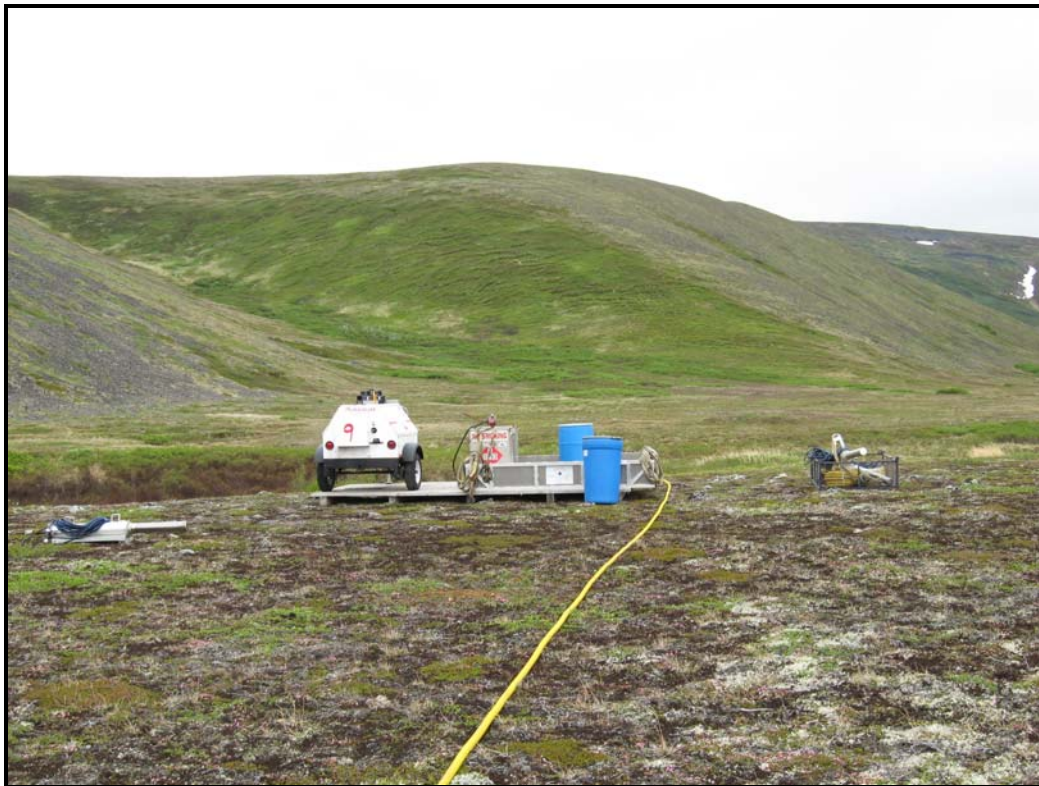
Figure 4. Water pump. Note fuel containment, with spill kit and oil scrubbers.

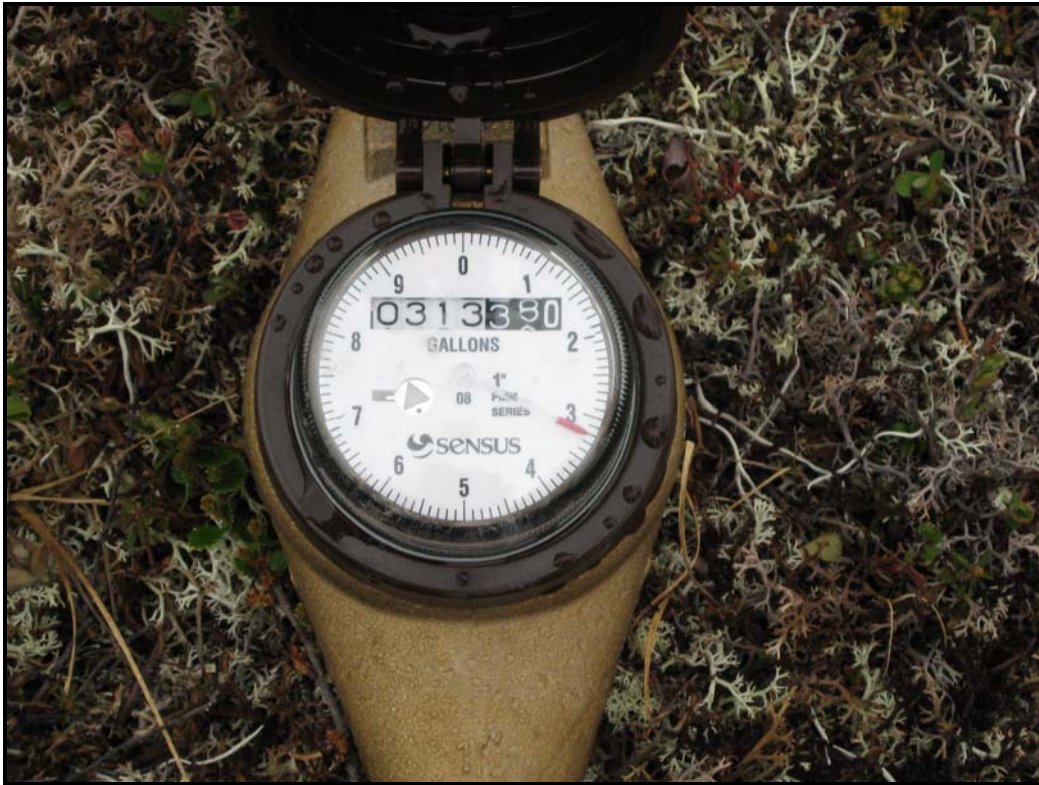
Figure 5. New totalizer that PLP is using to track water usage. During site visit, pumping rate was estimated at 20 gpm.

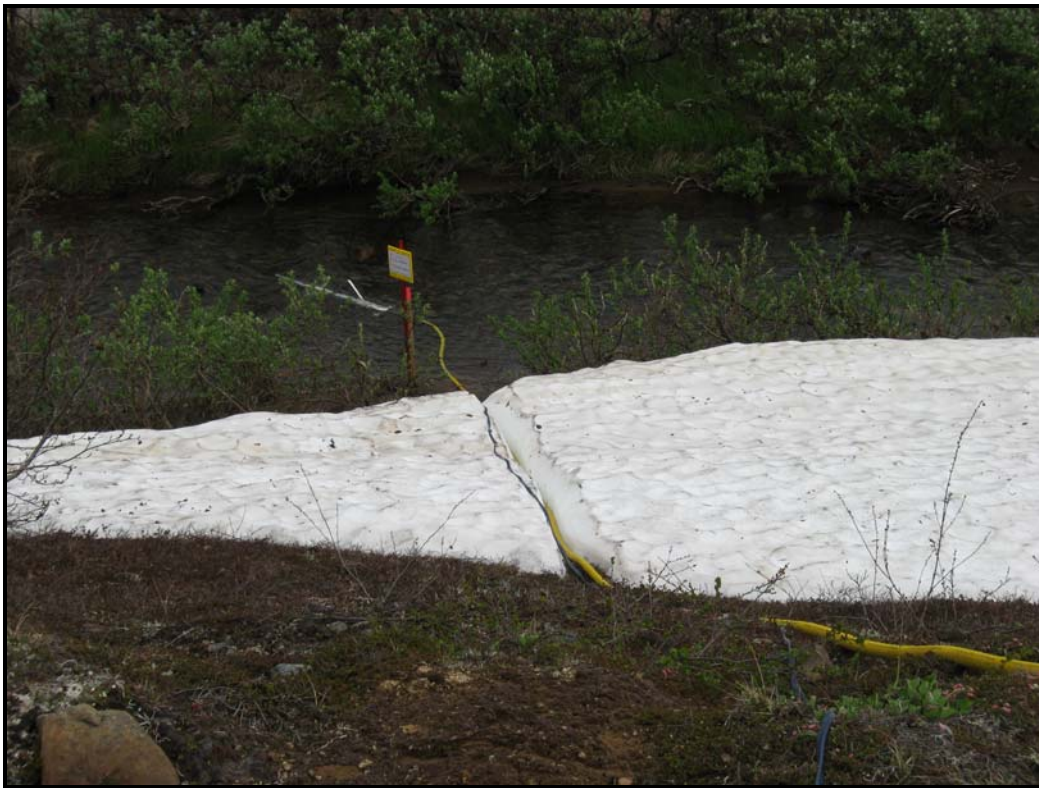
Figure 6. Water intake line extended from the upland down to the creek. Pump is visible in the water, as well as required sign indicating this is a water take location.

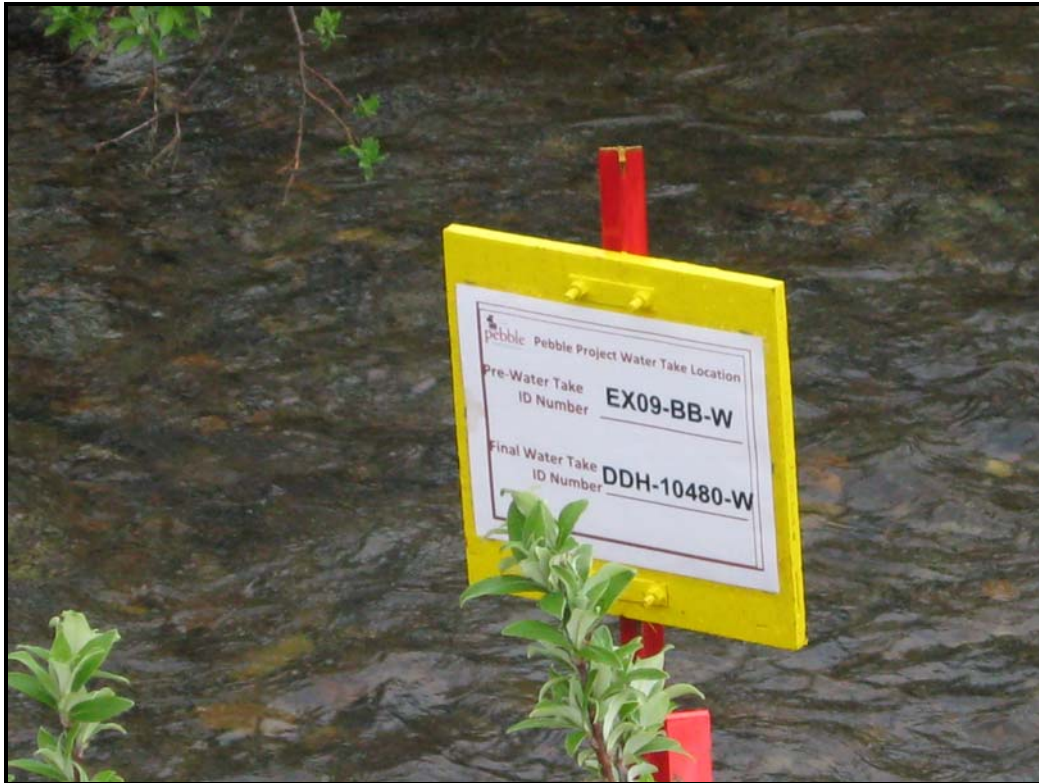
Figure 7. Close up of sign identifying this particular water take location and number.

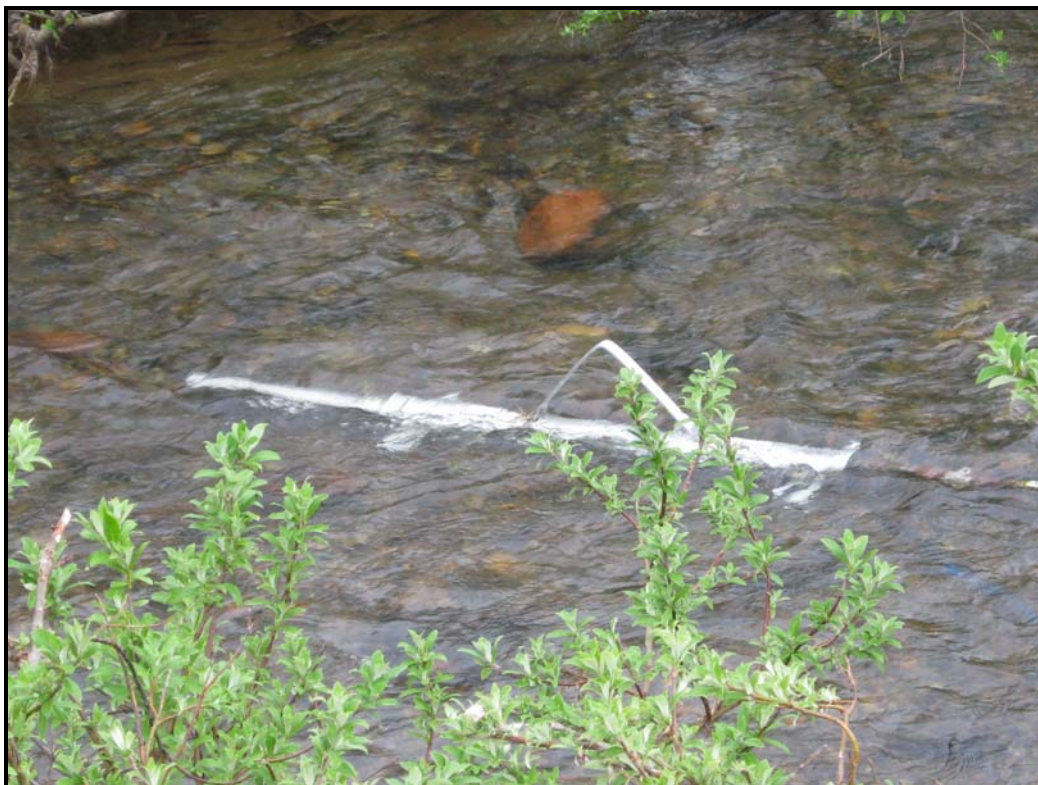
Figure 8. Screened water intake structure.

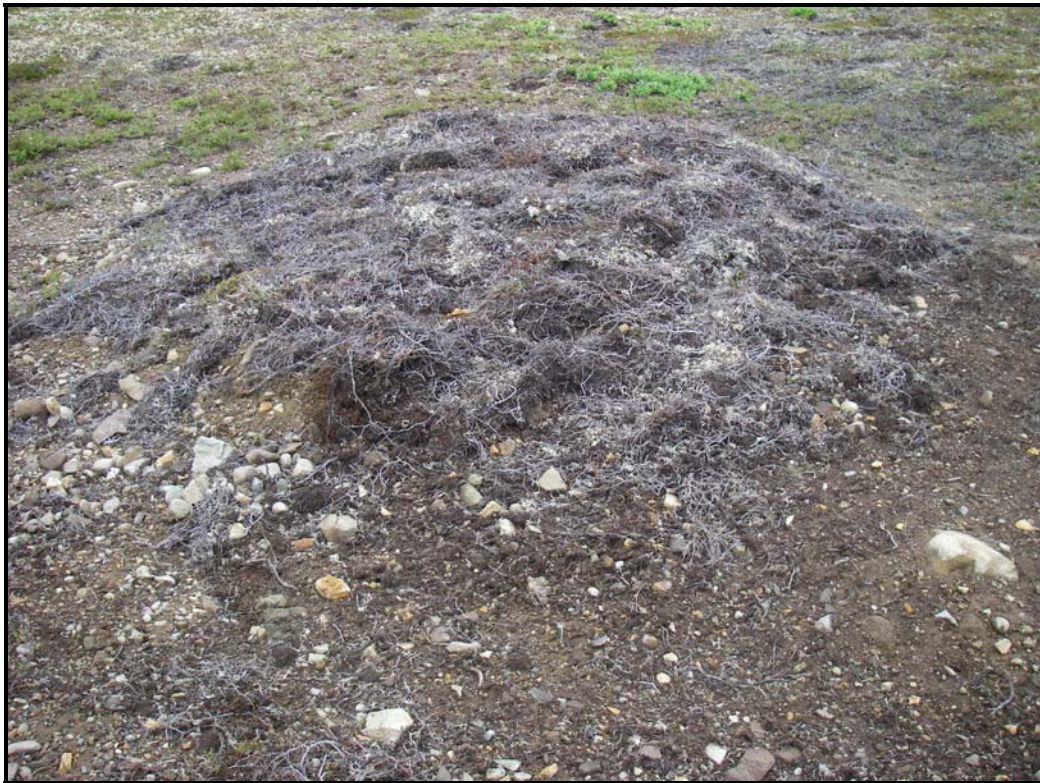
Abandoned Drill Hole/Site No.: 8429	Date: 6/15/2010
<ul style="list-style-type: none"> <li>■ Plugged: Not observed</li> <li>■ Cemented: Not observed</li> <li>■ Standing pipe: Casing not visible</li> <li>■ Sump pit filled in: Yes</li> <li>■ Water discharge trench filled in: Yes</li> <li>■ Site revegetated: Site was reclaimed but vegetation is not growing well.</li> <li>■ Artesian water present: None</li> <li>■ Any spills or staining: None</li> <li>■ Comments/General impression: Dead vegetation was main indicator of past drill activity at this site.</li> </ul>

Figure 9. Reclaimed drill site DH 8429; vegetation is not growing.

Recommendations: PLP should consider reclamation procedures and try to identify what might have caused certain sites to yield better results than others. Improve reclaimed sites where vegetation has died and did not reestablish. Particular attention should be given to clean up DH 8412.

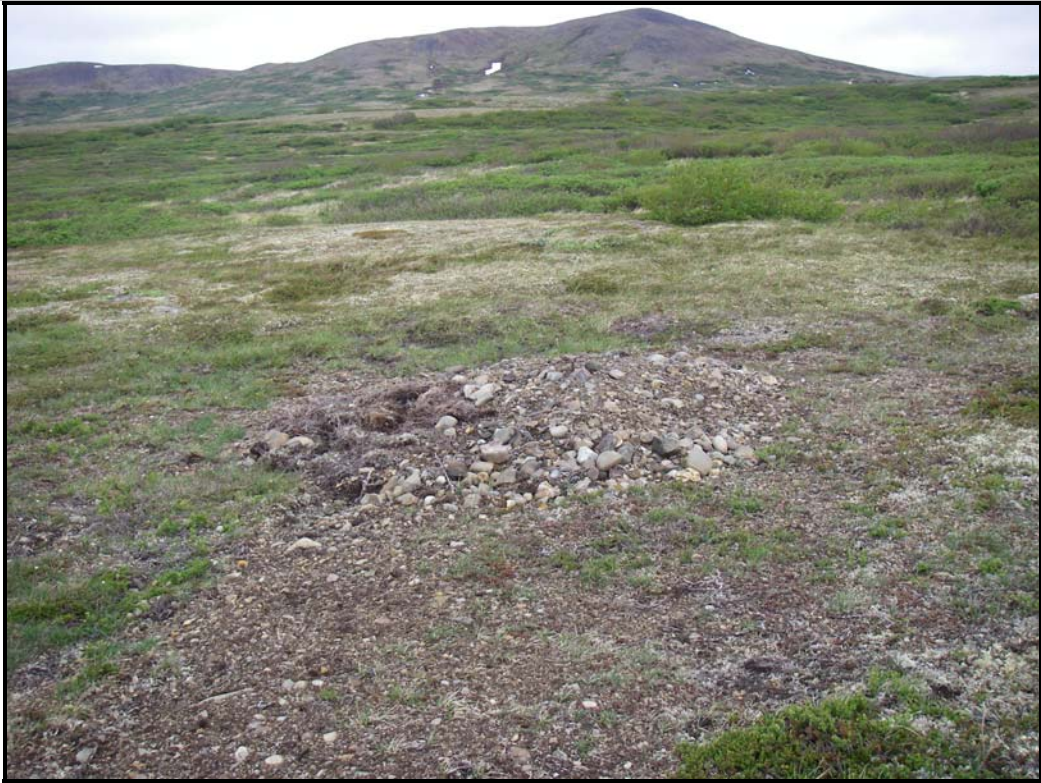
Abandoned Drill Hole/Site No.: 8432	Date: 6/15/2010
<ul style="list-style-type: none"> <li>■ Plugged: Not observed</li> <li>■ Cemented: Not observed</li> <li>■ Standing pipe: Casing not visible</li> <li>■ Sump pit filled in: Yes</li> <li>■ Water discharge trench filled in: Yes</li> <li>■ Site revegetated: Yes, site reclaimed but vegetation growth is limited and bare soil present.</li> <li>■ Artesian water present: None</li> <li>■ Any spills or staining: None</li> <li>■ Comments/General impression: Limited vegetation regrowth and bare soil was main indicator of past drill activity at this site.</li> </ul>

Figure 10. Reclaimed drill site DH 8432; vegetation has not become reestablished in some areas.

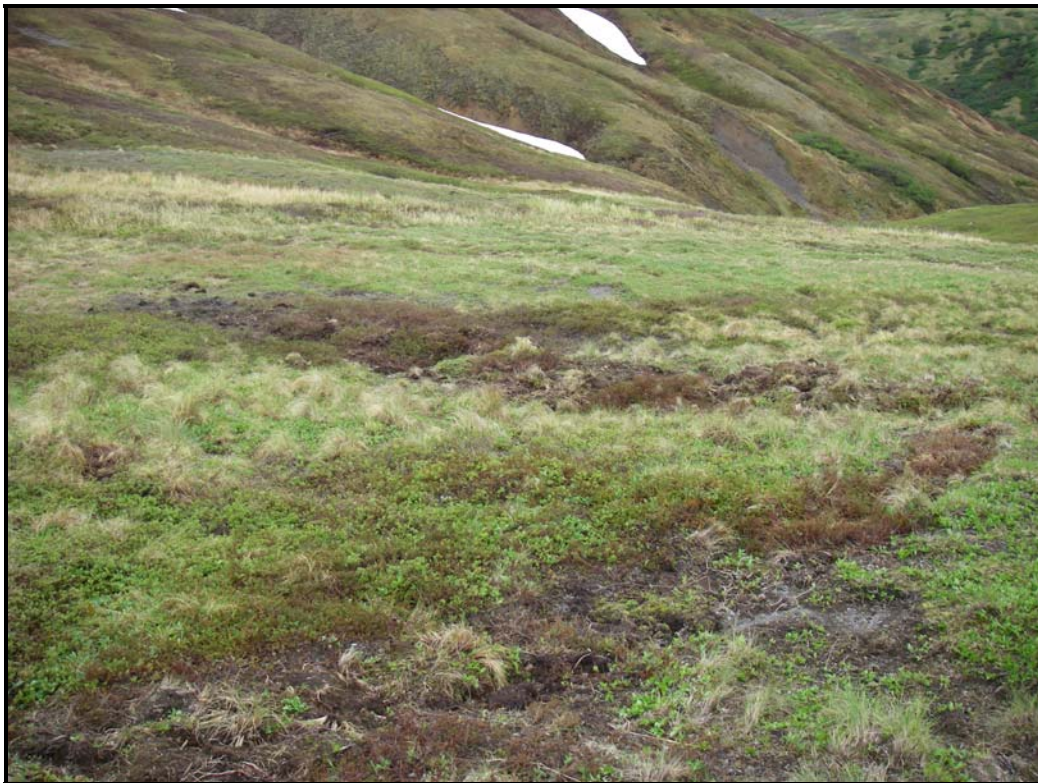
Abandoned Drill Hole/Site No.: 9455	Date: 6/15/2010
■ Plugged: Not observed	
■ Cemented: Not observed	
■ Standing pipe: Casing not visible.	
■ Sump pit filled in: Yes	
■ Water discharge trench filled in: Yes	
■ Site revegetated: Yes, site reclaimed and vegetation is growing.	
■ Artesian water present: None	
■ Any spills or staining: None	
■ Comments/General impression: Site generally looked good, vegetation reestablishing.

Figure 11. Reclaimed drill site DH 9455; vegetation is growing and filling in.

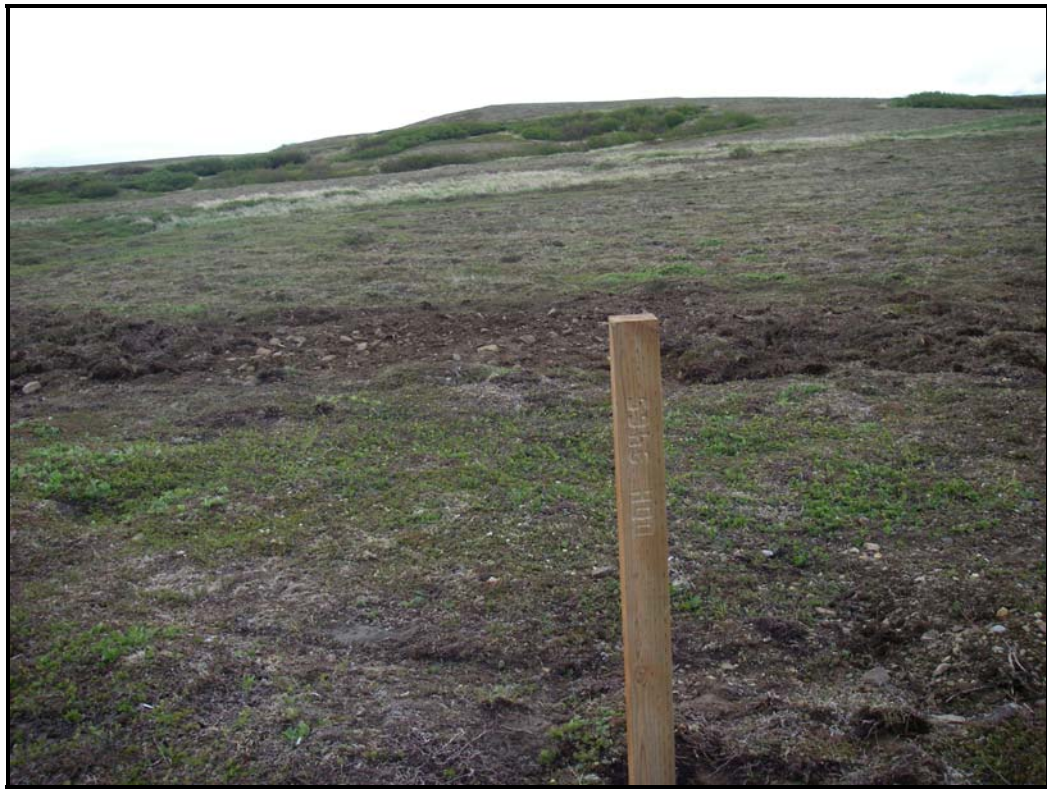
Abandoned Drill Hole/Site No.: 9466	Date: 6/15/2010
<ul style="list-style-type: none"> <li>■ Plugged: Not observed</li> <li>■ Cemented: Not observed</li> <li>■ Standing pipe: Casing not visible.</li> <li>■ Sump pit filled in: Yes</li> <li>■ Water discharge trench filled in: Yes</li> <li>■ Site revegetated: Yes, site reclaimed and vegetation is growing.</li> <li>■ Artesian water present: None</li> <li>■ Any spills or staining: None</li> <li>■ Comments/General impression: Vegetation growth appears slower here than other sites, but may be due to site specific conditions (i.e., harsher winds) or more recently reclaimed than other sites. It would be nice for agency to have reclamation completion dates at time of inspection.</li> </ul>

Figure 12. Reclaimed drill site DH 9466; vegetation is growing and still filling in.

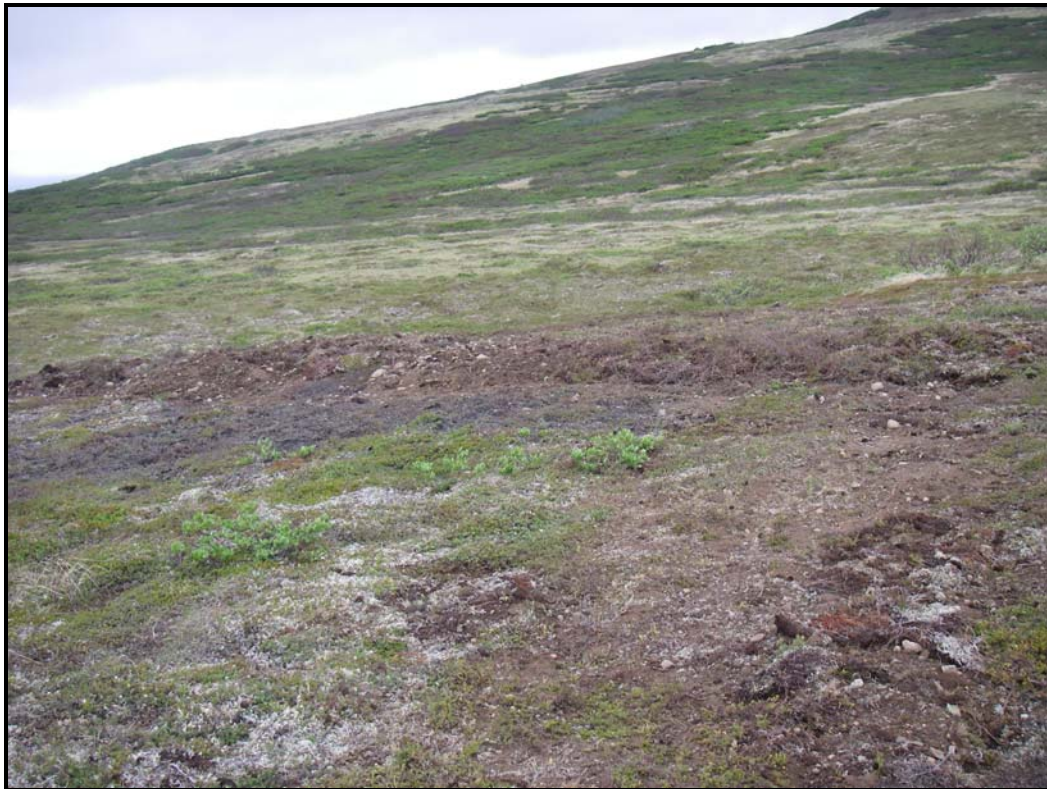
Abandoned Drill Hole/Site No.: 9470 and 9471	Date: 6/15/2010
<ul style="list-style-type: none"> <li>■ Plugged: Not observed</li> <li>■ Cemented: Not observed</li> <li>■ Standing pipe: Casing not visible.</li> <li>■ Sump pit filled in: Yes</li> <li>■ Water discharge trench filled in: Yes</li> <li>■ Site revegetated: Site reclaimed, but areas of exposed soil were observed were vegetation did not take.</li> <li>■ Artesian water present: None</li> <li>■ Any spills or staining: None</li> <li>■ Comments/General impression: Two drill holes located at same location.</li> </ul>

Figure 13. Reclaimed drill site DH 9470 and DH 9471; site is reclaimed but areas of bare soil are present.

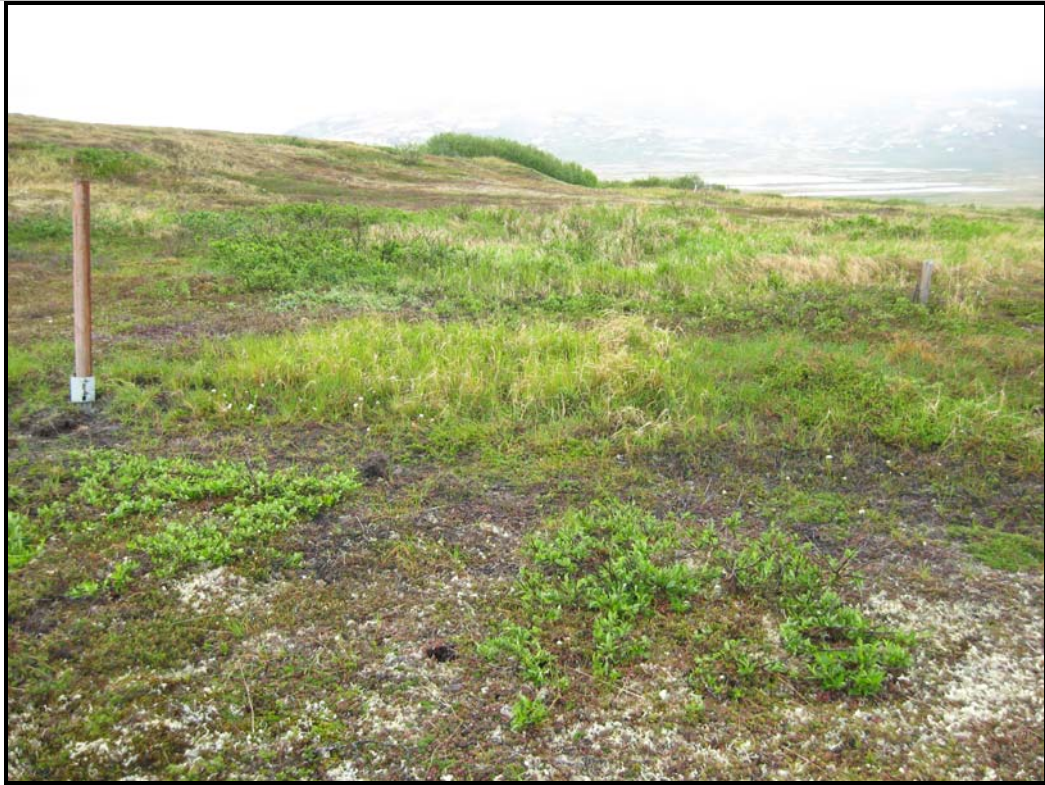
Abandoned Drill Hole/Site No.: 8427	Date: 6/16/2010
<ul style="list-style-type: none"> <li>■ Plugged: Not observed</li> <li>■ Cemented: Not observed</li> <li>■ Standing pipe: Casing not visible</li> <li>■ Sump pit filled in: Yes</li> <li>■ Water discharge trench filled in: Yes</li> <li>■ Site revegetated: Yes, vegetation is growing and site looks good.</li> <li>■ Artesian water present: None</li> <li>■ Any spills or staining: None</li> <li>■ Comments/General impression: Numbered drill post was only notable sign of past activity at this site.</li> </ul>

Figure 14. Reclaimed drill site DH 8427; vegetation is growing in and reclamation efforts appear successful.

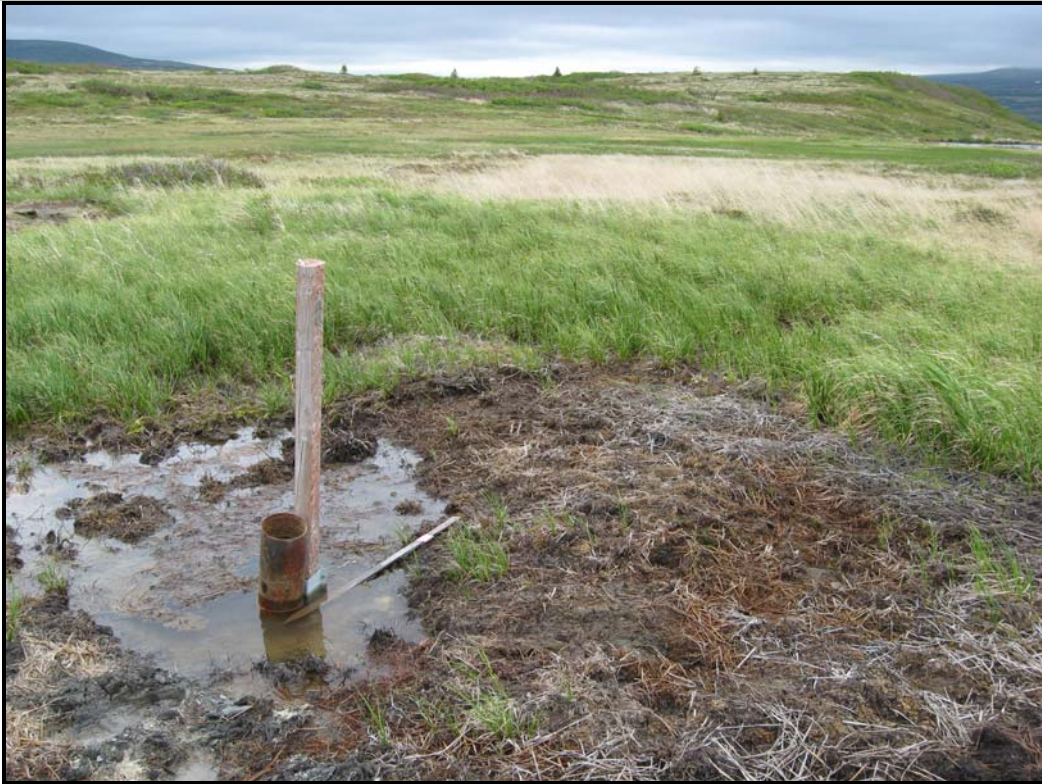
Abandoned Drill Hole/Site No.: 8412	Date: 6/16/2010
<ul style="list-style-type: none"> <li>■ Plugged: Partial (?)</li> <li>■ Cemented: Partial (?)</li> <li>■ Standing pipe: Yes</li> <li>■ Sump pit filled in: Yes</li> <li>■ Water discharge trench filled in: Yes</li> <li>■ Site revegetated: Vegetation is not regrowing at this site.</li> <li>■ Artesian water present: None</li> <li>■ Any spills or staining: None</li> <li>■ Comments/General impression: Site was messy and in poor condition. What appeared to be bentonite was present in clumps on the ground. Standing water around drill hole. The site did not look like reclamation was 100% complete.</li> </ul>

Figure 15. DH 8412 has standing water and dead vegetation, indicating reclamation efforts are either incomplete or unsuccessful.

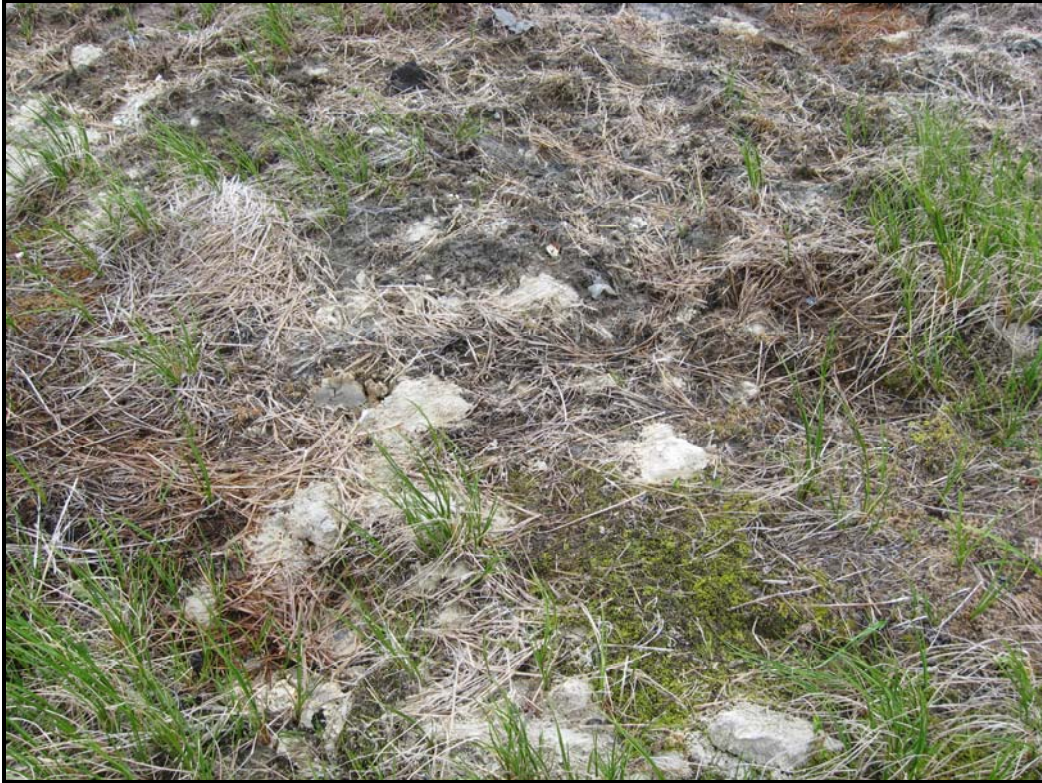
Figure 16. The ground surrounding DH 8412 was not clean and had, what appears to be, clumps of bentonite clay present.

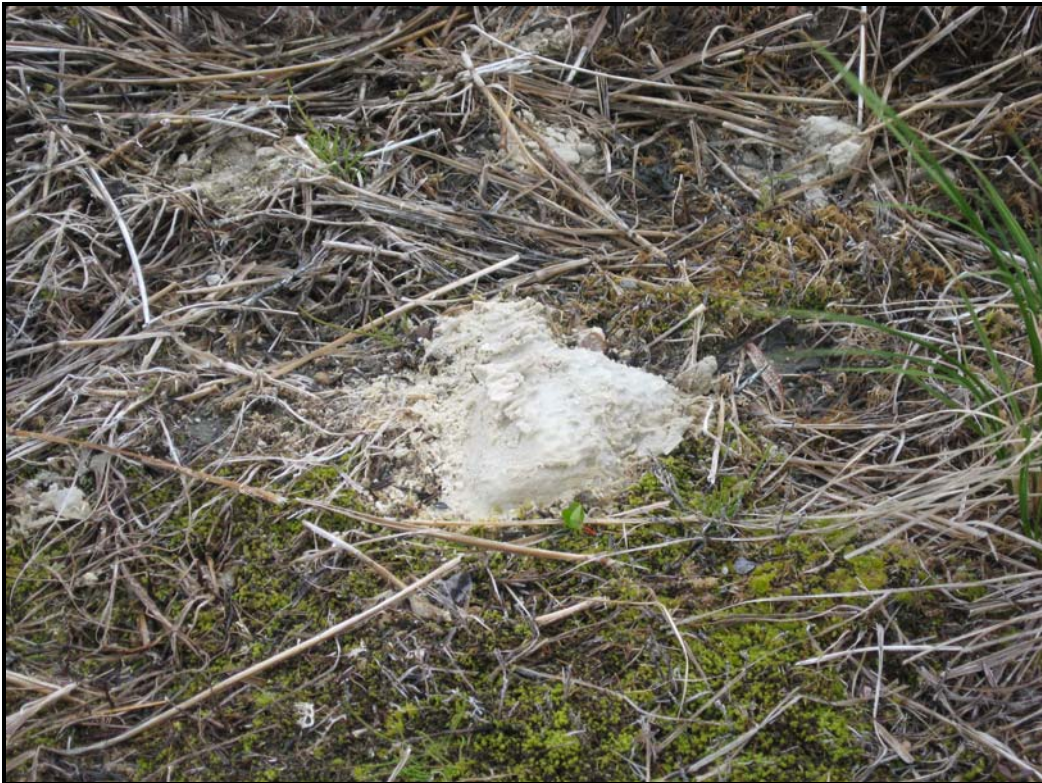
Figure 17. Close up of bentonite like material.

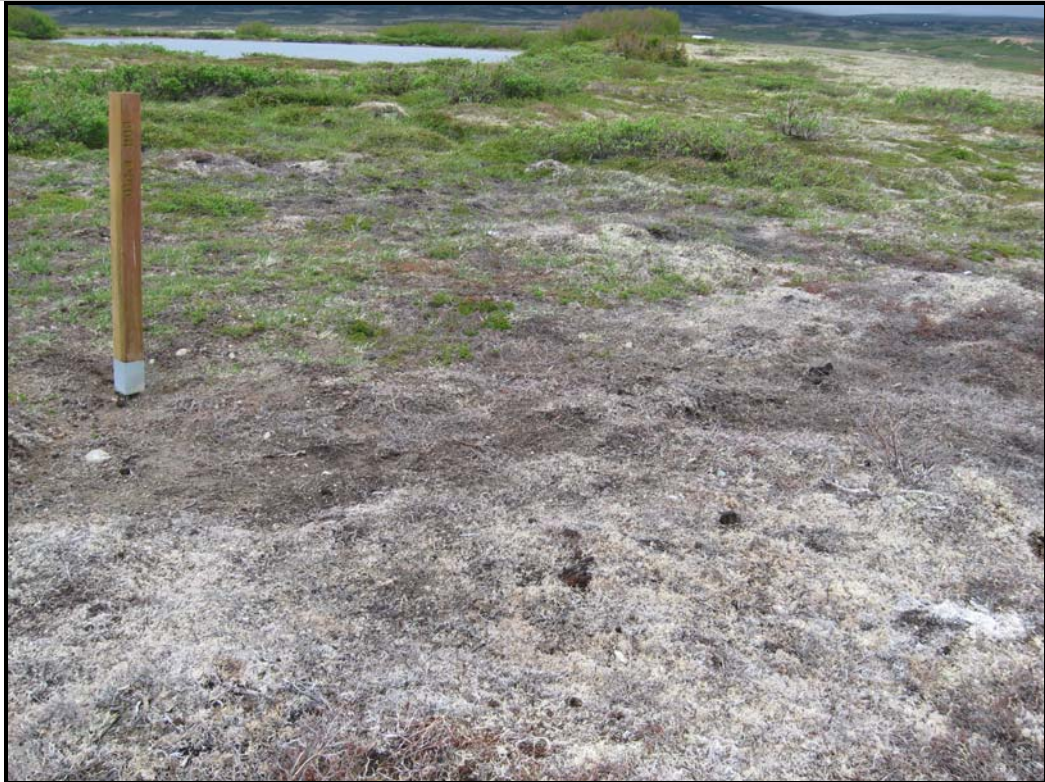
Abandoned Drill Hole/Site No.: 8440	Date: 6/16/2010
<ul style="list-style-type: none"> <li>■ Plugged: Not observed</li> <li>■ Cemented: Not observed</li> <li>■ Standing pipe: Casing not visible.</li> <li>■ Sump pit filled in: Yes</li> <li>■ Water discharge trench filled in: Yes</li> <li>■ Site revegetated: Most of the vegetation is dead and not growing back.</li> <li>■ Artesian water present: None</li> <li>■ Any spills or staining: None</li> <li>■ Comments/General impression: Site was much cleaner than previously visited drill hole (8412), but revegetation effort was not successful.</li> </ul>

Figure 18. Dead vegetation was observed at drill site DH 8440.

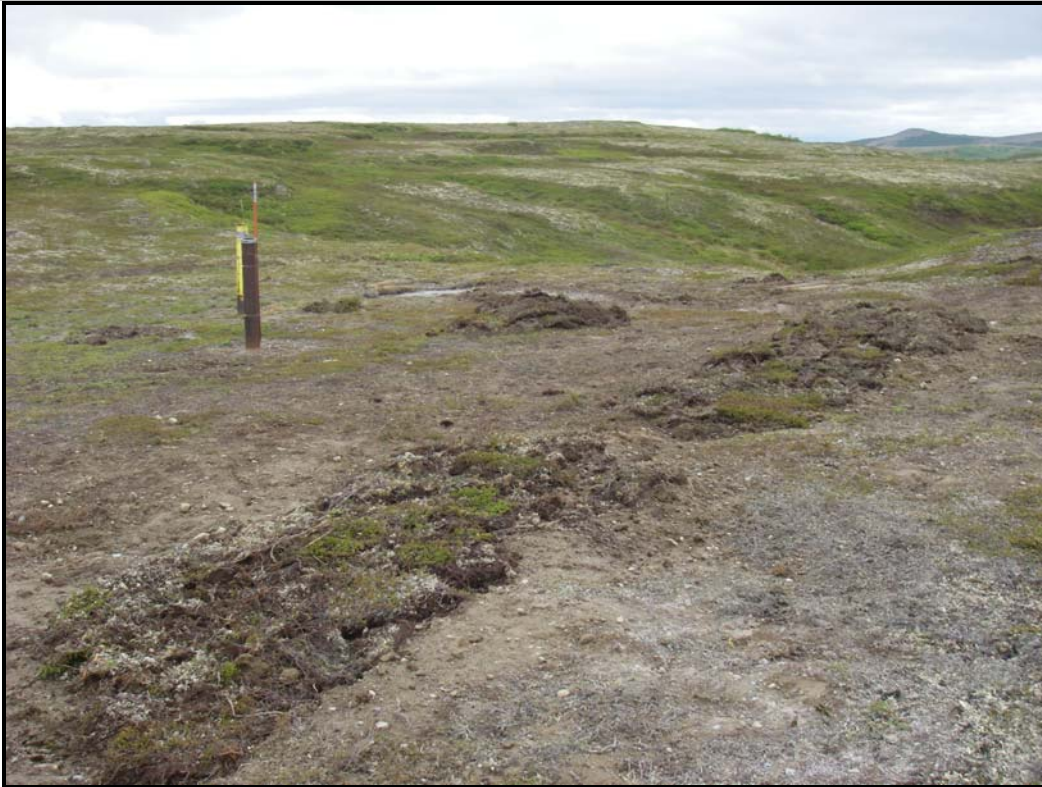
Abandoned Drill Hole/Site No.: 10478	Date: 6/16/2010
<ul style="list-style-type: none"> <li>■ Plugged: No</li> <li>■ Cemented: No</li> <li>■ Standing pipe: Yes</li> <li>■ Sump pit filled in: Partially, reclamation had just begun at time of inspection.</li> <li>■ Water discharge trench filled in: Yes</li> <li>■ Site revegetated: No, reclamation had just begun at time of inspection.</li> <li>■ Artesian water present: None</li> <li>■ Any spills or staining: None</li> <li>■ Comments/General impression: Drill rig was recently moved from site and reclamation had begun but was still early in the process at the time of inspection.</li> </ul>

Figure 19. The drill rig was recently moved from this site and reclamation has just begun.

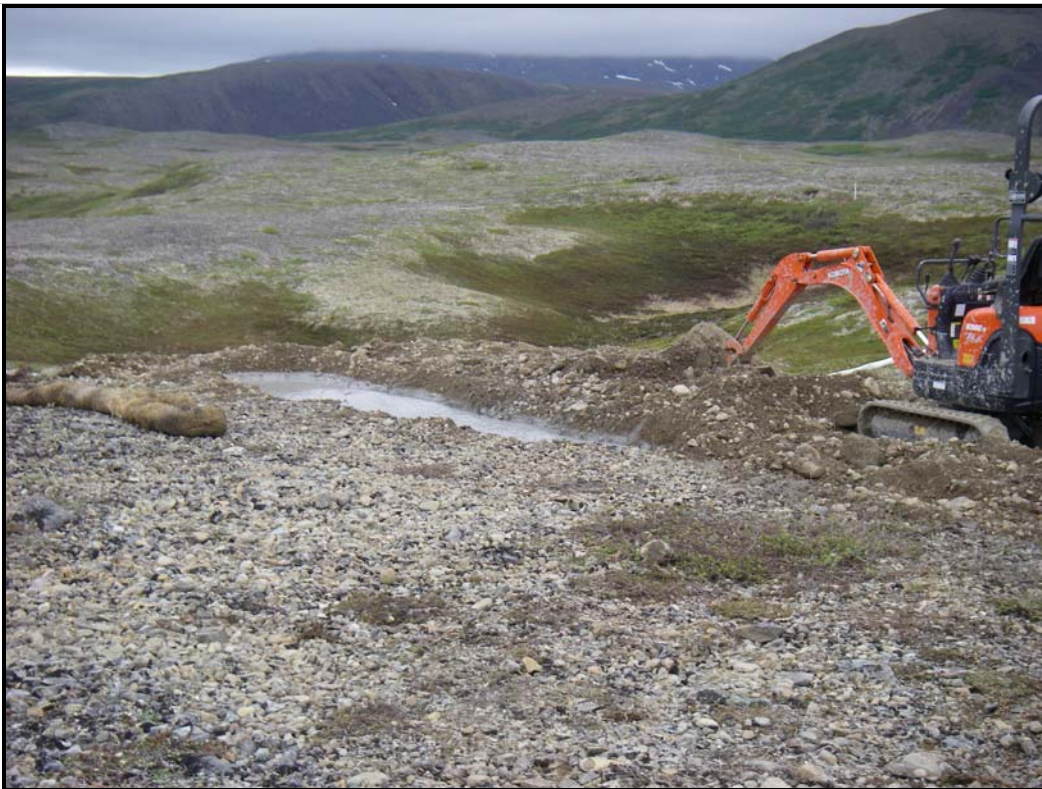
Abandoned Drill Hole/Site No.: 10479	Date: 6/16/2010
<ul style="list-style-type: none"> <li>■ Plugged: No</li> <li>■ Cemented: No</li> <li>■ Standing pipe: Yes</li> <li>■ Sump pit filled in: Partial</li> <li>■ Water discharge trench filled in: Yes</li> <li>■ Site revegetated: No, reclamation had just begun at time of inspection.</li> <li>■ Artesian water present: None</li> <li>■ Any spills or staining: None</li> <li>■ Comments/General impression: Drill rig was recently moved from site and reclamation had begun but was still early in the process at the time of inspection.</li> </ul>

Figure 20. The drill rig was recently removed from this site and the sump pits are being filled in as the beginning stage of reclamation.
