Field Monitoring Report -- Pebble Copper/Gold Exploration Project --

Personnel: Bill Cole (DNR/MLW), Melissa Hill (DNR/MLW), Jeff Norberg (Manager, Site Compliance & Reclamation, PLP)	Inspection Date: 06/19/2012
	Site Contact: Jeff Norberg
	APMA #: A126118
■ Inspection Type: <ul style="list-style-type: none"> • Complete: X ○ Partial: ○ Follow-up: ○ Response to Public Complaint: 	■ Wildlife Observed: <ul style="list-style-type: none"> ○ Bear: 1 grizzly ○ Caribou: ○ Moose: ○ Waterfowl: ~ 12 ducks, 3 swans ○ Fish: ○ Other:
■ Weather Conditions: <ul style="list-style-type: none"> ○ Temperature: 46°F ○ Wind: very light wind ○ Precipitation: none ○ Visibility: 10-15 miles ○ Sky Conditions: overcast ○ Ground Conditions: thawed 	
■ Comments: Overall, everything appears to be in compliance. We visited one drilling geotechnical hole (CH12-297) and a problem artesian well (site # 09462). Grouting has stopped the artesian flow, but the drill hole has not yet been reclaimed. Additionally, we visited three reclaimed drill sites and conducted a flyover of monitoring sites associated with TWUPs A2012-20 and A2012-22.

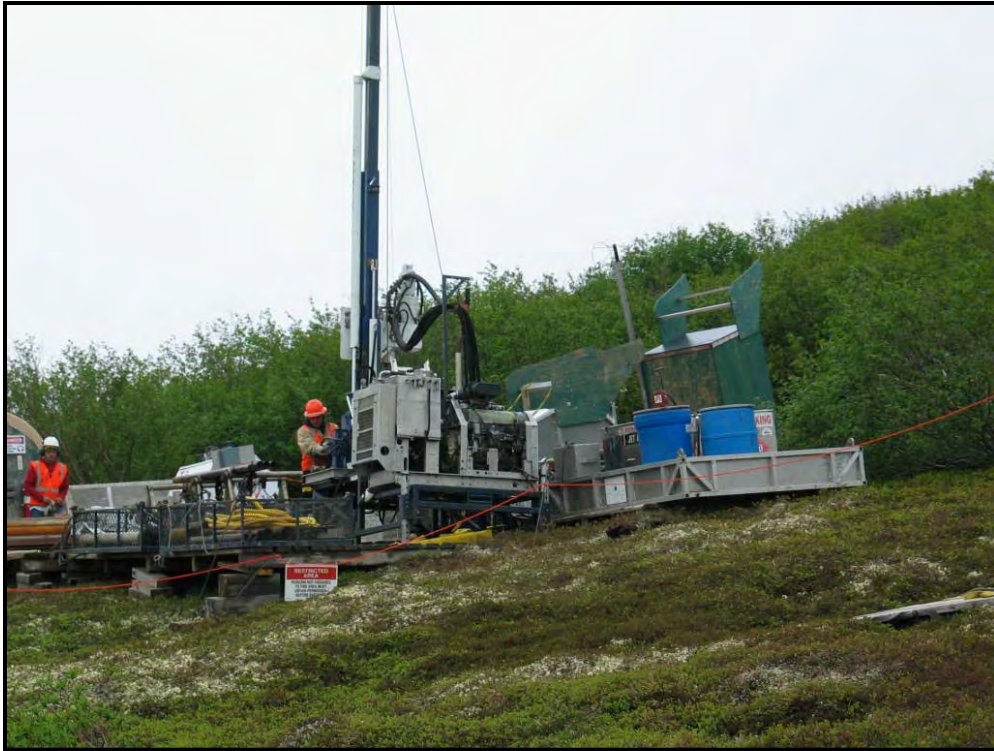
Photo #1. Drill Rig #4 on CH12-297. Note Blue hydrocarbon scrubber barrel and blue sorbent pad barrel, both in aluminum secondary fuel containment.

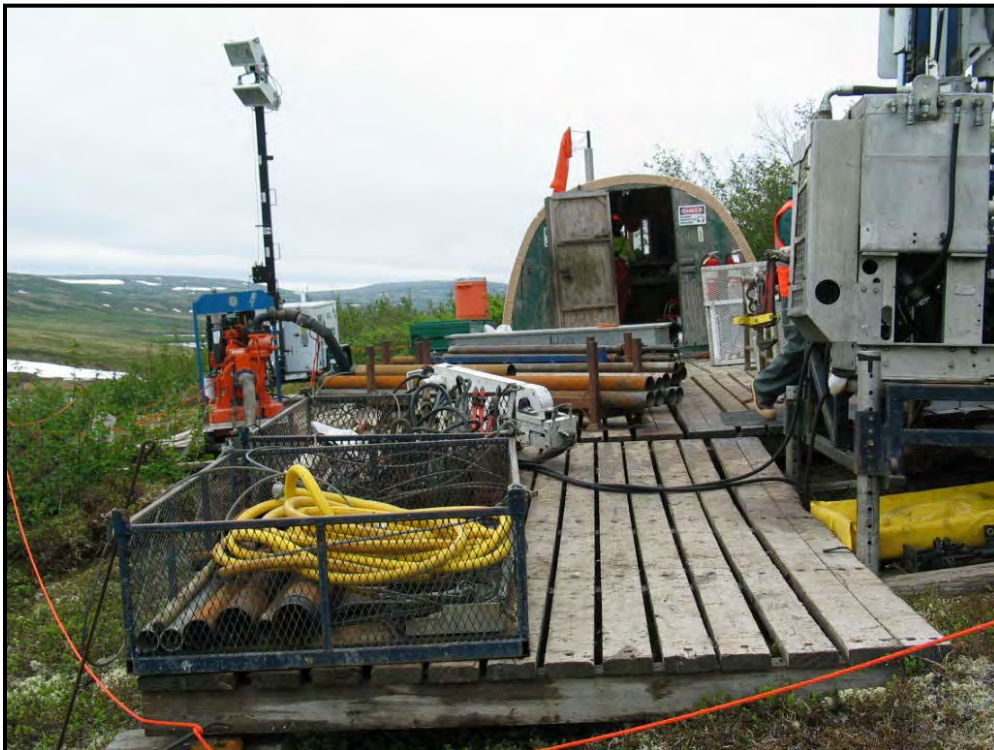
Photo #2. Tundra mat with drill rods.

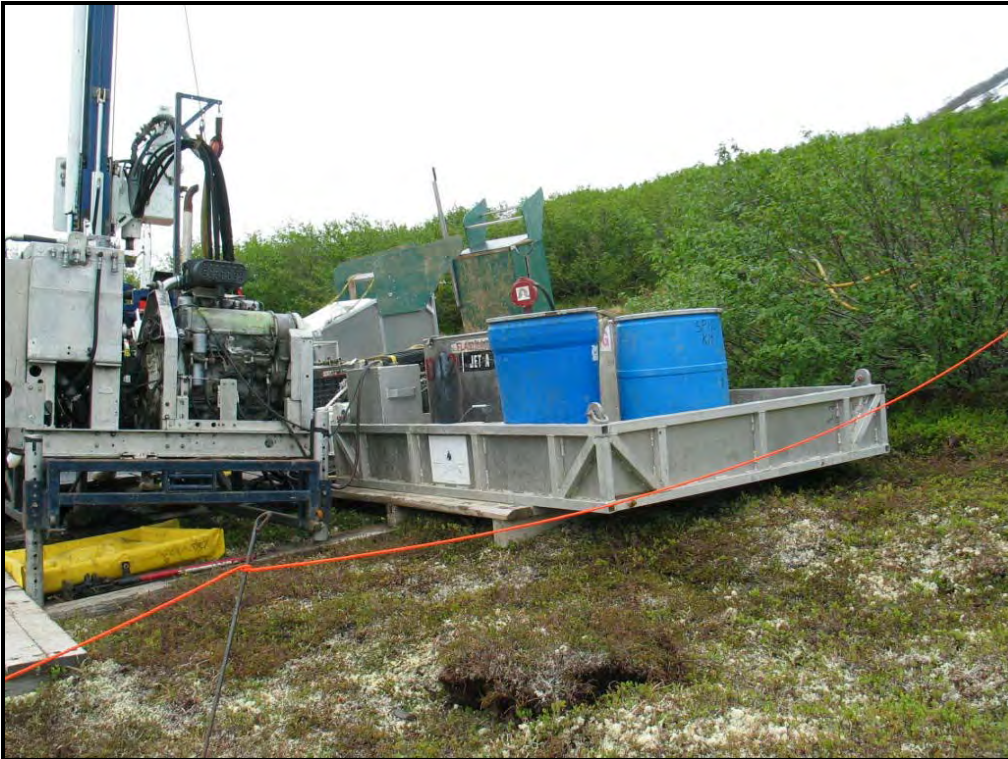
Photo #3. Fuel containment and spill materials, on tundra mat.

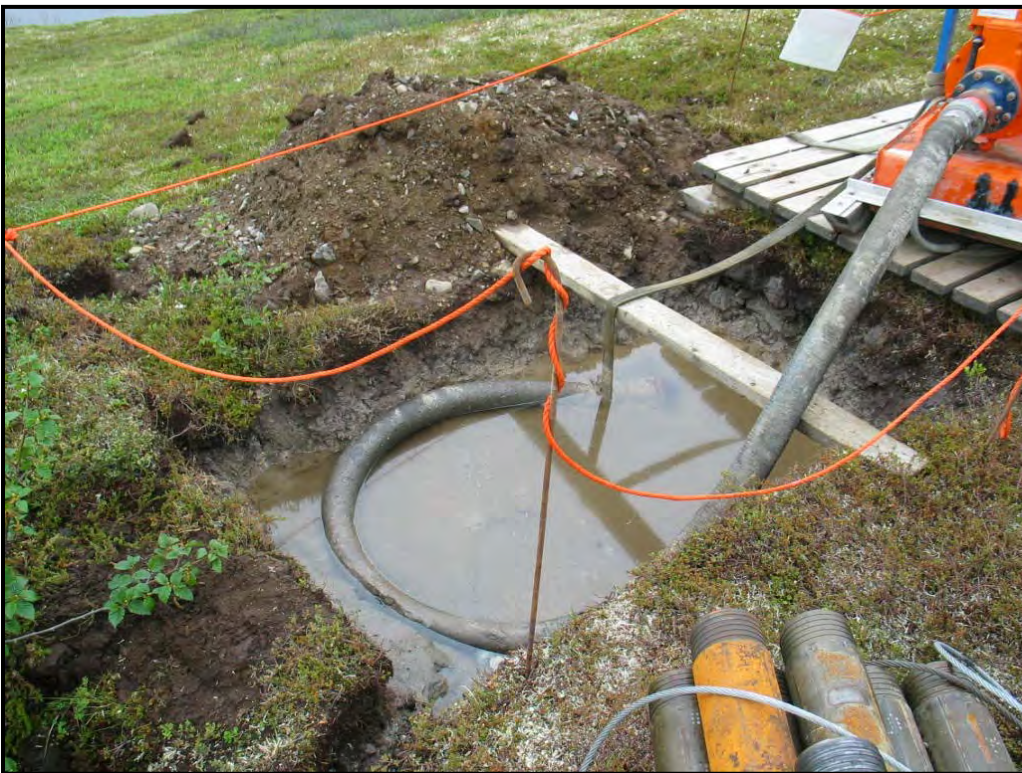
Photo #4. Mud sump.

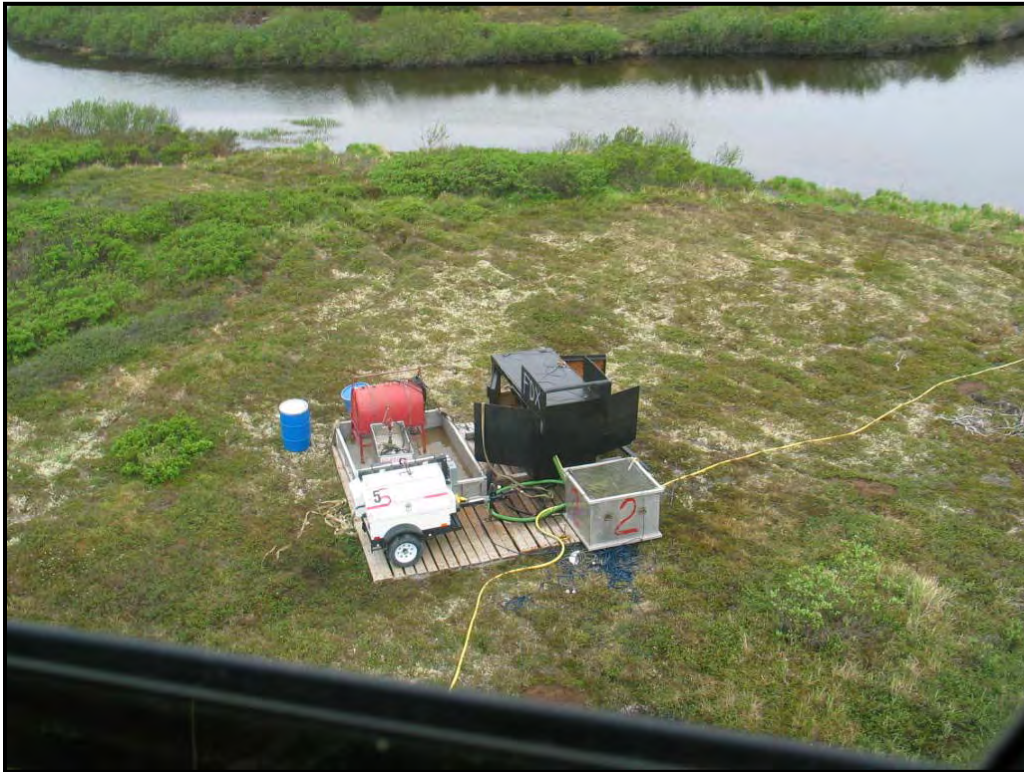
Photo #5. Generator and fuel for submersible water pump. Blue barrels are sorbent pads and scrubber barrel.

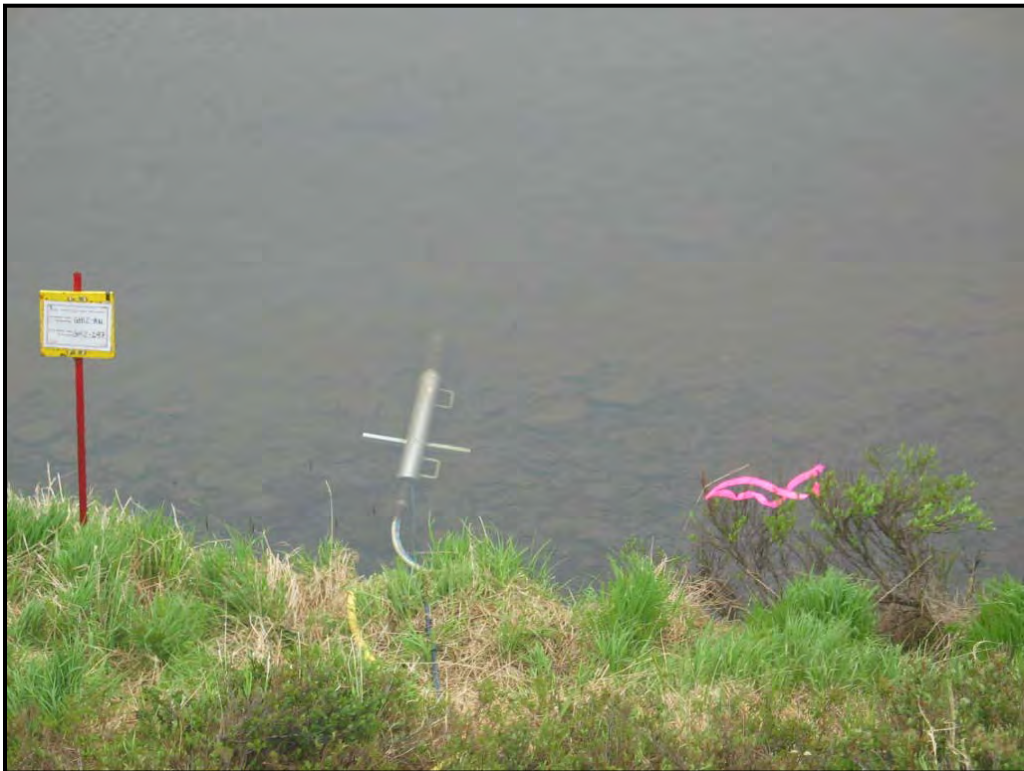
Photo #6. Submersible pump in Frying Pan Lake.

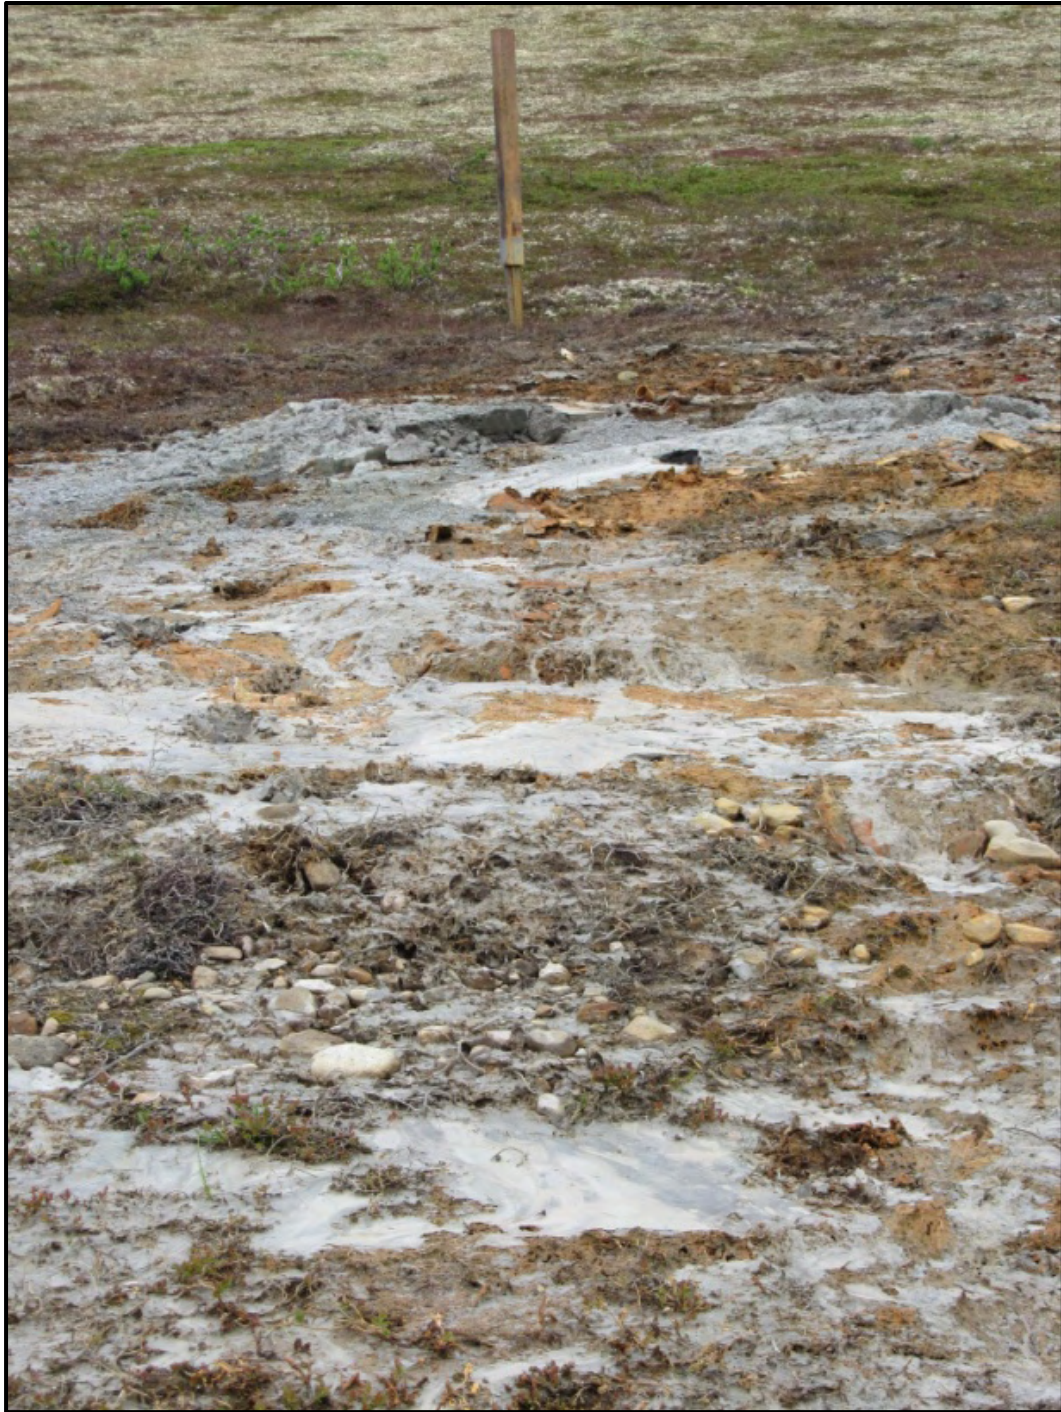
Abandoned Drill Hole/Site No.: DDH 09462	Date: 06/19/2012
	Time: 13:30
■ Plugged: Yes	
■ Cemented: yes	
■ Standing pipe: yes	
■ Sump pit filled in: yes	
■ Water discharge trench filled in: yes	
■ Site revegetated: no	
■ Date revegetated/reclaimed: not reclaimed	
■ Artesian water present: not during site inspection	
<p>Any spills or staining: Yes, iron staining and remnants of materials discharged from previous artesian upwelling were observed. Staining covered an area approximately 15' X 60-80' to the east of the drill hole. This artesian flow was described by Roger Allely, of DNR, Mining Section during an inspection on October 20,2011. Mr. Allely described the situation as follows:</p> <p style="padding-left: 40px;">“Artesian flow issues began at about 65 ft. depth, where a few feet of drilling encountered a flow increase from 10 to 90 gpm. Lots of water issued from the hole. It was producing 55-70 gpm; presently flow is about 35-40 gpm due to partially successful efforts to stem & seal off producing zones around 40 feet below grade.</p> <p style="padding-left: 40px;">Approximately 20 ft. of casing remain in the hole; the driller thinks there's a break in the casing around the 15 ft. depth.</p> <p style="padding-left: 40px;">Water is upflowing through subsurface materials, discharging to the ground surface in an area 10-20 feet wide, extending 40-80 ft. east of the drill rig. Freezing conditions are creating ice buildup in the discharge zone. Stake and flagging mark a point approximately 70 ft. east of the rig. Some groundwater is discharging into the filled sump pits.</p> <p style="padding-left: 40px;">Overland flow has created discolored, possibly iron stained zones on the surface 10-15 feet wide. One extends from the rig pad approximately 20 feet, the other extends from approximately 30 to 100 feet east of the rig pad. Overland water flow disappears into tundra approx. 150 ft. E of the drill hole.”</p> <p>In addition to the above, Jeff Norberg has indicated that flow was intermittent, and that it sometimes came up around the drill hole casing, and at other times seeped up some distance from the drill hole. Mr. Norberg said that the artesian flow never entered any surface waters. PLP drillers attempted to stem the flow last fall, but were unsuccessful.</p> <p>This June a grout specialist with Bandimere Grout Consulting Services was brought in to help Foundex Drilling abandon the hole. The companies grouted a washout zone in the overburden, stopping the artesian flow as of June 11, 2012. PLP personnel are optimistic that the problem has been resolved, but are monitoring the site should renewed seepage occur. Reclamation is pending per the efficacy of recent grouting efforts, and drier ground conditions.</p>

Photo #7. Remnants of discharged fluids and iron staining from previous artesian upwelling.

■ Recommendations: Suggest follow-up inspections at site # 09462 to evaluate the efficacy of recent grouting efforts to resolve artesian upwelling.	
■ Actions Needed: Jeff Norberg requested additional clarification/status updates regarding several TWUPs. M. Hill forwarded these questions to M. Walton and he responded to J. Norberg on 06/21/2012.

■ Comments/General impression: Continue to monitor.

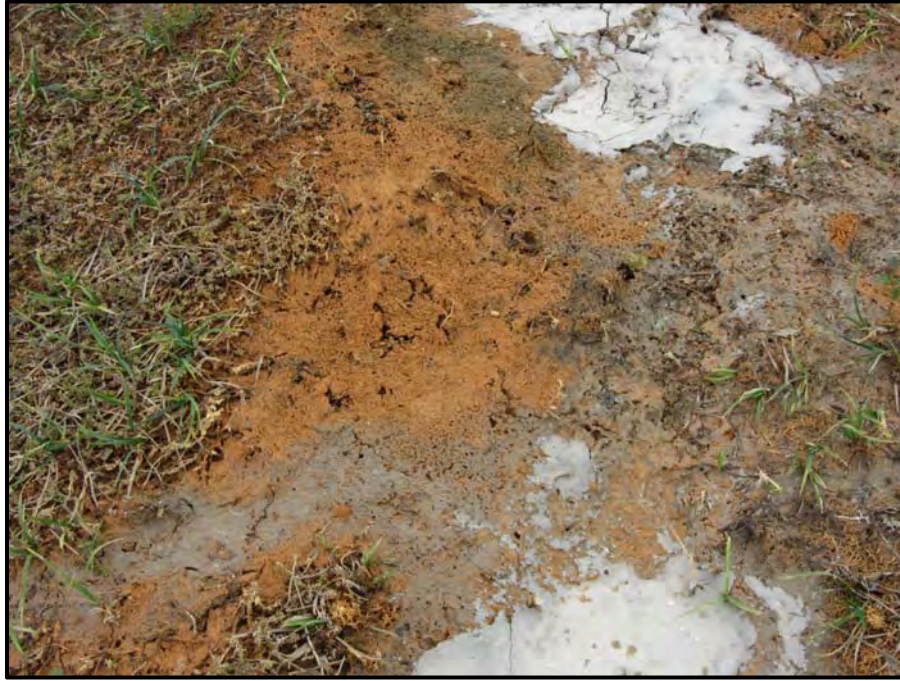
Photo #8. Staining from previous artesian upwelling

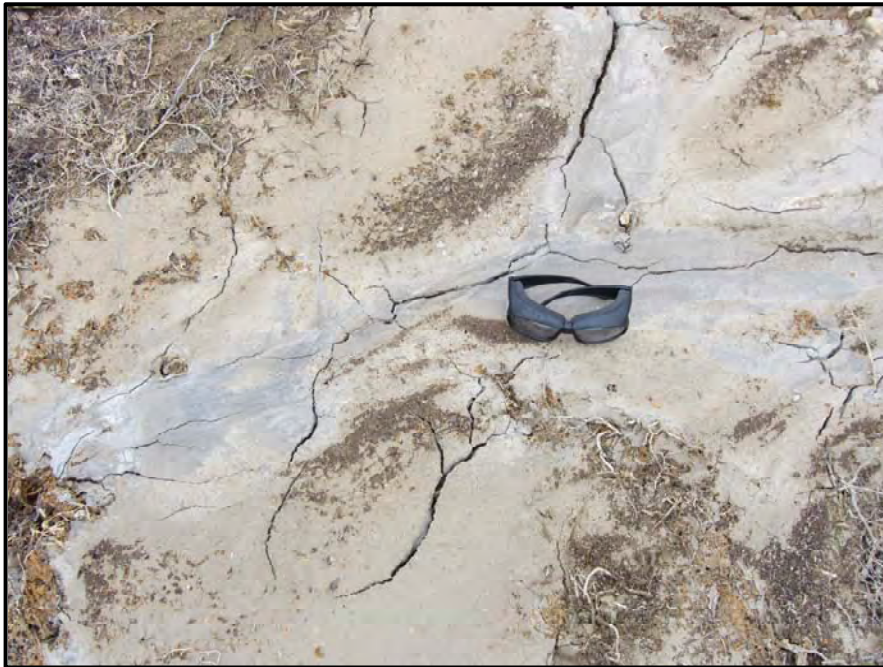
Photo #9. Desiccation cracks in remnants of discharged materials from previous artesian upwelling. No active upwelling has been detected since grouting. The site has not been remediated. Monitoring is ongoing to evaluate the efficacy of recent grouting efforts.

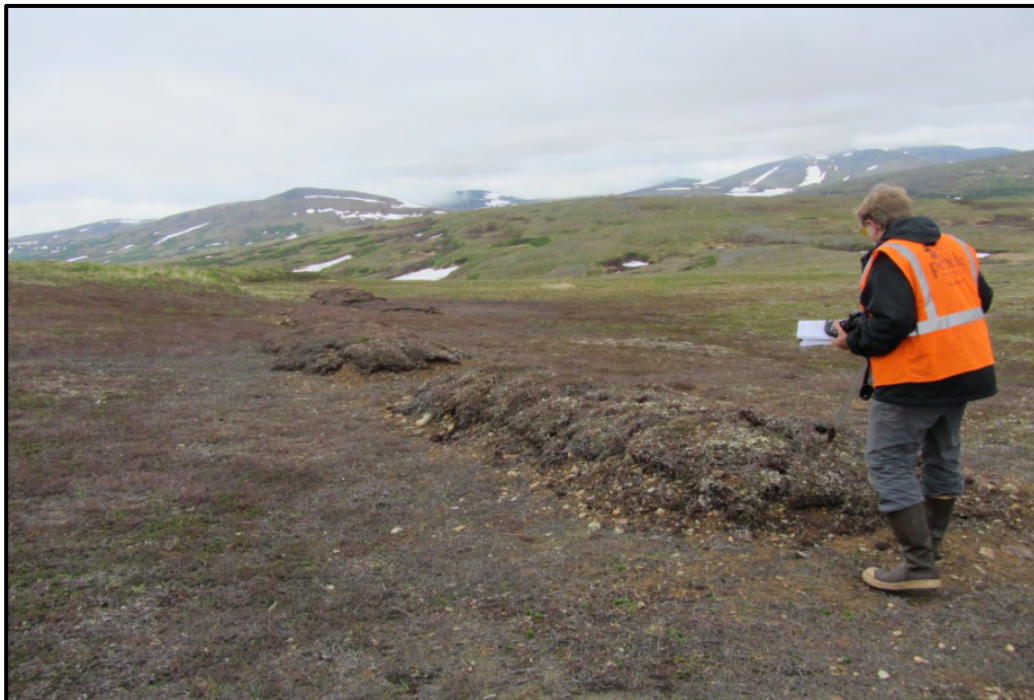
Photo #10. Trenches and sumps mounded as subsidence will occur during reclamation.

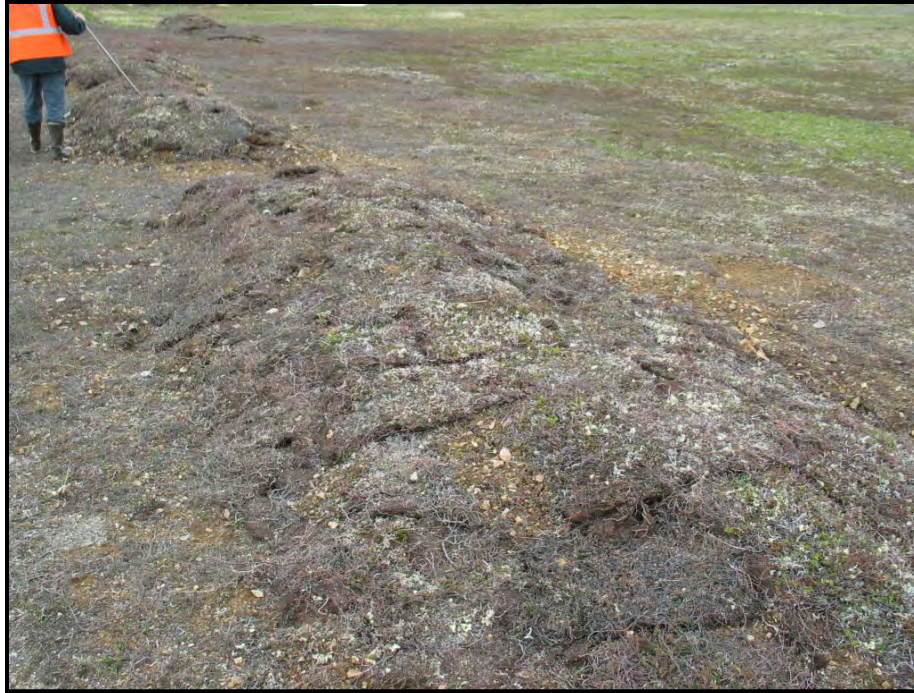
Photo #11. Pits filled and tundra replaced.

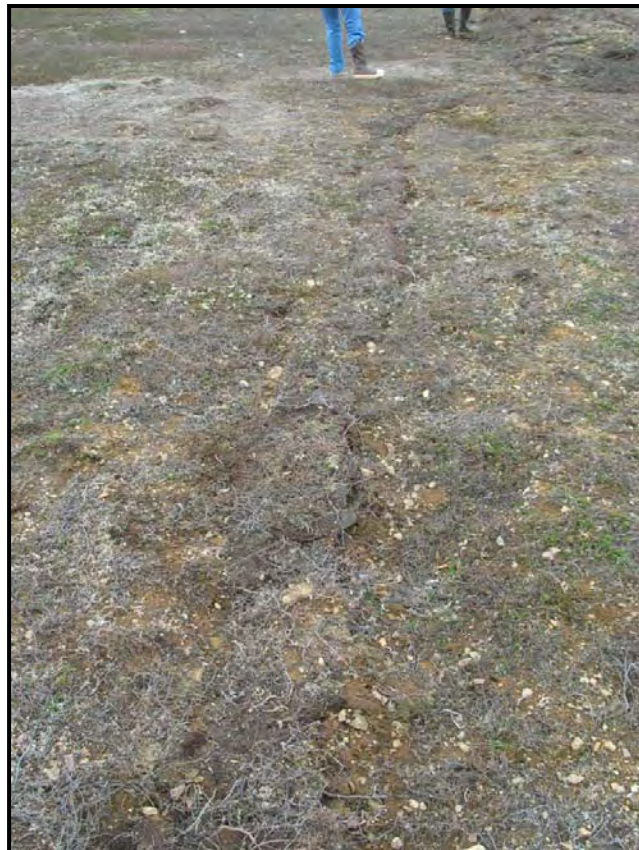
Photo #12. Fill and replaced tundra on discharge trench.

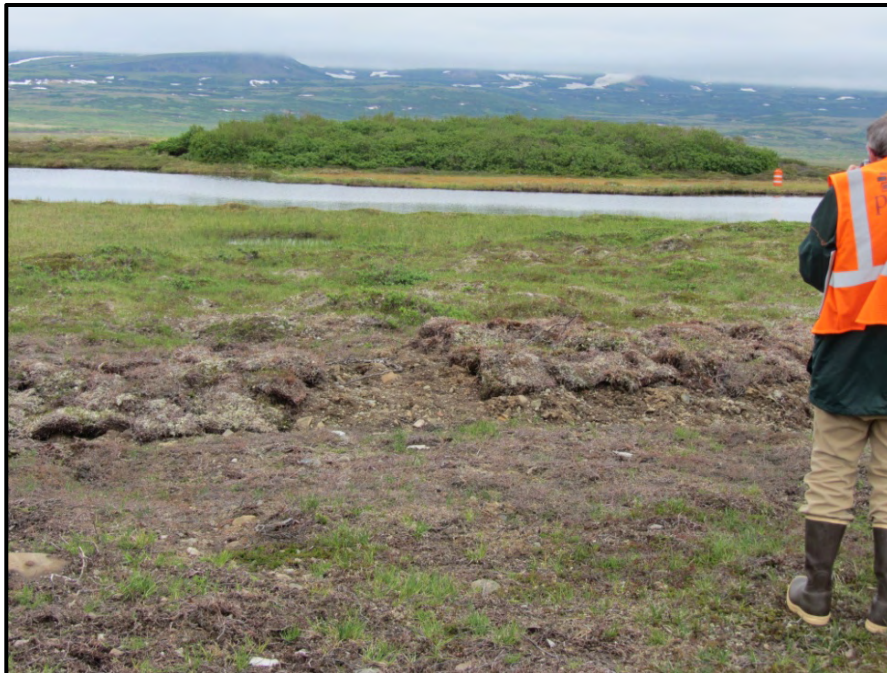
Photo #13. Sumps mounded as subsidence will occur during reclamation.

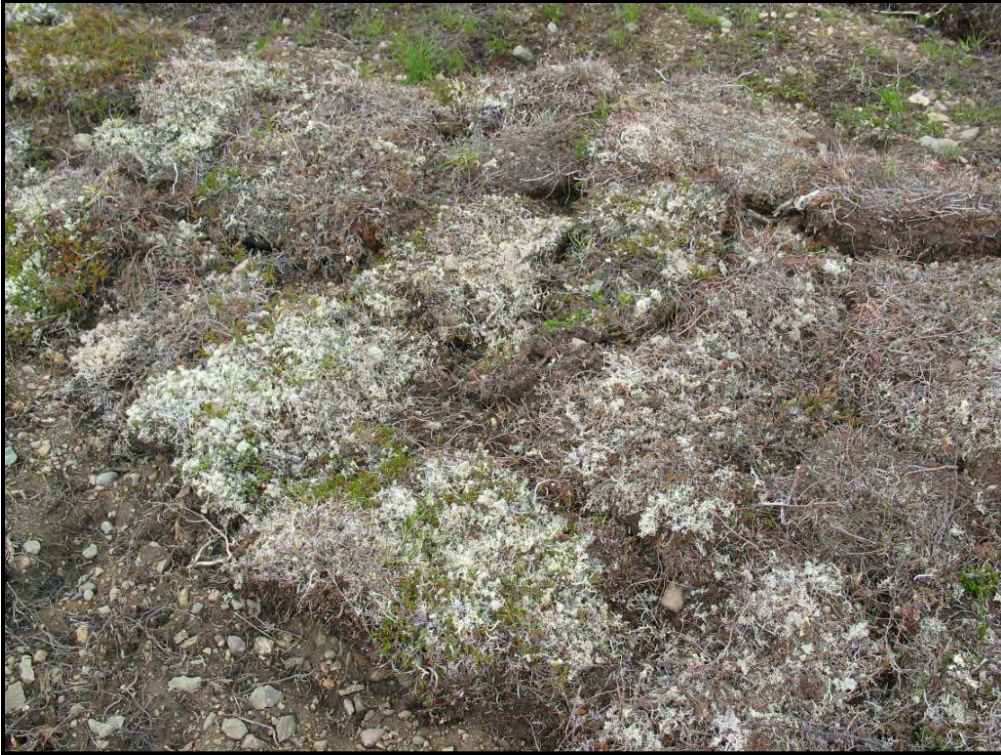
Photo #14. Replaced tundra on mud pit. Note that some tundra is doing well, while other pieces are somewhat slow to rejuvenate.

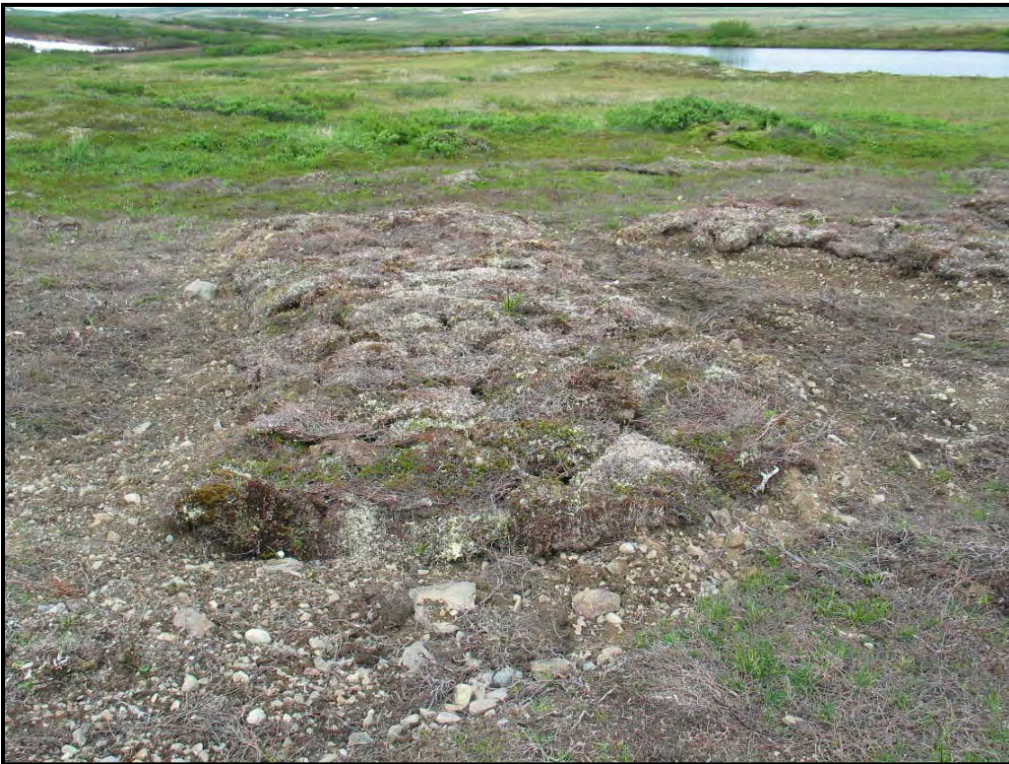
Photo #15. Reclaimed mud pit. Material is mounded in anticipation of subsidence. Tundra has been replaced.

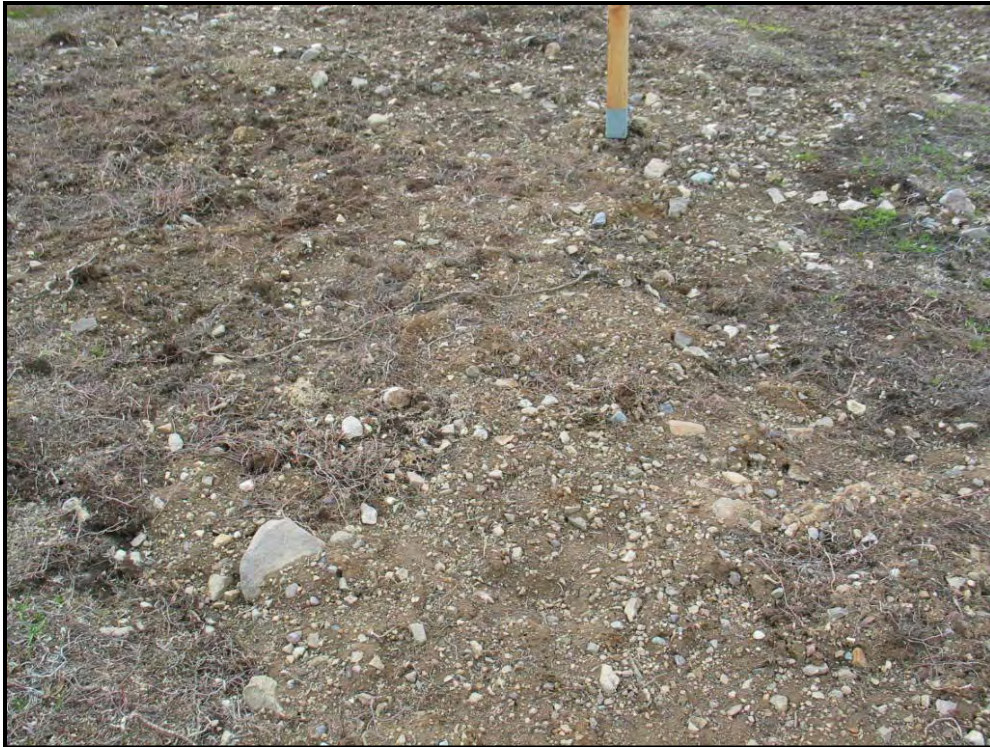
Photo #16. Disturbed area where hydraulic fluid was spilled. Contaminated soil and vegetation were removed and disposed of.

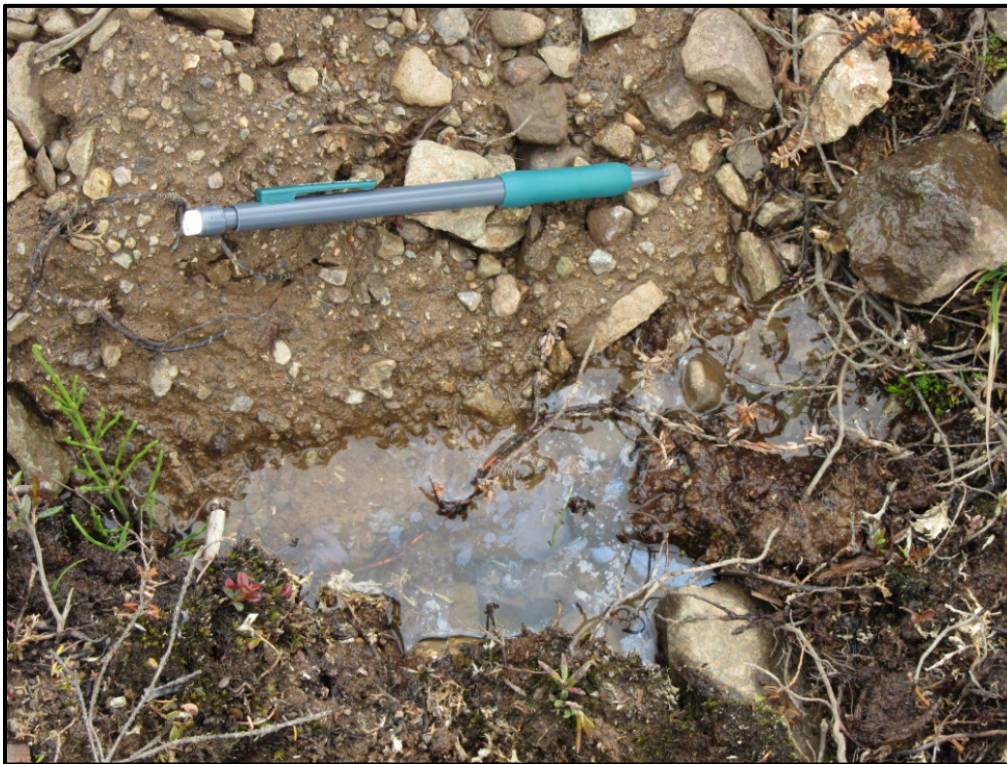
Photo #17. Iron bacteria sheen on water surface. Sheen disseminated when disturbed, which suggests that the source is not from a petroleum product.

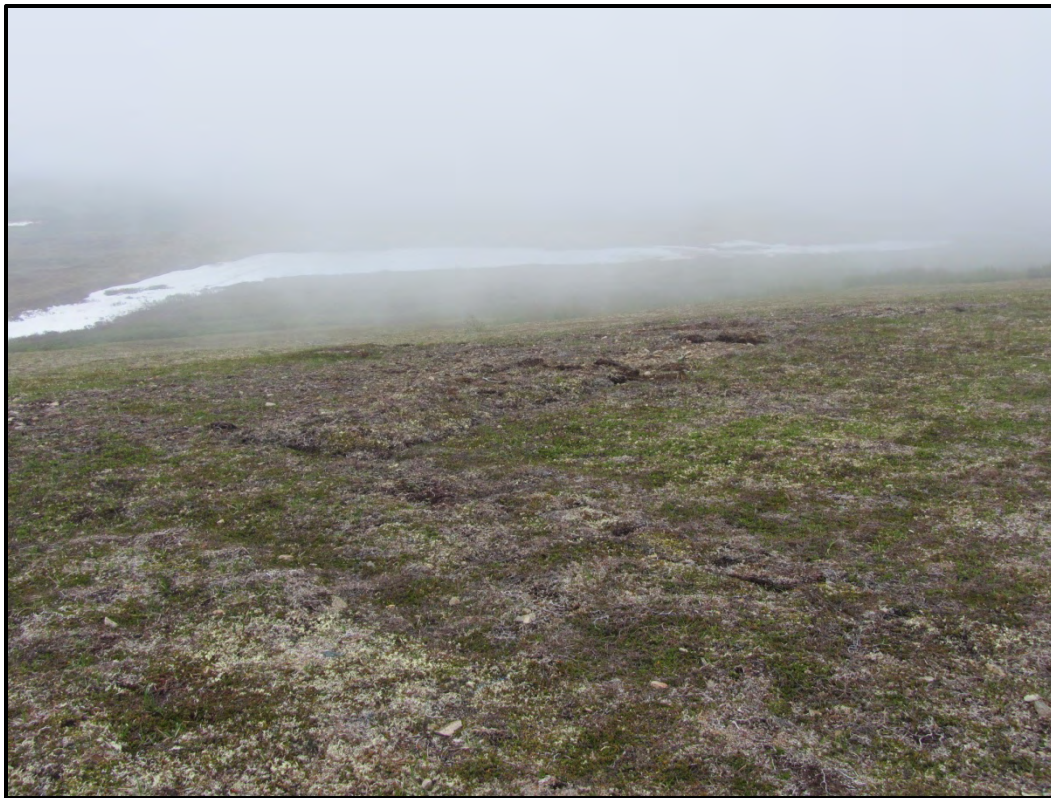
Photo #18. Sumps less recognizable as site returns to natural state.

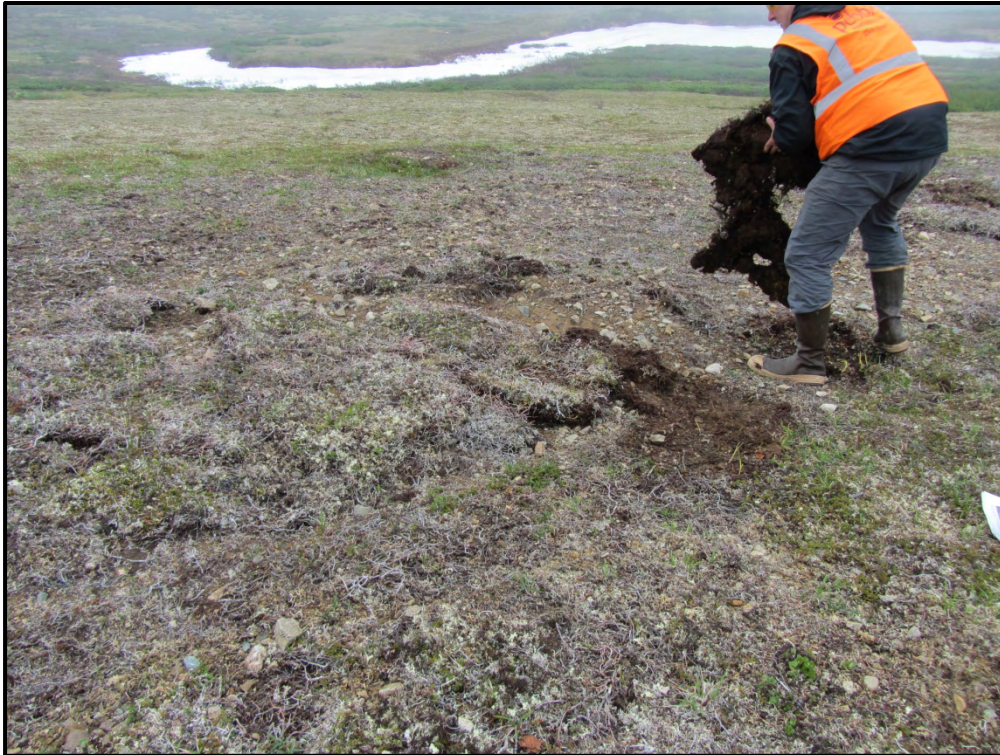
Photo #19. Replacing tundra mats that have been dug up and flipped over by bears.

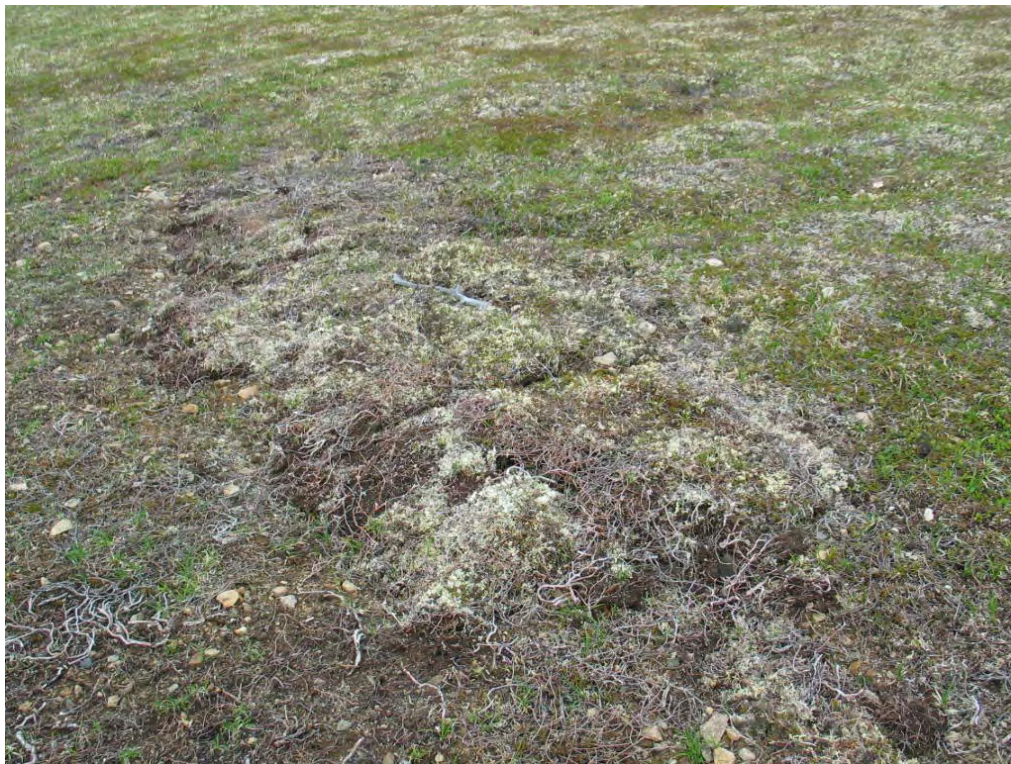
Photo #20. Replaced tundra is doing well.

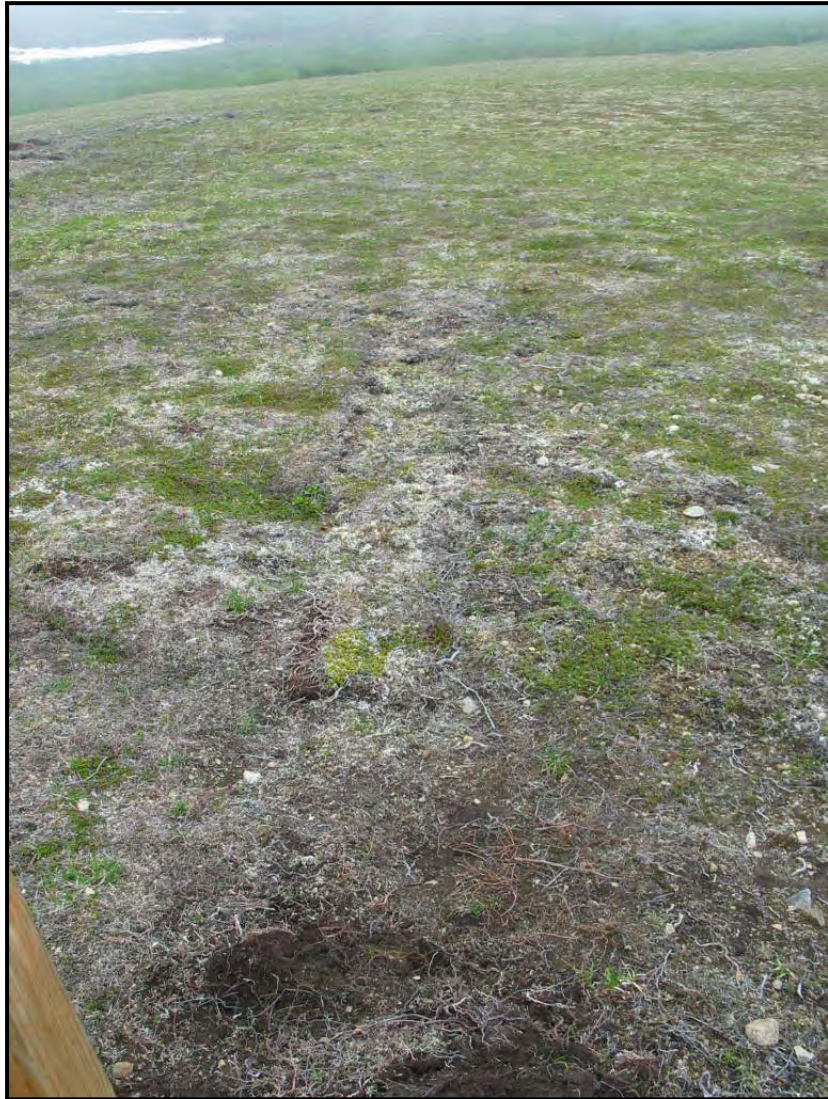
Photo #21. Reclaimed discharge trench.

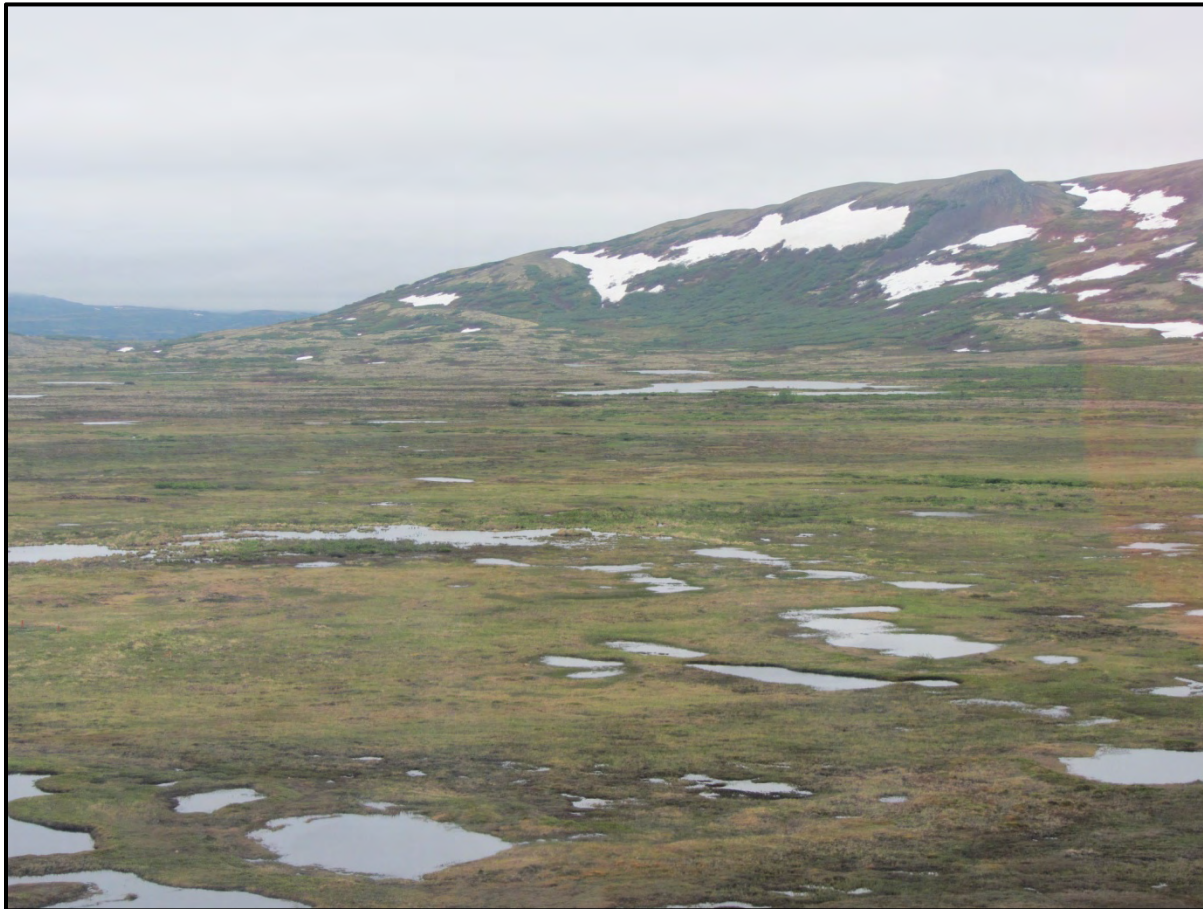
We conducted a flyover of the water sources (lakes and ponds) associated with TWUP A2012-22. No active drilling or water withdrawals were occurring at these specific ponds during the site inspection. Lakes and ponds in the general area appeared to be hydraulically well-connected to the surrounding wetlands.

Photo #22. Ponds and lakes in this area appear to be hydraulically well-connected to the surrounding wetlands.

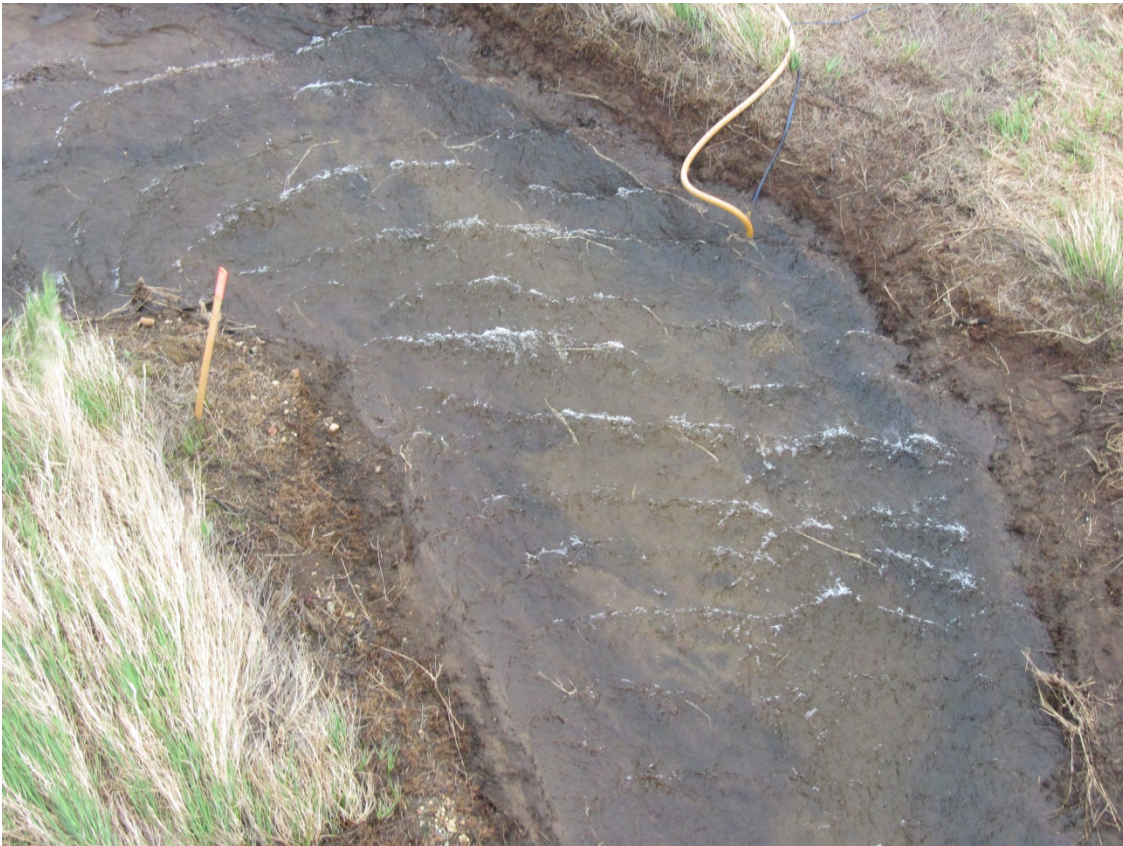
Photo #23. Image displays an example type of channel where transects for streamflow measurements would be conducted upstream from the withdrawal point (pump) using a Marsh-McBirney flowmeter.

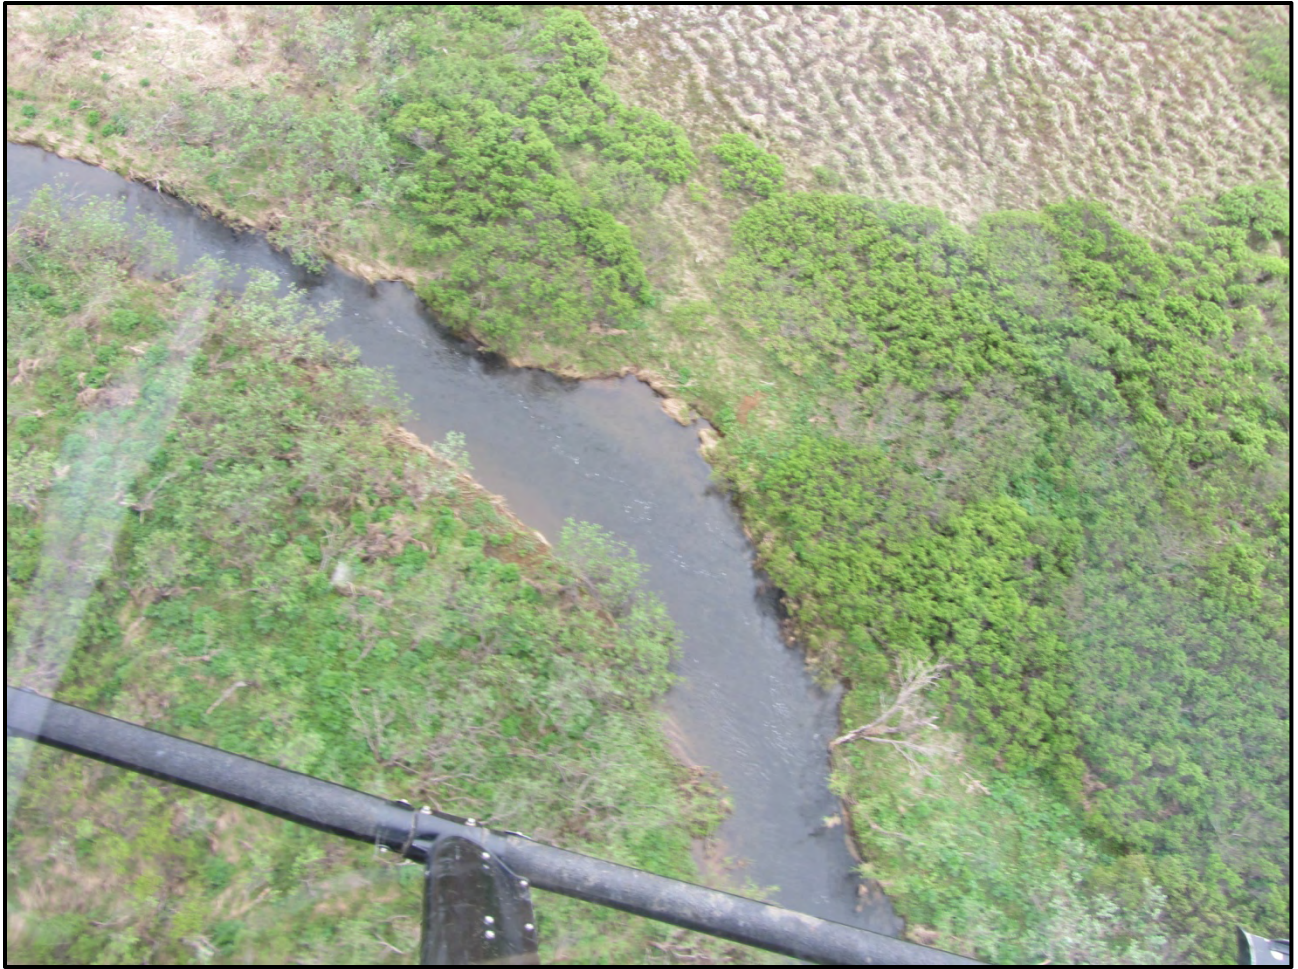
Photo #24. Image displays an example type of channel where streamflows would be calculated/estimated upstream from the withdrawal point (pump) using the float method. Note relatively deeper areas in thalweg.

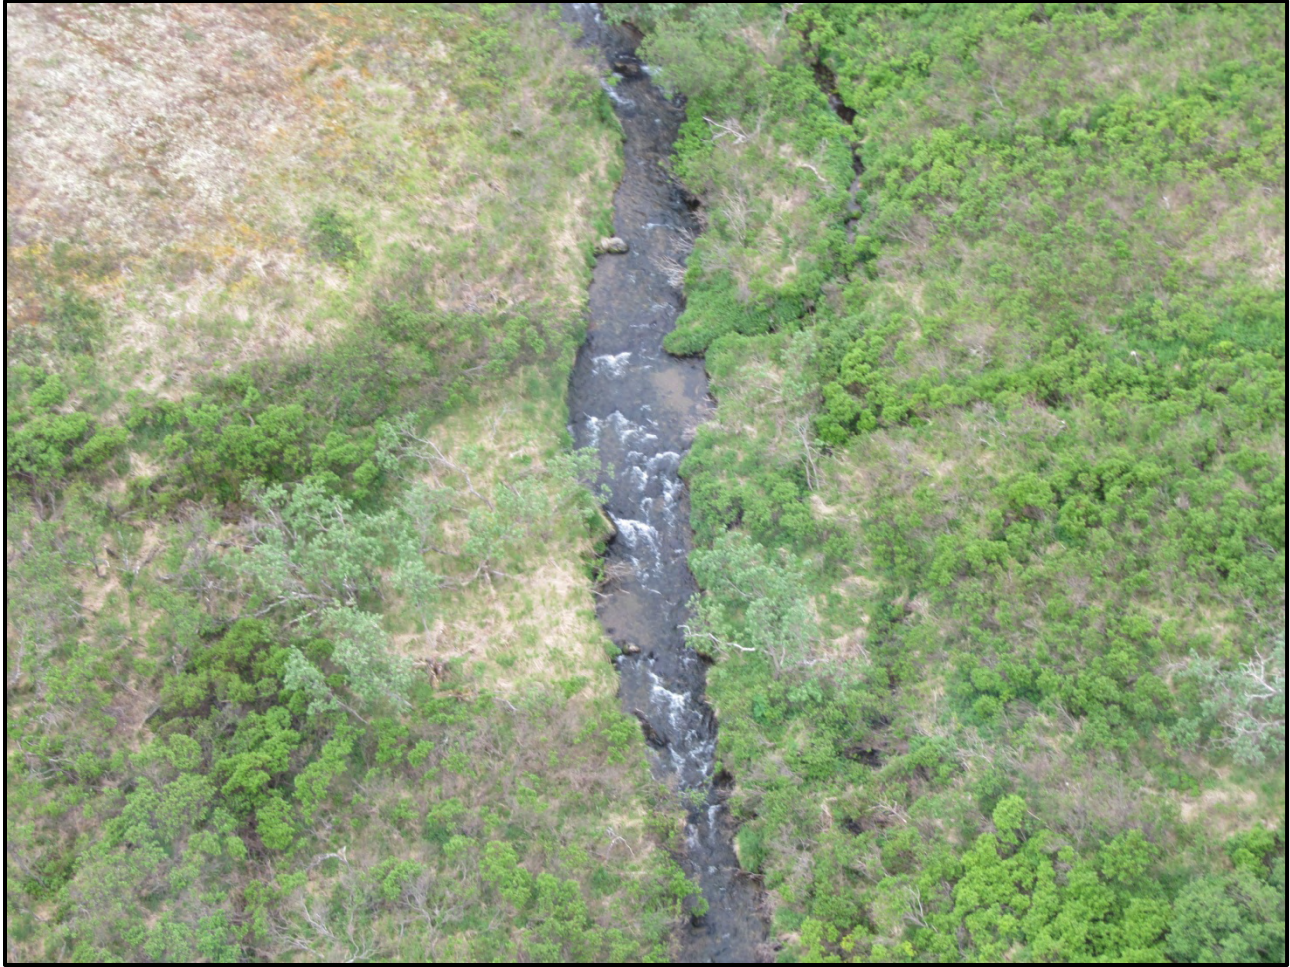
Photo #25. Image displays an example type of channel where streamflows would be calculated/estimated upstream from the withdrawal point (pump) using the float method.
