Field Monitoring Report -- Pebble Copper/Gold Exploration Project --

Personnel: Ron Benkert, ADF&G	Inspection Date: 6-22-2011
Stormy Haught, ADF&G	
Krystin Bablinskas, ADEC	APMA #: A116118
Michael Gravier, ADEC	
■ Inspection Type: <input type="radio"/> Complete: X <input type="radio"/> Partial: <input type="radio"/> Follow-up: <input type="radio"/> Response to Public Complaint:	■ Wildlife Observed: <input type="radio"/> Bear: <input type="radio"/> Caribou: <input type="radio"/> Moose: <input type="radio"/> Waterfowl: 2 pairs of swans with cygnets <input type="radio"/> Fish: <input type="radio"/> Other: 1 marmot
■ Weather Conditions: <input type="radio"/> Temperature: 9° C <input type="radio"/> Wind: 5-10 mph <input type="radio"/> Precipitation: light rain <input type="radio"/> Visibility: 6 miles <input type="radio"/> Sky Conditions: low overcast/fog <input type="radio"/> Ground Conditions: wet	
■ Comments: Overall the sites looked good. Pipe ends observed on ground at DH 11532. This drill rig was in the process of being moved, personnel stated that the pipes were a tripping hazard and were temporarily placed with ends on tundra for safety during helicopter transport of drill rig.

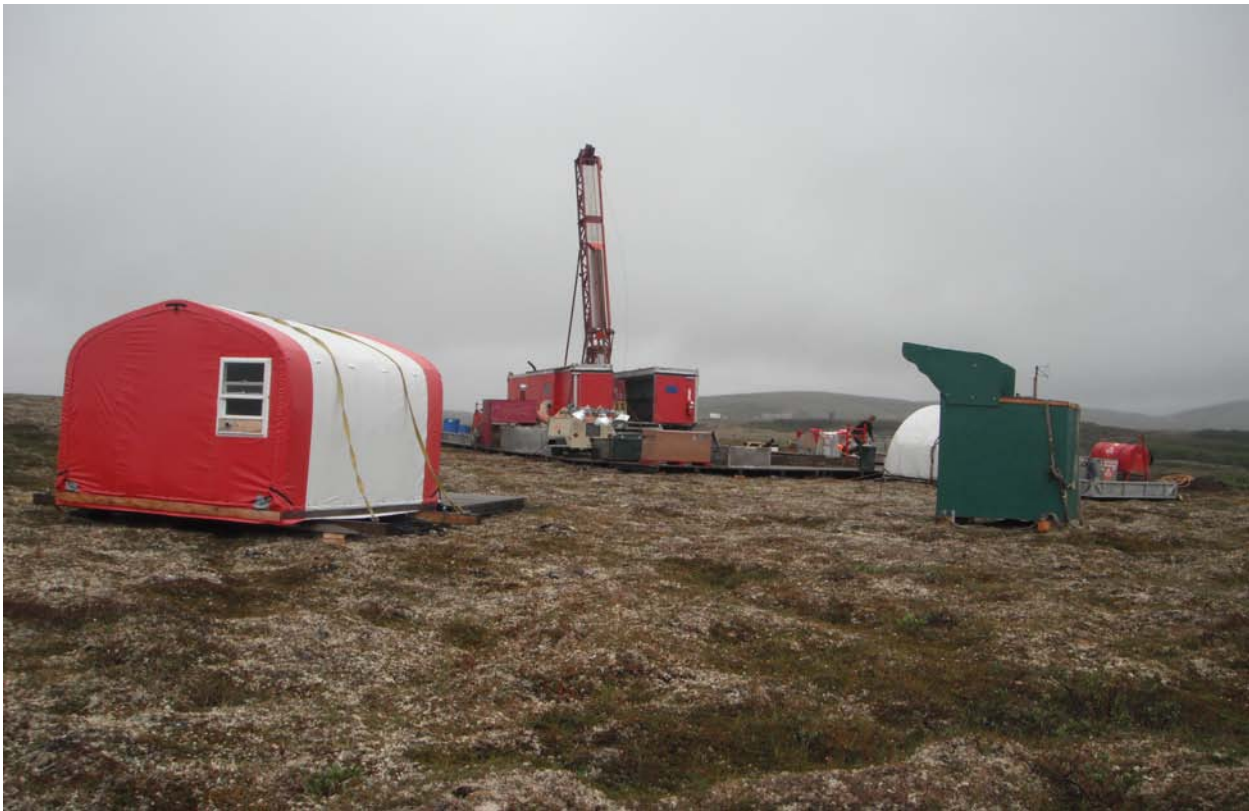
Figure 1 – Rig #2 Drill Hole 11533

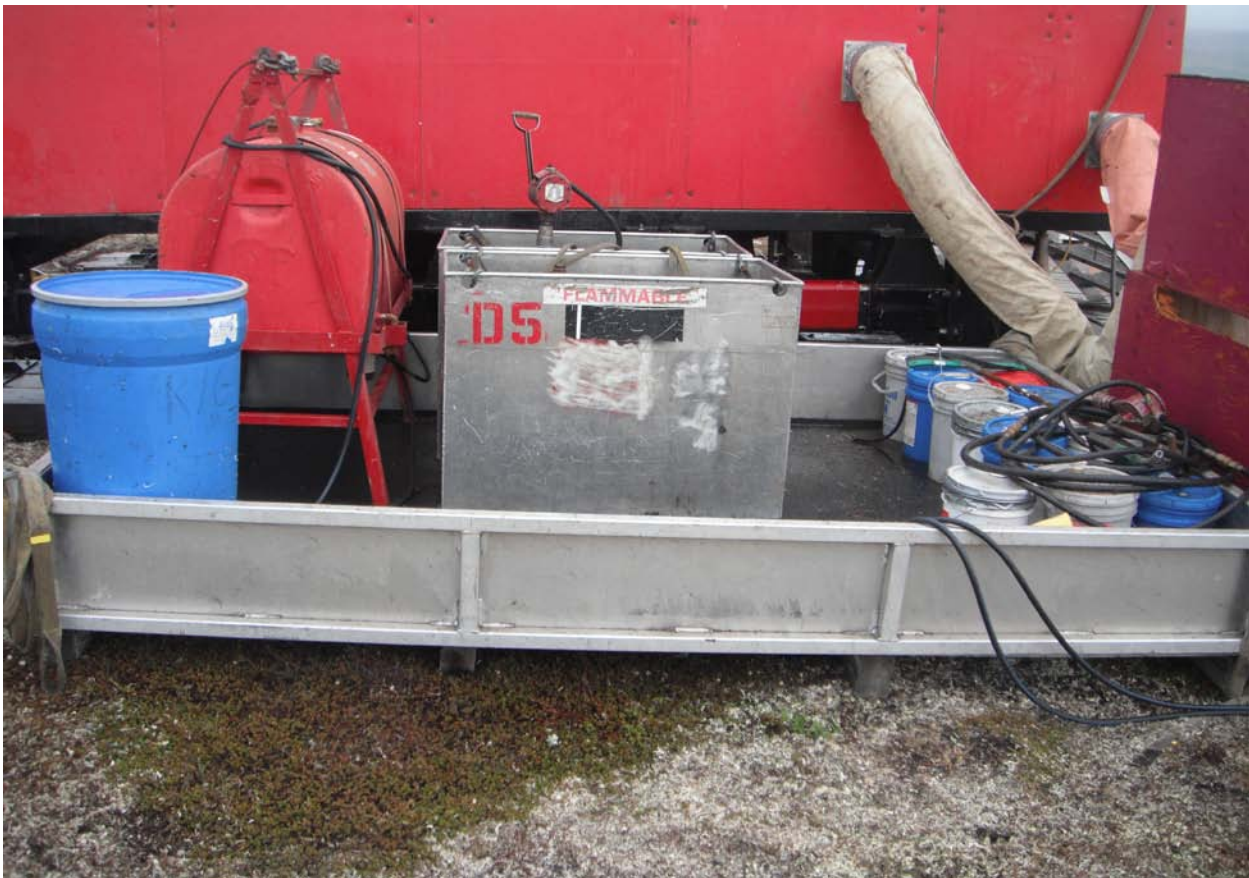
Figure 2 – Drill Hole 11533 Fuel Containment and Spill Kit

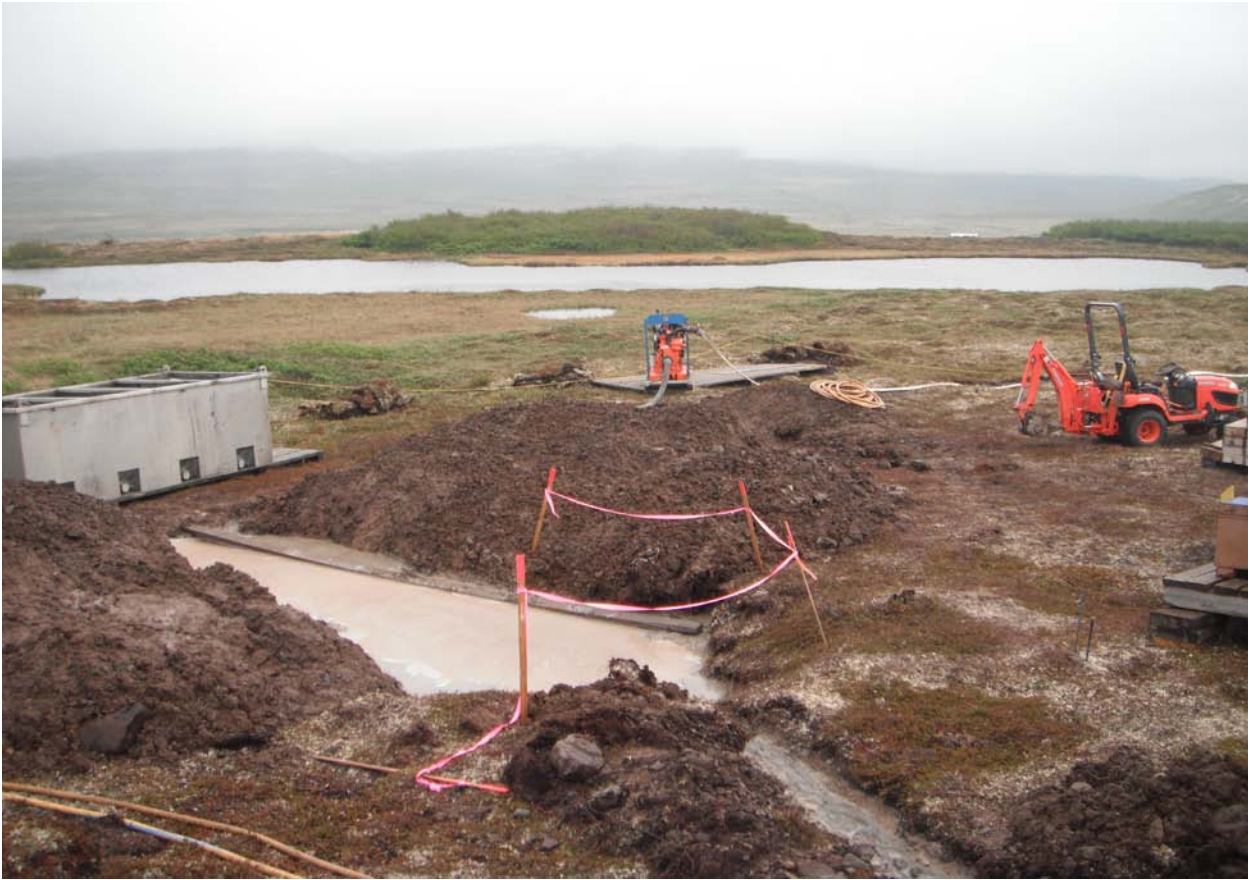
Figure 3 – Drill Hole 11533 Sump Pit, Recirculation Tank, and Discharge Pump

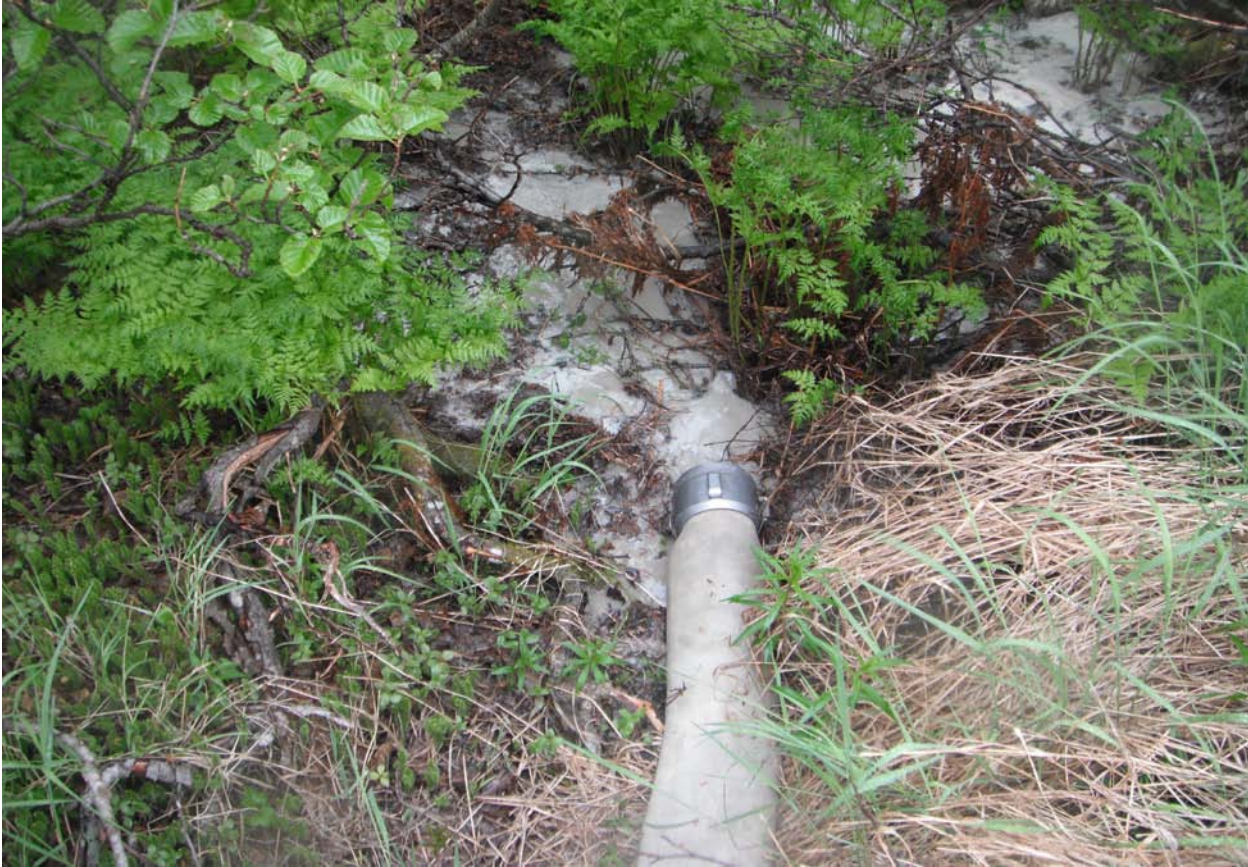
Figure 4 – DH 11533 Discharge Point

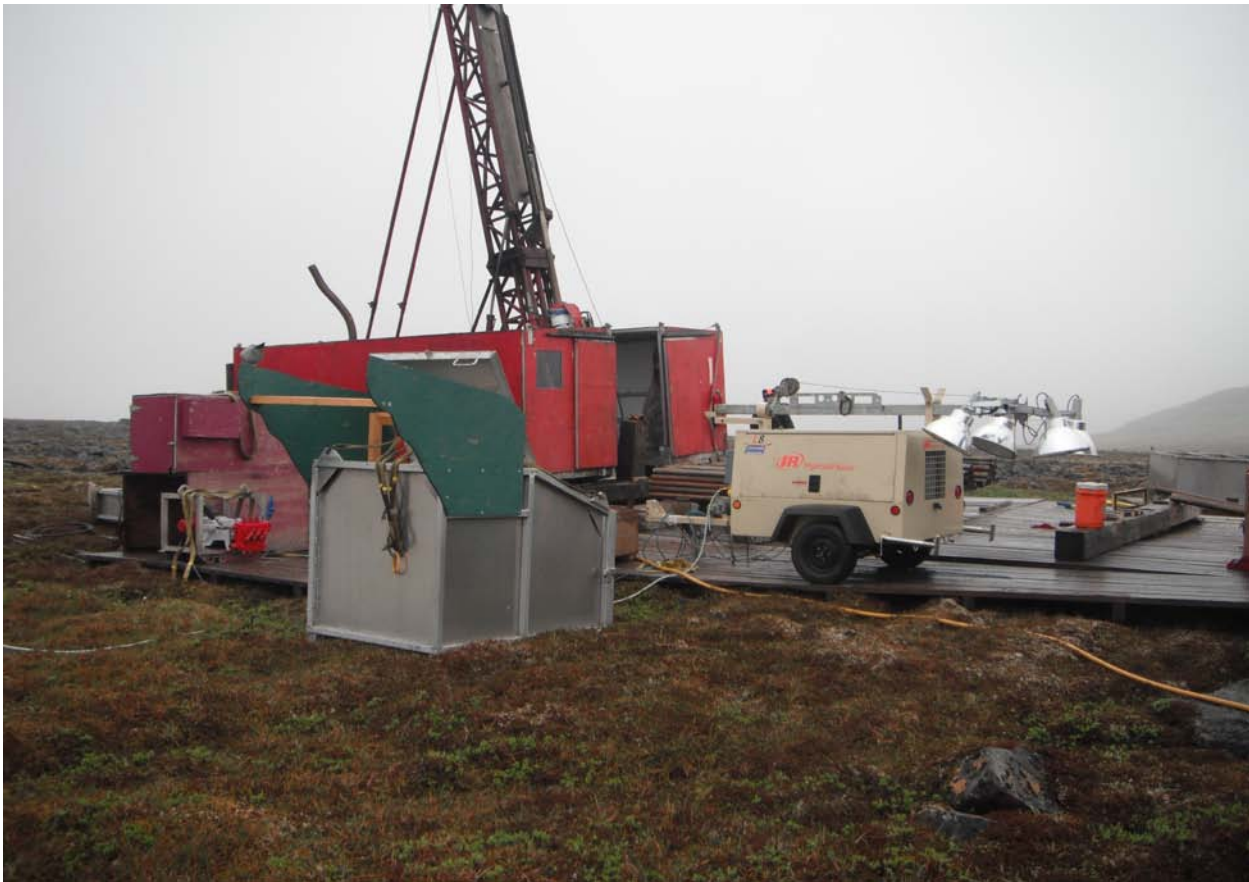
Figure 5 – Rig #3 Drill Hole 11532

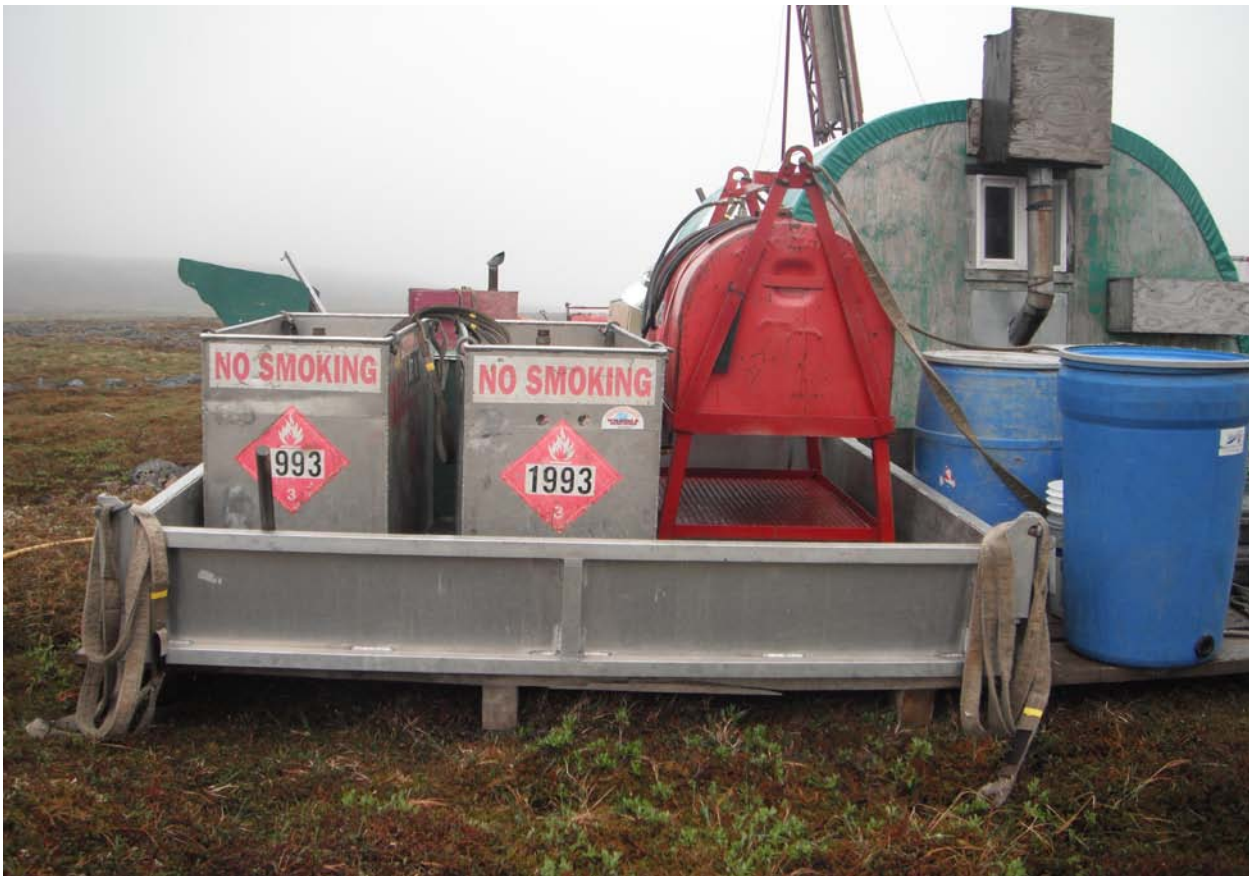
Figure 6 – Drill Hole 11532 Fuel Containment and Spill Kits

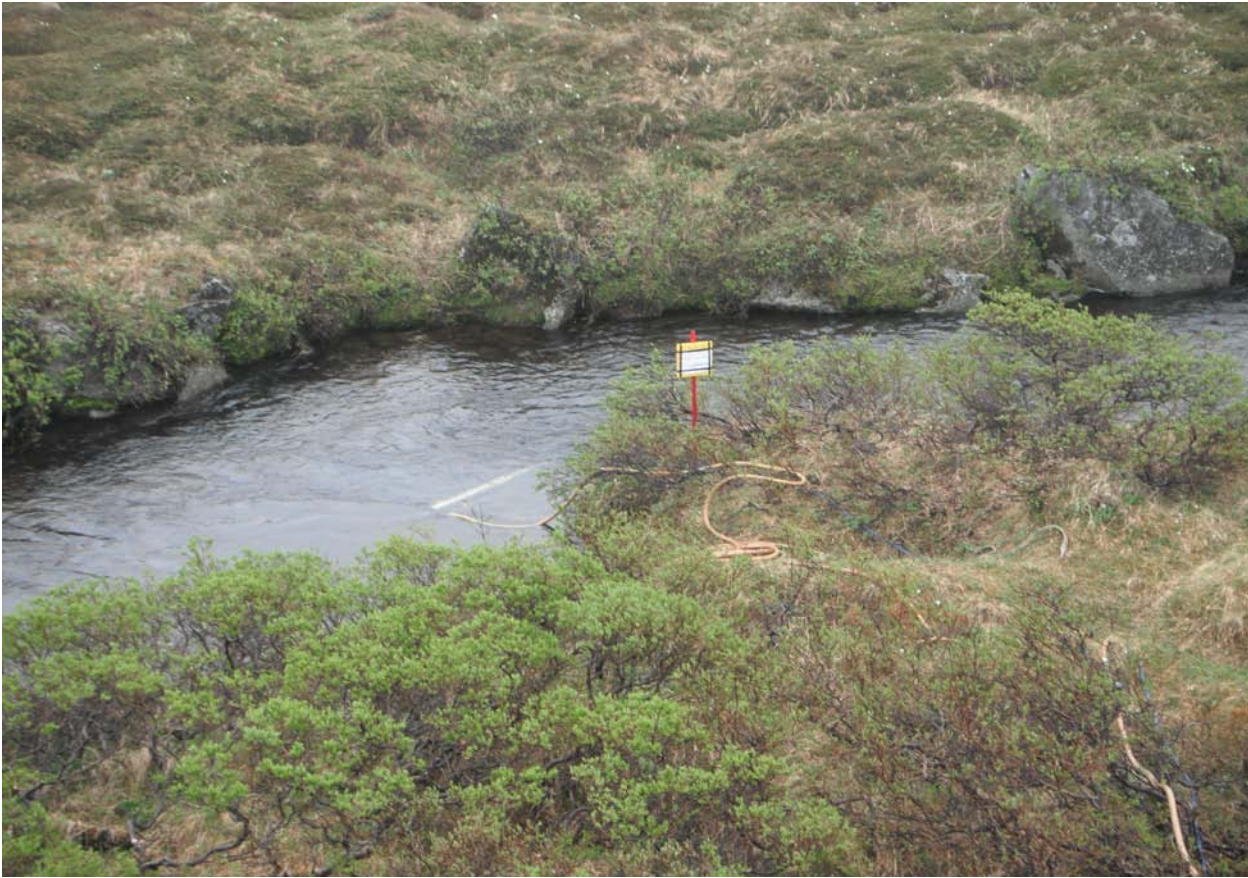
Figure 7 – DH 11532 Water Source Signage and Screened Intake

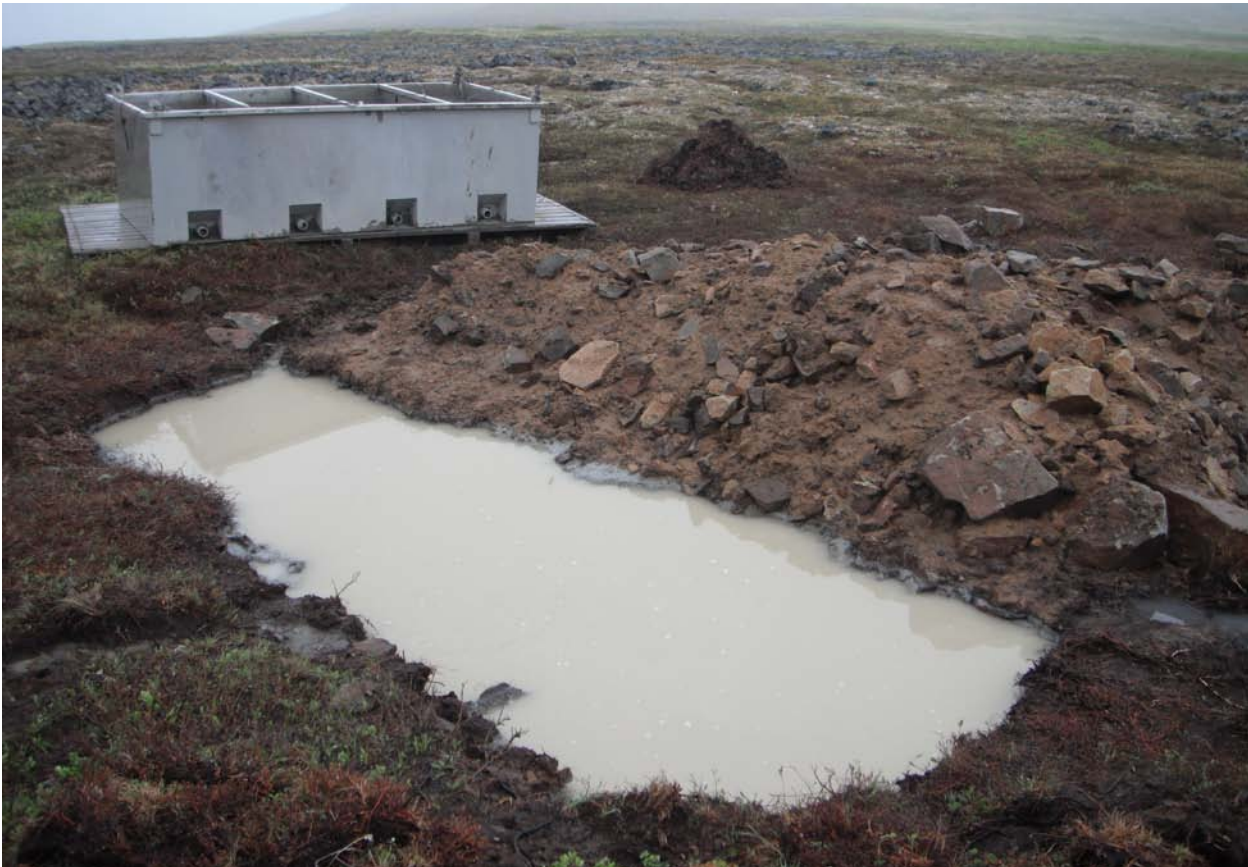
Figure 8 – DH 11532 Sump Pit and Recirculation Tank

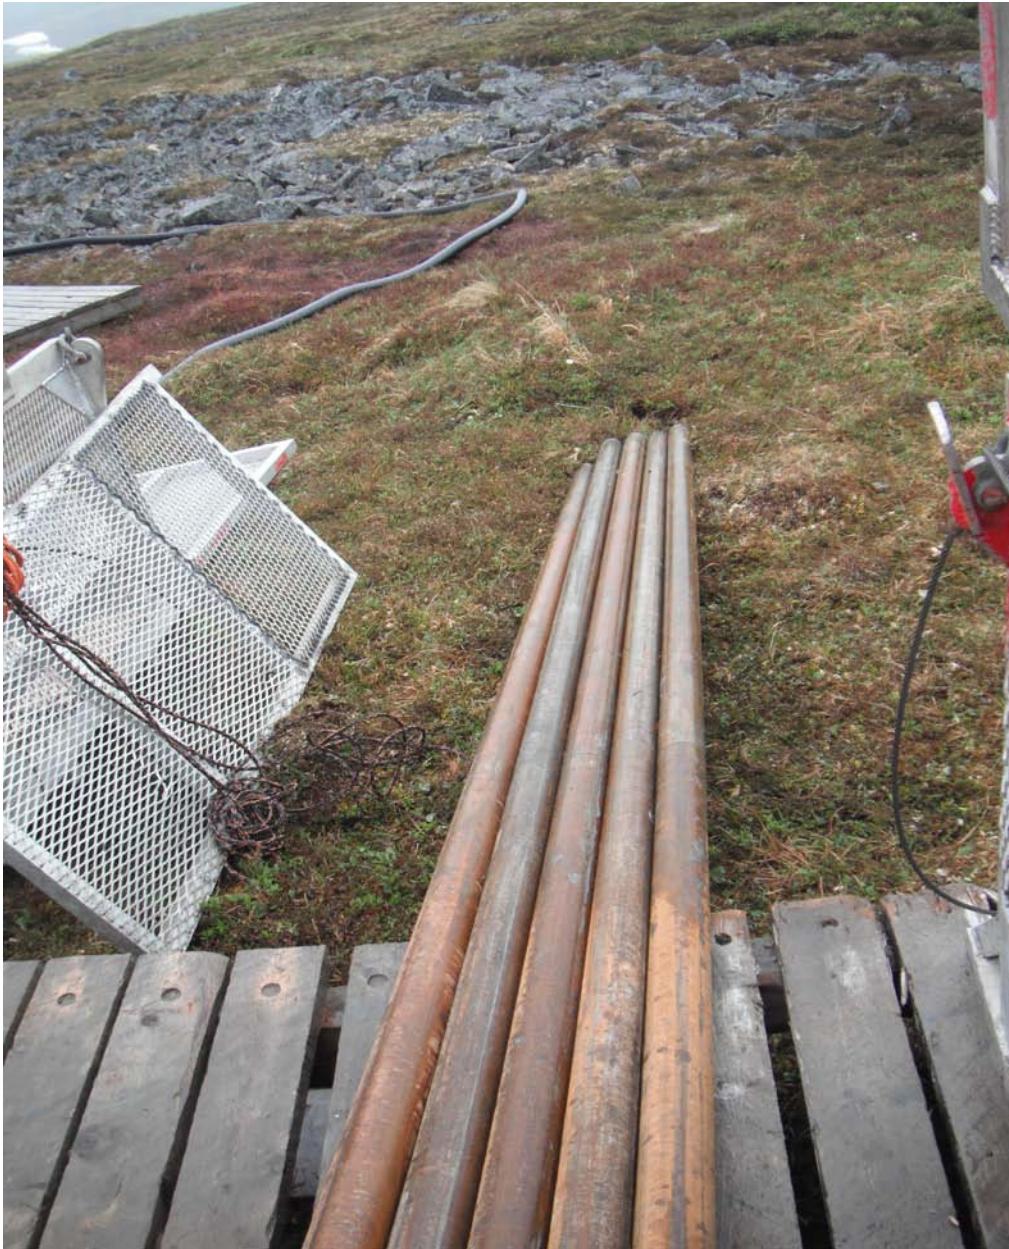
■ Sump Pit: two pits present <ul style="list-style-type: none"> ○ Location: 40 ft. from drill rig ○ Discharge trench: Yes ○ Dimensions of pit: 45' x 7' and 30' x 8' ○ In use: No. Drilling complete. 	■ Other Comments: Drill rig in process of being moved. Ends of drill casing on tundra.

Figure 9 – DH 11532 Pipe Ends on Tundra

■ Recommendations: Recommended management discusses the PLP Plan of Operation with drill crews to ensure that pipes are not placed on the tundra. Recommended remediation of petroleum staining at DH 10514 reclamation site.	
■ Actions Needed: Re- inspect DH 10514 to ensure site of spill has been remediated.

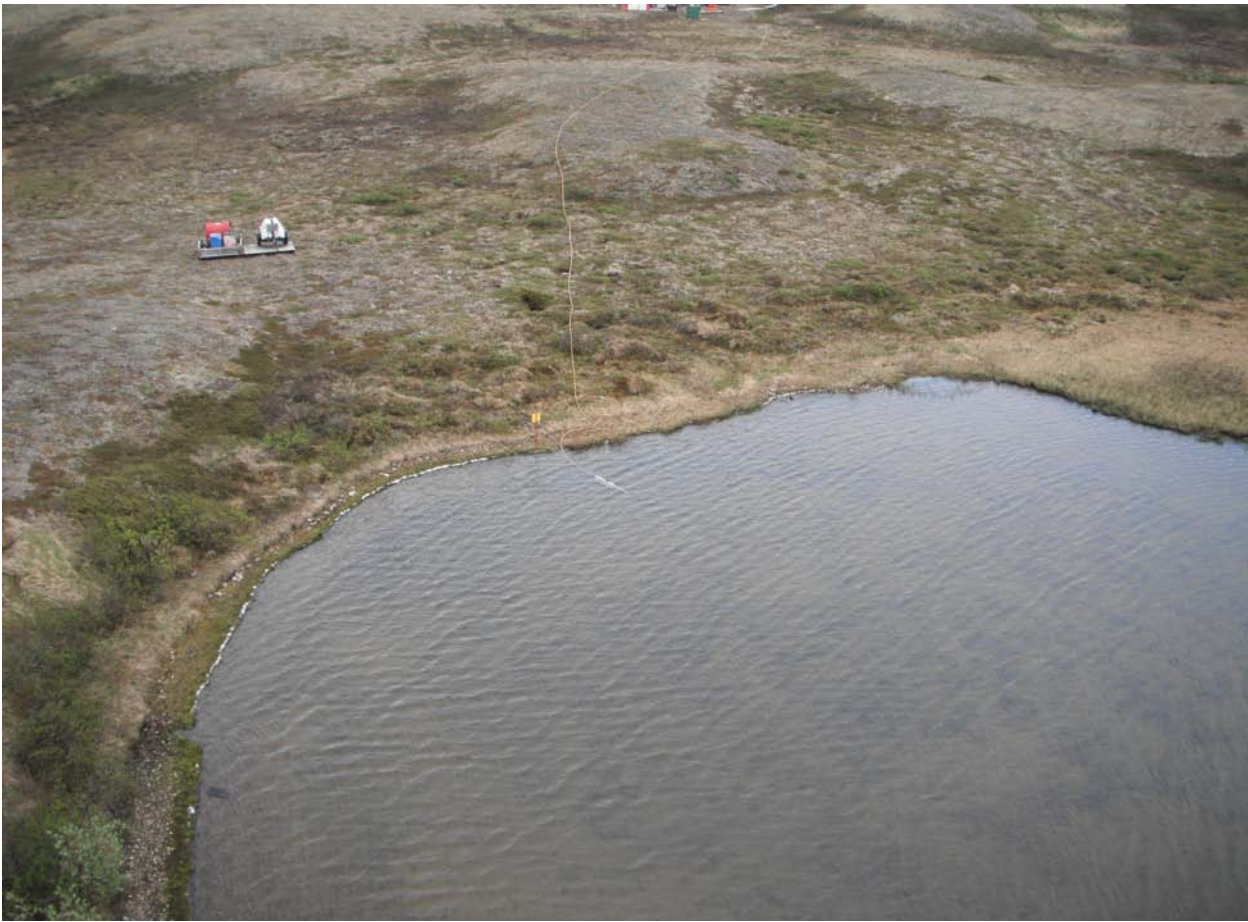
Figure 10 – GH 11235 Water Source and Pump – Set-up not complete

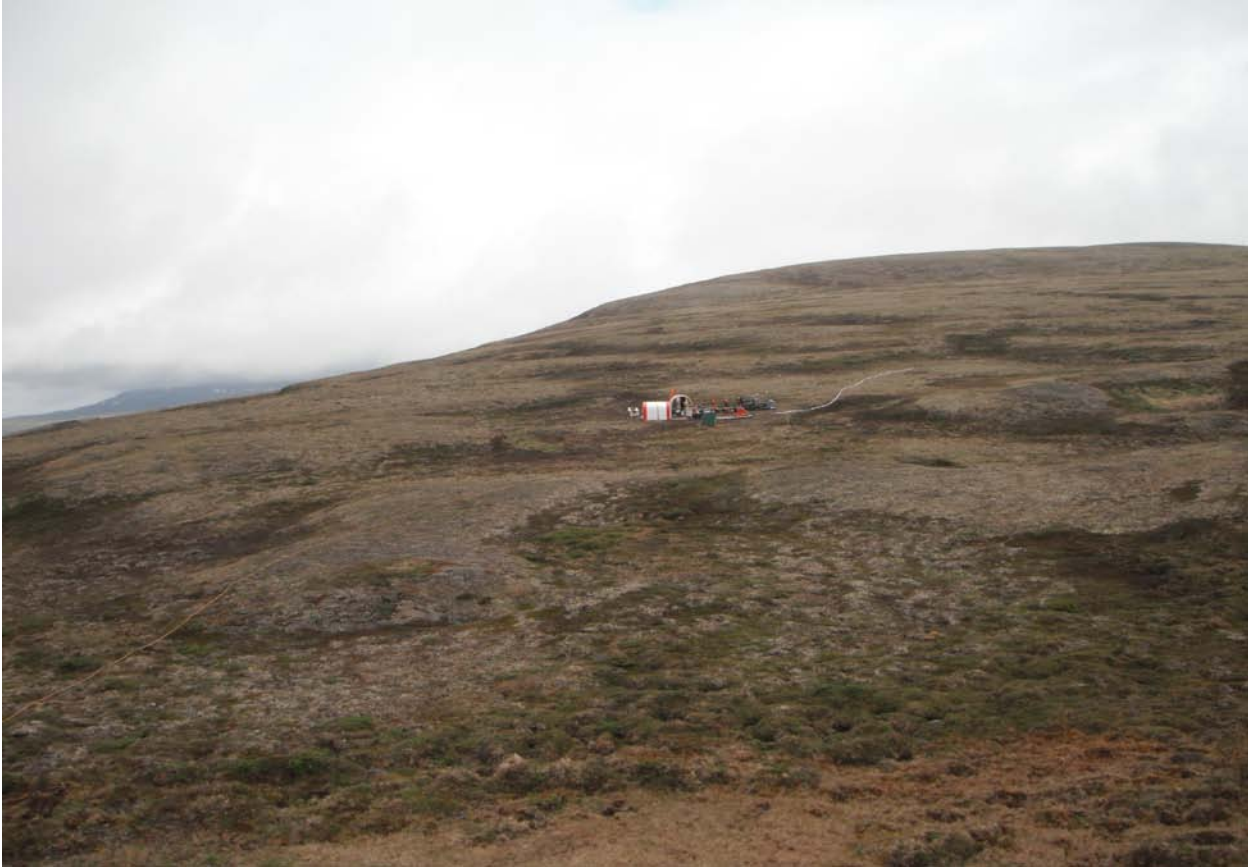
Figure 11 – Rig 4 GH 11235 Location – New Set-up – No Drilling Activity

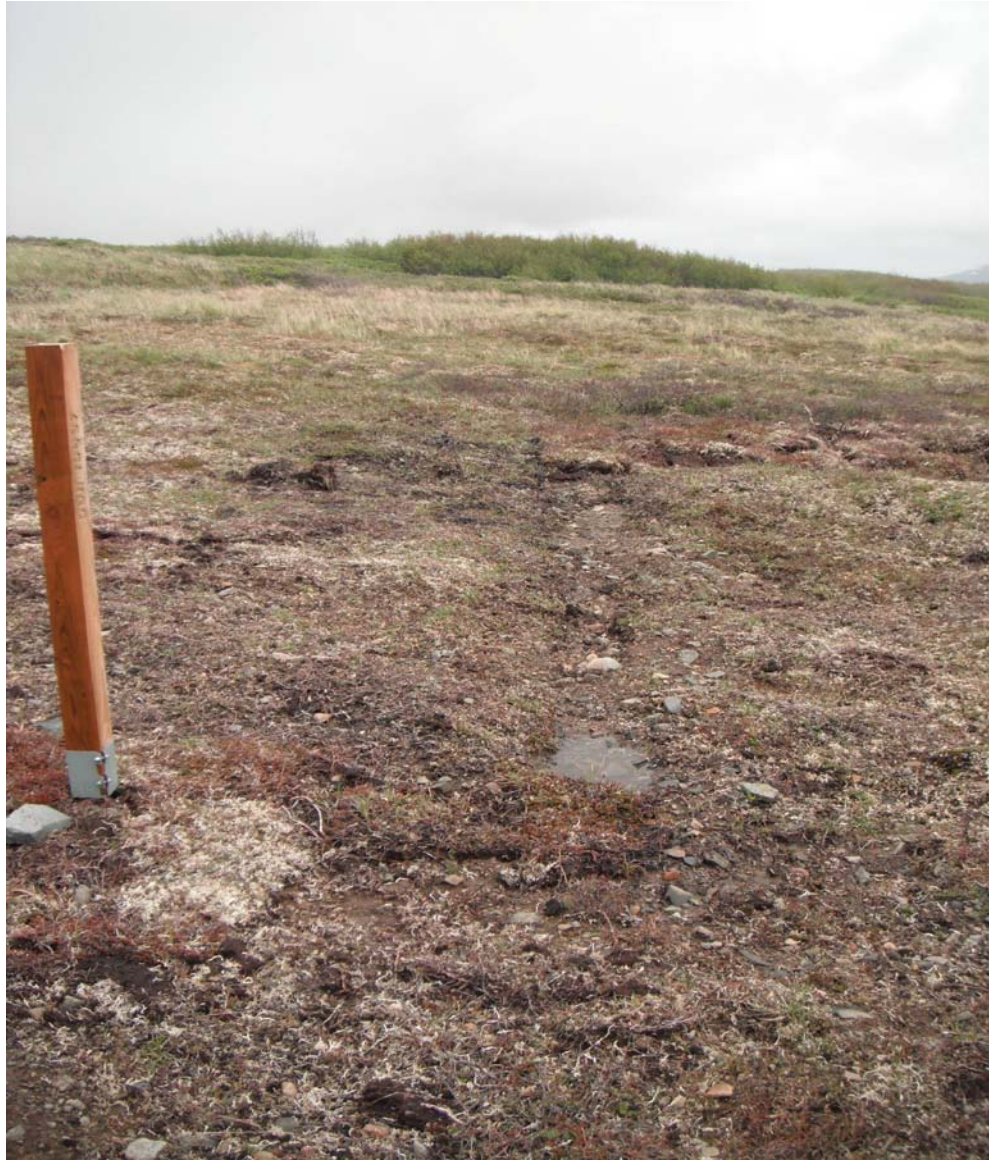
Abandoned Drill Hole/Site No.: 10497	Date: 6-22-11
	Time: 13:50
■ Plugged: Yes	
■ Cemented: Grouted	
■ Standing pipe: No	
■ Sump pit filled in: Yes	
■ Water discharge trench filled in: Yes	
■ Site revegetated: Yes	
■ Date revegetated/reclaimed: Fall 2010	
■ Artesian water present: No	
■ Any spills or staining: No	
■ Comments/General impression: The site was recently reclaimed. Vegetation appears to be surviving. Settling of the underlying soil not complete at time of inspection. Overall the site looked good.

Figure 12 - DH 10497 Reclamation – Discharge Trench and Sump Pit

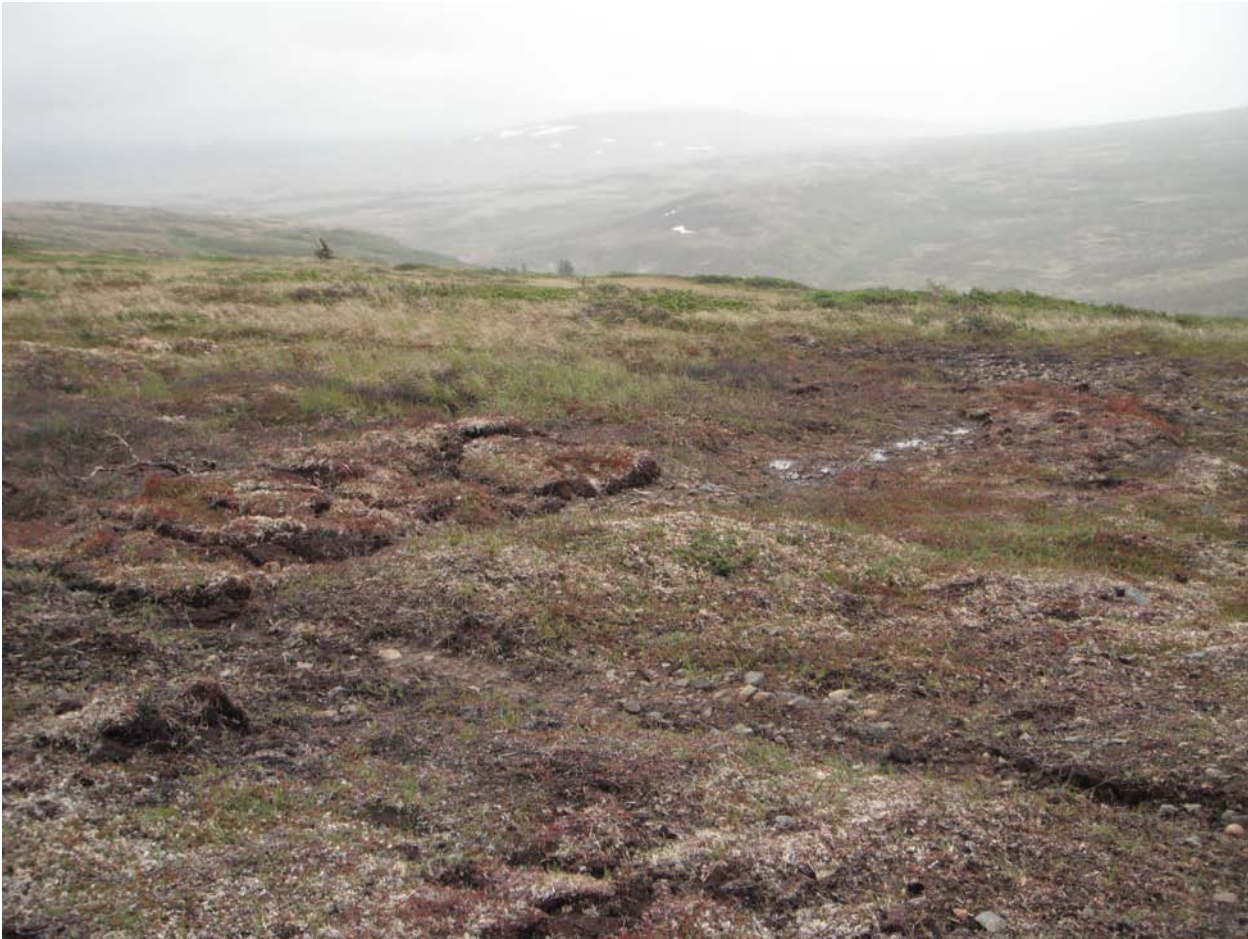
Figure 13 – DH 10497 Reclamation – Sump Pits - Site is still settling

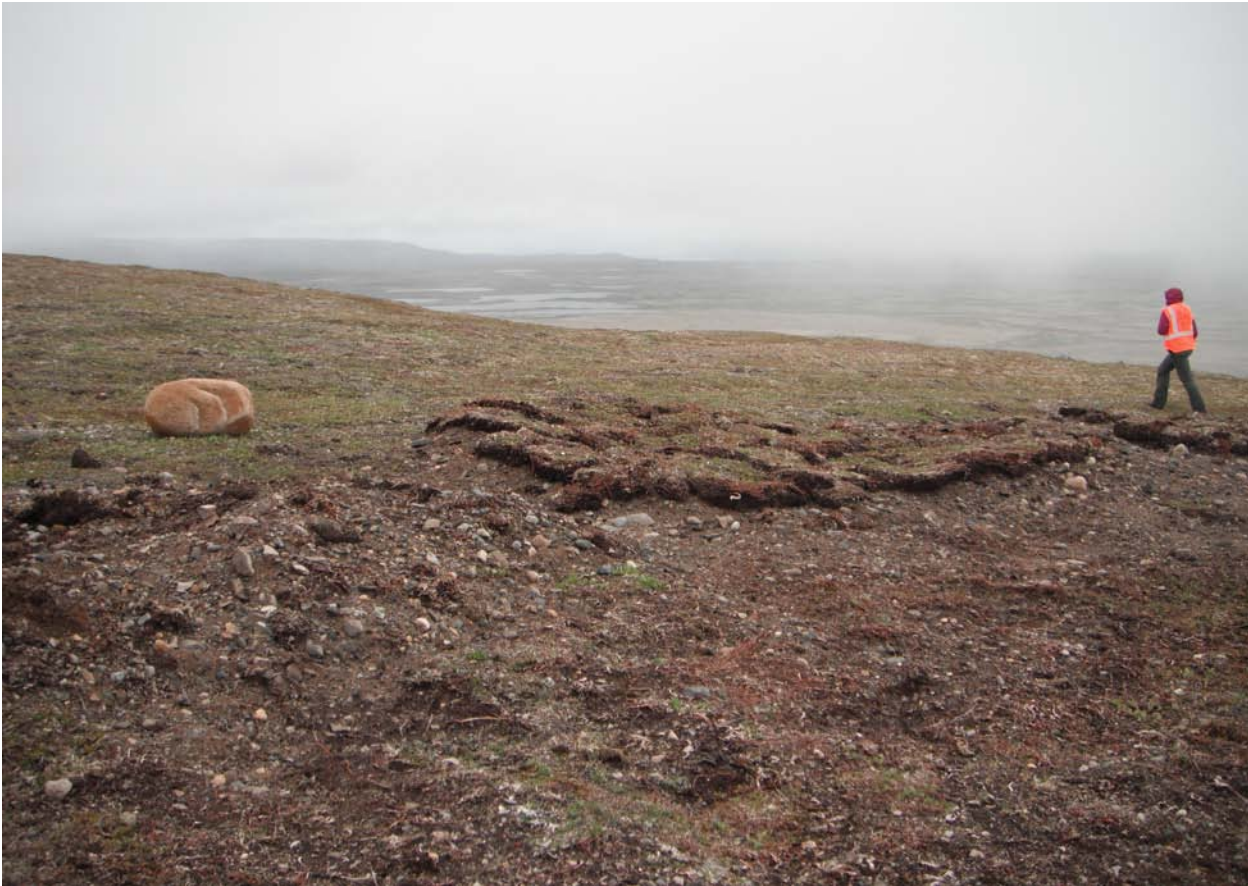
Figure 14 – DH 10514 Reclamation – Sump Pits – Site still settling

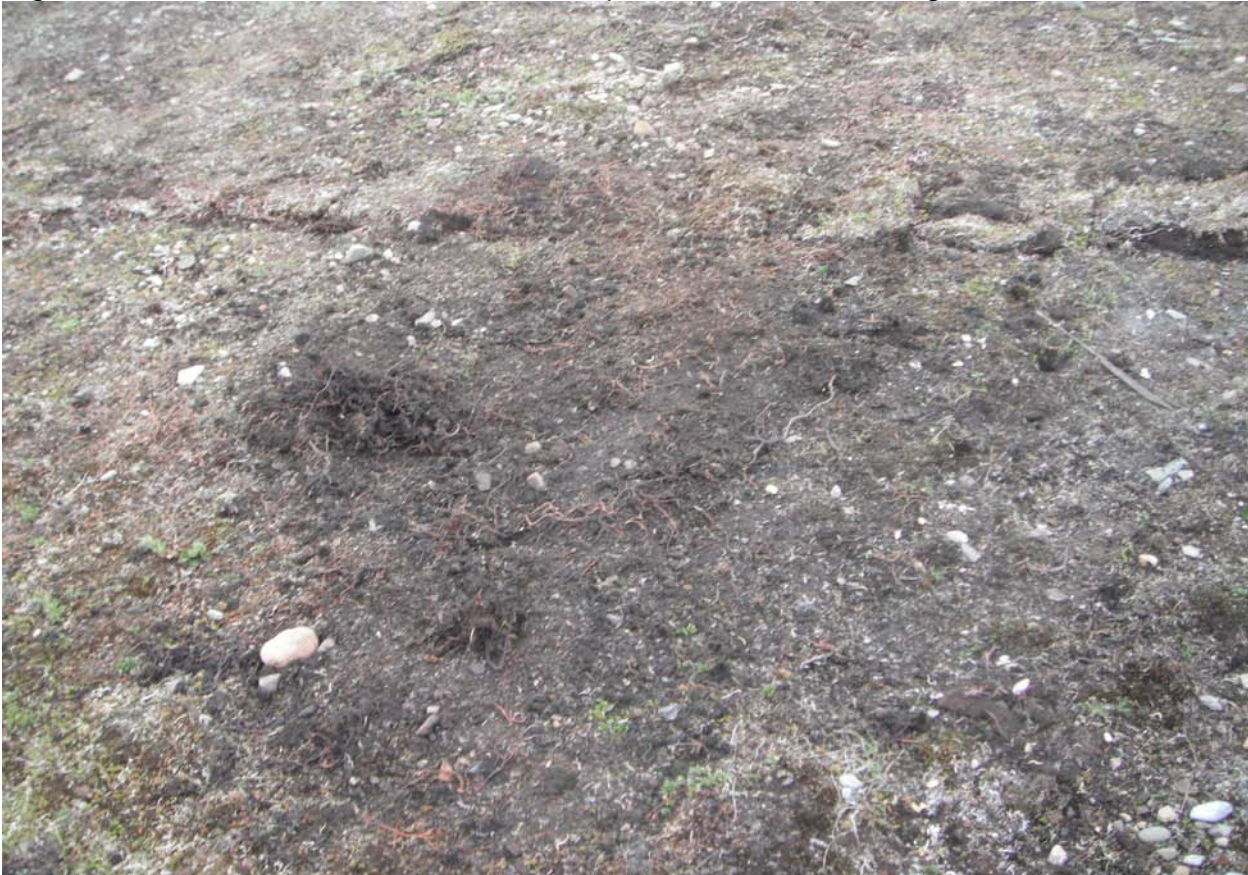
Abandoned Drill Hole/Site No.: 10514	Date: 6-22-11
	Time: 14:15
■ Plugged: Yes	
■ Cemented: Grouted	
■ Standing pipe: No	
■ Sump pit filled in: Yes	
■ Water discharge trench filled in: yes	
■ Site revegetated: Yes	
■ Date revegetated/reclaimed: Fall 2010	
■ Artesian water present: No	
■ Any spills or staining: Yes	
<p>■ Comments/General impression: Slight petroleum odor on vegetation adjacent to drill hole. Approximately a 4-foot diameter area was stained at this site. Reclamation site is still settling. Vegetation is alive.</p>

Figure 15 – DH 10514 – Staining of tundra at the site
