# INSPECTION REPORT

## --PEBBLE PROJECT--

**Inspection Date:** 7-8 July 2010  
**Weather:** Breezy, occasional showers, 50-60°F  
**Operator Contact:** Gernot Wober, PLP  
**Agency Personnel:** Jim Vohden-DNR, Gay Harpole-ADEC, Kate Malloy-ADF&G  
**Inspection Objectives:** Site visit to Pebble Project to inspect additional unauthorized water withdrawals not identified in the Settlement Agreement dated 11 Feb 2010.

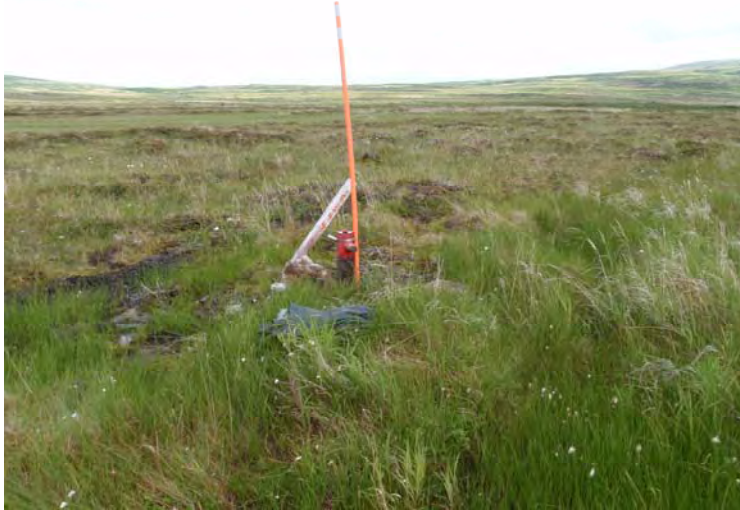
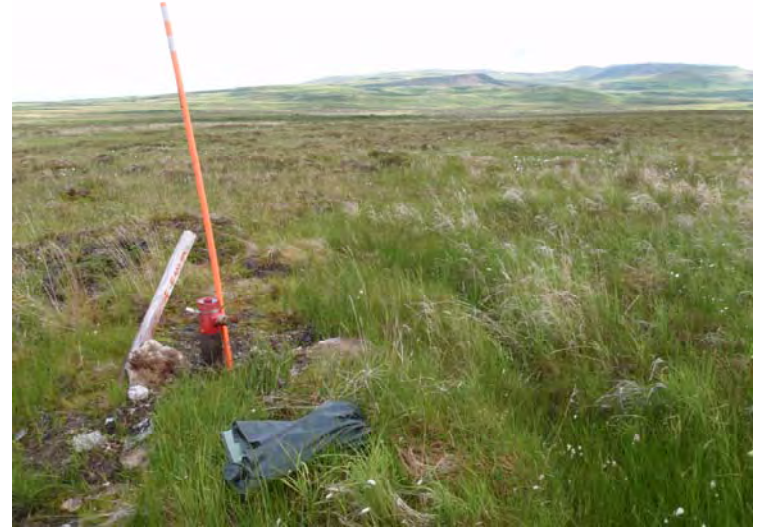
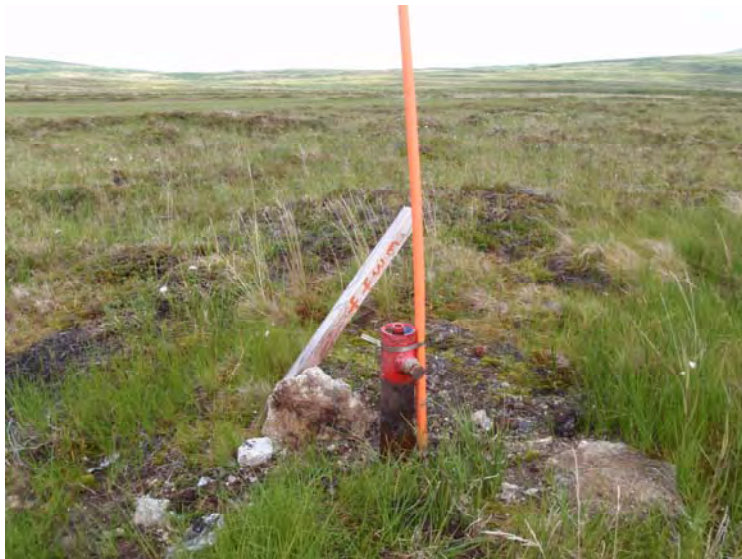
Water Source for Drillhole: 8405

- The source of water for drill hole 8405 is drill hole 6344 which is capped with a nut. The water source is groundwater, not surface water.
- The site of water withdrawals for drill holes 7387 and 7376 were at different locations on the same pond and were inspected as separate sites for the purpose of this field report. Drill holes 7359 and 7369 drew water from this same pond, but at a third location.

concrete/bentonite around well site, a little messier than others, some dead veg.

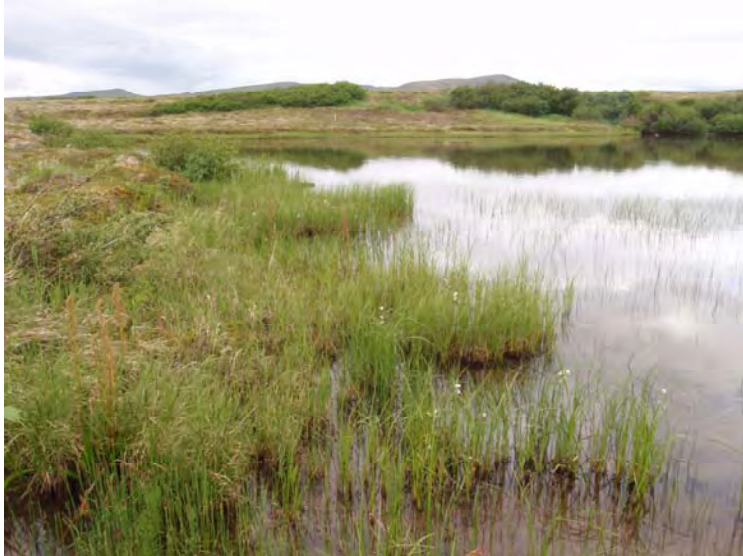
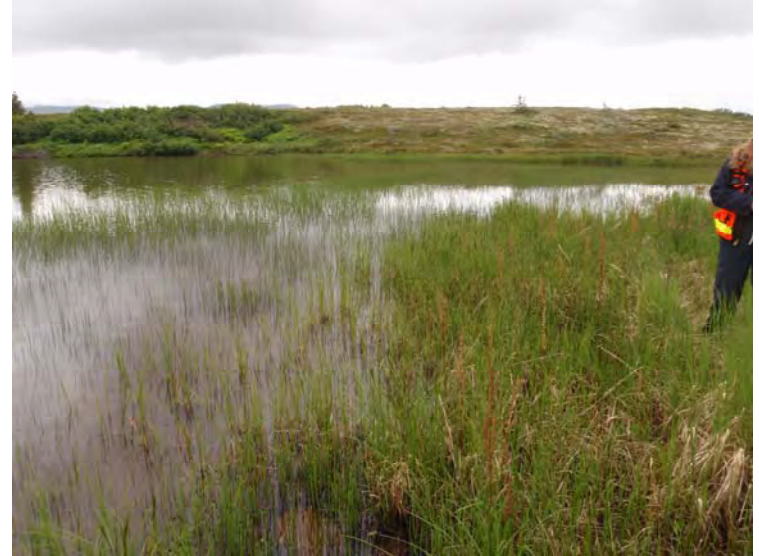
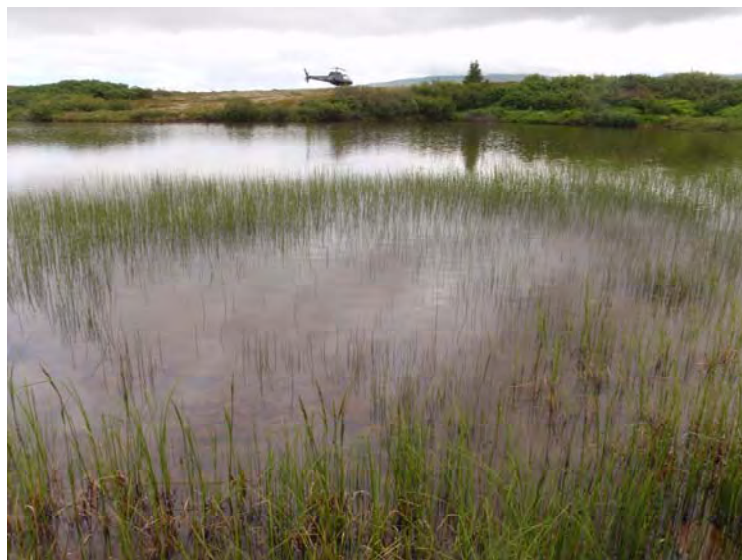
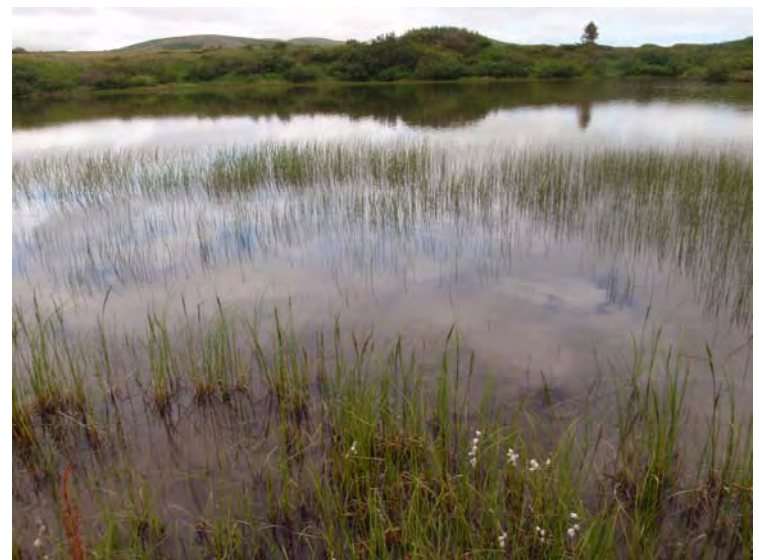
Water Source for Drillhole: 7376

same pond as 7384  
but otherside

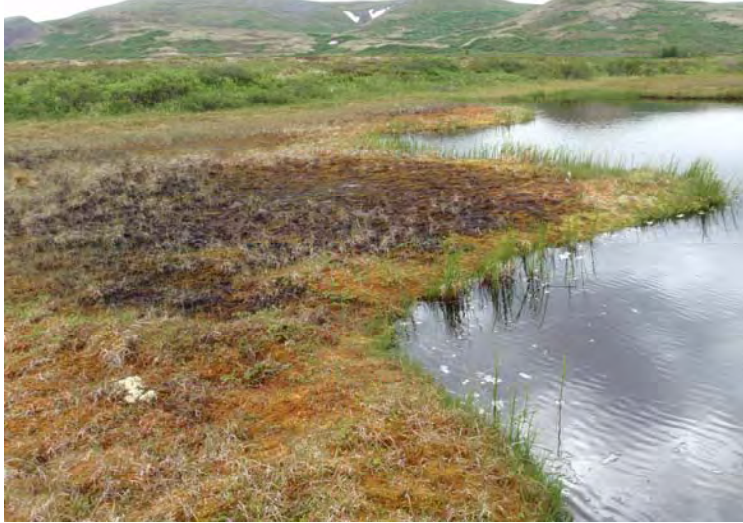
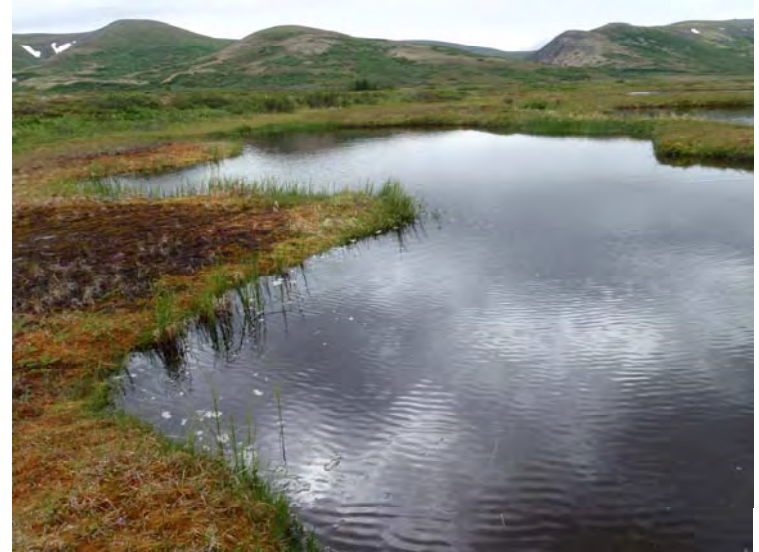
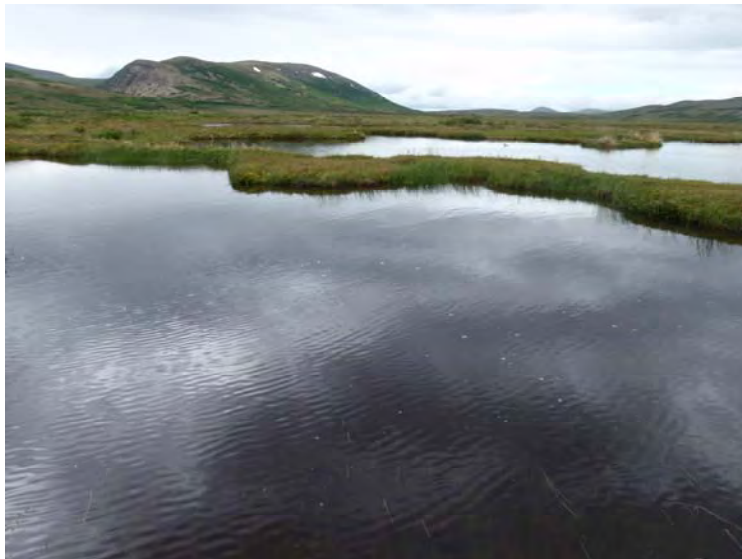
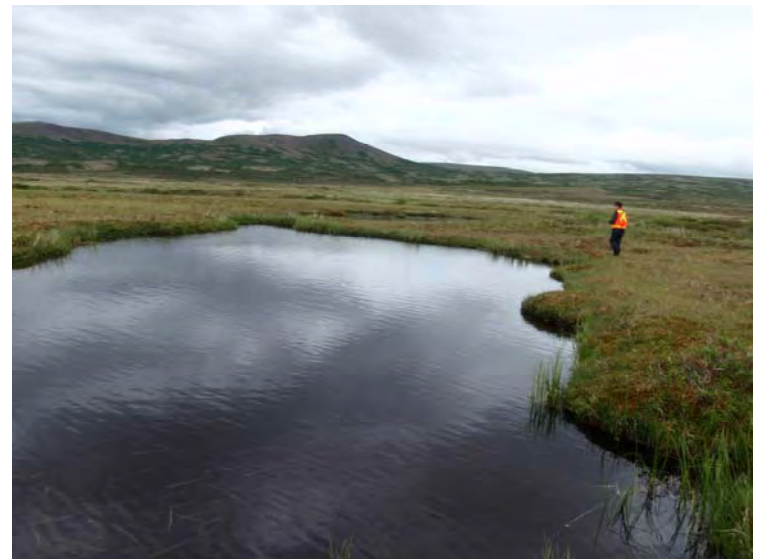
Water Source for Drillhole: 8430

Any disturbance at water source? dead veg near site, dry swampy area
