## Field Monitoring Report -- Pebble Copper/Gold Exploration Project --

Personnel:	Inspection Date: August 3, 2010
Bill Cole, DNR, Mining Section	Site Contact: Jim Male, Jeff Norberg
Melinda O'Donnell, DNR, DCOM	APMA #: A106118
<b>■ Inspection Type:</b> <ul style="list-style-type: none"> <li>○ Complete: Inspected two active drill rigs, the Big Wiggly Fuel facility, and five abandoned drill sites.</li> <li>○ Partial:</li> <li>○ Follow-up:</li> <li>○ Response to Public Complaint:</li> </ul>	<b>■ Wildlife Observed:</b> <ul style="list-style-type: none"> <li>○ Bear: Two brown bears observed along Upper Talarik Creek</li> <li>○ Caribou: Six caribou sighted near Frying Pan Lake</li> <li>○ Moose: None</li> <li>○ Waterfowl: None</li> <li>○ Fish: None</li> <li>○ Other: Various birds</li> </ul>
<b>■ Weather Conditions:</b> <ul style="list-style-type: none"> <li>○ Temperature: Approximately 50° F</li> <li>○ Wind: 20-25 mph</li> <li>○ Precipitation: None</li> <li>○ Visibility: 10 miles, except where obscured by clouds</li> <li>○ Sky Conditions: Overcast, cloud ceiling around 3,000'</li> <li>○ Ground Conditions: Dry</li> </ul>	<b>■ Water level at Frying Pan Lake: Full</b> <ul style="list-style

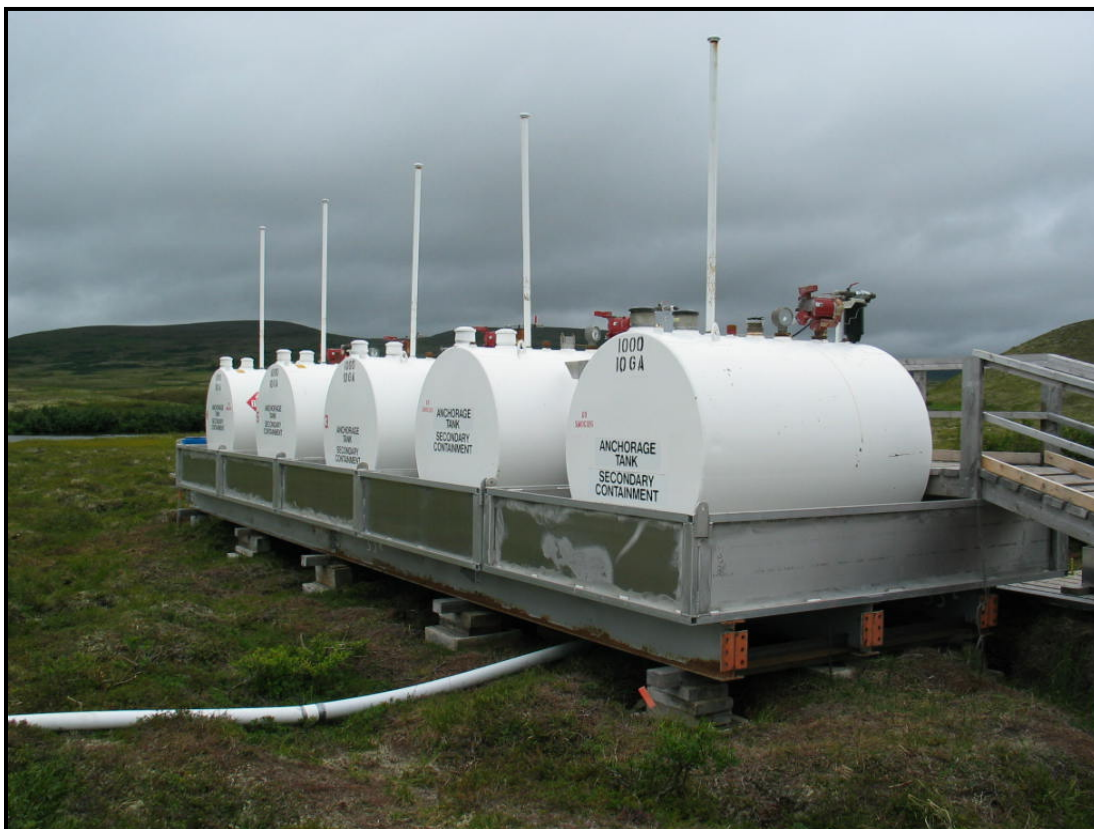
Figure #1. Fuel Storage and Secondary Containment at Big Wiggly Lake

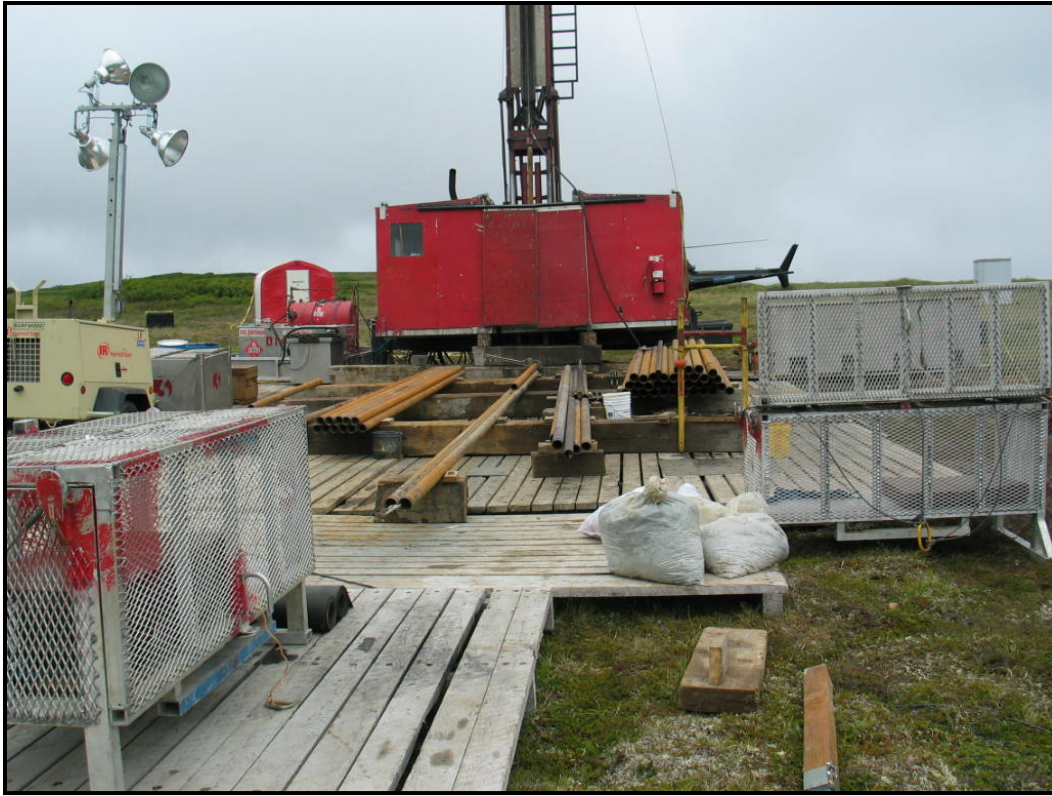
Figure #2. Drill #3 on DDH 10497. Note tundra pads.

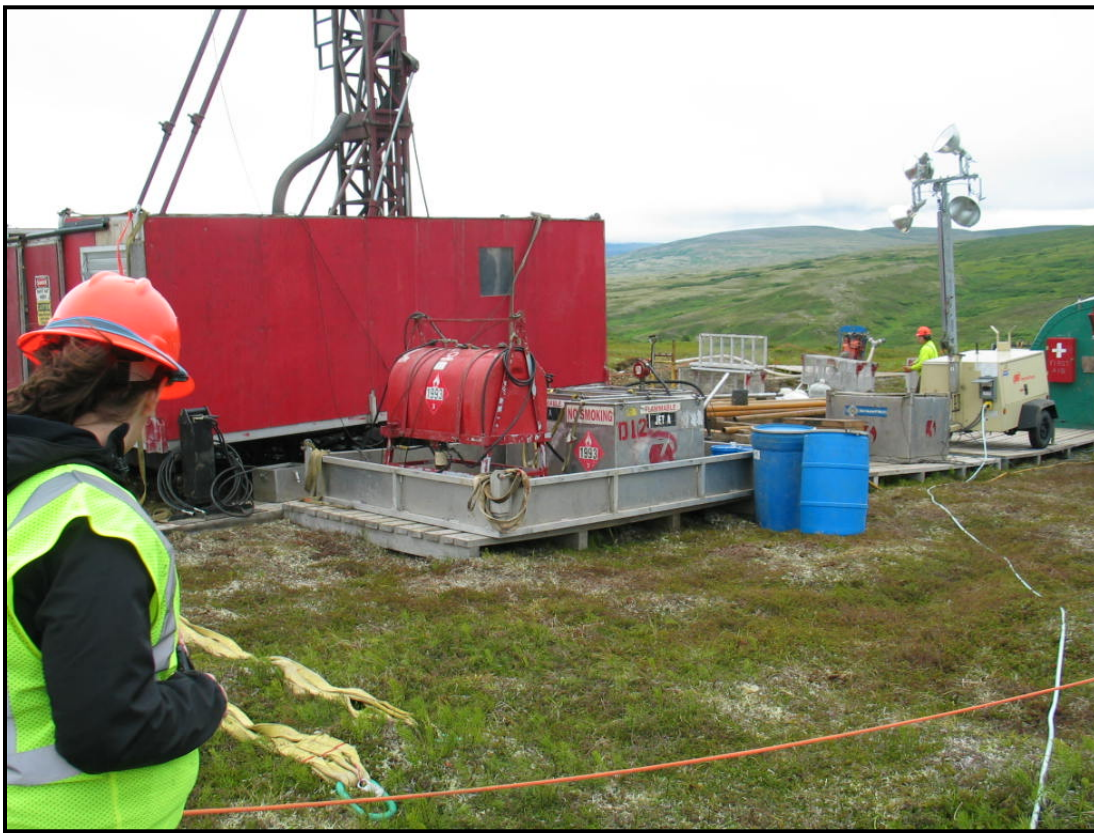
Figure #3. Drill #3. Fuel containment, spill kit, and scrubber barrel.

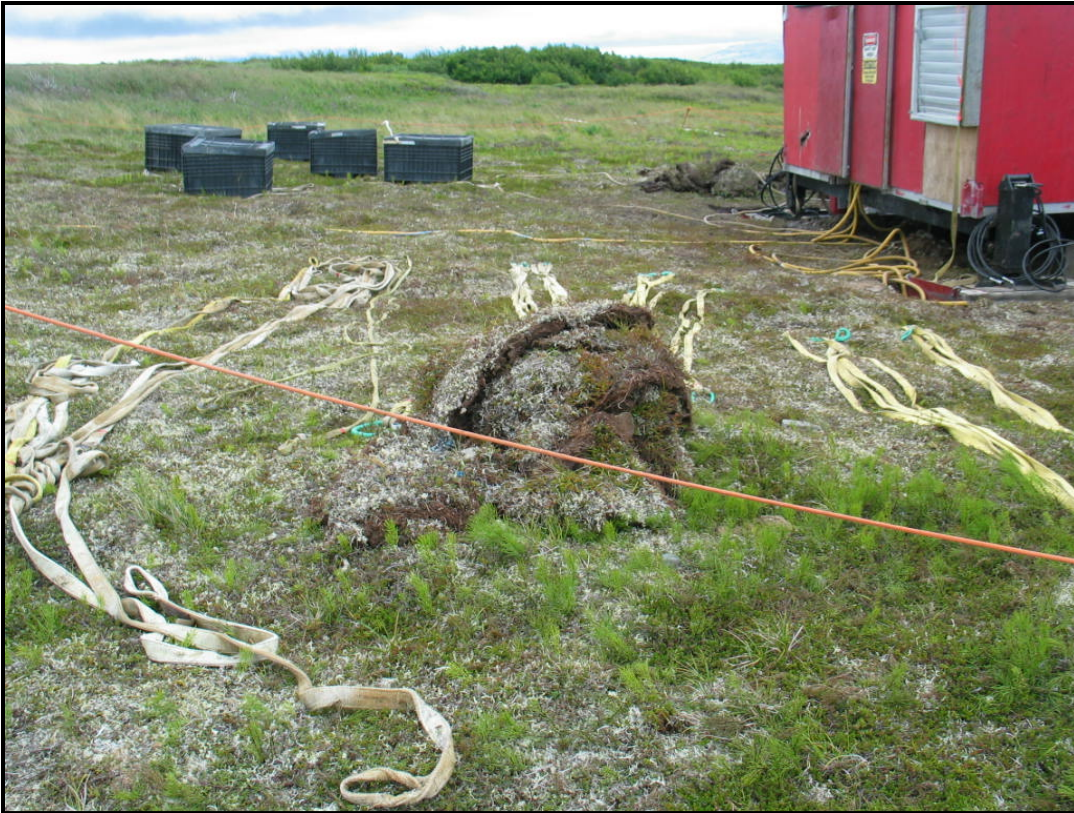
Figure #4. Tundra stockpiled at DDH 10497.

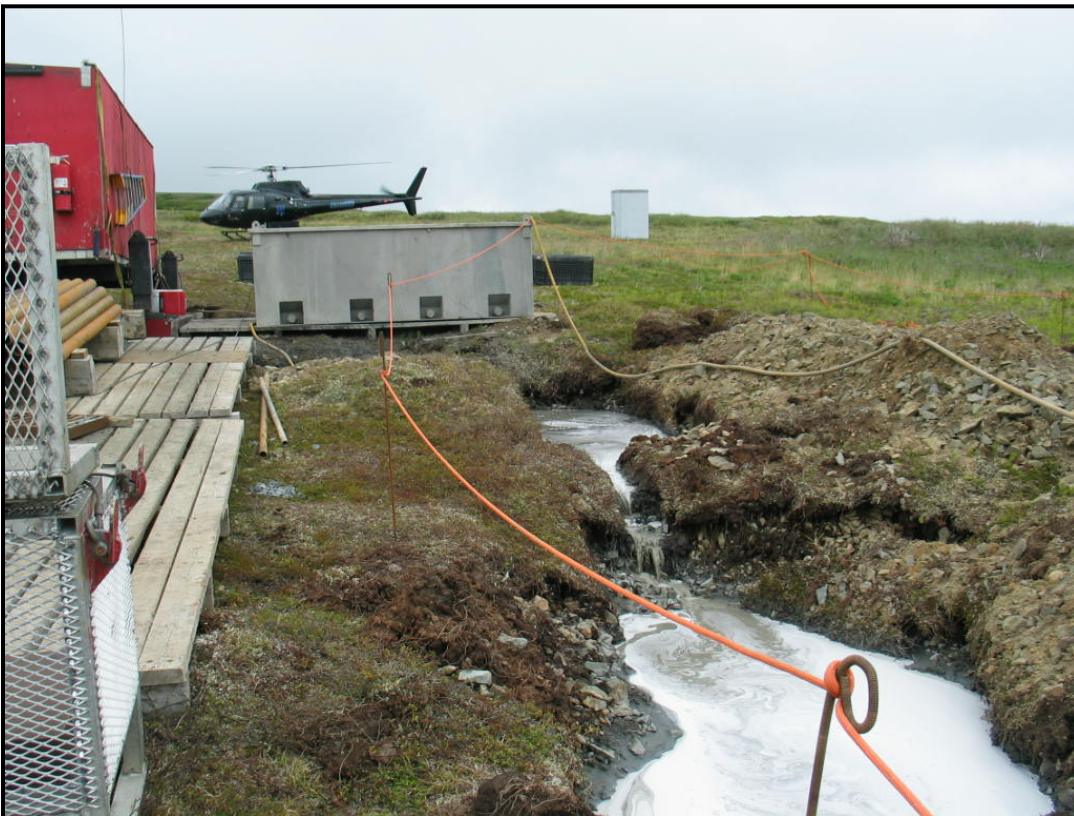
Both drills observed were recirculating drilling fluid. The drilling fluid first flowed through three settling sump pits. A pump in the third pit moved the fluid back to a recirculating tank next to the drill. In the tank, fluid moved through three baffled sections to further settle out cuttings, then was fed back to the drill. Excess fluids were being pumped from the third sump to be discharged onto the tundra.

Figure #5. Sump pits and mud recycling tank at DDH 10497  
Pebble Field Monitoring Report  
Cole and O'Donnell

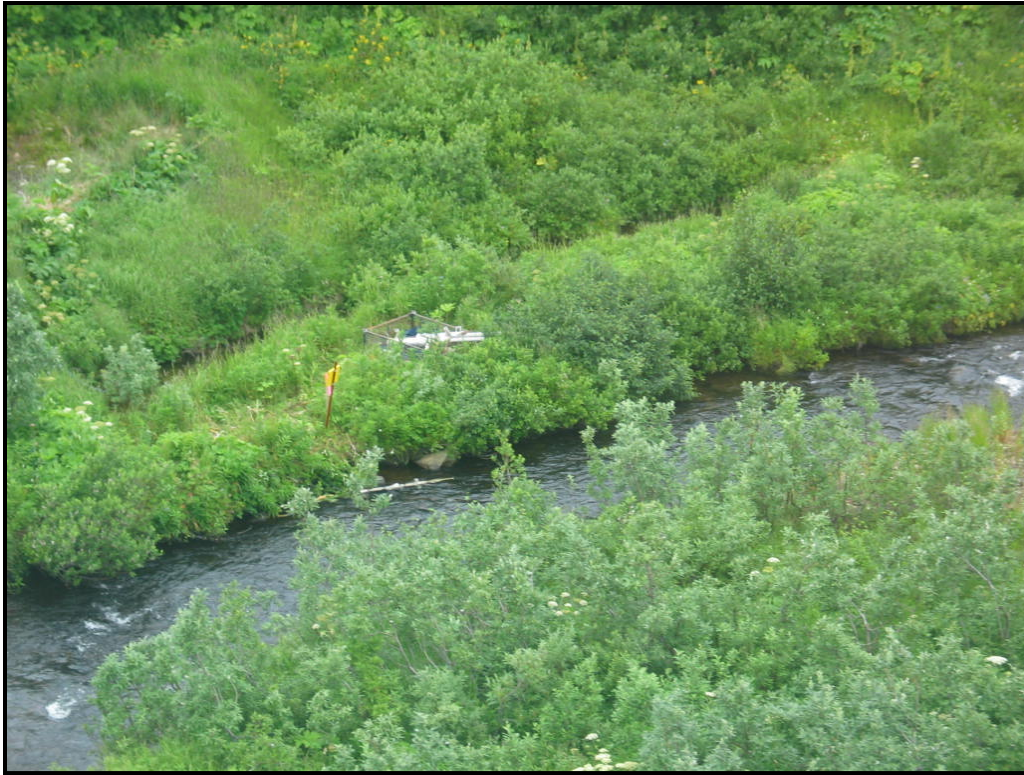
Figure #6. Water withdrawal point for DDH 10497. An electric pump in the water pumps water uphill to the main pump, 100' away.

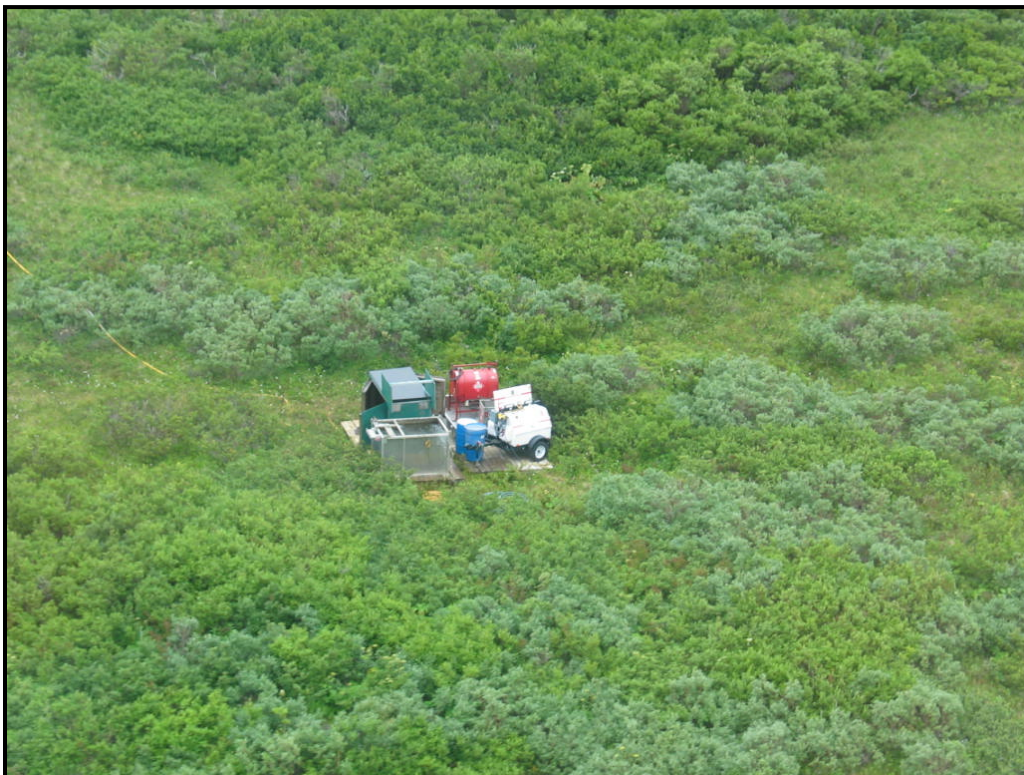
Figure #7. Water pump for DDH 10947. Note fuel containment, spill kit, and scrubber barrel.

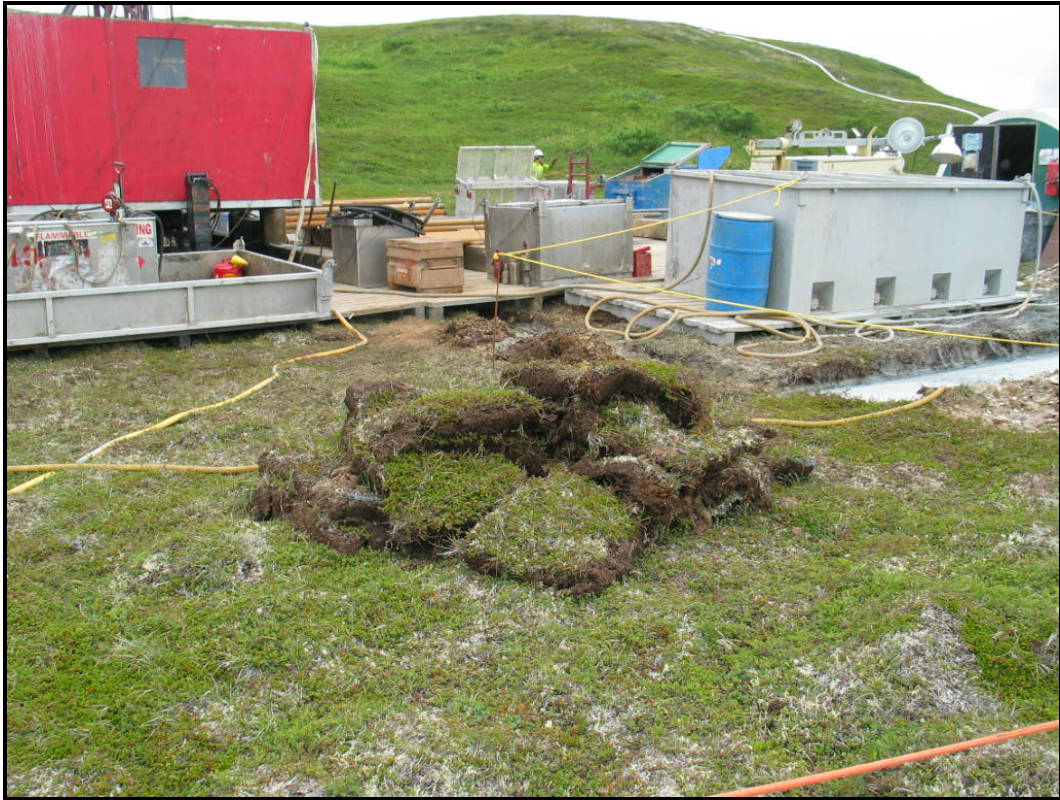
Figure #8. Tundra stockpiled at DDH 10498. Tundra is being piled to prevent dehydration.

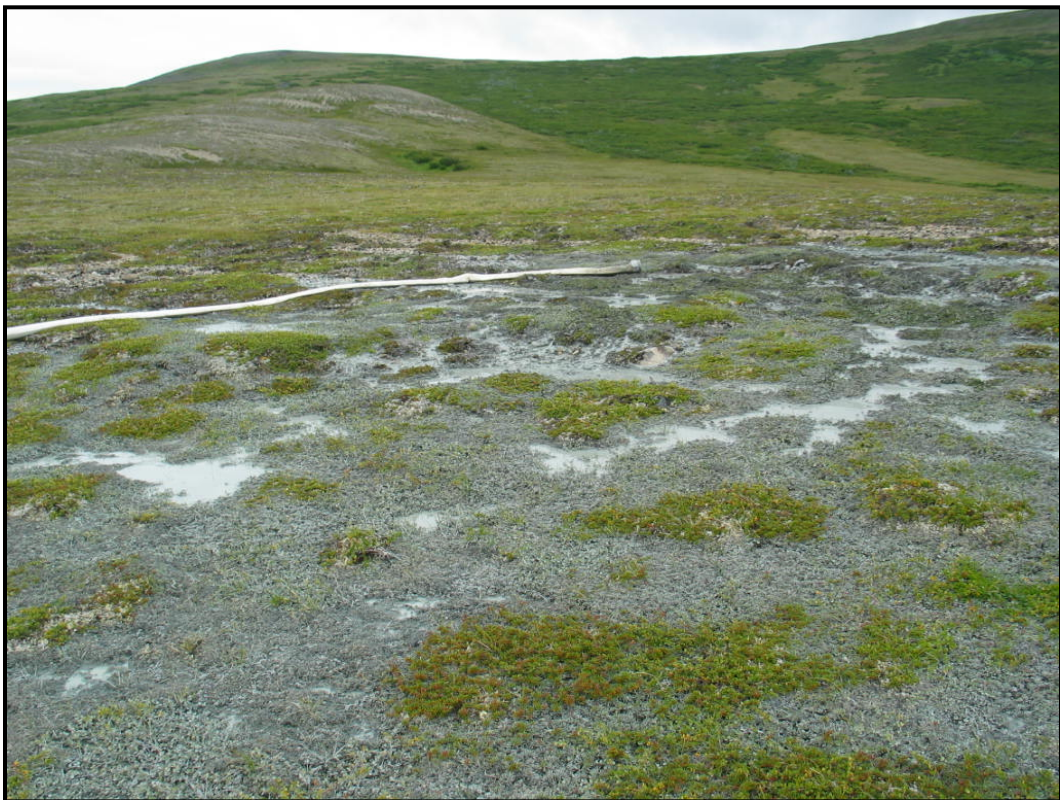
Figure #9. Discharge area from DDH 10498.

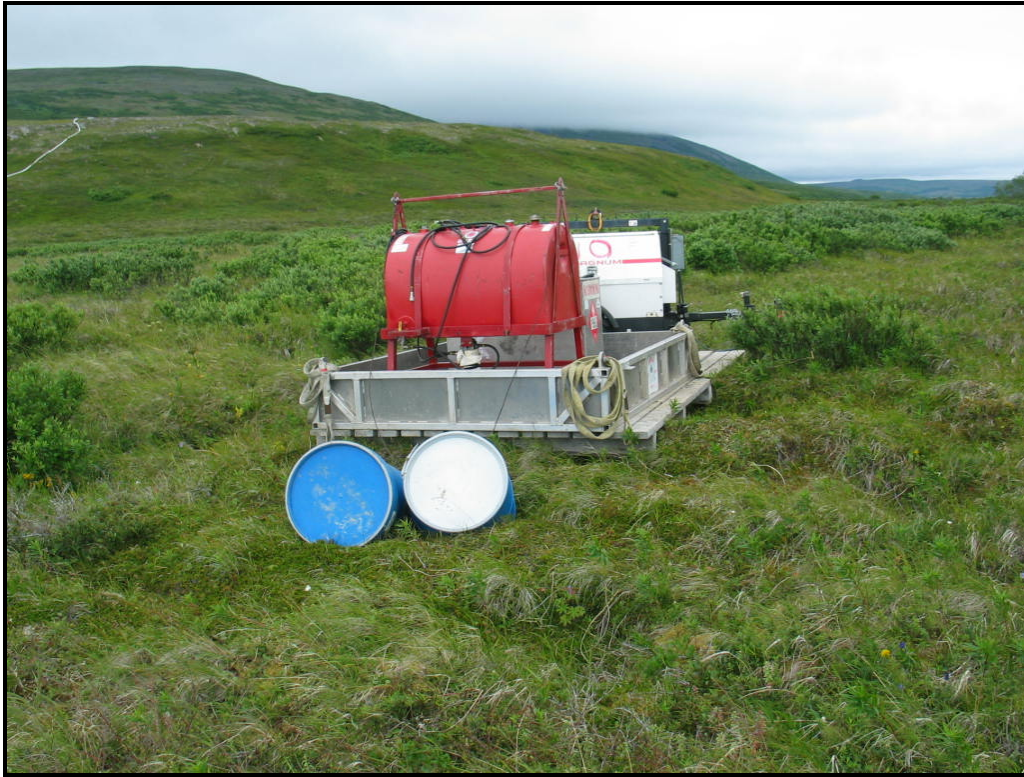
Figure #10. Water pump for DDH 10498. Note fuel containment, scrubber barrel, and spill kit.

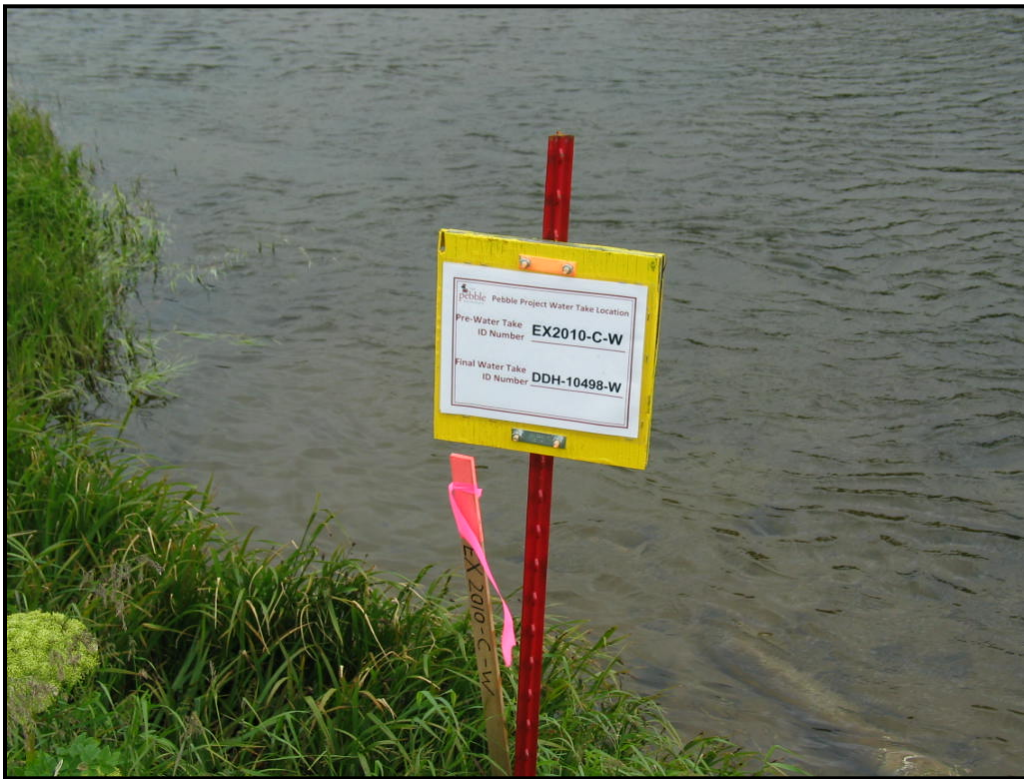
Figure #11. Water intake signage for DDH 10498.

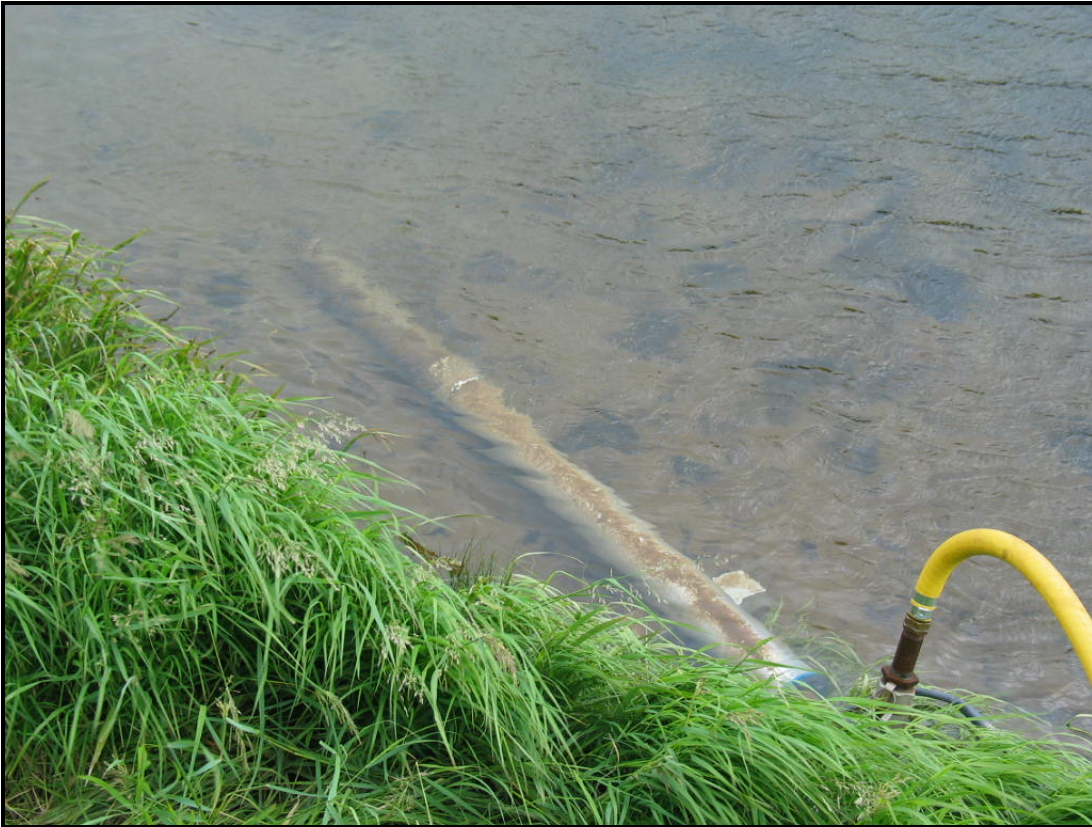
Figure #12. Water intake for DDH 10498

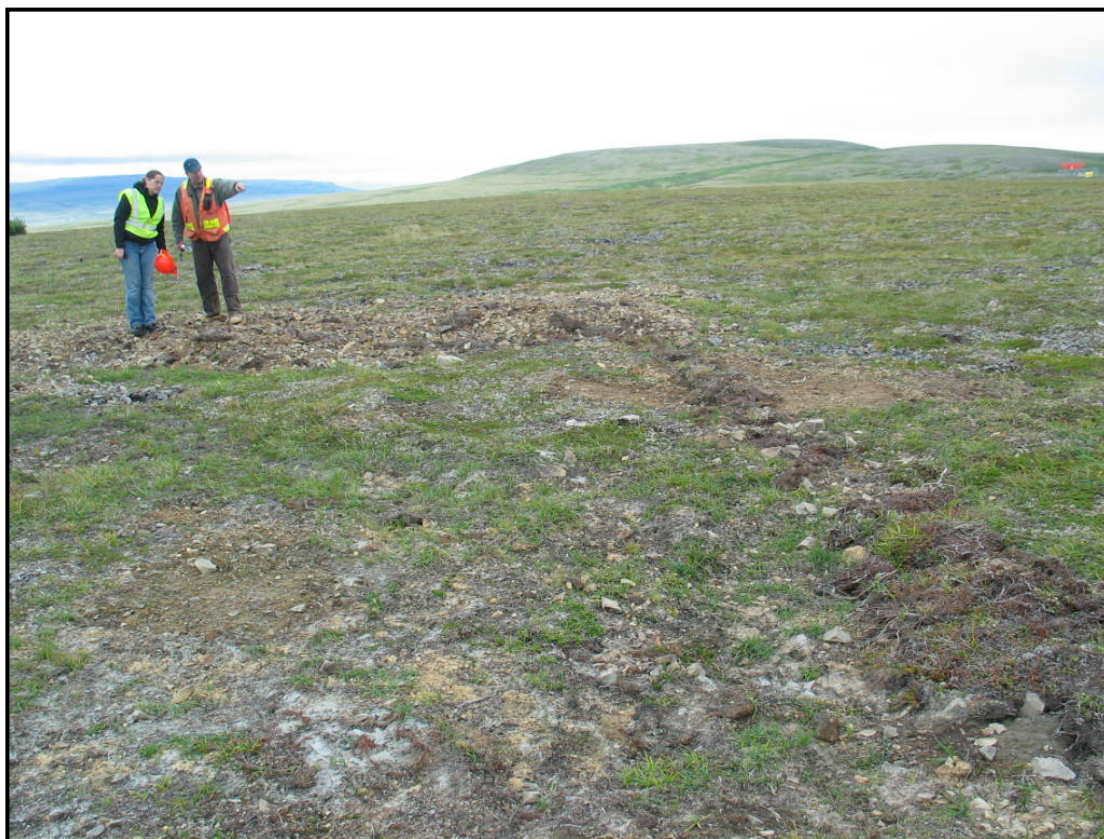
■ Site revegetated: Partially

■ Comments/General impression: Area around hole is rocky, with little soil or vegetation. Tundra has been replaced to extent possible, and some is surviving. In other areas there is some revegetation occurring, but much of the site has not revegetated.

Figure #13. DDH 9464 reclamation.

**Recommendations:** DNR and Pebble Partnership personnel will research better methods of reclaiming drill sites on rocky ground. Early consultations with industry consultants indicate that 5-10 years is a reasonable time to expect revegetation of disturbed tundra. Over time, the tundra will revegetate on its own; however, it may be possible to enhance revegetation by seeding or fertilization.

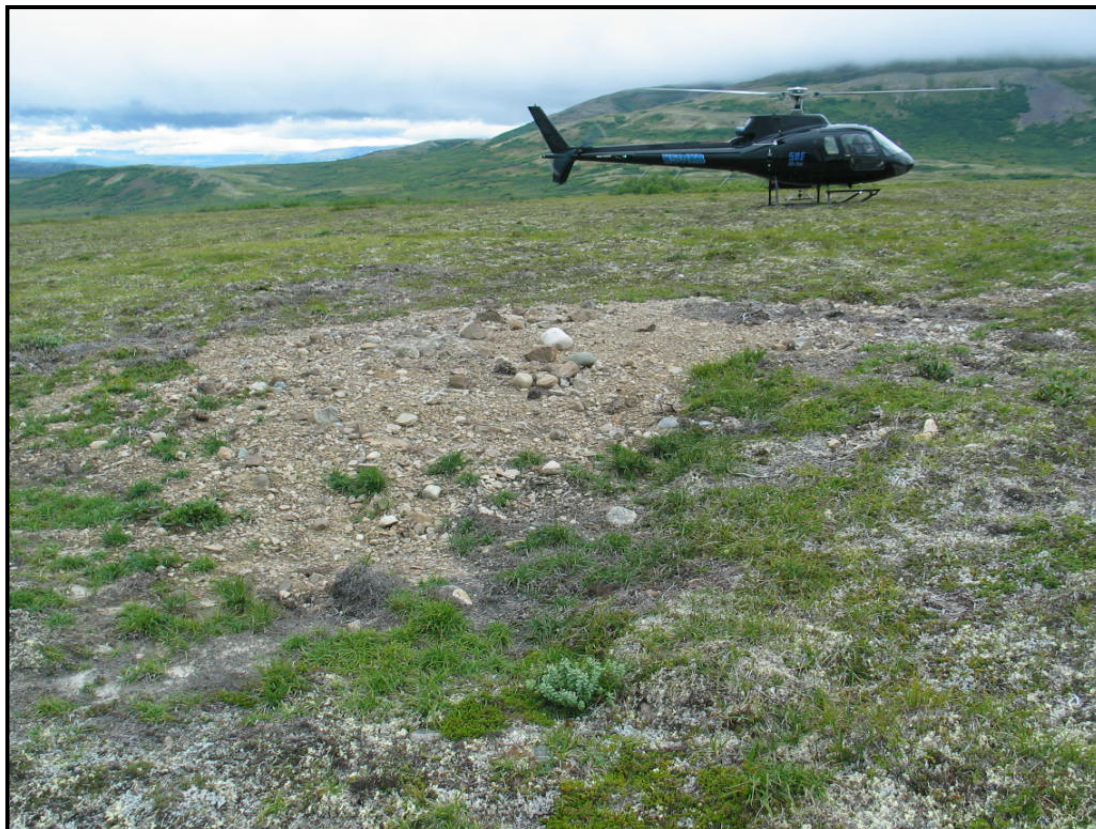
■ Site revegetated: Revegetation very limited

■ Comments/General impression: Area around hole is rocky, with little soil or vegetation. Tundra has been replaced to extent possible, but has not survived. Very limited grass is growing around the edges of the reclaimed areas. The fill material around the standpipe has been eroded out from an area about 4"-6" wide around the pipe, and 3' deep.

Figure #14. Reclaimed sump pit at DDH 8441. Note sparse grasses growing around edge of fill area.

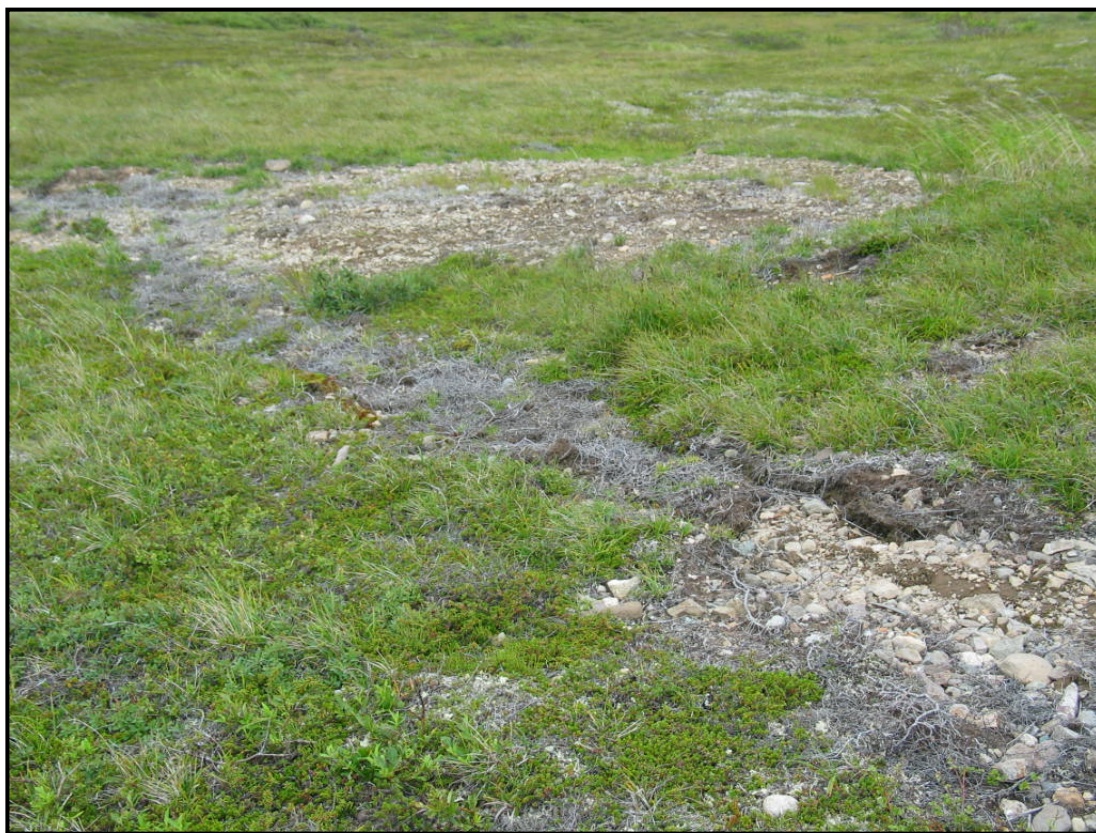
■ Site revegetated: Partially

■ Comments/General impression: Tundra has been replaced, but growth of the vegetation is quite limited.

Figure #15. Reclamation at DDH 7378.

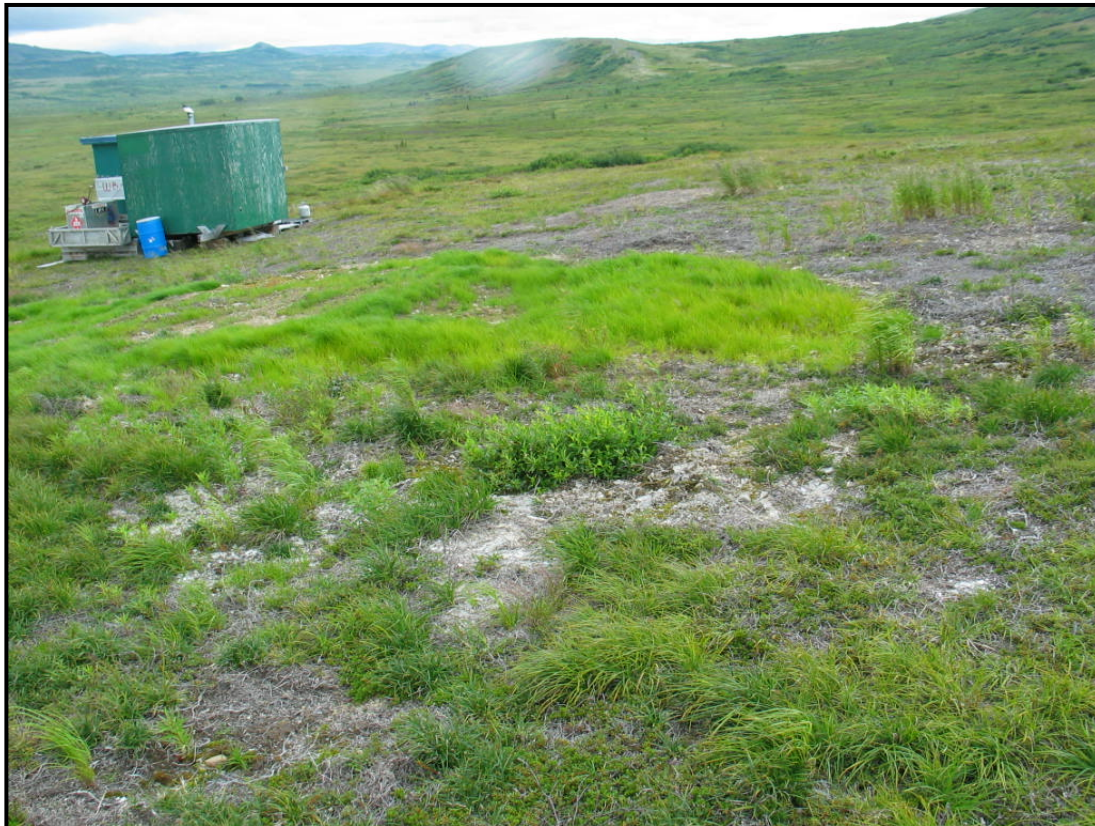
■ Comments/General impression: Area around drill hole is rocky, with thin soil and limited vegetation. Reclaimed area was seeded with Kentucky Bluegrass to prevent erosion. The grass has taken well. Some other species are coming back as well, including fireweed, willow, and a natural grass observed to be growing nearby. Observed some areas of dead vegetation, but overall, vegetation is doing well.

Figure #16. Reclamation at DDH 8417. Seeded with Kentucky blue grass.

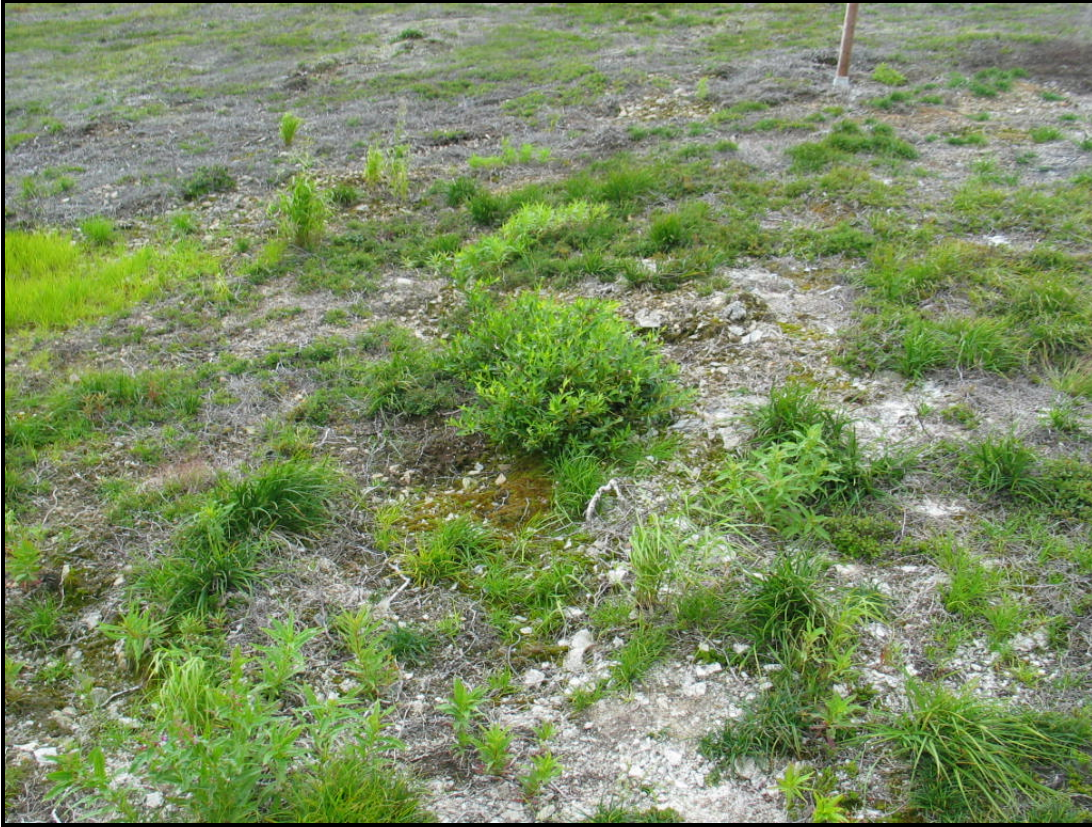
Figure #17. Willow, fireweed, and grass growing on disturbed area of DDH 8417.
