Field Report -Pebble Copper/Gold Exploration Project-

Site Visit Date: 13 September 2007

APMA No.: A076118

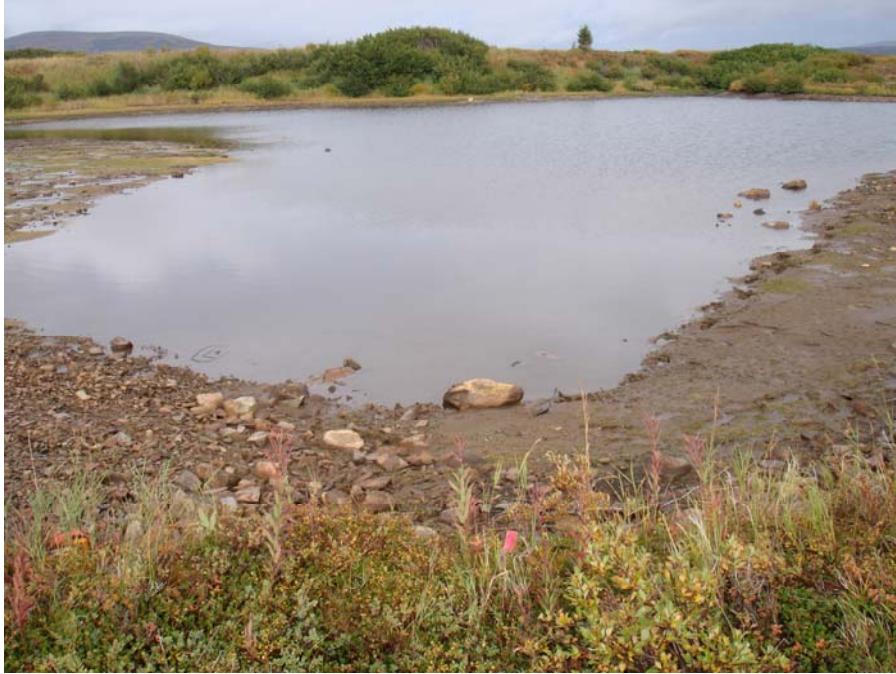
- In response to previous comments regarding apparently decreasing water levels at area ponds, two stakes were installed perpendicular to the waters edge at an unnamed pond where water is being utilized for drilling. The first stake (wooden lathe, 6" stickup with pink on top) is located at N59 53 34.7 W155 15 37.8 (NAD27AK). The stake is approximately 1' into the tundra vegetation away from the cobbled/muddy substrate of the pond. The current edge of water is 16' from this stake. A second stake was set 10' away from this stake, and is 26' from the edge of water. These stakes will be located after breakup 2008 to assess the water level of the pond at that time.

The inlet to this pond is across the diameter from the stake location and appears to be comprised of drainage from the immediate vicinity, the flow is estimated at 10gpm. The water level of the pond itself was typical of some ponds in the vicinity and the region; some ponds appear to be at "normal" water levels, others appear to be below "normal" levels.

Figure 1. Unnamed lake near Drill Rig 6, pink stake is in foreground marking distance to edge of water.

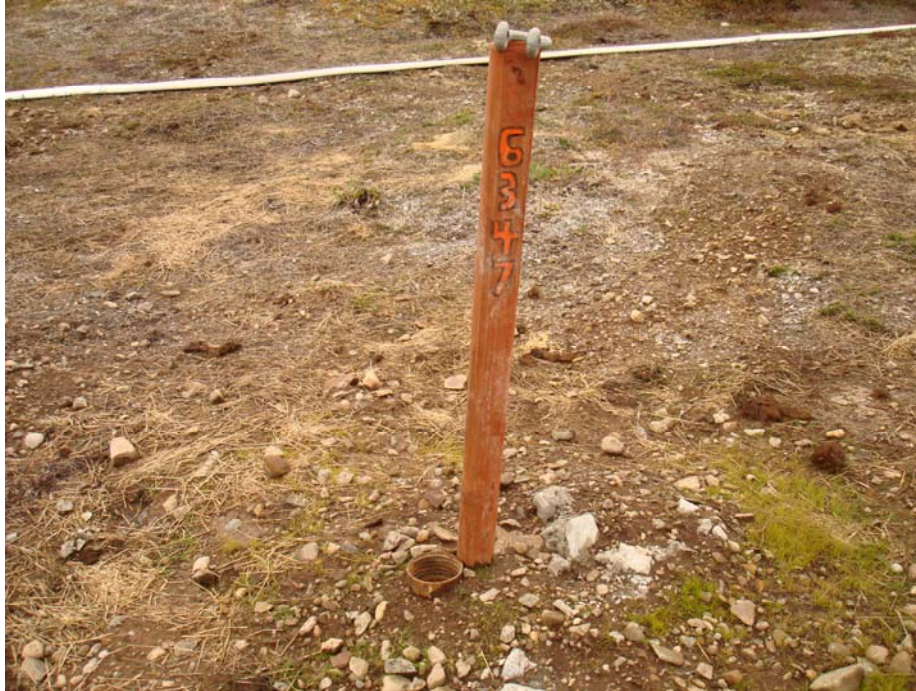
- Plugged: **No.**
- Cemented: **No.**
- Standing pipe: **Yes, and wooden stake marked location site.**
- Sump filled in: **NA.**
- Water discharge trench filled in: **Yes.**
- Site re-vegetated: **No.**
- Artesian water present: **No.**
- Any spills or staining, or 'none': **None observed.**
- Comments: **Drill hole is not plugged or cemented yet and site has apparently not been reclaimed although there is straw/hay onsite indicative of seeding activities. Looking down the borehole a glare is apparent 10'-20' downhole. No trenches, pits or sumps seen. It appears as if this site utilized the centralized cuttings pond adjacent to site for discharge via a surface expression.**

Figure 5. Ground surface near borehole 6347.

- Drillholes not in use anymore should be plugged appropriately and drill sites reclaimed. One hole was located that was drilled in 2006 and not plugged or reclaimed (drill hole 6347).

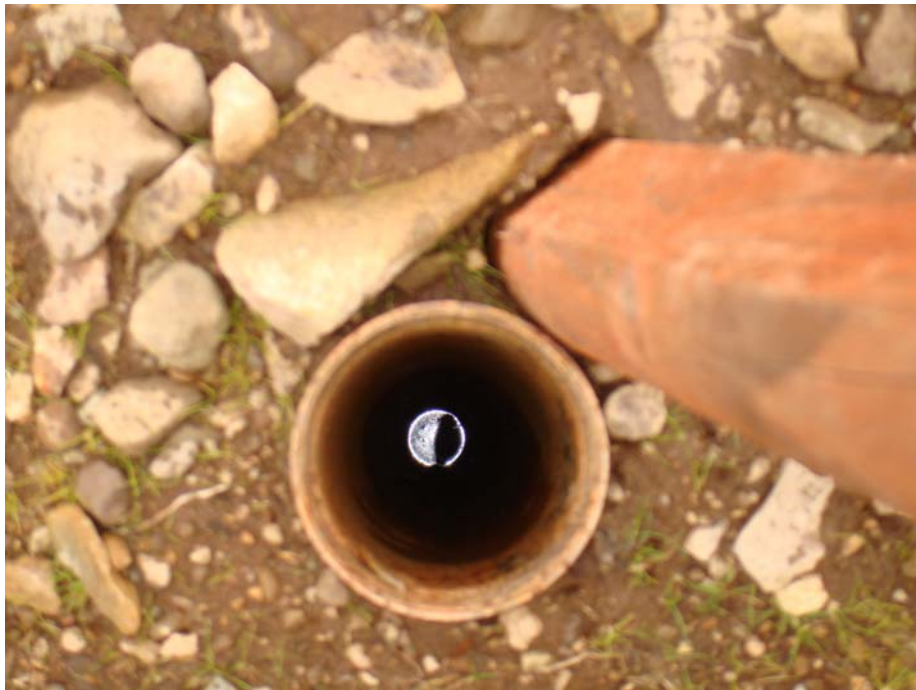
Figure 6. View down borehole 6347.
