## Field Monitoring Report -- Pebble Copper/Gold Exploration Project --

Personnel: Kate Malloy (ADF&G)	Inspection Date: 9/21/2010
Stephanie Lovell (ADNR)	Site Contact: Jim Male
Phyllis Scannell (consultant to ADF&G)	APMA #: A106118
<input checked="" type="checkbox"/> Inspection Type:	<input checked="" type="checkbox"/> Wildlife Observed:
<input type="checkbox"/> Complete: Yes	<input type="checkbox"/> Bear: 1 sow, 2 cubs
<input type="checkbox"/> Partial:	<input type="checkbox"/> Caribou:
<input type="checkbox"/> Follow-up:	<input type="checkbox"/> Moose:
<input type="checkbox"/> Response to Public Complaint:	<input type="checkbox"/> Waterfowl:
	<input type="checkbox"/> Fish:
<input checked="" type="checkbox"/> Weather Conditions:	<input type="checkbox"/> Other: ground squirrel, flock of ptarmigan, bear scat near 2 of drill rigs.
<input type="checkbox"/> Temperature: Approx. 45 degrees F	
<input type="checkbox"/> Wind: Ranged from 15-50 knots throughout the day	<input checked="" type="checkbox"/> Water level at Frying Pan Lake: N/A

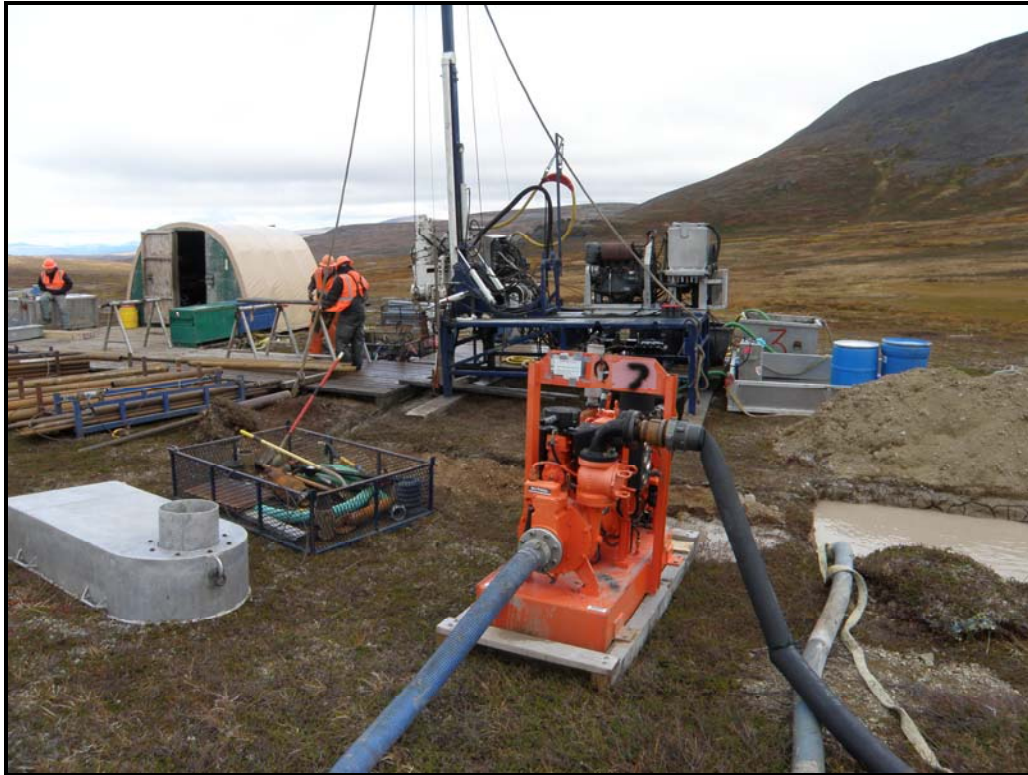
Photo 1. Foundex geotechnical drill rig (GH10-A1). Drill rig is in center of photo, to the right are the blue spill containment barrels. Also visible are sump pump and sump pit (lower right).

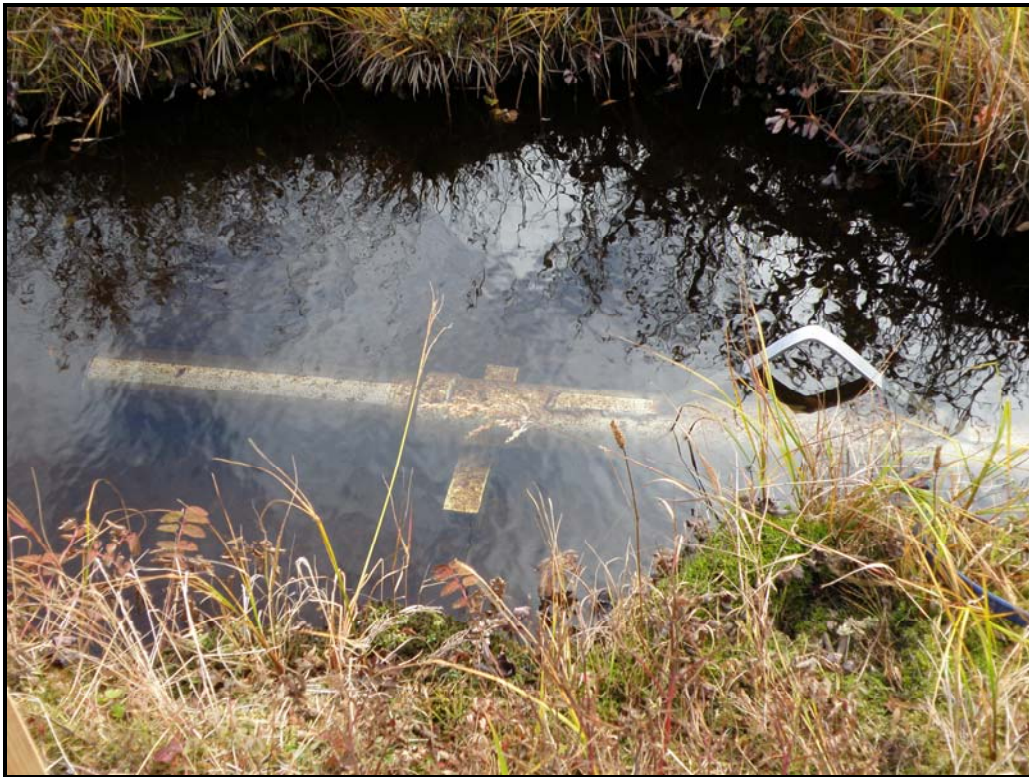
Photo 2. Close up of screened water intake structure in place in creek.

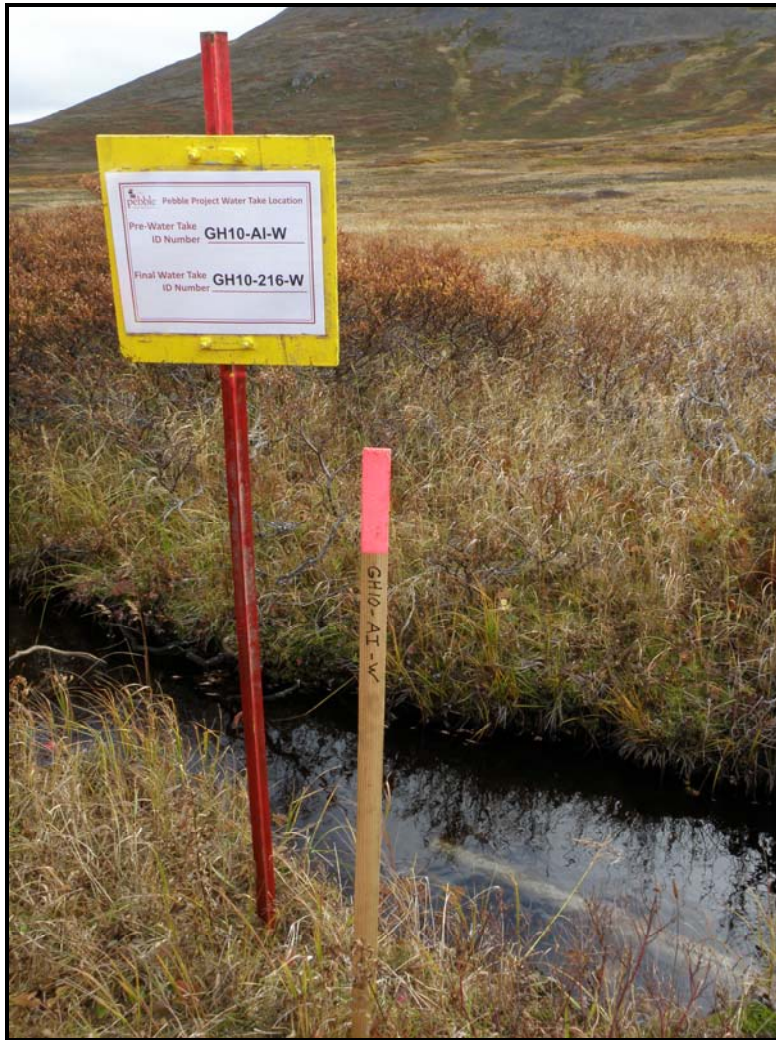
Photo 3. Sign and stake identifying the water source associated with drill hole GH10-AI.

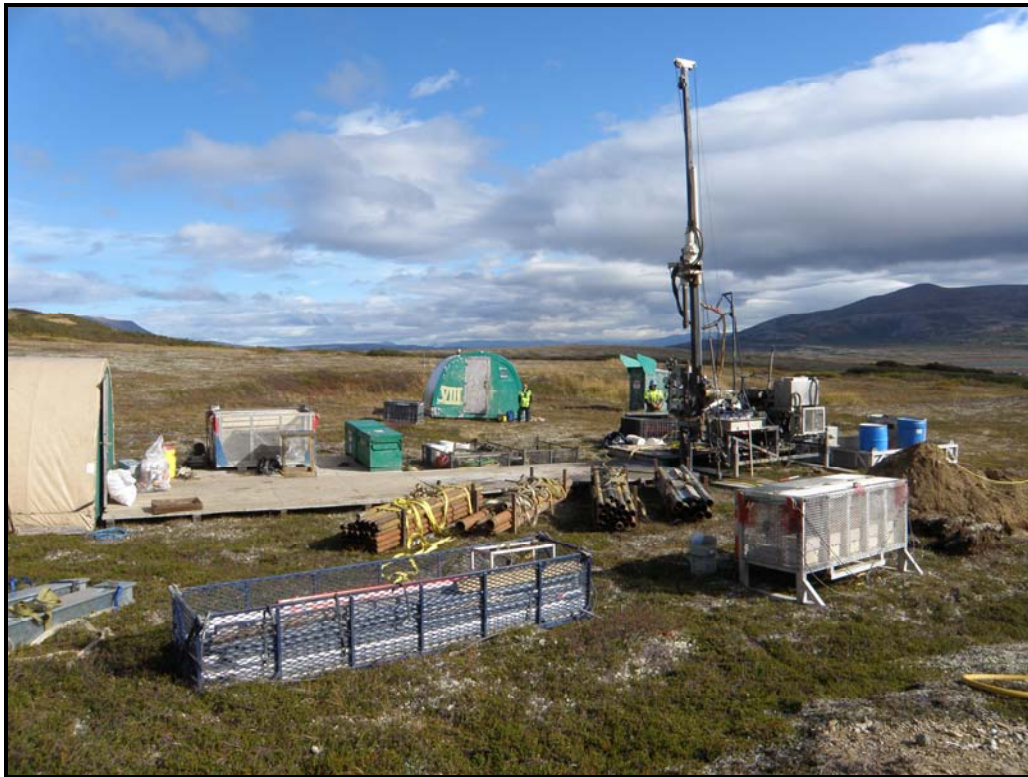
Photo 4. Overview of drill site GH10-I, which was the second Foundex geotechnical drill rig in use at the time of inspection.

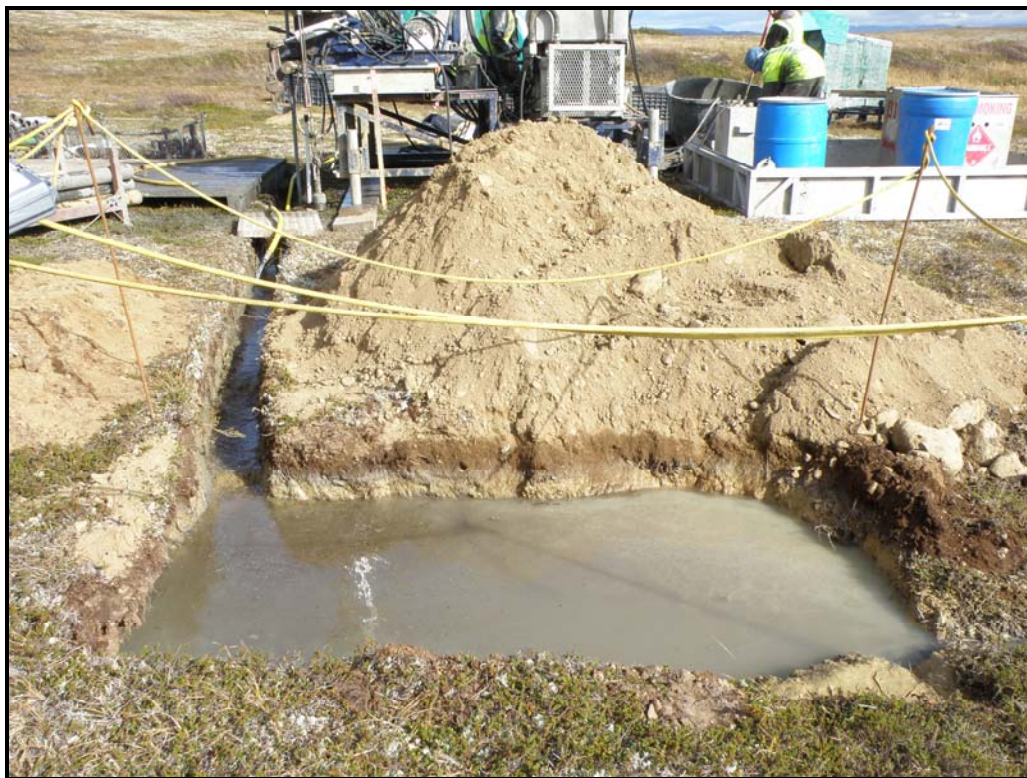
Photo 5. Sump pit for drill hole GH10-I. Because this is a smaller, geotechnical drill hole, only one sump pit was needed.

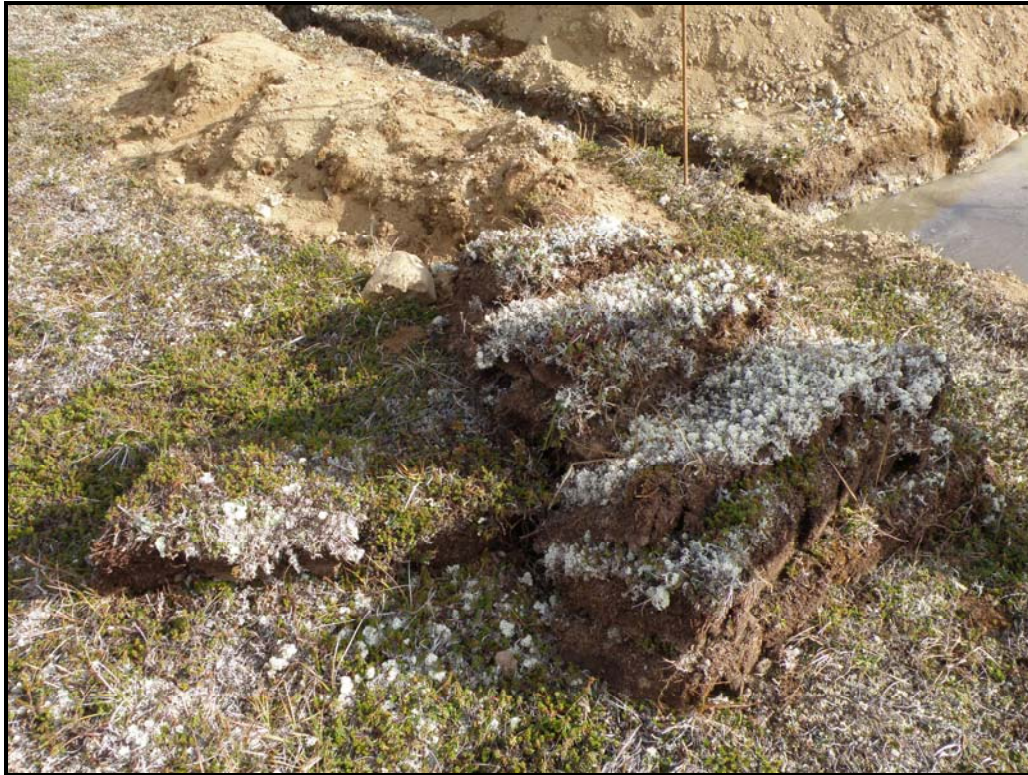
Photo 6. Stockpile of tundra mat for reuse during reclamation of sump pit.

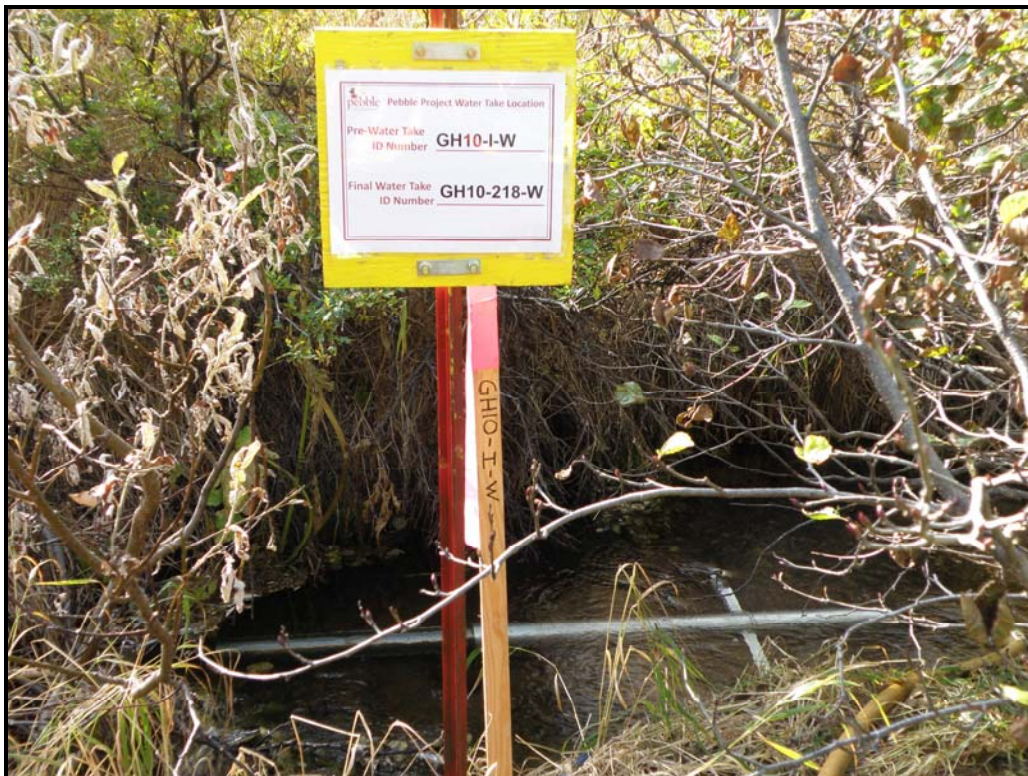
Photo 7. Sign showing pre-water take id number (GH10-I-W) and final water take id number (GH10-218-W). Screened water intake structure is visible in creek behind sign.

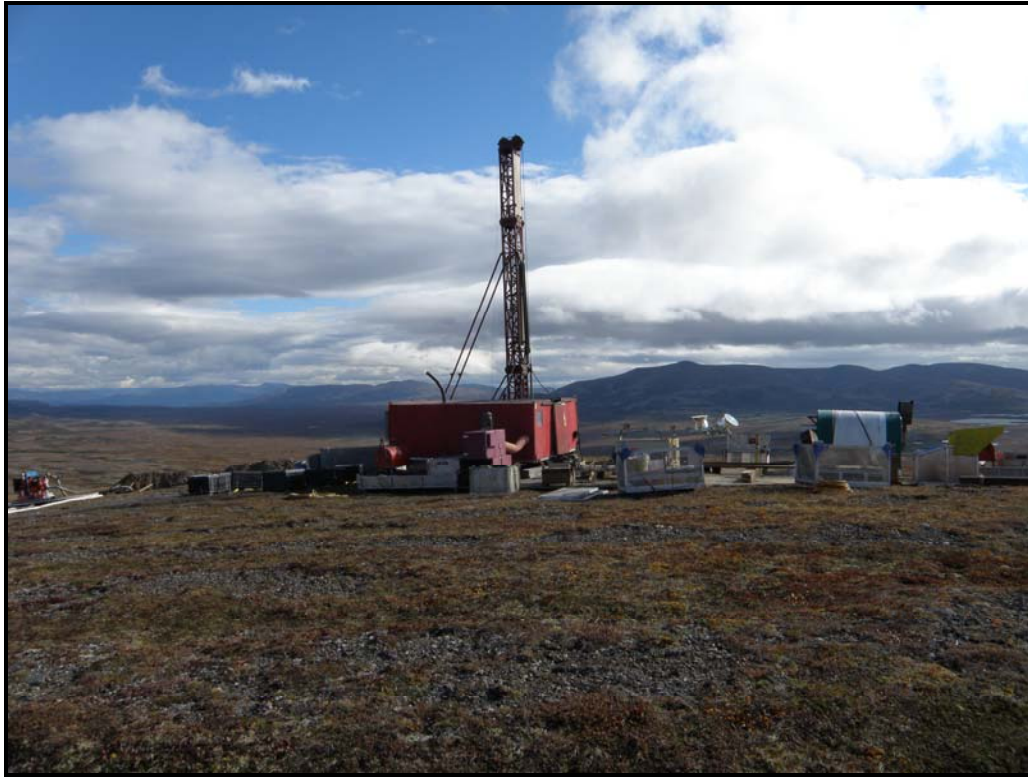
Photo 8. Overview of drill site for drill hole EX2010-AN.

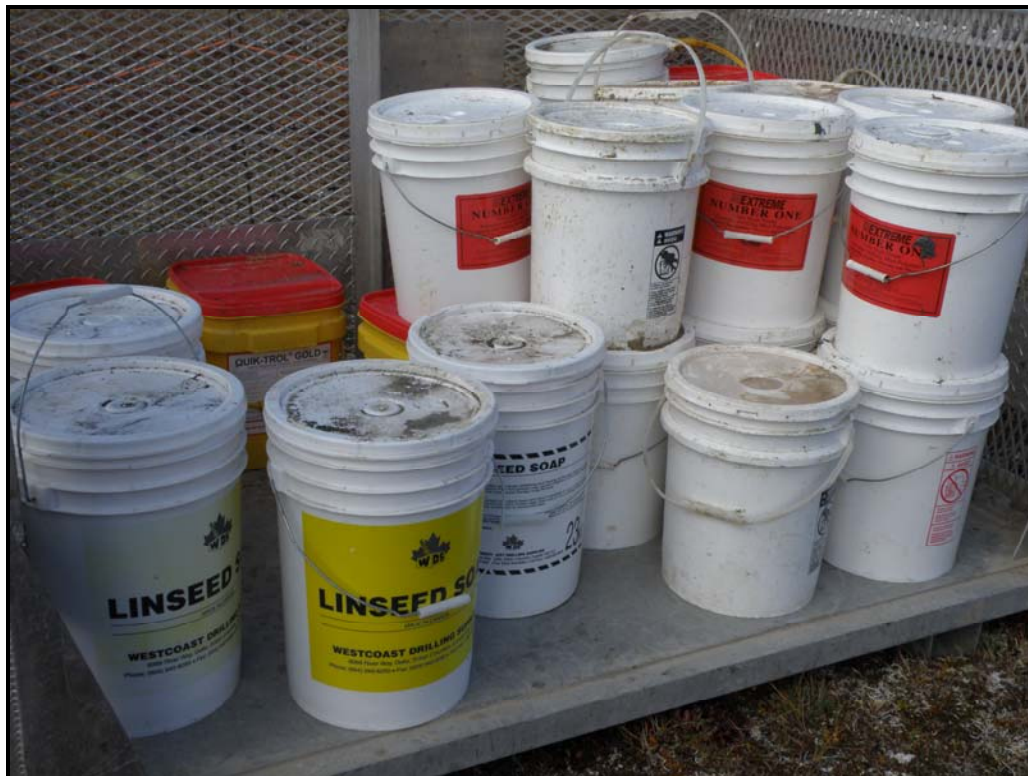
Photo 9. Additives in use at this drill site include, linseed soap, Extreme #1 Mud Polymer, and Quickrol Gold.

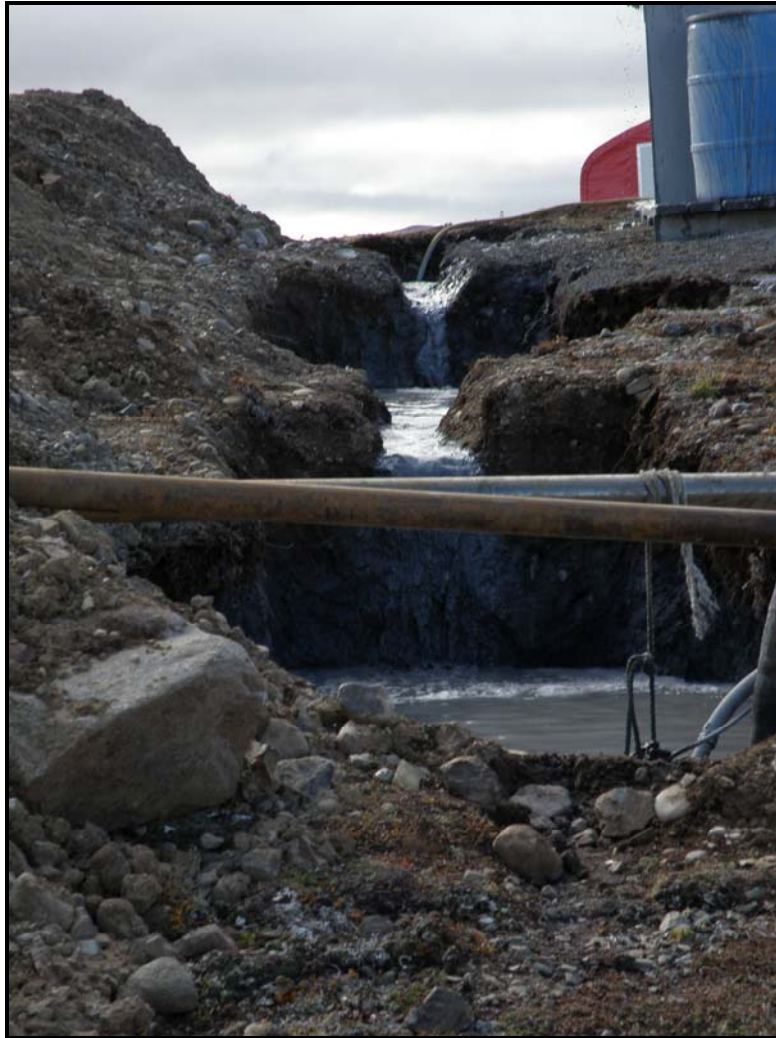
Photo 10. A series of three sump pits were in use for drill hole EX2010-AN.

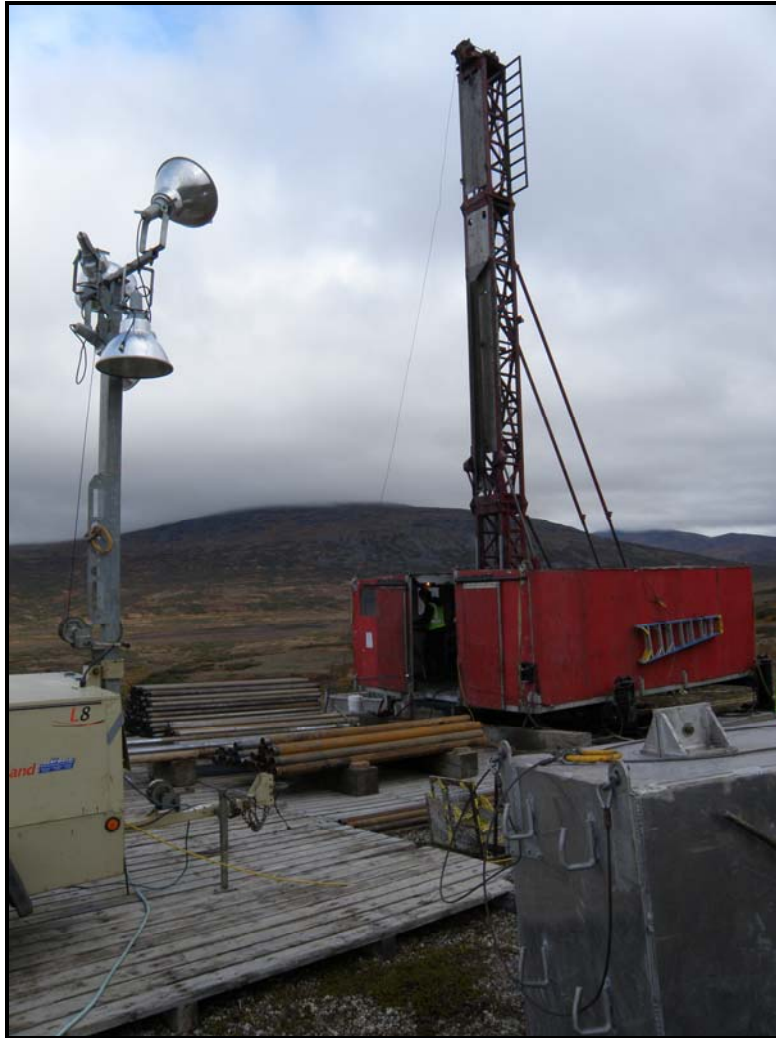
Photo 11. Drill rig at drill hole EX2010-DE. The site was just set up the morning of inspection and the rig was at 40 ft.

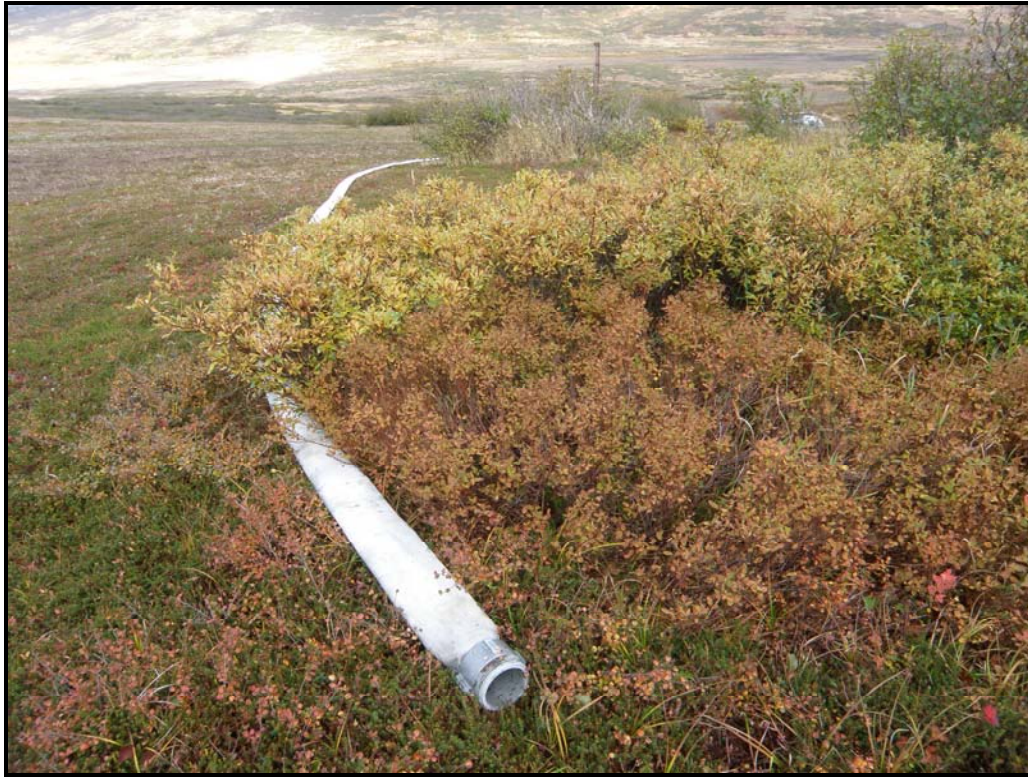
Photo 12. The end of the sump overflow hose was approximately 162 feet from the drill rig and was not in use at the time of the inspection.

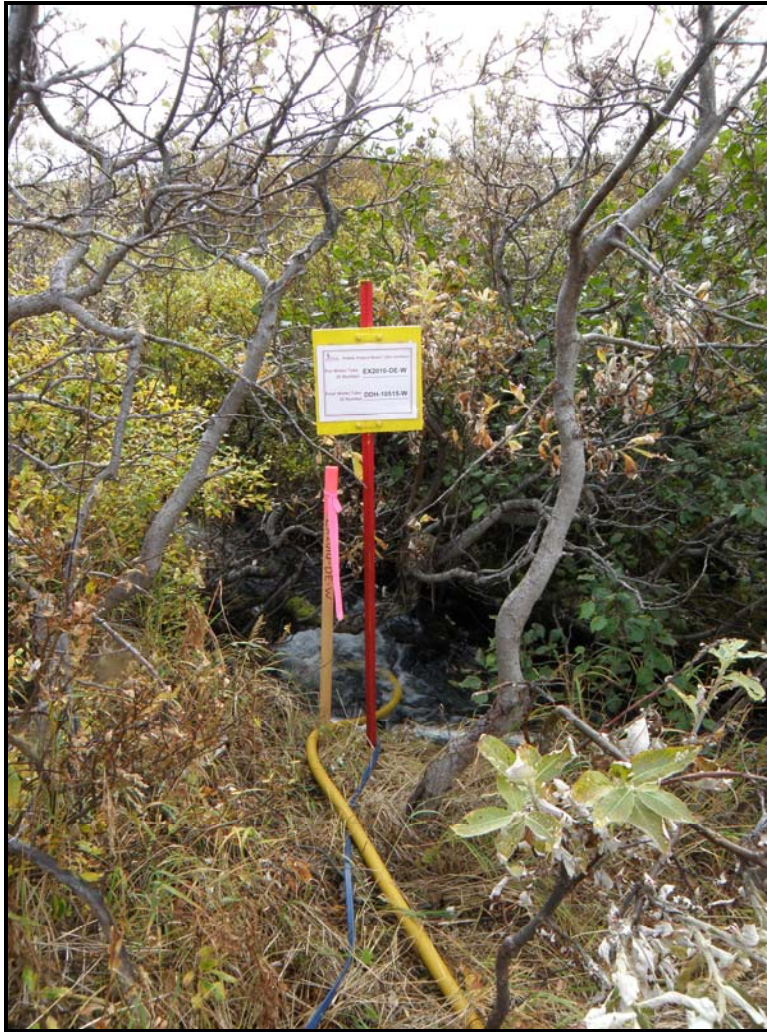
Photo 13. Sign showing pre-water take id number (EX2010-DE-W) and final water take id number (DDH-10515W). The screened water intake structure is partially visible in creek behind sign.
