Field Monitoring Report

-- Pebble Copper/Gold Exploration Project --

Inspection Date: September 23 & 24, 2008

APMA #: A086118

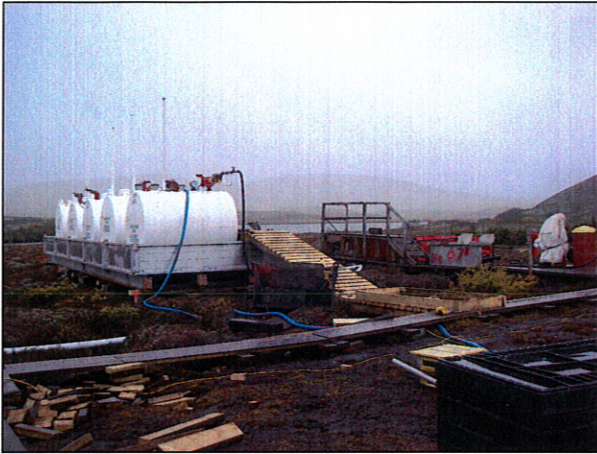
Figure 1. Fuel storage facility, former site on right side of picture.

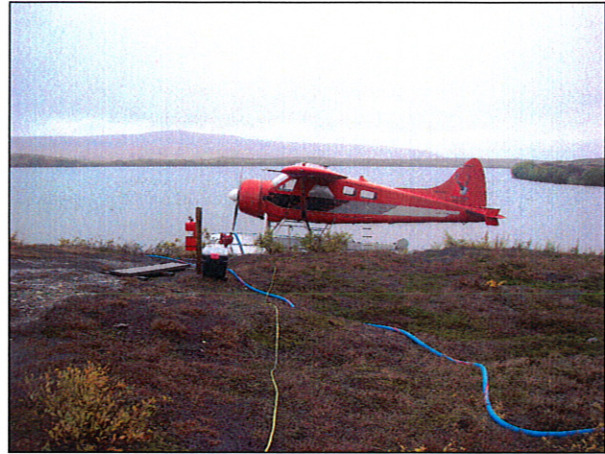
Figure 2. Fuel transport brought in via Beaver on floats, 200 gallons/trip.

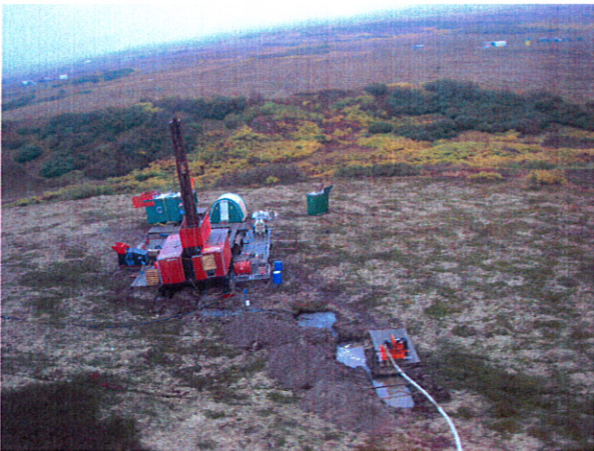
Figure 3. Drill rig 2 with series of three sump pits.

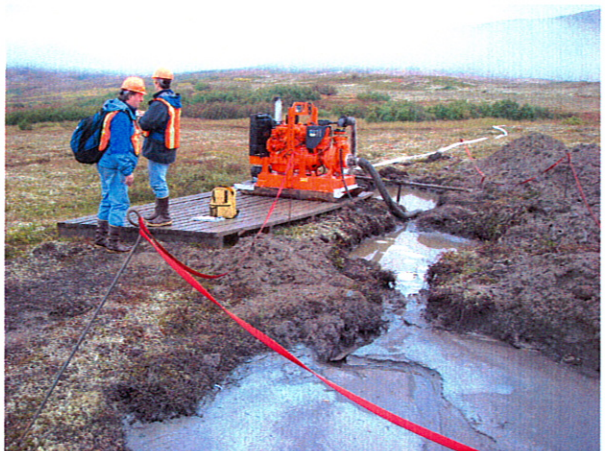
Figure 4. Series of three sump pits with Godwin pump and discharge to uplands.

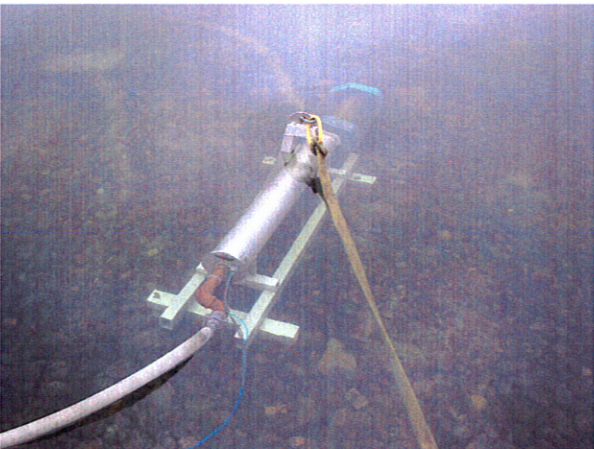
Figure 5. Water intake pump and screen.

Actions Needed: Inspect and repair water intake screens prior to use in fish bearing waters. Observed two screened intake boxes, one with holes larger than the mesh size, stored near rig 6.

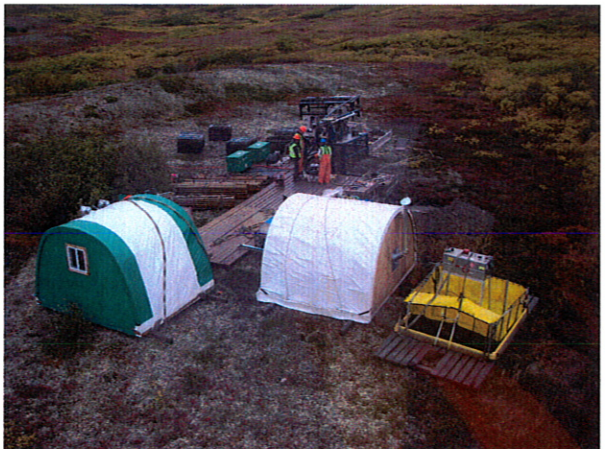
- Drill additives in use: n/a
- Water recirculation: no
- Water discharged: no
- Artesian zone encountered: yes, encountered at 47 and 87 feet, sealing with chips and cement.

Figure 6. Drill rig 9, geotechnical drill hole.

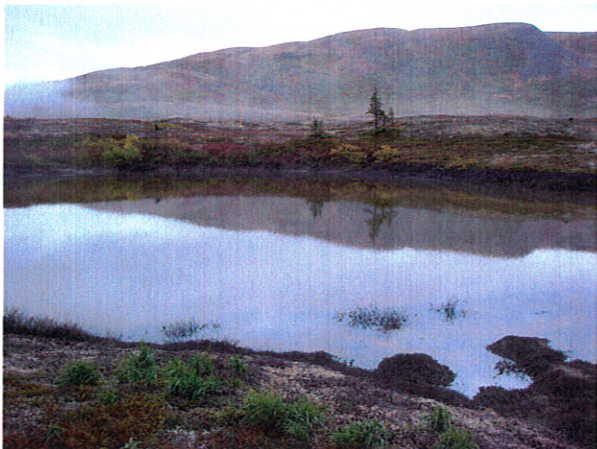
Figure 7. Riparian vegetation of a kettle pond impacted by previously elevated water levels. Located southeast of Rig 5.

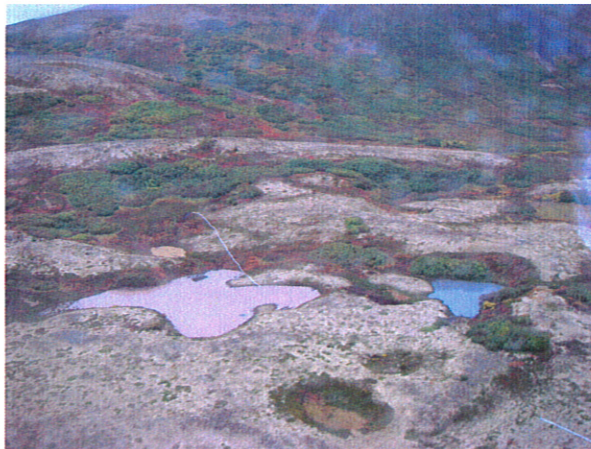
Figure 8. Discharge water pooling in swales. Located southeast of Rig 5, near foothill.

Recommendations: Continue to provide staff with updated operations map and inform staff of any new developments or changes in operational plans prior to site visits. Consider skirting fuel containers to shed precipitation away from tertiary containment structures. Consider moving upland discharge points frequently or dispersing discharge over a larger area to avoid impacting ground cover vegetation and potentially altering water quality in kettle ponds adjacent to discharge locations. Replace pressure relieving (leaking) water lines with newer high pressure hoses to avoid potential soil surface erosion.
