# Pebble Project – Field Inspection Report

Inspection Date: October 17, 2007

Exploration Project #: A076113

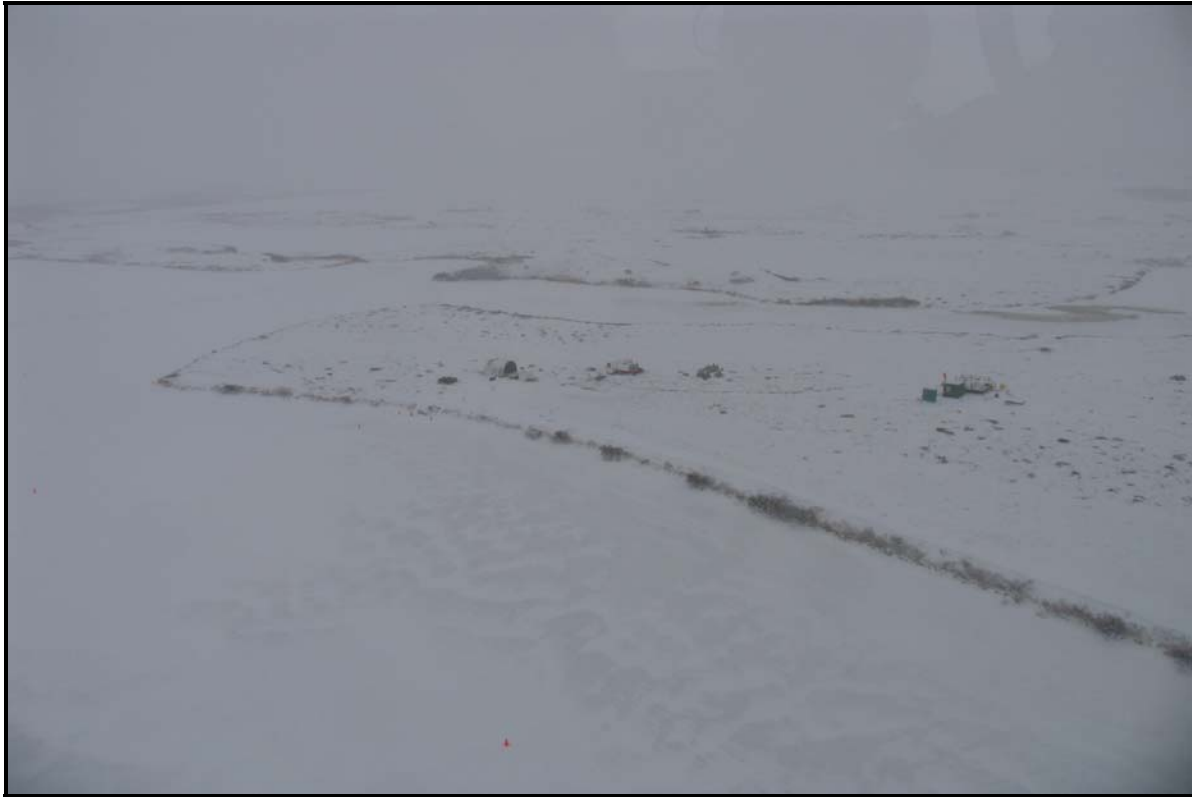
Picture 1 - Fuel Depot – Wiggly Lake

The first stop inspected (flyover only) was the fuel depot adjacent to Wiggly Lake (see attached map for location). The fuel tanks were empty and the depot was not being used due to thin ice on Wiggly Lake as early winter weather was setting in. The fuel depot is supplied with fuel from Illiamna using a Beaver airplane with floats in the summer and skis in the winter. Until the ice is thick enough in the fall to early winter period, fuel cannot be flown in by airplane. Picture 1 (see photo appendix at end) shows the depot area and lake ice area being groomed for landings.

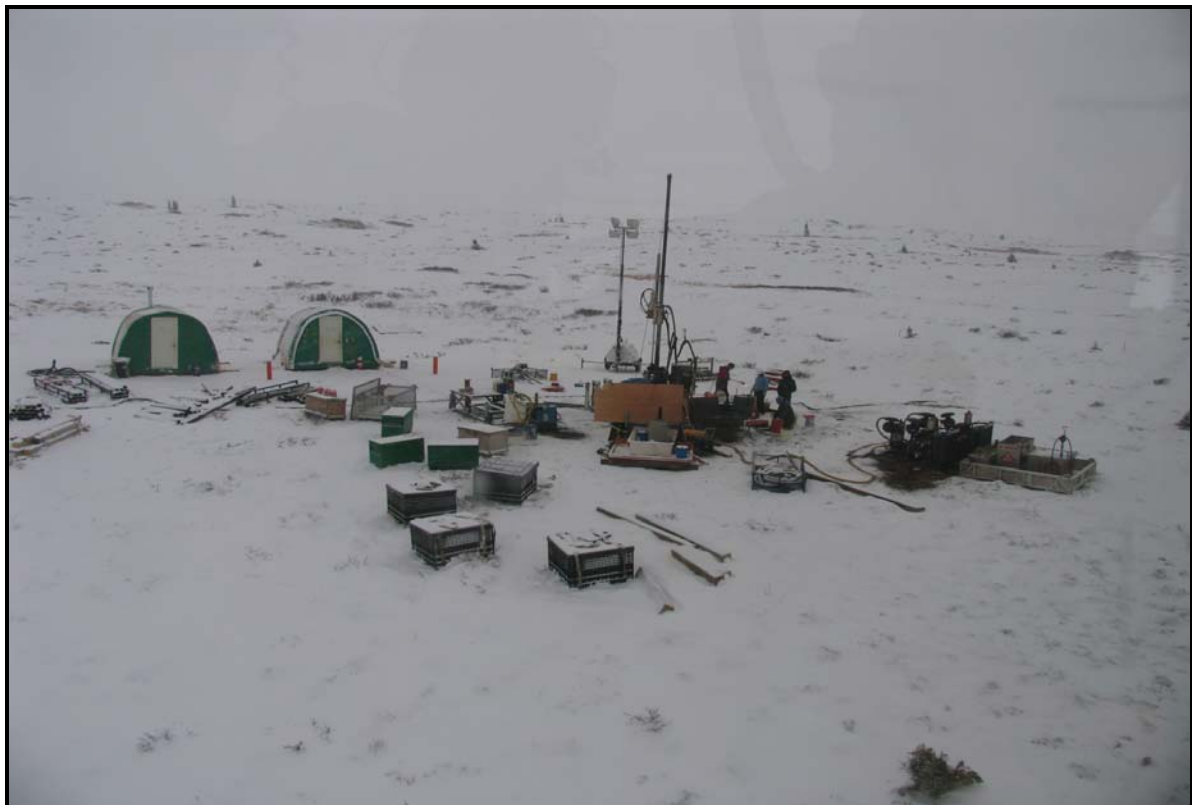
Picture 2 - Hydro-Geology Monitoring Drill Site HH07-0

The second site inspected was Hydro-Geology Drill Site HH07-0 located on the N. Fork of the Kuktuli River (see attached map for location). The contractors involved at this drill site were Foundex Explorations (drilling contractor) and SLR Consulting (hydro-geological contractor). The investigations planned for this drill site consisted of groundwater monitoring. Seven 160' deep holes were drilled consisting of a center pump test well and six surrounding monitoring wells. The water table at this site is 60' below ground. Two generators with compressors were present at this site as well as the air rotary drilling rig. Drill water encountered below the water table was being pumped into a small excavated sump where it was percolating below the ground surface. Secondary fuel containment was present for all containerized fuel in case of an accidental spill. Fuel spill clean up kits were present on site. Picture 2 (see photo appendix at end) depicts the drill site.

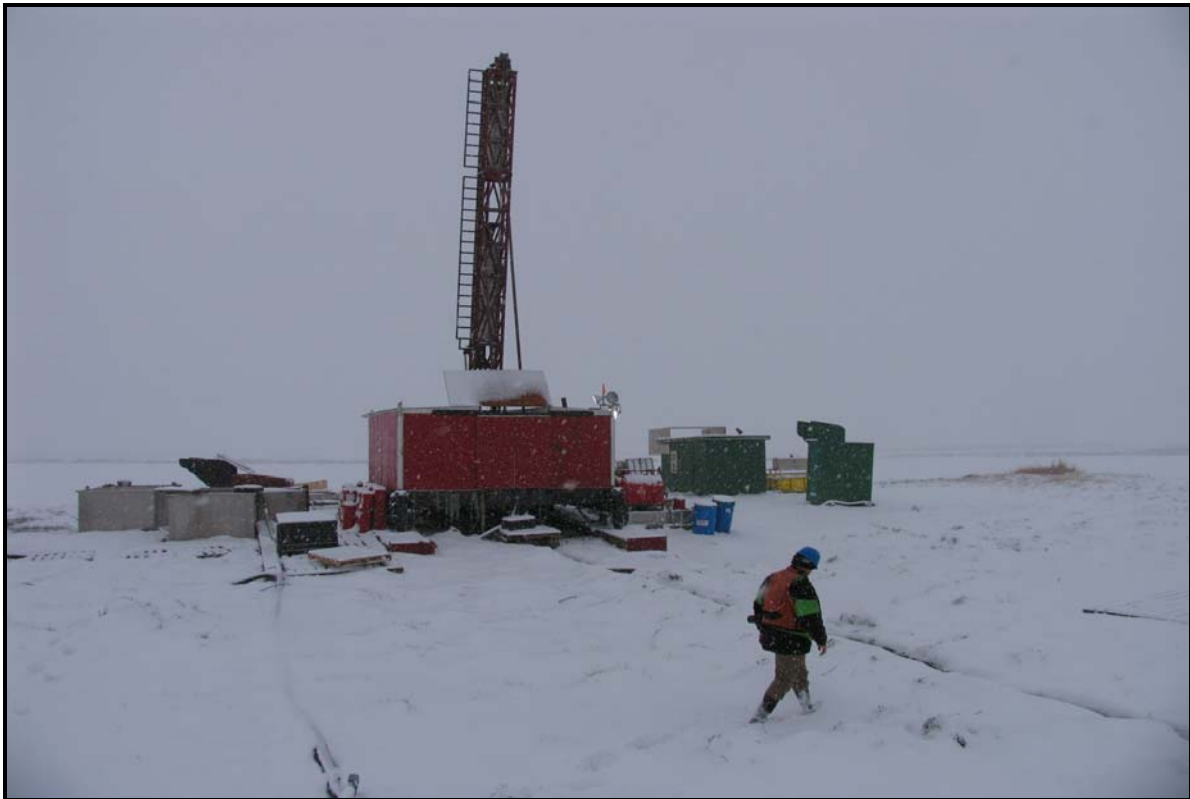
Picture 3 - DDH 077368

The third site inspected was DDH site 7386 (Drill Rig 5). Quest Drilling was the drilling contractor on this hole (see attached map for location). This drill site like the other DDH sites inspected on this trip are in the Pebble east zone. The planned drill depth for this hole is 6,900 feet. At the time of our visit the drill depth was 3,871 feet. Quest was using one of their newly manufactured deep drilling rigs (18,500 lbs) that can be moved in about 24 helicopter sling

loads. The drill water source for this hole was from large pond several hundred feet to the west. Secondary fuel containment was present for all containerized fuel in case of an accidental spill. Fuel spill clean up kits were present on site. Tundra platforms were in use around the drill site particularly in the areas where there was heavy foot traffic. The drill site was clean and orderly and trash was properly disposed of before it got covered with snow. Picture 3 and 4 (see photo appendix at end) are of the drill site, small discharge ditch and sump. Two 1,500 gallon recycle tanks were being actively used at this site (left of the drill), so very little drill water was being discharged from this hole. The small amount of drill water that was being discharged was beginning to freeze as it reached the sump, however minor overflow to the immediate surrounding down gradient area was occurring. This was not a problem because the discharge water was freezing as soon as the concentrated flows subside. Penetrol and Ez-Mud were the two drill additives being used on this hole.

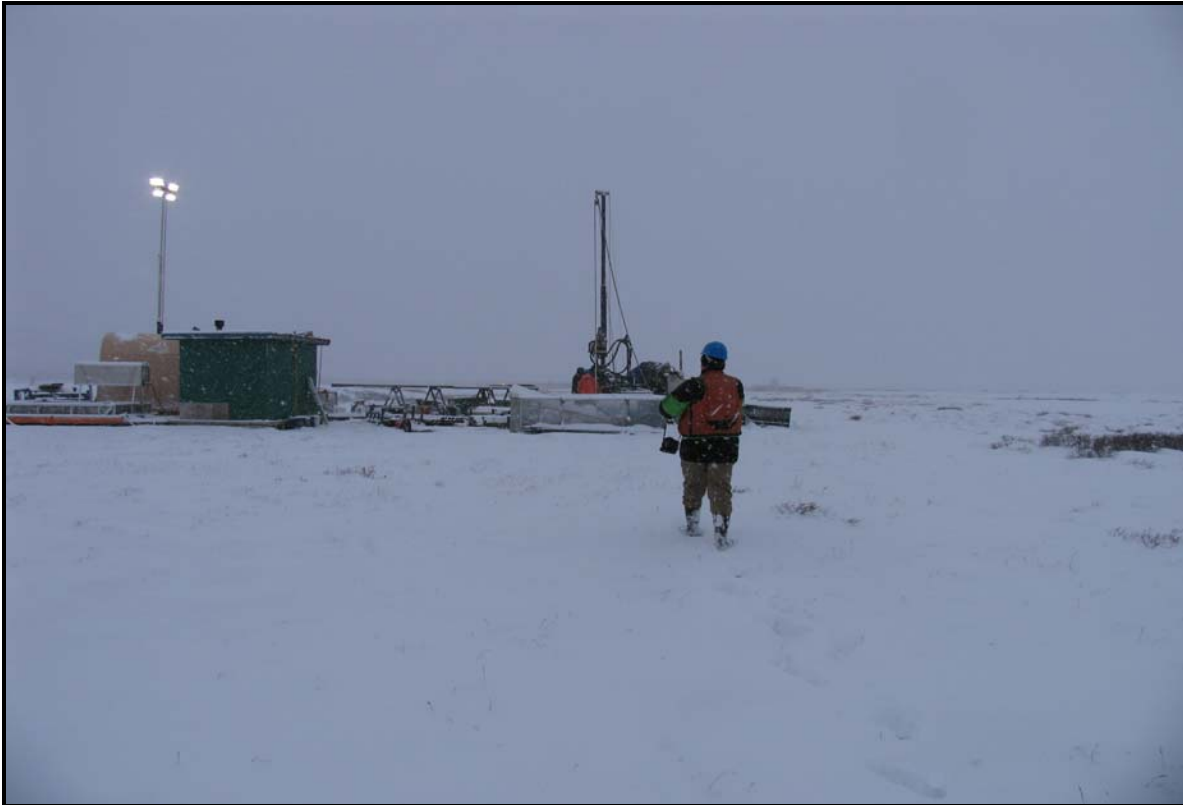
Picture 5 - Rotary Bore Hole #076351

The fourth site inspected was geo-technical rotary bore hole #076351. This site (see attached map for location) is shown in Picture 5 (see photo appendix at end). The drilling is being done by Foundex Exploration and the geo-technical testing being done by Knight Piesold. This bore hole is in one of the possible locations for a waste rock and tailings dam if the mine is ever built. Secondary fuel containment was present for all containerized fuel in case of an accidental spill, and fuel spill clean up kits were present on site.

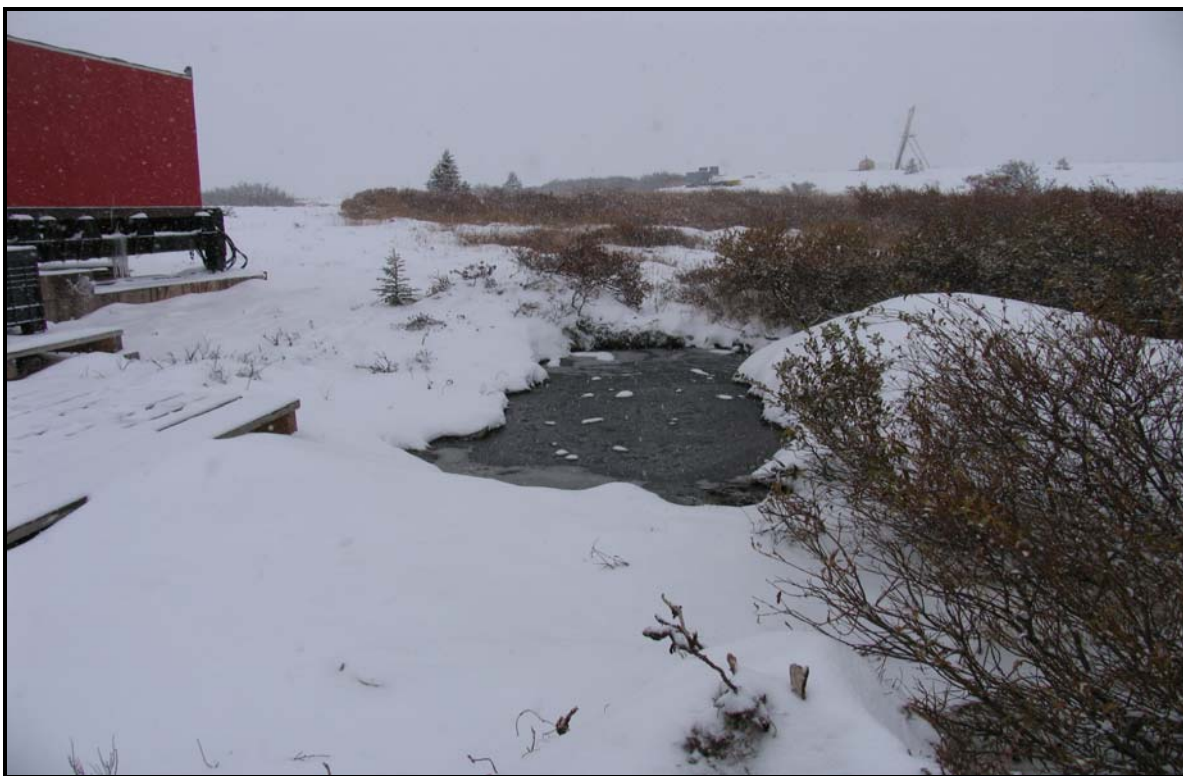
Picture 6 - DDH site 7376 (Drill Rig 6) Sump

The fifth site inspected was DDH site 7376 (Drill Rig 6). Quest Drilling was the drilling contractor on this hole (see attached map for location). This drill site like the other DDH sites inspected on this trip was in the Pebble East zone. The planned drill depth for this hole is 5,000 feet. At the time of our visit the drill depth was 2,035 feet. Quest was using one of their newly manufactured deep drilling rigs (18,500 lbs) that can be moved in about 24 helicopter sling loads. Tundra platforms were in use around the drill site particularly in the areas where there was heavy foot traffic. The drill site was clean and orderly and trash was properly disposed of before it got covered with snow. The drill water source for this hole was from small pond about 60 feet to the north. Secondary fuel containment was present for all containerized fuel in case of an accidental spill. Fuel spill clean up kits were present on site. Pictures 6 and 7 (see photo appendix at end) are of the small discharge ditch and sump and of the drill site. In these pictures, Rig 1 is shown in the background. The small amount of drill water that was being discharged was beginning to freeze as it reached the sump, however minor overflow to the immediate surrounding down gradient area was occurring. This was not a problem because the discharge water was freezing as soon as the concentrated flows subside. Penetrol and Ez-Mud were the two drill additives being used on this hole.

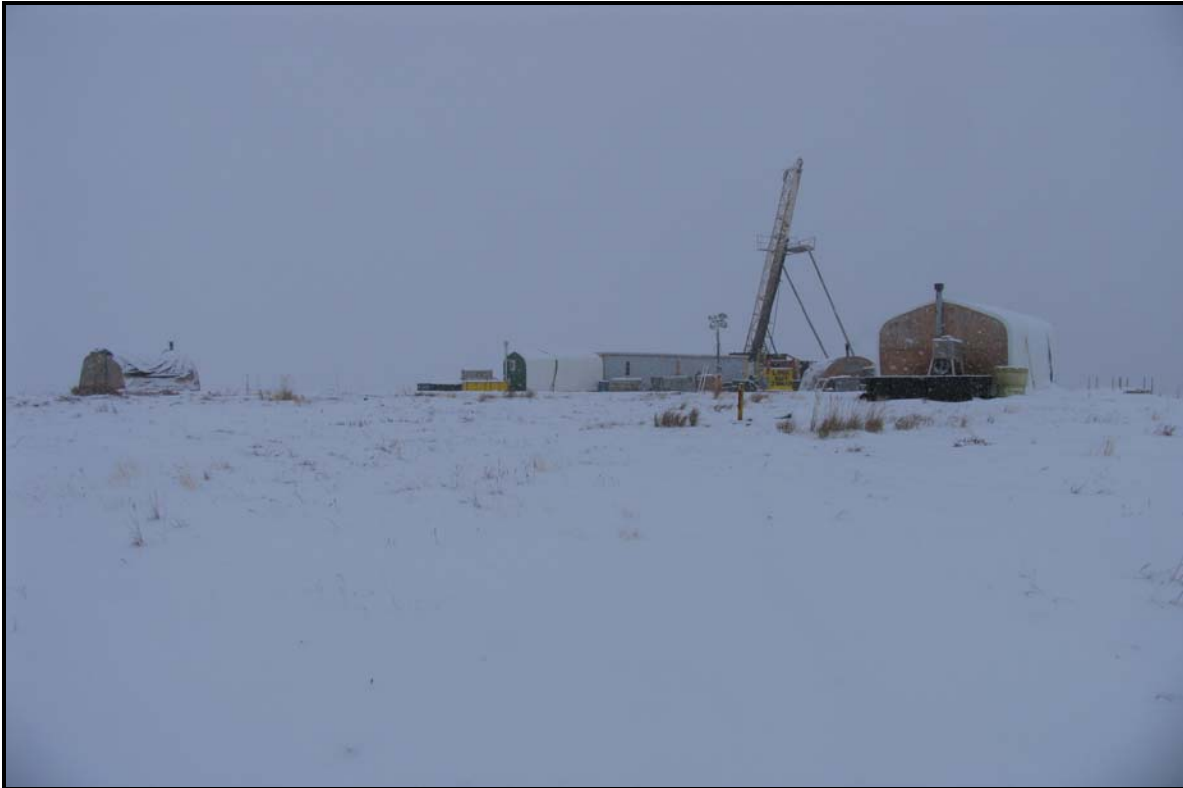
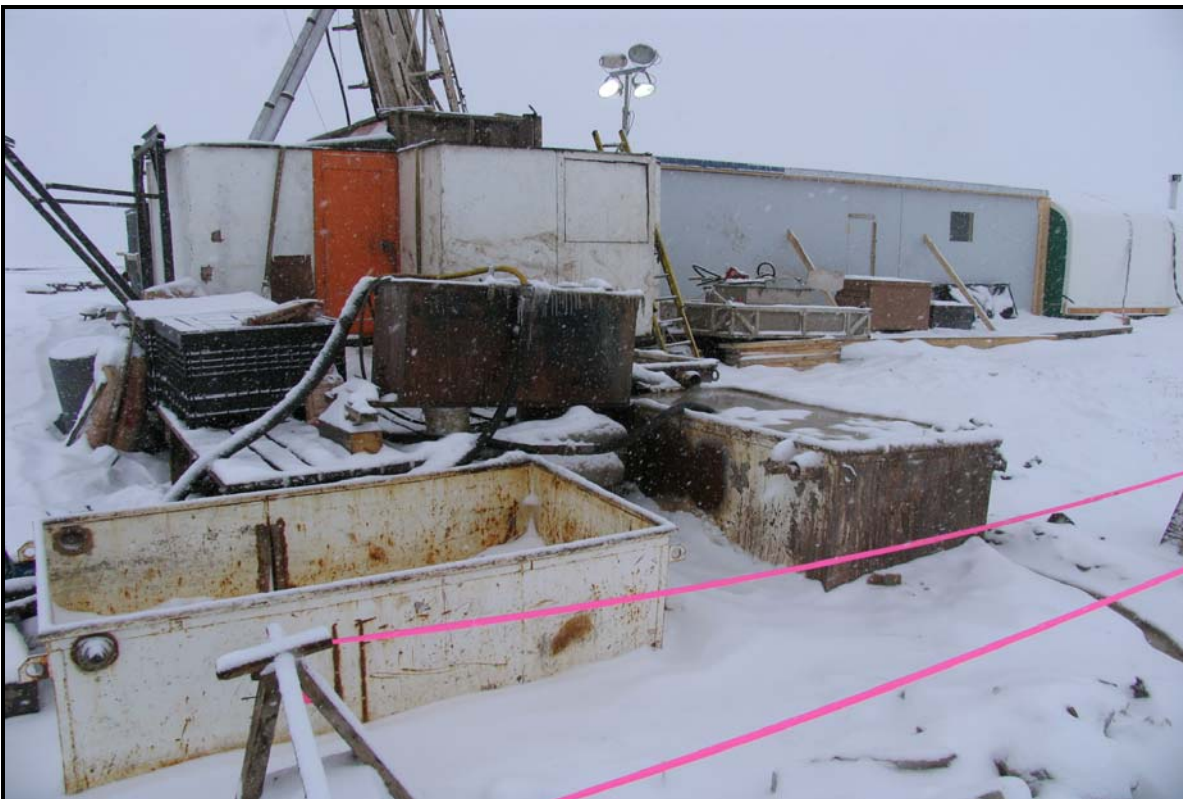
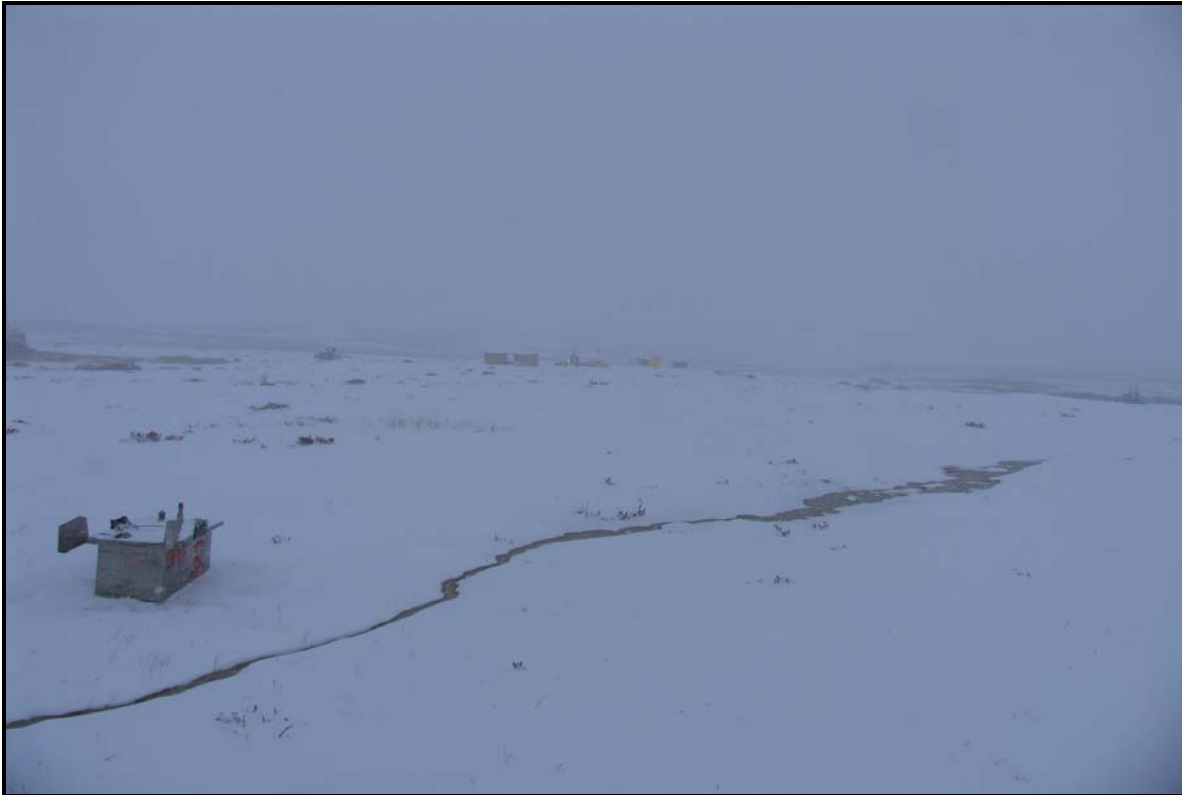
The sixth site inspected was DDH site 7387 (Drill Rig 1). Longyear was the drilling contractor on this hole (see attached map for location). This site like the others is in the Pebble East zone. The planned drill depth for this hole is 4,200 feet. At the time of our visit, the depth was 1,994 feet. Tundra platforms were in use around the drill site particularly in the areas where there was heavy foot traffic. The drill site was clean and orderly and trash was properly disposed of before it got covered with snow. The drill water source for this hole was from a small pond about 300 feet to the southwest. Secondary fuel containment was present for all containerized fuel in case of an accidental spill. Fuel spill clean up kits were present on site. Circulation of drill water using two tanks was occurring at this site due to the use Penetrol and Ez-Mud. Pictures of this

drill site are shown in pictures 8-10. Drill water that was discharging from the casing was being channelized in a small linear ditch that had been trenched about 400 feet to the north where it was percolating into the tundra beneath a covering of snow.

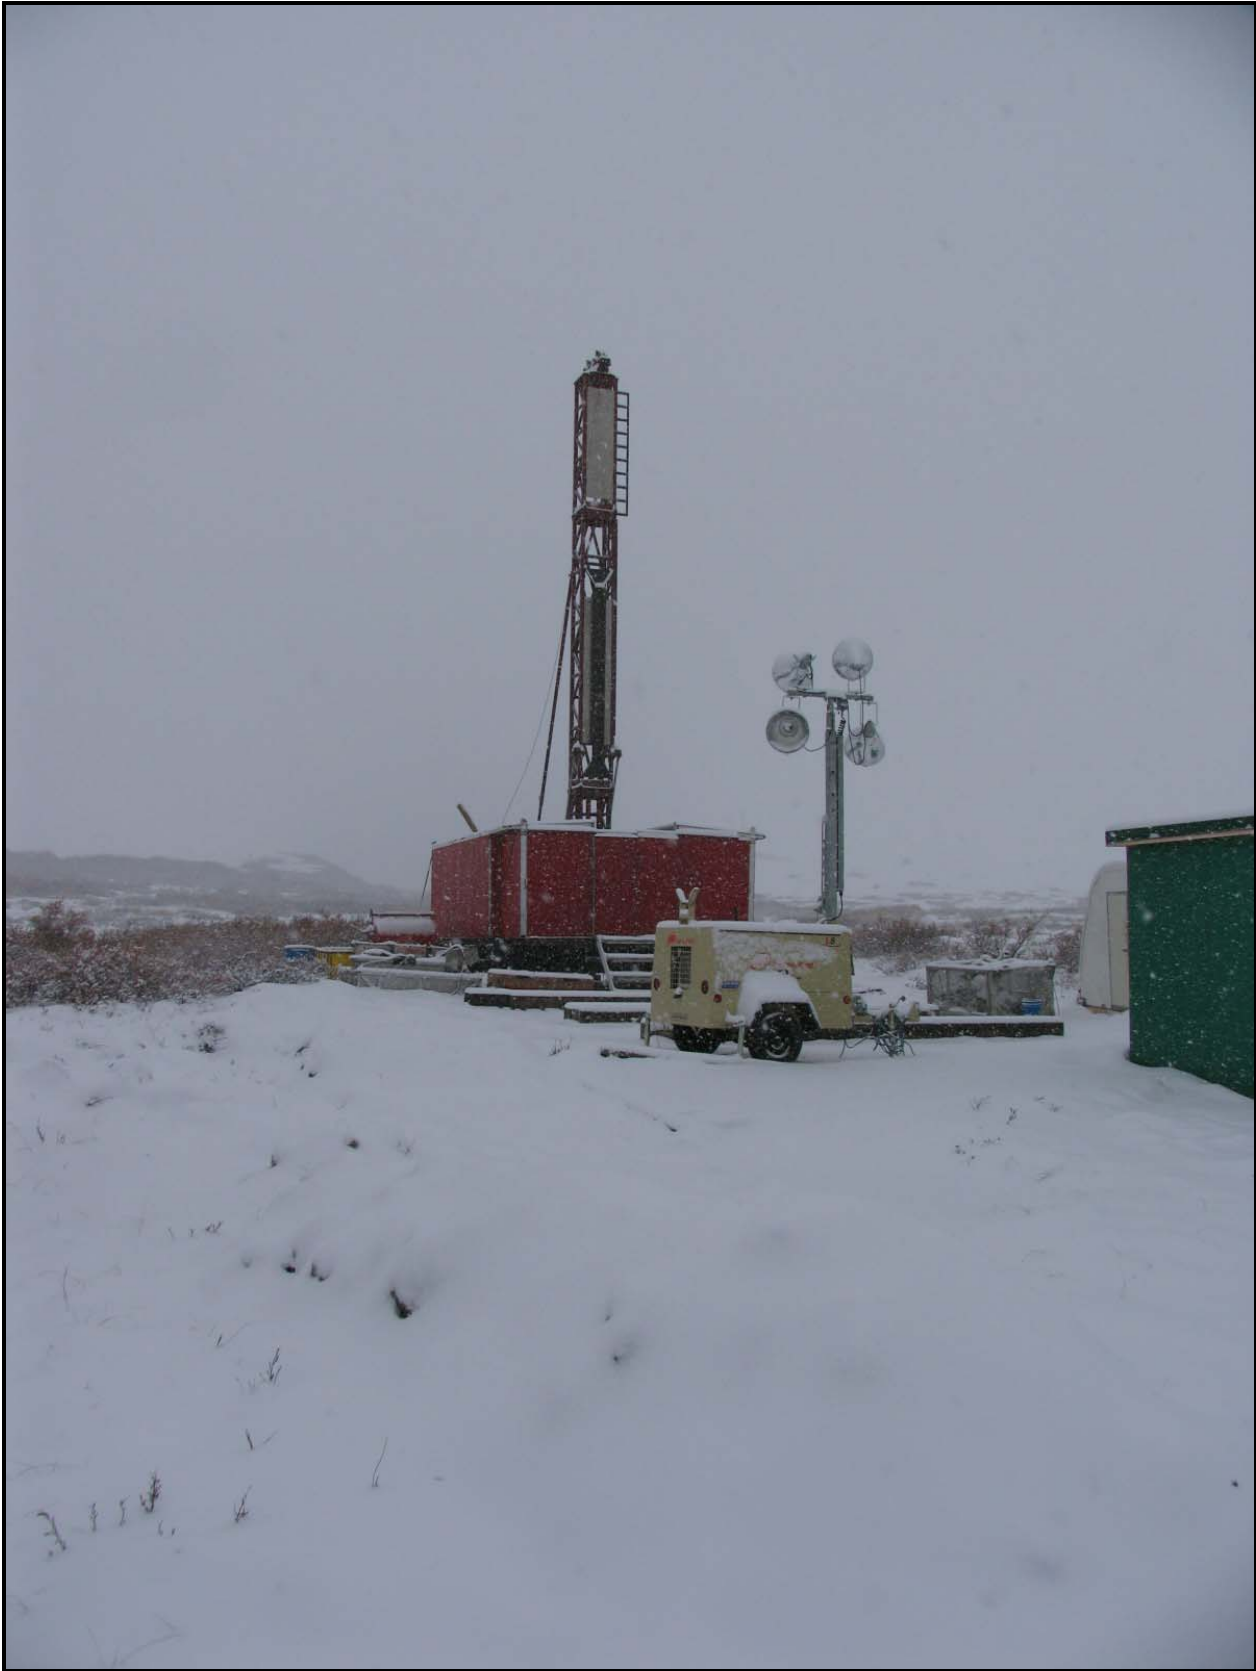
Picture 11 – DDH 7388 (Drill Rig 2)

The seventh site inspected was DDH site 7388 (Drill Rig 2). Quest was the drilling contractor on this hole (see attached map for location). This drill site like the other DDH sites inspected on this trip was in the Pebble East zone. We failed to get a planned depth for this hole, however at the time of our visit the depth was 1,500 feet. The drill was shut down and the plan was to move it to site 8 below. Tundra platforms were in use around the drill site particularly in the areas where there was heavy foot traffic. This drill site was clean and orderly and secondary fuel containment was present for all containerized fuel in case of an accidental spill. Fuel spill clean up kits were present on site. The drill water source for this hole was from a small pond 100 feet away to the southwest. At the time of our visit the drillers were repairing the ‘drill chuck’ so they were temporarily shut down. There was a slight artesian flow of about 4 gallons/minute. Drill water discharge was flowing along a small short trench into a sump which was allowed to overflow into a small depression nearby and spill on to the surrounding tundra. Picture 11 depicts this drill site.

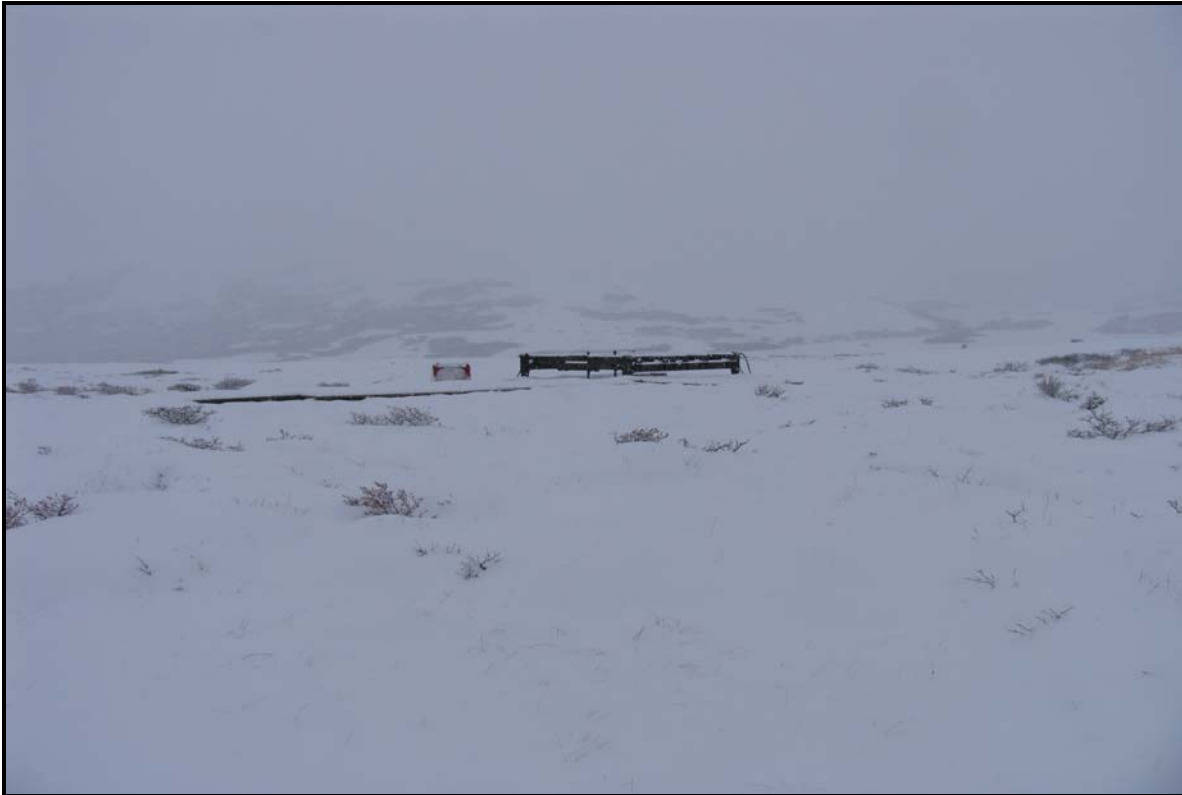
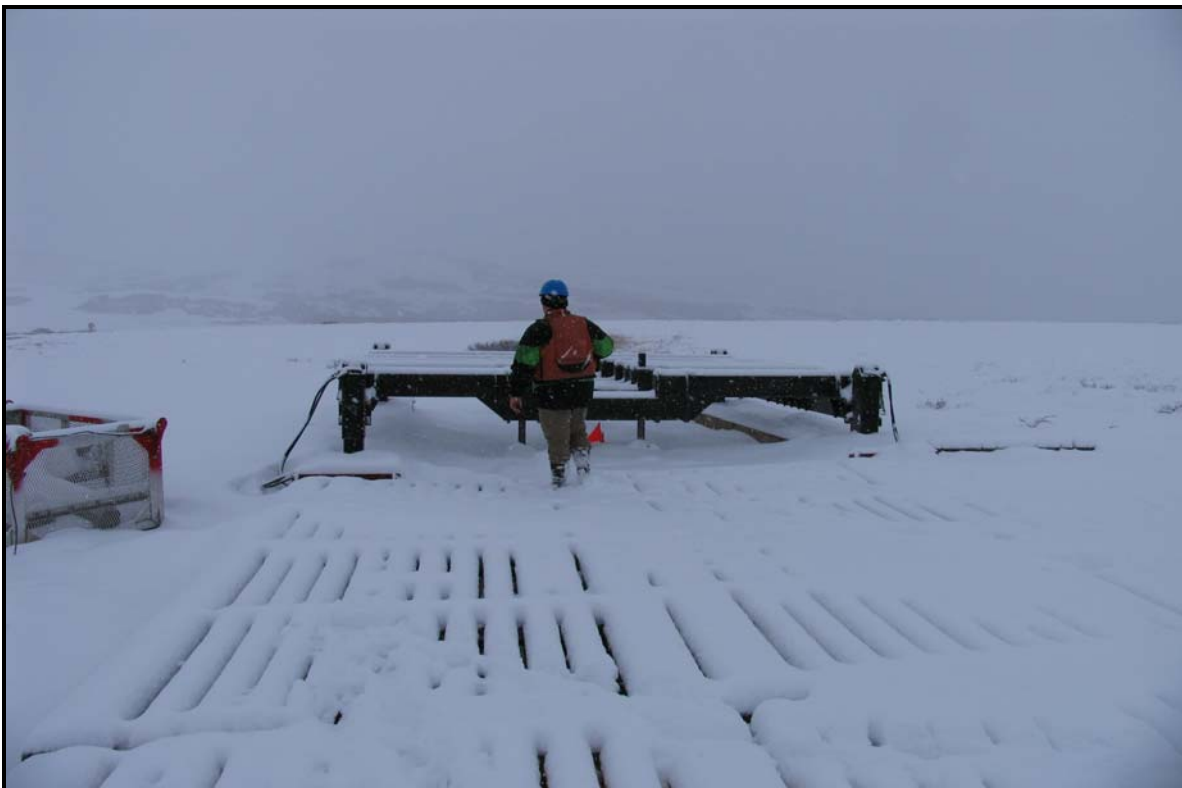
The eighth site inspected was supposedly the next drill site for Drill Rig 2 (see attached map for location). The only thing on site was the hydraulic platform and tundra pads. See Pictures 14 and 15.

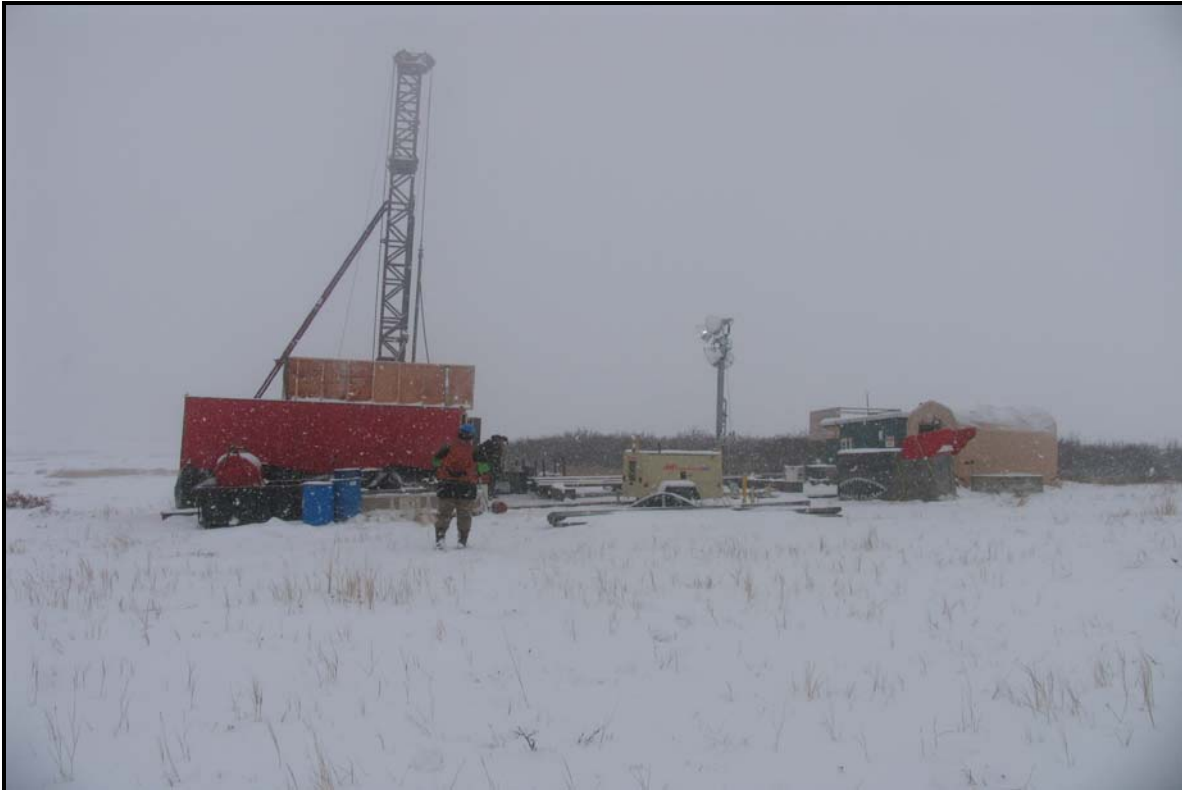
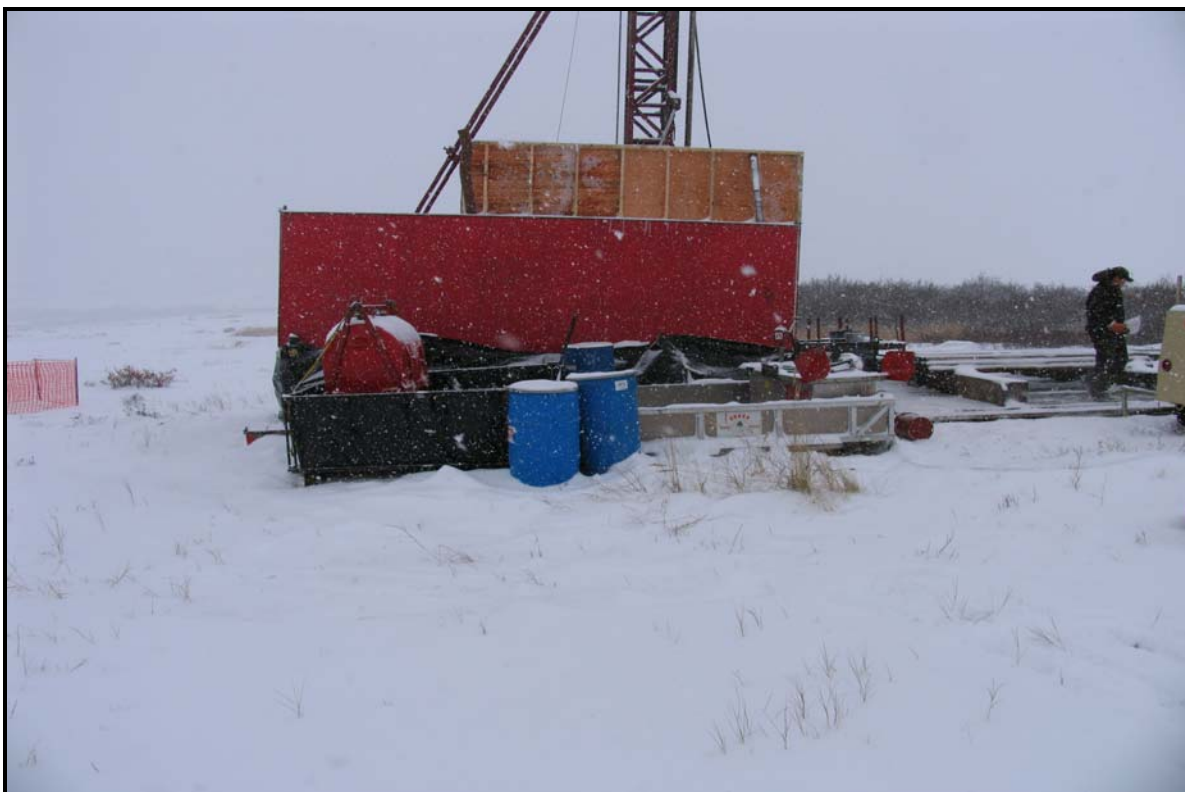
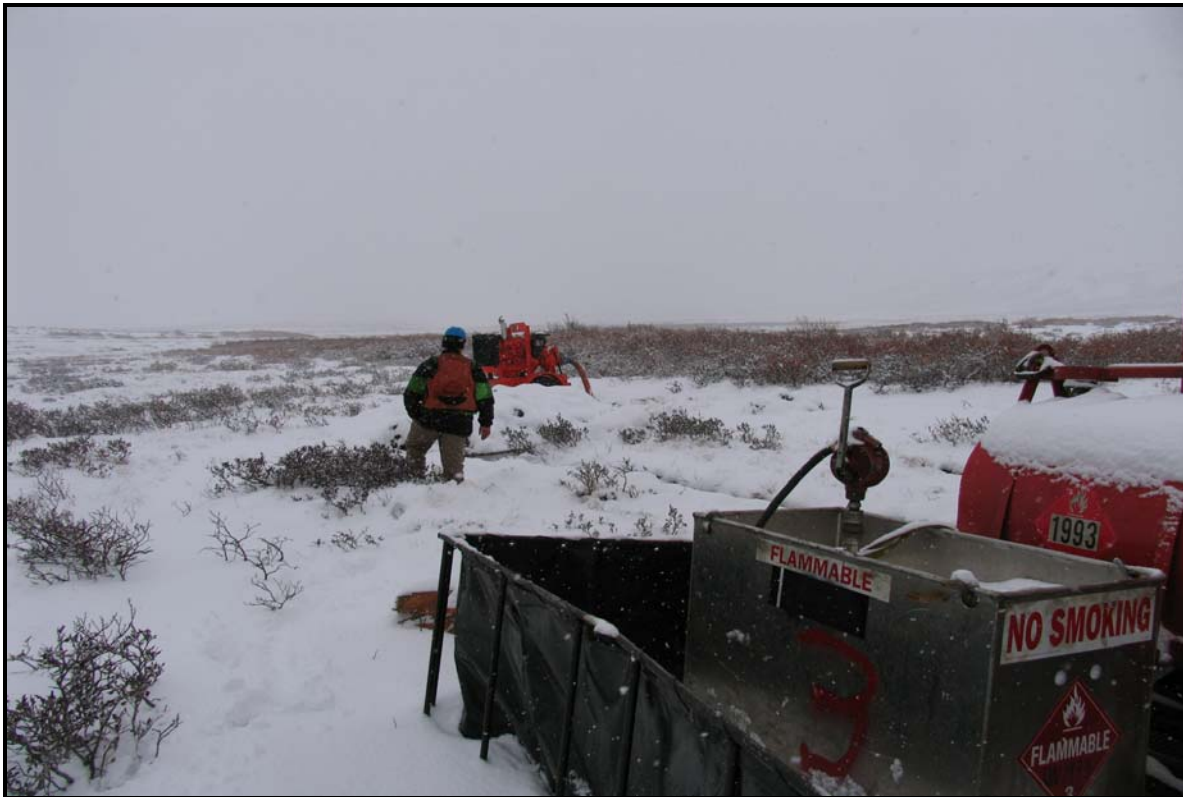
The ninth site inspected was DDH site 7385 (Drill Rig 3). Quest was the drilling contractor on this hole (see attached map for location). This drill site like the other DDH sites inspected on this trip was in the Pebble East zone. The planned depth for this hole was 4,200 feet. At the time of our visit, the rods were stuck at 2,100 feet, so the drillers were cutting them off above this depth so they could drill through to the desired depth. As a result they were pulling rods when we there. Tundra platforms were in use around the drill site particularly in the areas where there was heavy foot traffic. This drill site was clean and orderly and secondary fuel containment was present for all containerized fuel in case of an accidental spill. Fuel spill clean up kits were present on site. Drill water discharge from this site was channeled to a sump behind the drill and then pumped through a hose to a basin area where it was released on the tundra. Pictures 16-18 are of this site.

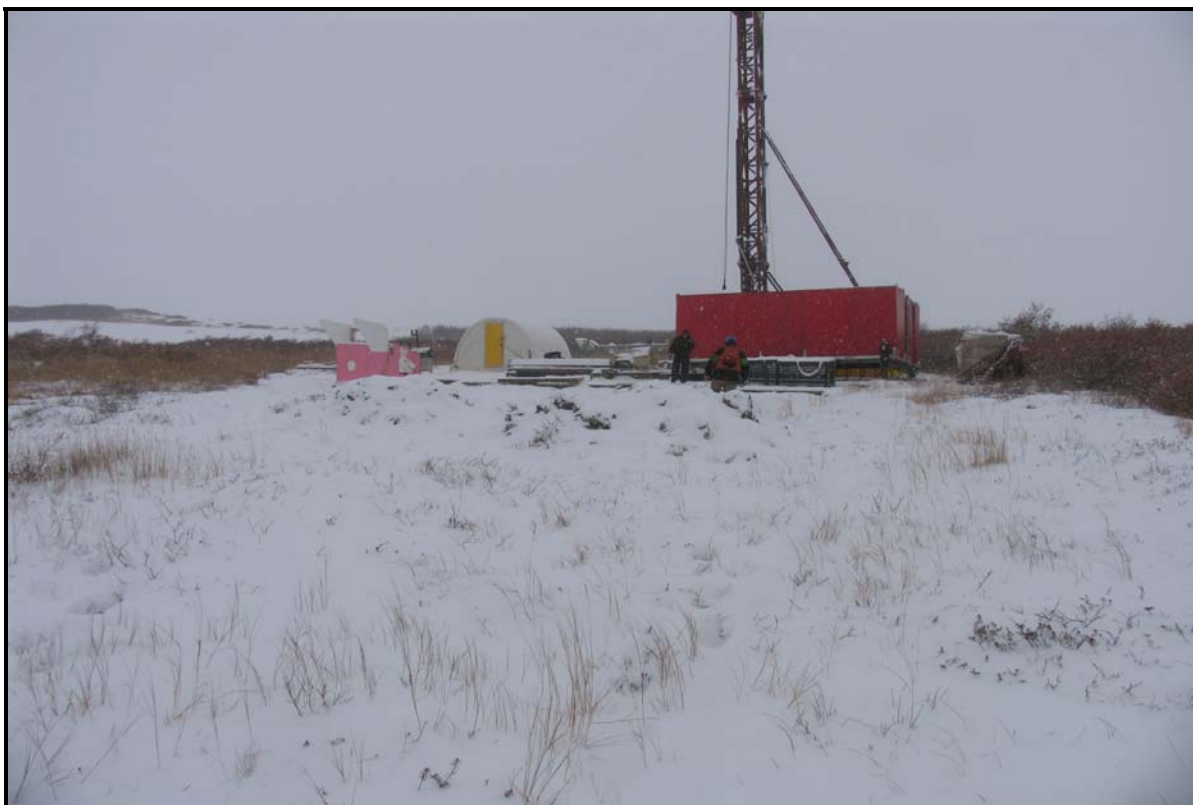
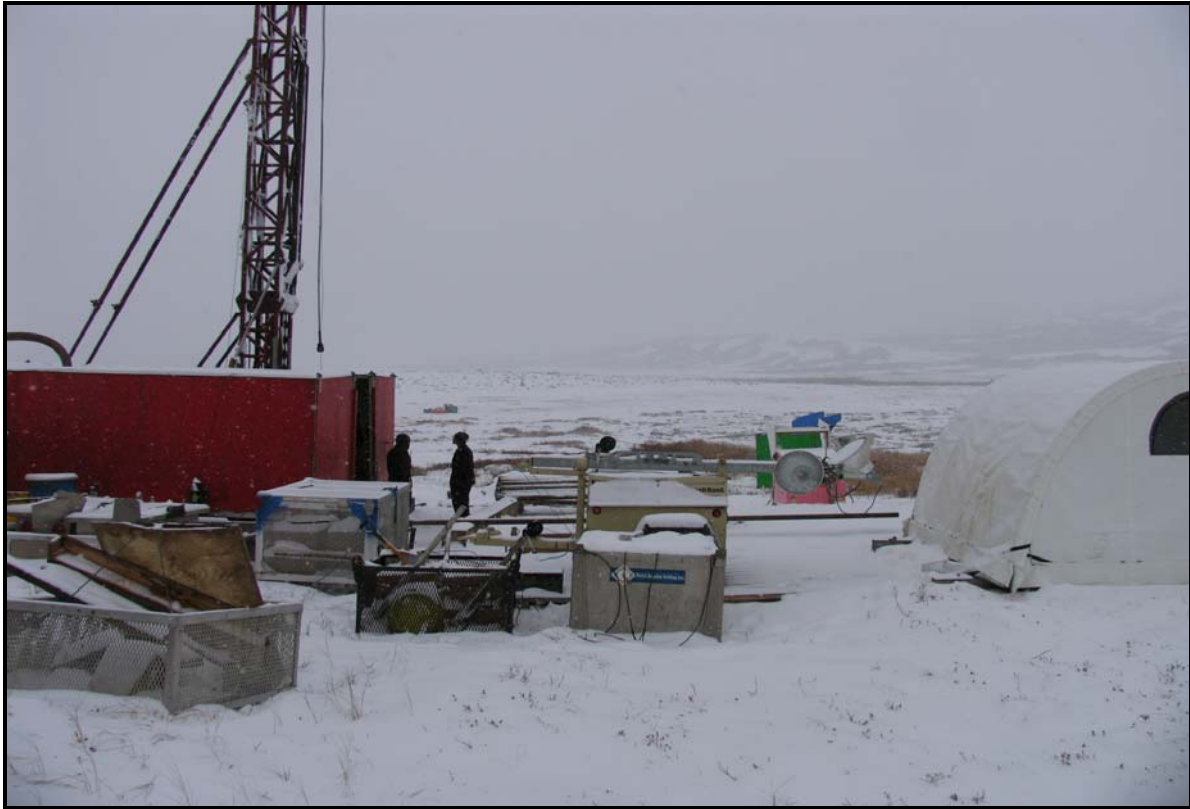
The tenth site inspected was DDH site 4. Quest was the drilling contractor on this hole (see attached map for location). This drill site like the other DDH sites inspected on this trip was in the Pebble East zone. The planned depth for this hole was 4,500 feet. At the time of our visit, they were setting up and had not started drilling yet. Tundra platforms were in place around the drill site, and the site was clean and orderly and secondary fuel containment was present for all containerized fuel in case of an accidental spill. Fuel spill clean up kits were present on site. Pictures 19 and 20 depict this site.
