Field Monitoring Report -- Pebble Copper/Gold Exploration Project --

Personnel: Roger Allely (DNR), Stormy Hought (ADF&G), Jeff Norberg (geologist to Pebble), Clint Roehl (bear guard), Glenn Summa (Astar pilot)	Inspection Date: 10-20-11
	Site Contact: Jeff Norberg
	APMA #: A116118
<ul style="list-style-type: none"> ■ Inspection Type: 	<ul style="list-style-type: none"> ■ Wildlife Observed:
<ul style="list-style-type: none"> ● Complete: 	<ul style="list-style-type: none"> ○ Bear: 2 grizzlies, ~ 8 & 15 miles N of Iliamna on return leg.
<ul style="list-style-type: none"> ○ Partial: 	<ul style="list-style-type: none"> ○ Caribou:
<ul style="list-style-type: none"> ○ Follow-up: 	<ul style="list-style-type: none"> ○ Moose:
<ul style="list-style-type: none"> ○ Response to Public Complaint: 	<ul style="list-style-type: none"> ○ Waterfowl:
	<ul style="list-style-type: none"> ○ Fish:
<ul style="list-style-type: none"> ■ Weather Conditions: 	<ul style="list-style-type: none"> ○ Other:

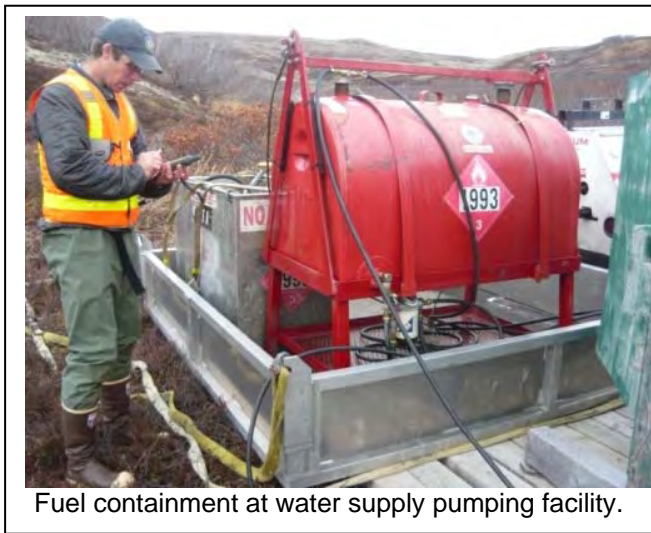
Fuel containment at water supply pumping facility.

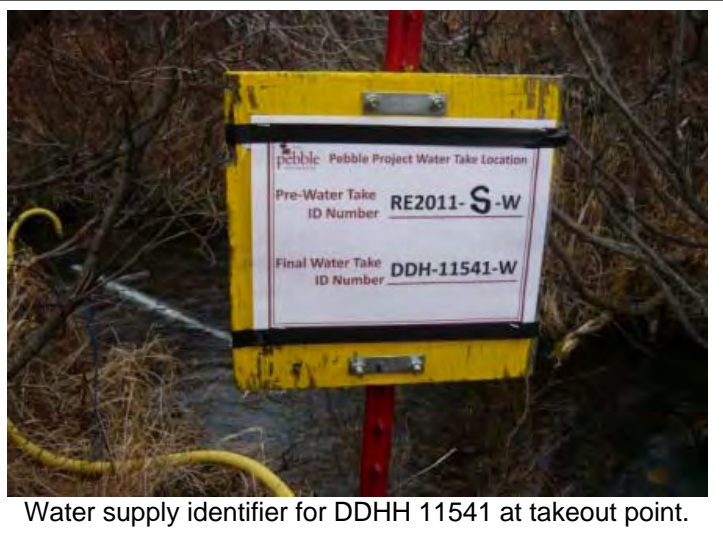
Water supply identifier for DDHH 11541 at takeout point.

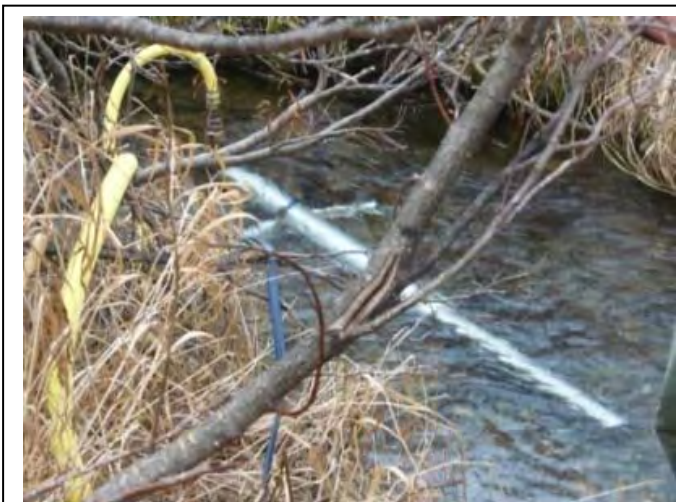
Submerged well screen in stream, DDHH 11541.

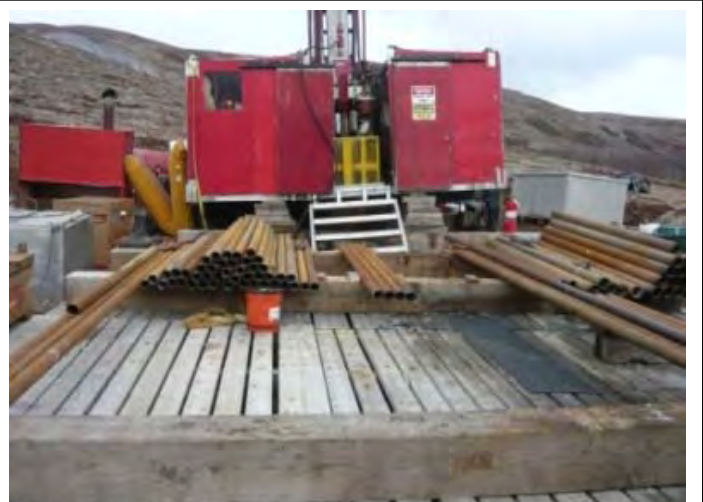
Drill rig #2, pipe stacked on tundra pad, DDHH 11541.

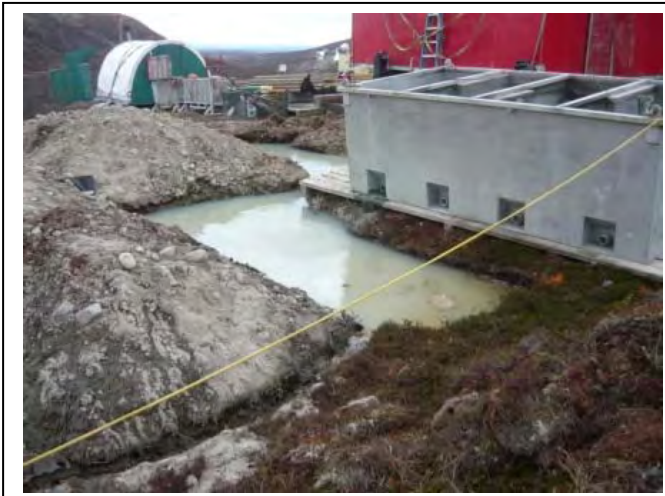
Upper sump pits, empty recirc. tank, DDHH 11541.

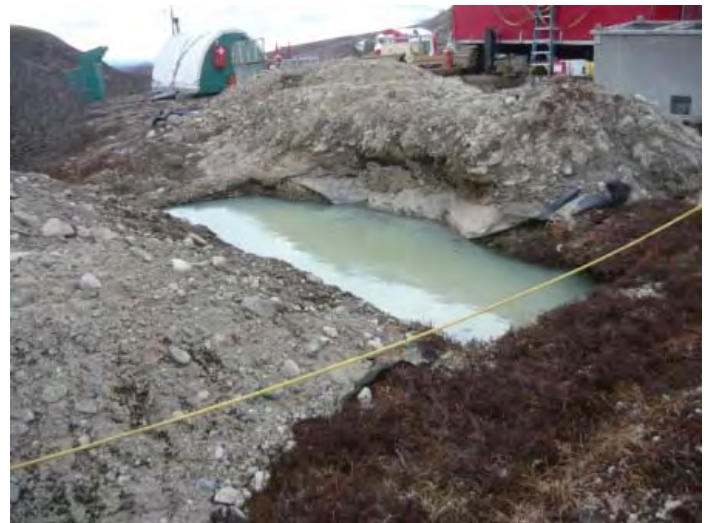
Lower sump pit and excavated material, DDHH 11541.

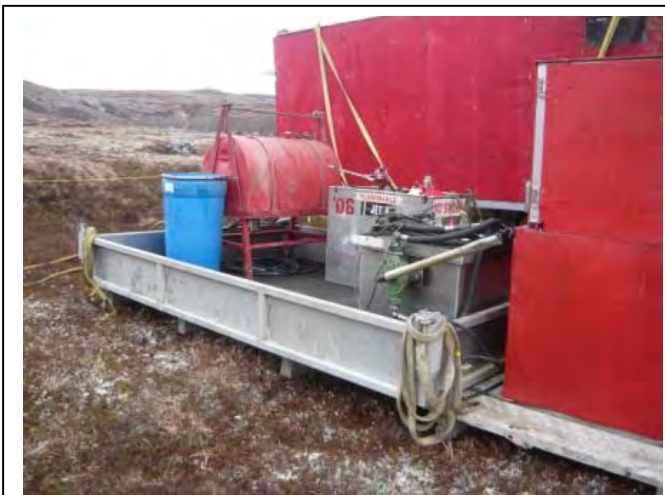
Fuel containment and cleanup kit, next to drill rig #2.

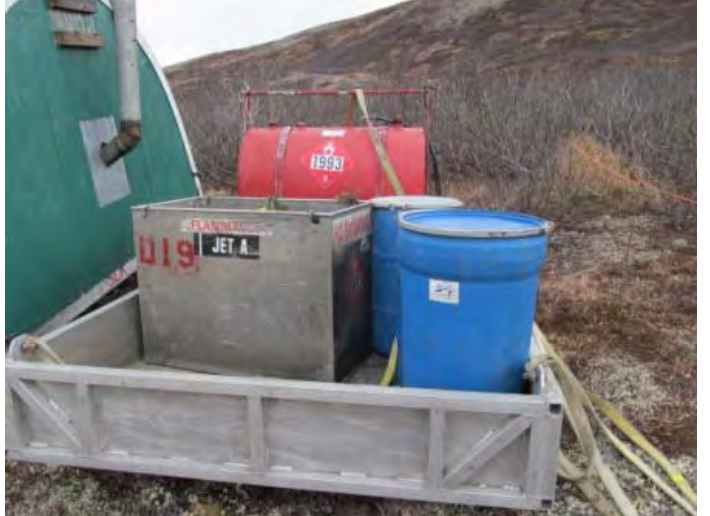
Fuel containment and cleanup kits by warming hut.

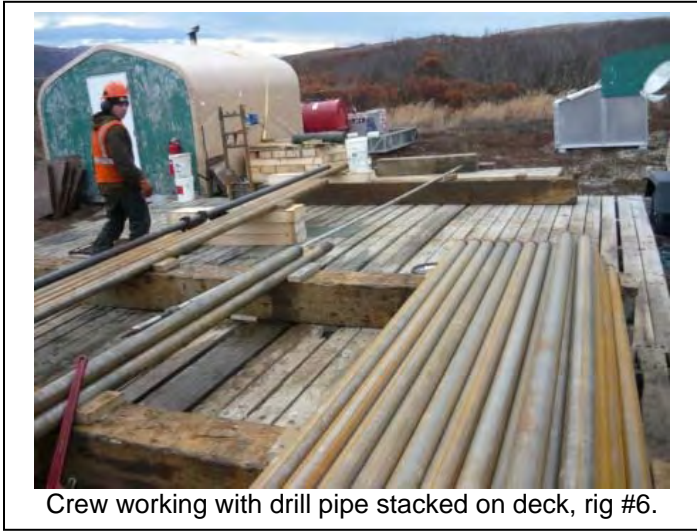
Crew working with drill pipe stacked on deck, rig #6.

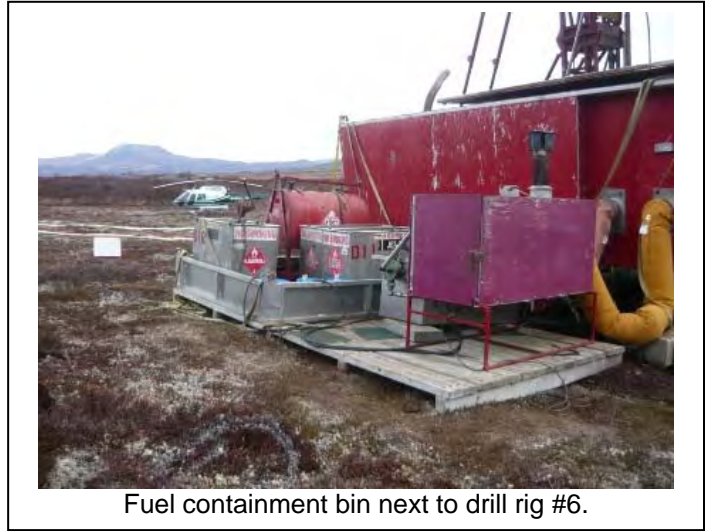
Fuel containment bin next to drill rig #6.

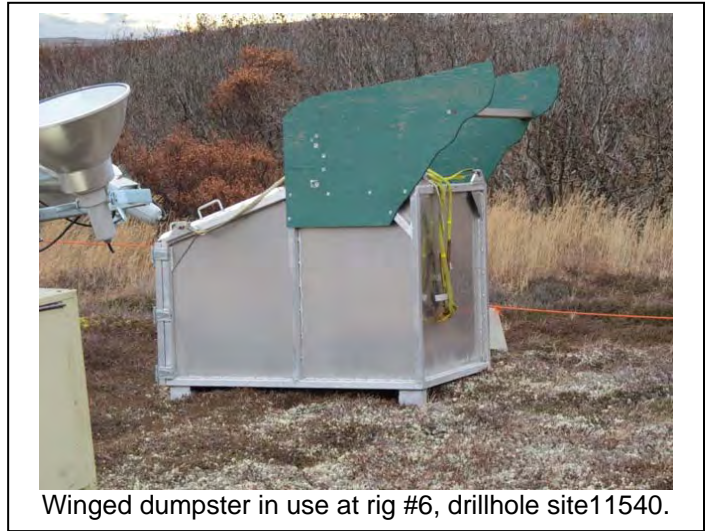
Winged dumpster in use at rig #6, drillhole site 11540.

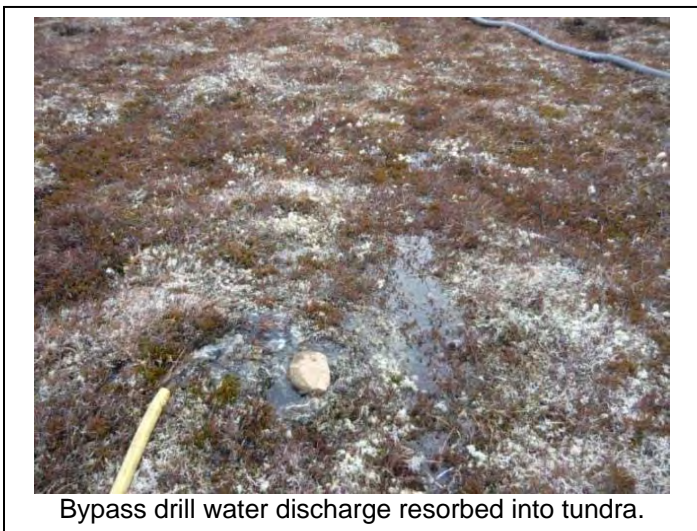
Bypass drill water discharge resorbed into tundra.

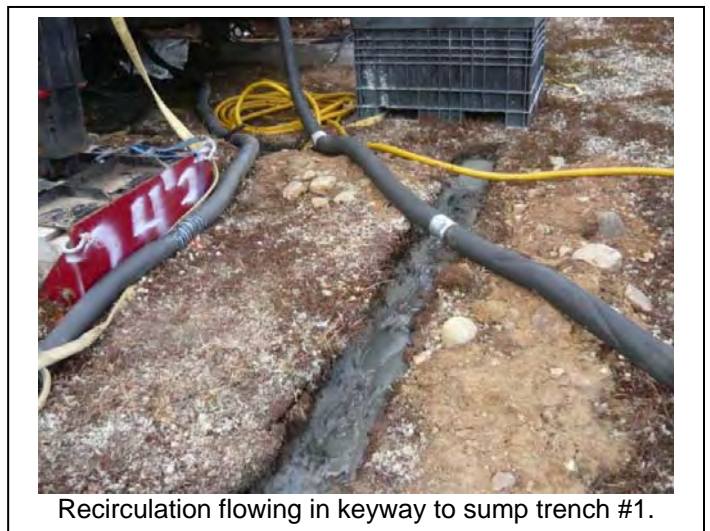
Recirculation flowing in keyway to sump trench #1.

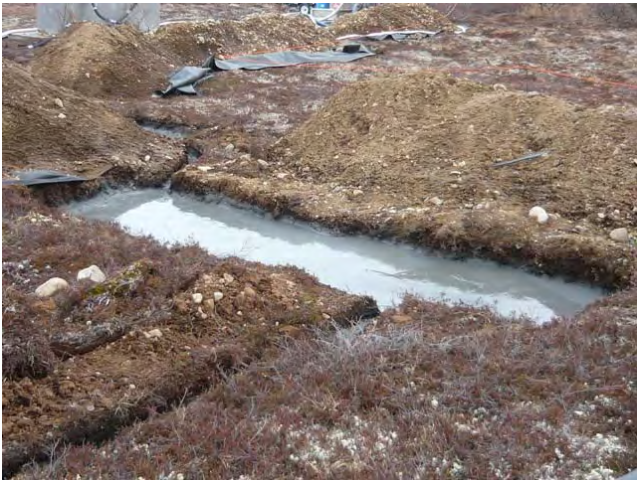
Keyway inlet into first sump pit, rig #6, site 11540.

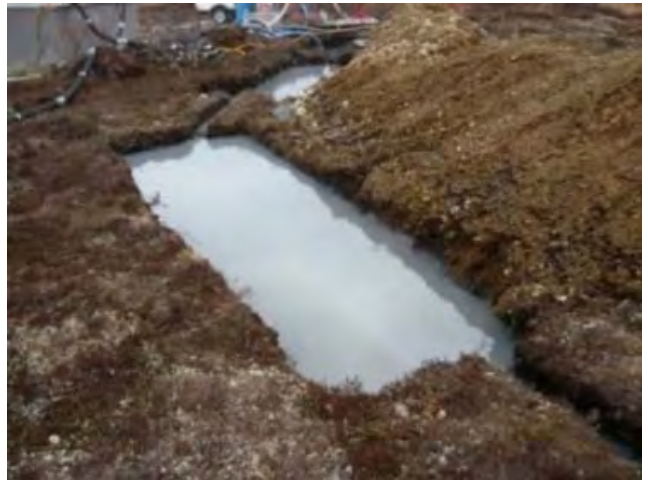
Sump trench #3, (4 in background), soil stockpiles.

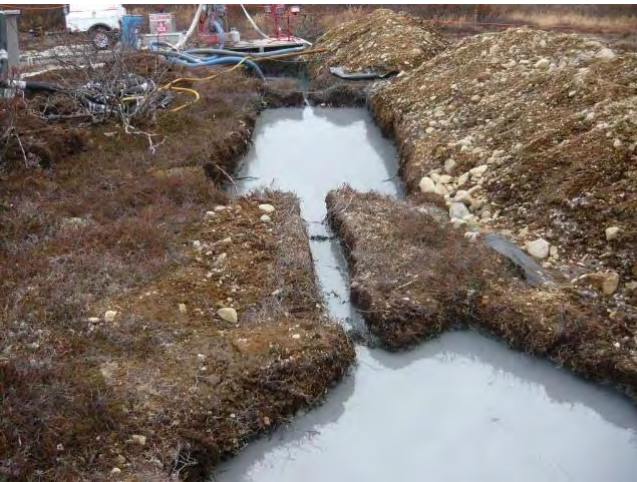
Sump trench #3 outlet to trench #4, soil stockpiles.

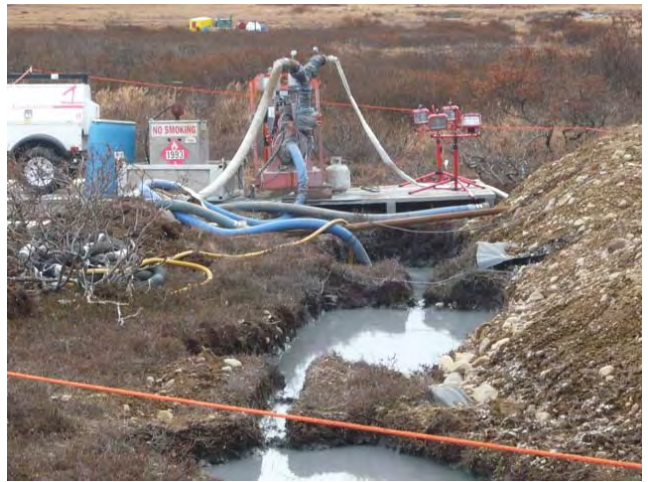
Sump trenches 4&5, Godwin redistribution pump.

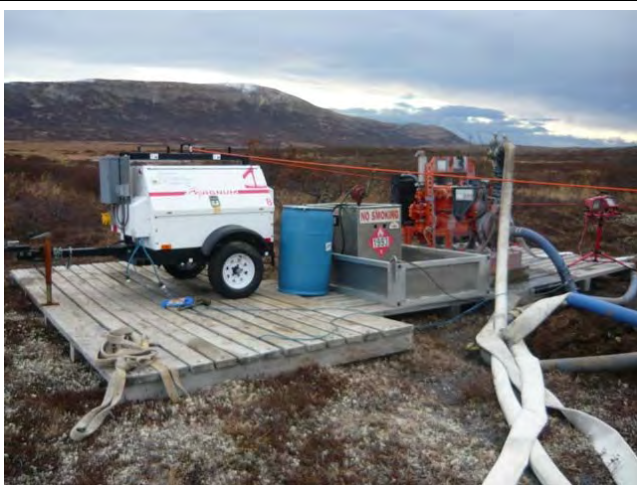
Godwin pump platform, fuel containment, generator.

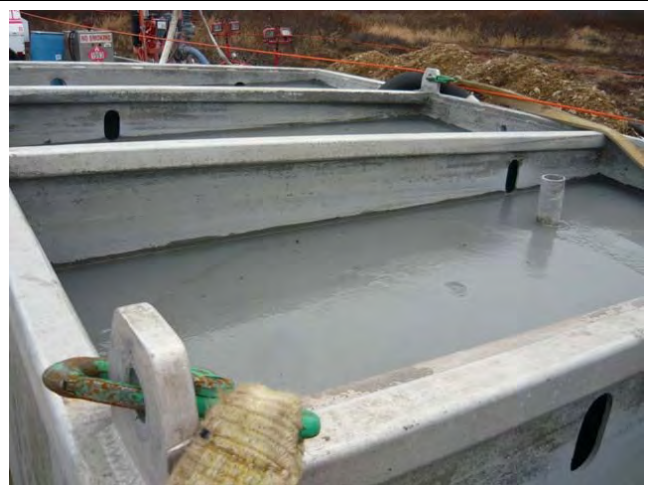
Recirculation tank, three compartments full, one empty.

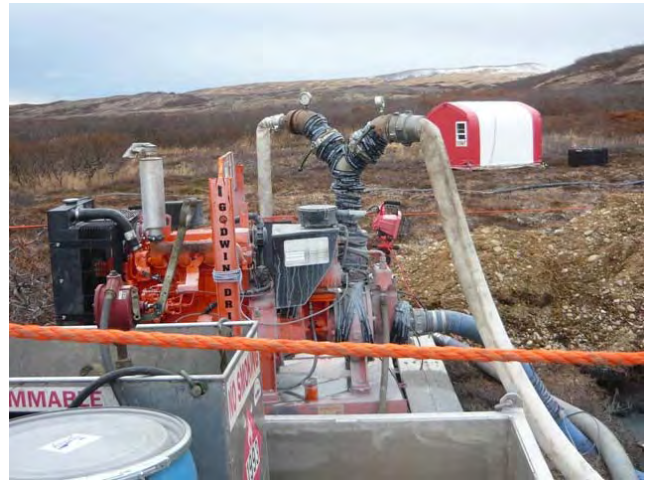
Recirculation tank, three compartments full, one empty.

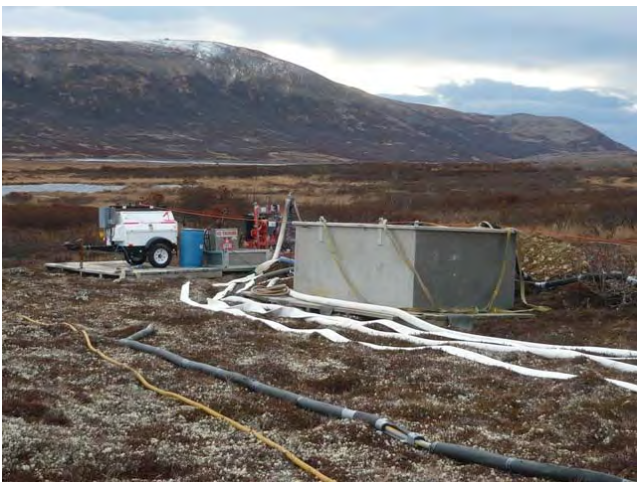
White outfall hoses running uphill from Godwin pump.

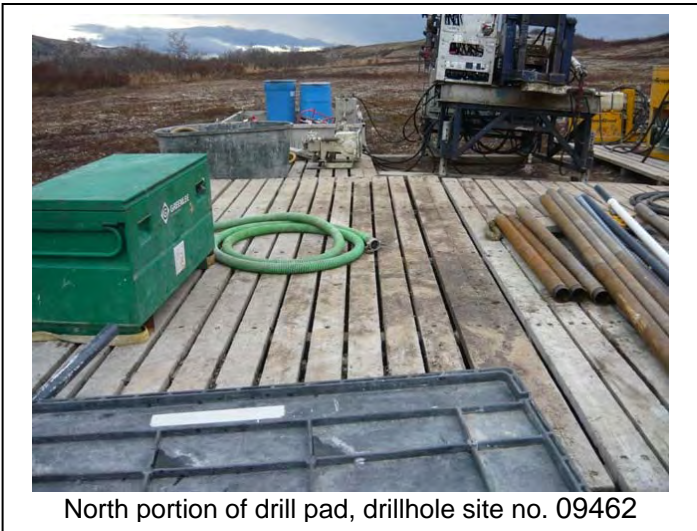
North portion of drill pad, drillhole site no. 09462

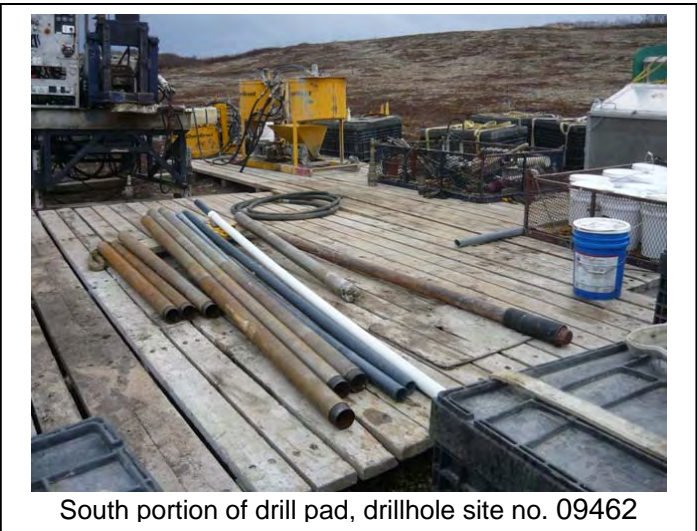
South portion of drill pad, drillhole site no. 09462

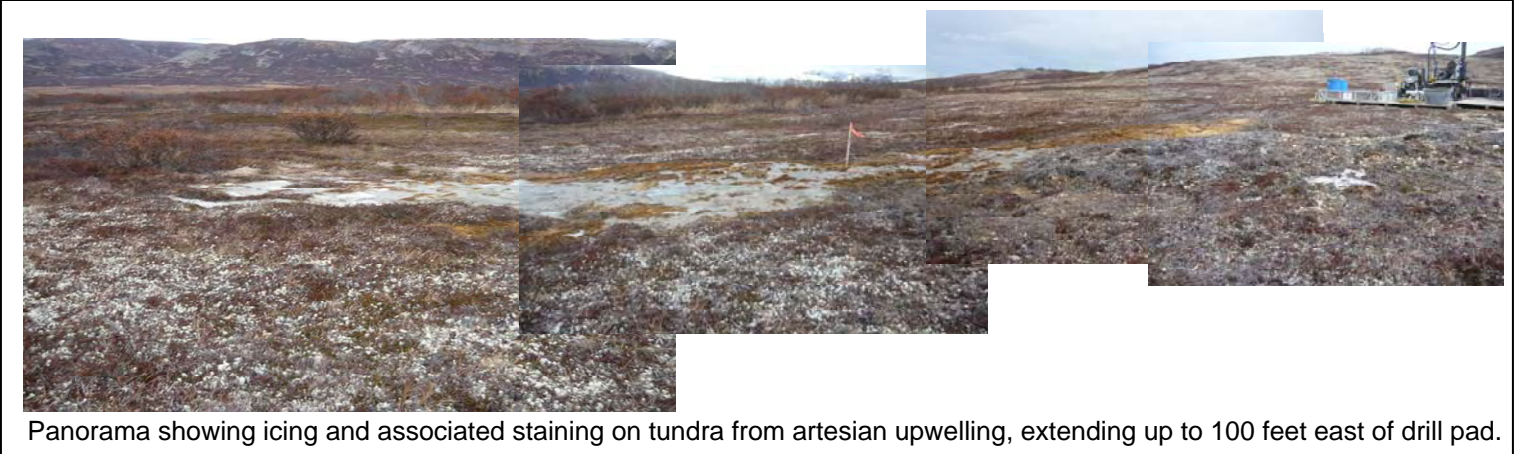
<p>Approximately 20 ft. of casing remain in the hole; the driller thinks there's a break in the casing around the 15 ft. depth.</p>	
<p>Water is upflowing through subsurface materials, discharging to the ground surface in an area 10-20 feet wide, extending 40-80 ft. east of the drill rig. Freezing conditions are creating ice buildup in the discharge zone. Stake and flagging mark a point approximately 70 ft. east of the rig. Some groundwater is discharging into the filled sump pits.</p>	
<p>Overland flow has created discolored, possibly iron stained zones on the surface 10-15 feet wide. One extends from the rig pad approximately 20 feet, the other extends from approximately 30 to 100 feet east of the rig pad.</p>	
<p>Overland water flow disappears into tundra approx. 150 ft. E of the drill hole.</p>	
<p>The sumps are filled and mounded, tundra materials are separately stockpiled.</p>

Panorama showing icing and associated staining on tundra from artesian upwelling, extending up to 100 feet east of drill pad.

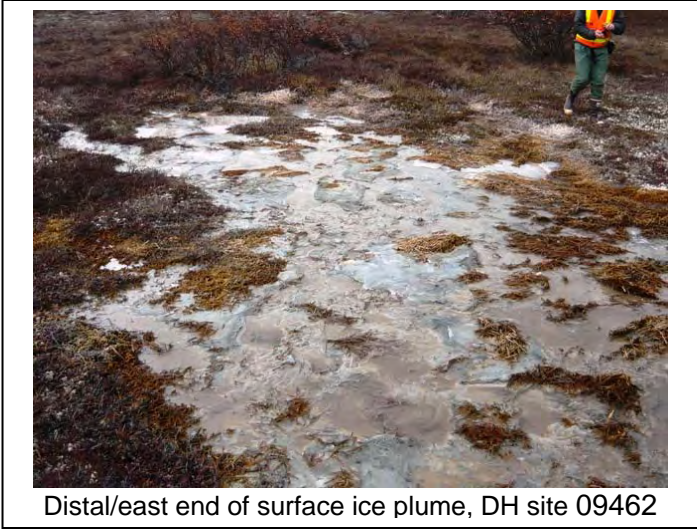
Distal/east end of surface ice plume, DH site 09462

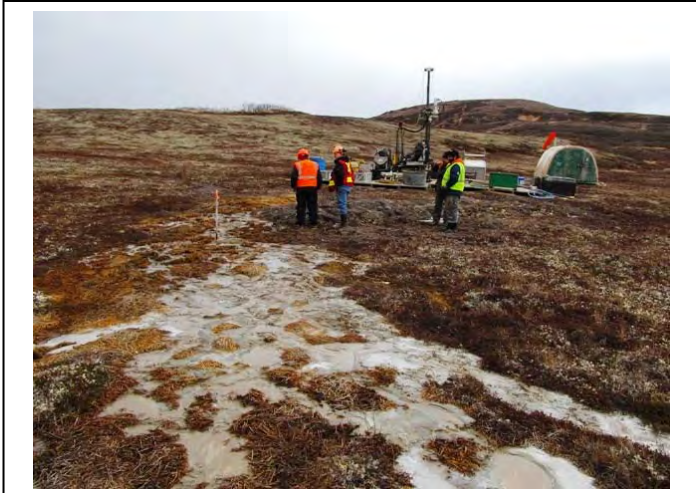
Distal end of surface ice plume, looking west.

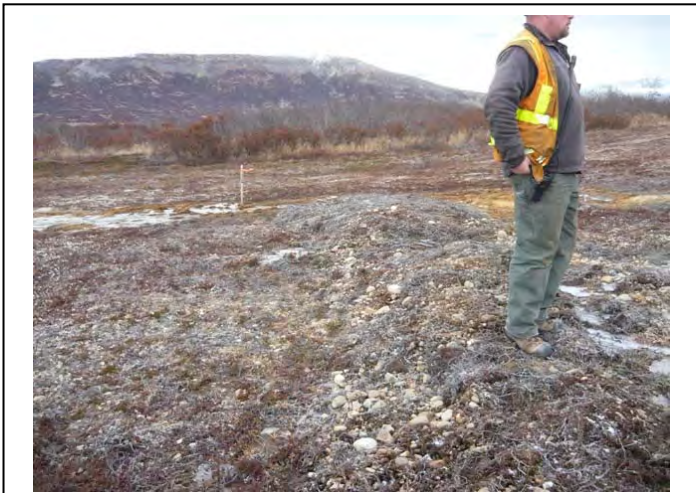
Mounded soil filling recirculation trenches.

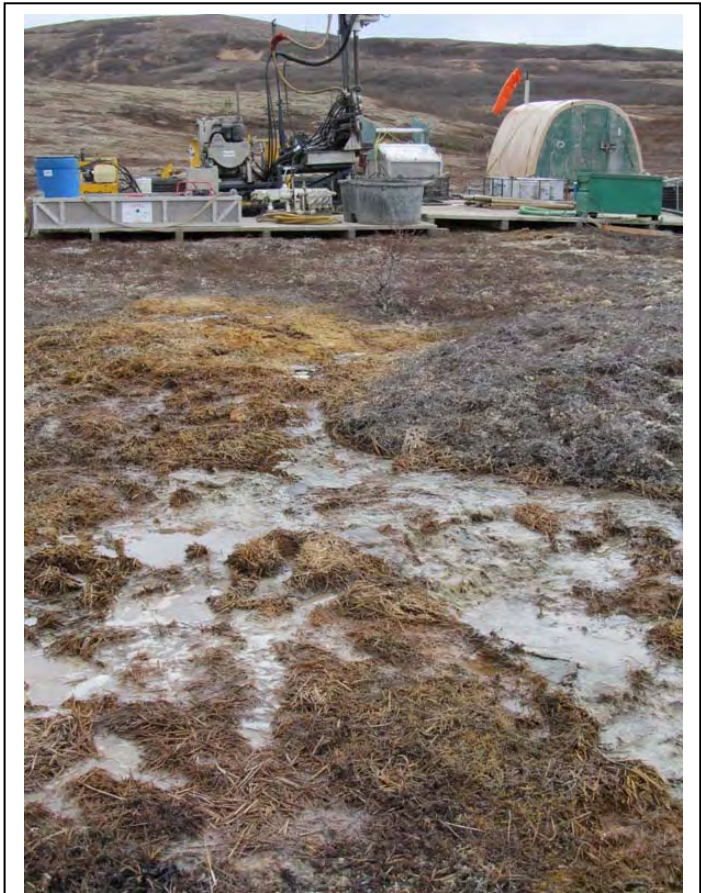
Middle portion of artesian upwelling, showing surface icing and staining, DH 09462

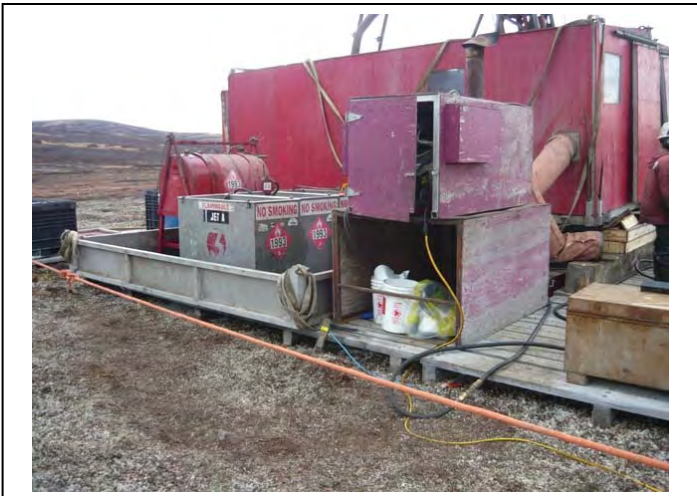
Fuel containment and trash disposal near drill rig.

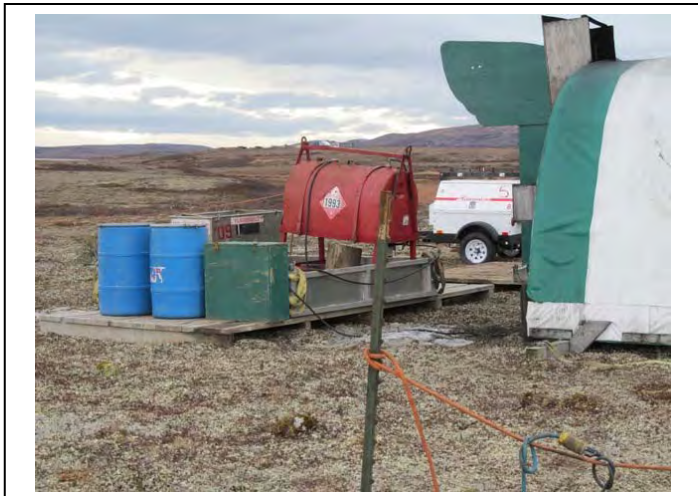
Fuel containment behind driller shack.

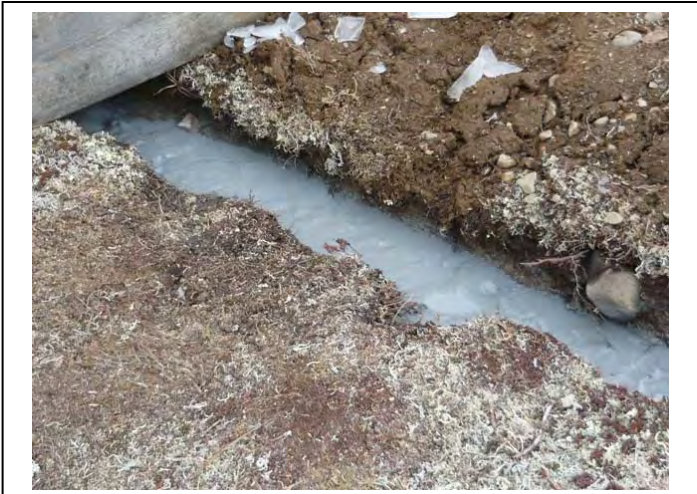
Recirculation flowing in keyway trench from drill rig.

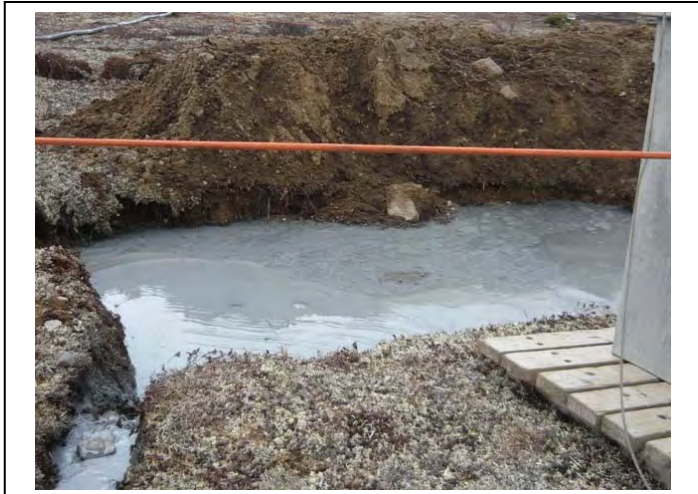
Recirculation water flow filling sump pit #1.

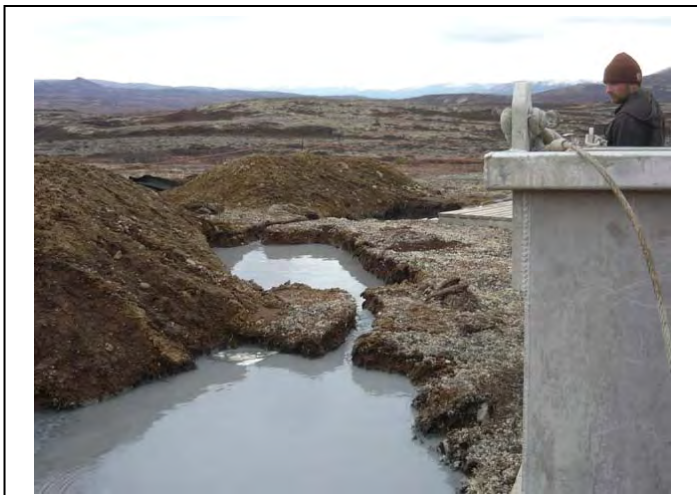
Sump pits 1 and 2, DH site 11539

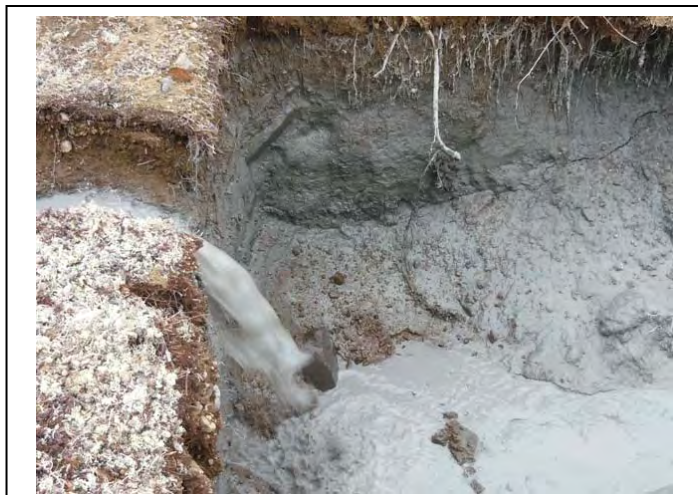
Outfall to sump pit #3, beginning to refill.

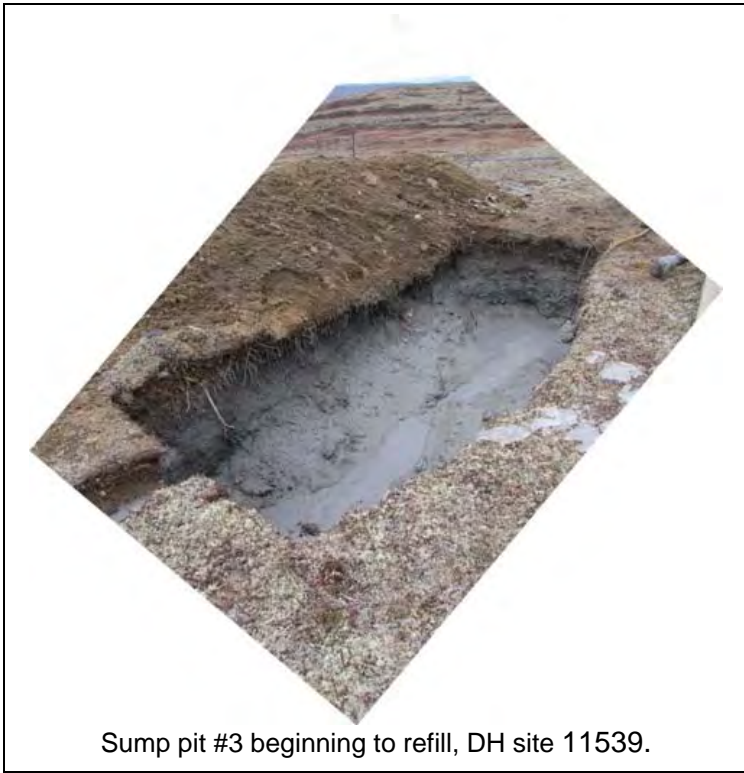
Sump pit #3 beginning to refill, DH site 11539.

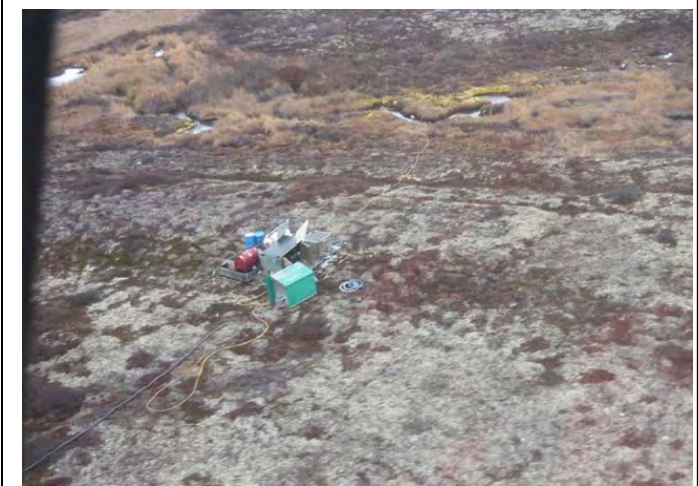
Water source pump station, near creek, DH site 11539
