Field Monitoring Report

-- Pebble Copper/Gold Exploration Project --

Inspection Date: October 28 & 29, 2008

APMA #: A086118

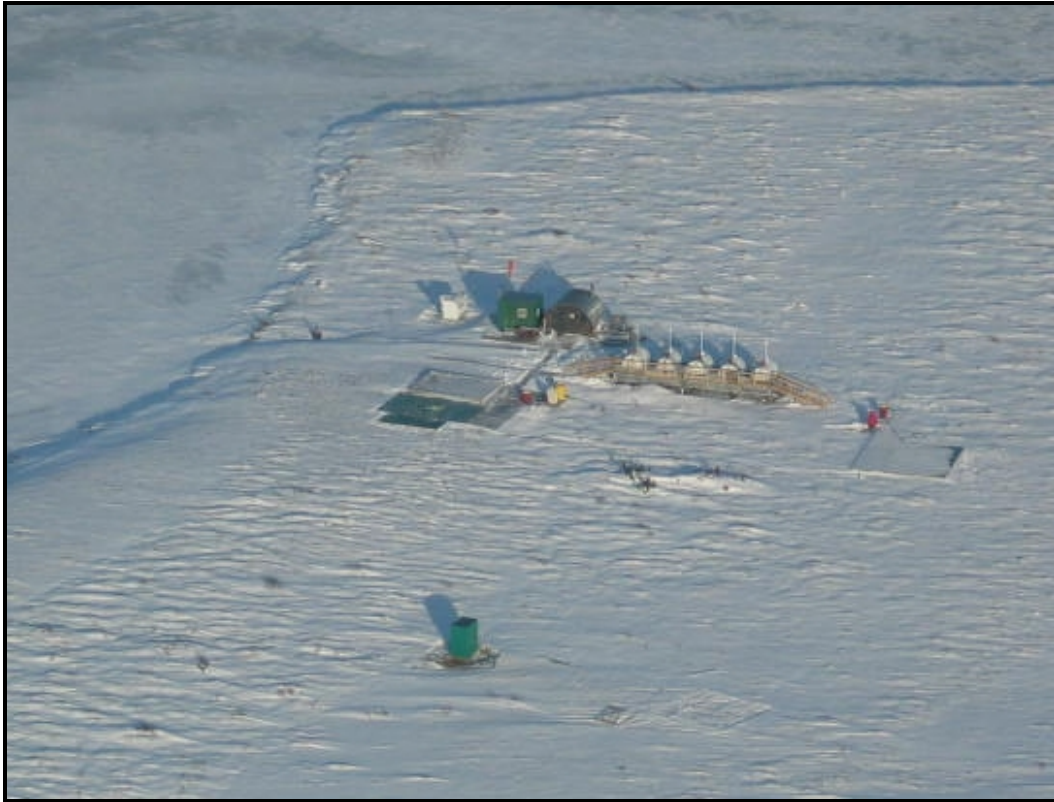
Comments: Drill rigs were largely clean and in good order. All fuel containments were in good order as well. The Big Wiggly fuel storage facility was not in use at the time of our inspection because the lake is freezing over. Currently there are 12" of ice, and PLP will begin flying the Beaver on skis for fuel transfer soon. Most water intake points were not visible due to snow and ice cover. Geotechnical drilling has been stopped for this year. Planned winter shut down of drilling will be December 13.

Photo #1. Big Wiggly fuel storage. Not in use at time of inspection.

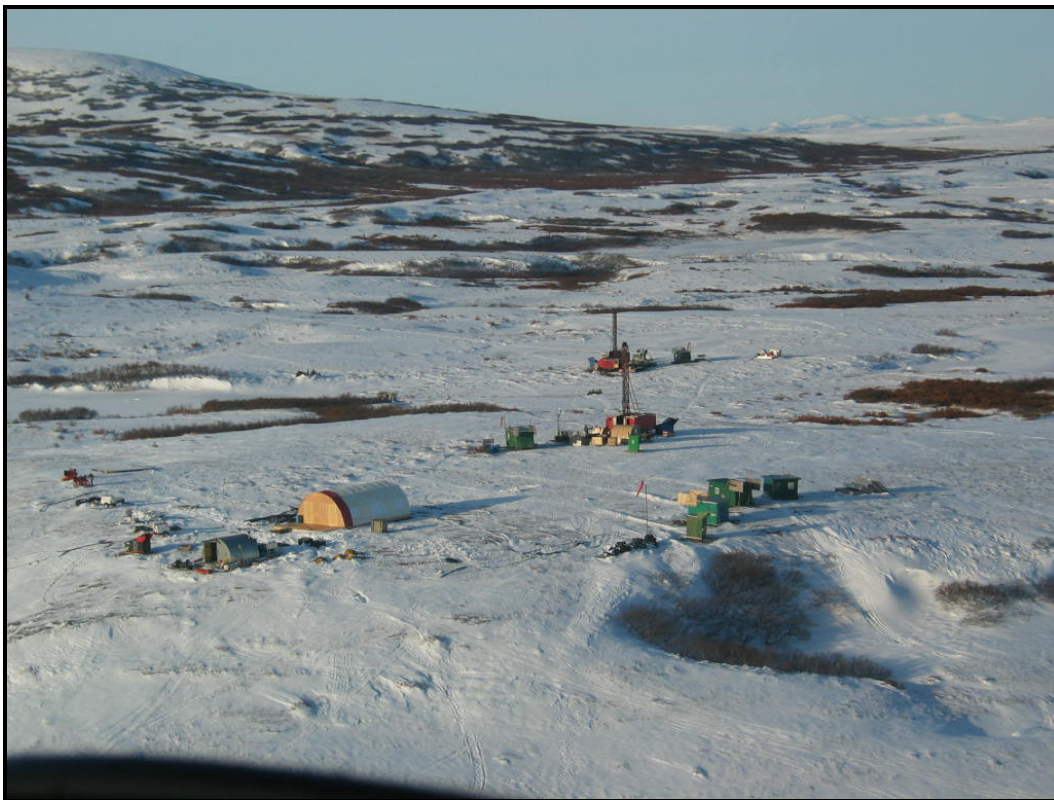
Photo #2. Drills and water line storage area at Pebble Project.

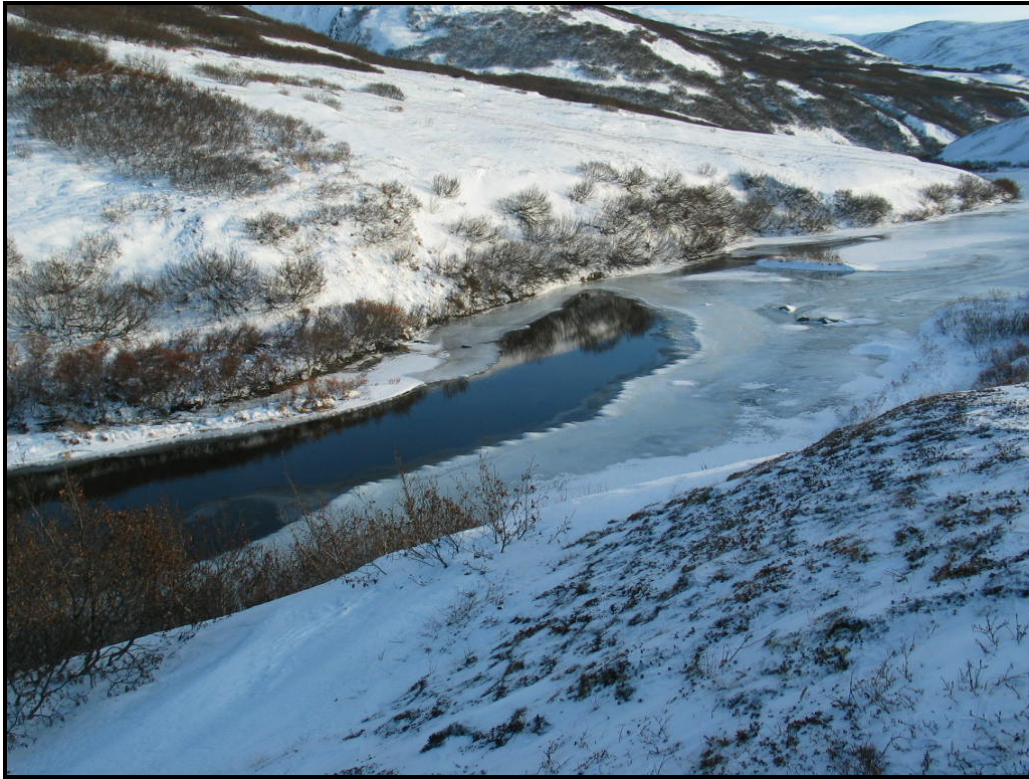
Photo #3. South Fork Kaktuli River immediately below Frying Pan Lake.

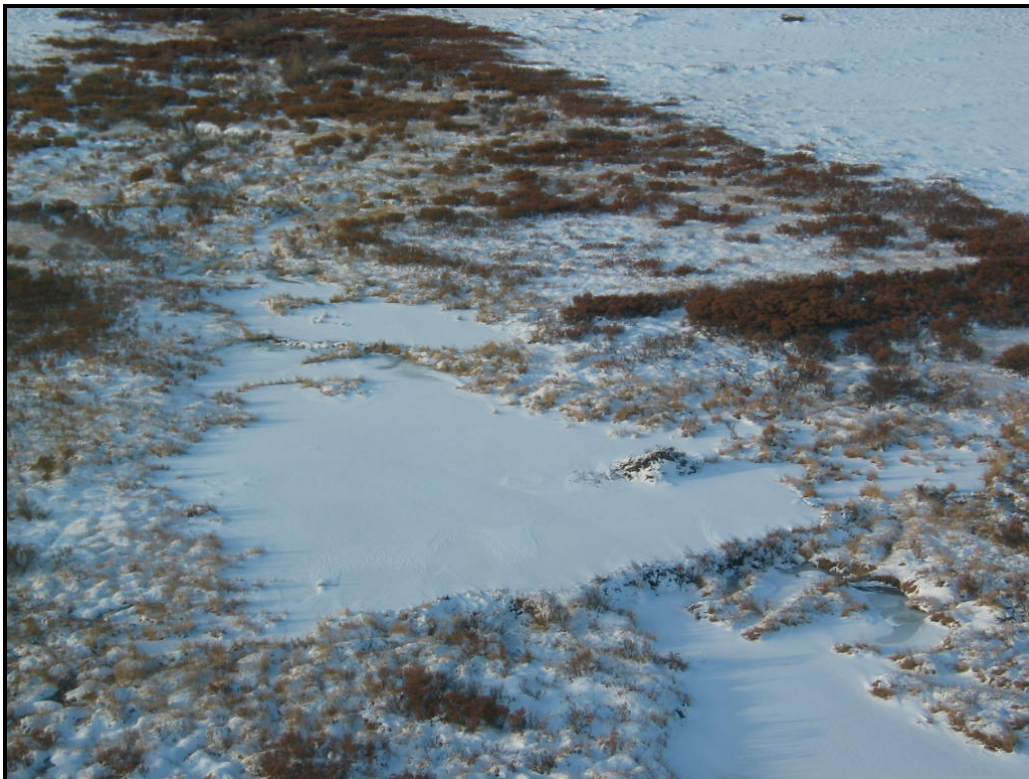
Photo #4. Beaver pond and lodge in uppermost South Fork Kaktuli drainage, above Frying Pan Lake.

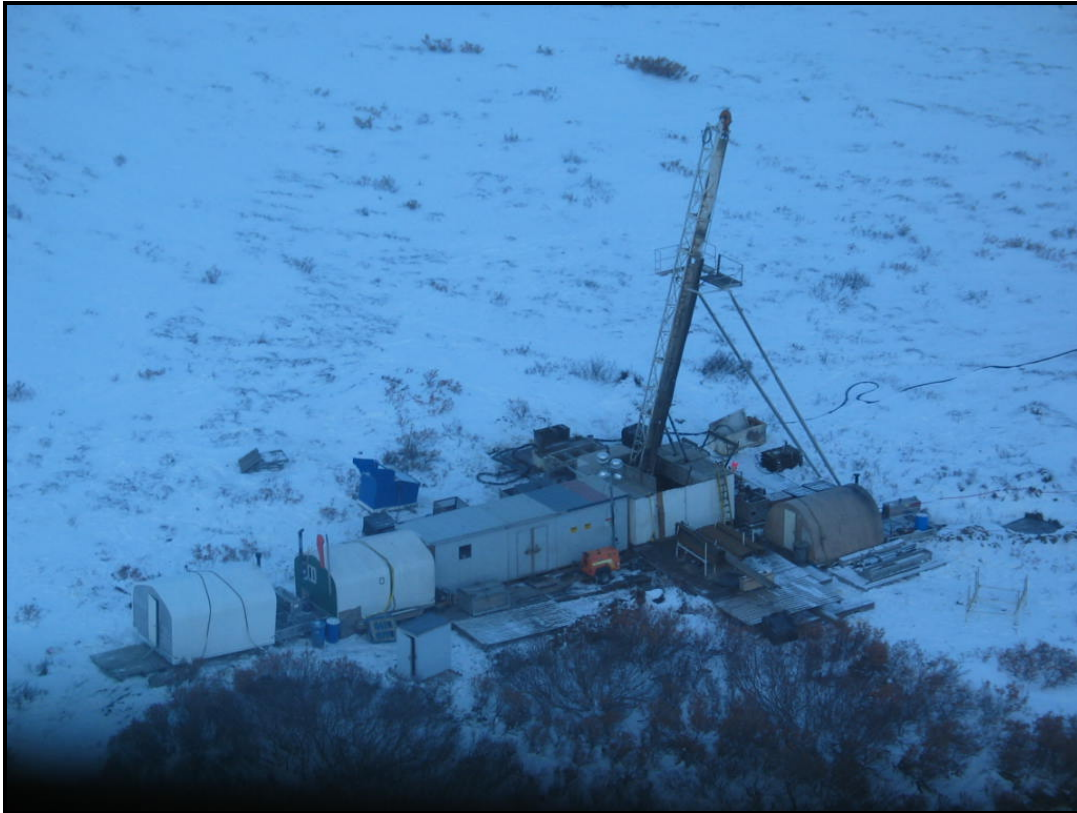
- Distance from waterbody: >500'; wetland approx. 300' away.
- Location of fuel storage: Next to drill, on tundra pad.
- Sorbent pads present: Yes
- Tundra mat: Yes
- Pipe off tundra: Yes
- Litter: Picked up 2 or 3 pieces of plastic.
- Trash containment: Yes
- Sanitary facilities: Yes
- Any spills or staining: No
- General impression: Clean and orderly, except for minor trash

Photo #5. Drill rig #1 on hole #8438.

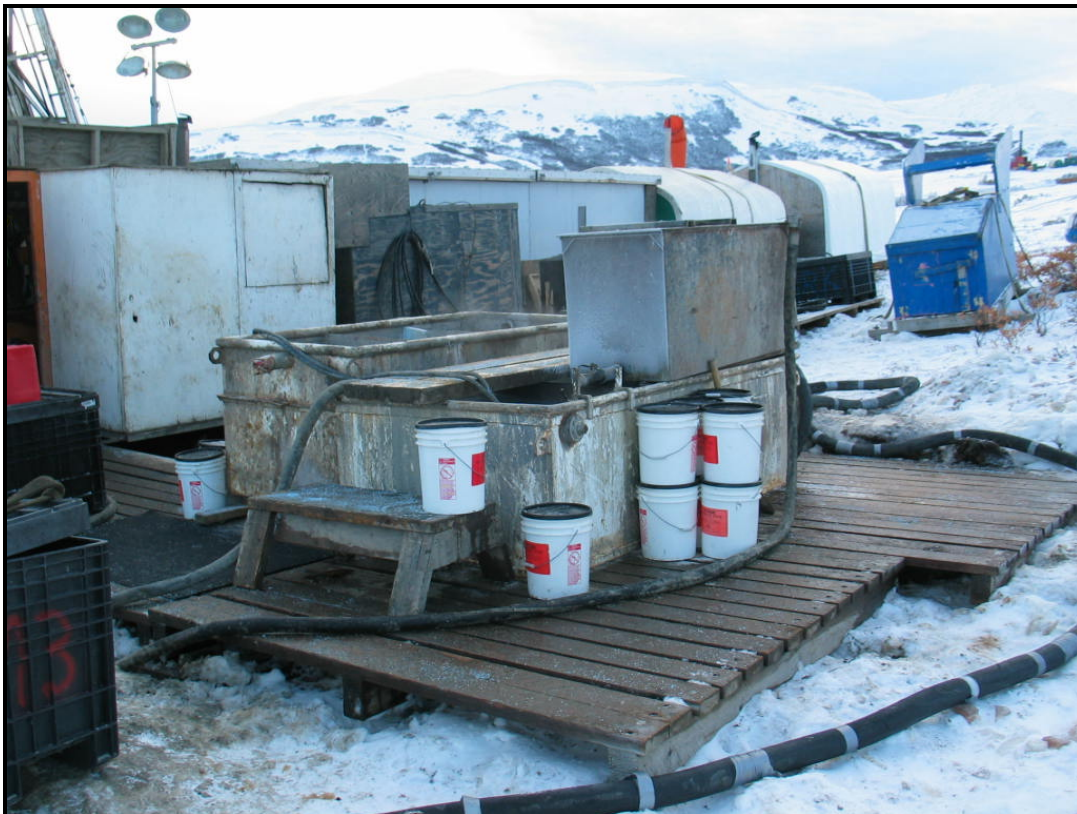
Photo #6. Recirculation mud tank on drill #1.

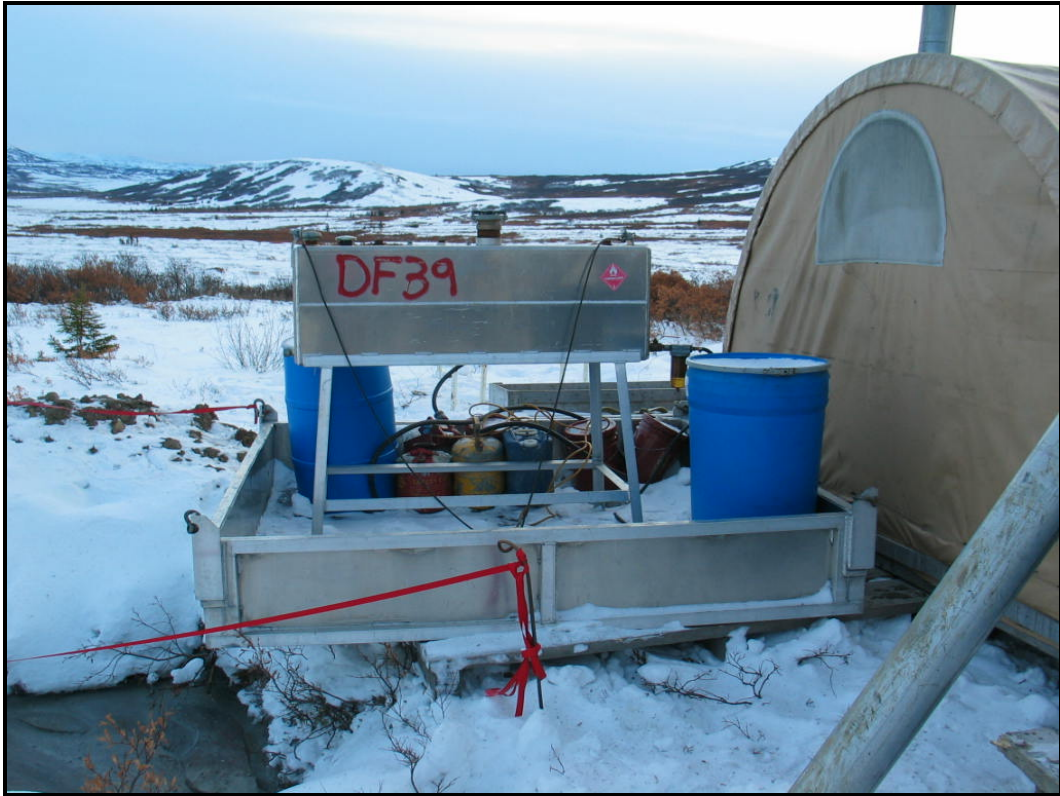
Photo #7. Fuel and containment for crew shed.

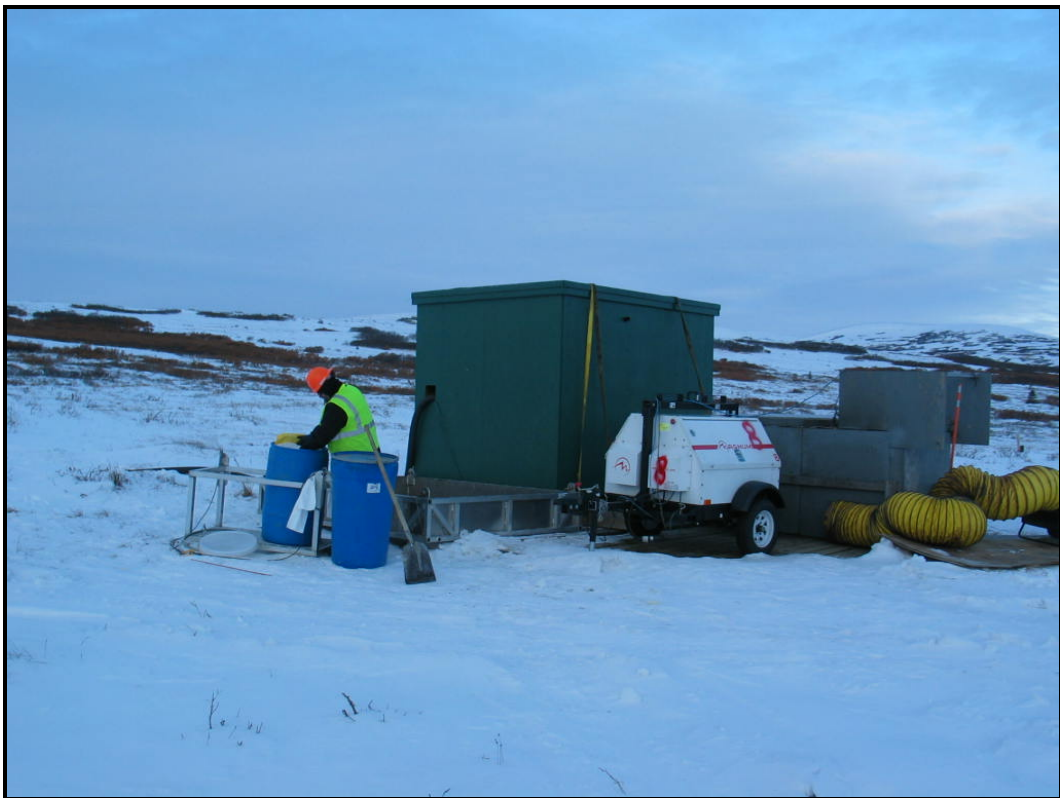
Photo #8. Crew member changing out spill kit at water pump for drill #1.

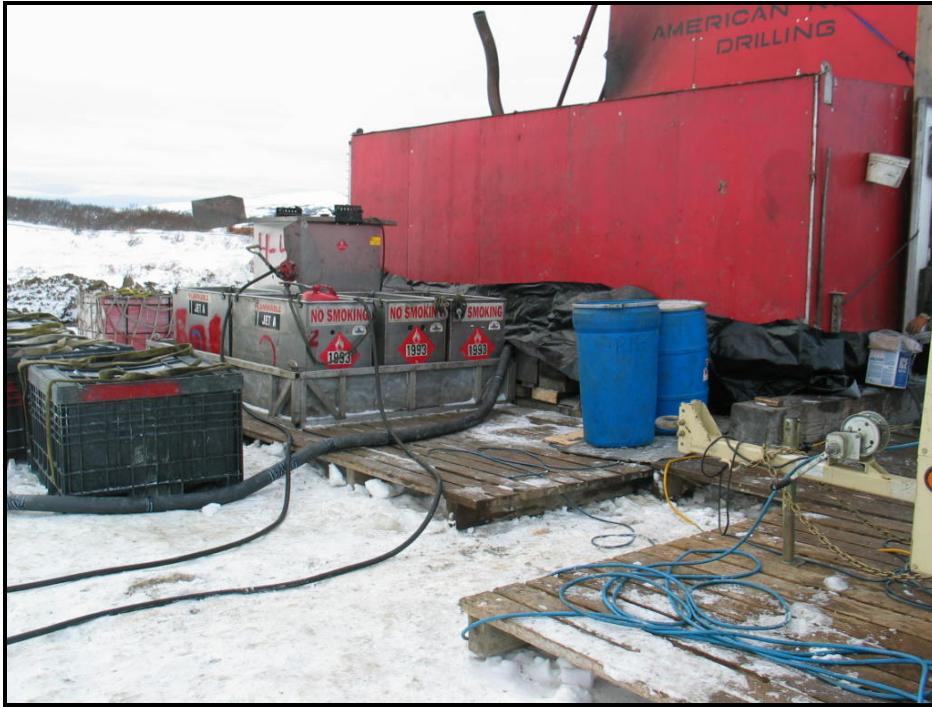
Photo #9. Fuel and containment at drill #2. Spill kit and scrubber barrel are in place.

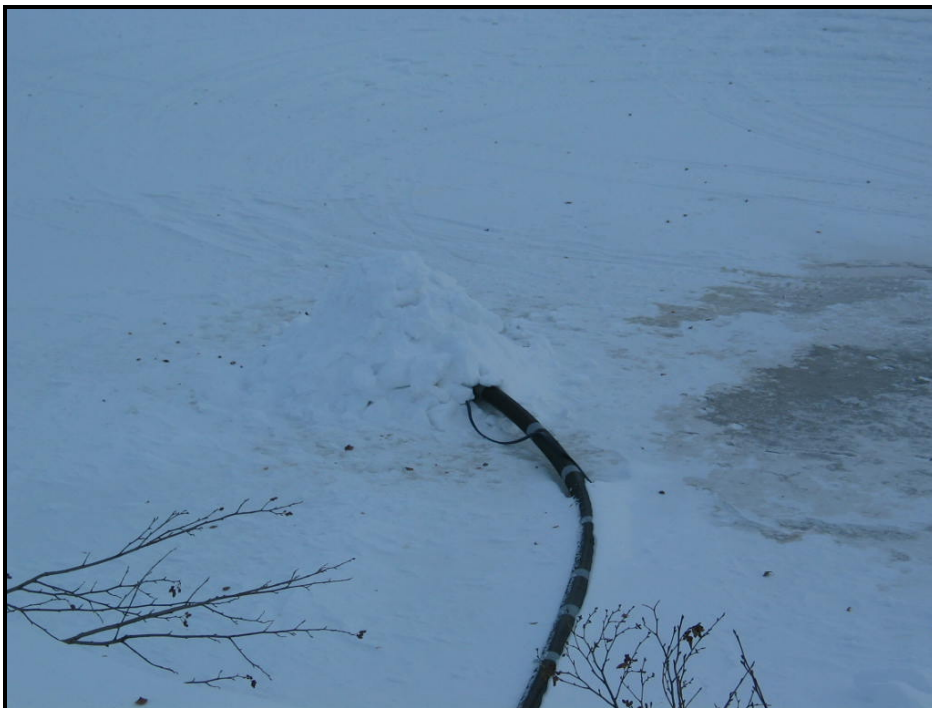
Photo #10. Water intake for drill #2, in kettle pond.

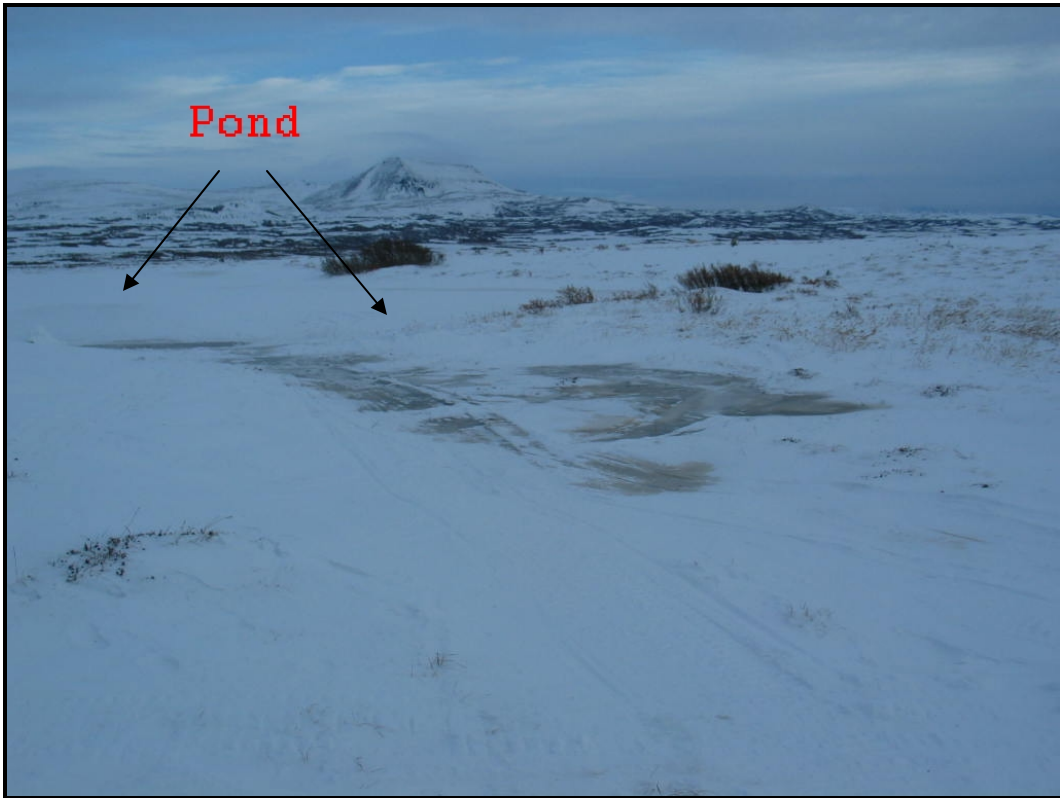
- Location and extent of discharged material: Before mud tank was installed mud flowed downhill to NE, toward kettle pond. Straw bales placed to stop flow. Photo
- Topsoil, muck, tundra stockpiled: Yes
- Location of secondary sump pit: Adjacent to pad
- Hose color:

Photo #11. Ice where discharge has flowed toward pond.

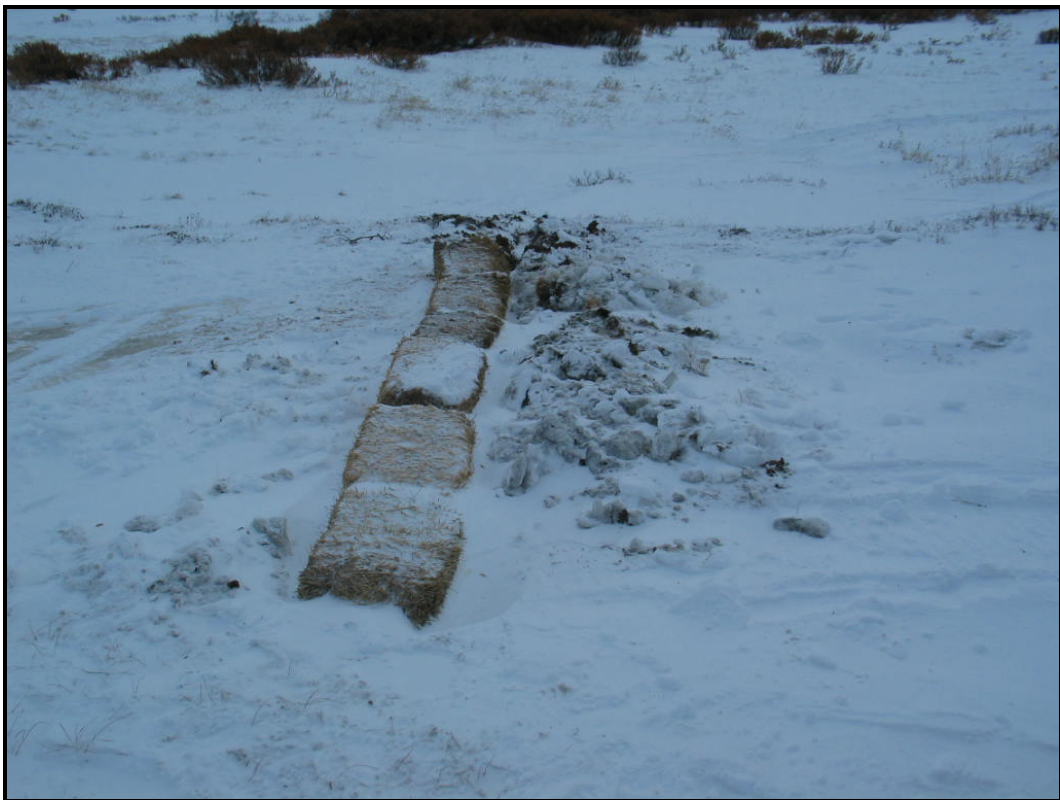
There were bales of straw placed to stop flow of discharged fluids from going into a nearby pond at drill #2. We asked PLP personnel if the straw was weed/invasive free. Gary Deschutter has since informed me that the straw is not weed/invasive free, but the Partnership will look into using weed free straw next season.

Photo #12. Straw bales placed to block flow of discharge toward pond.

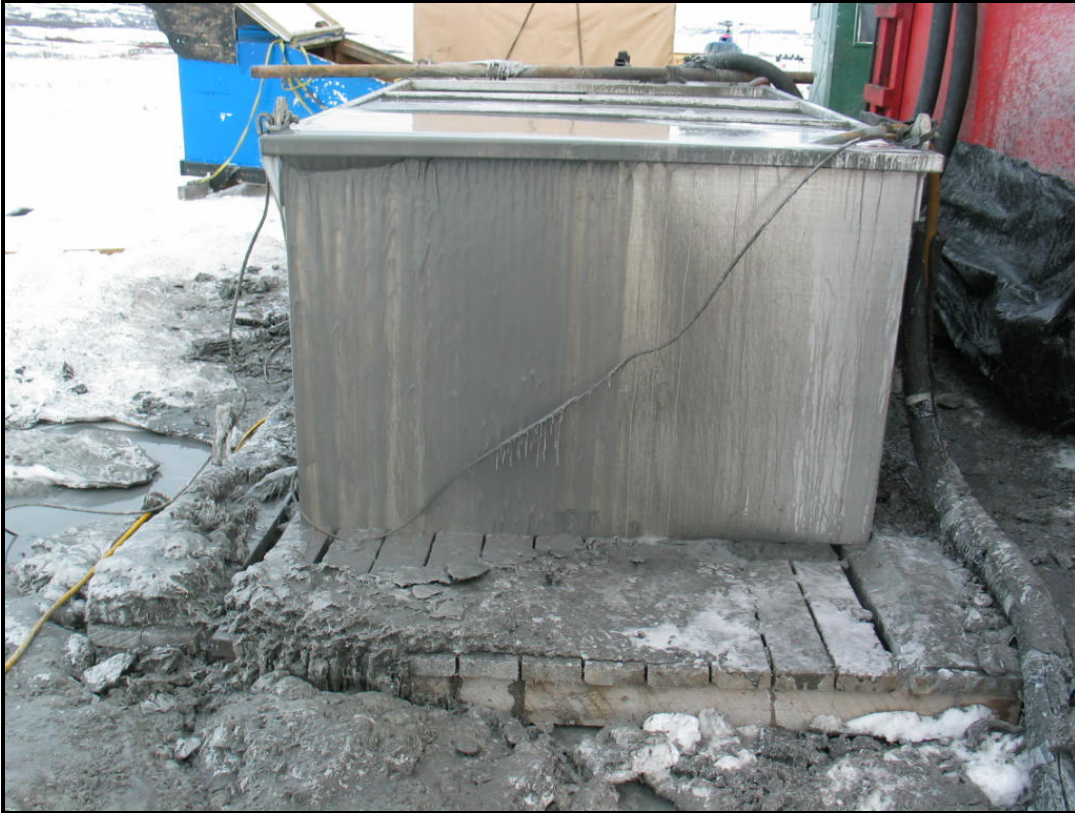
Mud was flowing out of the recirculation tank. Most flowed into sump, but some was flowing onto ground next to drill. Photos

Photo #13. Drilling mud overflowing from recirculation tank at drill #2.

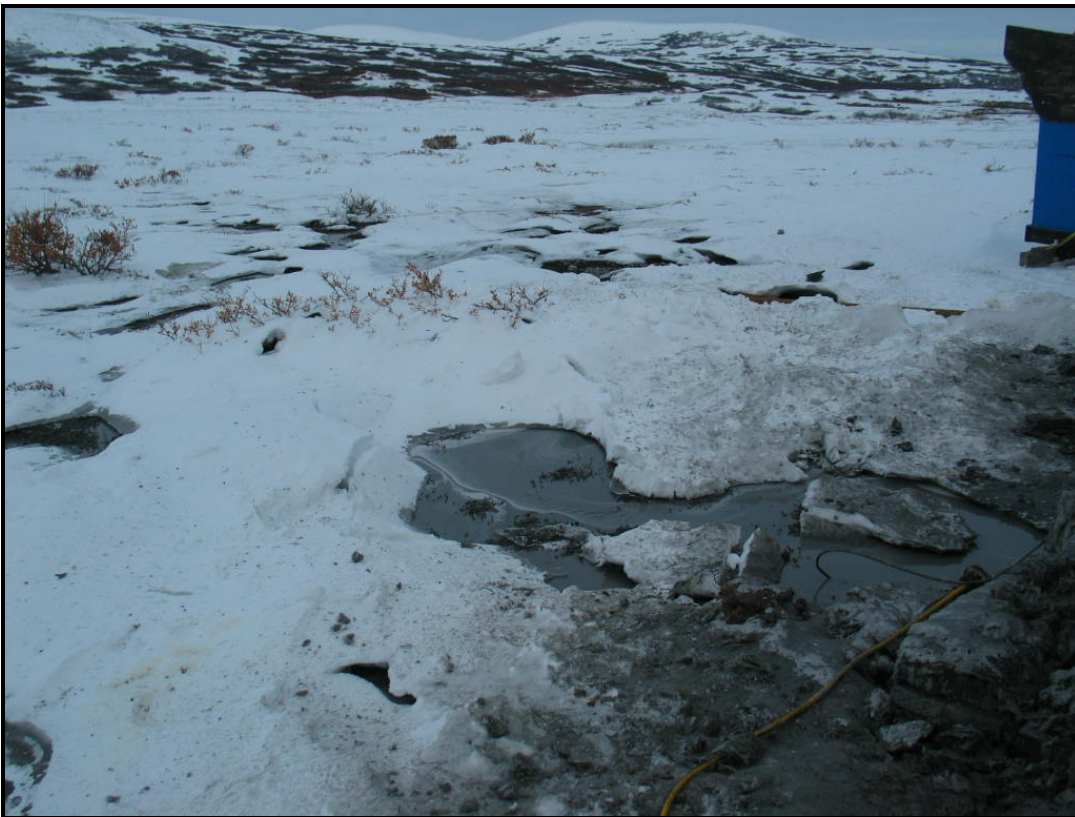
Photo #14. Fluid discharge from recirculation tank onto ground on west side of drill #2.

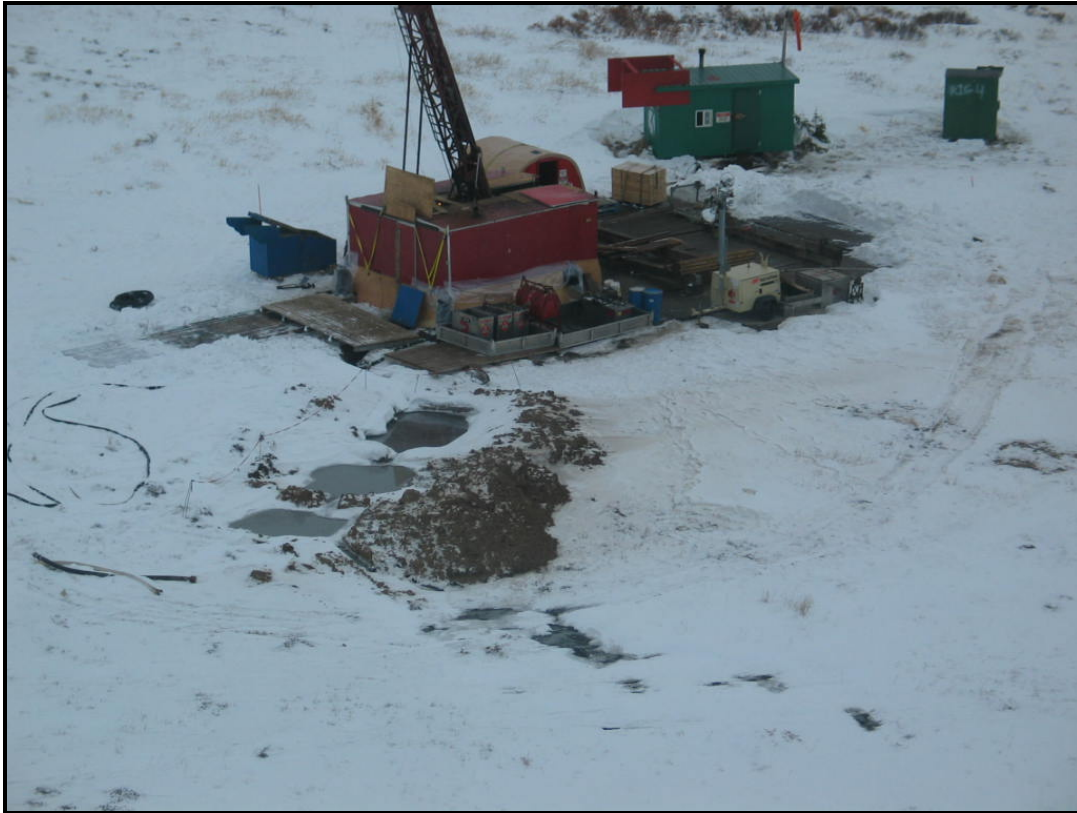
- Location and extent of discharged material: SSE, 2-3 gpm discharge extends ~200' down slope.
- Topsoil, muck, tundra stockpiled: Yes
- Location of secondary sump pit: Adjacent to pad
- Hose color:

Photo #15. Drill #3, sump pits and drilling discharge.

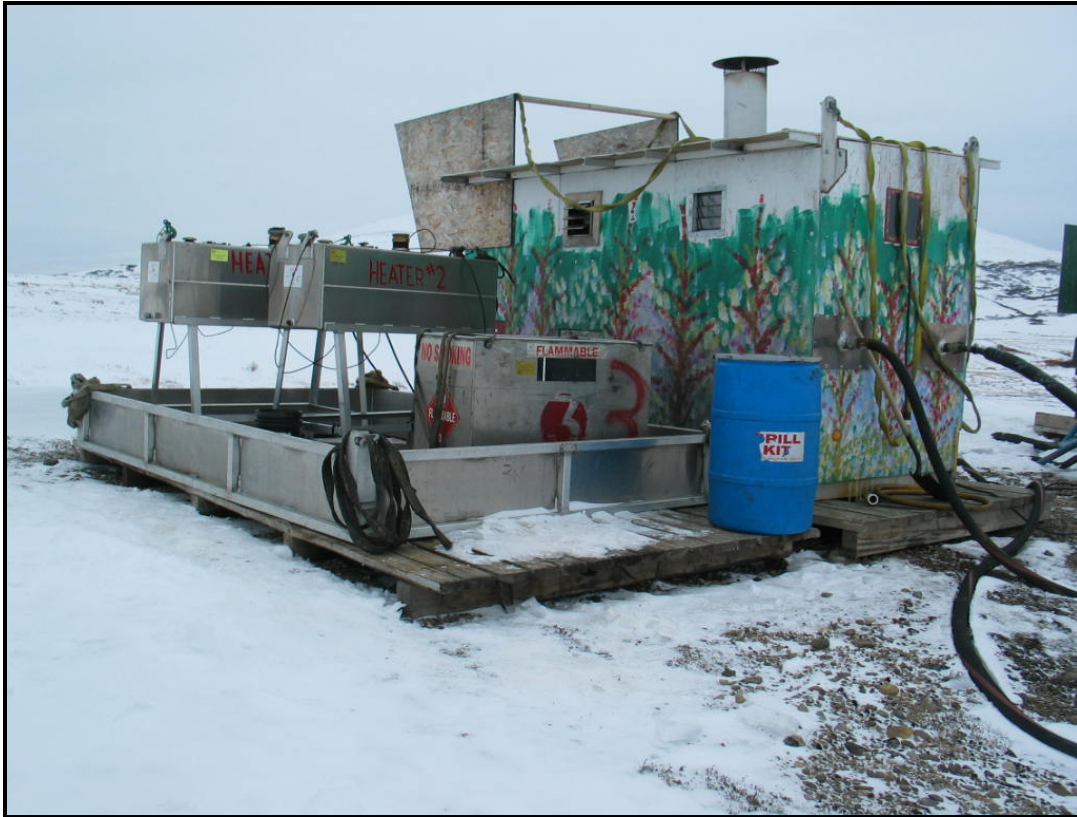
Photo #17. Shed and fuel containment at water pump for drill #3.

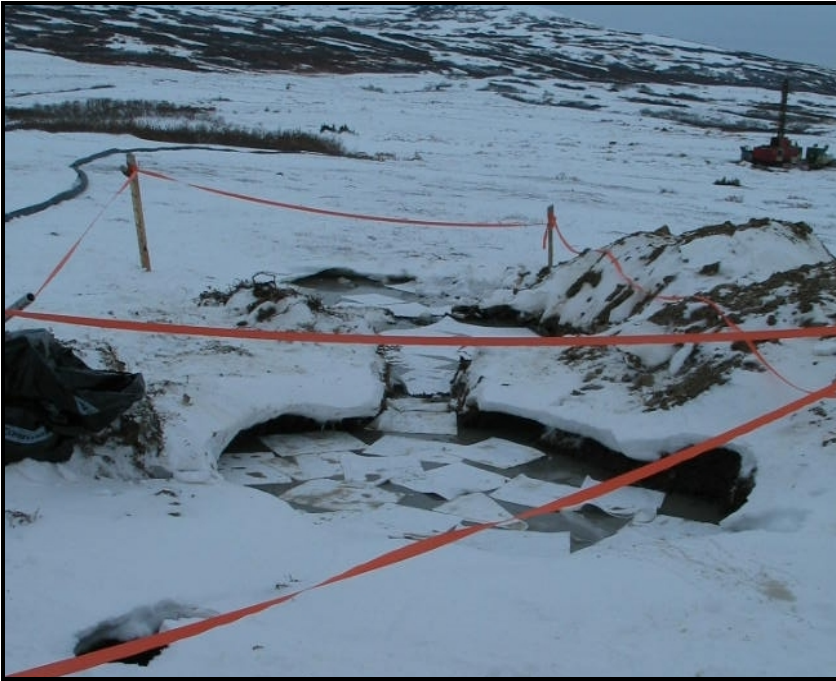
Photo #19. Sorbent pads on sump pits at drill #4.

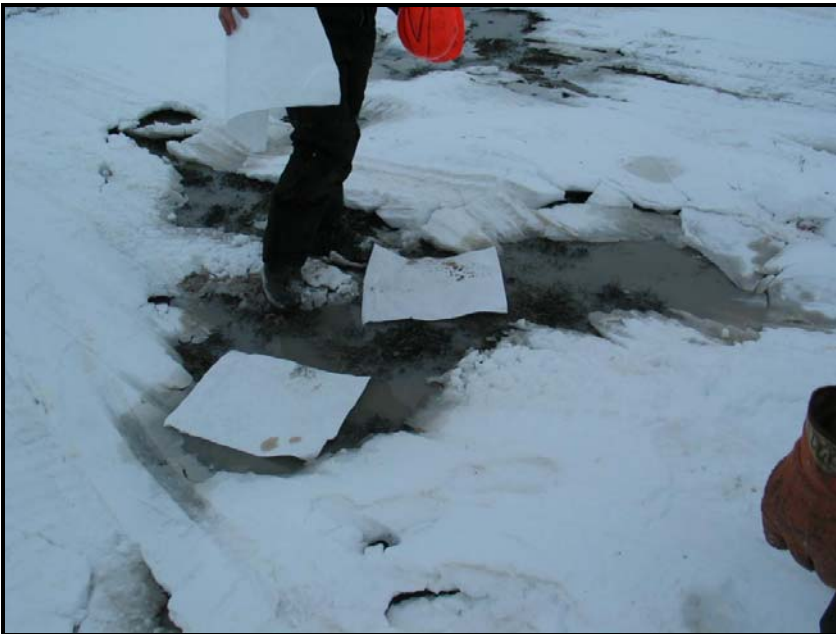
Photo #20. Sorbent pads being placed on discharge from drill #4.

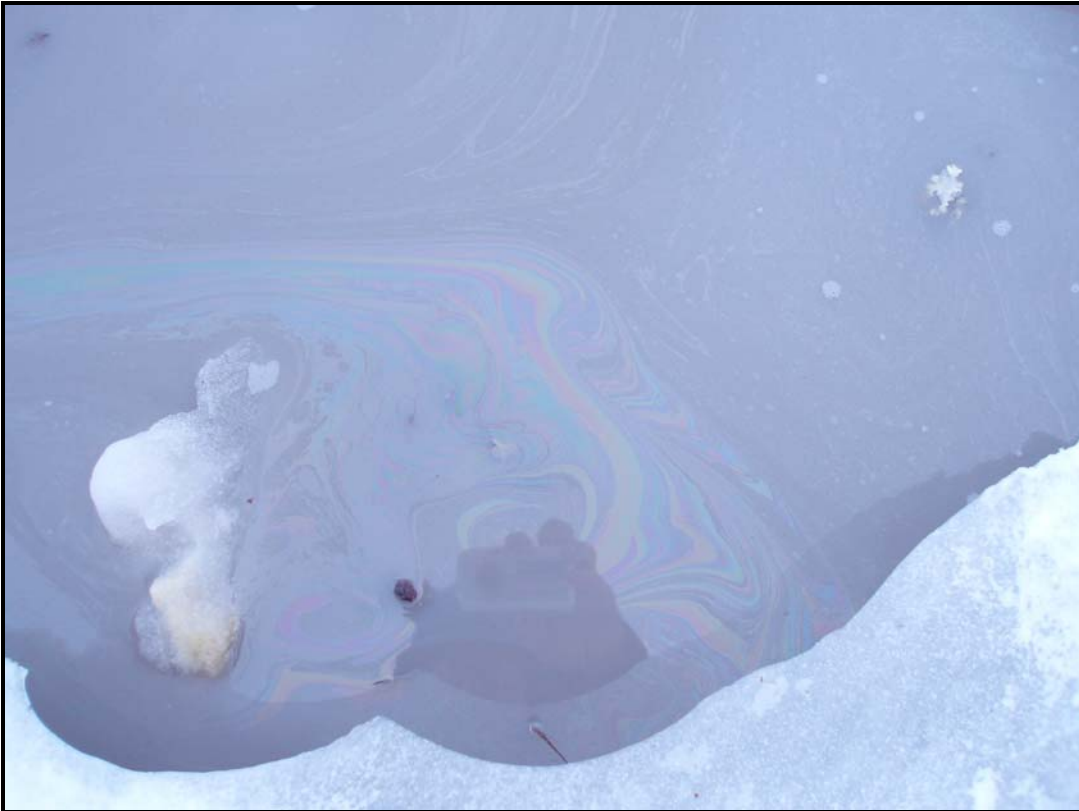
- Distance from waterbody: 600'
- Location of fuel storage: At drill on tundra pad
- Sorbent pads present: Yes
- Tundra mat: Yes
- Pipe off tundra: Yes
- Litter: None
- Trash containment: Yes
- Sanitary facilities: Yes
- Any spills or staining: Approx. 1 gal. hydraulic fluid was spilled this morning. Most was captured at the time of spill. Some got into the sump. There were a few places where a minor sheen could be seen on the sumps and discharge area. Drillers were placing sorbent pads to collect remaining fluid.
- General impression: Clean and orderly

Photo #21. Sheen from hydraulic fluid on discharge from drill #4.

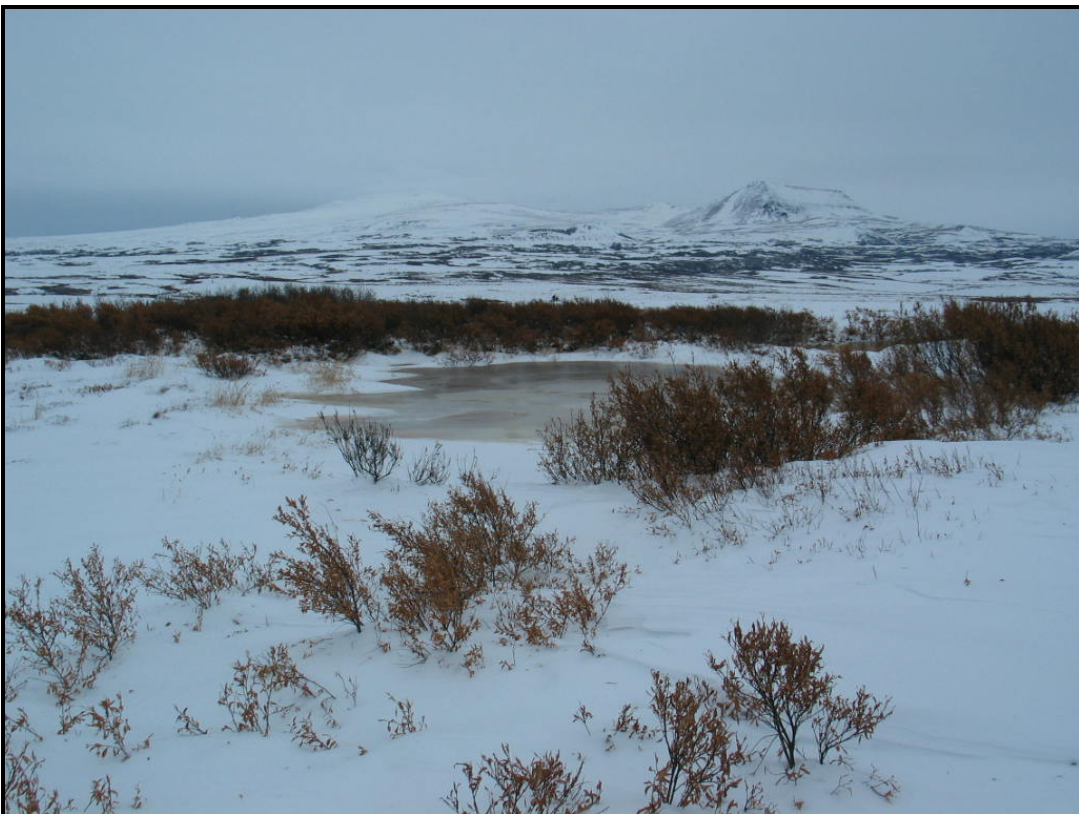
- Location and extent of discharged material: Approx. 23 gpm flowing down hill to NE about 250'. Collecting in a depression. Photo.
- Topsoil, muck, tundra stockpiled: Yes
- Location of secondary sump pit: Adjacent to pad
- Hose color:

Photo #22. Depression catching discharge from drill #4.

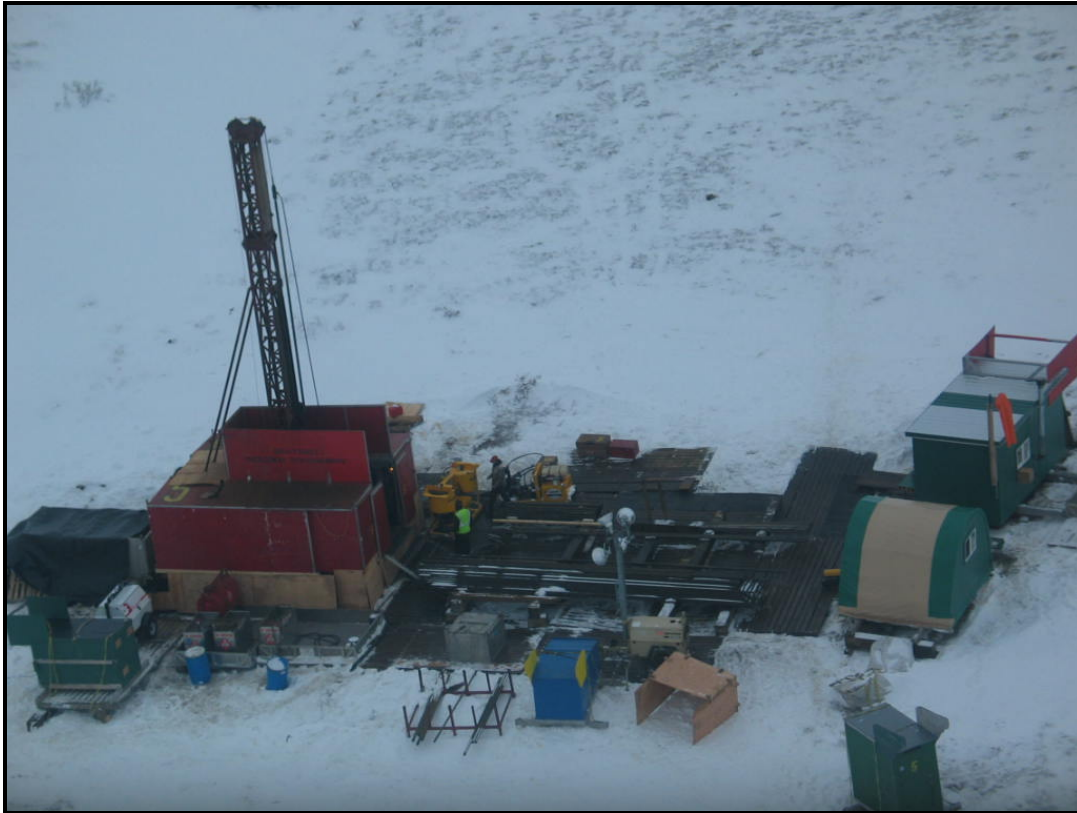
Photo #23. Drill #5.

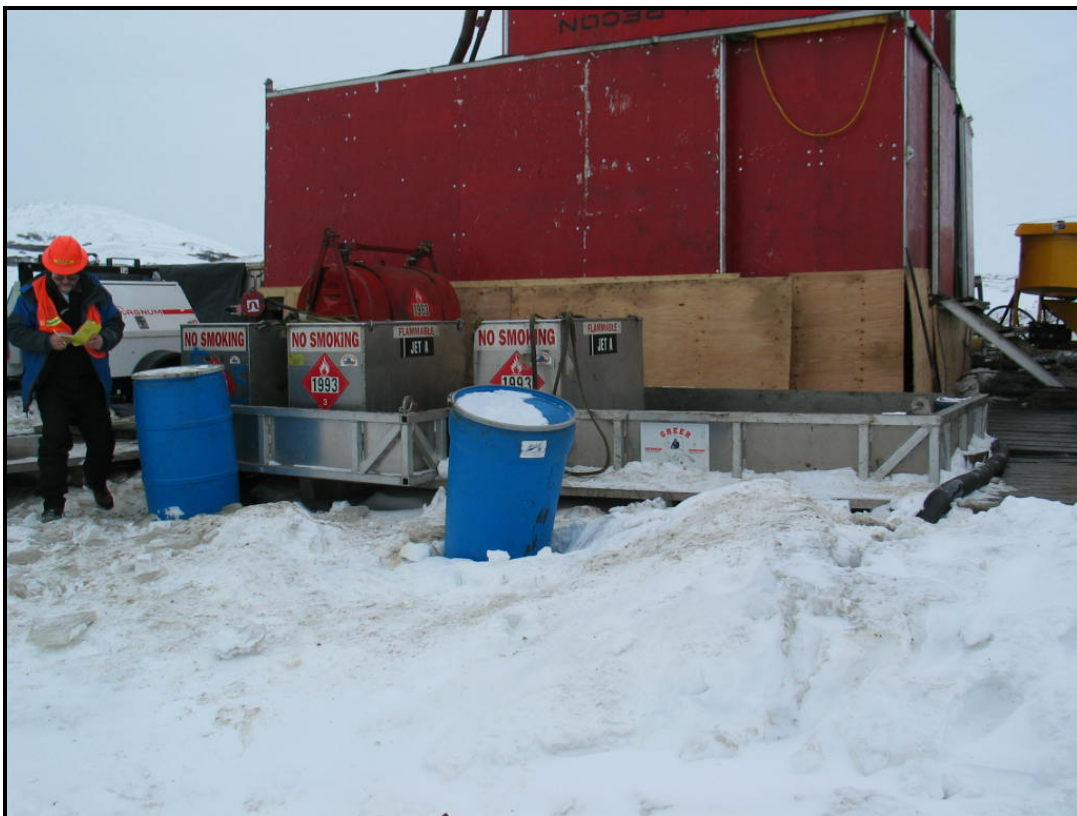
Photo #24. Chris Foley, of DEC, inspecting fuel containment at Drill #5.

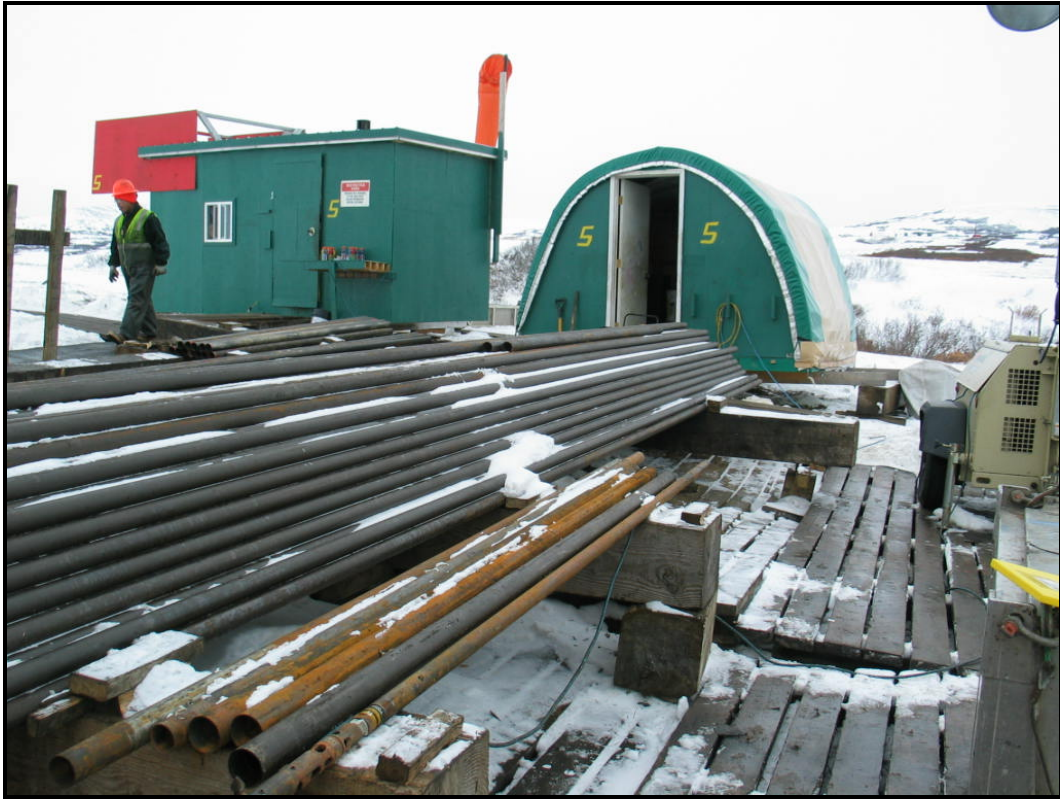
Photo #25. Drill rods at rig #5.

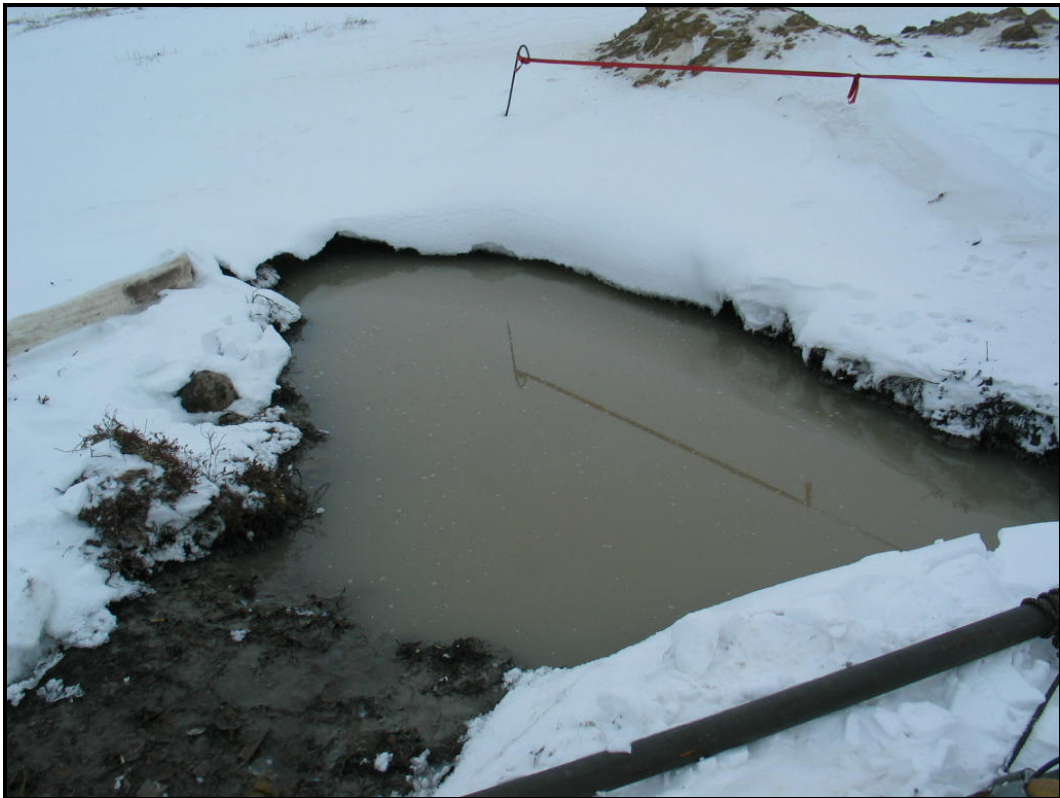
Photo #26. One of two sump pits at drill #5. Outflow is to bottom left of photo.

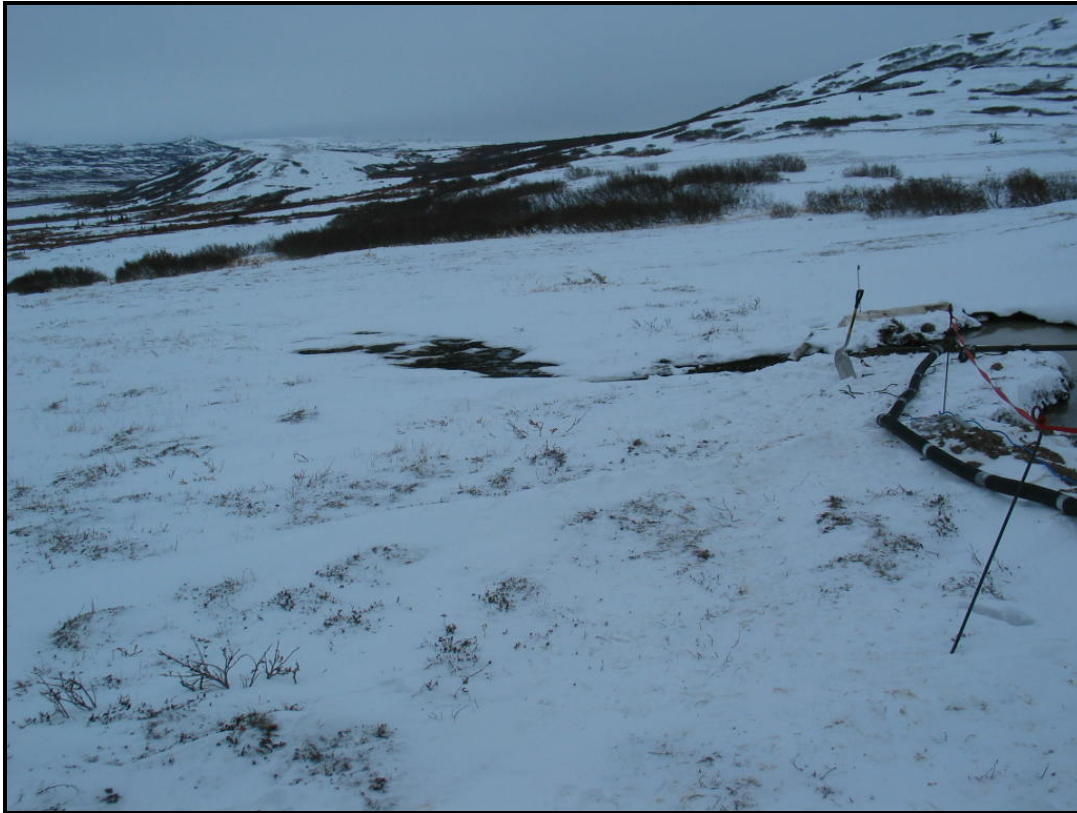
- Location and extent of discharged material: Extends ~200' downhill to NNE
- Topsoil, muck, tundra stockpiled: Yes
- Location of secondary sump pit: Adjacent to pad
- Hose color:

Photo #27. Fluid discharge extends approximately 200' downhill from drill #5.

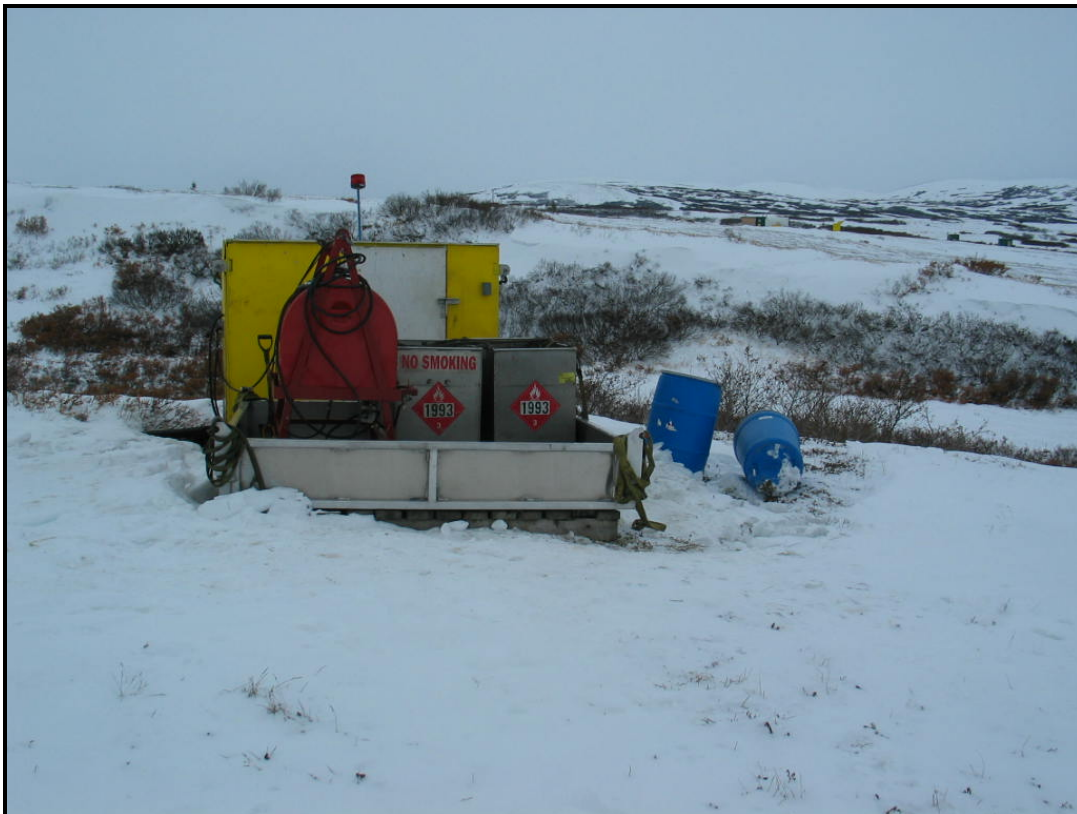
Photo #28. Water pump at drill #5.
