Field Monitoring Report

-- Pebble Copper/Gold Exploration Project --

Inspection Date: October 28 & 29, 2008

APMA #: A086118

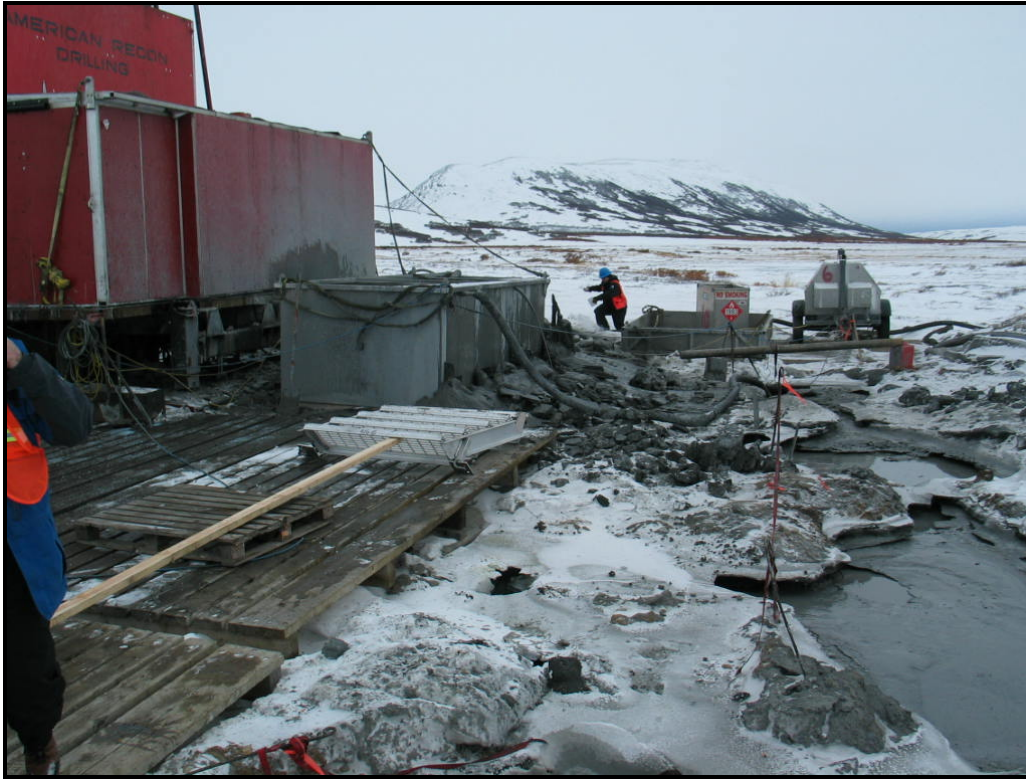
Photo #29. Sump pits and recirculation tank at Drill #6. Mud was overflowing from the tank into the pits, but none was leaving the sumps.

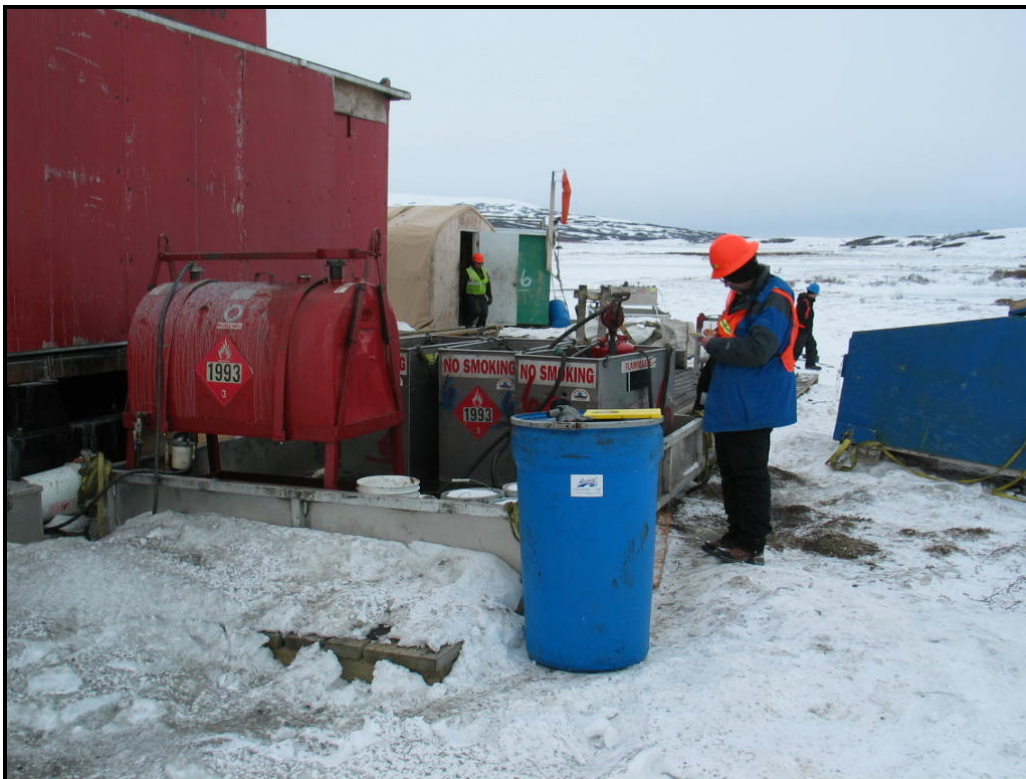
Photo #30. Fuel containment at drill #6.

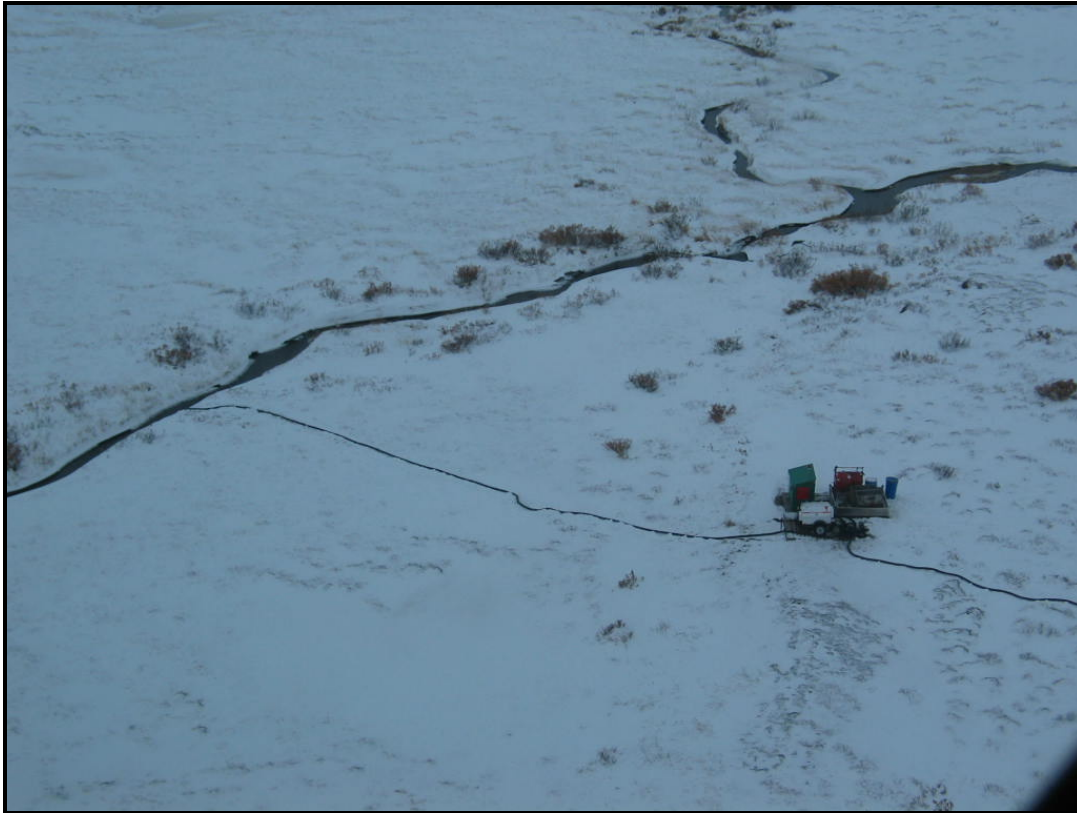
Photo #31. Water pump and intake stream for drill #6.

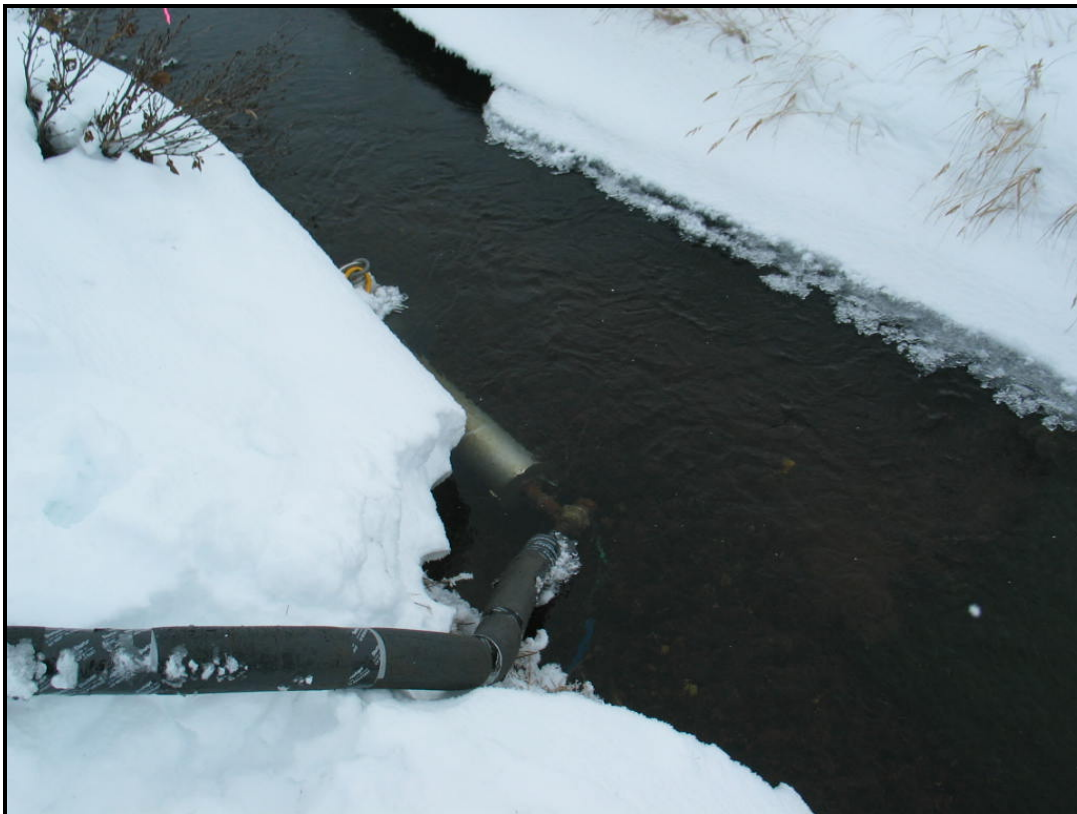
Photo #32. Water intake for drill #6.

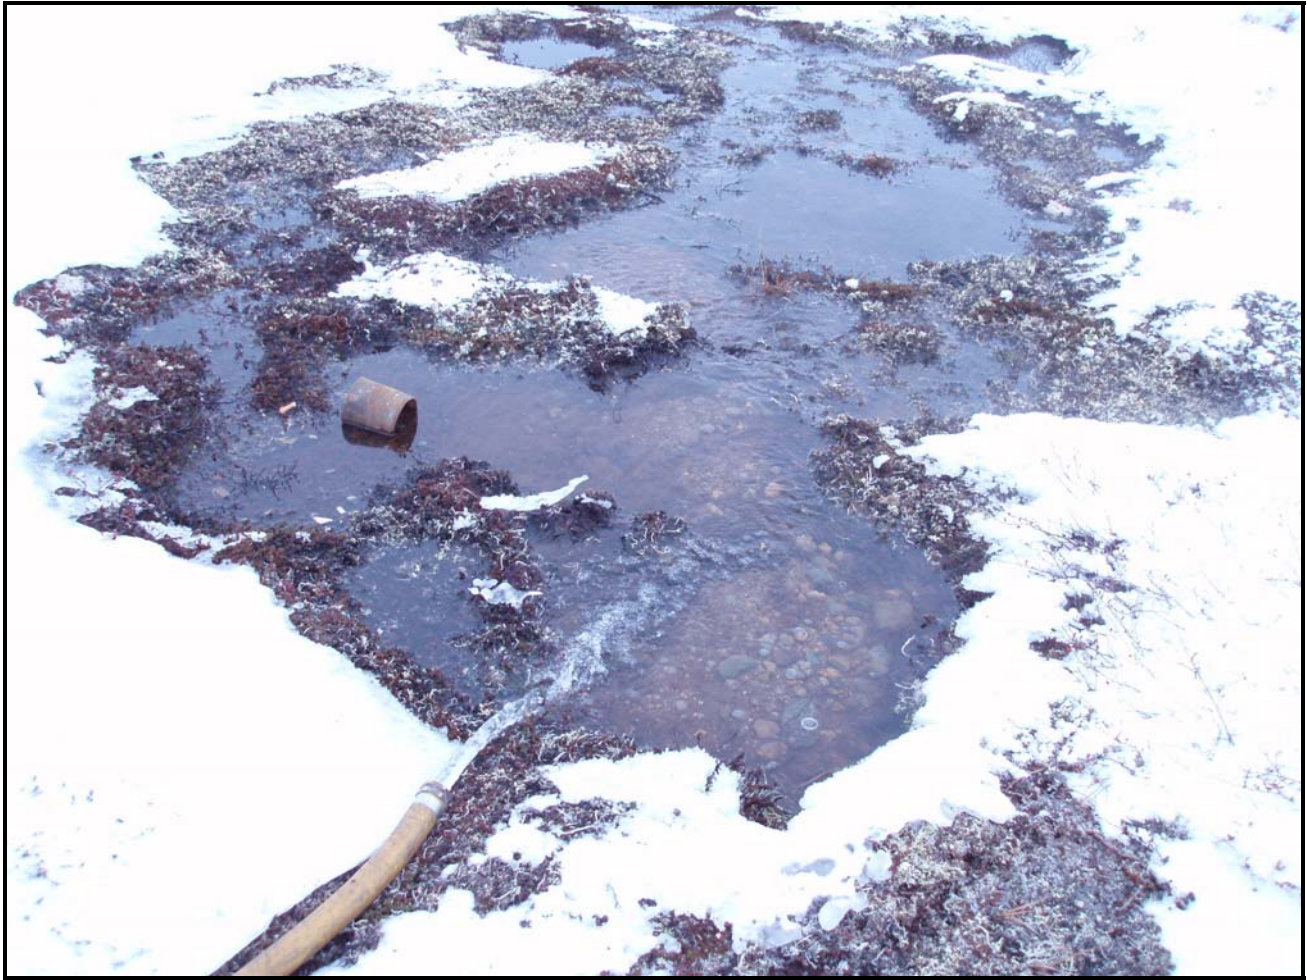
- Drill additives in use: EZ MUD, Extreme #1
- Water recirculation: Yes
- Water discharged: Yes, excess water from water line being discharged from 1" hose.
- Artesian zone encountered: Unknown

Photo #32. Excess water being discharged onto the tundra at drill #6.

- State regulatory agencies and the PLP should further discuss the relative merits of handling drill fluids by discharge onto the ground, discharge into dry depressions, or recirculation.
- If sorbent pads are in use, they should be picked up before helicopters enter the rig area.
- The discharge of excess water directly onto the ground in a concentrated stream could cause erosion. The effects of direct discharge should be evaluated, and possibly some sort of diffuser should be placed to reduce damage. Something as simple as a sheet of plywood, possibly with a rough surface, might be effective.
- Request information from PLP on whether seed mix used for rehabilitation of drill sites is consistent with native vegetation.
