APMA A20176118- FIELD SUMMARY REPORT

Inspection Date: 20 July 2017 11:13am
Weather: Broken Skies (8,000+ ft), Winds N 5 MPH, Air Temp. Approx. 58° F
Agency Personnel: Hollie Chalup (Mining Section), Logan Stolpe (Mining Section)
Operator Contact: NA
Pilot: David Lorrington, Wrights Air
Inspection Type: General Aerial Inspection

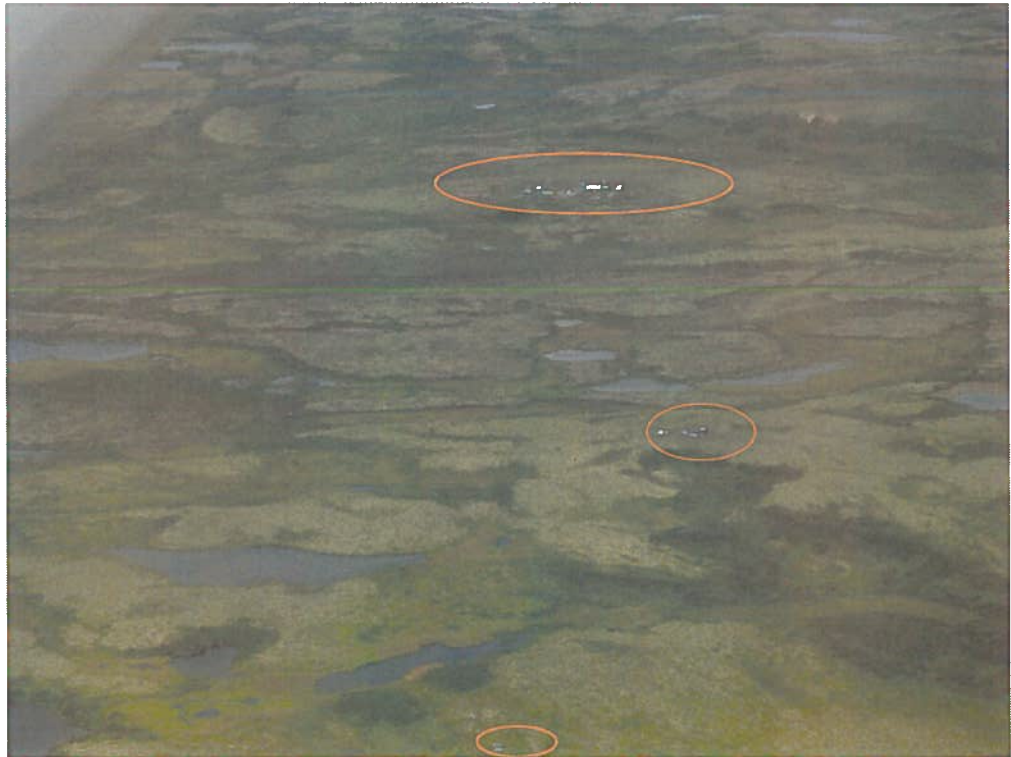
1. Main Supply Depot Overview
20 July 2017

Main Supply Depot including West Bay 4, Watershed, and ARD Test Site.
