## Field Monitoring Report -- Pebble Copper/Gold Exploration Project --

Personnel:	Inspection Date: June 4, 2009
Jim Vohden	Site Contact: Jeff Norberg
Scott Maclean	APMA #: A096118
Ron Benkert	
<b>■ Inspection Type:</b> <ul style="list-style-type: none"> <li>○ Complete: Drill rig #2, 3 abandoned drill sites, and a monitoring site were visited</li> <li>○ Partial:</li> <li>○ Follow-up:</li> <li>○ Response to Public Complaint:</li> </ul>	<b>■ Wildlife Observed:</b> <ul style="list-style-type: none"> <li>○ Bear: 3 brown bears observed ½ mile north of the deposit.</li> <li>○ Caribou: none observed</li> <li>○ Moose: none observed</li> <li>○ Waterfowl: One swan on Frying Pan Lake.</li> <li>○ Fish: none observed</li> <li>○ Other: One raven near drill rig 2.</li> </ul>
<b>■ Weather Conditions:</b> <ul style="list-style-type: none"> <li>○ Temperature: 40-45 degrees F</li> <li>○ Wind: 35-50 knots</li> <li>○ Precipitation: rain intermittent</li> <li>○ Visibility: 2-5 miles</li> <li>○ Sky Conditions: high overcast</li> <li>○ Ground Conditions: saturated</li> </ul>	<b>■ Water level at Frying Pan Lake:</b> <ul style="list-style-type: none"> <li>○ Observed inflow: high, bank full</li> <li>○ Obser

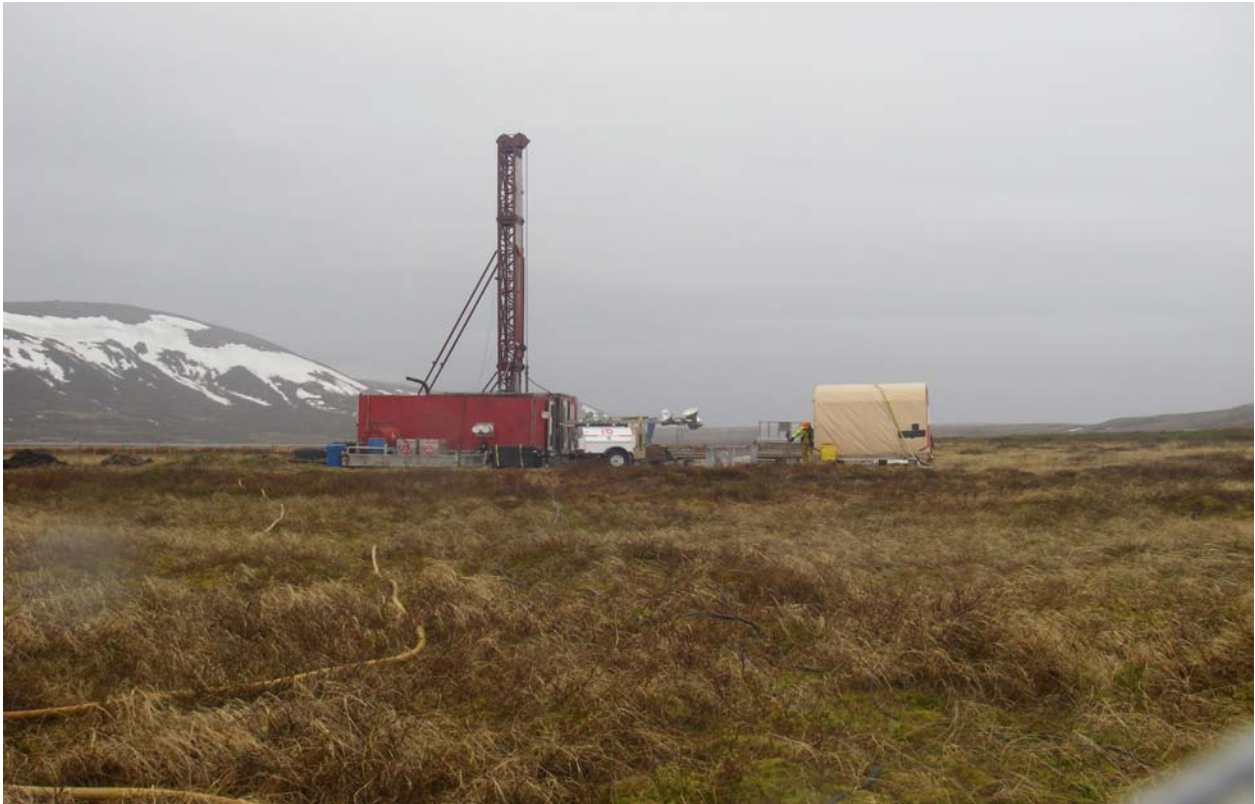
Drill Rig #2- Drill Hole/Site #9451

<b>Drill Hole/Site No.: 9541</b>	<b>Rig No.: 2</b>
Activity: condemnation drilling	Date: 6/4/09
<ul style="list-style-type: none"> <li>■ Condition of Drilling Site: good</li> </ul>	<ul style="list-style-type: none"> <li>■ Sump Pit (continued):</li> </ul>
<ul style="list-style-type: none"> <li>○ Distance from waterbody: 100 feet</li> </ul>	<ul style="list-style-type: none"> <li>○ Location and extent of discharged material: N/A</li> </ul>
<ul style="list-style-type: none"> <li>○ Location of fuel storage: onsite</li> </ul>	<ul style="list-style-type: none"> <li>○ Topsoil, muck, tundra stockpiled: 2 cubic yards</li> </ul>
<ul style="list-style-type: none"> <li>○ Sorbent pads present: yes</li> </ul>	<ul style="list-style-type: none"> <li>○ Location of secondary sump pit: N/A</li> </ul>
<ul style="list-style-type: none"> <li>○ Tundra mat: yes</li> </ul>	<ul style="list-style-type: none"> <li>○ Hose color: none</li> </ul>

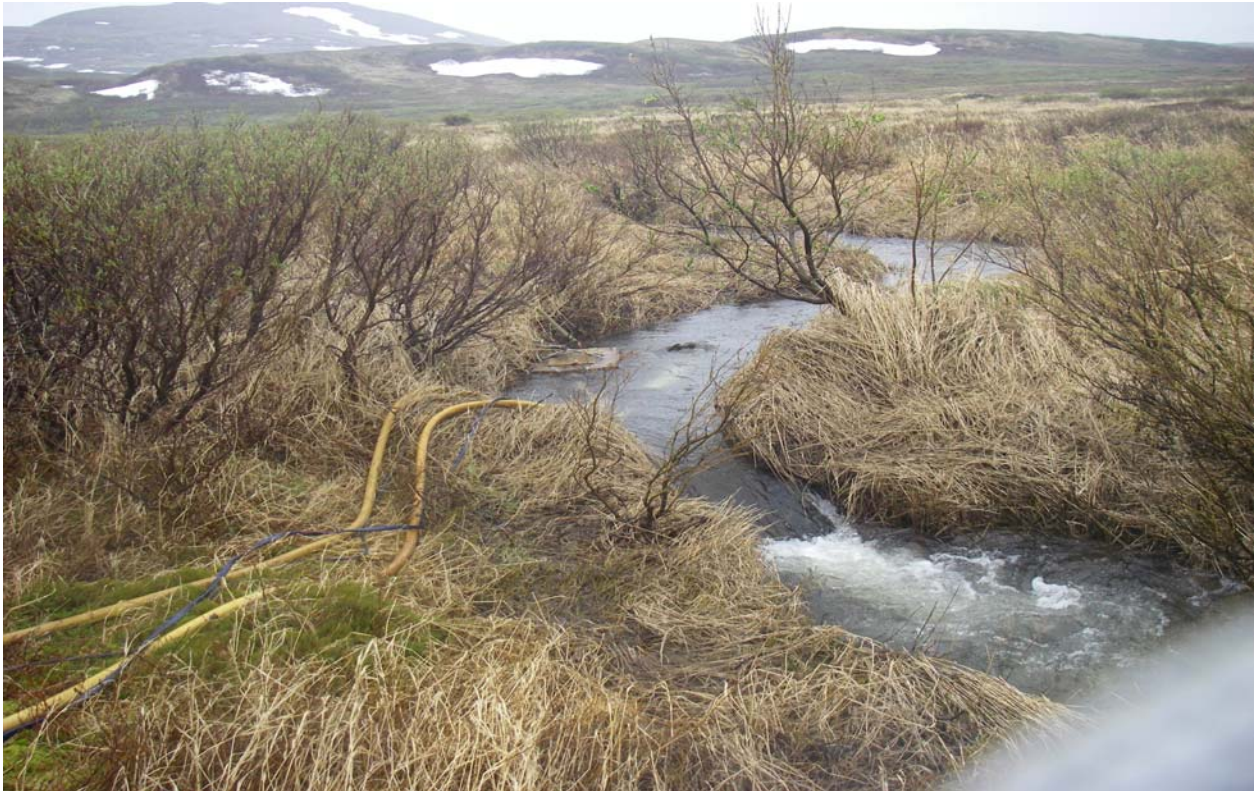
Drill Water Supply Site #9451

<ul style="list-style-type: none"> <li>○ Relative water level: high</li> </ul>
<ul style="list-style-type: none"> <li>■ Drilling Activity: yes</li> </ul>	<ul style="list-style-type: none"> <li>○ General impression of water body, i.e. clear, turbid, tannic: clear</li> </ul>
<ul style="list-style-type: none"> <li>○ Drill additives in use: yes</li> </ul>	<ul style="list-style-type: none"> <li>○ Intake structure: yes</li> </ul>
<ul style="list-style-type: none"> <li>○ Water recirculation: no</li> </ul>	<ul style="list-style-type: none"> <li>○ Structure clear of debris: yes</li> </ul>
<ul style="list-style-type: none"> <li>○ Water discharged: yes</li> </ul>	<ul style="list-style-type: none"> <li>○ Mesh size: 1mm x 12mm</li> </ul>
<ul style="list-style-type: none"> <li>○ Artesian zone encountered: no</li> </ul>	<ul style="list-style-type: none"> <li>○ Submerged: yes</li> </ul>
	<ul style="list-style-type: none"> <li>○ Pump location to source: 100 feet</li> </ul>

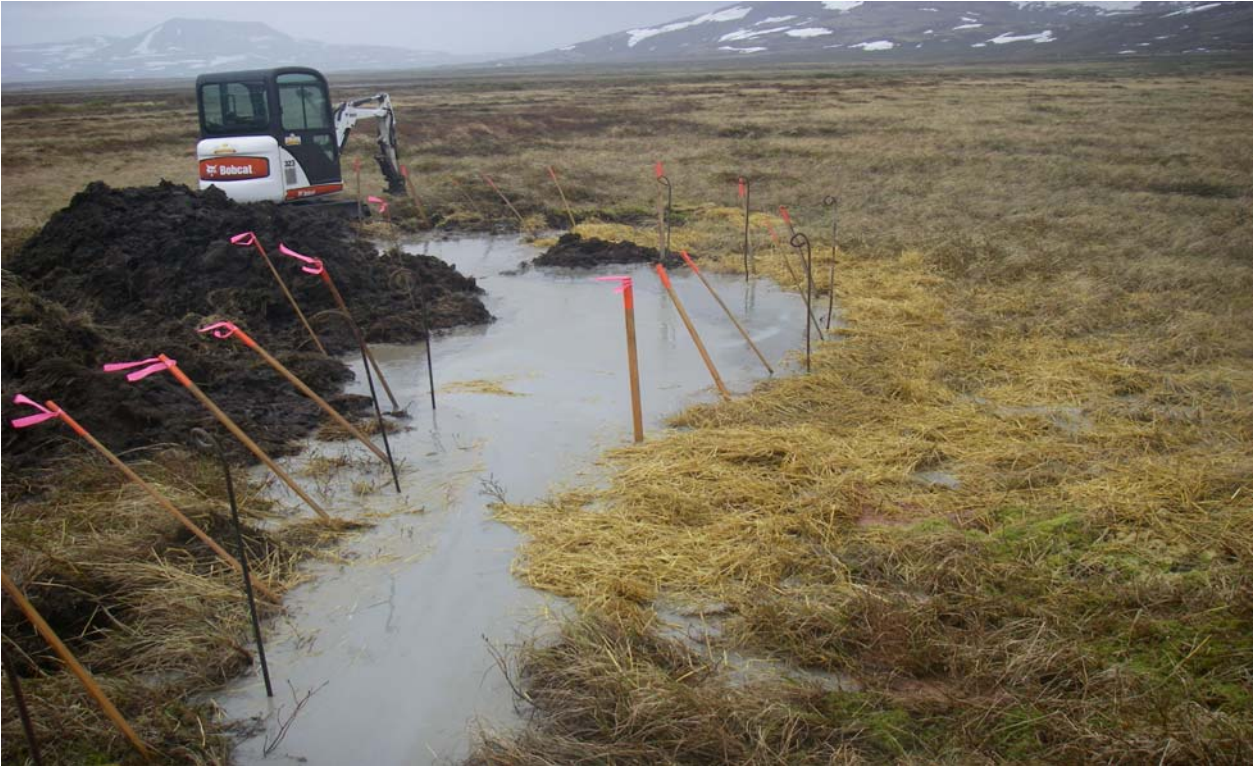
Sump Pit- Site #9451

<ul style="list-style-type: none"> <li>■ Sump Pit:</li> </ul>	<ul style="list-style-type: none"> <li>○ Catch basin for fuel supply: adjacent</li> </ul>
<ul style="list-style-type: none"> <li>○ Location: 50 feet NE of rig</li> </ul>	<ul style="list-style-type: none"> <li>○ Sorbent pads: yes</li> </ul>
<ul style="list-style-type: none"> <li>○ Discharge trench: yes</li> </ul>	<ul style="list-style-type: none"> <li>○ Hose color: yellow</li> </ul>
<ul style="list-style-type: none"> <li>○ Dimensions of pit: 6' x 6'</li> </ul>	
<ul style="list-style-type: none"> <li>○ In use: yes</li> </ul>

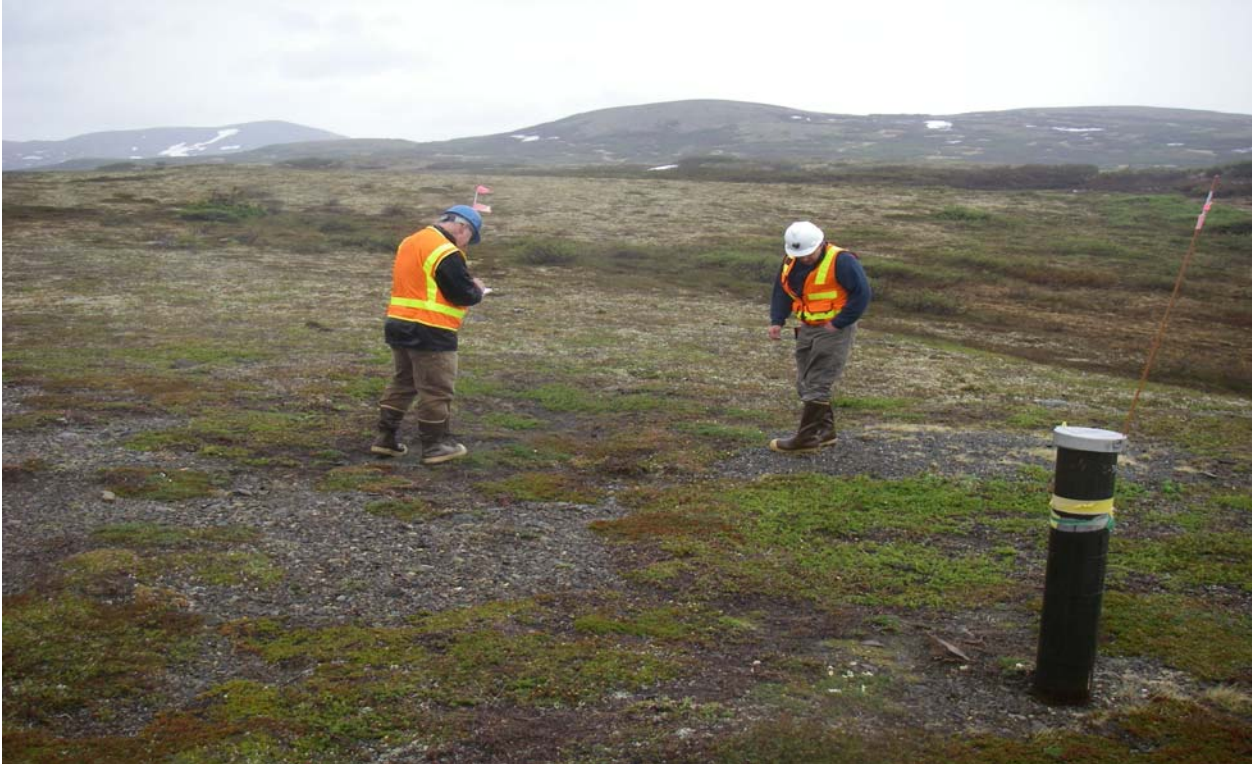
<b>Abandoned Drill Hole/Site No.: 8415</b>	Date: 6/4/09
■ Plugged: yes	
■ Cemented: yes	
■ Standing pipe: yes	
■ Sump pit filled in: yes	
■ Water discharge trench filled in: yes	
■ Site revegetated: yes	
■ Artesian water present: no	
■ Any spills or staining: no	
■ Comments/General impression: Site abandoned in 2008. Site is in good condition with reclamation complete.

Site #8415- Abandoned 2008- Reclamation Complete

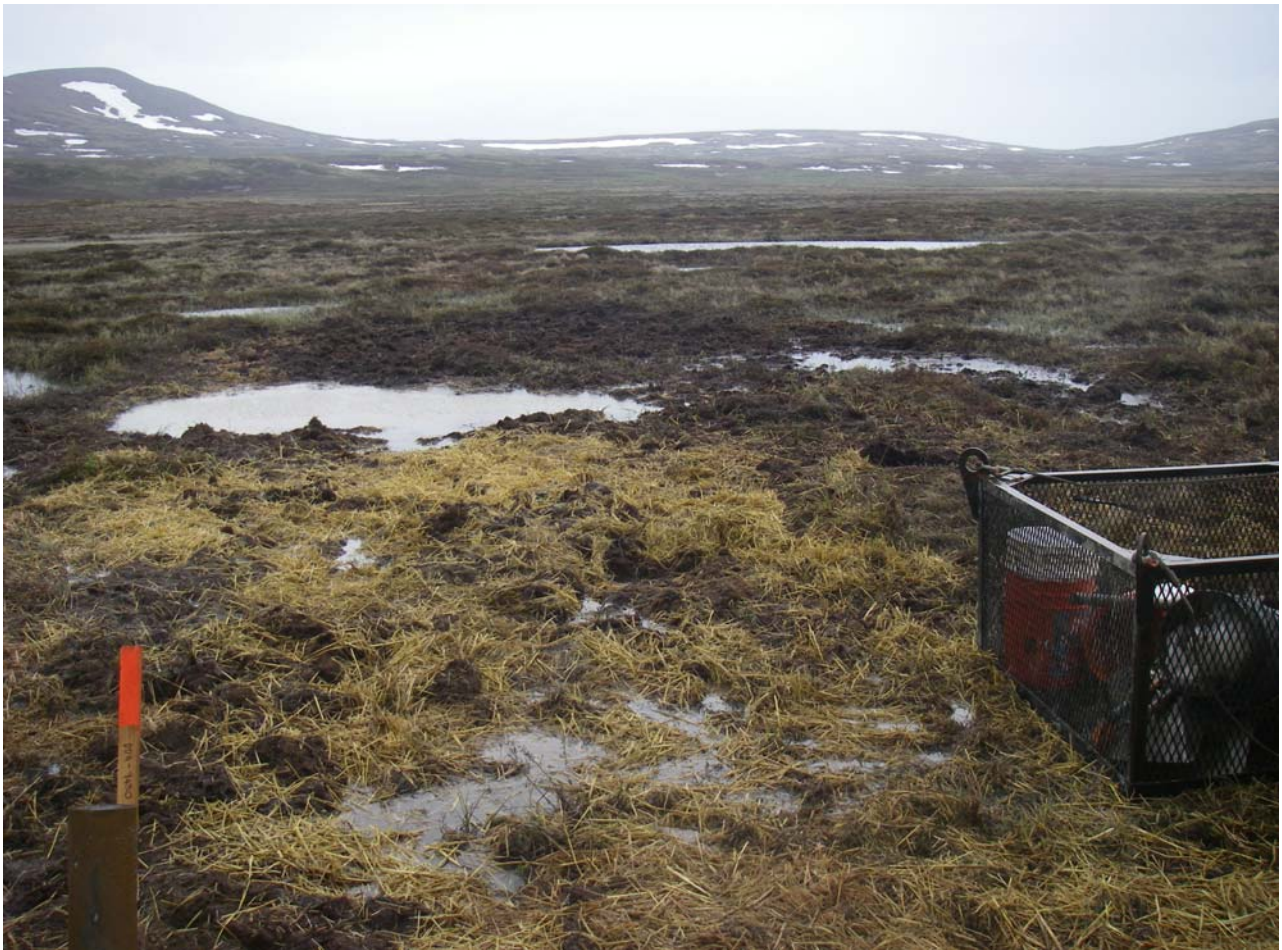
<b>Abandoned Drill Hole/Site No.: 9450</b>	Date: 6/4/09
<ul style="list-style-type: none"> <li>■ Plugged: unable to determine</li> <li>■ Cemented: no</li> <li>■ Standing pipe: yes</li> <li>■ Sump pit filled in: N/A</li> <li>■ Water discharge trench filled in: yes</li> <li>■ Site revegetated: no</li> <li>■ Artesian water present: no</li> <li>■ Any spills or staining: no</li> <li>■ Comments/General impression: Site recently abandoned and in generally good condition.</li> </ul>

Site # 9450- Recently abandoned site- reclamation not yet completed
