## Field Monitoring Report -- Pebble Copper/Gold Exploration Project --

Personnel: Bill Cole (DNR/MLW)	Inspection Date: 7/12/11
Michele Sherwood DEC/SPAR)	Site Contact: Jeff Norberg
Gay Harpole DEC/SPAR)	APMA #: A116118
<b>■ Inspection Type:</b> <input type="radio"/> Complete: X <input type="radio"/> Partial: <input type="radio"/> Follow-up: <input type="radio"/> Response to Public Complaint:	<b>■ Wildlife Observed:</b> <input type="radio"/> Bear: <input type="radio"/> Caribou: <input type="radio"/> Moose: <input type="radio"/> Waterfowl: <input type="radio"/> Fish: <input type="radio"/> Other:
<b>■ Weather Conditions:</b> <input type="radio"/> Temperature: 45-50° F <input type="radio"/> Wind: 15-20 mph <input type="radio"/> Precipitation: None <input type="radio"/> Visibility: Variable <input type="radio"/> Sky Conditions: Low overcast, fog at higher elevations <input type="radio"/> Ground Conditions: Damp to dry	
<b>■ Comments:</b> Inspected DDH 10514, where petroleum staining and odor were noted on 6/22/11 (See 6/22/11 Pebble Field Monitoring Report). Spill has been remediated. There was a release of hydraulic fluid at drill #2, on hole #11533 on June 26. Release was contained

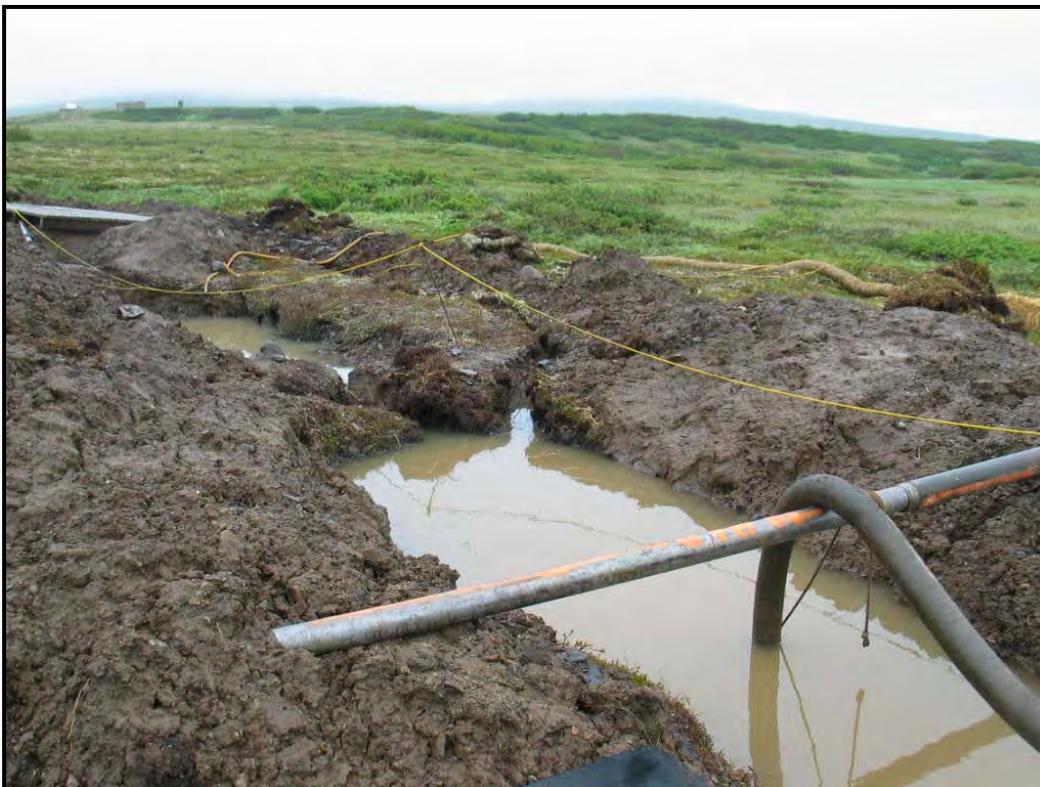
Photo #1. Mud pits at drill rig #2.

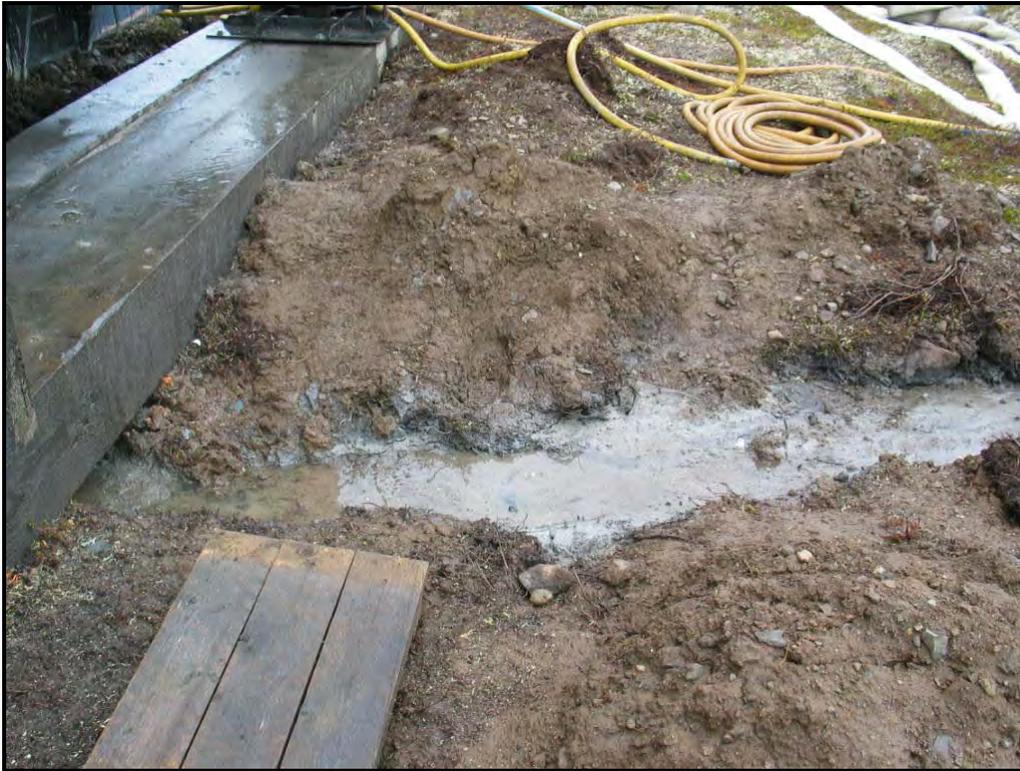
Comments: On June 26 this drill experienced a spill of approximately 40 gallons of hydraulic fluid, as was reported to DEC within 24 hours of the incident. The fluid was released from a broken hose fitting connecting the mud mixing motor to the hydraulic hose. The fitting was positioned within the mud tank on the drill platform. The hydraulic fluid was injected down the drill hole, so the leak was not noticed until drill circulation brought it back to the surface, when it was noted in the mud tank. At that time drilling was stopped, and clean up began immediately. The release was confined to the trench and three sump pits. Absorbent materials were used to recover hydraulic fluid floating on top of the drill water. Hydraulic fluid was also skimmed from the water surface and flushed through Absorbent W water scrubber. Water/drill mud/hydraulic fluid emulsion remaining in the mud tank (and therefore not part of the released volume) was transferred into four 55 gallon drums. The hydraulic oil reserve tank on the drill rig holds a total of 80 gallons. After the release, 40 gallons of hydraulic fluid remained either in the reserve tank or in the mud tank.

At the time of the July 12 inspection no petroleum product staining was visible in the area of the trench or pits.

Photo #2. Trench from drill #2 to mud pit. No hydraulic fluid staining was visible.

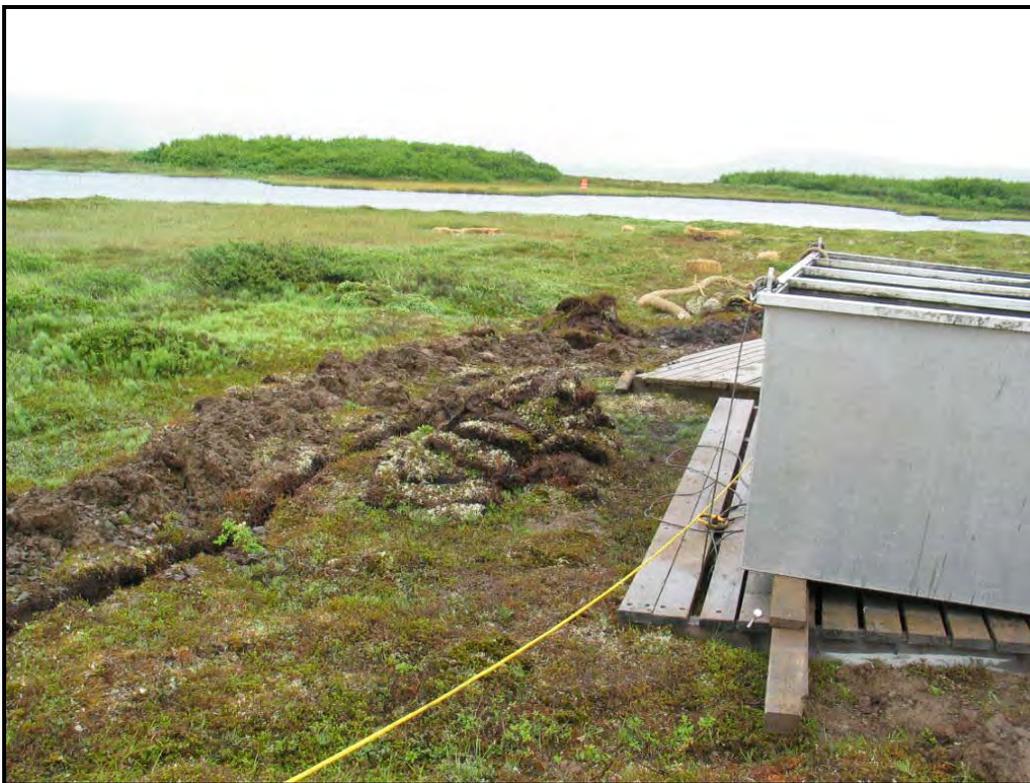
Photo #3. Stockpiled tundra from mud pits.

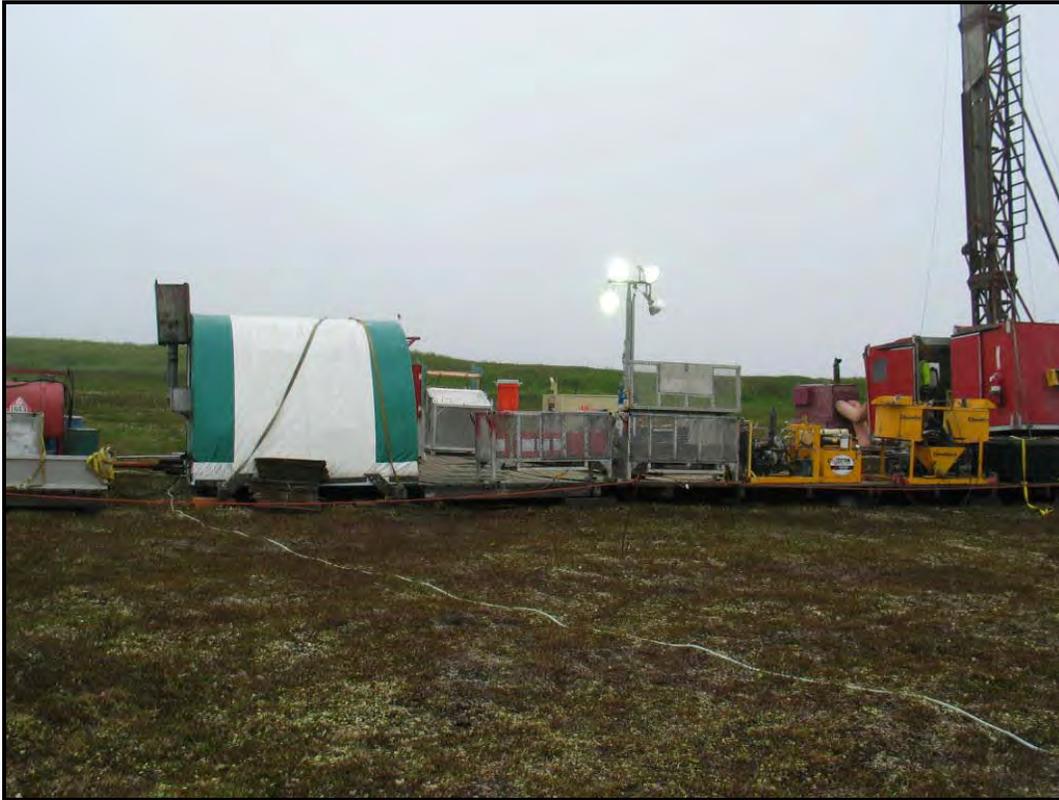
Photo #4. Drill Rig #3 on DDH 11534.

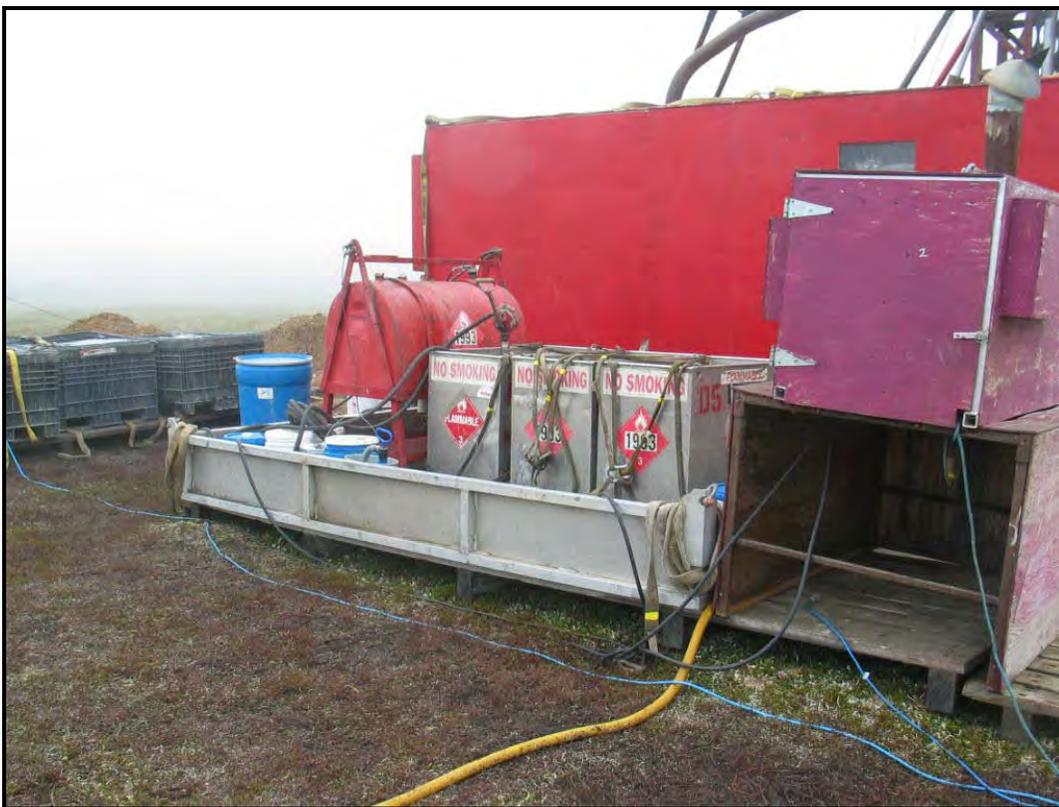
Photo #5. Fuel containment at drill #3.

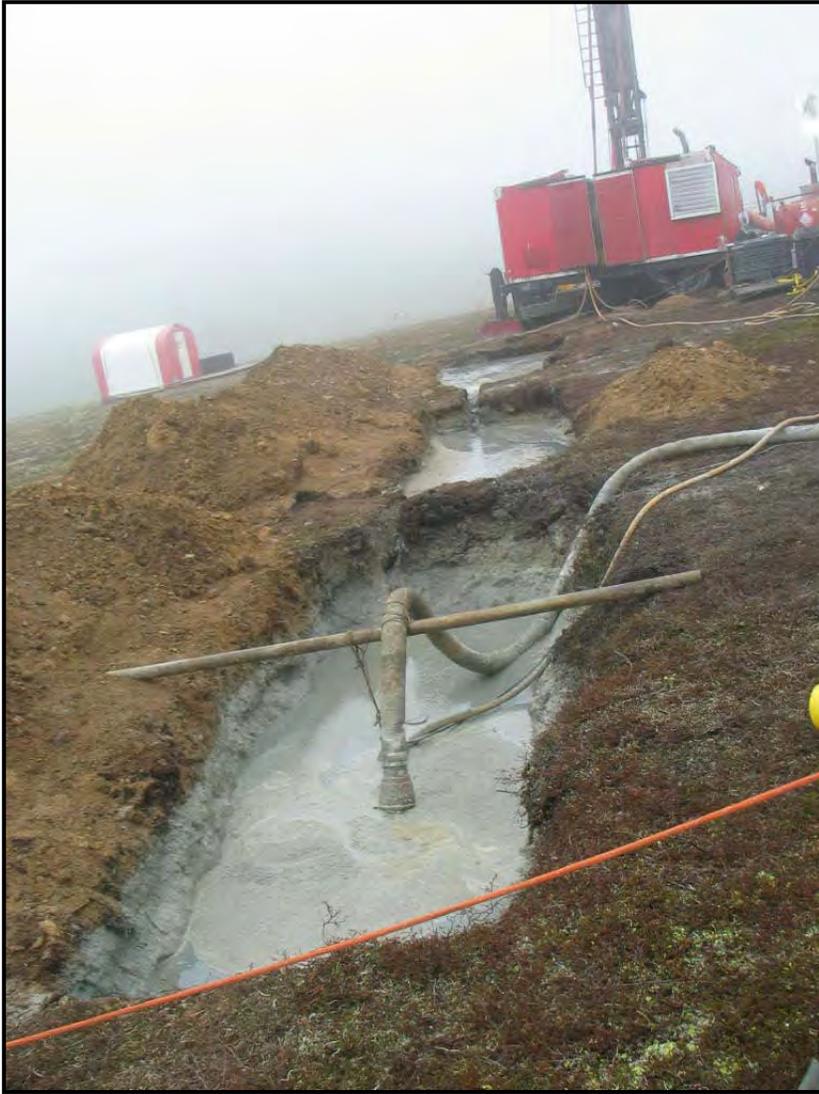
Photo #6. Mud pits at drill #3.

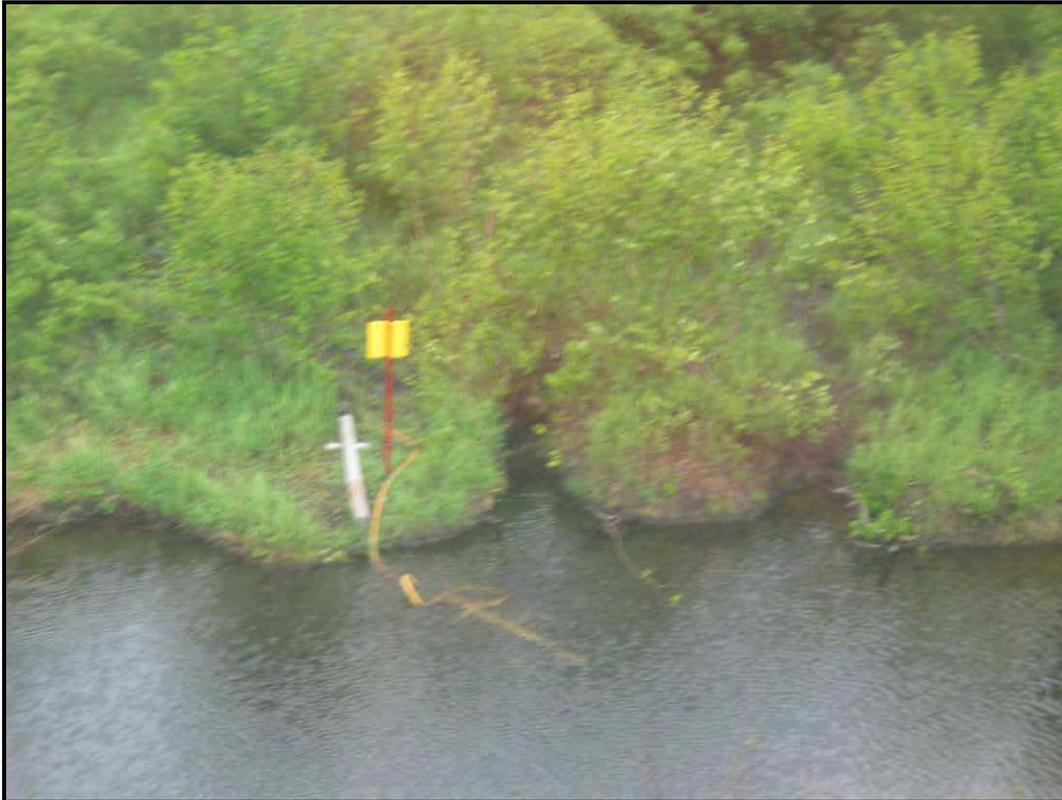
Photo #7. Submerged pump and water intake for drill #3.

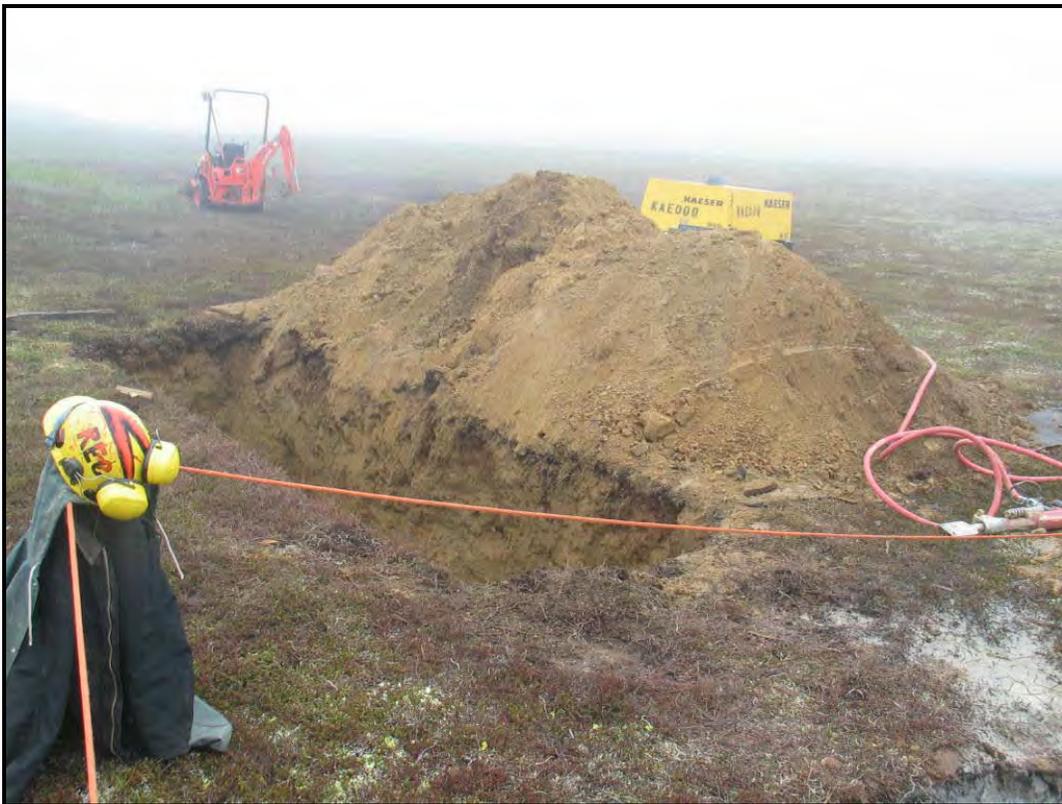
Photo #8. New mud pit for drill #3.

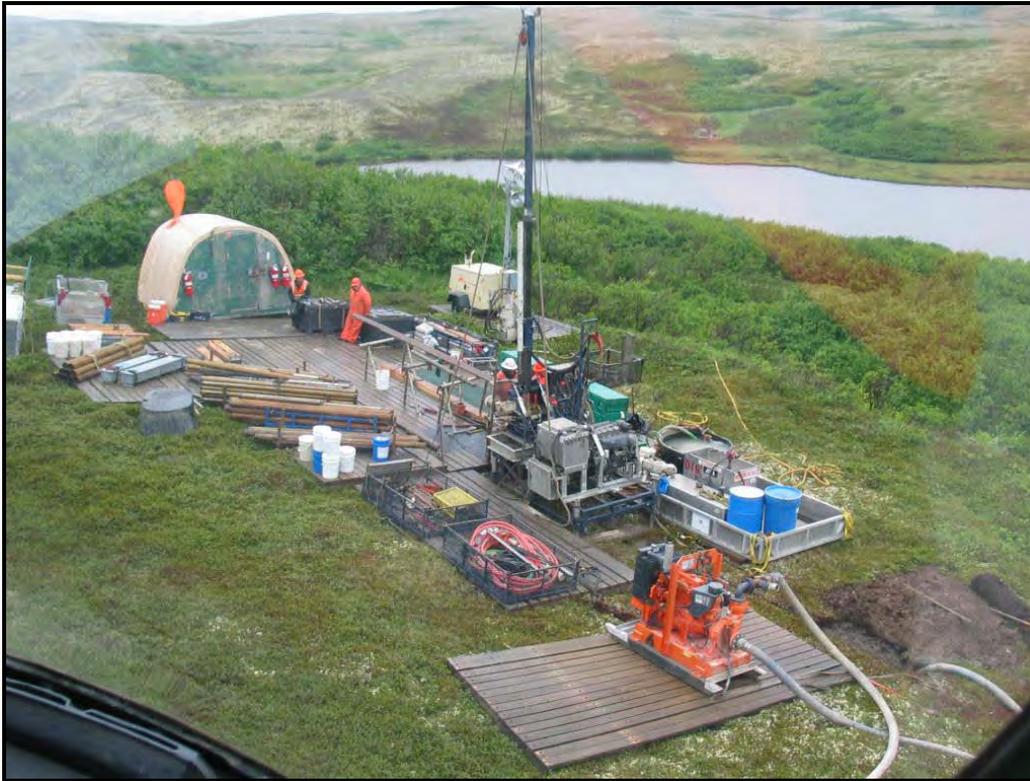
Photo #9. Drill #4 at hole GH11-240. Note several items are on the tundra.

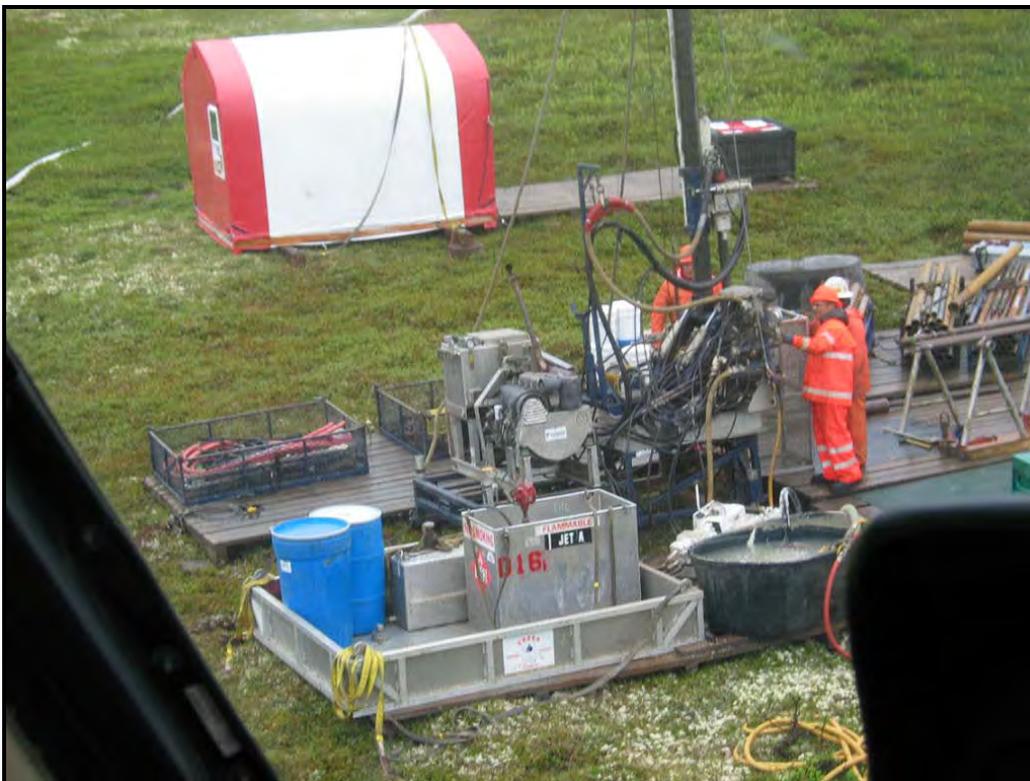
Photo #10. Fuel containment and mud tank at drill #4.

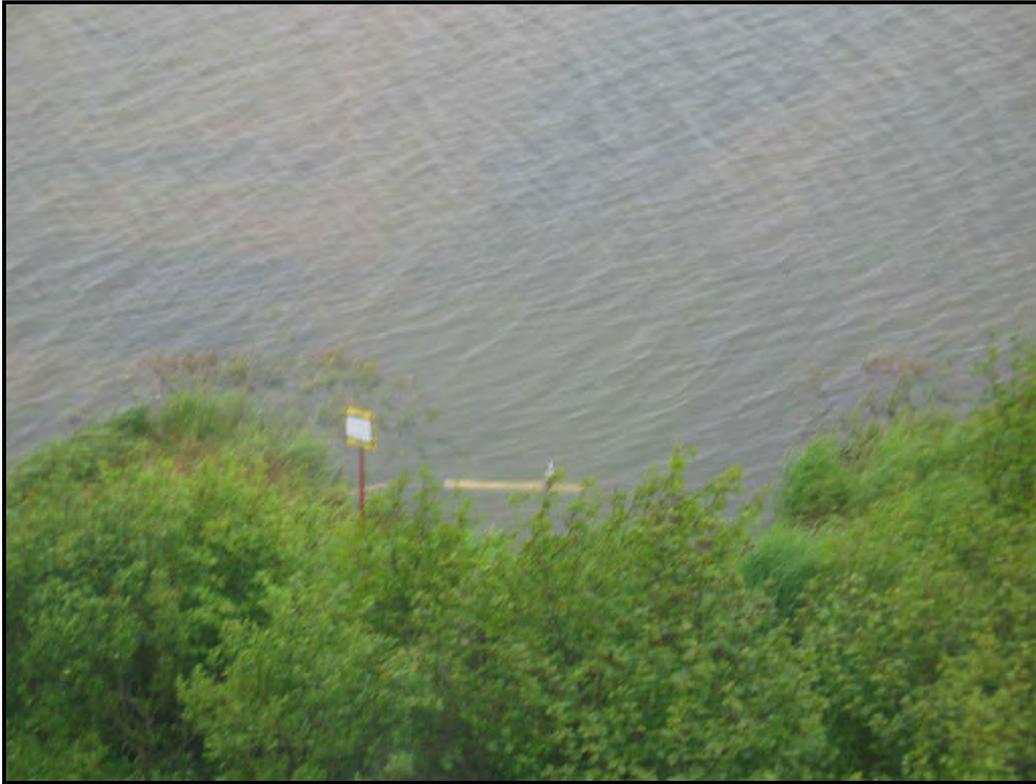
Photo #11. Submerged electric pump and water intake in Frying Pan Lake.

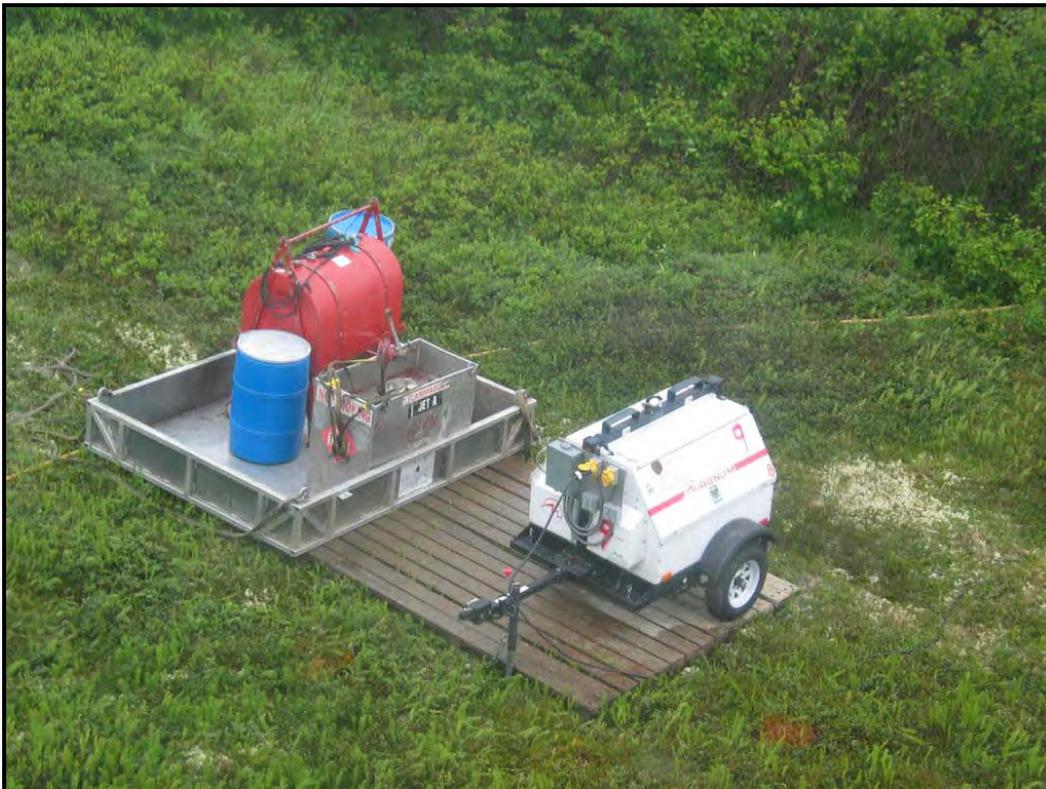
Photo #12. Fuel and generator for drill #4 water source.

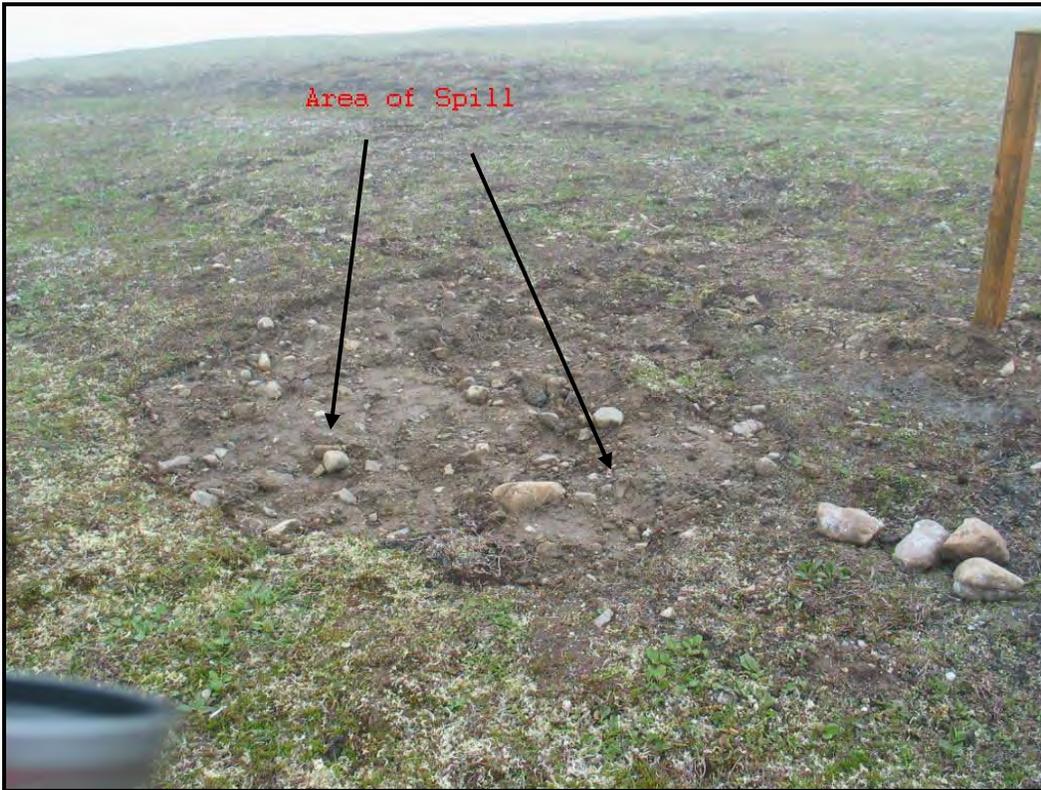
Abandoned Drill Hole/Site No.: 10514	Date: 7/12/11
	Time: 1:40 PM
■ Plugged: Yes	
■ Cemented: Grouted	
■ Standing pipe: No	
■ Sump pit filled in: Yes	
■ Water discharge trench filled in: Yes	
■ Site revegetated: Yes, tundra replaced	
■ Date revegetated/reclaimed: Fall, 2010	
■ Artesian water present: No	
■ Any spills or staining: No	
<p>■ Comments/General impression: Replaced tundra is surviving in the trench and mud pits, but the ground is still settling. Vegetation around drill site is generally somewhat sparse. A 4' wide spill was noted adjacent to this drill hole on 6/22/11. The spill has been remediated. The contaminated soil was dug up and removed. See Photo #13.</p>

Photo #13. Remediated area of spill at DDH 10514.

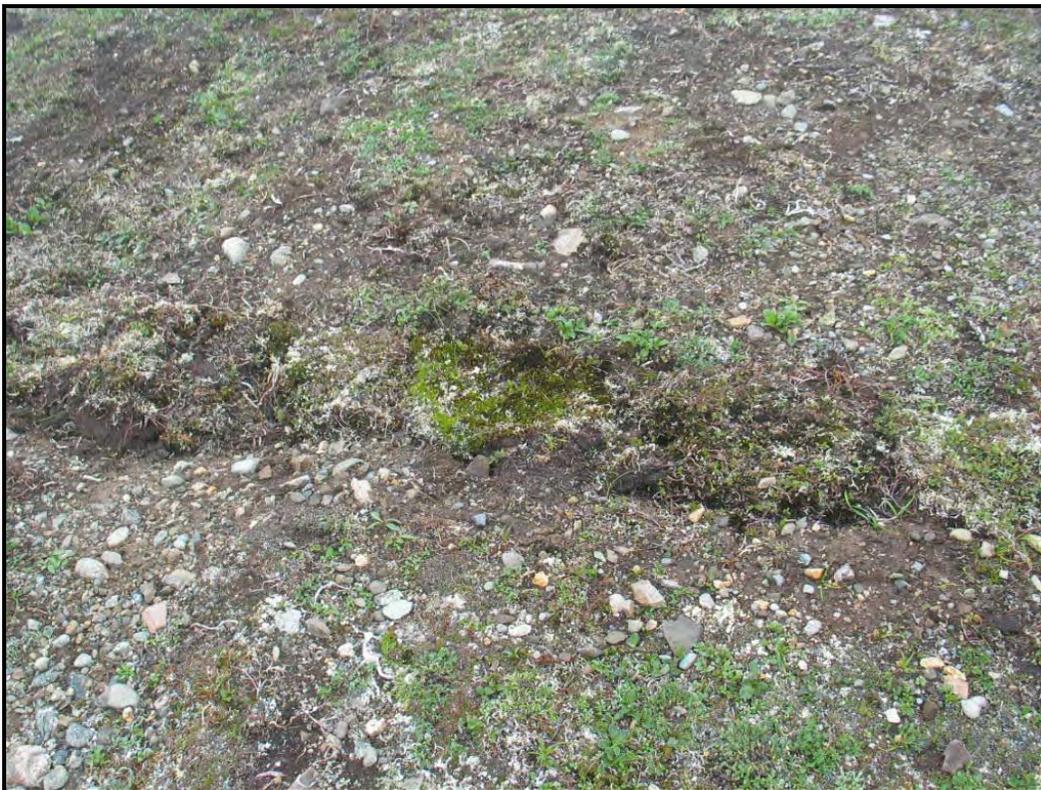
Photo #14. Tundra replaced in trench.

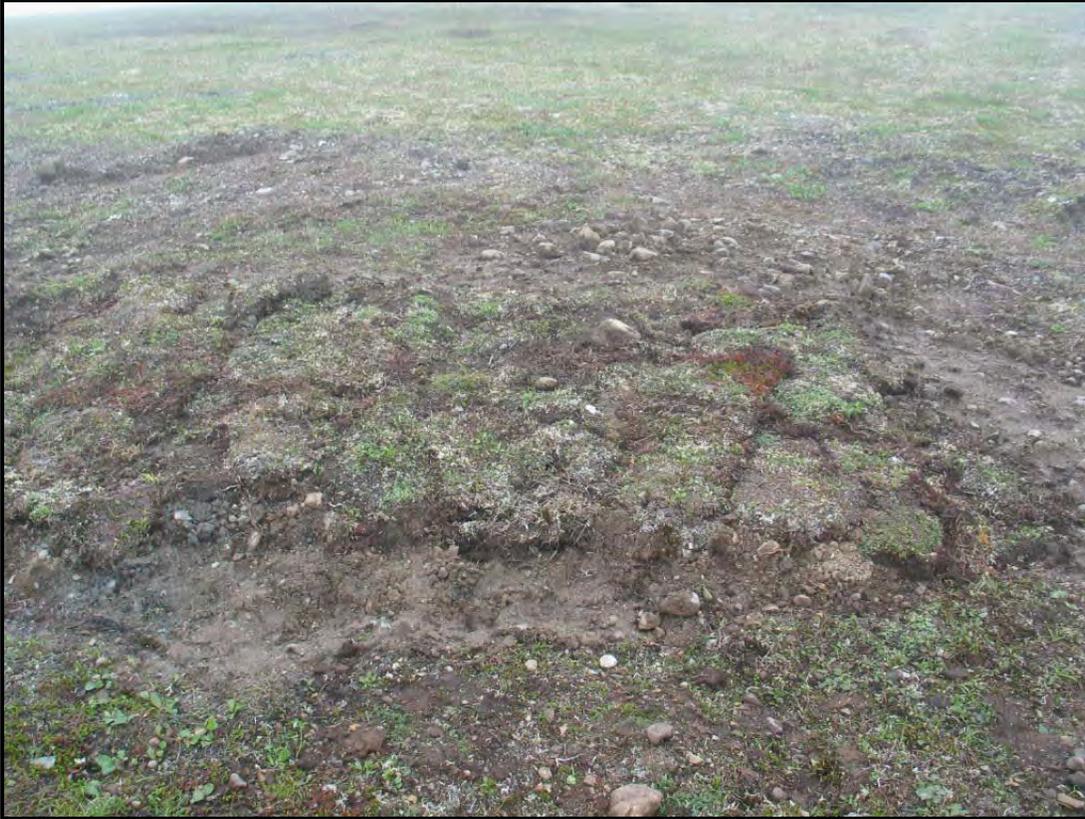
Photo #15. Tundra replaced over mud pit. Note that site is still settling.

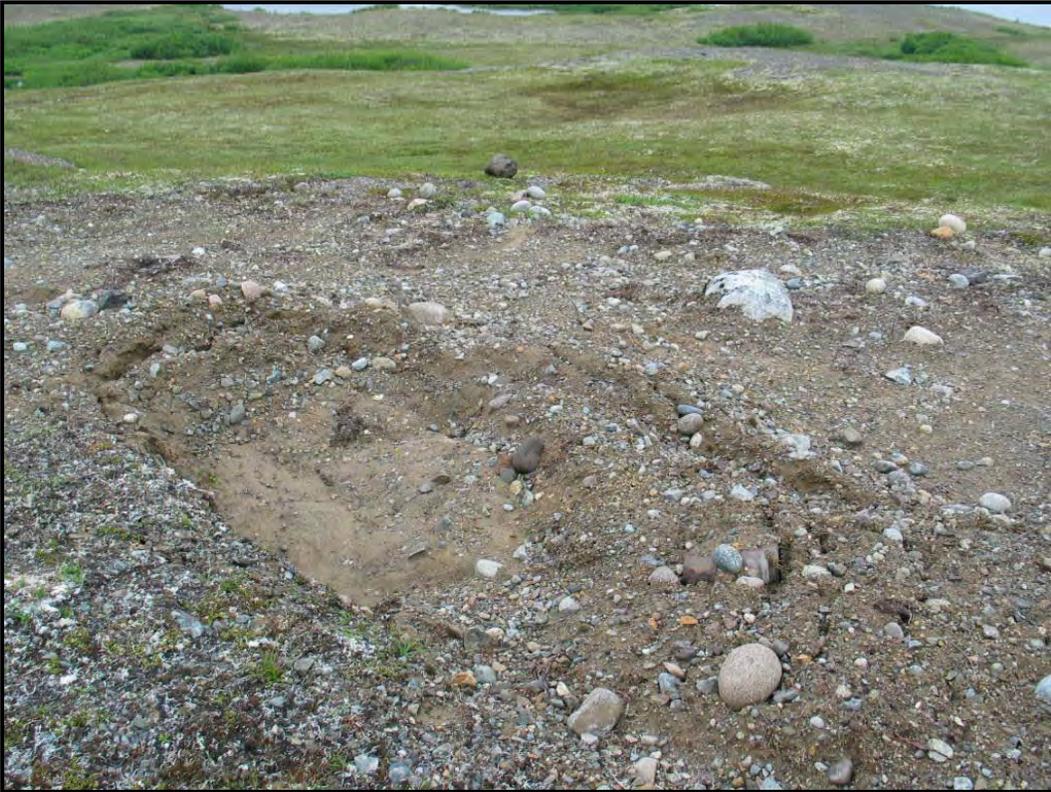
Abandoned Drill Hole/Site No.: 10523	Date: 7/12/11
	Time:2:05 PM
■ Plugged: Yes	
■ Cemented: Grouted	
■ Standing pipe: No	
■ Sump pit filled in: Yes, but there has been some settling, and there is a need to refill one pit.	
■ Water discharge trench filled in: Yes	
■ Site revegetated: Yes. Replaced tundra looks good.	
■ Date revegetated/reclaimed:10/2010	
■ Artesian water present: No	
■ Any spills or staining: No	
■ Comments/General impression: Parts of area have sparse vegetation, and there was little tundra to stockpile where the sump pits were dug. Therefore, they are largely bare, and have not settled yet (See Photo #16.) The fill in one pit has collapsed, however, and needs refilling. Where there was tundra to replace, it looks good (See Photos #18 and 19).

Photo #16. Depression where sump pit at DDH 10523 has subsided.

<b>■ Recommendations:</b> Add fill to sump at DDH 10523.	
<b>■ Actions Needed:</b> Re-inspect DDH 10523 to ensure sump has been filled.

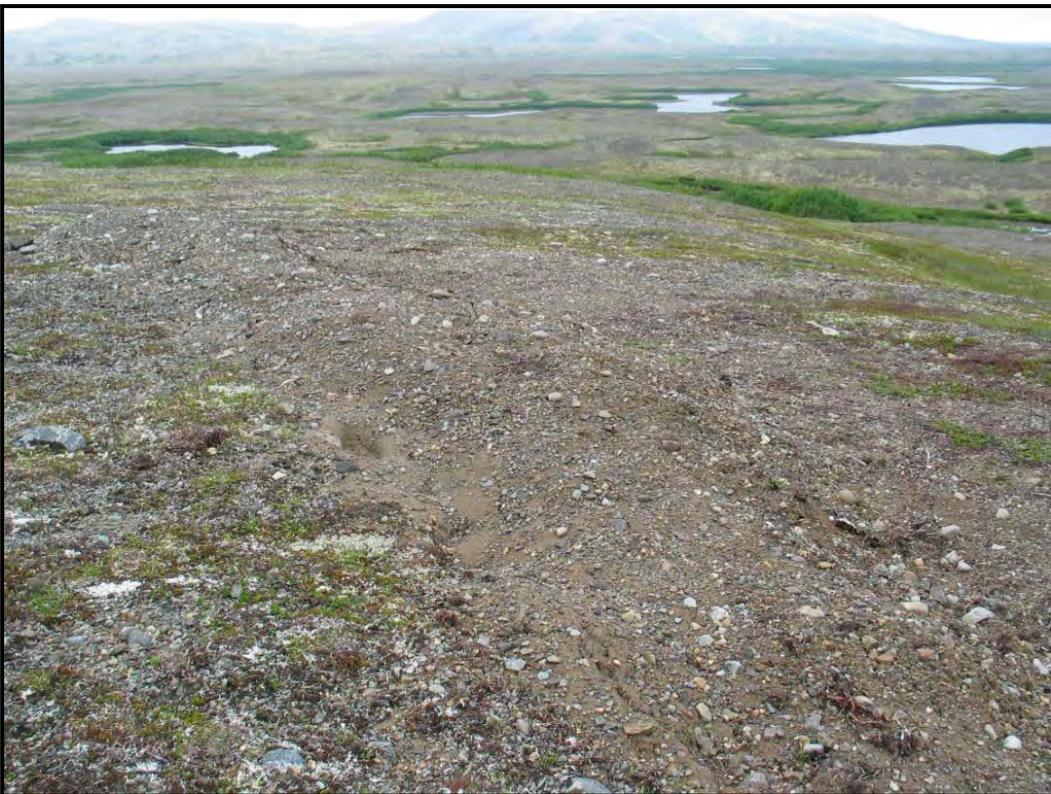
Photo #17. Filled sump pits at DDH 10523.

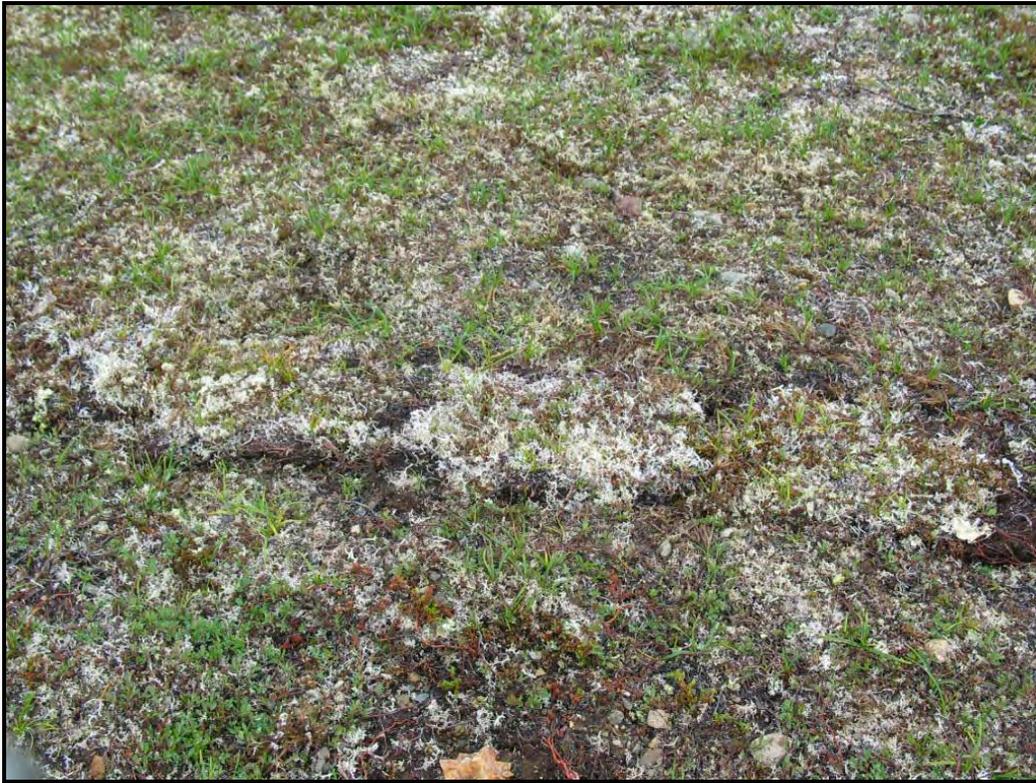
Photo #18. Replaced tundra in trench.

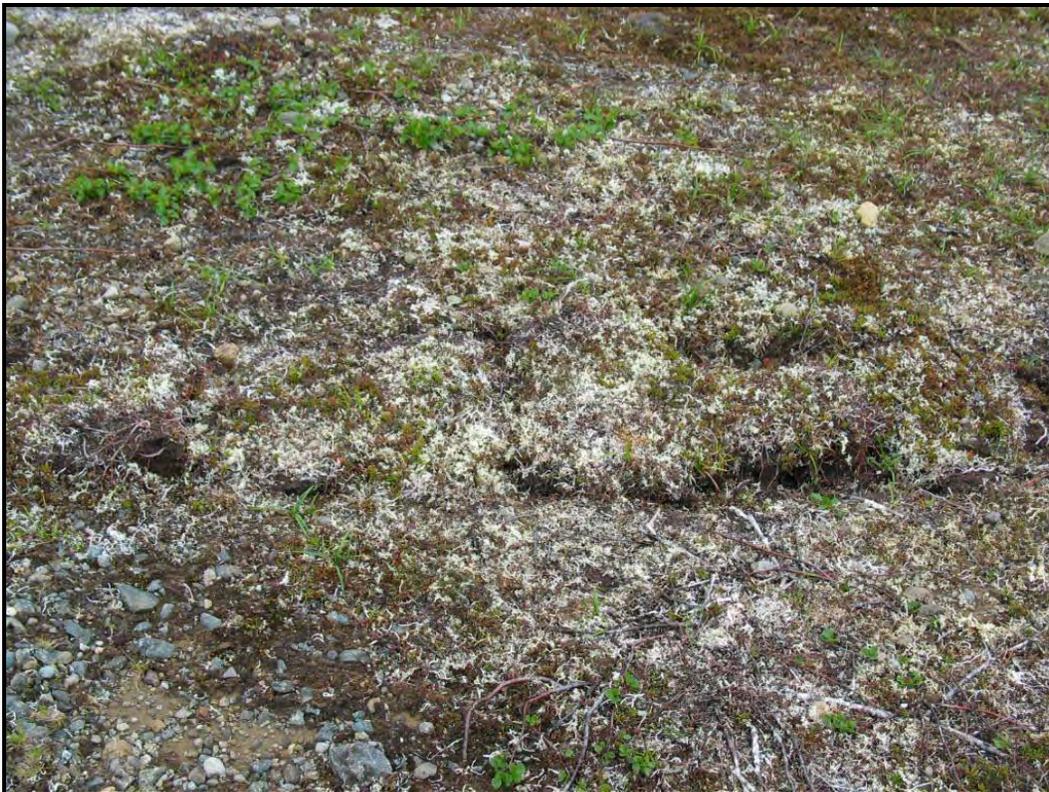
Photo #19. Replaced tundra at DDH 10523.

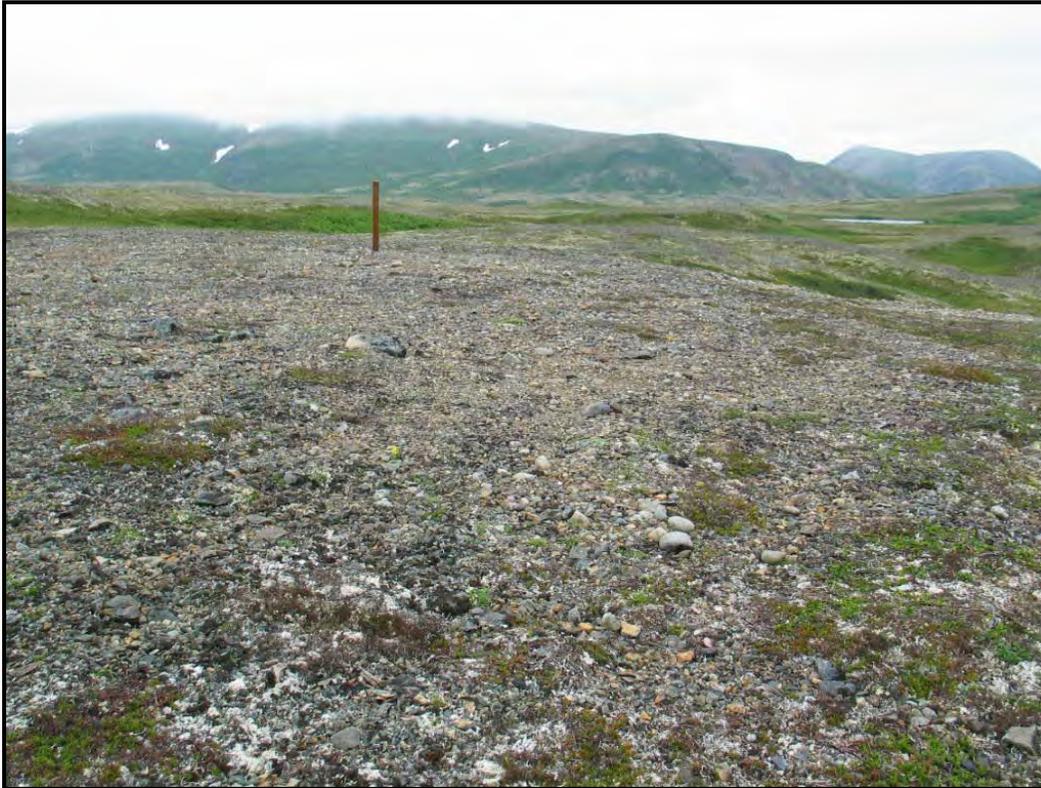
Photo #20. Reclaimed site of DDH 10479. Note sparse vegetation in the area.

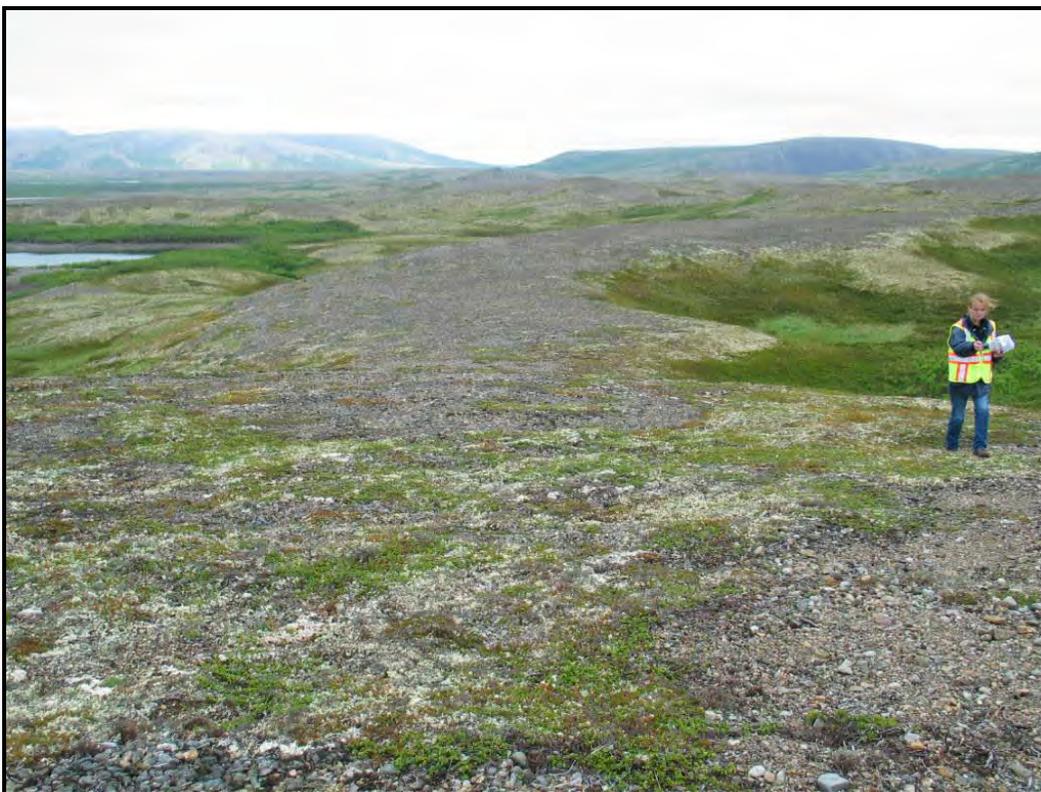
Photo #21. Knoll adjacent to DDH 10479. Note lack of vegetation on high ground.

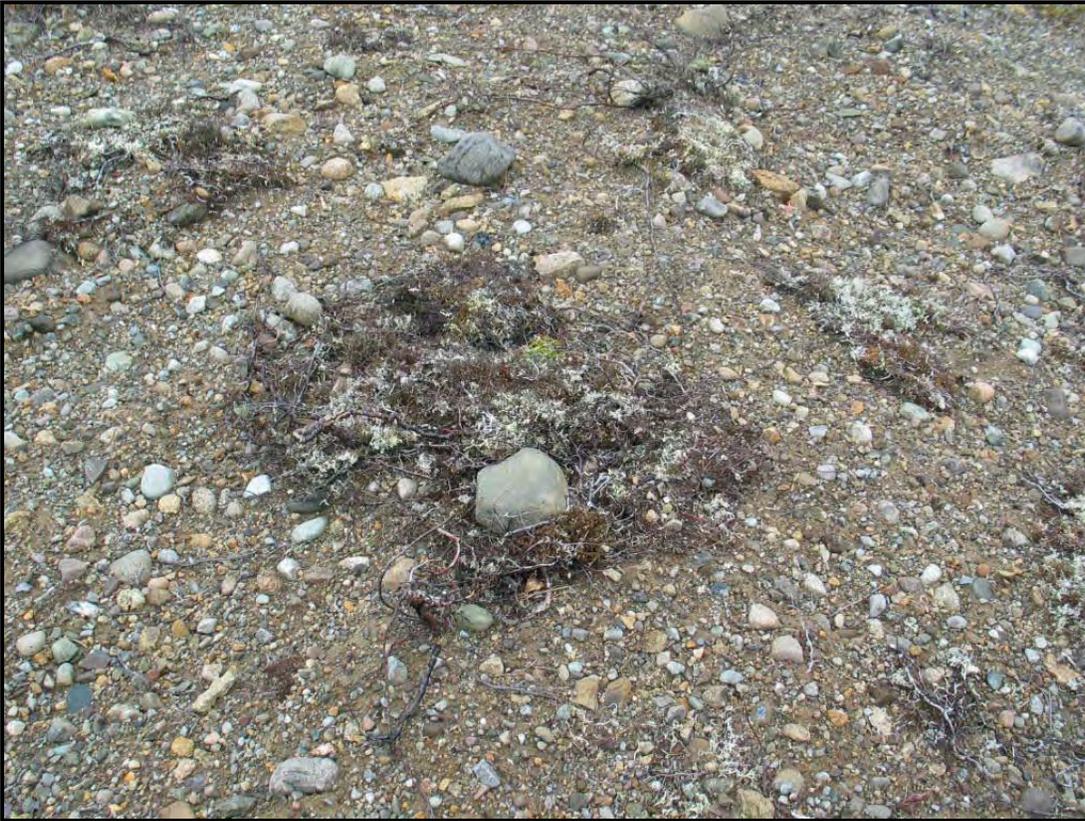
Abandoned Drill Hole/Site No.: 10479	Date: 7/12/11
	Time: 2:15 PM
■ Plugged: Yes	
■ Cemented: Grouted	
■ Standing pipe: No	
■ Sump pit filled in: Yes	
■ Water discharge trench filled in: Yes	
■ Site revegetated: Yes, but there was very little vegetation on site before drilling	
■ Date revegetated/reclaimed:6/2010	
■ Artesian water present: No	
■ Any spills or staining: No	
■ Comments/General impression: Drill site was on a knoll, and this area and similar high ground in the area has little natural vegetation (See Photos #20 & 21). Replaced tundra is alive, but not doing very well (See Photo #22).

Photo #22. Replaced tundra at DDH 10479.

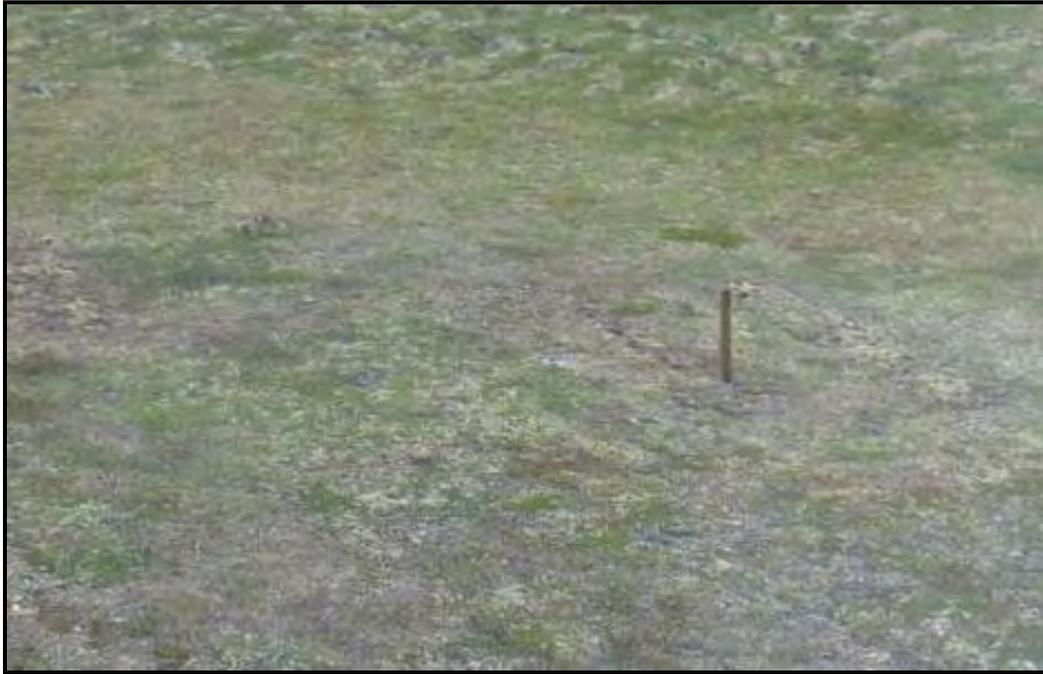
Photo #23. Reclaimed site of DDH 10490.

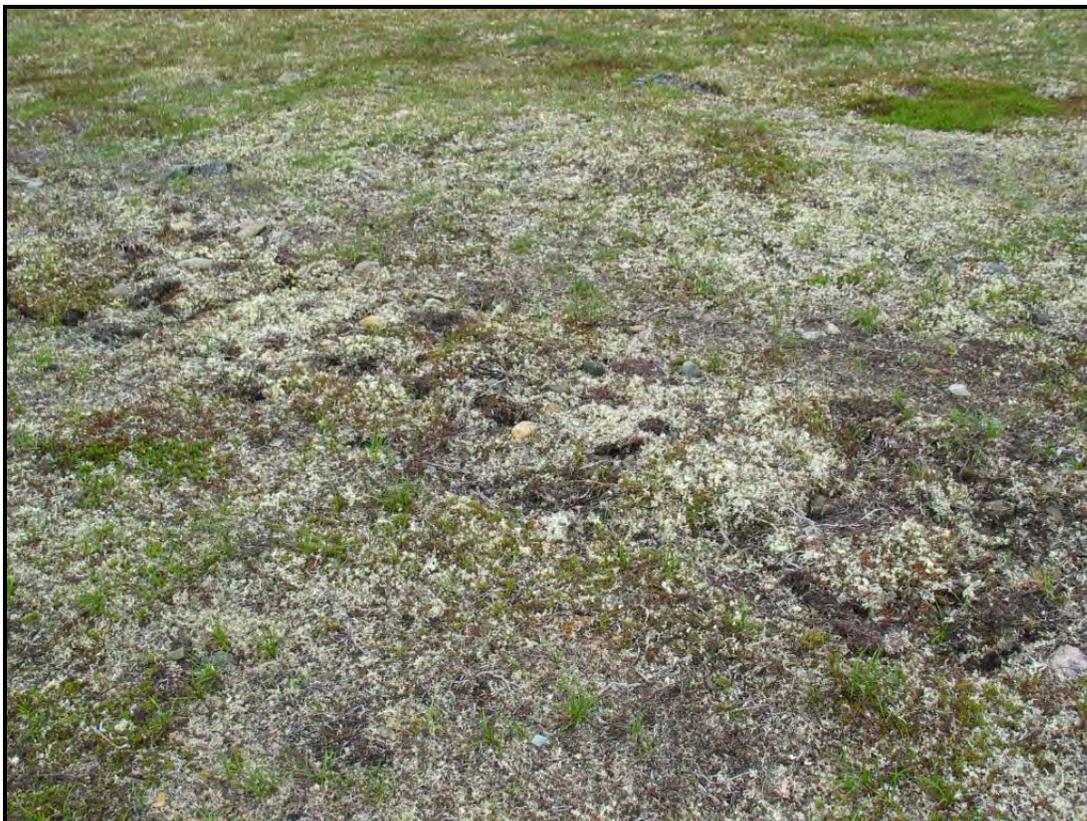
Abandoned Drill Hole/Site No.: 10490	Date: 7/12/11
	Time: 2:25 PM
■ Plugged: Yes	
■ Cemented: Grouted	
■ Standing pipe: No	
■ Sump pit filled in: Yes	
■ Water discharge trench filled in: Yes	
■ Site revegetated: Yes	
■ Date revegetated/reclaimed:8/2010	
■ Artesian water present: No	
■ Any spills or staining: No	
■ Comments/General impression: Good. Although vegetation is somewhat sparse in the area, the replaced tundra is doing well. (See photos #24 and 25)

Photo #24. Replaced tundra on mud pit at DDH 10490.

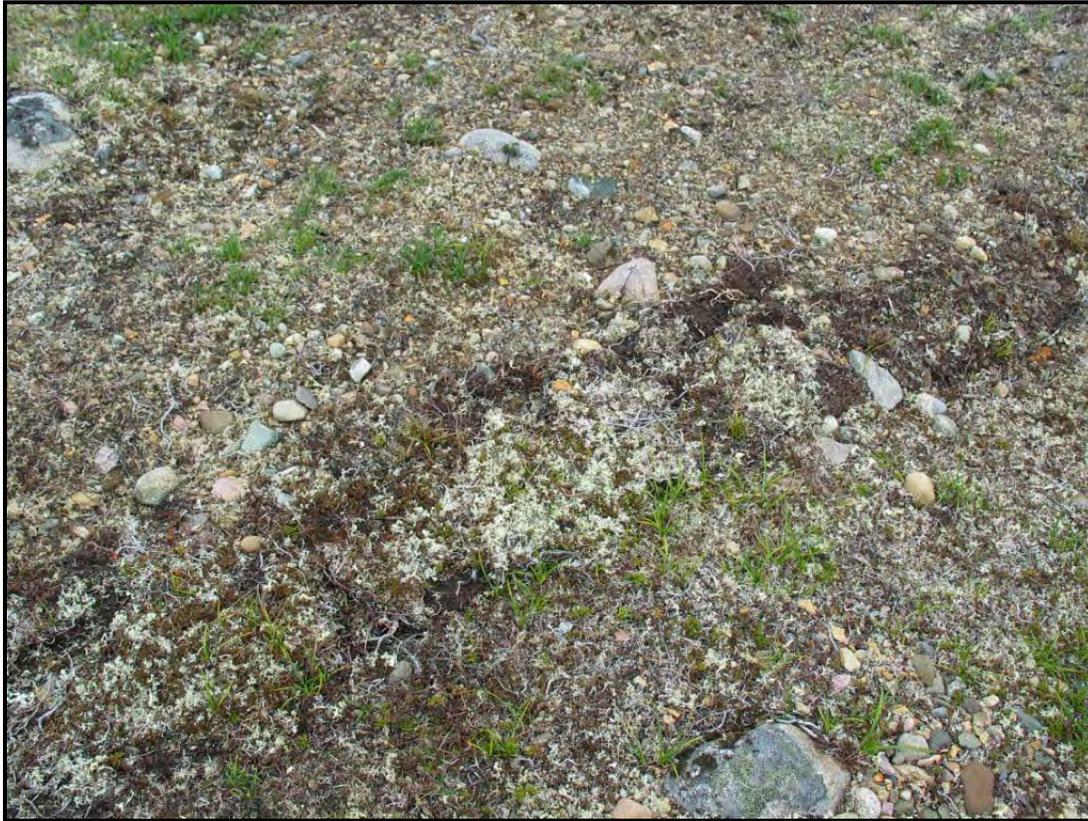
Photo #25. Replaced tundra on trench, DDH 10490.
