## Field Monitoring Report -- Pebble Copper/Gold Exploration Project --

Personnel: Bill Cole (DNR/MLW)	Inspection Date: 7/12/11
Michele Sherwood DEC/SPAR)	Site Contact: Jeff Norberg
Gay Harpole DEC/SPAR)	APMA #: A116118
<b>■ Inspection Type:</b> <input type="radio"/> Complete: X <input type="radio"/> Partial: <input type="radio"/> Follow-up: <input type="radio"/> Response to Public Complaint:	<b>■ Wildlife Observed:</b> <input type="radio"/> Bear: <input type="radio"/> Caribou: <input type="radio"/> Moose: <input type="radio"/> Waterfowl: <input type="radio"/> Fish: <input type="radio"/> Other:
<b>■ Weather Conditions:</b> <input type="radio"/> Temperature: 45-50° F <input type="radio"/> Wind: 15-20 mph <input type="radio"/> Precipitation: None <input type="radio"/> Visibility: Variable <input type="radio"/> Sky Conditions: Low overcast, fog at higher elevations <input type="radio"/> Ground Conditions: Damp to dry	
<b>■ Comments:</b> Inspected DDH 10514, where petroleum staining and odor were noted on 6/22/11 (See 6/22/11 Pebble Field Monitoring Report). Spill has been remediated. There was a release of hydraulic fluid at drill #2, on hole #11533 on June 26. Release was contained

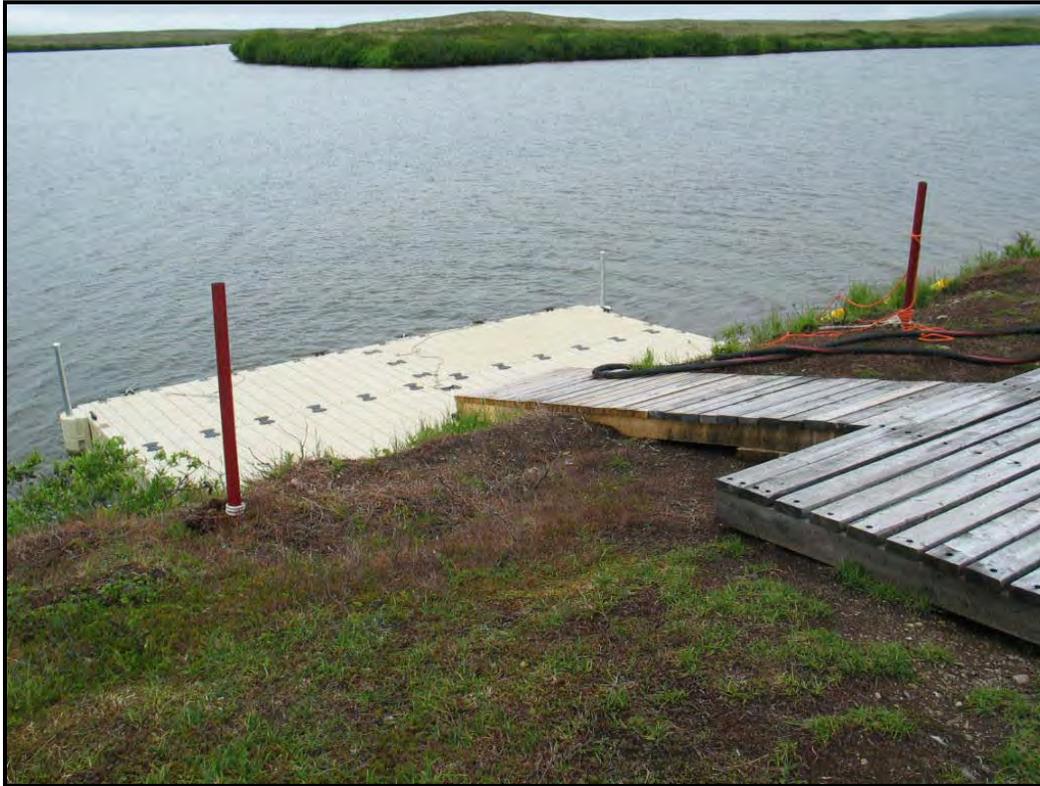
Photo #26. Walkway and dock at Big Wiggly Lake.

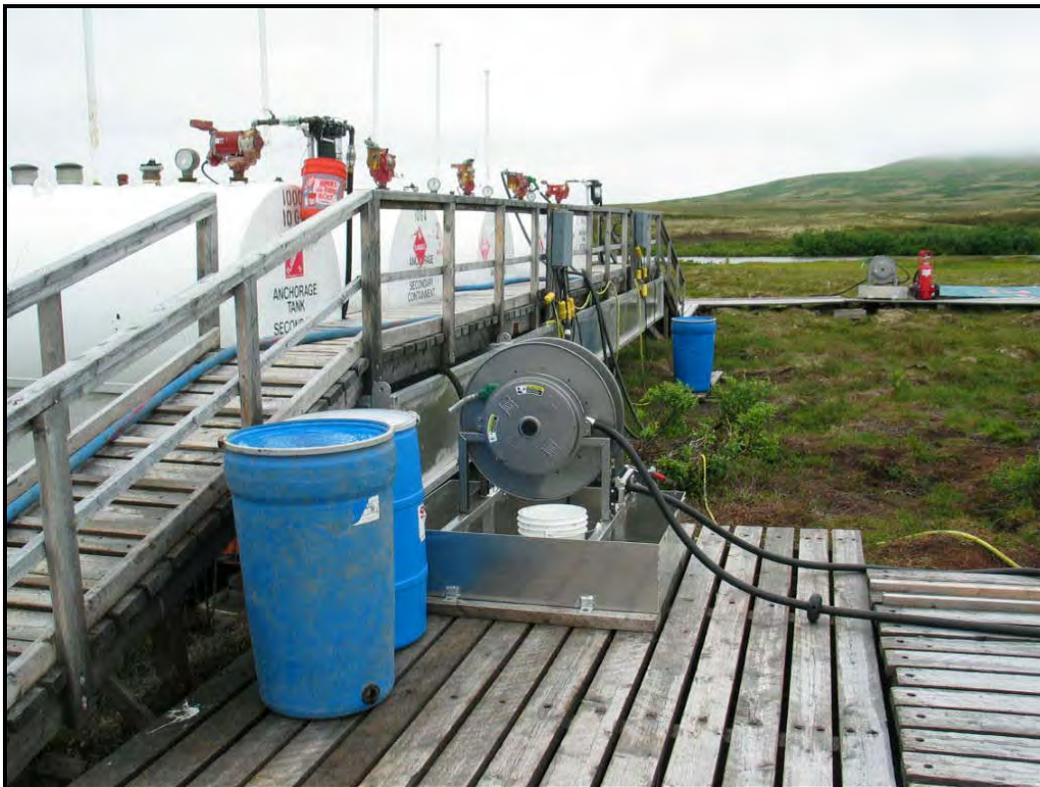
Photo #27. Fuel storage at Big Wiggly Lake.
