MINING SECTION -- MEMORANDUM

To: Files
From: Rick S. Fredericksen, CPG, PG Alaska *RSF*
Date: August 23, 2007
Subject: Site Visit to Pebble Project on August 21, 2007

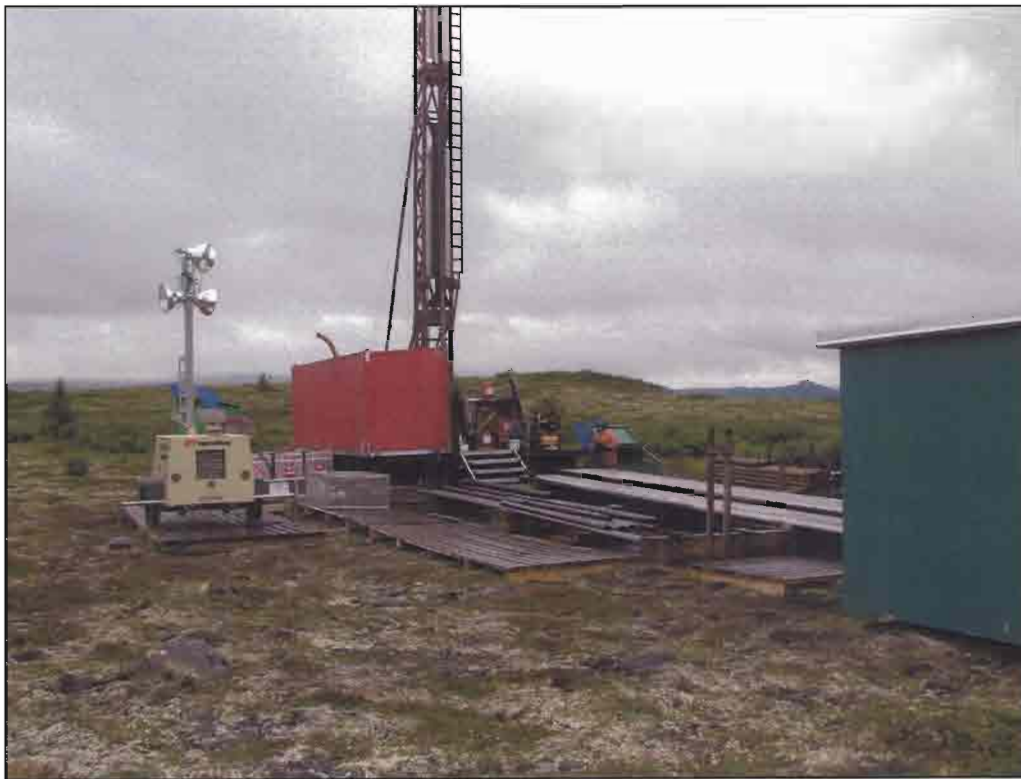
was operating satisfactorily and within conditions of the permit. The drill platforms are utilizing wooded decking for setup of the drills and rod handling thus minimizing impacts to the ground and vegetation. Sumps are being reclaimed by filling with growth media and replacement of the vegetative matt.

Drill Site – note use of decking to reduce impacts on tundra.

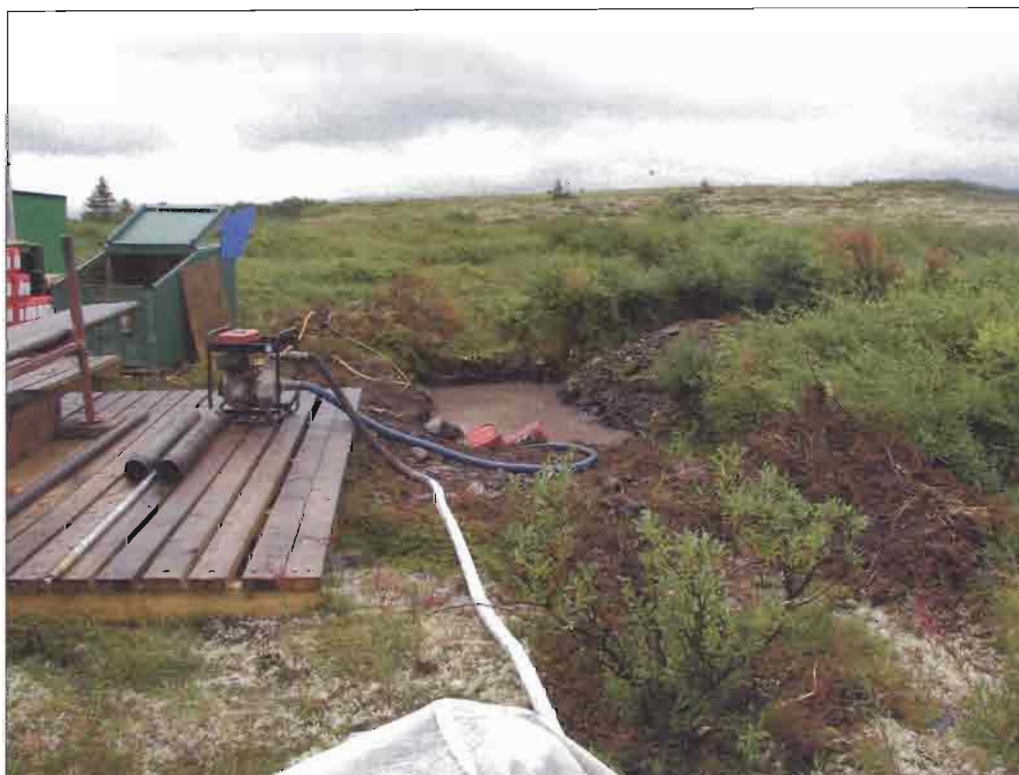
I inspected Rig #2 and looked at the sumps, water supply pump setup, drill decking, and sump oversupply discharge. The sump oversupply discharge was being periodically pumped to a small depression that was adequate for infiltration. This depression was being used by a least four of the drills in the area and was serving well. I discussed reclamation options for the depression with Lena Brommeland. The project has adopted an innovative color scheme for the water handling system whereby yellow hose is used for water supply and white hose for water discharge or recycling. No discharges to waters of the State were observed and the operation

Sump at drill site to collect rock cuttings.

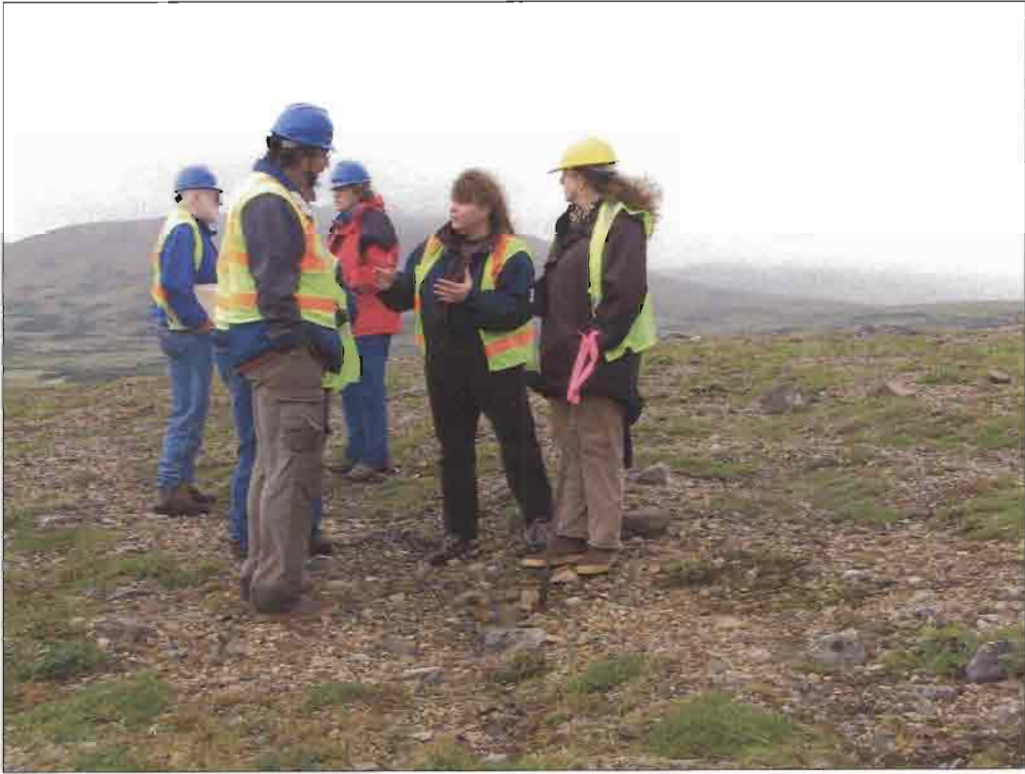
In excess of four hundred drill holes have been drilled in the Pebble copper-gold-molybdenum deposit. Virtually none of the sites older than a year or two are easily discernable. We examined a drill site on the hillside in the Pebble West deposit and unless the short stand pipe and lath were seen, the site was indistinguishable from the surrounding terrain.

Pebble West – site of old Cominco Drill Hole (flagged)

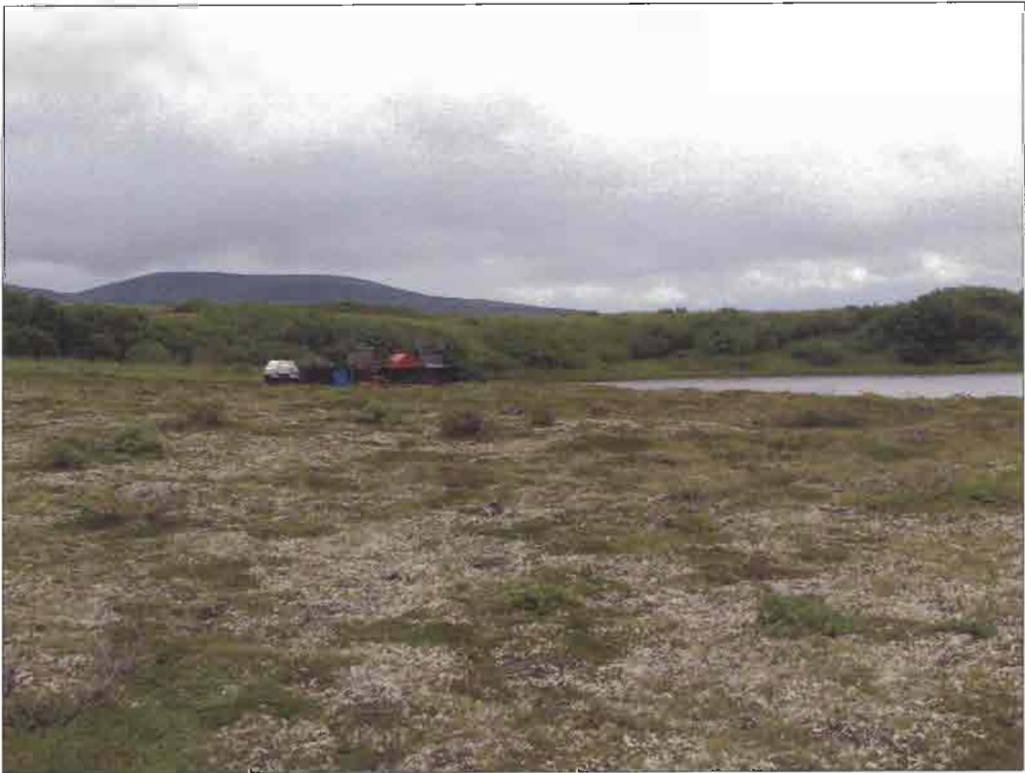
Drill water is supplied using a method whereby a generator and fuel supply is setup at some distance from the water being used. An electric screened sump pump is then used to pump water from the supply source to the drill. This technique keeps fuel and lubricants away from the water sources. The water supply pumps are enclosed in a screened box if the water source contains anadromous fish. These screens prevent even small smolt or fry from being pulled in to the pumps.

Water supply generator and pump

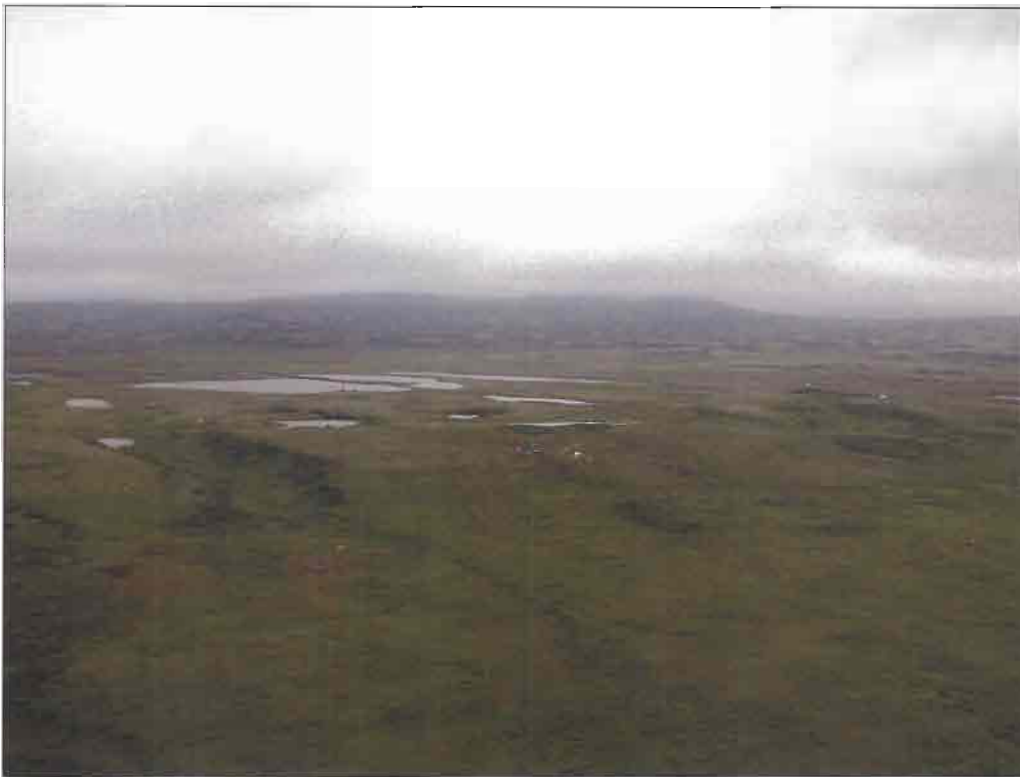
Drill sites overview

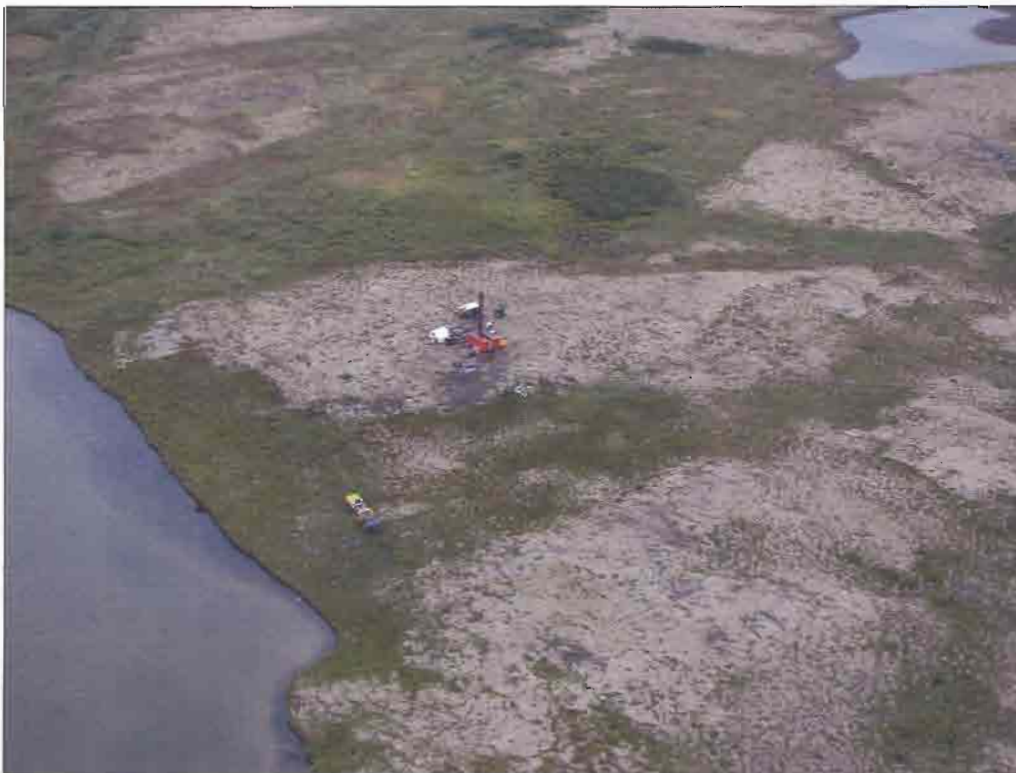
Water supply generator and submersible pump

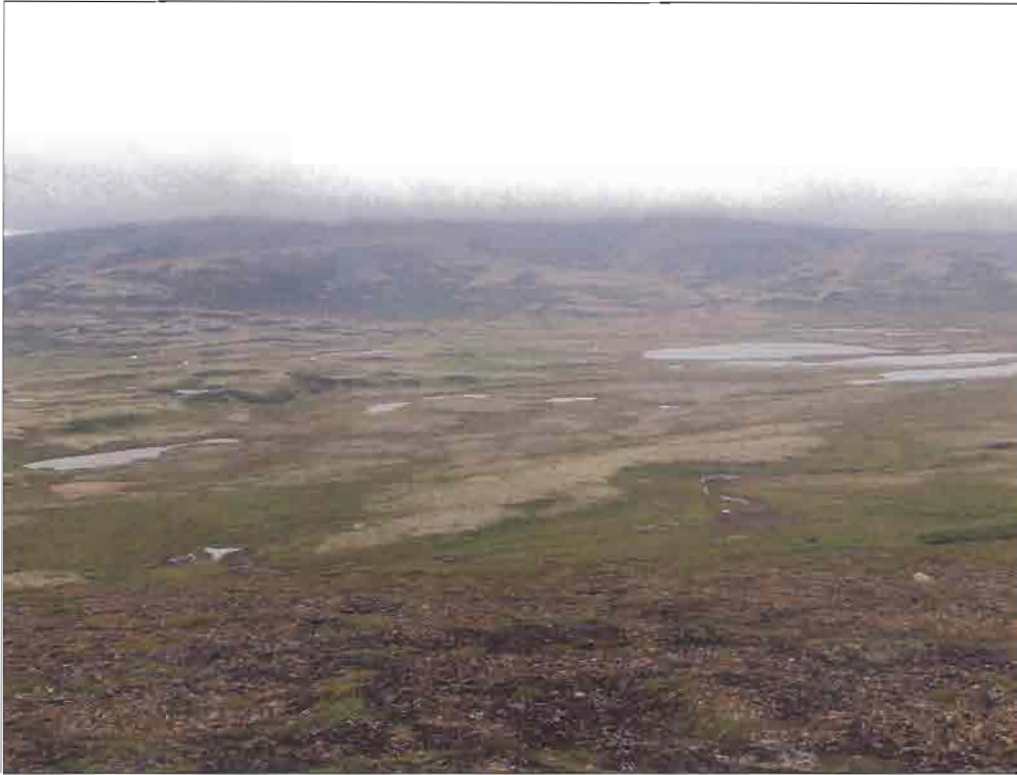
Overview of Pebble deposit from edge of Pebble West towards Pebble East

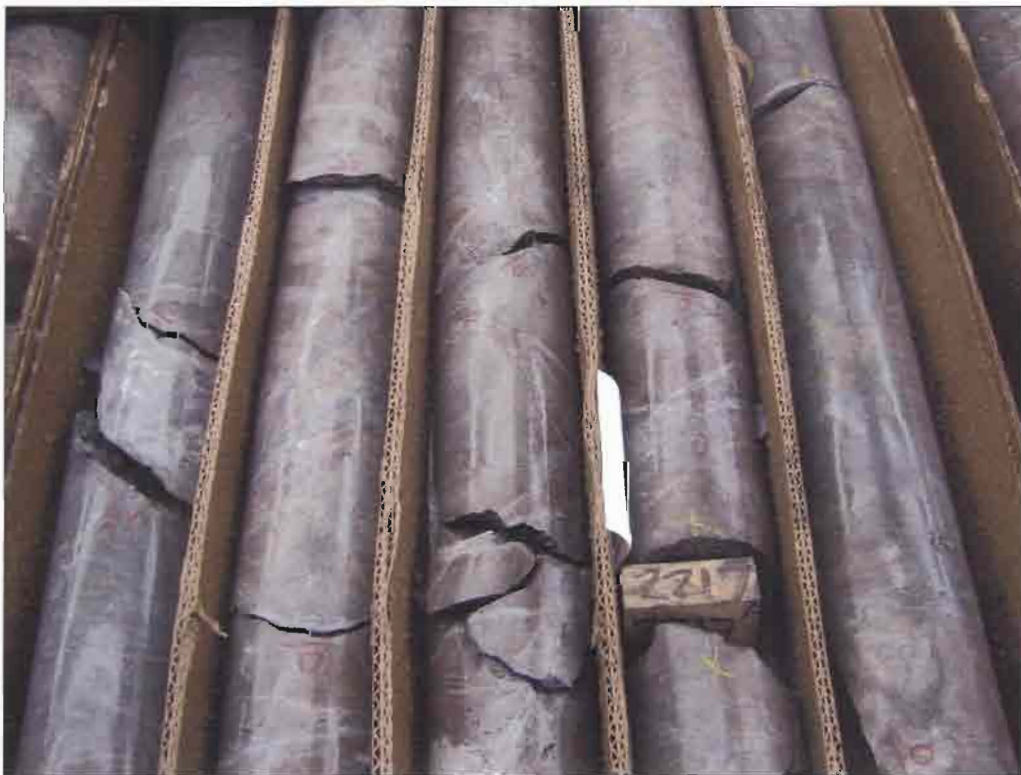
A visit was paid to the core handling, logging, and sampling facility in Iliamna. Core typical of east zone mineralization was laid out on the tables. The logging is complex due to the varying and intermixed lithologies, a multitude of overlapping veining events, as well as disparate and telescoped hydrothermal alteration assemblages. The sulfide mineralogy is relatively simple; the hole that I observed contains pyrite veinlets, chalcopyrite on fractures, quartz-molybdenite veinlets, and possibly some chalcocite. Geotechnical logging is also being completed to assess rock strength and competency with the aim of investigating if block caving can be utilized to mine the Pebble East deposit.

Core from Pebble East showing multiple vein sets and secondary biotite alteration.
