Field Monitoring Report
-- Pebble Exploration Project --

Personnel: William Groom (ADNR)	Inspection Date: June 16, 2014
Charlene Bringham (ADNR)	Site Contact:
Hollie Chalup (ADNR)	APMA #: 6118
<input checked="" type="checkbox"/> Inspection Type:	<input checked="" type="checkbox"/> Wildlife Observed:
<input type="checkbox"/> Complete:	<input type="checkbox"/> Bear: None
<input checked="" type="checkbox"/> Partial: Overflight	<input type="checkbox"/> Caribou: None
<input type="checkbox"/> Follow-up:	<input type="checkbox"/> Moose: None
<input type="checkbox"/> Response to Public Complaint:	<input type="checkbox"/> Waterfowl: None
	<input type="checkbox"/> Fish: None
<input checked="" type="checkbox"/> Weather Conditions:	<input type="checkbox"/> Other:
<input type="checkbox"/> Temperature: Mid 60's F	
<input type="checkbox"/> Wind: Light	<input checked="" type="checkbox"/> Water level at _____ Lake:
<input type="checkbox"/> Precipitation: Light	<input type="checkbox"/> Observed inflow:

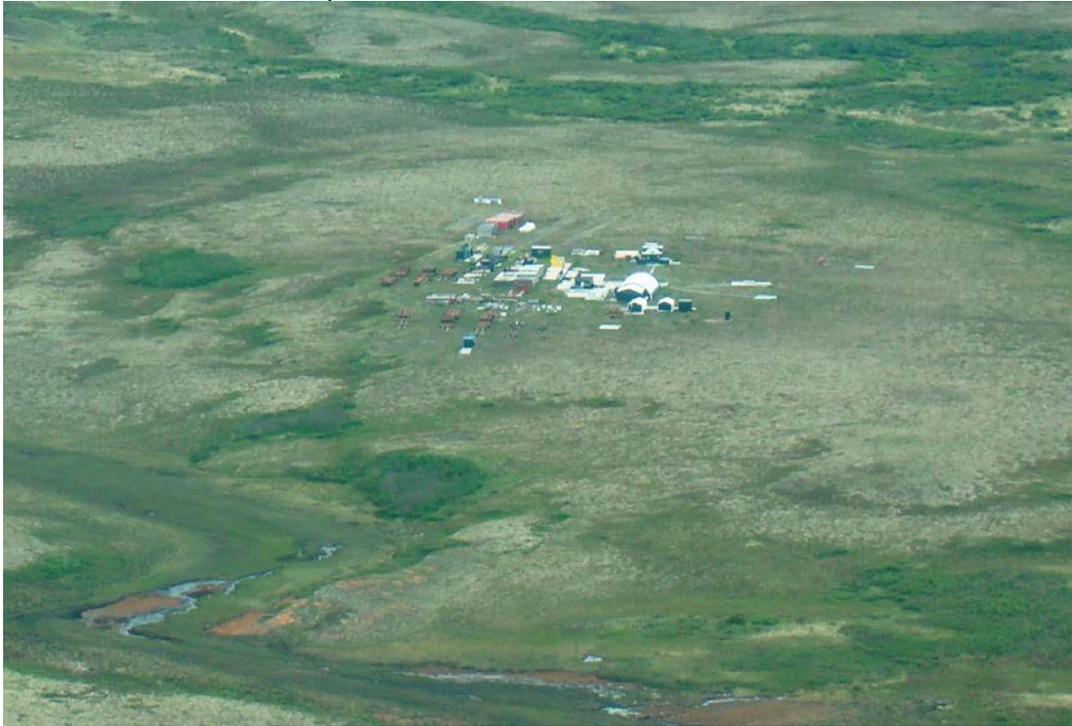
Photo 1: Pebble Camp Location on Claim block

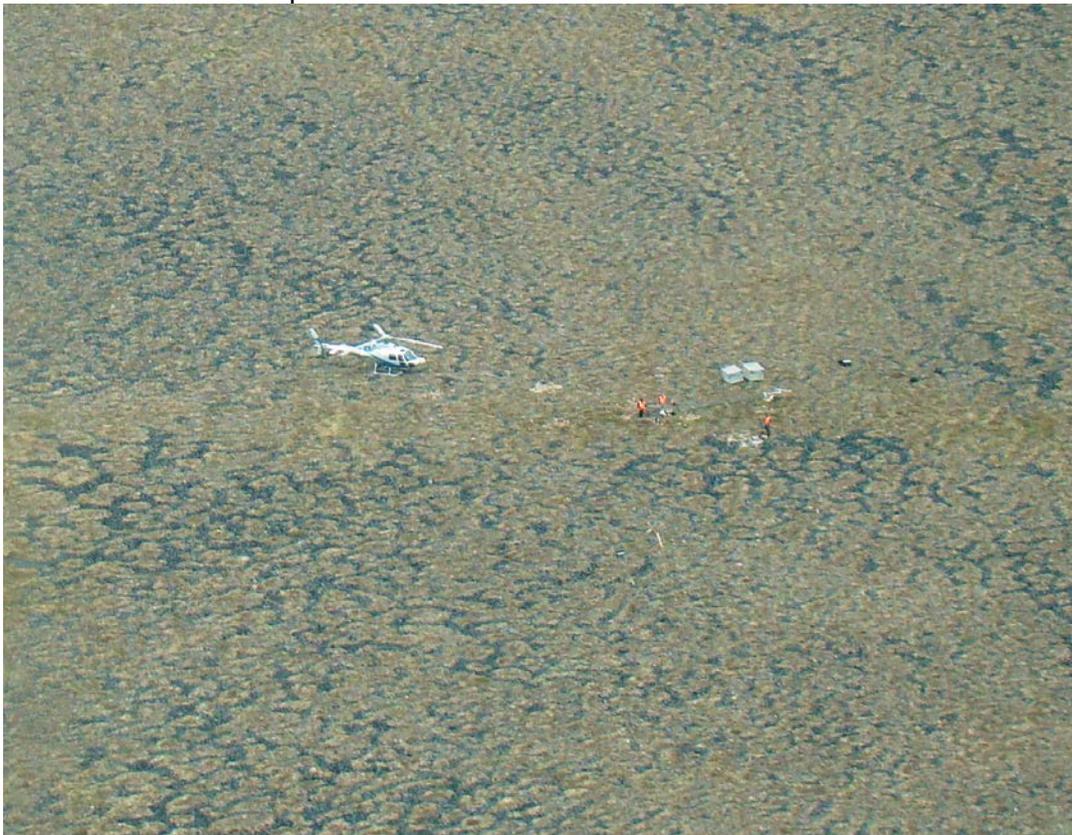
Photo 2: Ground crew conducting work to the northwest of Pebble Camp location

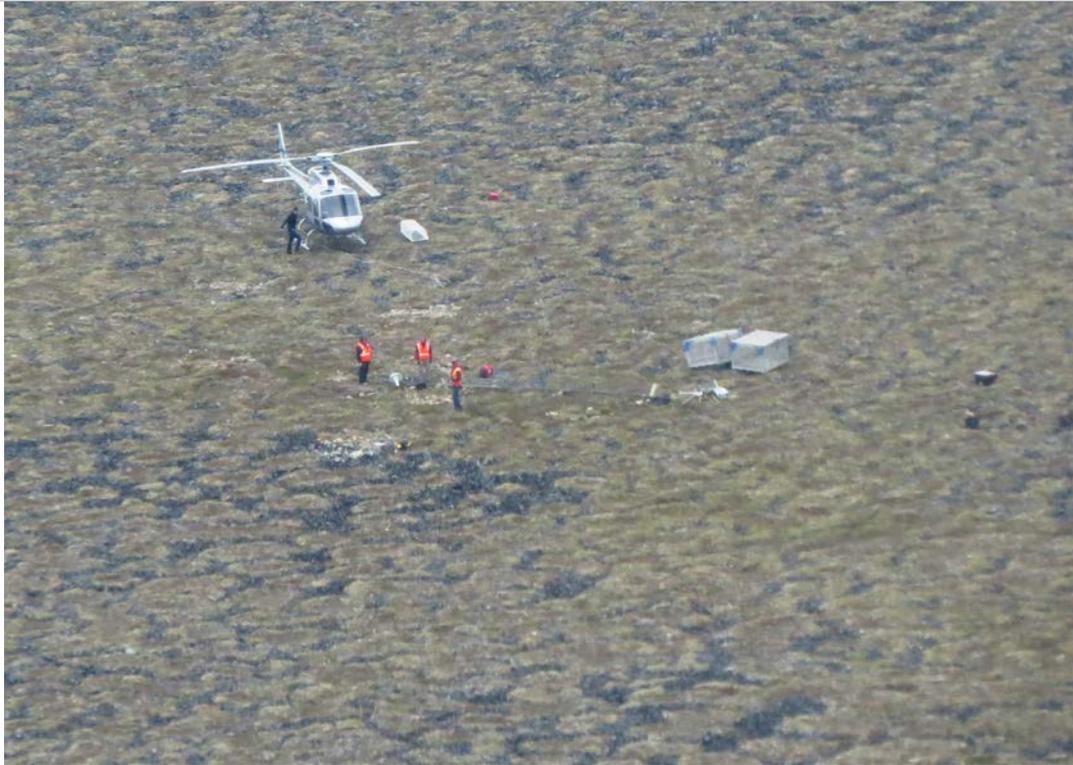
Photo 3: Ground crew working on tower structure northwest of Pebble Camp.

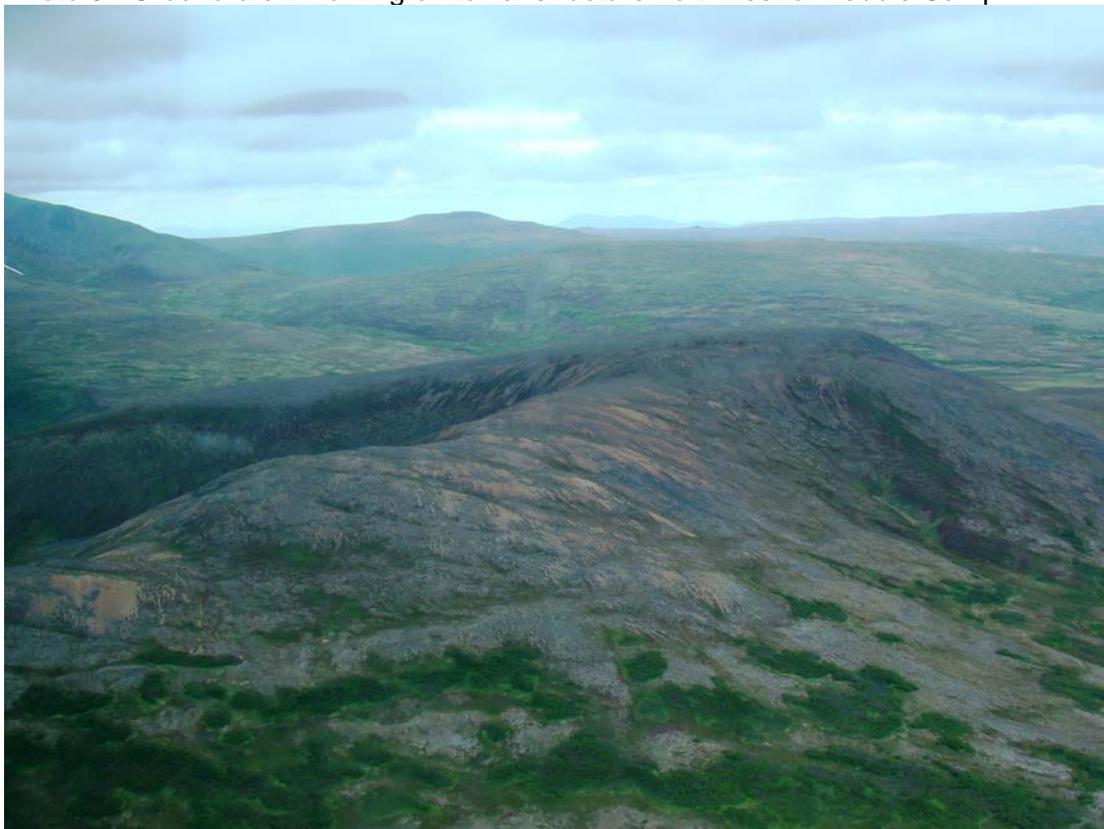
Photo 4: Pebble Deposit to the West of Pebble Camp
