STATE OF ALASKA

DEPARTMENT OF ENVIRONMENTAL CONSERVATION

FIELD INSPECTION REPORT HECLA GREENS CREEK MINING COMPANY

Inspection Date:	September 09, 2010, 7:30 AM to 12:30 PM.
Report Date:	September 23, 2010
Weather:	Light rain then fine
HGCMC Personnel:	Jennifer Saran, Environmental Affairs Manager Pete Condon, Geochemist
Tetra Tech:	Ron Rimelman, Gene Weglinski, Dave Cox, Henry Saver, Mark Williamson, Joe Fran, Susan Corser, Tim Reeves, Steve Negri, Mike Henderson, Brita Woeck, Henry Saver, Joe Frank
Agency Personnel:	Kenwyn George, ADEC, Tom Crafford, Steve McGroarty, Carrie Bohan, William Groom, ADNR; Kate Kanouse, Katie Eaton, ADF&G Habitat; Myra Gilliam, Sarah Samuelson, Chad Hood, Steve Paustian, Barbara Adams, Dave Barto, Karen Iwamota, USFS; Cindy Hartmann Moore, Linda Shaw, NMFS; Deborah Rudis, USFWS; Cindi Godsey, Lynne McWhorter, Phil North, EPA; Teri Camery CBJ

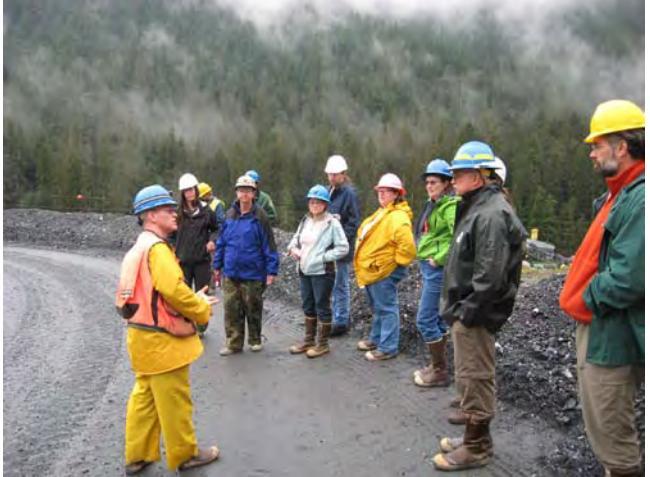
Pete Condon talks to agency personnel at Site 23

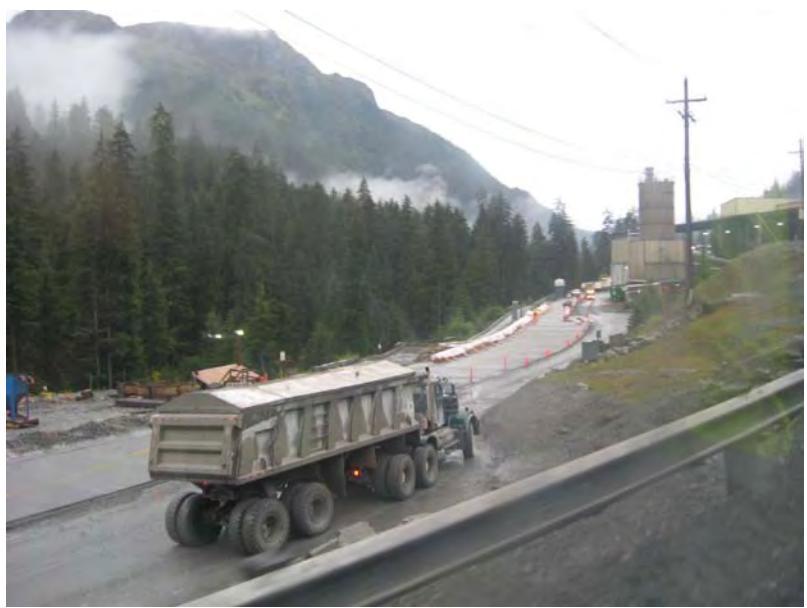
<u>Mill:</u> A concrete overlay to the road was partially complete, and there will be a high curb alongside this road to contain contaminants and act as a safety barrier. Completion of this concrete overlay to the portal will occur in 2011. A mill tour was provided.

Concrete overlay over the road at the mill site

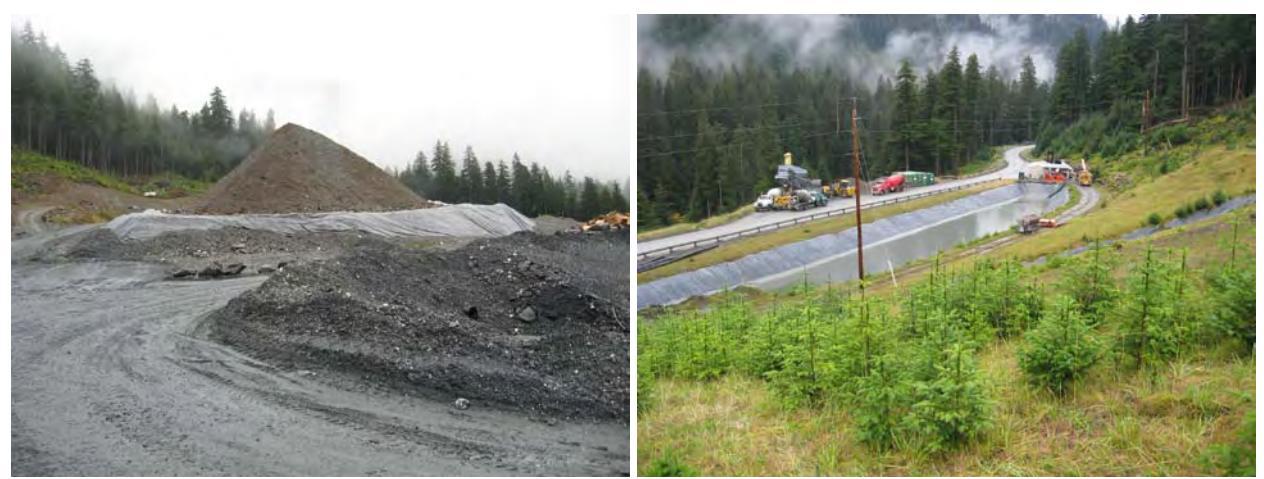
Site 23: The site had material from the 1350 site piled on the containment area awaiting transport underground. This material is to be placed underground rather than in Site 23 because it already has some of its carbonate used up in neutralizing pyrite within the waste rock. It would create acid within site 23, which is to be avoided as much as is feasible before this material is encapsulated to keep oxygen from it. There is approximately 30,000 cy of material left at Site 1350 to be brought to Site 23 and placed underground. When material was first placed at site 23, it was thought that native rock underlay the site. However, subsequent investigation indicates it is quite likely the waste rock is placed on landslide material. An inclinometer located on Site 23 has indicated a 3mm/year movement of the waste rock pile. HGCMC will be further investigating the movement during the coming year with new inclinometers that were installed this summer, and will make a determination as to whether or not the material, or some of it, should be re-located to the tailings facility. Water quality predictions presently indicate the cadmium fresh water quality standard will not be met at closure for discharge from this site.

Site 1350 material on containment pad at site 23. Naturally occurring revegetation on the cap.

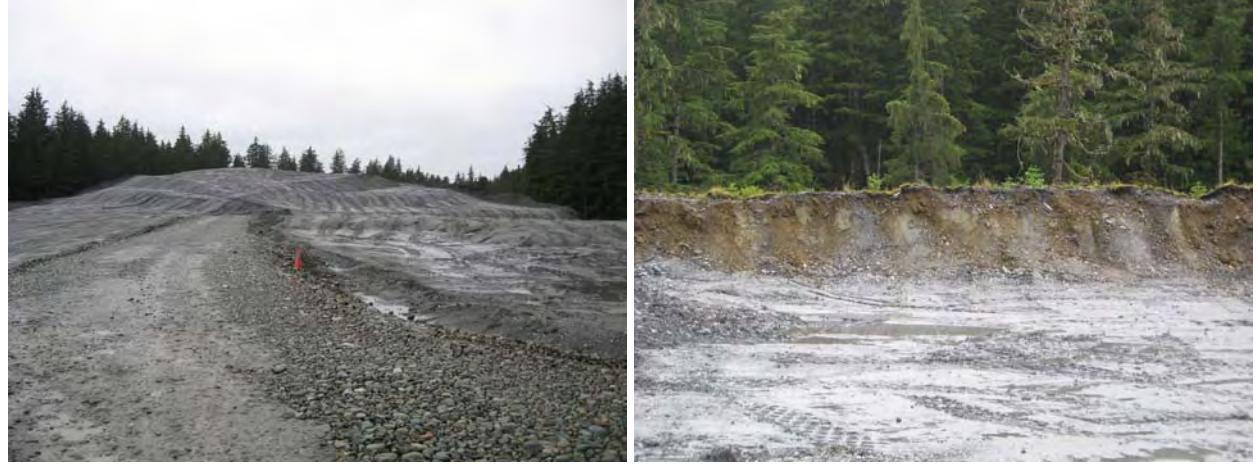
Material was first placed at this site in 1988. There was 25'-30' of waste rock (270,000 cy) on top of cells filled with till. This material is being moved to the tailings facility for co-disposal with tails. So far 80,000 cy has been moved; 40,000 cy in 2009 and the same this year. It will be a 5-year project to move all the potentially acid generating material from this site. At the time of the site visit the site had been graded, compacted and closed for the winter. Since being placed at the site the material has oxidized to a depth of 5 feet; this is a brown colored material, while the unoxidised material is a grey color.

Site E contoured for runoff

Site E oxidized/unoxidized materials

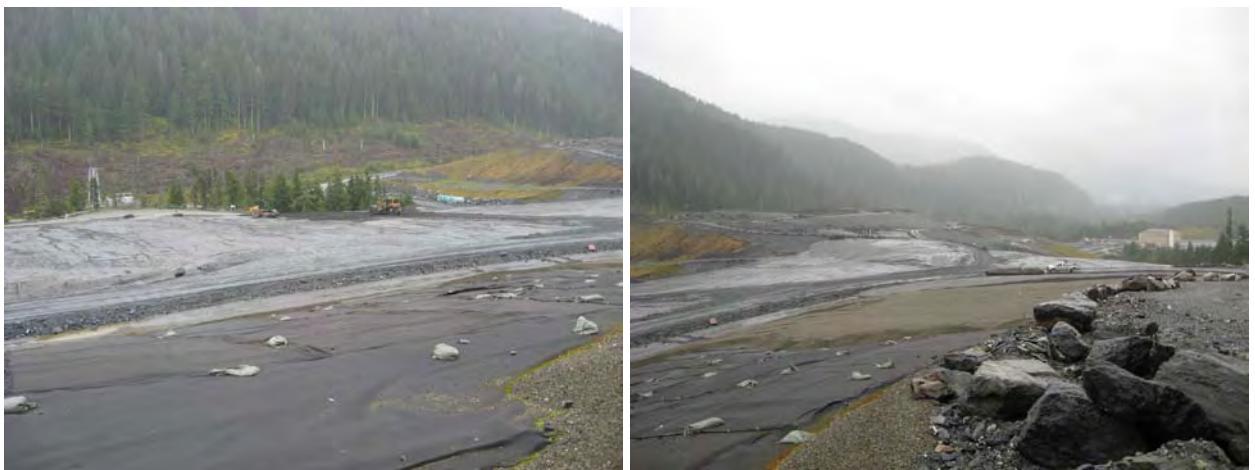
Tails were being placed in the NW corner of the site.

Tailings placement in NW

If tailings expansion to the south occurs, the pile would eventually rise to the level of the dip in the hills in the distance, from this viewpoint.

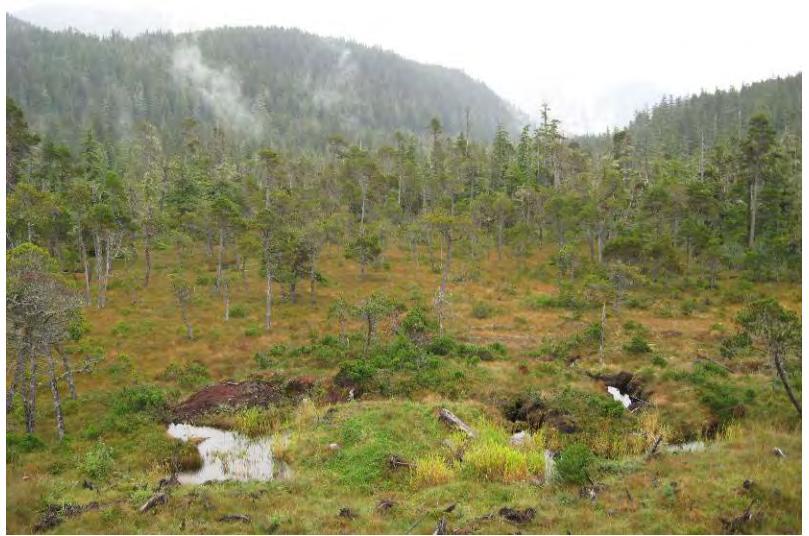
The group toured the water treatment plant and then was able to observe the proposed tailings expansion area from a vantage point to the south of Pond 7 that overlooks the Tributary Creek valley. Expansion options were discussed with approximate boundary lines pointed out.

Tailings expansion site – it will extend roughly to the far distant ridge of trees to the right of the picture.
