# 2011 Satellite Photograph Site 23/D, Mill Site, and 1350

# Appendix 2 Site 23/D Conceptual Cross Section

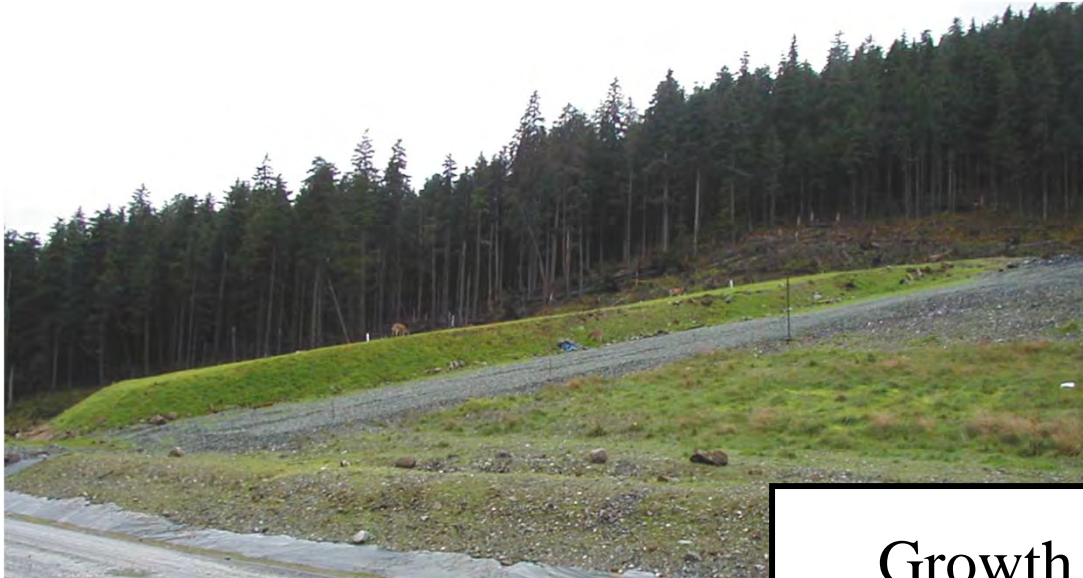
# Cover Design

Growth Medium

Capillary Break

Barrier Layer

2 meters
