MEMORANDUM

Department of Fish and Game Division of Habitat

THRU: Kate Kanouse subject: Greens Creek Mine Tailings

Habitat Biologist IV Disposal Expansion Trip Report

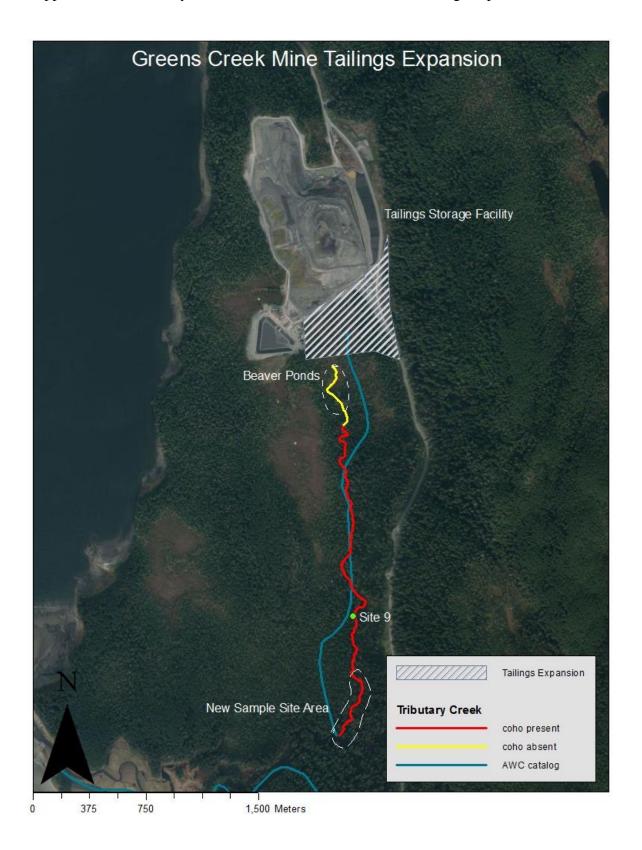
Appendix A1. Tributary Creek anadromous fish use and the tailings expansion area.

During my site visit, I walked the approximate approved TDF expansion footprint to better understand the potential for impacts to wetlands at the headwaters of Tributary Creek. Based on a topographic map provided by HGCMC, I documented several small wetland drainages within the TDF expansion area (Figure 1). There are two inactive beaver dams and an old beaver pond complex south of the approved expansion area (Figure 2). We have recently observed beaver activity and dam building approximately 1500m downstream near the biomonitoring site 9, during our annual biomonitoring. I planned on setting minnow traps in the ponds to investigate juvenile fish presence, however ice and snow cover prevented my effort. In June 2010, Habitat Biologists Kate Kanouse and Katie Eaton investigated fish presence in the beaver ponds and upper Tributary Creek and did not capture fish in the ponds (Kanouse 2010); they returned to the ponds in October 2010 and captured one Dolly Varden char and one cutthroat trout near the lower extent of the beaver pond complex at 58.1119° N, 134.7455° W. A map illustrating the Tributary Creek course I walked and extent of anadromous fish use (Kanouse 2010) is included in Appendix A1.

new biomonitoring site when the creek is ice free. I will also submit a route correction and reduce the upper extent of anadromous fish for Tributary Creek in the Anadromous Waters Catalog (Appendix A2).
