**INACTIVE PRODUCTION ROCK SITES AND QUARRIES  
2008 ANNUAL REPORT**

**Hecla Greens Creek Mining Company**

**April 15, 2009**

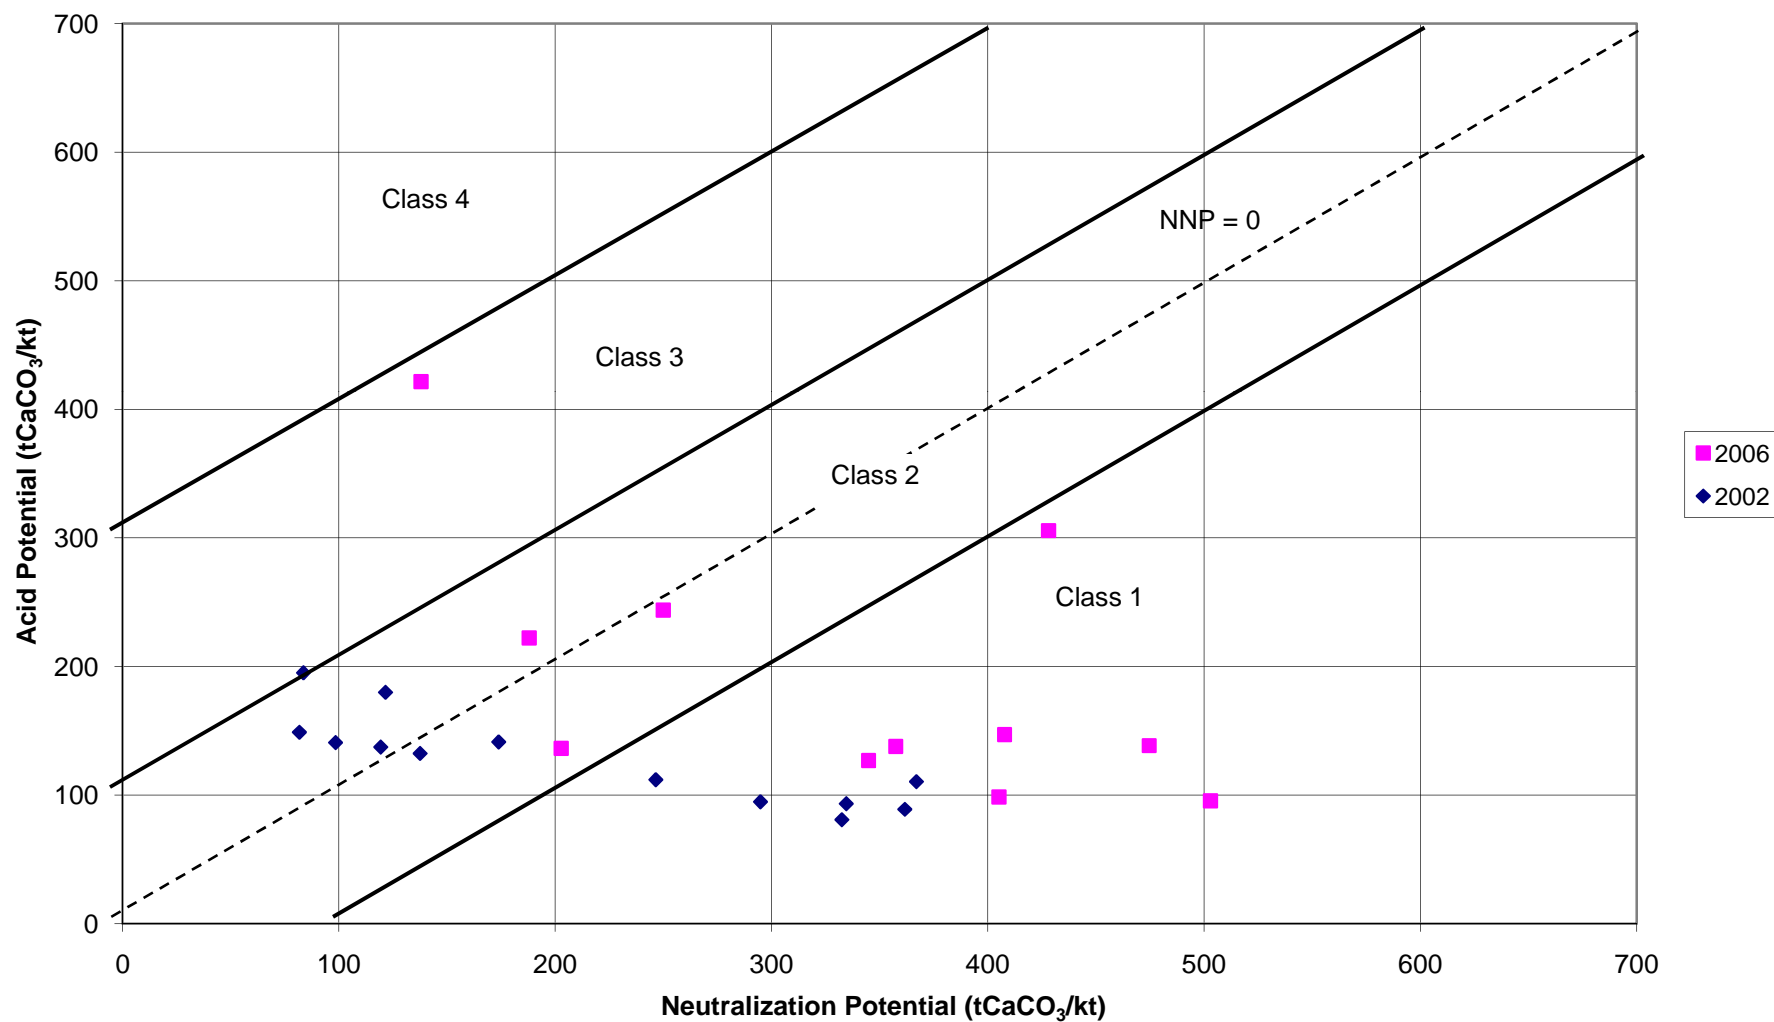
Figure 2.3 2002 & 2006 Inactive Production Rock Site Acid-Base Accounting Analyses Site E

Figure 2.3 compares acid potential (AP) with neutralization potential (NP) for 2002 and 2006 surface grid samples for Site E. Grid samples were taken at all of the inactive sites in 2008, however the ABA analysis was not available in time for this report. The pending data will be provided when available. The inactive sites were constructed prior to development of the

classification protocol that HGCMC currently uses. At the time the inactive piles were constructed HGCMC did not classify or segregate its production rock. Symbols in Figure 2.3 represent actual laboratory data points. Lines indicating the currently utilized production rock classes are shown on Figure 2.3 for reference only. Figure 2.3 shows the distribution of potentially acid generating (upper left half of figure) and potentially acid neutralizing (lower right half of figure) samples. Seven of the eleven Site E 2006 samples would be classified as Class 1 (acid neutralizing) under the current classification procedure. Regardless of pyrite content, almost all production rock at Greens Creek contains substantial carbonate (5 to 40%). This carbonate content indicates that there is a relatively long lag time to potential acid generation for the majority of the samples.

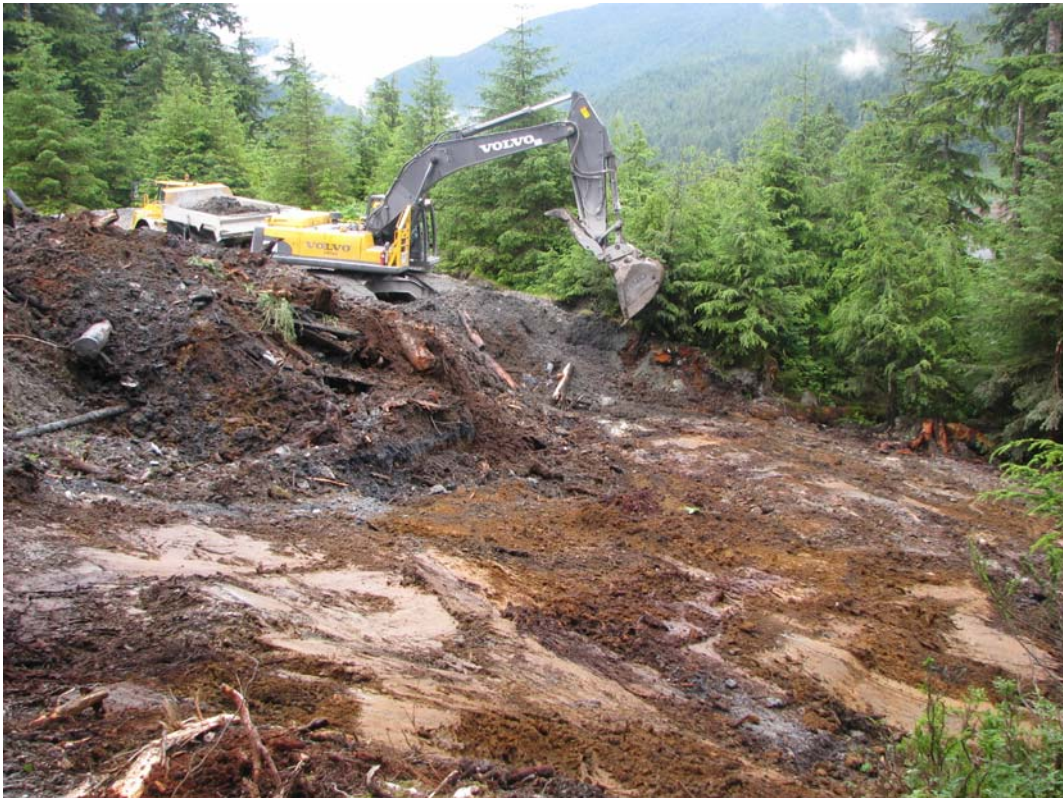
Figure 2.4 1350 Removal July 2008

To date approximately 10,900 cubic yards (cy) have been removed from the 1350. In 2005 4,120 cy of material was removed, and a portion of that material was returned to the underground as backfill while the remainder was placed into Site 23. The material placed in Site 23 was weakly oxidized and contained low pyrite and abundant carbonate. Inclement weather and lack of backfill capacity underground prevented haulage of additional waste rock from the 1350 in 2006. In September 2007 2,560 cy of material was removed from the 1350 and hauled underground. In 2008 approximately 4,220 cy were removed and placed in the new Site 23 interim storage facility.

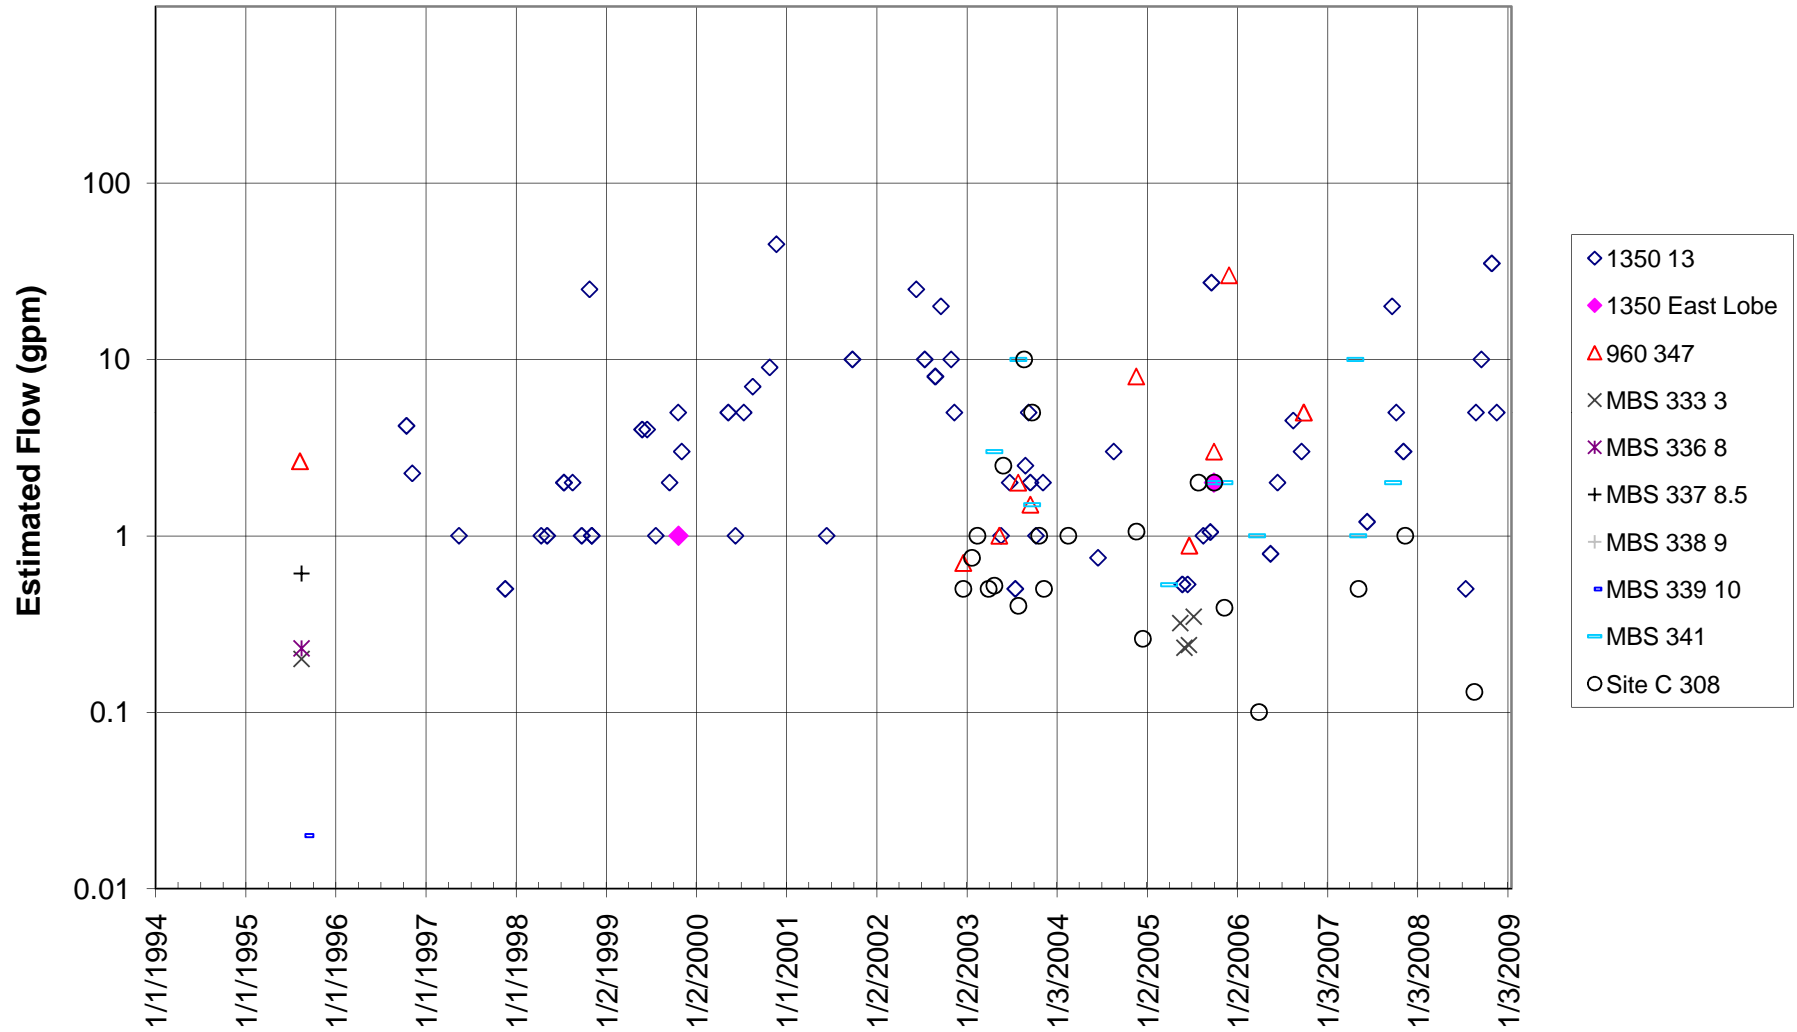
Figure 2.5 Inactive Production Rock Site Flow Data

Flow data presented in Figures 2.5 and 2.20 demonstrate that flows at most of the sample locations are generally low (less than 10 gpm) with the exception of Site E. Some of the flow data were collected as part of the NPDES stormwater monitoring program. Collected during or following storm events, flow data from these locations (e.g. Site E 356, 960 347) represent short-term maximum flow values in response to relatively large precipitation events. Lack of significant flow from inactive sites is a positive characteristic because it reflects minimization of potential off-site impacts.

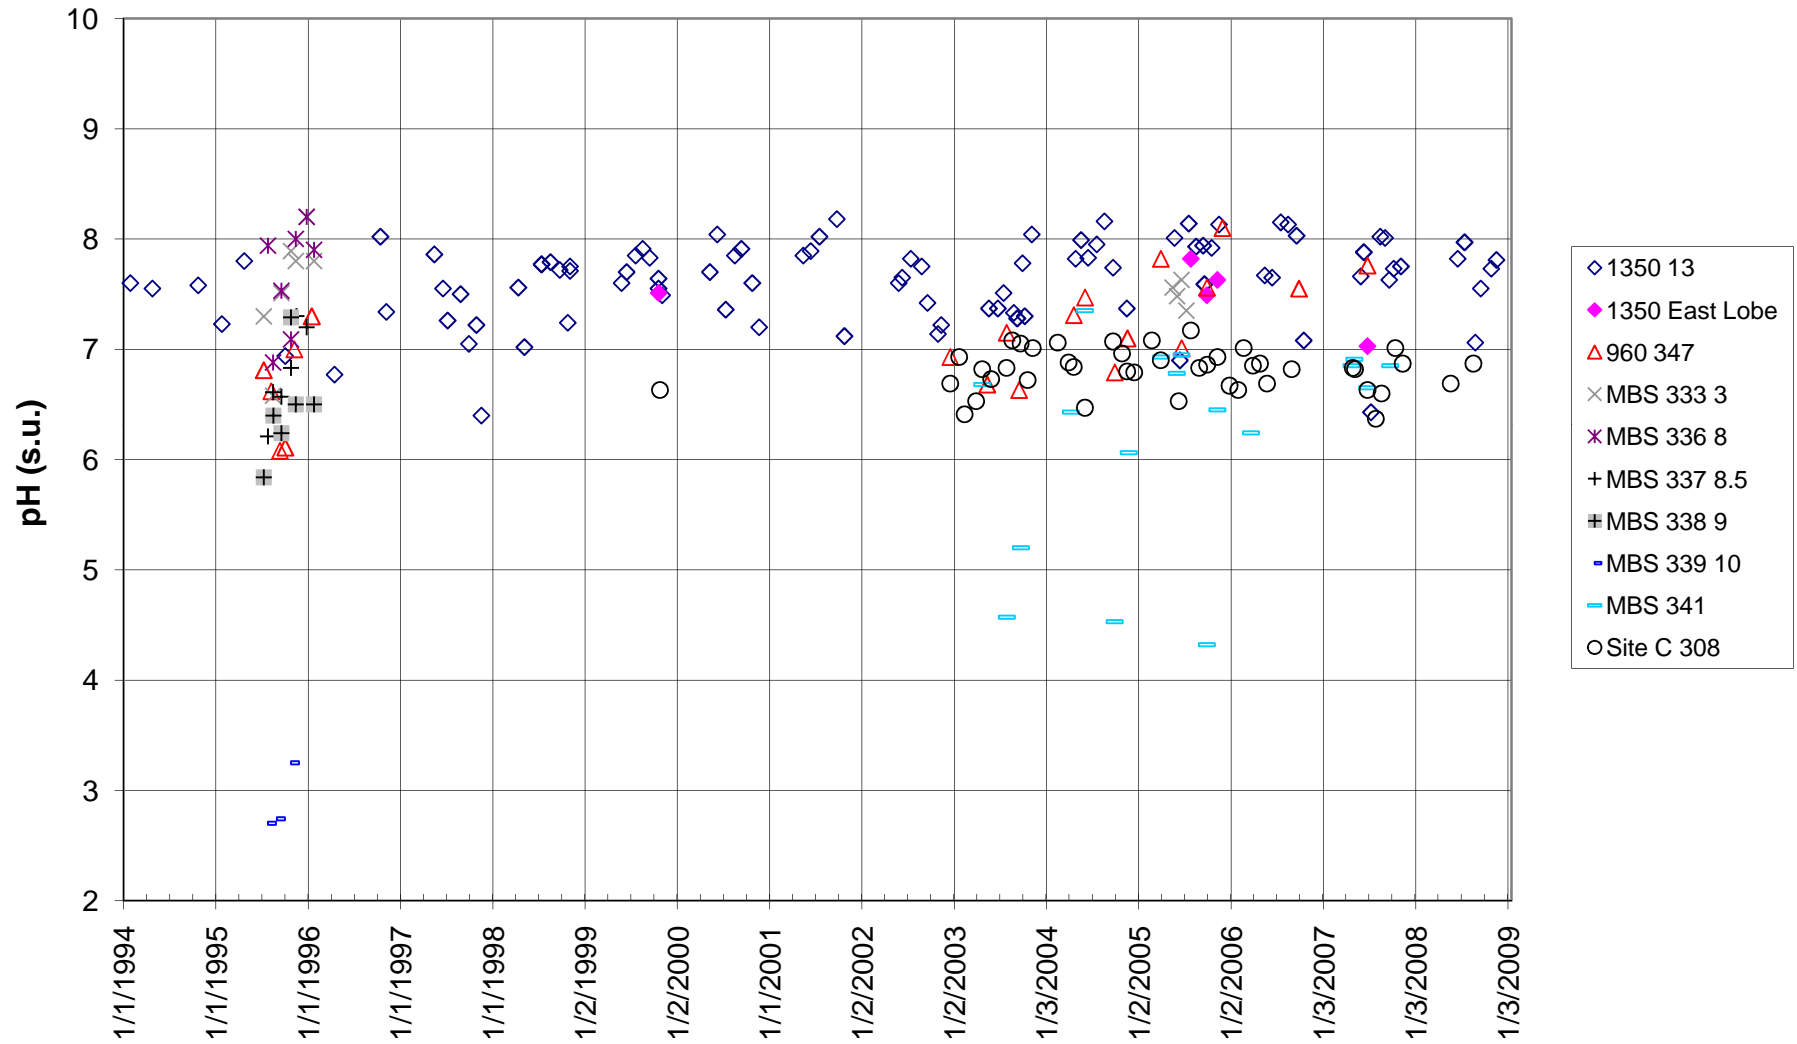
Figure 2.6 Inactive Production Rock Site pH Data

Figures 2.6 and 2.21 show pH data from inactive site sampling locations. Lower pH values can represent influences from pyrite oxidation and/or organic acids from muskeg and forest soils. The data show that the vast majority of the site drainage remains above pH 6.0. The sample from the Mill Backslope in 1995 was runoff collected from a bench containing zones of heavily pyritized rock. For a brief period in 1998 and 1999, acidic conditions began developing at the 960 (site 347). HGCMC applied lime and removed 1000 cubic yards of oxidized pyritic rock from the site in 2000. The pH of the drainage quickly rebounded and has remained near-neutral since 2000. Removal of additional Site 960 material in 2003, 2004 and 2005 is discussed below in Section 2.3. The material removal activities may also be responsible for the pH of 8.0 measured at the 960 site in 2005. This is the highest recorded for this site. The reason for the elevated pH is likely due to the removal of pyritic rock that had consumed much of its readily available buffering capacity. Fresh carbonate mineral surfaces exposed during the excavation and the placement of the toe buttress may have contributed to the higher pH values observed. Alkalinity data presented in Figures 2.7 and 2.22 are consistent with the pH results in Figures 2.6 and 2.21. Sample locations continued to maintain measurable alkalinity provided by dissolution of carbonate minerals.

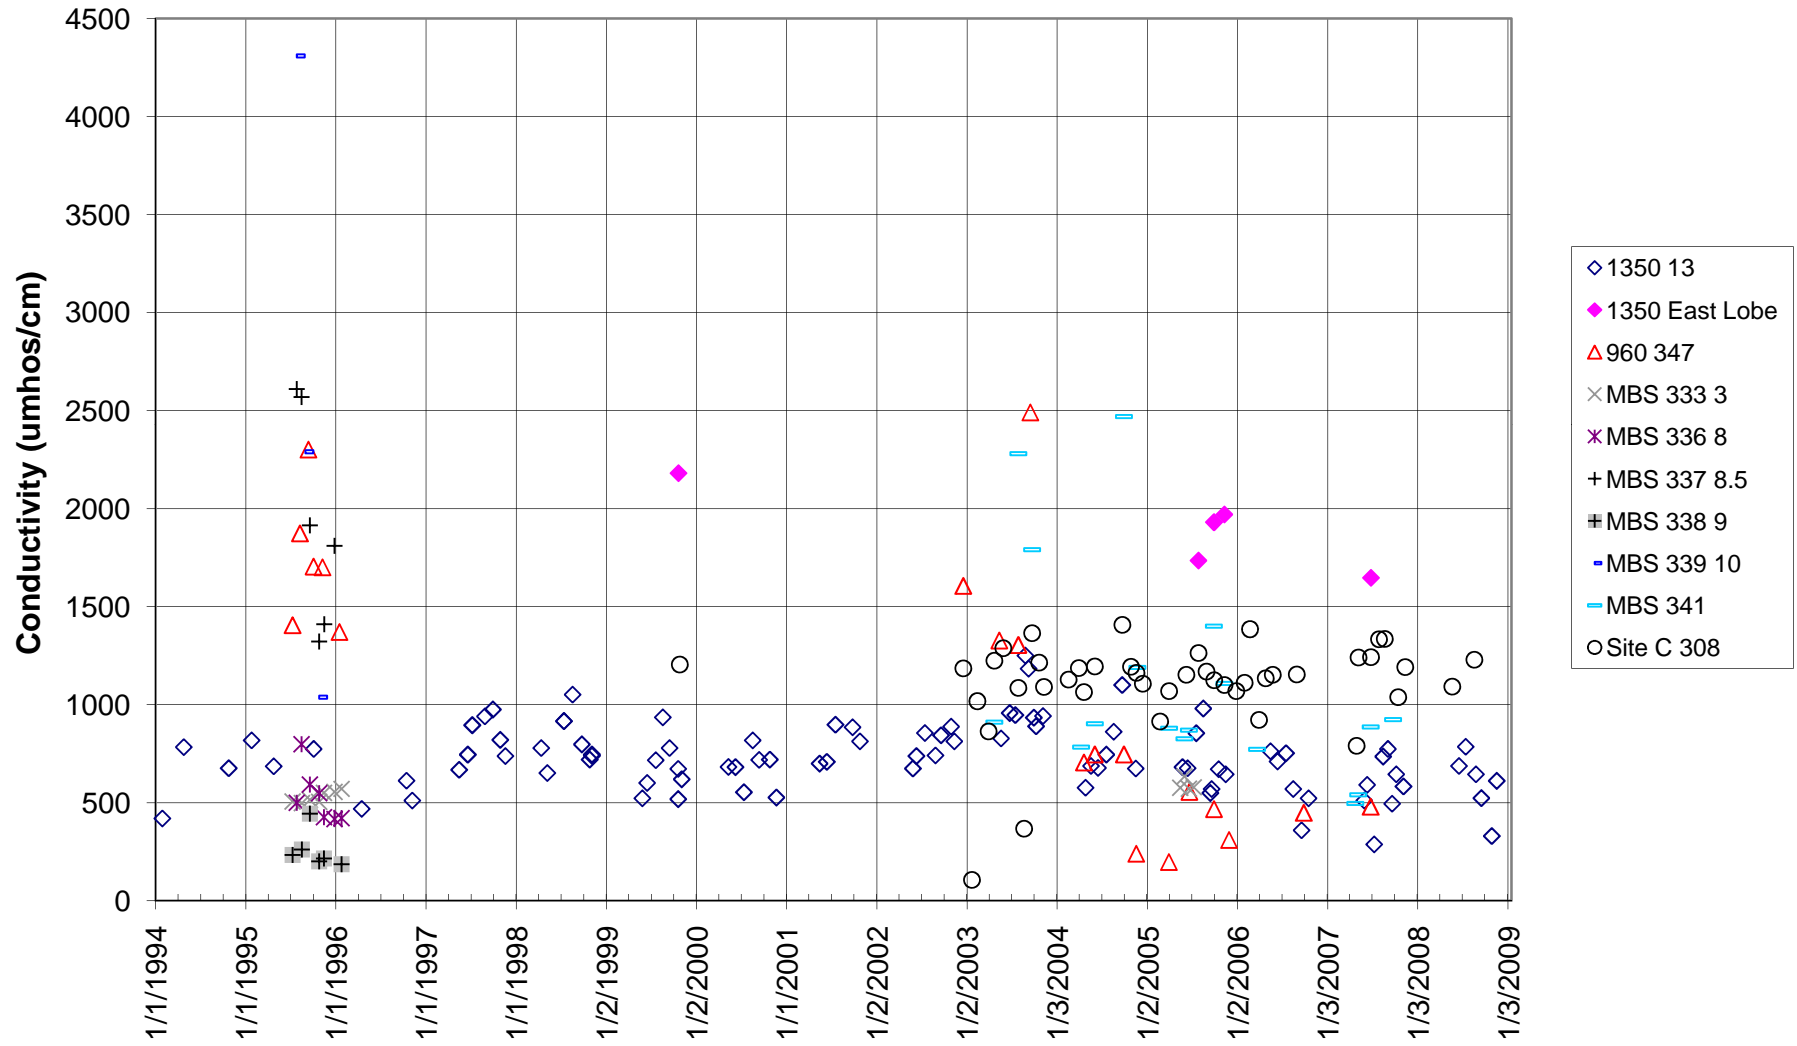
Figure 2.8 Inactive Production Rock Site Conductivity Data

Conductivity data are shown in Figures 2.8 and 2.23. Conductivity indicates the amount of dissolved constituents in the water. HGCMC samples having higher conductivity values usually have higher sulfate, calcium and magnesium (hardness) concentrations, reflecting influences from sulfide oxidation and carbonate mineral dissolution. Water that has contacted production rock is expected to have higher conductivity values than background waters. The 960 (site 347) shows an overall decreasing trend in conductivity, while the Site 1350 data remains unchanged. The combined drainage from the Mill Backslope area (Site 341) showed a lower average for the dissolved load in 2007. Site C had a slightly higher average annual conductivity in 2007 than 2006 (1,166  $\mu\text{mhos/cm}$  in 2007 versus 1,143  $\mu\text{mhos/cm}$  in 2006). The decreasing trends apparent in Figures 2.8 and 2.23 are the result of decreasing reactive surface area available for oxidation and dissolution. The reactive surface area decreases as reactants are consumed and mineral surfaces become coated with oxidation products. The results for sulfate, magnesium and hardness, shown in Figures 2.9 and 2.24, 2.10 and 2.25, and 2.11 and 2.26, respectively, correlate with conductivity results and are consistent with the concept of generally decreasing or static reactive surface area.

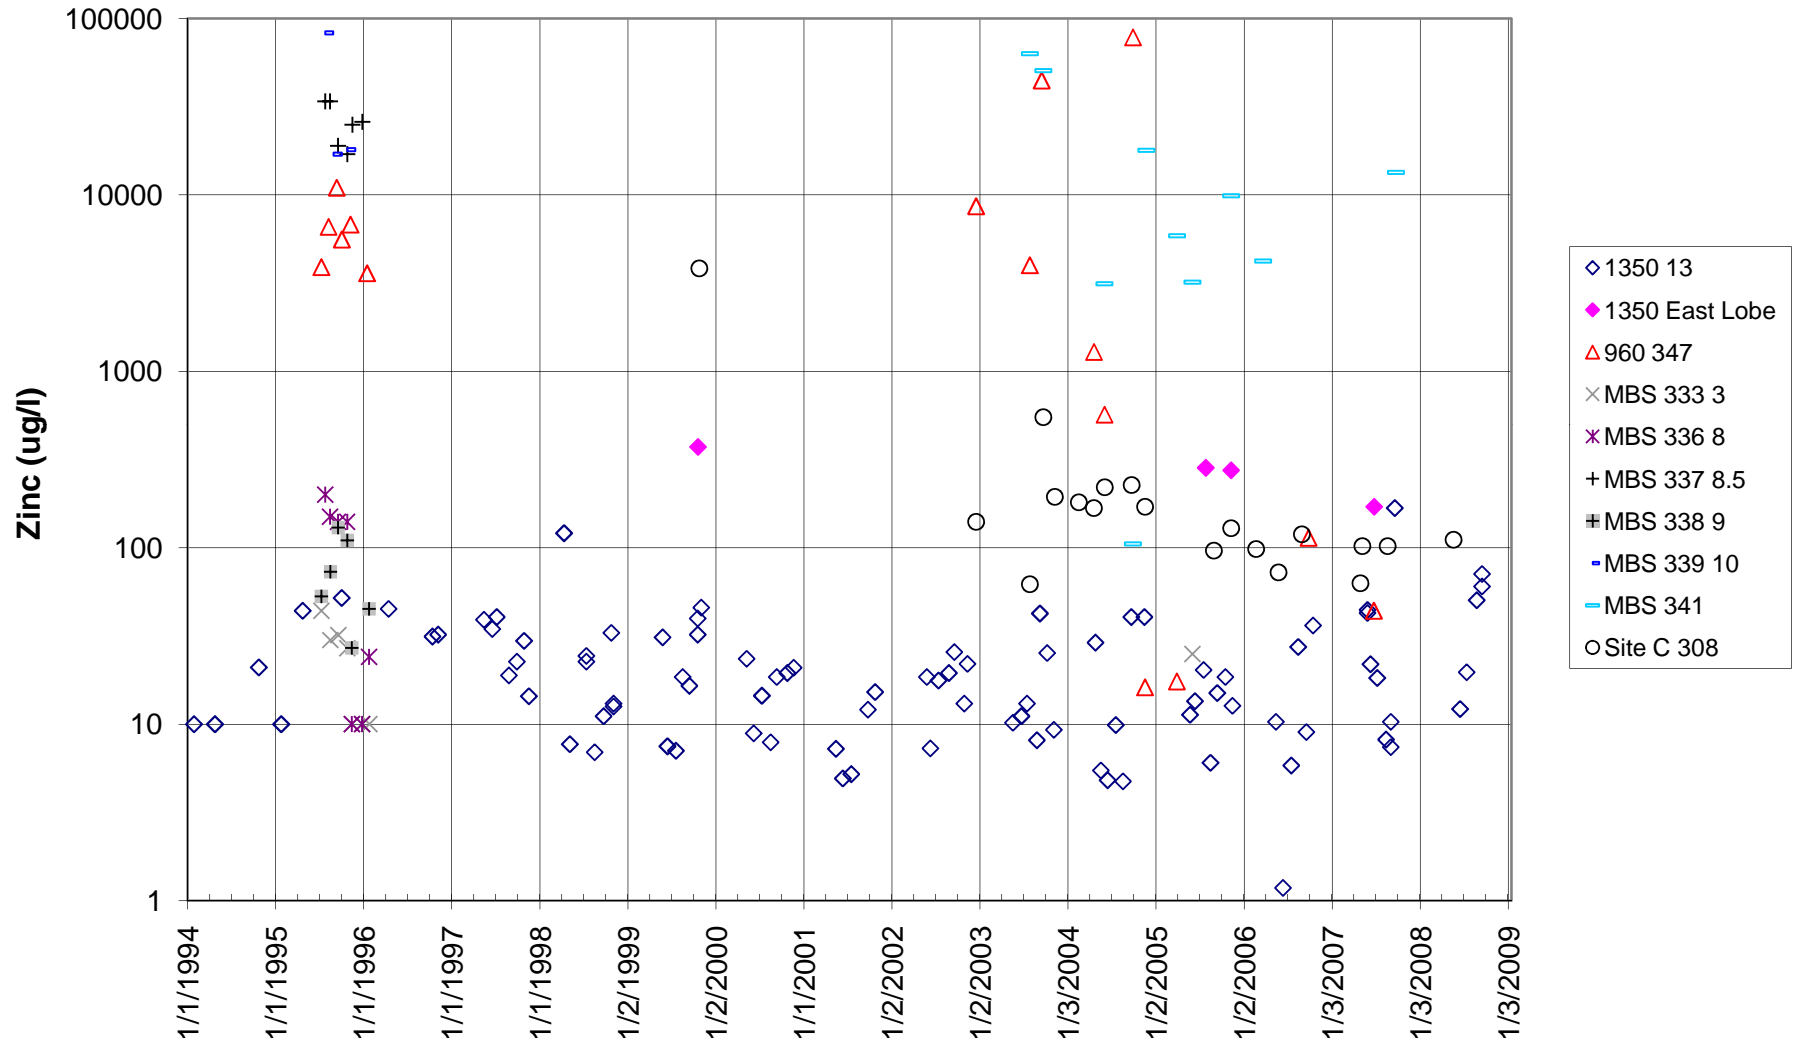
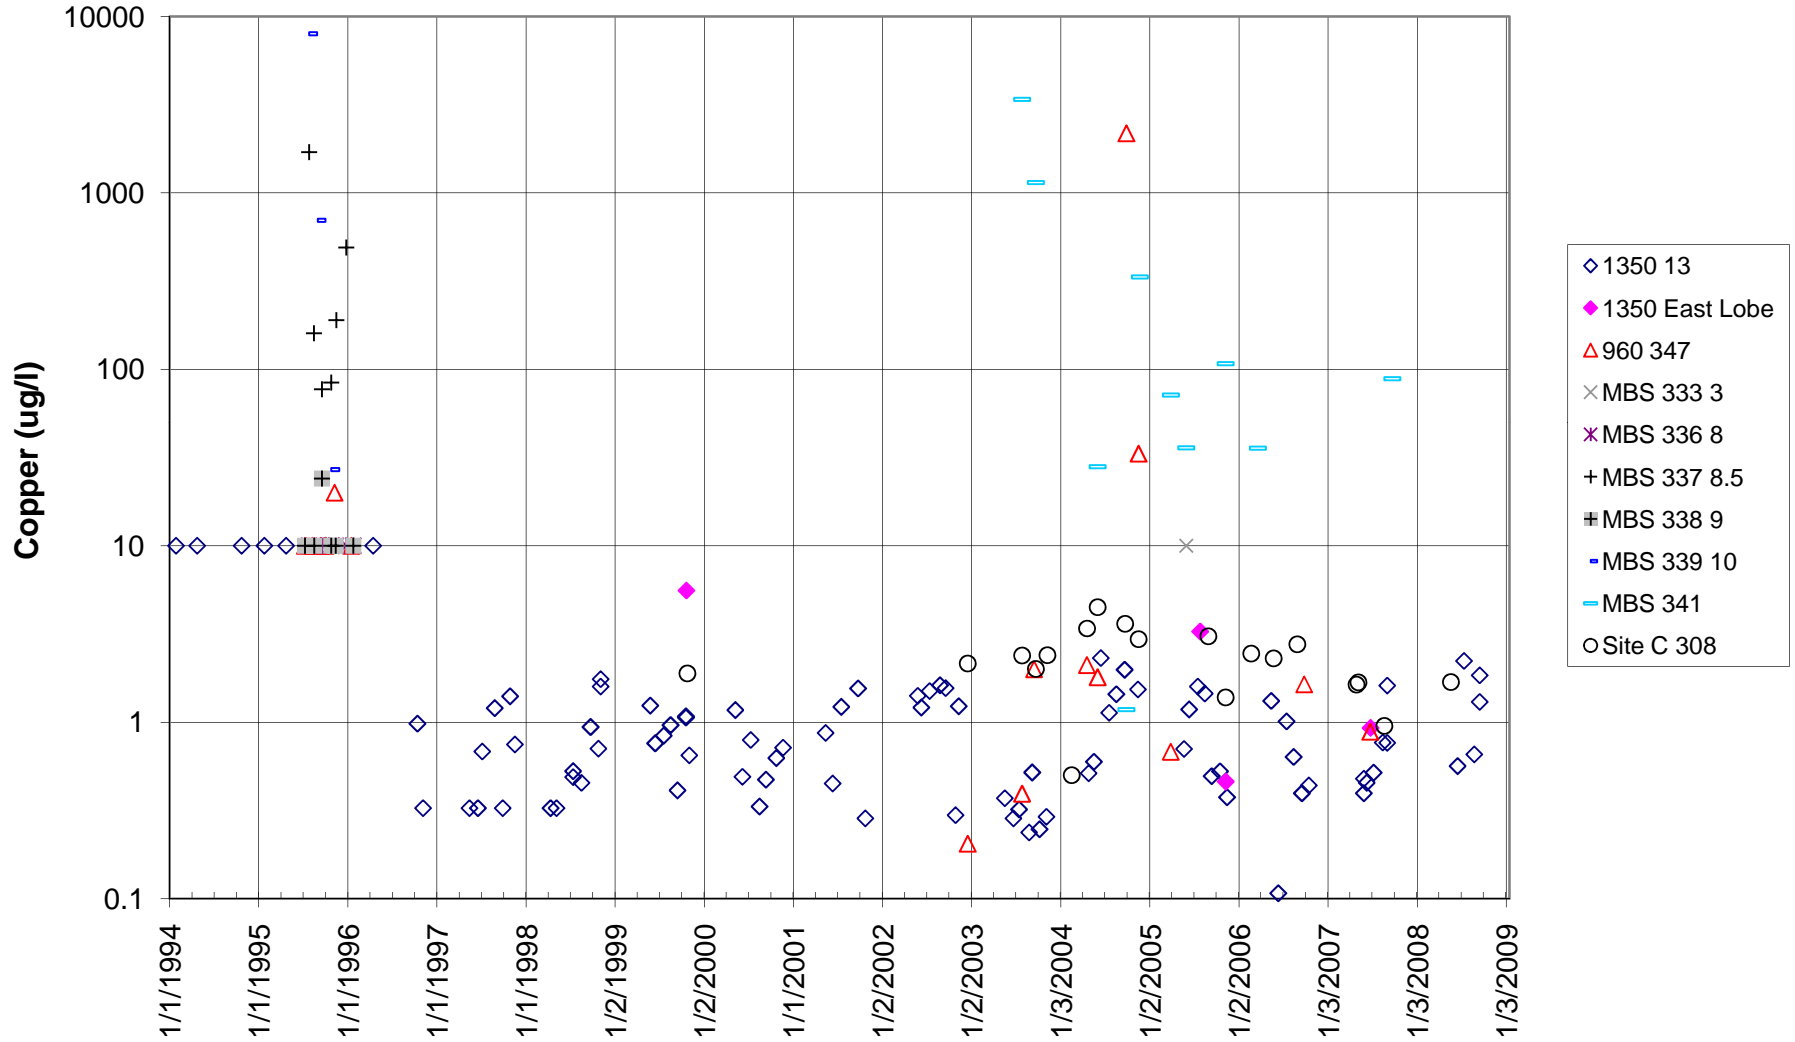
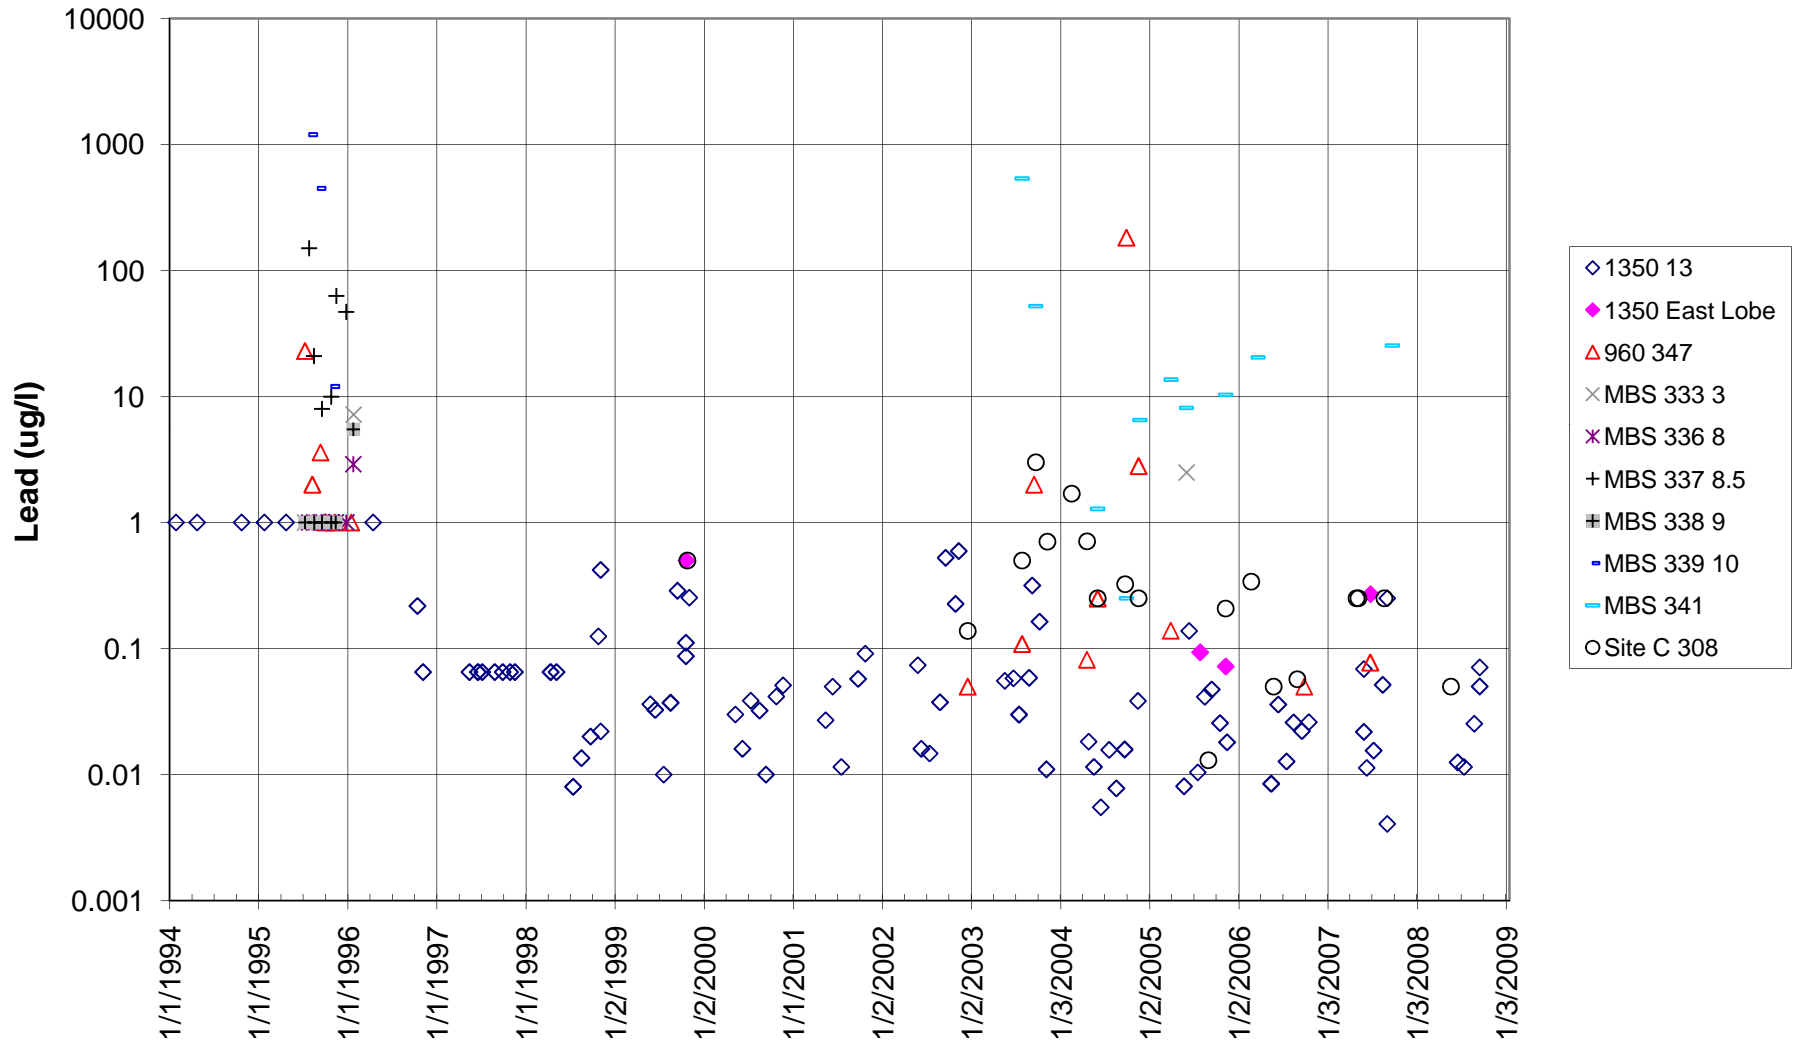
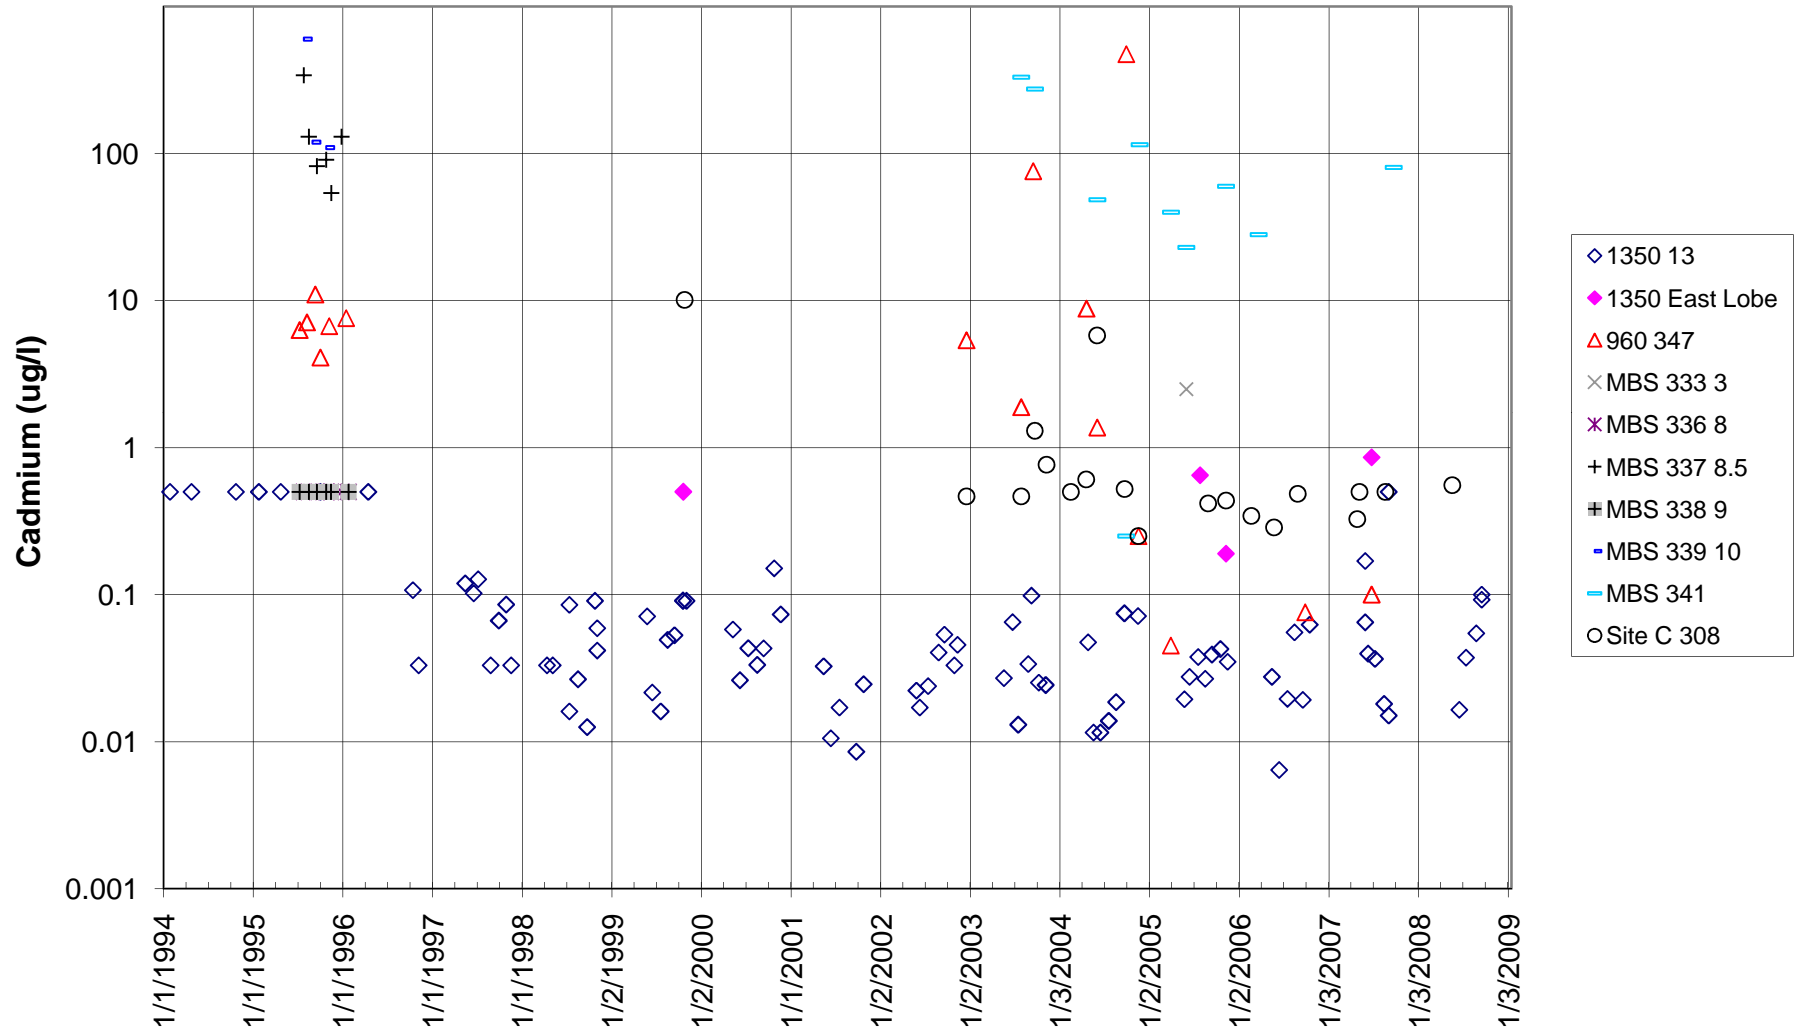
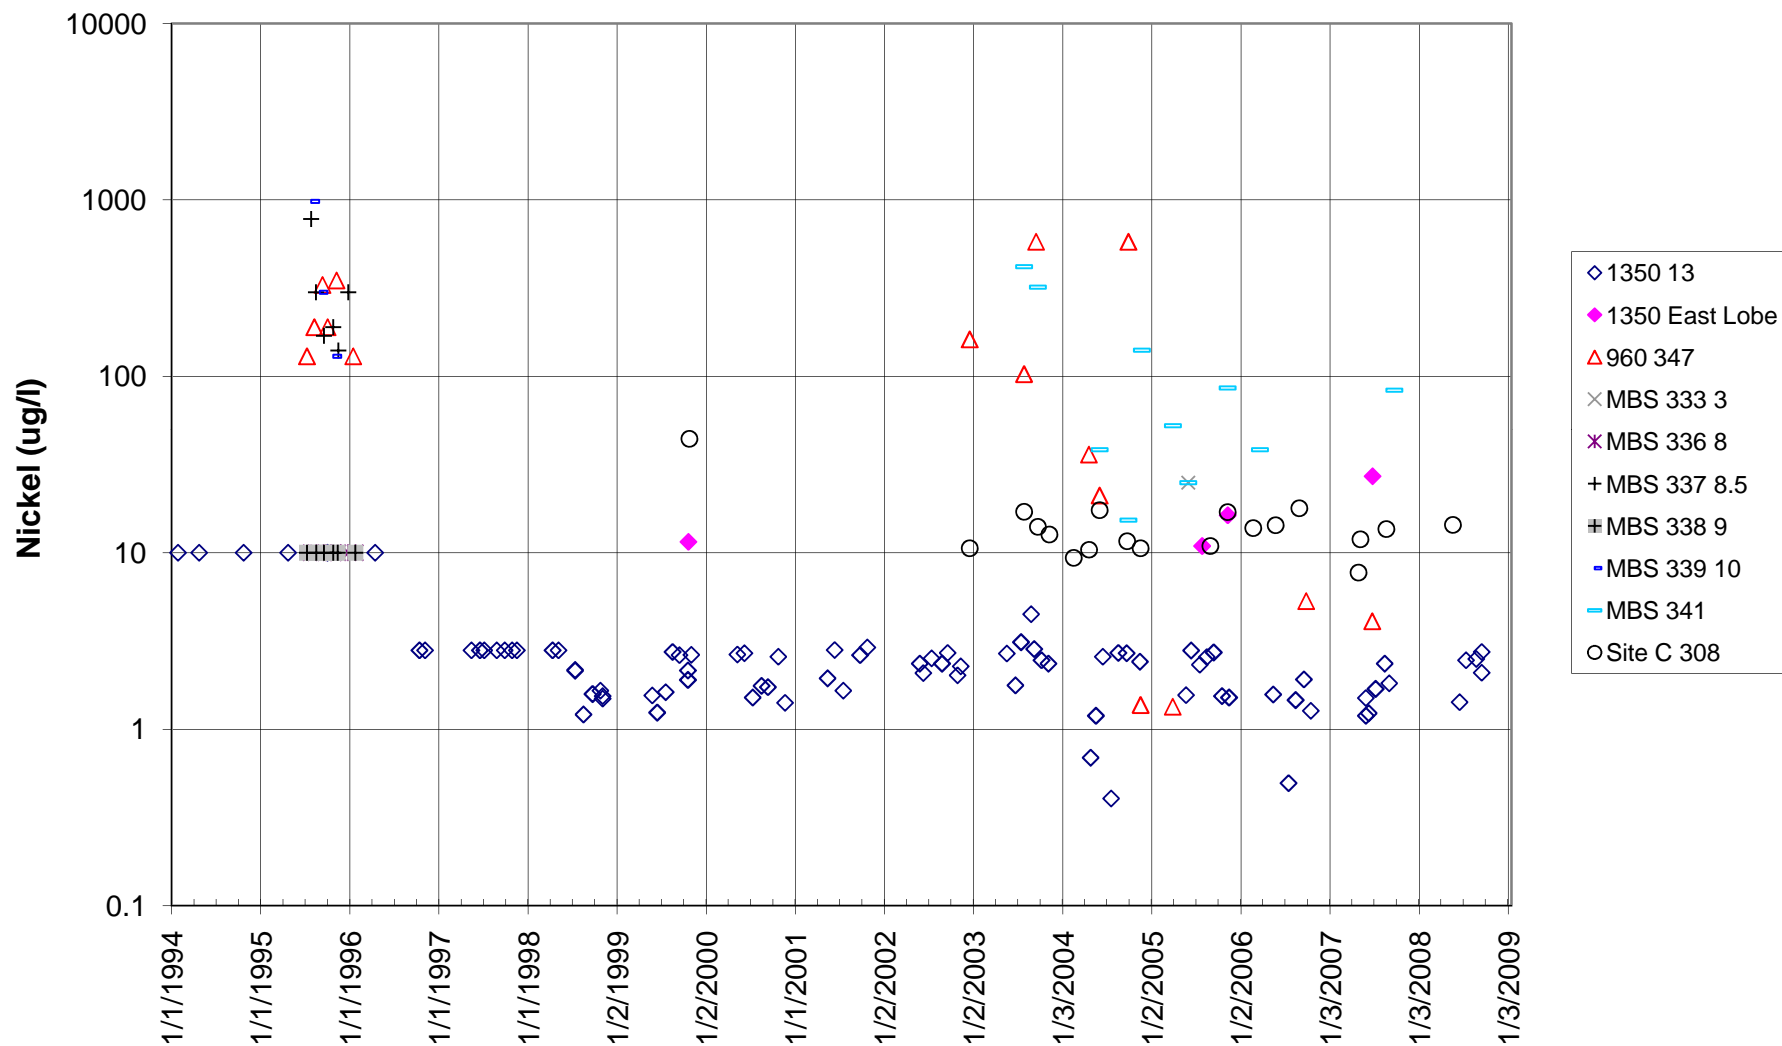
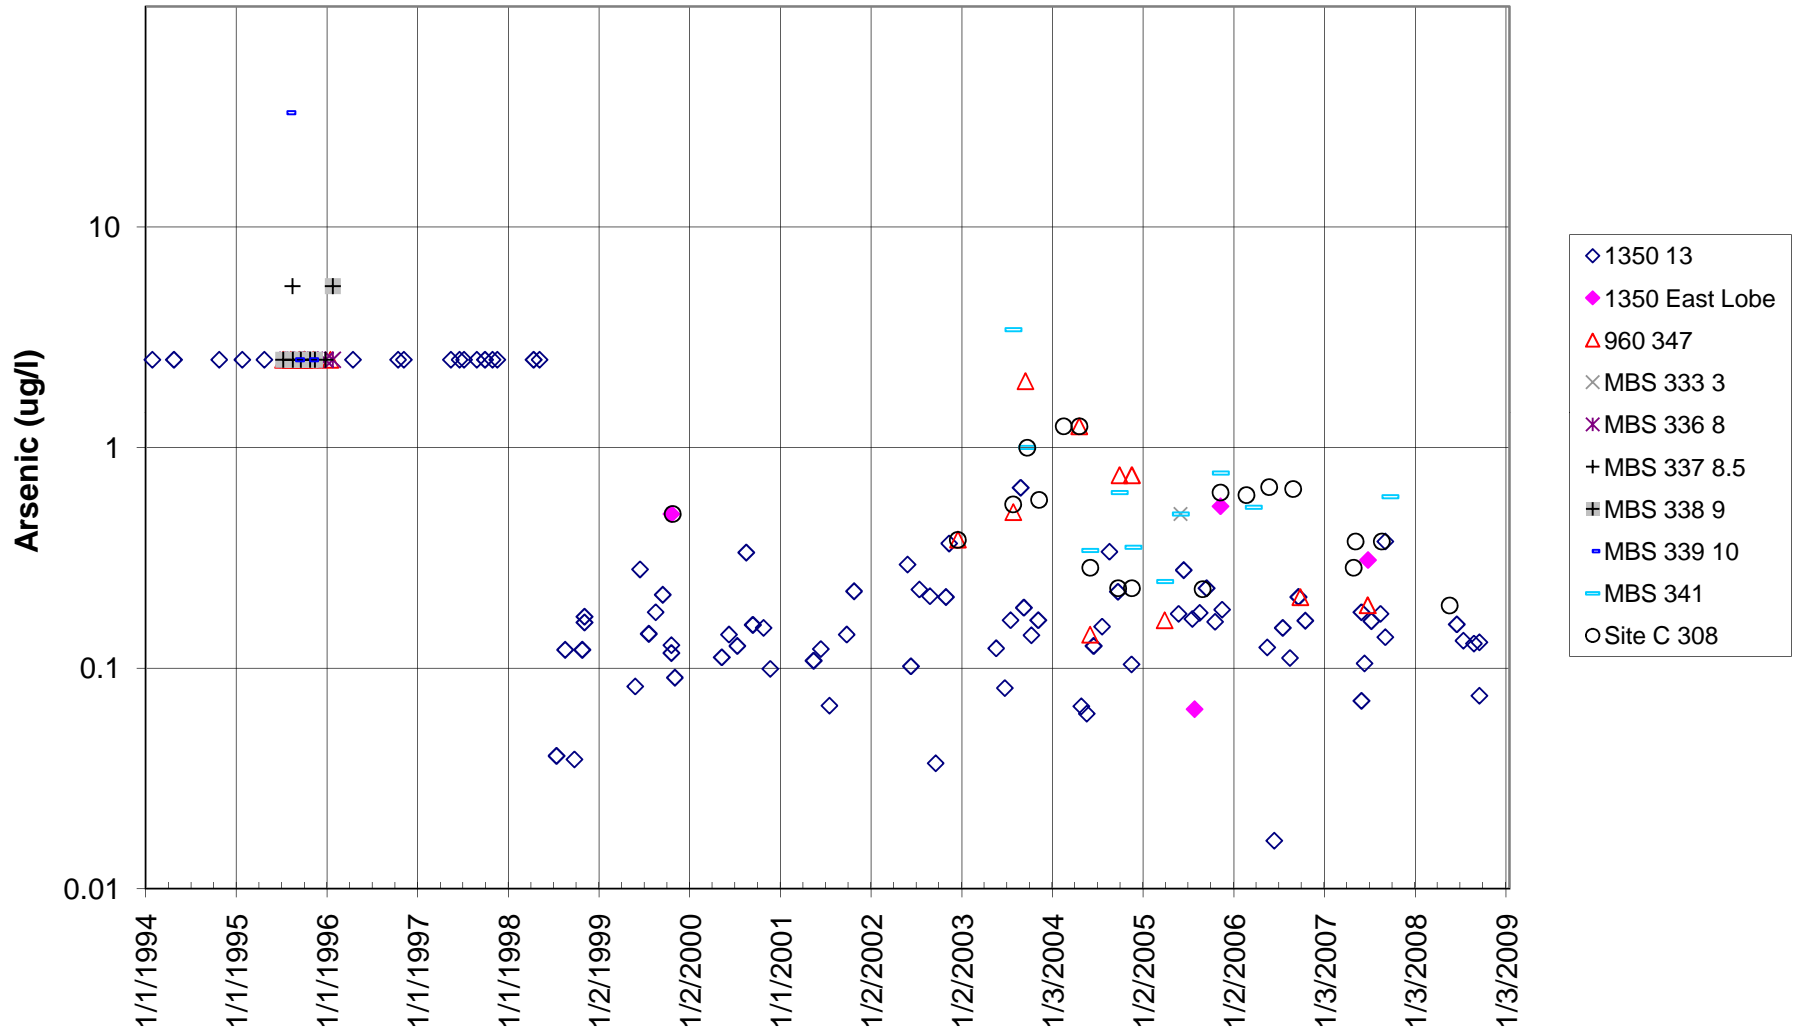
The data for zinc, copper, lead, cadmium, nickel, arsenic, iron and manganese are presented in Figures 2.12 to 2.19 and Figures 2.27 to 2.34. Sample results that were less than the detection limit are plotted at one half the limit value. While this allows the results to be plotted on a logarithmic scale, it causes non-detect results with high detection levels to appear more concentrated than they actually are. Detection limits have varied with time and are often evident on the graphs as horizontal groupings of symbols. The results for metals generally correlate with conductivity values. Zinc concentrations reflect the higher solubility of this element relative to the other metals at these near-neutral pH conditions. Manganese concentrations are elevated at most of the inactive sites, indicating the generation of secondary products from localized redox and buffering reactions as well as this metal's higher solubility in the prevailing pH conditions. Metal loads from inactive sites have either remained relatively constant or decreased with time. The decrease in metal loading is attributed to the reduction of reactive surface area discussed above. Site 960 showed some elevated copper, zinc and cadmium concentrations in 2004. This was likely due to the removal of production rock from the area, which exposed additional production rock materials in the base of the road, and rerouted additional water sources into the sampling area, confounding comparative water sampling with pre-removal data. Post removal Site 960 data in 2005 have shown a decrease in most metal concentrations, with close to an order of magnitude decrease in cadmium, nickel, manganese and zinc.
