**INACTIVE PRODUCTION ROCK SITES AND QUARRIES  
2008 ANNUAL REPORT**

**Hecla Greens Creek Mining Company**

**April 15, 2009**

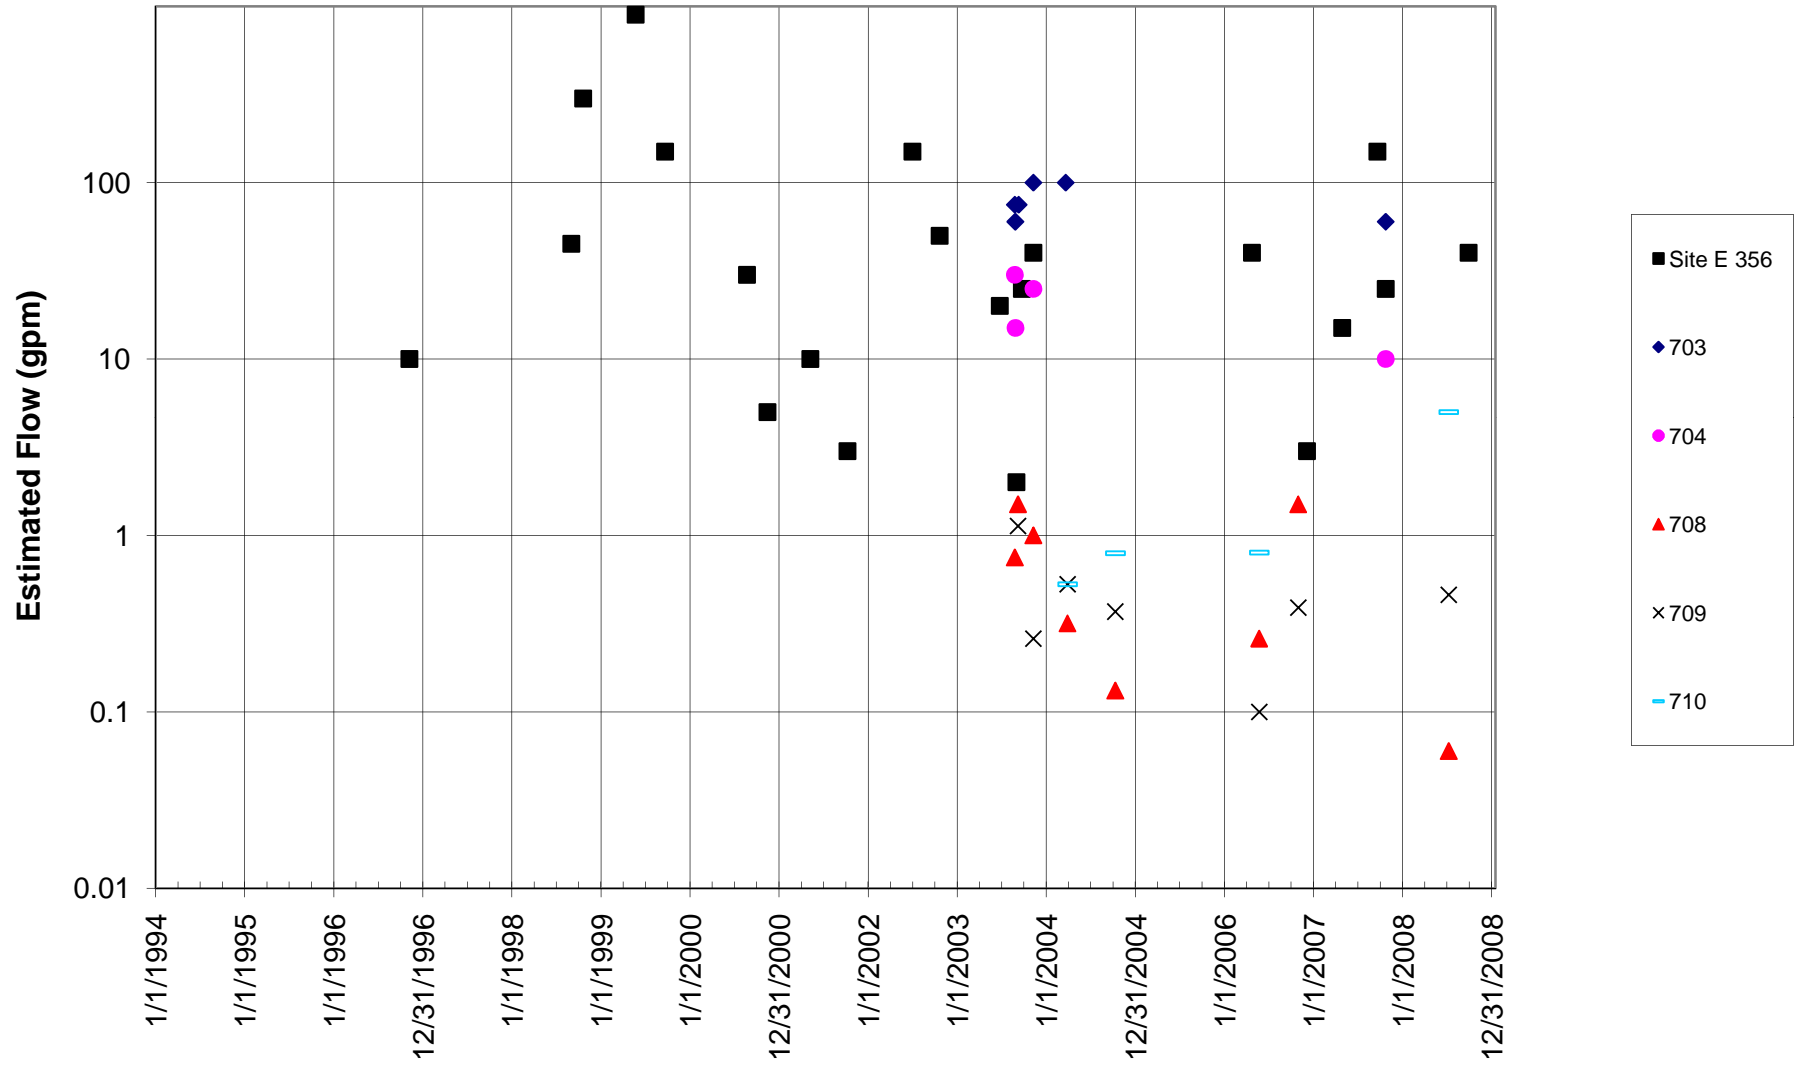
Figure 2.20 Inactive Production Rock Site E Flow Data

Flow data presented in Figures 2.5 and 2.20 demonstrate that flows at most of the sample locations are generally low (less than 10 gpm) with the exception of Site E. Some of the flow data were collected as part of the NPDES stormwater monitoring program. Collected during or following storm events, flow data from these locations (e.g. Site E 356, 960 347) represent short-term maximum flow values in response to relatively large precipitation events. Lack of significant flow from inactive sites is a positive characteristic because it reflects minimization of potential off-site impacts.

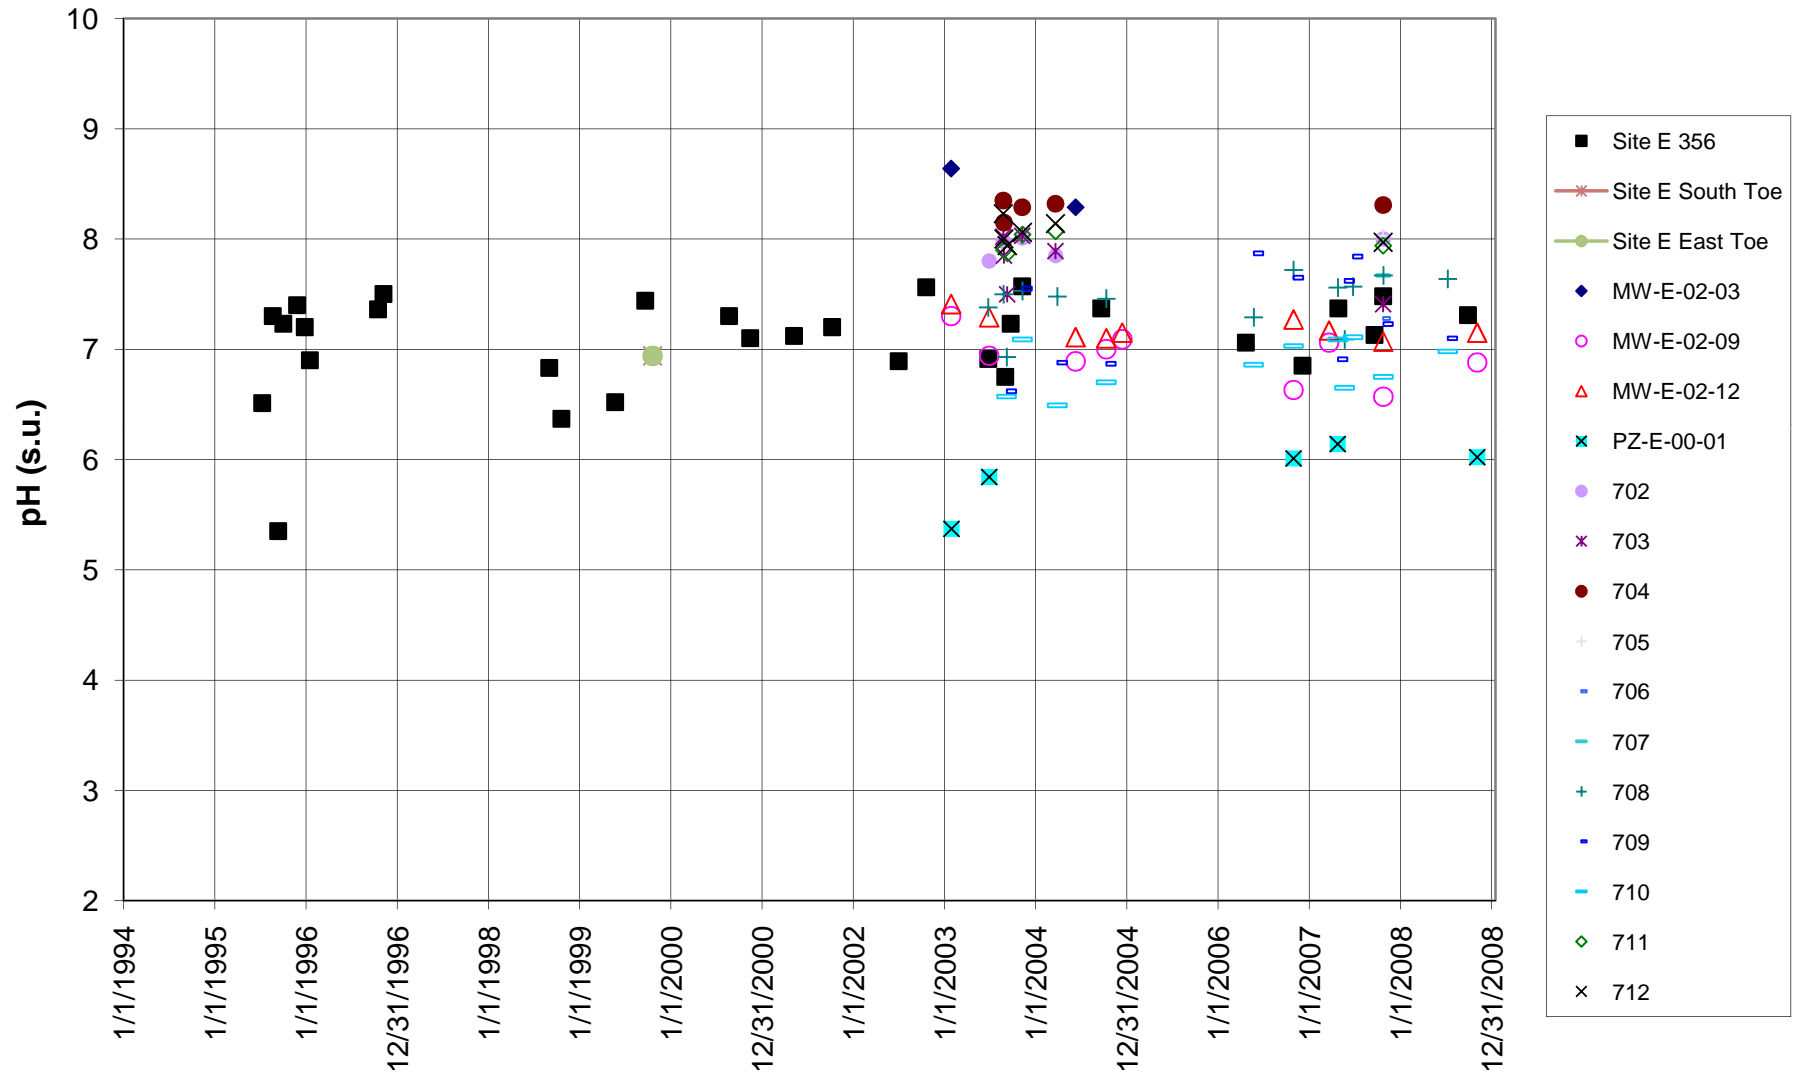
Figure 2.21 Inactive Production Rock Site E pH Data

Figures 2.6 and 2.21 show pH data from inactive site sampling locations. Lower pH values can represent influences from pyrite oxidation and/or organic acids from muskeg and forest soils. The data show that the vast majority of the site drainage remains above pH 6.0. The sample from the Mill Backslope in 1995 was runoff collected from a bench containing zones of heavily pyritized rock. For a brief period in 1998 and 1999, acidic conditions began developing at the 960 (site 347). HGCMC applied lime and removed 1000 cubic yards of oxidized pyritic rock from the site in 2000. The pH of the drainage quickly rebounded and has remained near-neutral since 2000. Removal of additional Site 960 material in 2003, 2004 and 2005 is discussed below in Section 2.3. The material removal activities may also be responsible for the pH of 8.0 measured at the 960 site in 2005. This is the highest recorded for this site. The reason for the elevated pH is likely due to the removal of pyritic rock that had consumed much of its readily available buffering capacity. Fresh carbonate mineral surfaces exposed during the excavation and the placement of the toe buttress may have contributed to the higher pH values observed. Alkalinity data presented in Figures 2.7 and 2.22 are consistent with the pH results in Figures 2.6 and 2.21. Sample locations continued to maintain measurable alkalinity provided by dissolution of carbonate minerals.

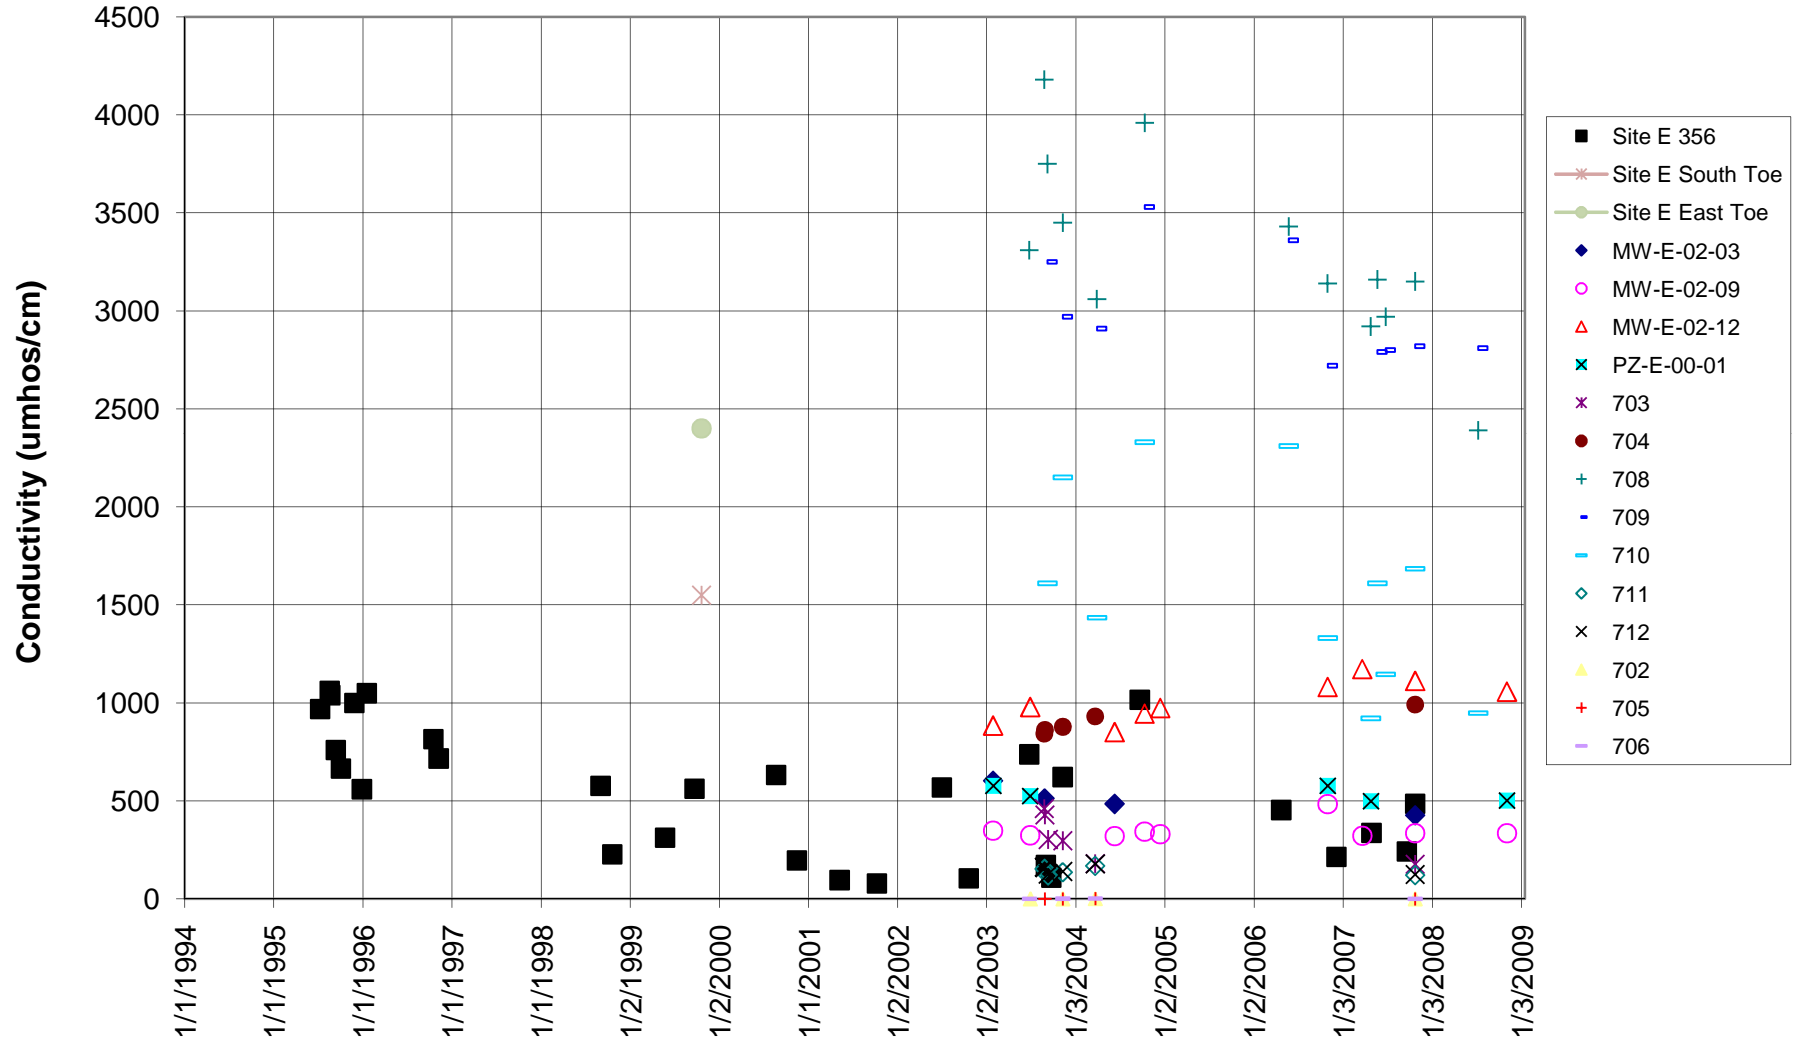
Figure 2.23 Inactive Production Rock Site E Conductivity Data

Conductivity data are shown in Figures 2.8 and 2.23. Conductivity indicates the amount of dissolved constituents in the water. HGCMC samples having higher conductivity values usually have higher sulfate, calcium and magnesium (hardness) concentrations, reflecting influences from sulfide oxidation and carbonate mineral dissolution. Water that has contacted production rock is expected to have higher conductivity values than background waters. The 960 (site 347) shows an overall decreasing trend in conductivity, while the Site 1350 data remains unchanged. The combined drainage from the Mill Backslope area (Site 341) showed a lower average for the dissolved load in 2007. Site C had a slightly higher average annual conductivity in 2007 than 2006 (1,166  $\mu\text{mhos/cm}$  in 2007 versus 1,143  $\mu\text{mhos/cm}$  in 2006). The decreasing trends apparent in Figures 2.8 and 2.23 are the result of decreasing reactive surface area available for oxidation and dissolution. The reactive surface area decreases as reactants are consumed and mineral surfaces become coated with oxidation products. The results for sulfate, magnesium and hardness, shown in Figures 2.9 and 2.24, 2.10 and 2.25, and 2.11 and 2.26, respectively, correlate with conductivity results and are consistent with the concept of generally decreasing or static reactive surface area.

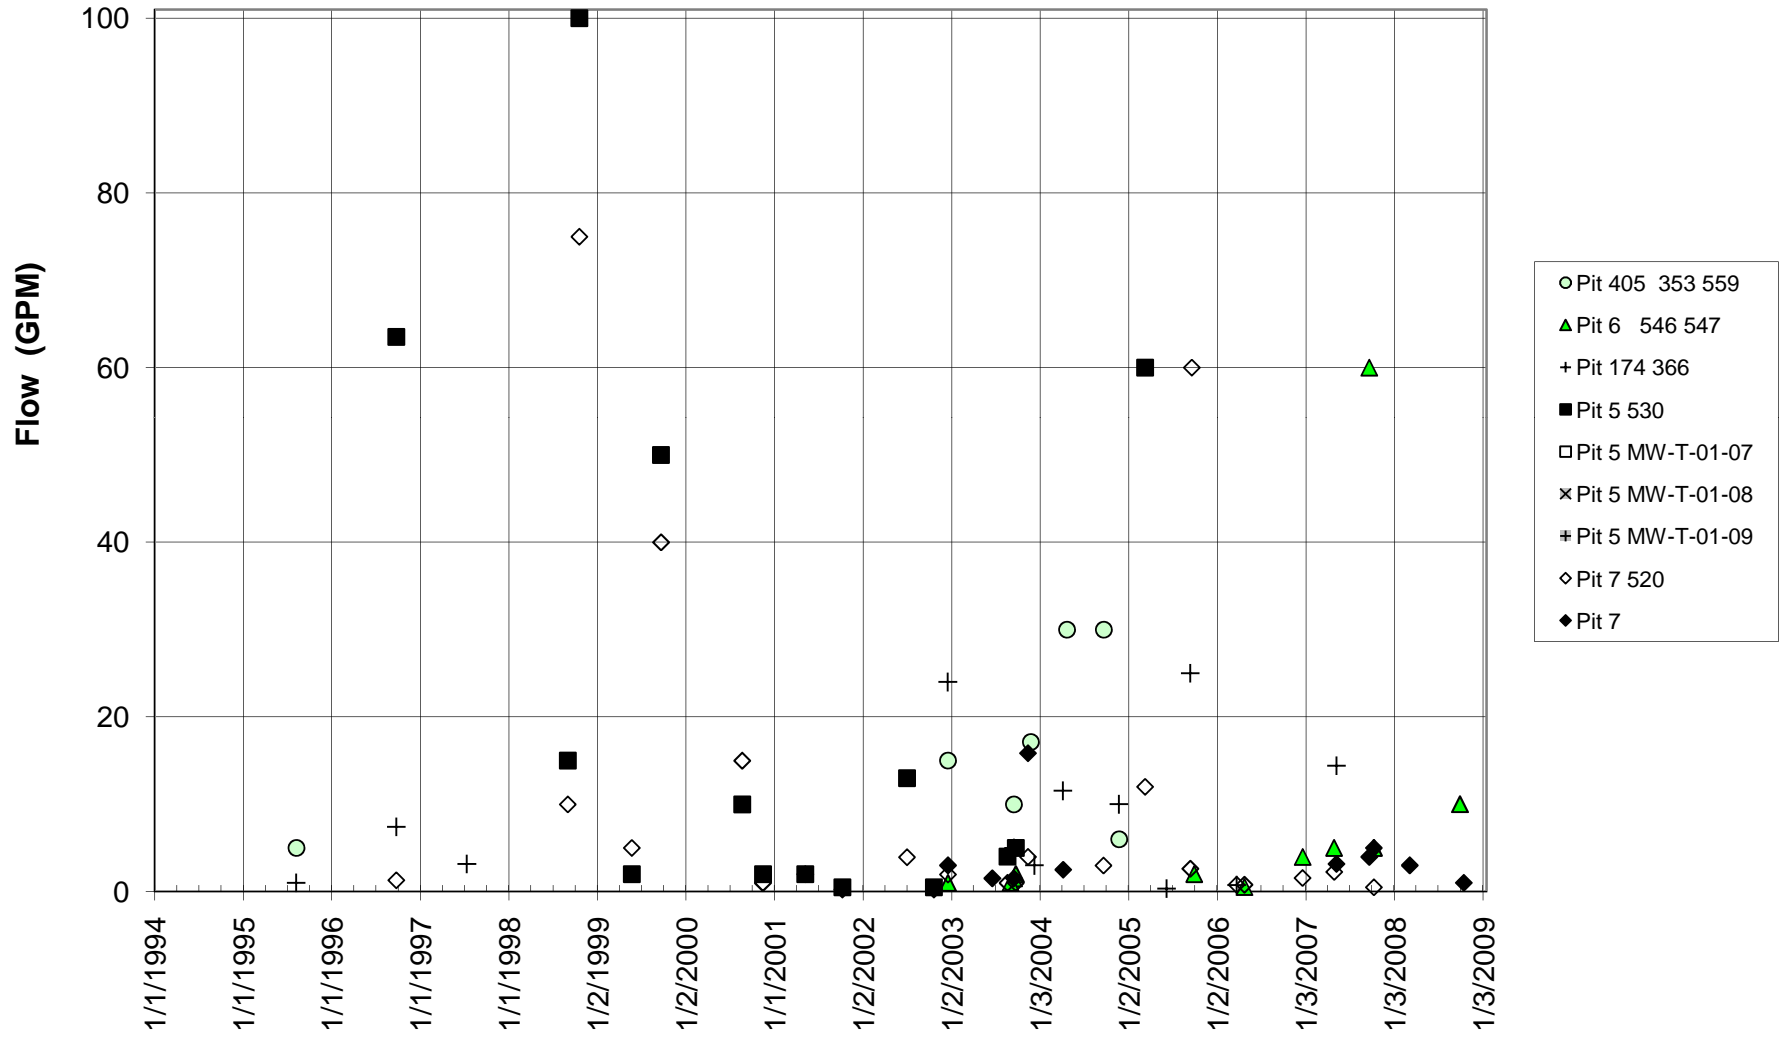
Figure 3.1 Quarry Site Flow Data

Acid base accounting data for this site can be found in the 2002 annual report (KGCMC, 2003). Monitoring of drainage downgradient of the quarry (Figures 3.1 to 3.15) demonstrates that influences from the site are negligible. Barring a significant change in downstream water quality, the site will be reclaimed when the reclamation materials stored in the quarry have been utilized at other sites. The production rock in the quarry will either be removed or covered in-situ. Removal of the rock could prove detrimental as this would increase exposure of the now covered pyritic quarry wall.

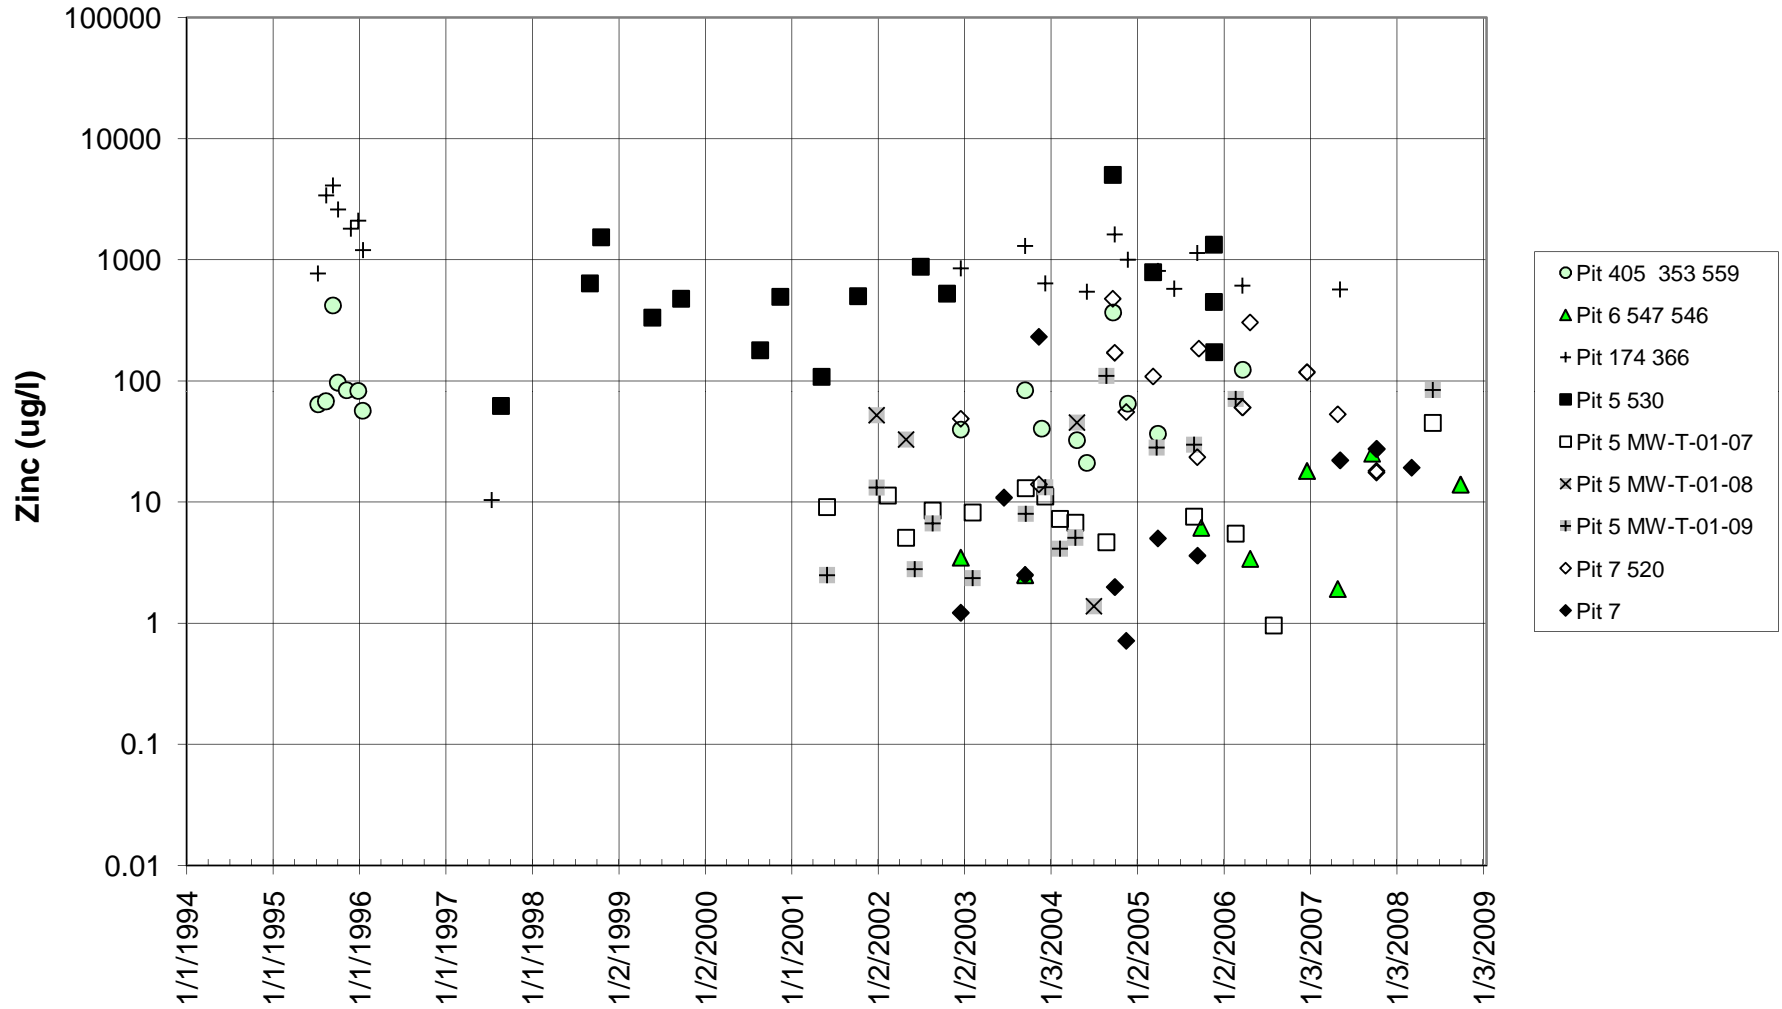
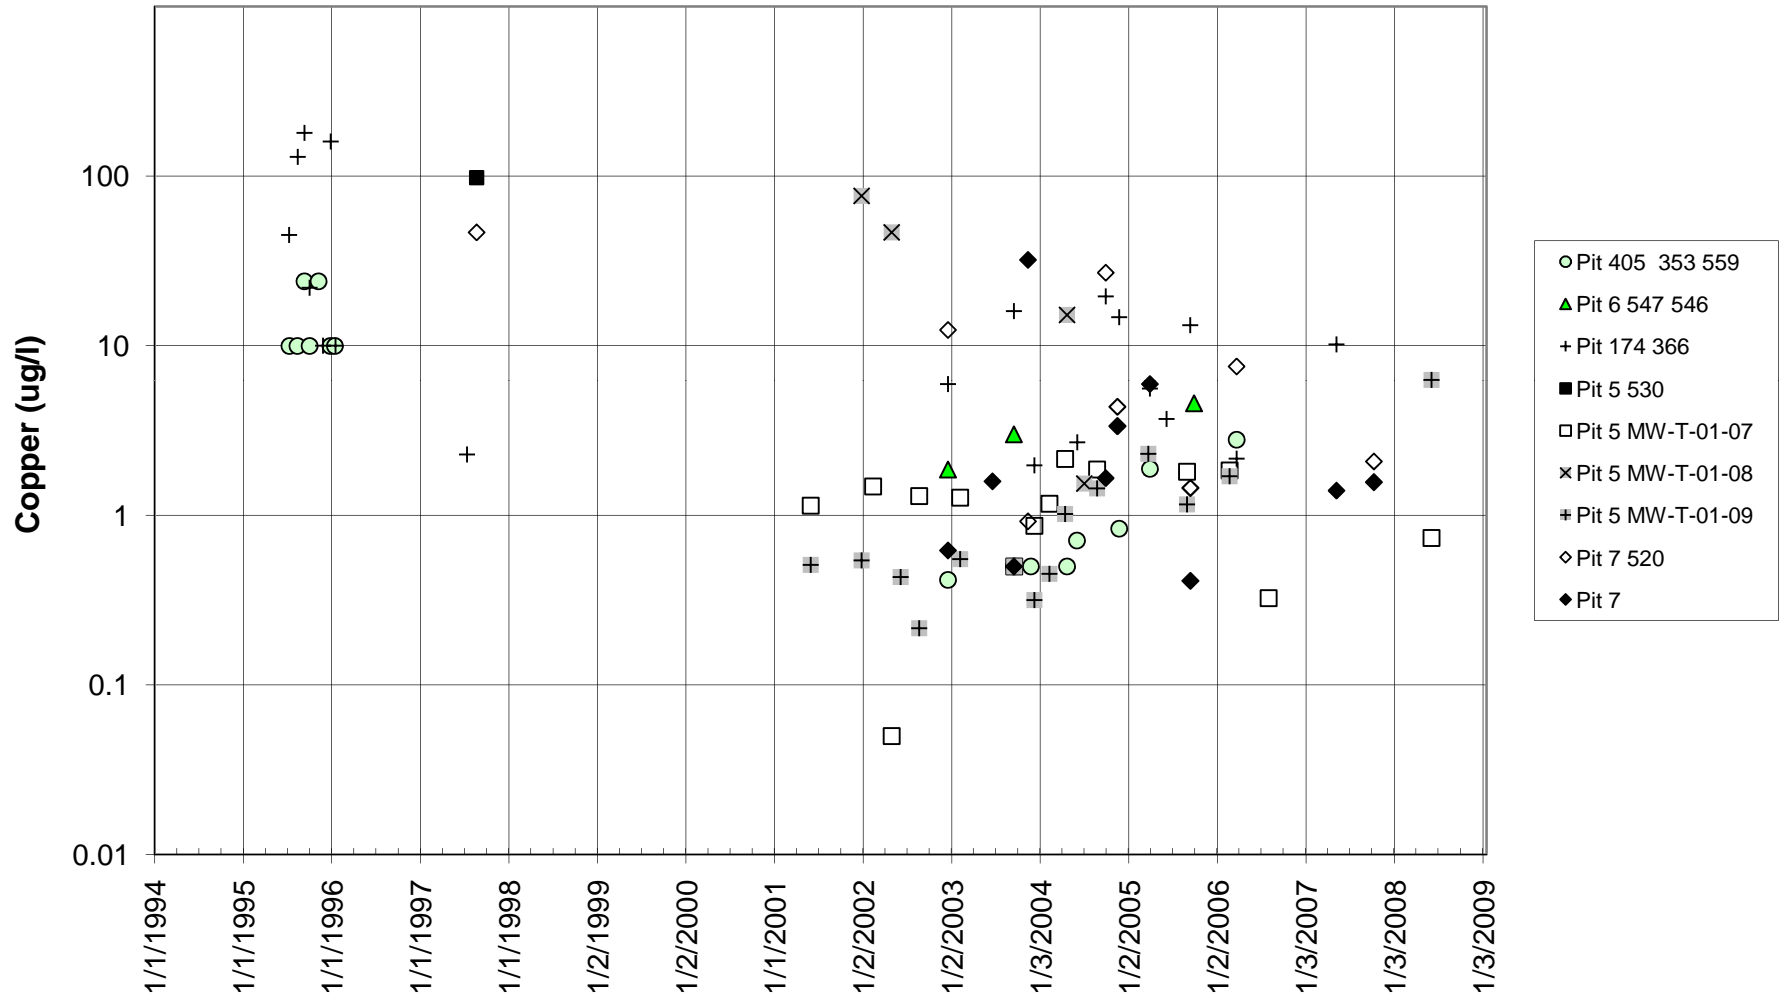
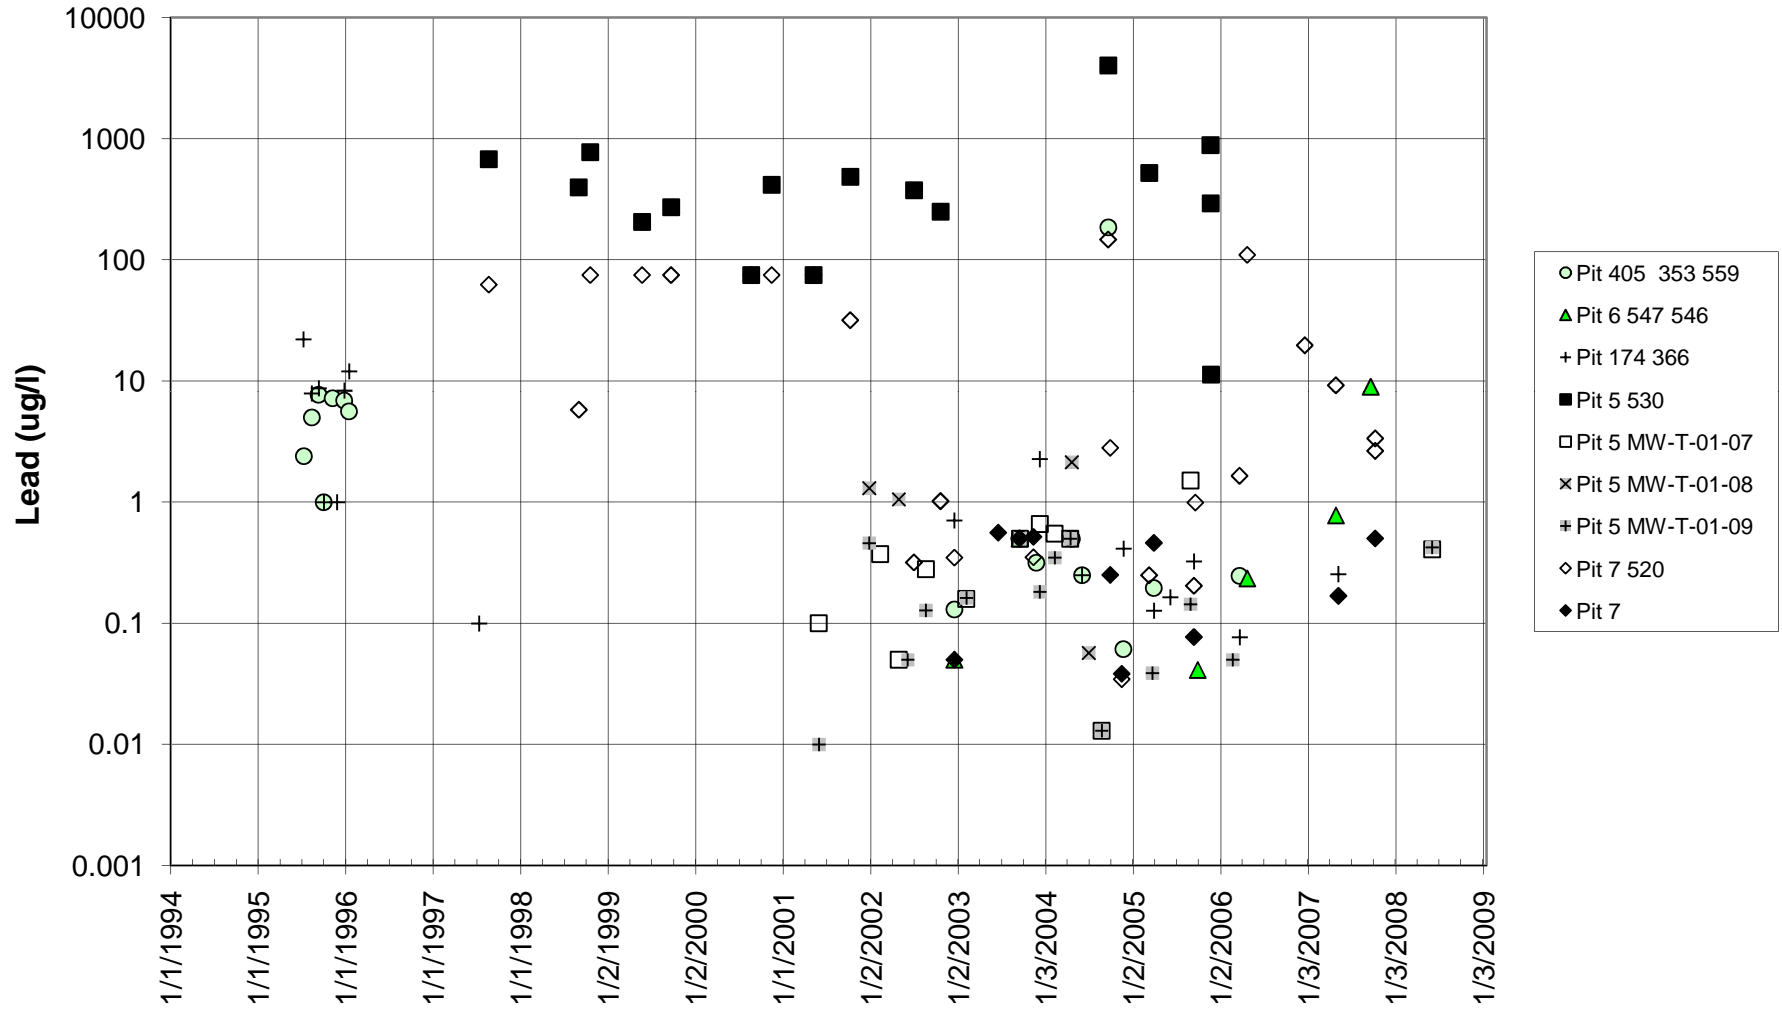
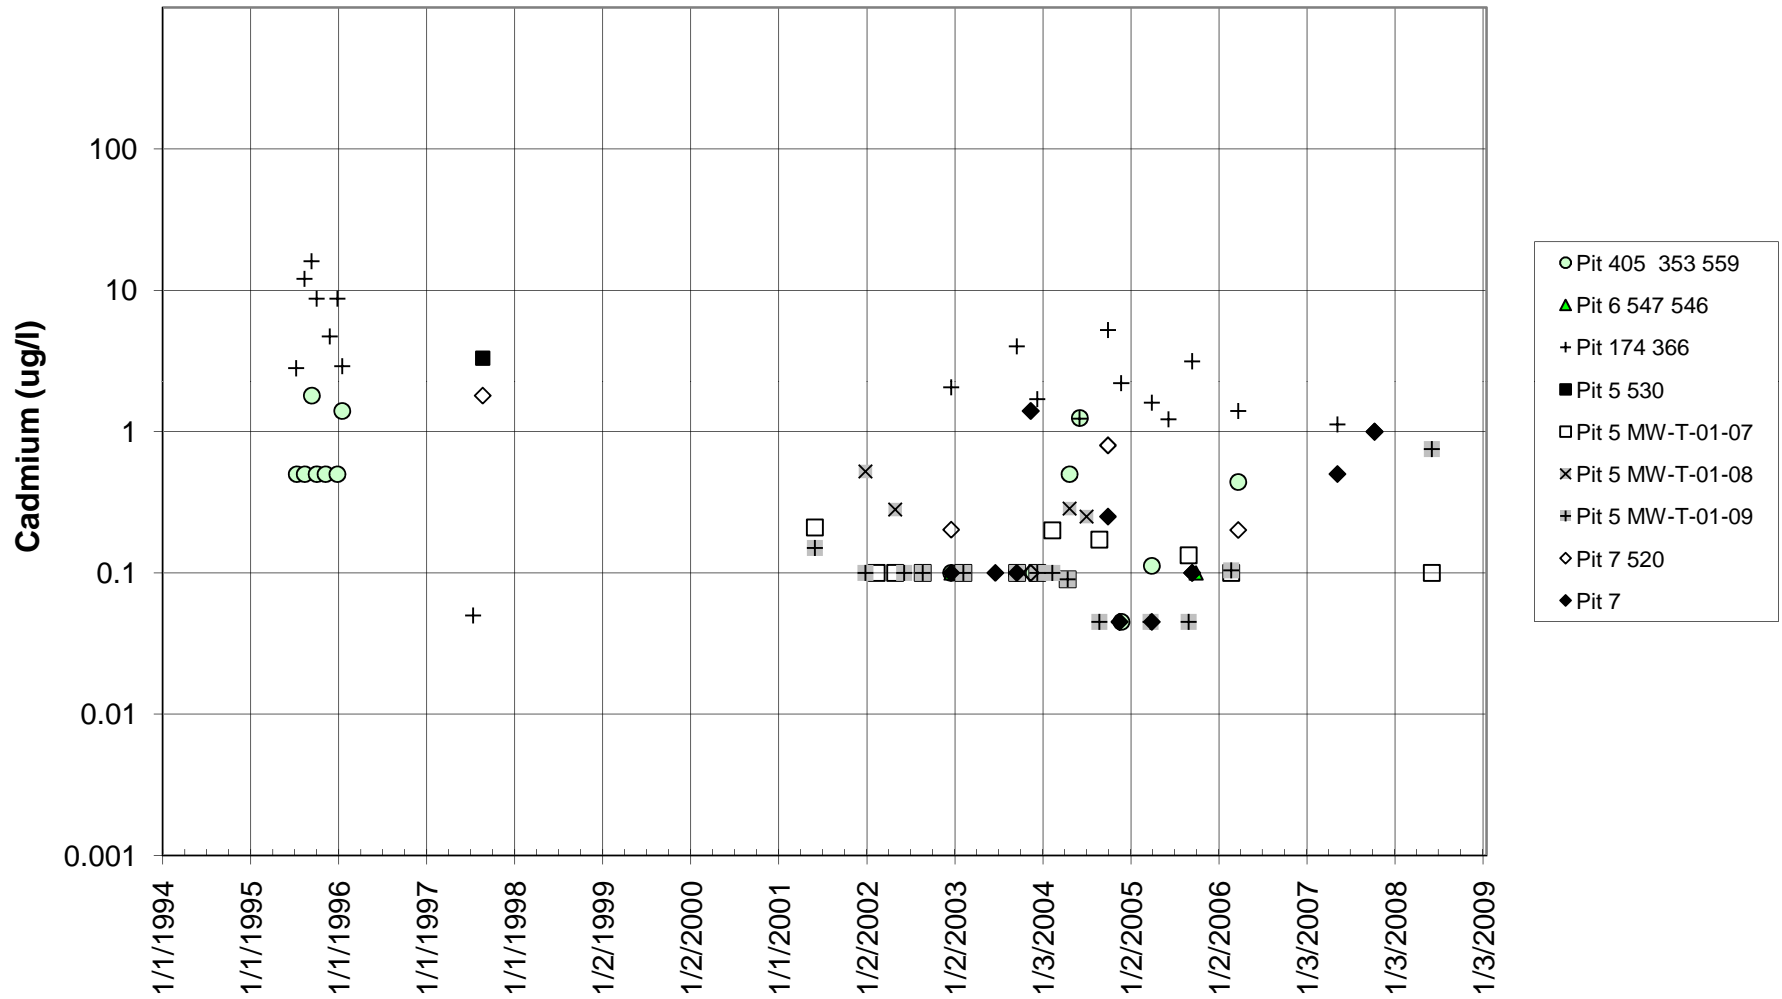
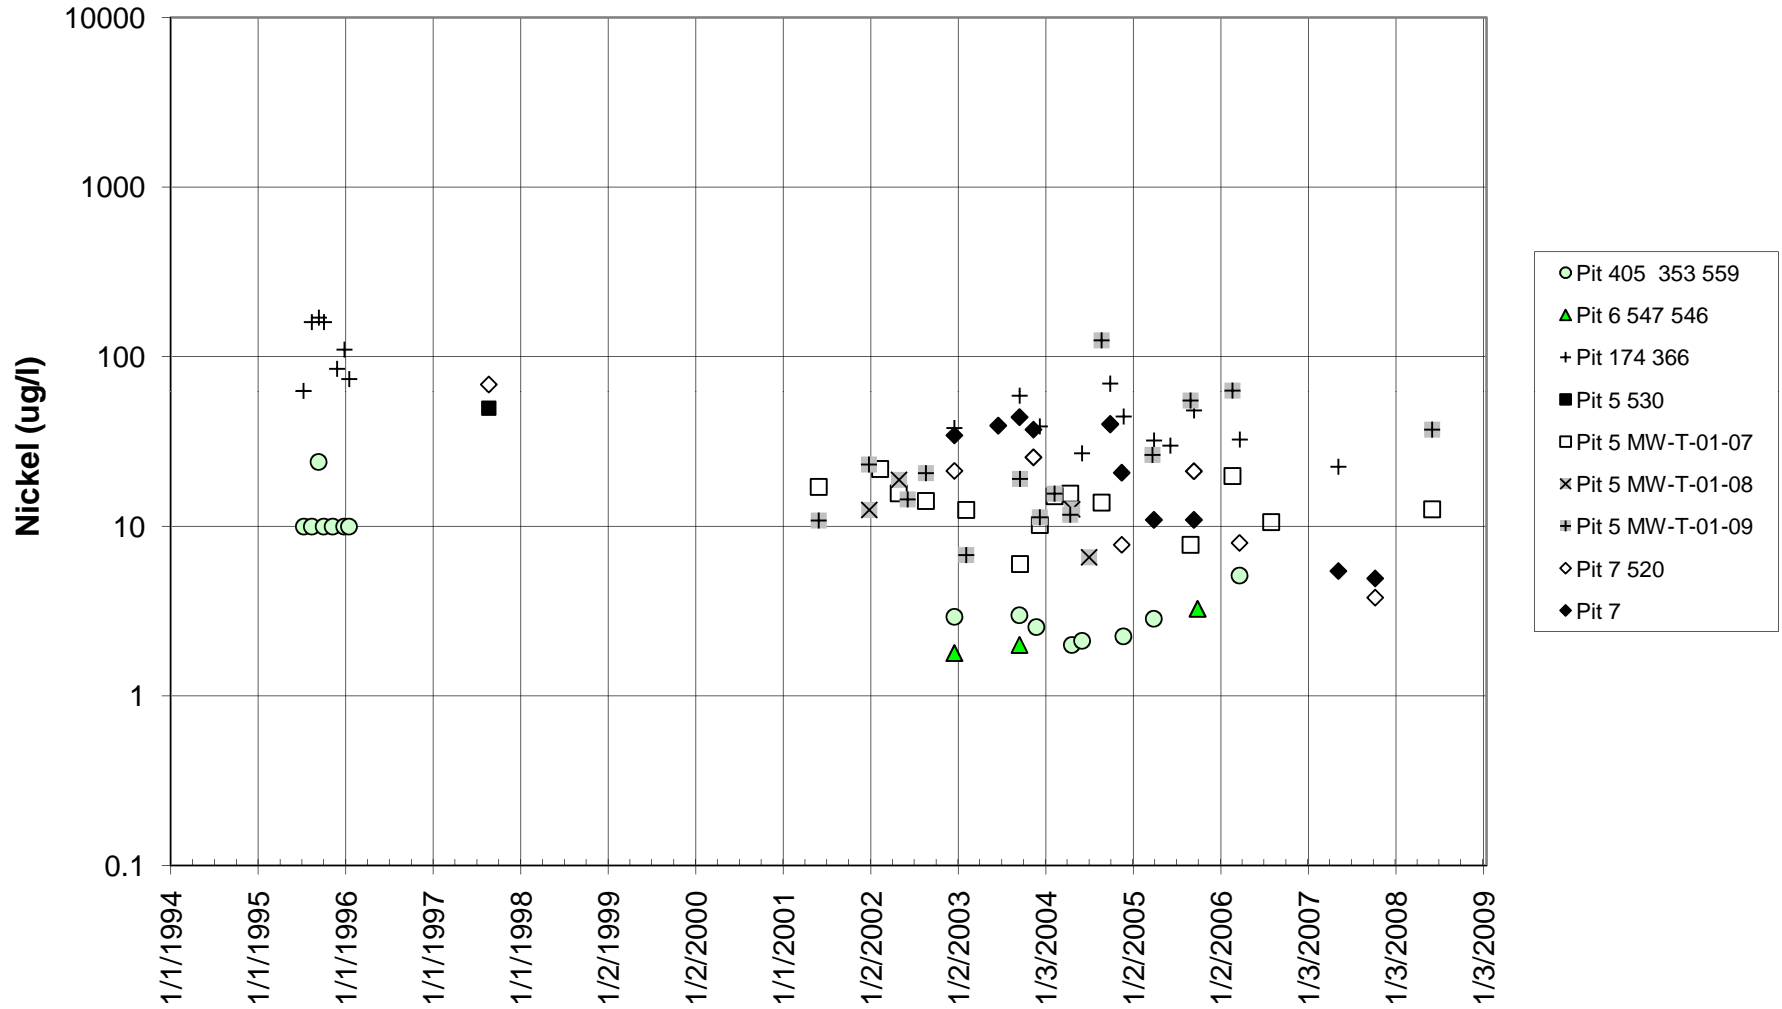
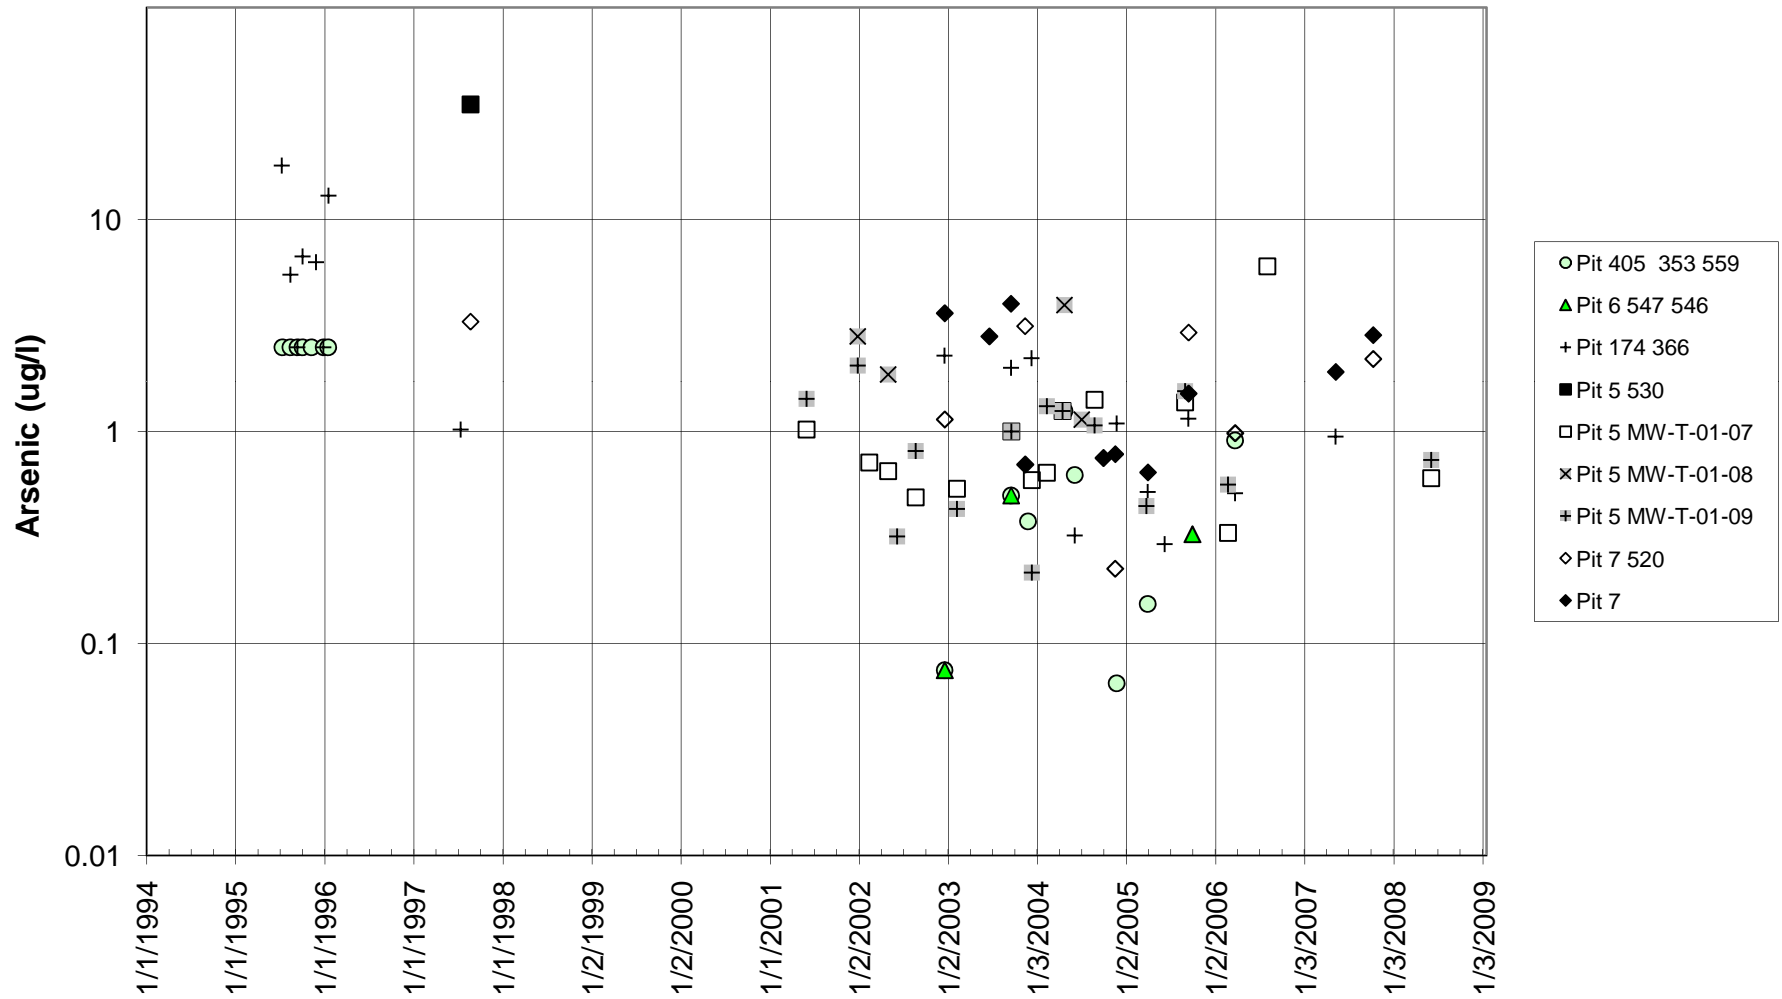
The data for zinc, copper, lead, cadmium, nickel, arsenic, iron and manganese are presented in Figures 3.8 to 3.15. Sample results that were less than the detection limit are plotted at one half the limit value. While this allows the results to be plotted on a logarithmic scale, it causes non-detect results with high detection levels to appear more concentrated than they actually are. Detection limits have varied with time and are often evident on the graphs as horizontal groupings of symbols. The results for metals generally correlate with conductivity values. Zinc and manganese concentrations reflect the higher solubility of these elements relative to the others at the near-neutral pH conditions. Dissolved metal loads from quarry sites have been consistently low and either remained fairly constant or decreased with time. The decrease in dissolved metal loading is attributed to a reduction of reactive surfaces as reactants are consumed and coatings form on mineral surfaces. Elevated total metal concentrations occur periodically in response to increased suspended solids during storm events. The storm water monitoring data are presented to provide a general indication of the effects of sediment loading, typically from road surfaces, and do not reflect dissolved loading from the quarry walls.
