TRIP REPORT

State of Alaska
Department of Fish and Game

Location(s): **Red Dog Mine**

Objective(s): Juvenile fish sampling and collection of juvenile Dolly Varden for element analysis

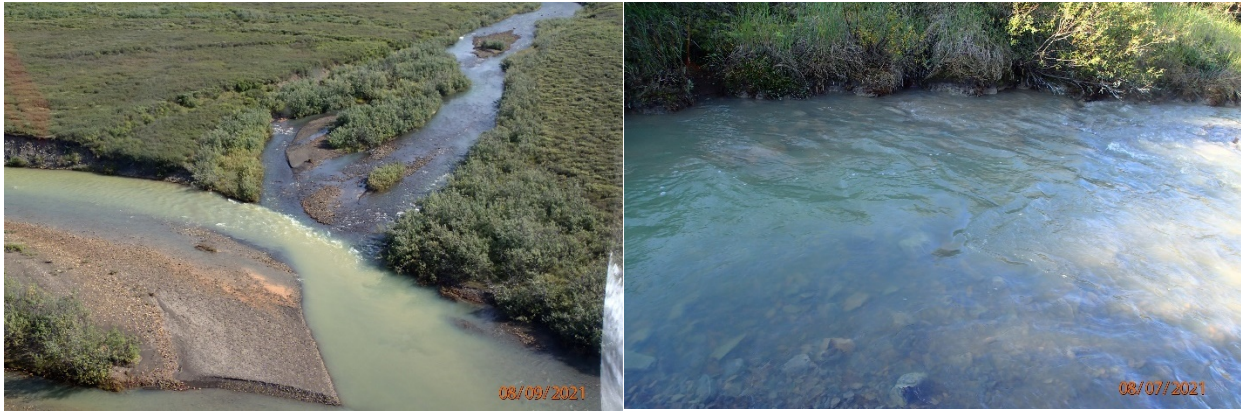
Figure 3. The mouth of Red Dog Creek on Ikalukrok Creek (left). Red Dog Creek is the clearer creek entering from the right. Turbid water on lower Competition Creek (right).

Water levels continued to drop during our visit, resulting in good conditions for minnow trapping. The turbid water conditions first observed in fall 2019 were still present in West Fork Ikalukrok Creek, Ikalukrok Creek, Grayling Jr. Creek, Competition Creek, and Sourdock Creek (Figure 3). Red Dog Creek was less turbid than in 2020. East Fork Ikalukrok Creek, Buddy Creek, Anxiety Ridge Creek, and Dudd Creek were all clear. Evaingiknuk Creek was tannic and reddish-brown in color, but was not turbid.

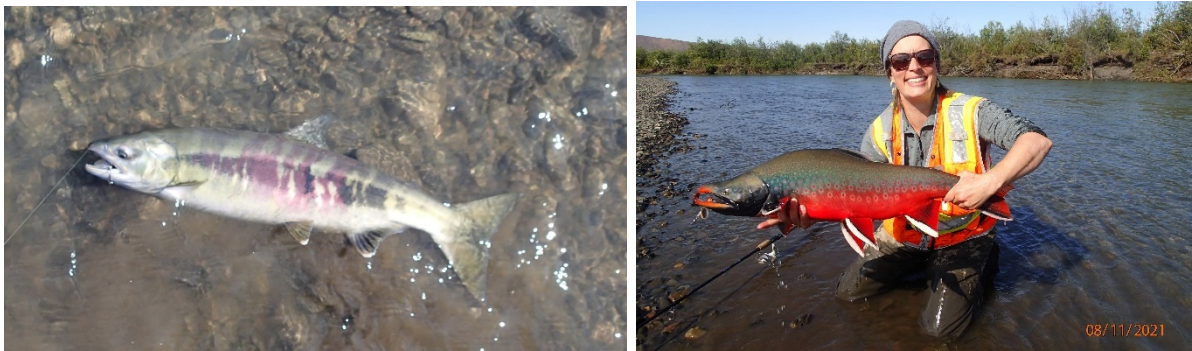
Figure 4. Chum salmon (left) and Dolly Varden (right) caught on Ikalukrok Creek.

On August 11th, we flew Ikalukrok Creek from Station 160 down to the mouth on the Wulik River. Although Ikalukrok Creek was very turbid, we did observe some spawning chum salmon. We landed and did some angling to confirm species identification in one location, and caught nearly ripe chum salmon, Dolly Varden in spawning colors, non-spawning Dolly Varden, and several large Arctic grayling (Figure 4). There were also groups of spawning chum on the Wulik River, upstream of the mouth of Ikalukrok Creek.

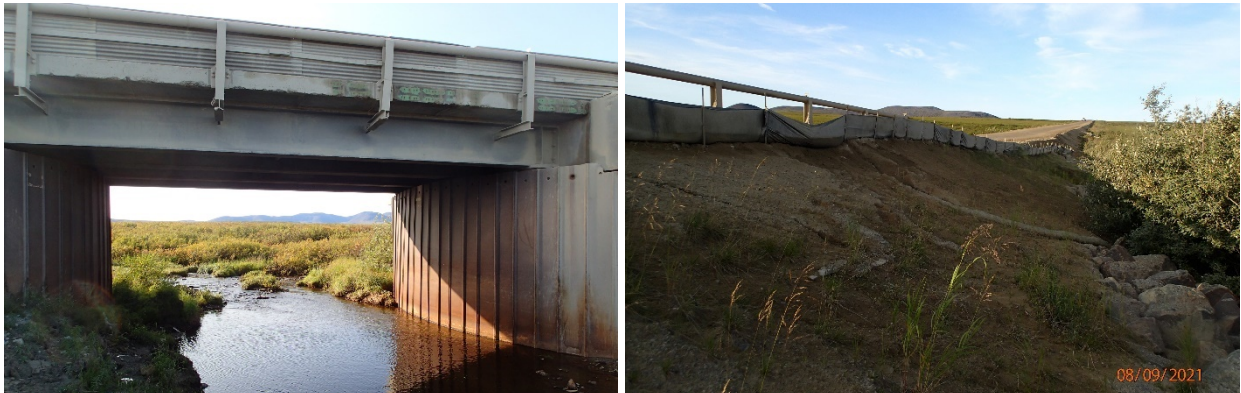
On August 12th we drove the road from Red Dog Mine to the port, and inspected bridges and culverts along the way. The systems in place to prevent dust and silt from washing into creeks and bridges were all in good condition and functioning well, even after the extremely heavy rains in late July. The combination of silt fencing directing runoff away from the creeks on either side of each bridge and the corrugated sheet metal that forms a barrier on the bridge railings appeared to be effective in keeping road runoff out of the water bodies (Figure 5).

Figure 5. The bridge over Little Creek with metal sheeting in place to prevent road runoff on the bridge (left), and silt fencing directing runoff away from Anxiety Ridge Creek (right).
