TRIP REPORT

State of Alaska
Department of Fish and Game

Field Dates: August 1-6, 2022

Objective: To sample juvenile fish in the area and collect juvenile Dolly Varden for tissue element analysis

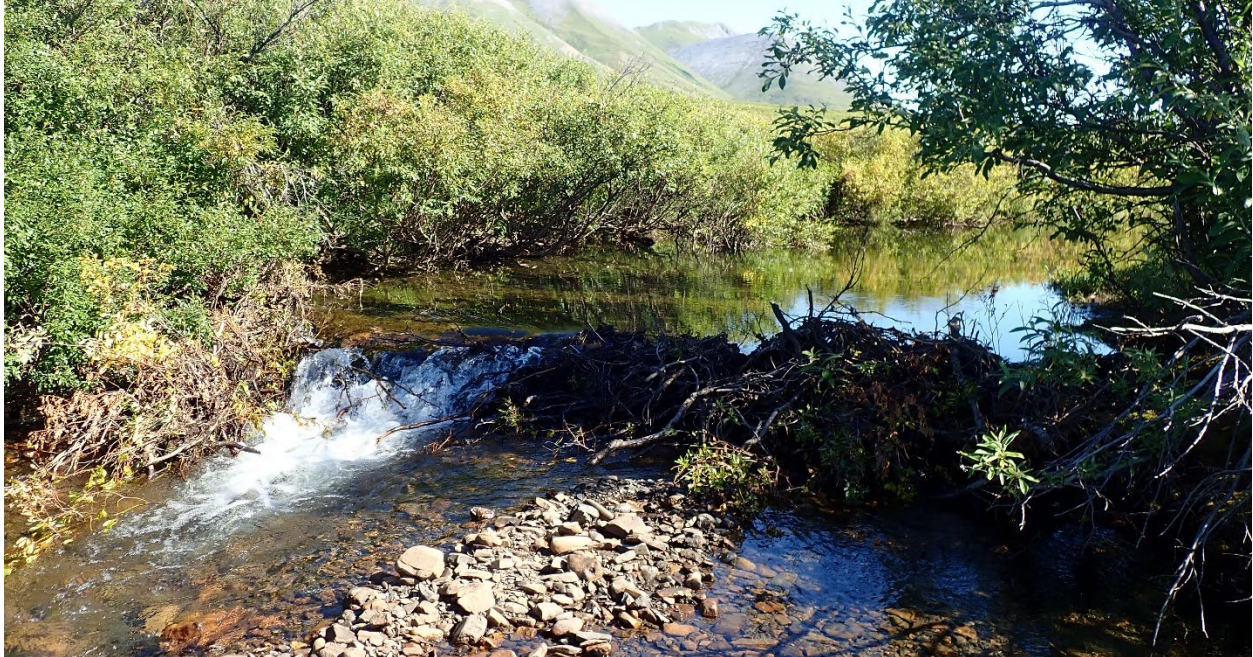
Figure 2. Small beaver dam located just upriver of uppermost minnow trap location in Anxiety Ridge Creek, August 2022.

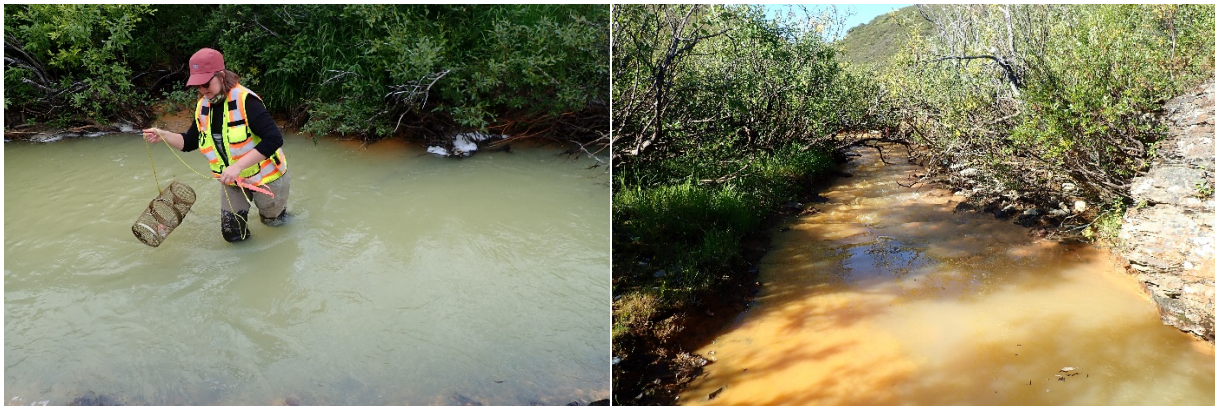
Several tributaries were sampled in the Upper Ikulukrok drainage, near the Anarraaq/ Aktigirug deposits (Competition and Sourdock creeks, and both the East and West Forks of Ikalukrok Creek). There were no fish caught in these systems and most creeks were turbid with heavy mineralized staining on the rocks (Figures 3 & 4).

Figure 3. Lower Competition Creek (left) and Upper Competition Creek (right); August 2022.

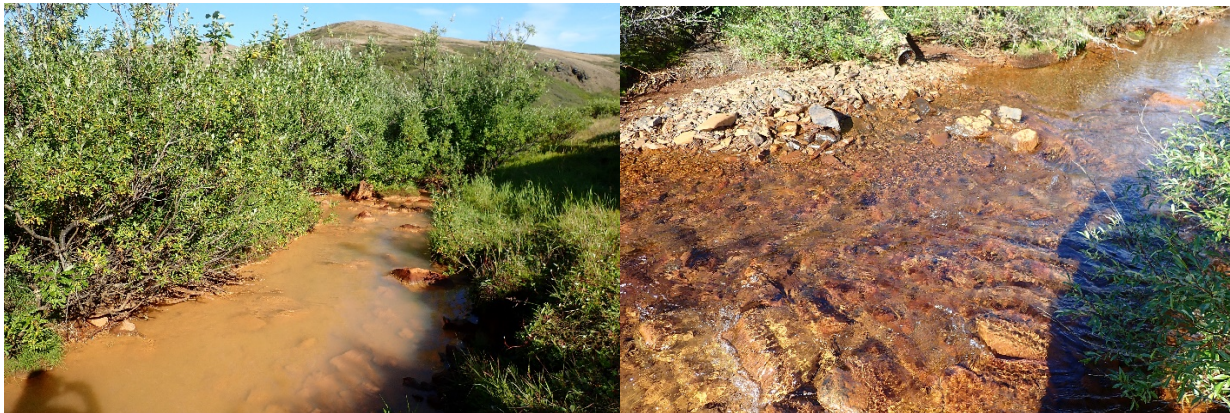
Figure 4. Sourdock Creek (left) and West Fork Ikalukrok Creek (right); August 2022.

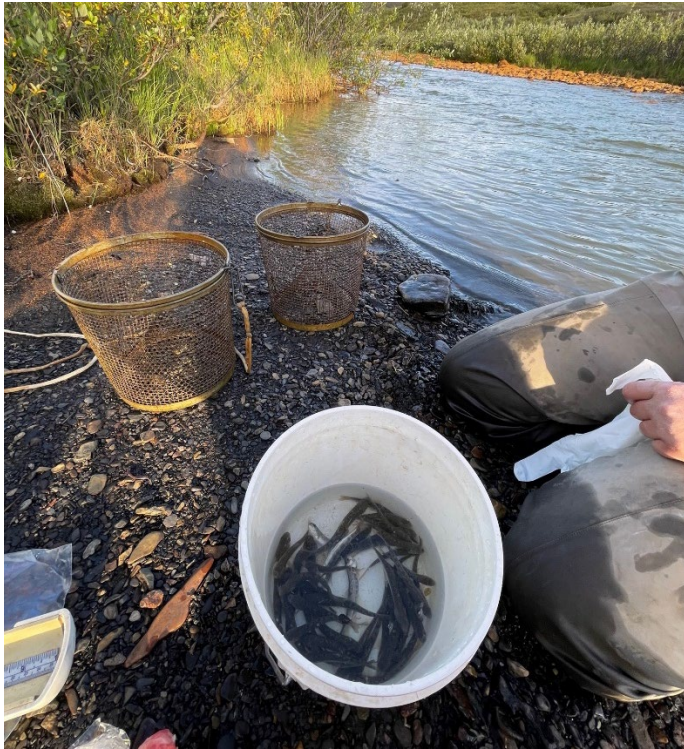
A total of 64 Dolly Varden were captured in Red Dog Creek downstream of the North Fork (Station 151). In the last four years, no more than nine Dolly Varden have been captured at this site. However, the fish captured this year appeared underweight and there were four fish that died in the time between removal from the trap and being measured for length (Figure 5). These fish mortalities were all smaller than the established size threshold for tissue element analysis (90-140 mm), but we chose to retain them for examination of elemental anomalies. Red Dog Creek still appeared red and turbid as in recent years (Figure 6).

Figure 5. Juvenile Dolly Varden captured in Red Dog Creek downstream of the North Fork (Station 151) August 2022. Note the mortalities that came out of this minnow trap.

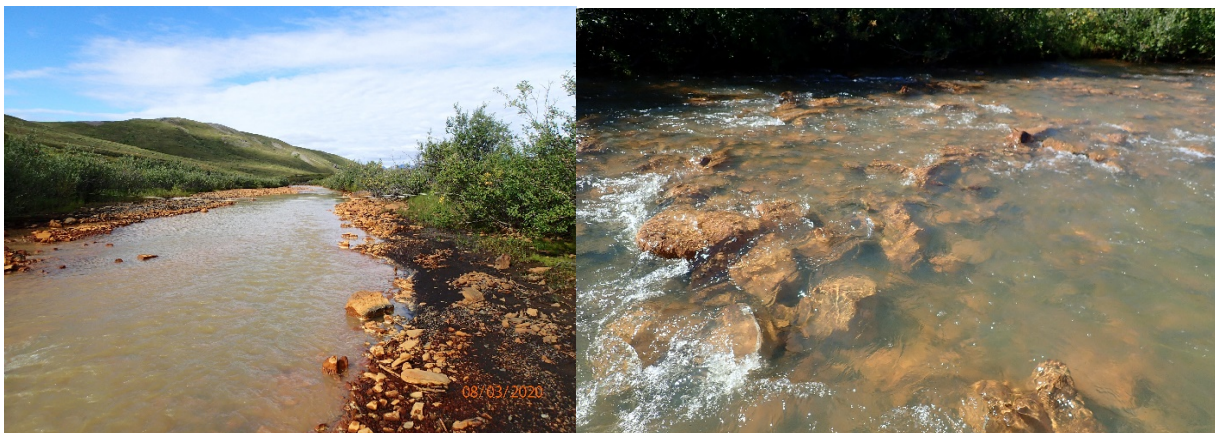
Figure 6. Red Dog Creek downstream of the north fork (Station 151) near Red Dog Mine, Alaska in August 2020 (left) and August 2022 (right).

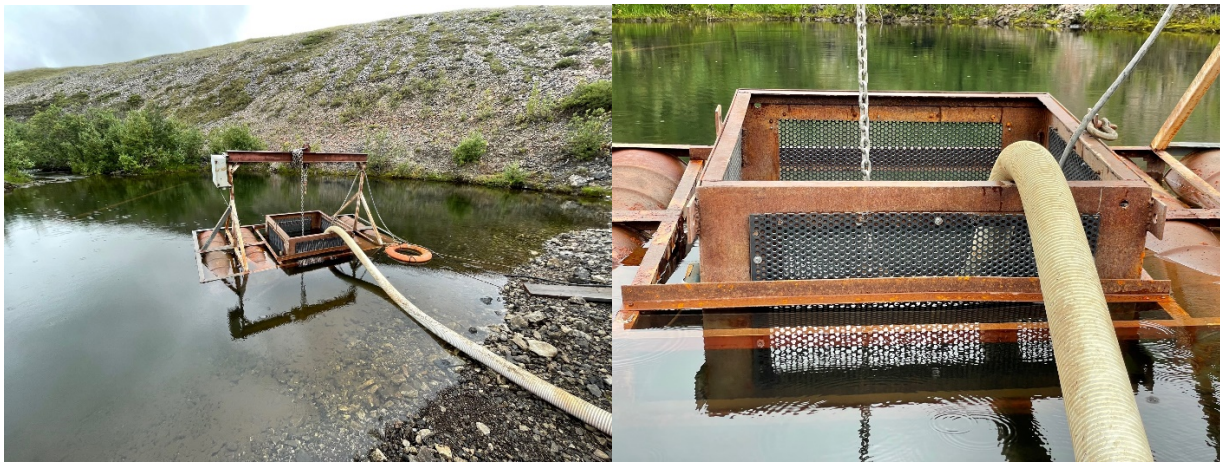
On August 5th, we drove to the area below Bons Pond to check on an intake structure that was reported to be tipped on its side and had a damaged screen (See ADF&G Trip Report from June 2022). We found the intake structure to be upright, and the outer screen had been replaced (Figure 7). However, it appeared that the mesh size is larger than the 0.25” diameter required by water withdrawal permit stipulations (Figure 7). There is not a current water withdrawal permit for this intake. ADF&G has notified Teck Environmental staff of these issues.

Figure 7. Water intake structure below Bons Pond in August 2022. The structure is now upright (left), but the mesh size on the screen is larger than current stipulations require (right).

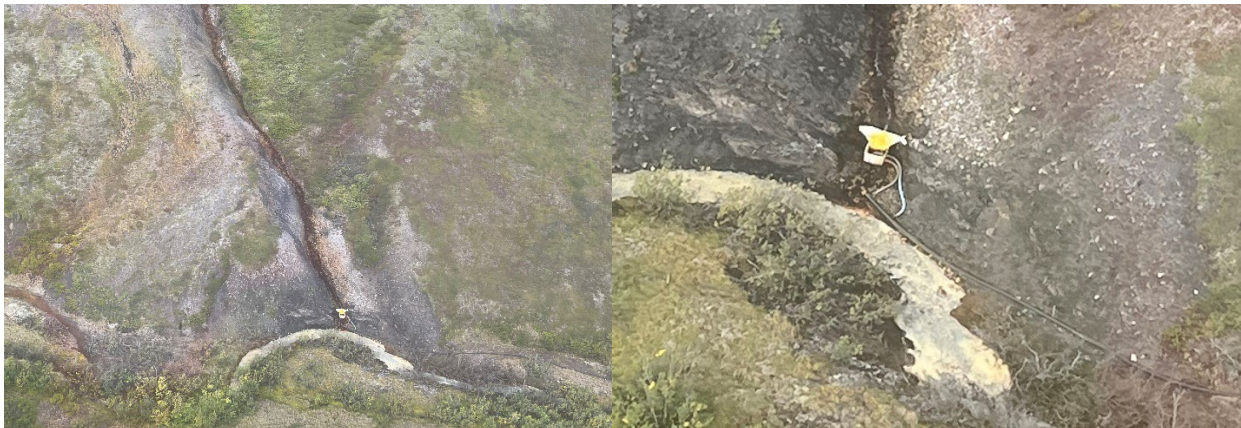
On August 6th, we flew over the Kaviksaq Seep and surrounding tributaries south of the main pit (Figure 8). A water capture/ bypass system was installed in 2020 to divert the heavy metals from the seep from Red Dog Creek. We departed the mine site that afternoon.

Figure 8. Kaviksaq seep near Red Dog Mine (left) and water diversion structure (right); August 2022.
