Field Monitoring Report

-- Pebble Copper/Gold Exploration Project --

Inspection Date: September 23 & 24, 2008

APMA #: A086118

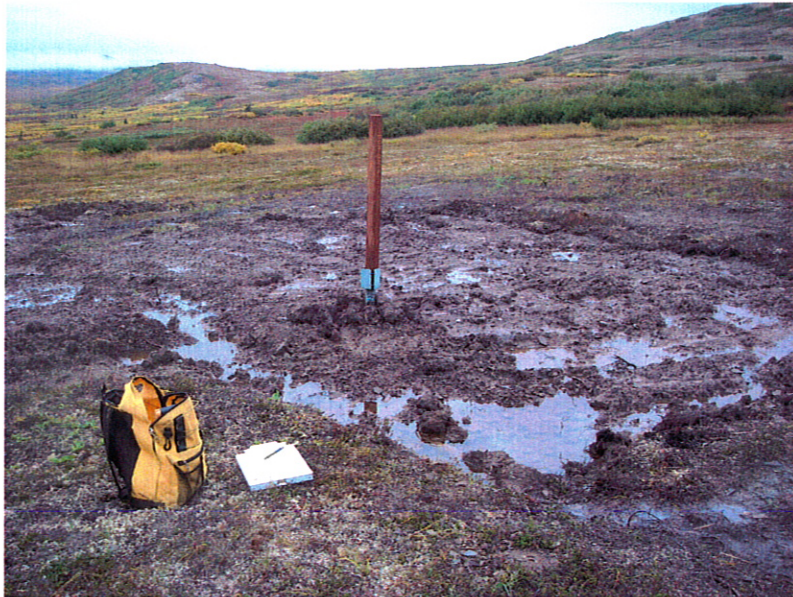
- Plugged: yes
- Cemented: unknown
- Standing pipe: none
- Sump pit filled in: yes
- Water discharge trench filled in: yes
- Site revegetated: no
- Artesian water present: no
- Any spills or staining: none
- Comments/General impression: Appears to have been leveled recently, exposed soil needs to be stabilized and seeded.
