The purpose of this O&M Manual is to describe operating and monitoring procedures for the dam and reservoir under normal and unusual conditions, and to provide guidance and procedures for monitoring, maintenance, and routine inspection for the Pogo RTP Dam.

# RECYCLING TAILINGS POND OPERATING AND MAINTENANCE MANUAL

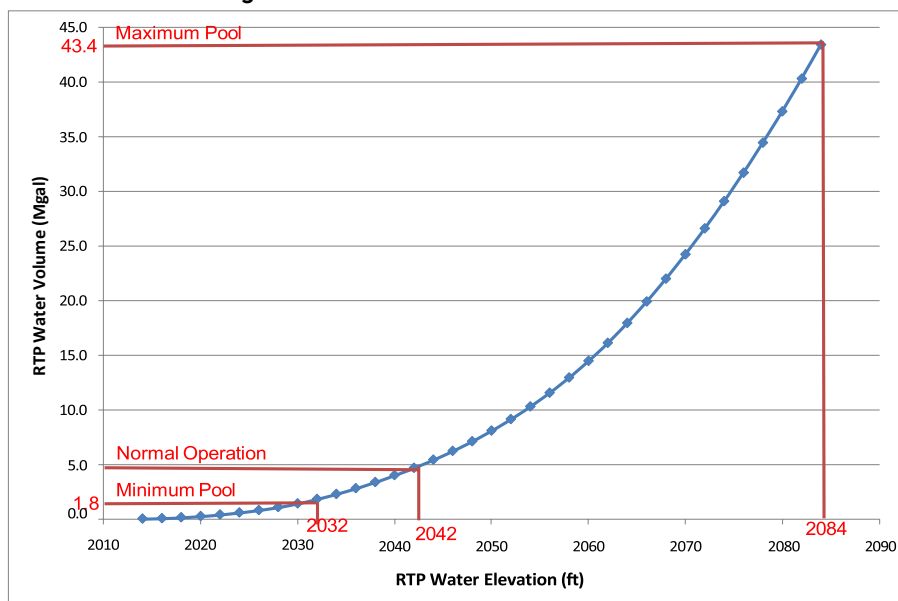
**Figure 2: RTP volume-elevation curve**

- Summer season (June to September): 5 Mgal target. This is enough to supply makeup water to the mill for about 20 days, assuming a water consumption rate of 100 gpm at the Mill. Figure 2 shows the RTP reservoir volume-elevation curve. If the RTP water volume exceeds 5 Mgal (RTP reservoir elevation: 2,042 feet amsl), the RTP water is discharged into MWTP#3, treated and then discharged into ORTW. Figure 3 shows the drawdown curve for 300 gpm discharge from the RTP.
- Winter season (October to May): 15 Mgal target. In order to handle a potential shortage of process makeup water during winter season, the RTP water storage volume is increased to 15 Mgal by the end of October. The water volume is then reduced over the winter to 5 Mgal before the spring breakup or by the end of May.

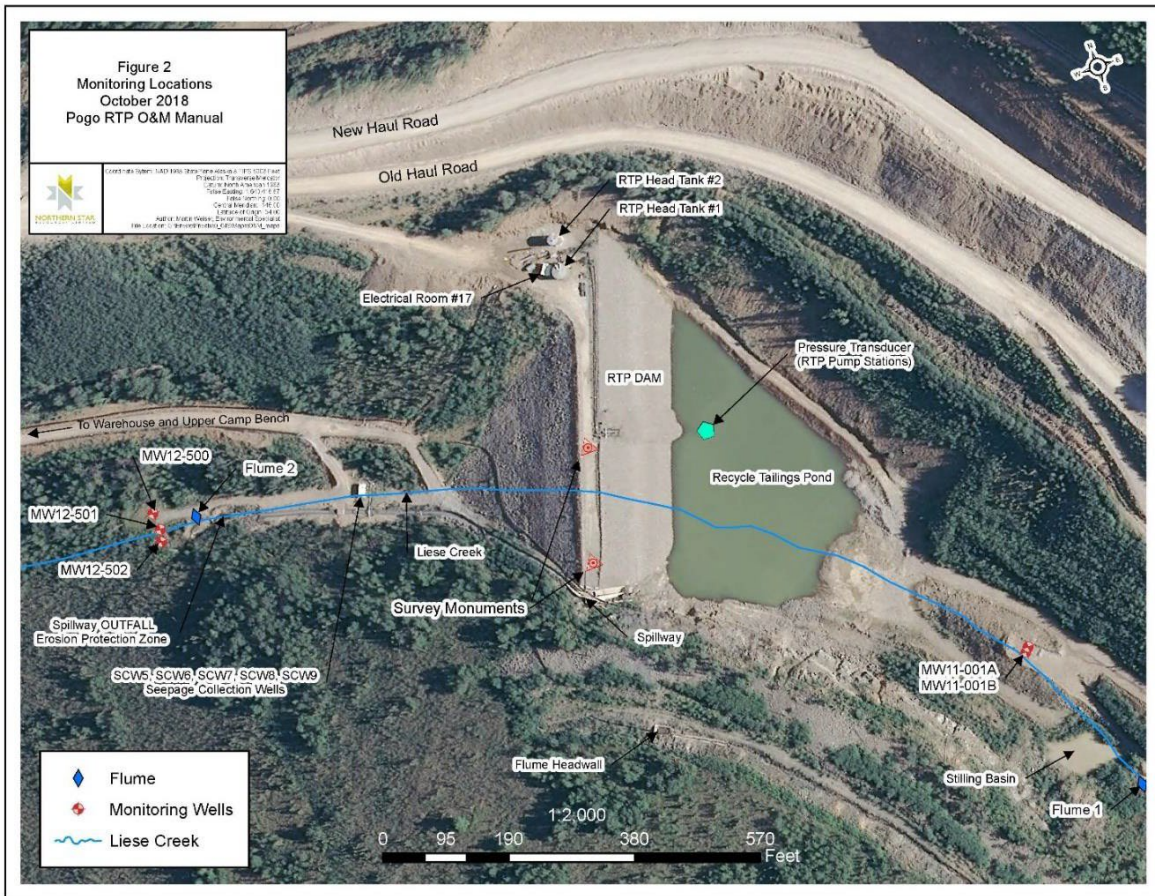
Figure 4: Pogo RTP Dam monitoring

Monitoring frequencies are summarized in Table 2. Figure 4 shows the location of monitoring points.

The flow rate from DSTF flow-through drain is monitored at Liese Creek Flume #1 upstream of the RTP (see Figure 4). Liese Creek Flume #1 was installed in April 2013. A pressure transducer is installed during summer season to monitor the water level every hour. The data is downloaded from the pressure transducer by Environmental Staff monthly, and this information is used to evaluate the water balance of the RTP along with the flows recorded by flow meters placed throughout the system.

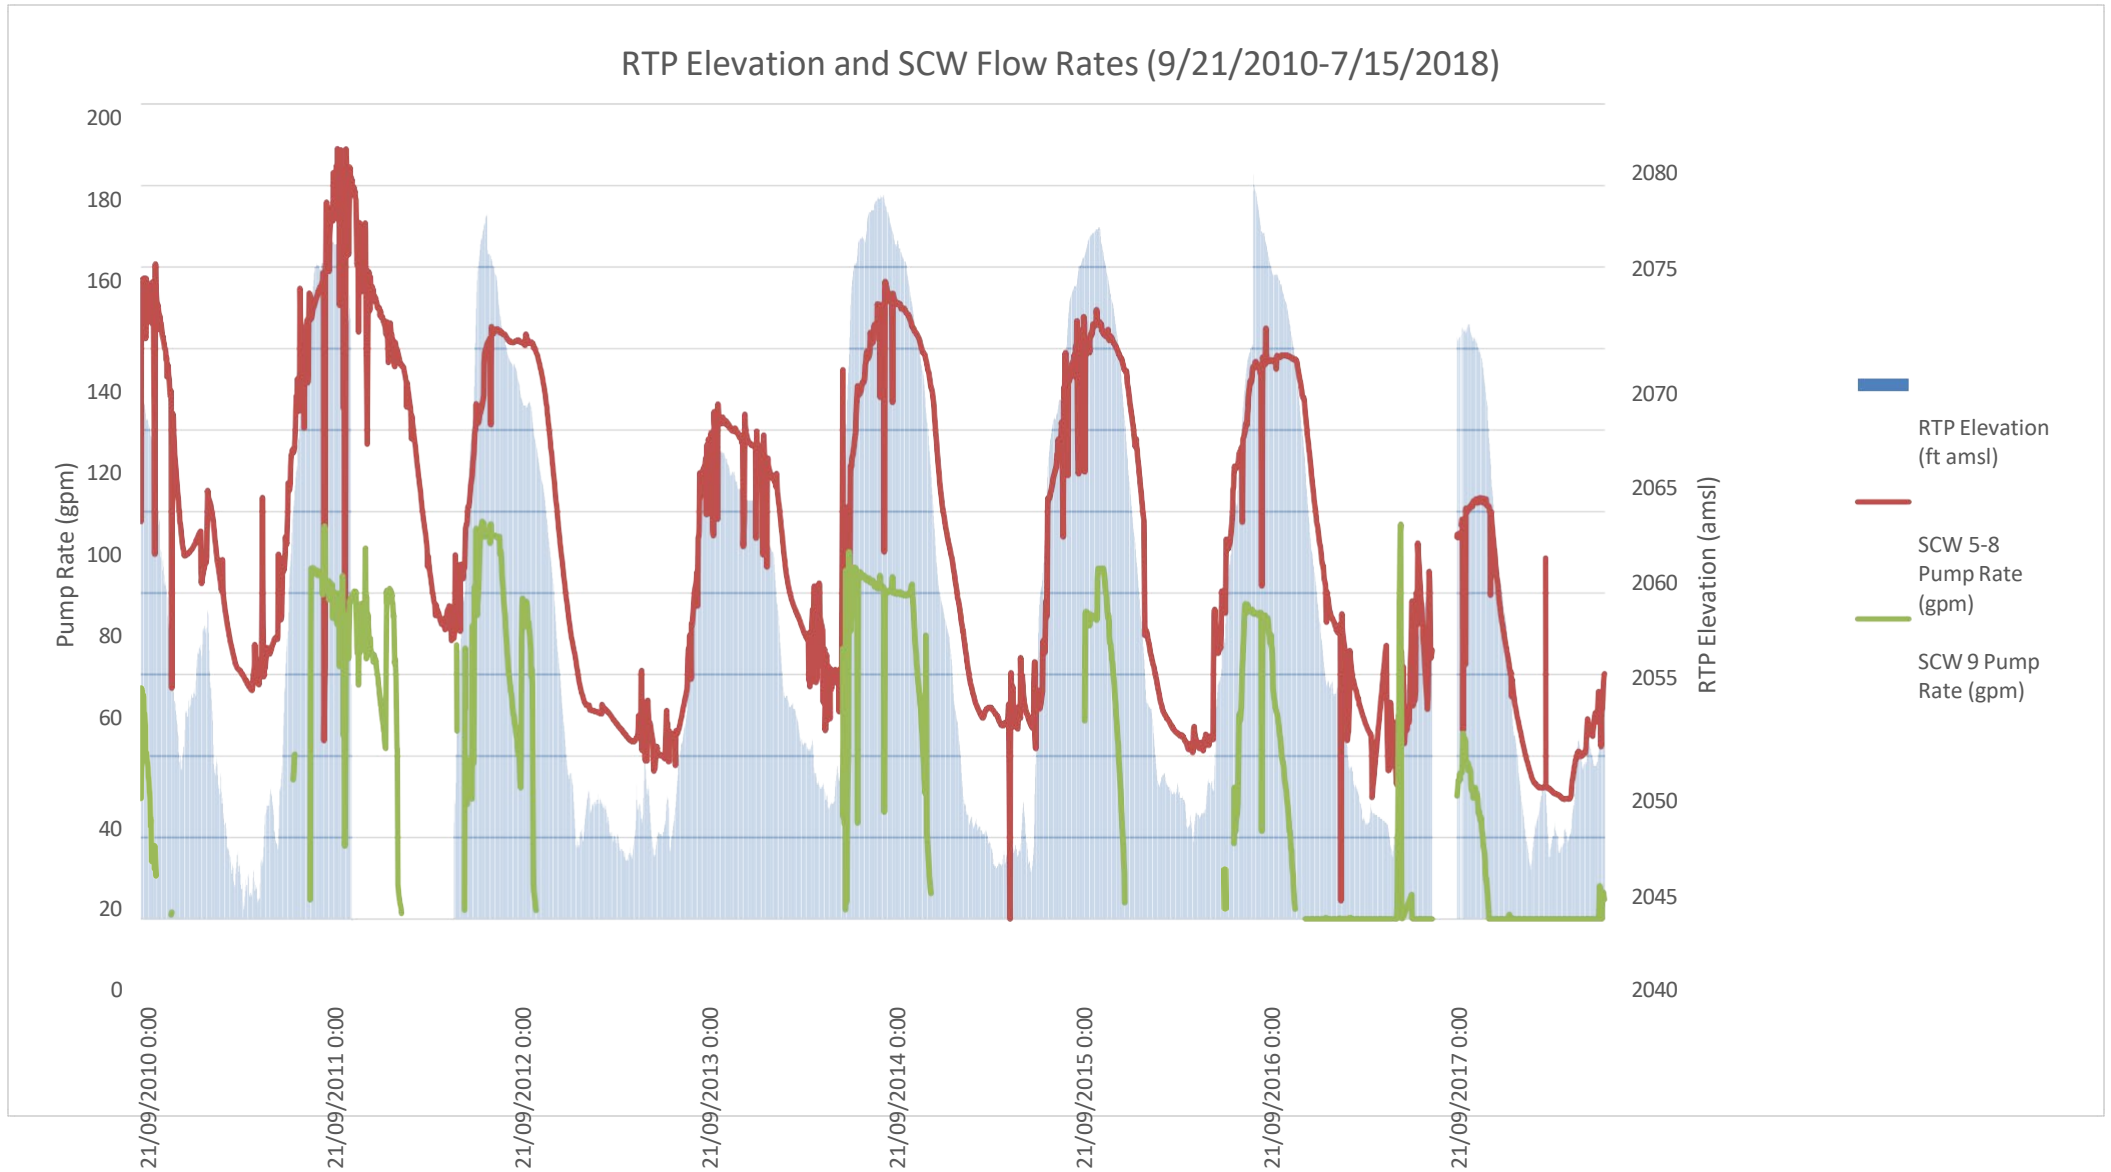
Figure 5: RTP Elevation and SCW Flow Rates

The pump rates of the SCWs vary by season and can be correlated to RTP water elevation. Historically, the pump rate from SCW#5 - 8 increases from 70 gpm up to 170 gpm in relation to the reservoir elevation. The rate reduced by approximately 50 gpm in 2013 due to grouting conducted in April 2013 (see Figures 5 and 6). SCW#9 dries up when the reservoir elevation is 2,062 feet amsl (RTP volume: 16 Mgal) or lower. Once the reservoir level exceeds 2,062 feet amsl, the pump-up rate from SCW#9 increases up to 80 gpm in proportion to the reservoir elevation (see Figures 5 and 7). SCW#9 remained dry in 2013 even though the reservoir level reached to 2,064 feet amsl in late September. The combined pump up rate from SCW#5 - 8 and SCW#9 historically ranges between 70 gpm and 340 gpm under normal operating conditions.
