Fort Knox

ANNUAL ACTIVITY REPORT
for
REPORTING YEAR 2022

February 2023

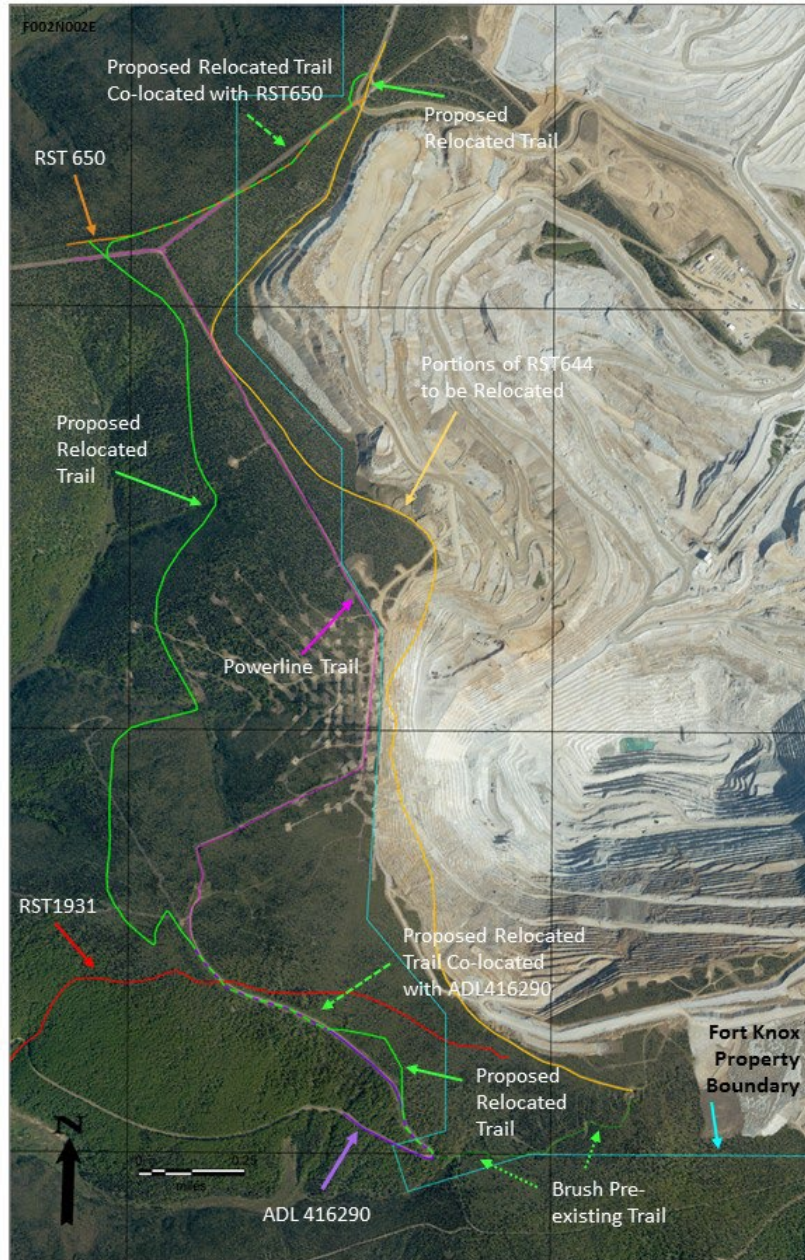
Figure 3: RSTs 644 and 1931 Partial Relocations

In 2018, FGMI submitted an Application to Relocate Portions of RST644 and RST1931 trails to ADNR, Land. ADNR approved the application and construction was completed (Figure 3).

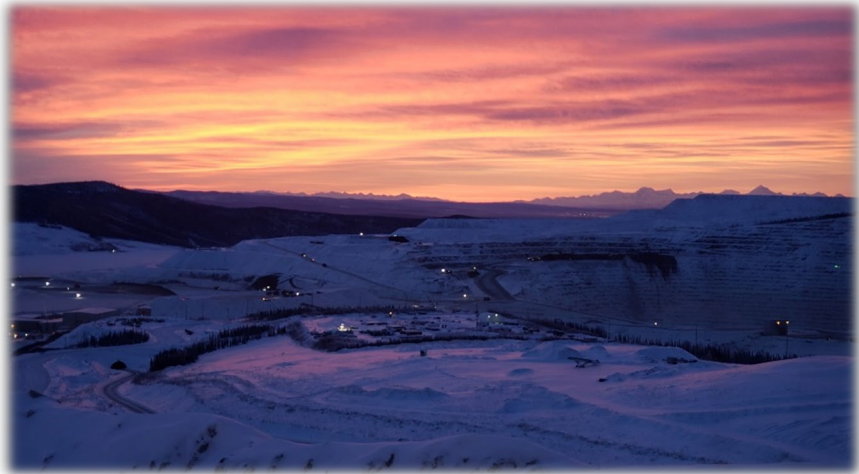
Figure 4: Fort Knox Pit Phases

Phase 7 stripping commenced in the 4th quarter of 2008. Stripping for phase 7 continued into 2012 before sustained ore was achieved. In 2015, mining within the Fort Knox open pit occurred in Phase 7 and Phase 8. Phase 7 is now incorporated into Phases 8, 9, and 10 mining areas (Figure 4).

Mining activities continued in 2017 for the pit layback area known as Phase 8. This phase of the pit delivered ore to the mill and the leach pad beginning in 2015 and will continue through 2022.

Mining in Phase 9 commenced in June 2019. Ore from this phase is expected to be delivered to the mill and heap leach pad from the first bench and will continue until the phase is mined out in 2024.

Phase 10 mining commenced in 2021 and will continue until mining activities end in 2027.

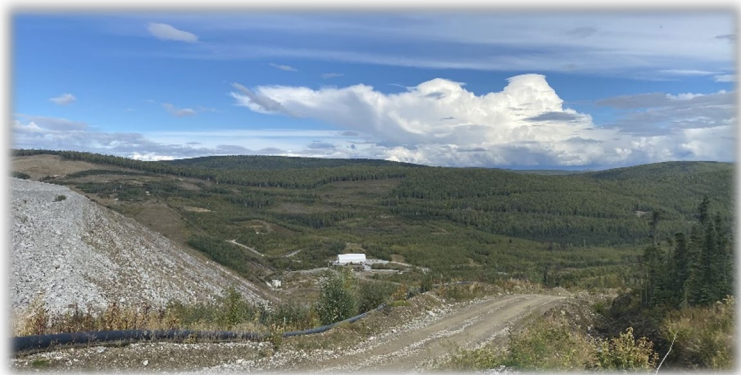
Figure 13: PMW Wells

In 2017 seven monitoring wells with sampling pumps were installed between the interceptor wells and the compliance monitoring wells. The purpose of these wells is to monitor the water quality. These wells were constructed with the option to be converted to interceptor wells (Figure 13).

A line of groundwater compliance monitoring wells MW-5, MW-6, and MW-7 located immediately downstream of the interception system and pre-compliance wells are monitored to insure that no process water is escaping the system and moving downstream (Figure 12 and 13).
