RE: Hawk Inlet Monitoring Program 2014 Annual Report (APDES Permit AK-004320-6)

**HAWK INLET MONITORING PROGRAM
2014 ANNUAL REPORT**

Hecla Greens Creek Mining Company

January 2015

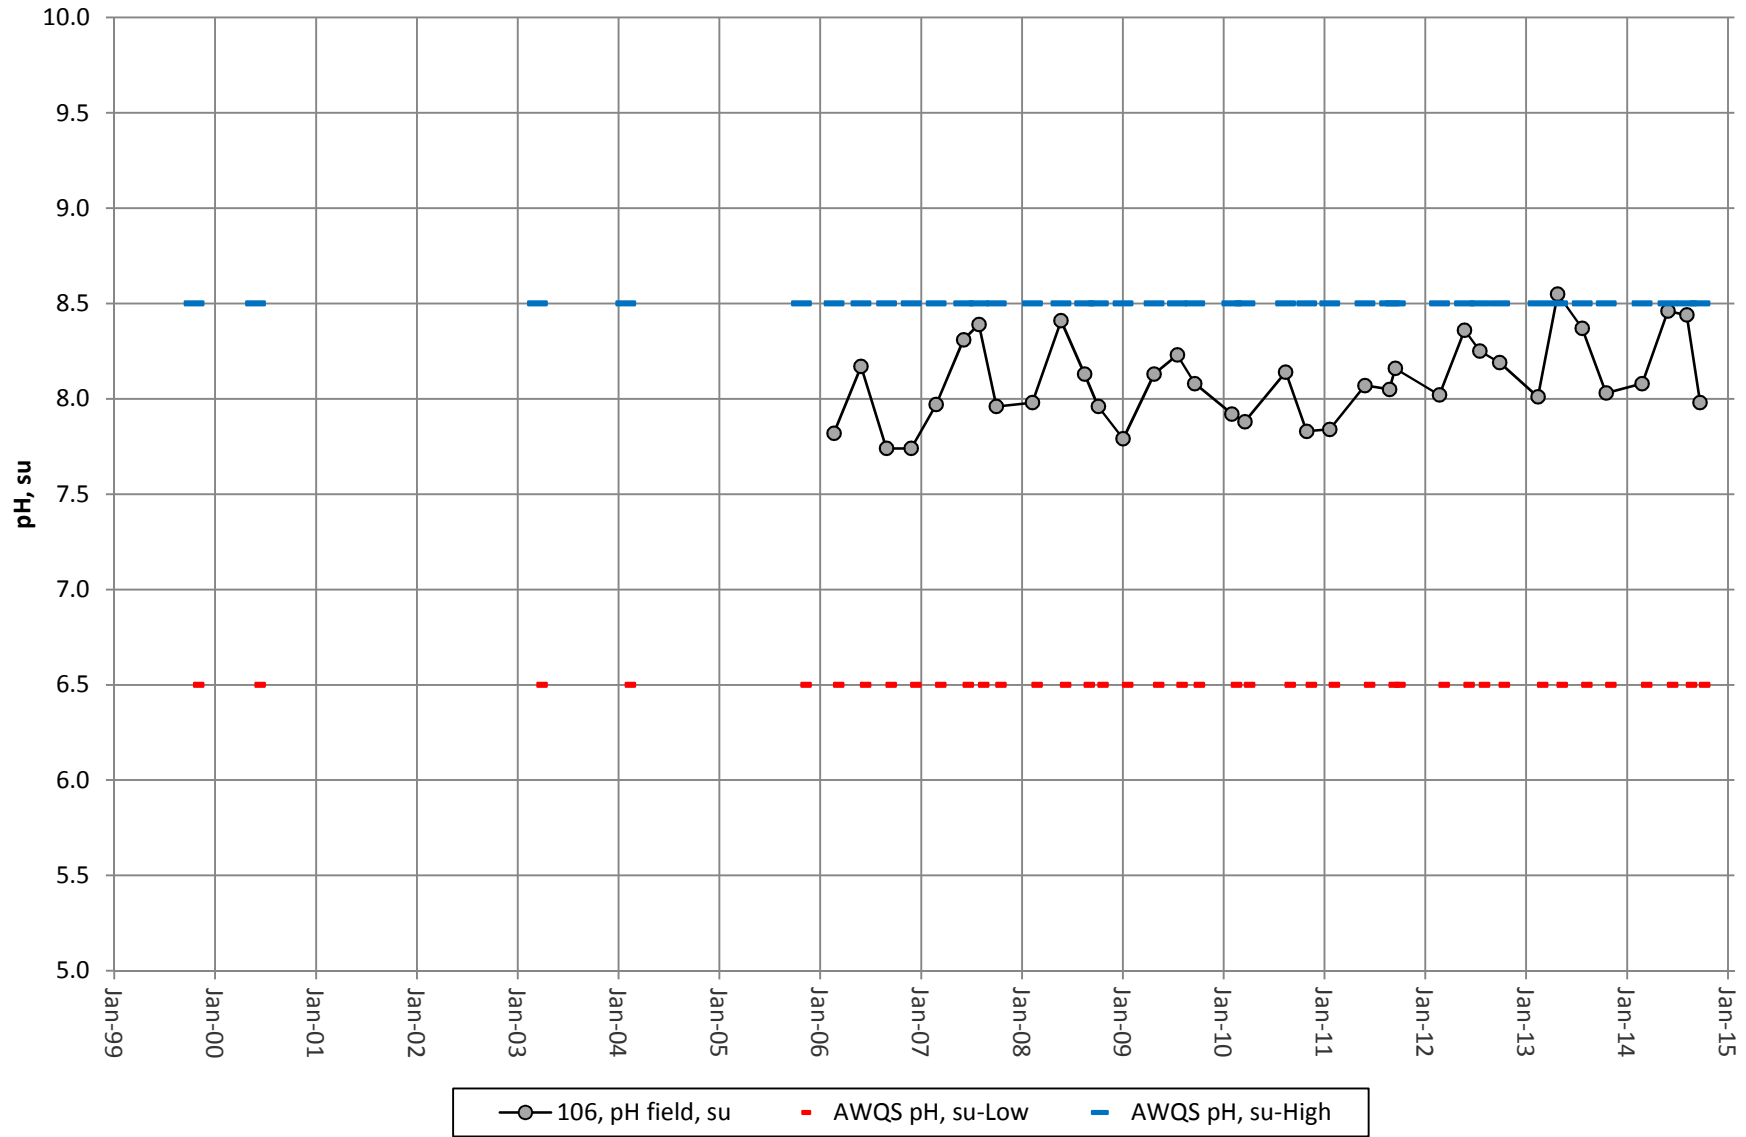
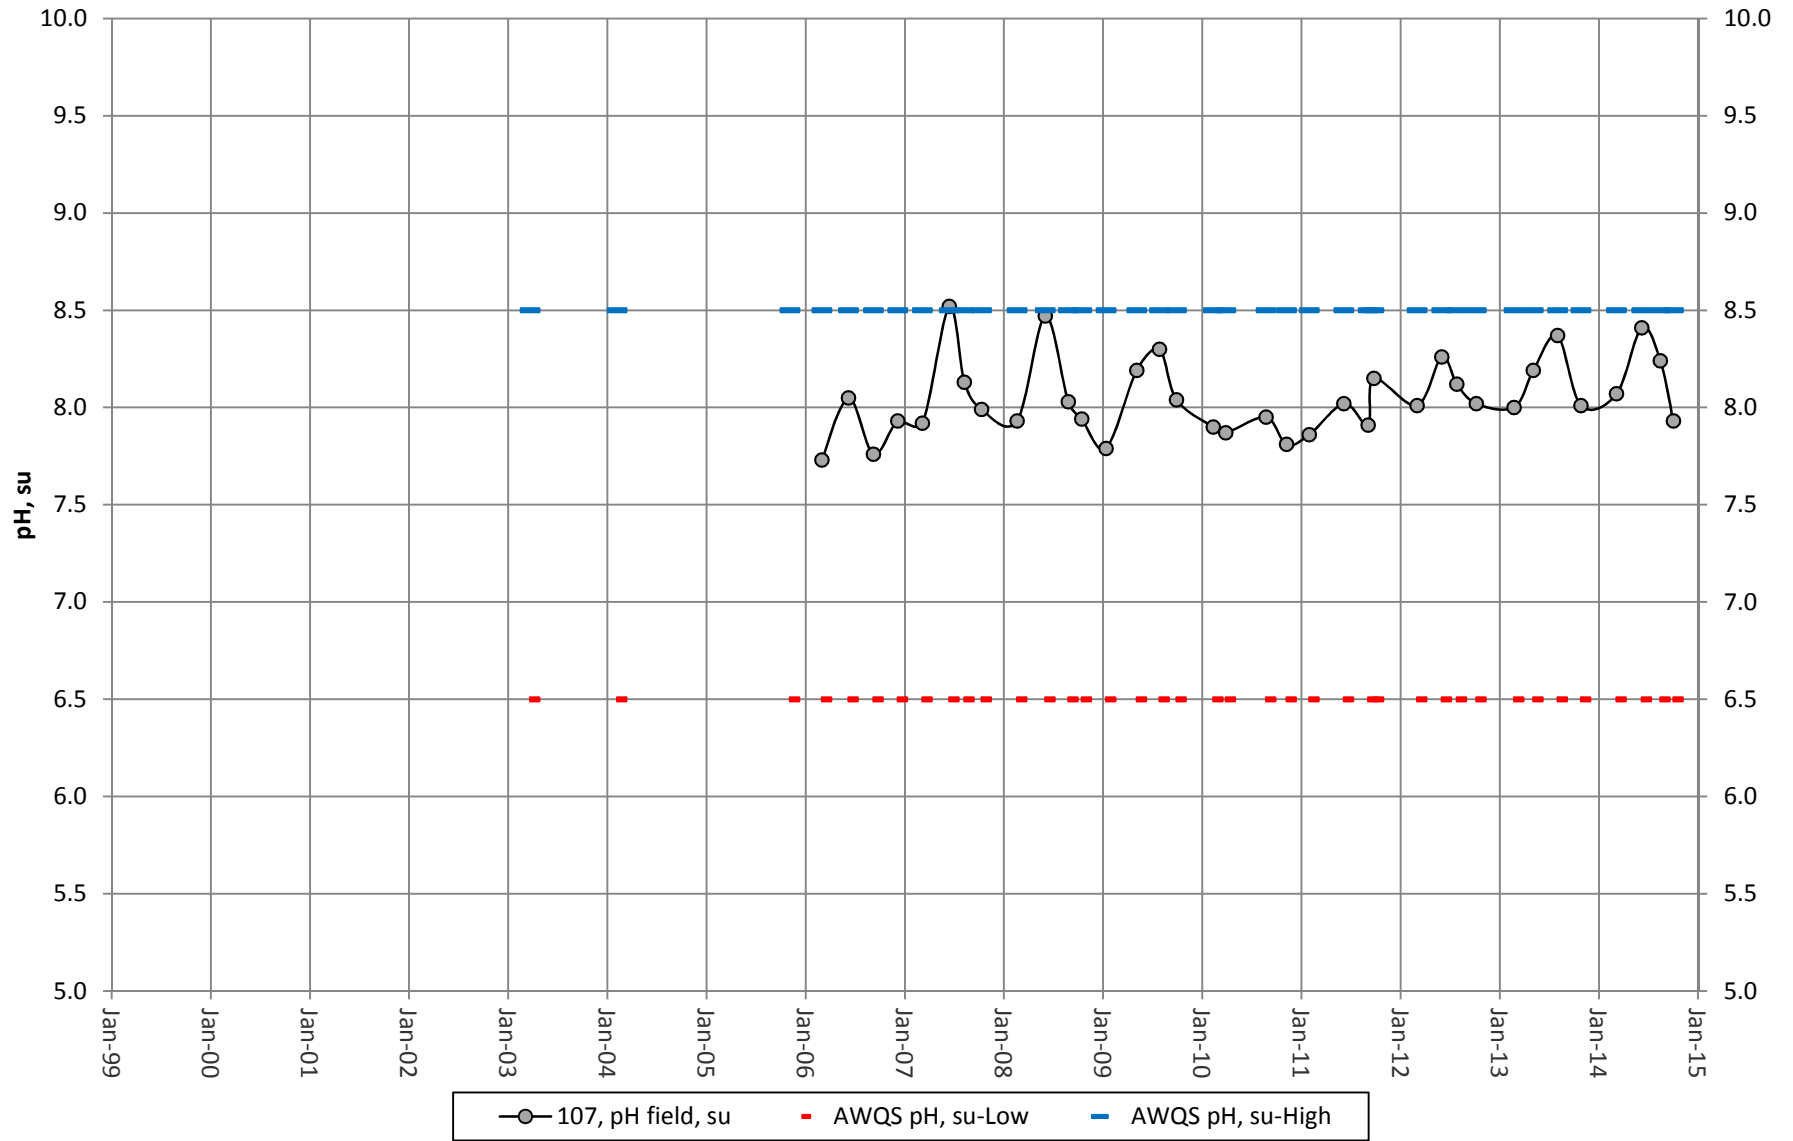
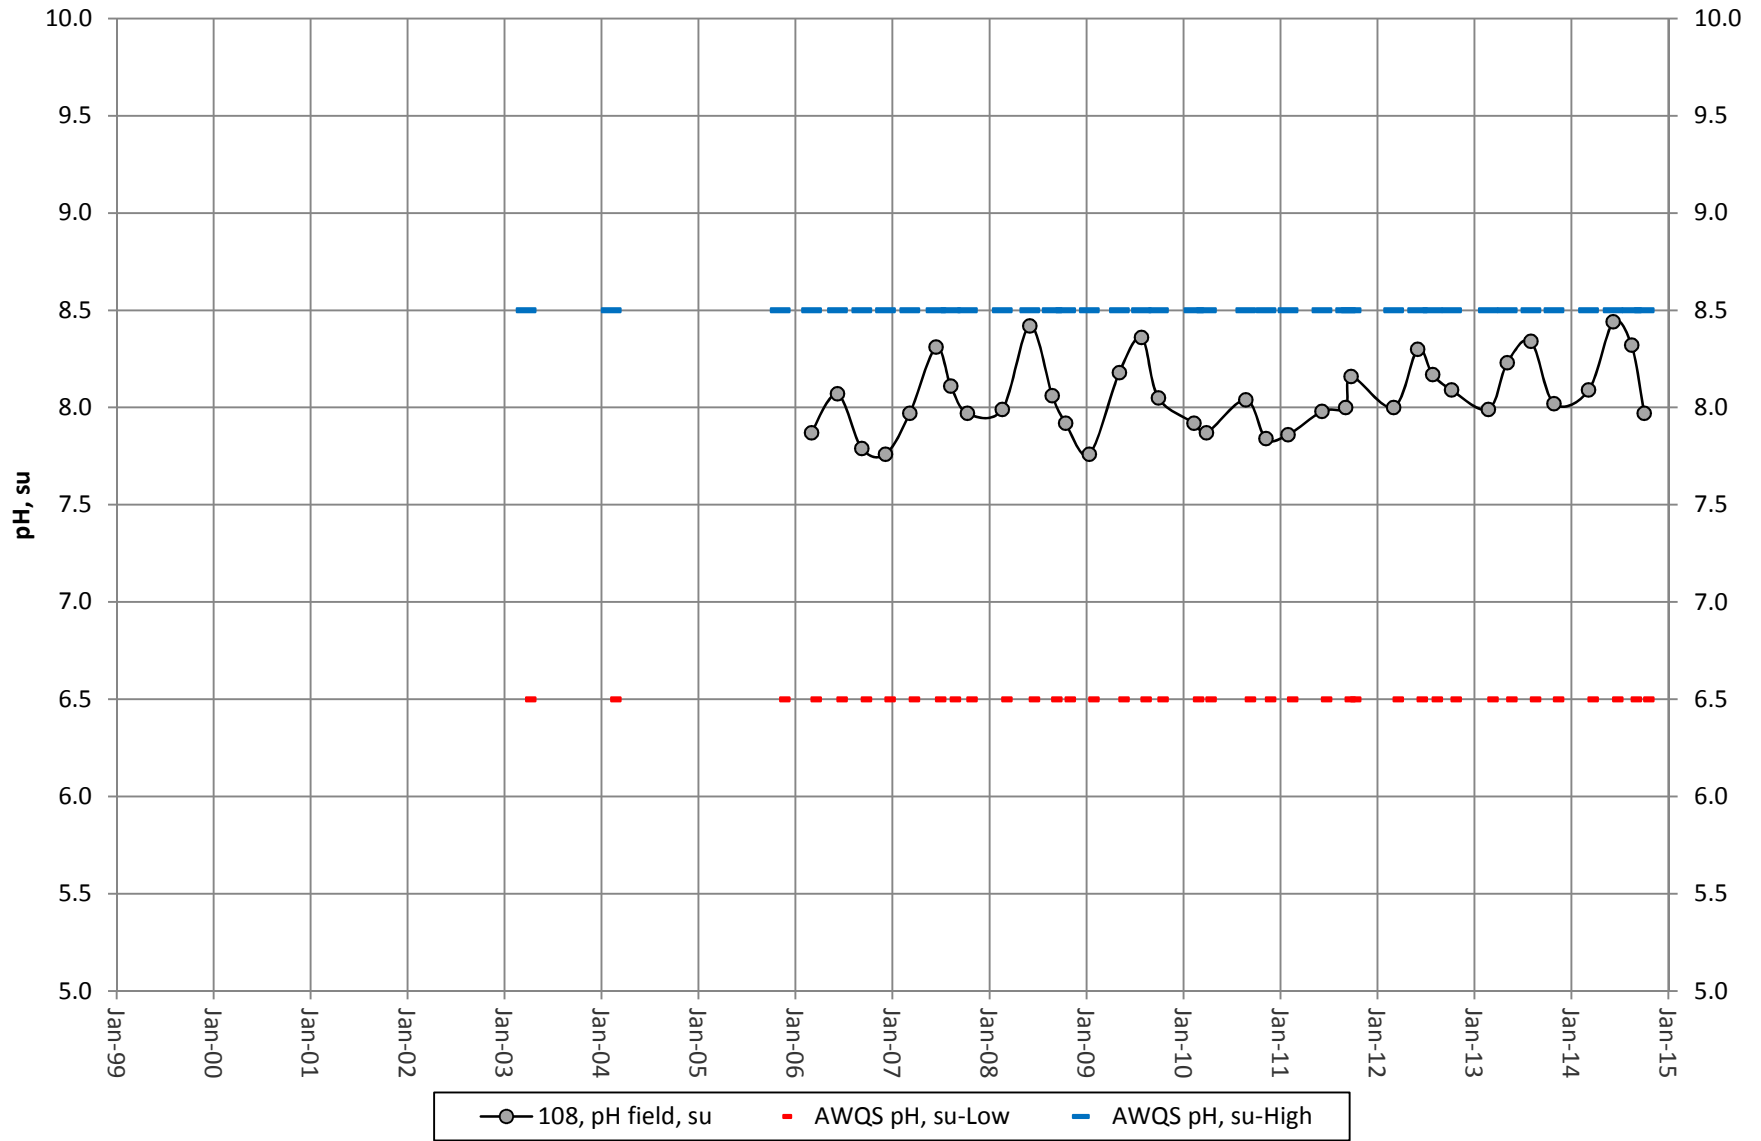
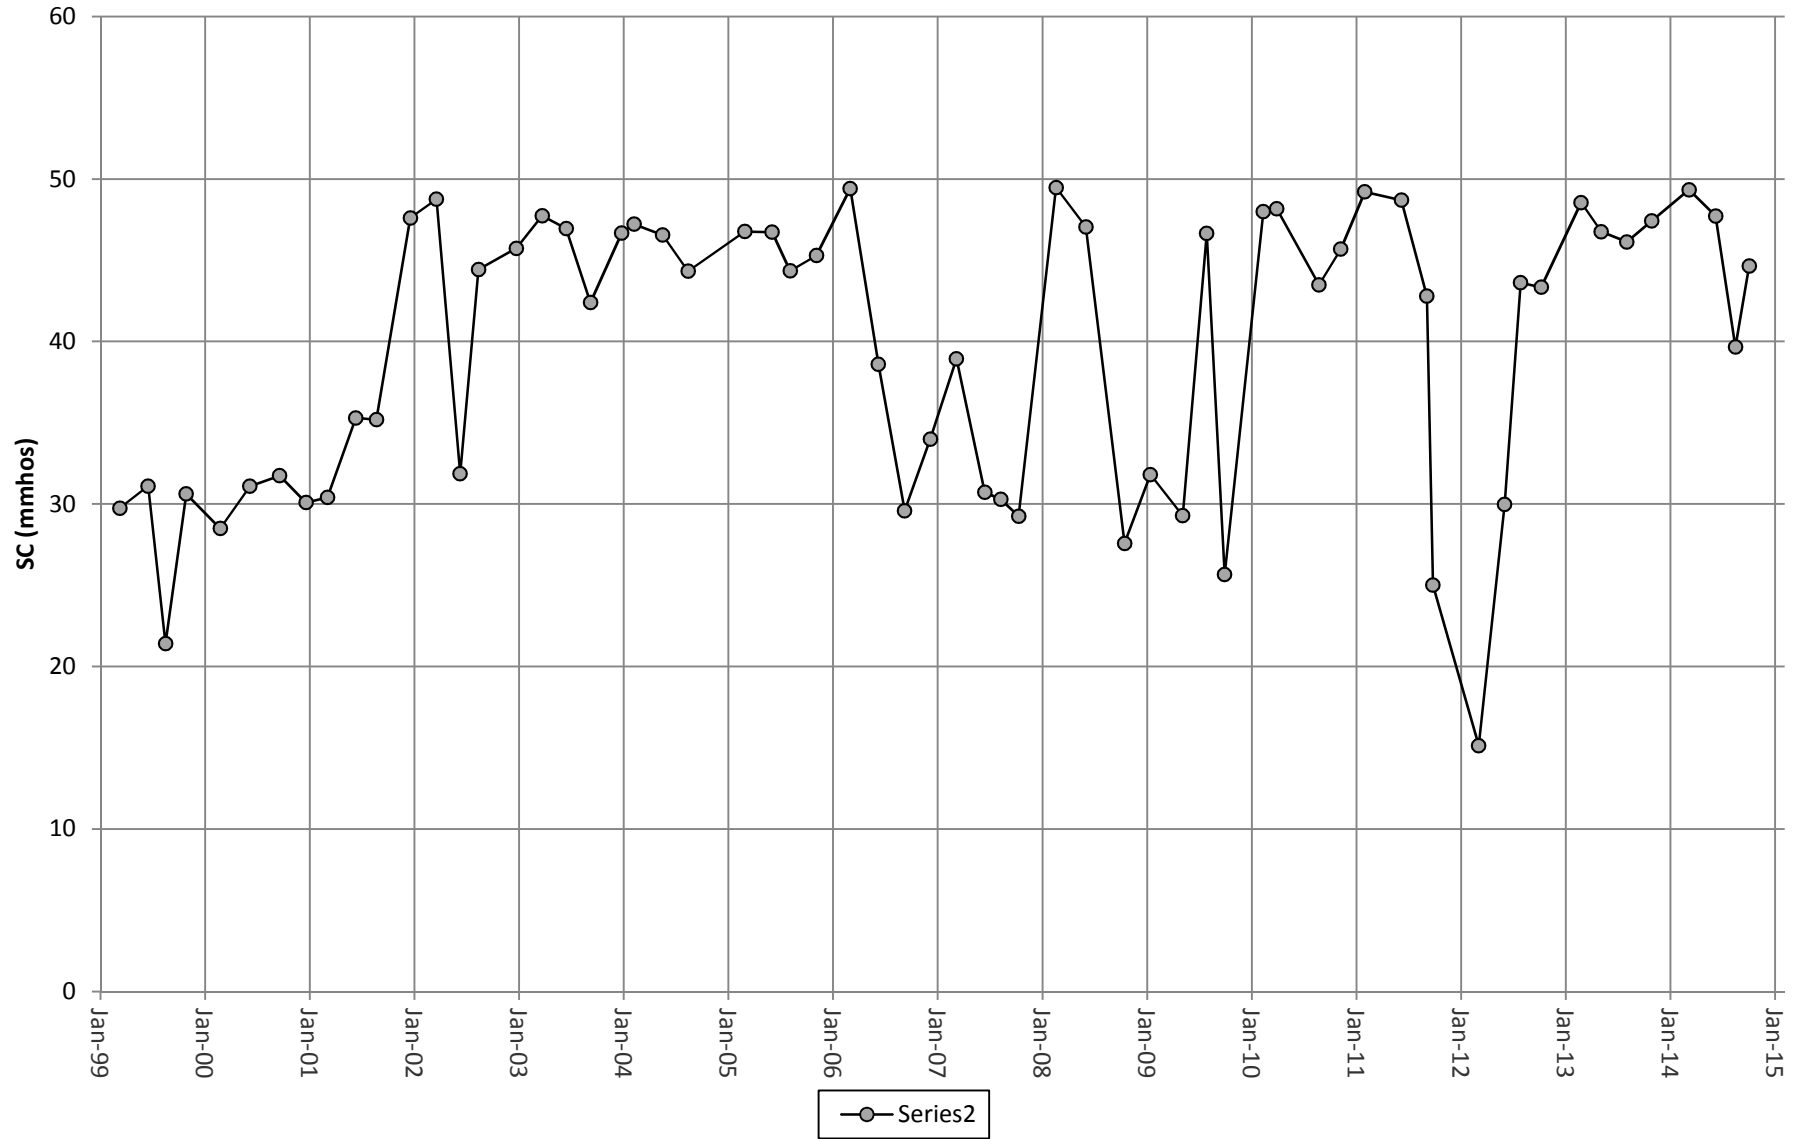
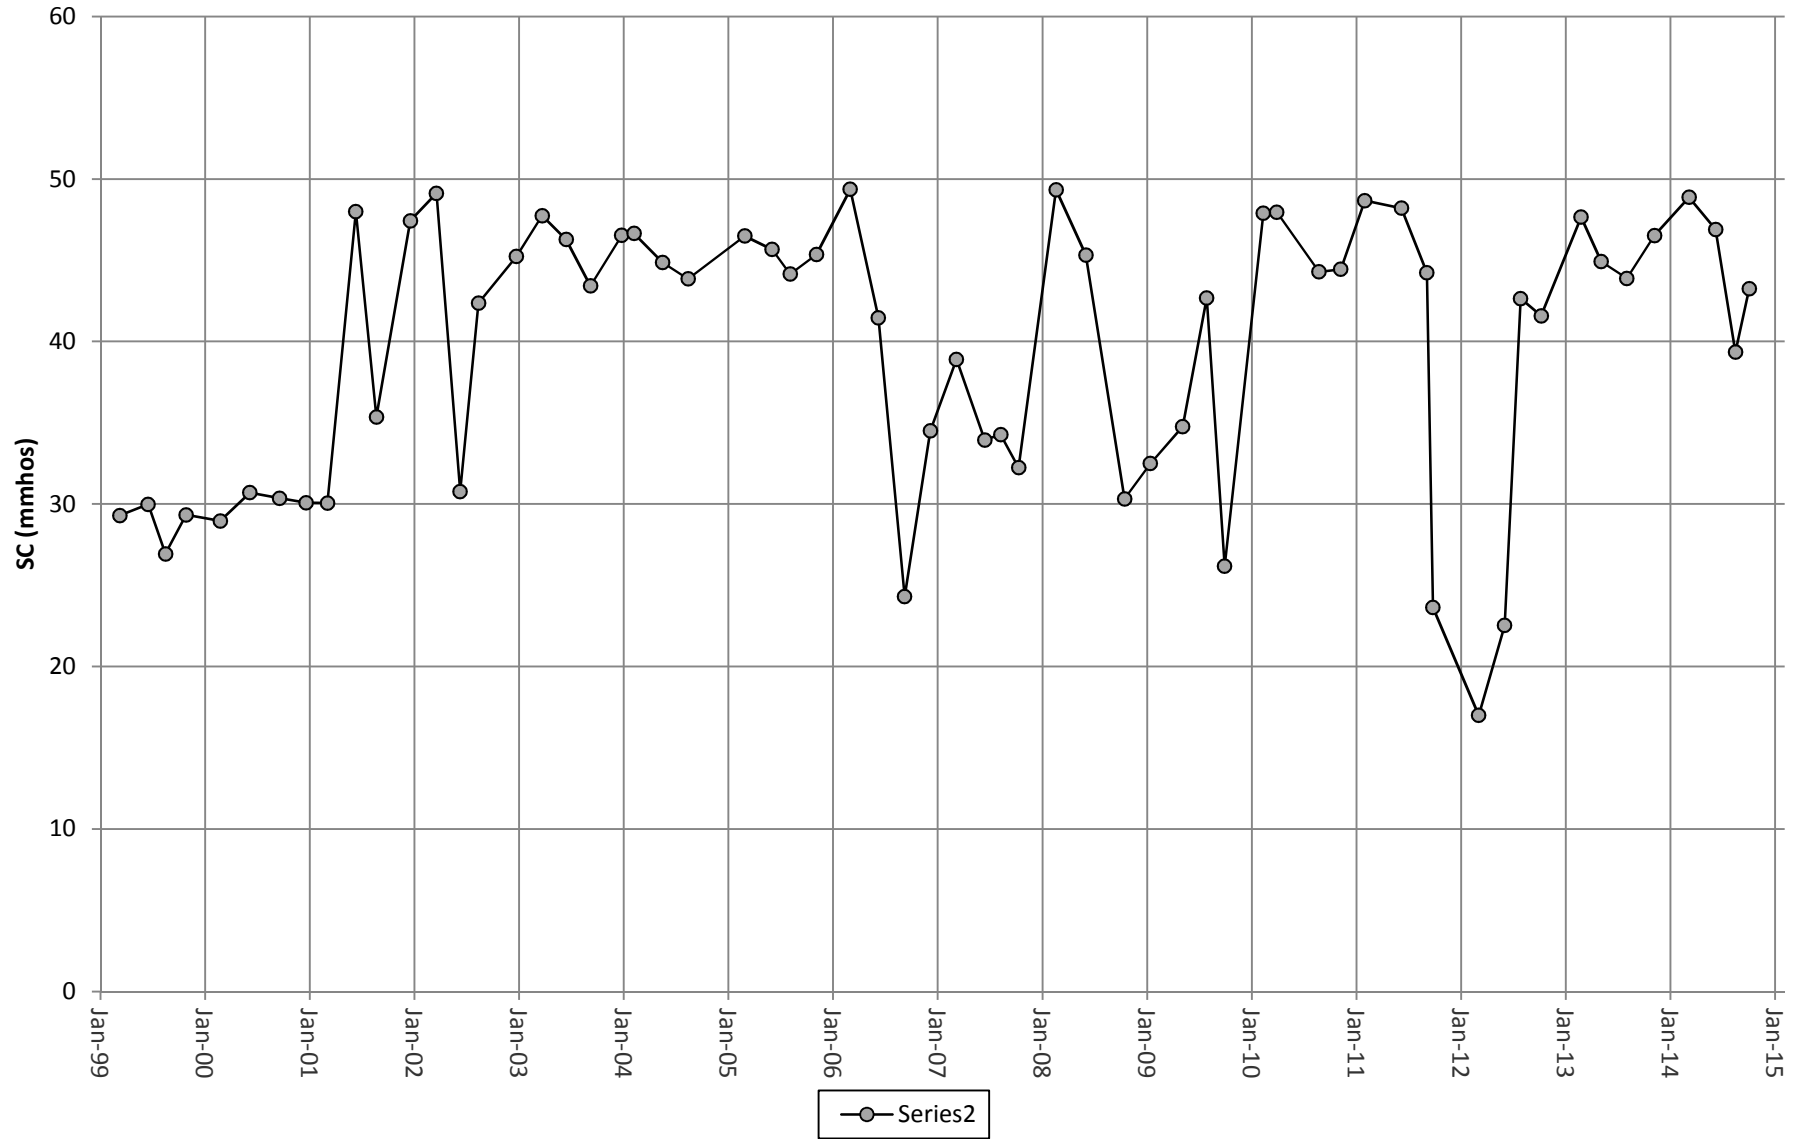
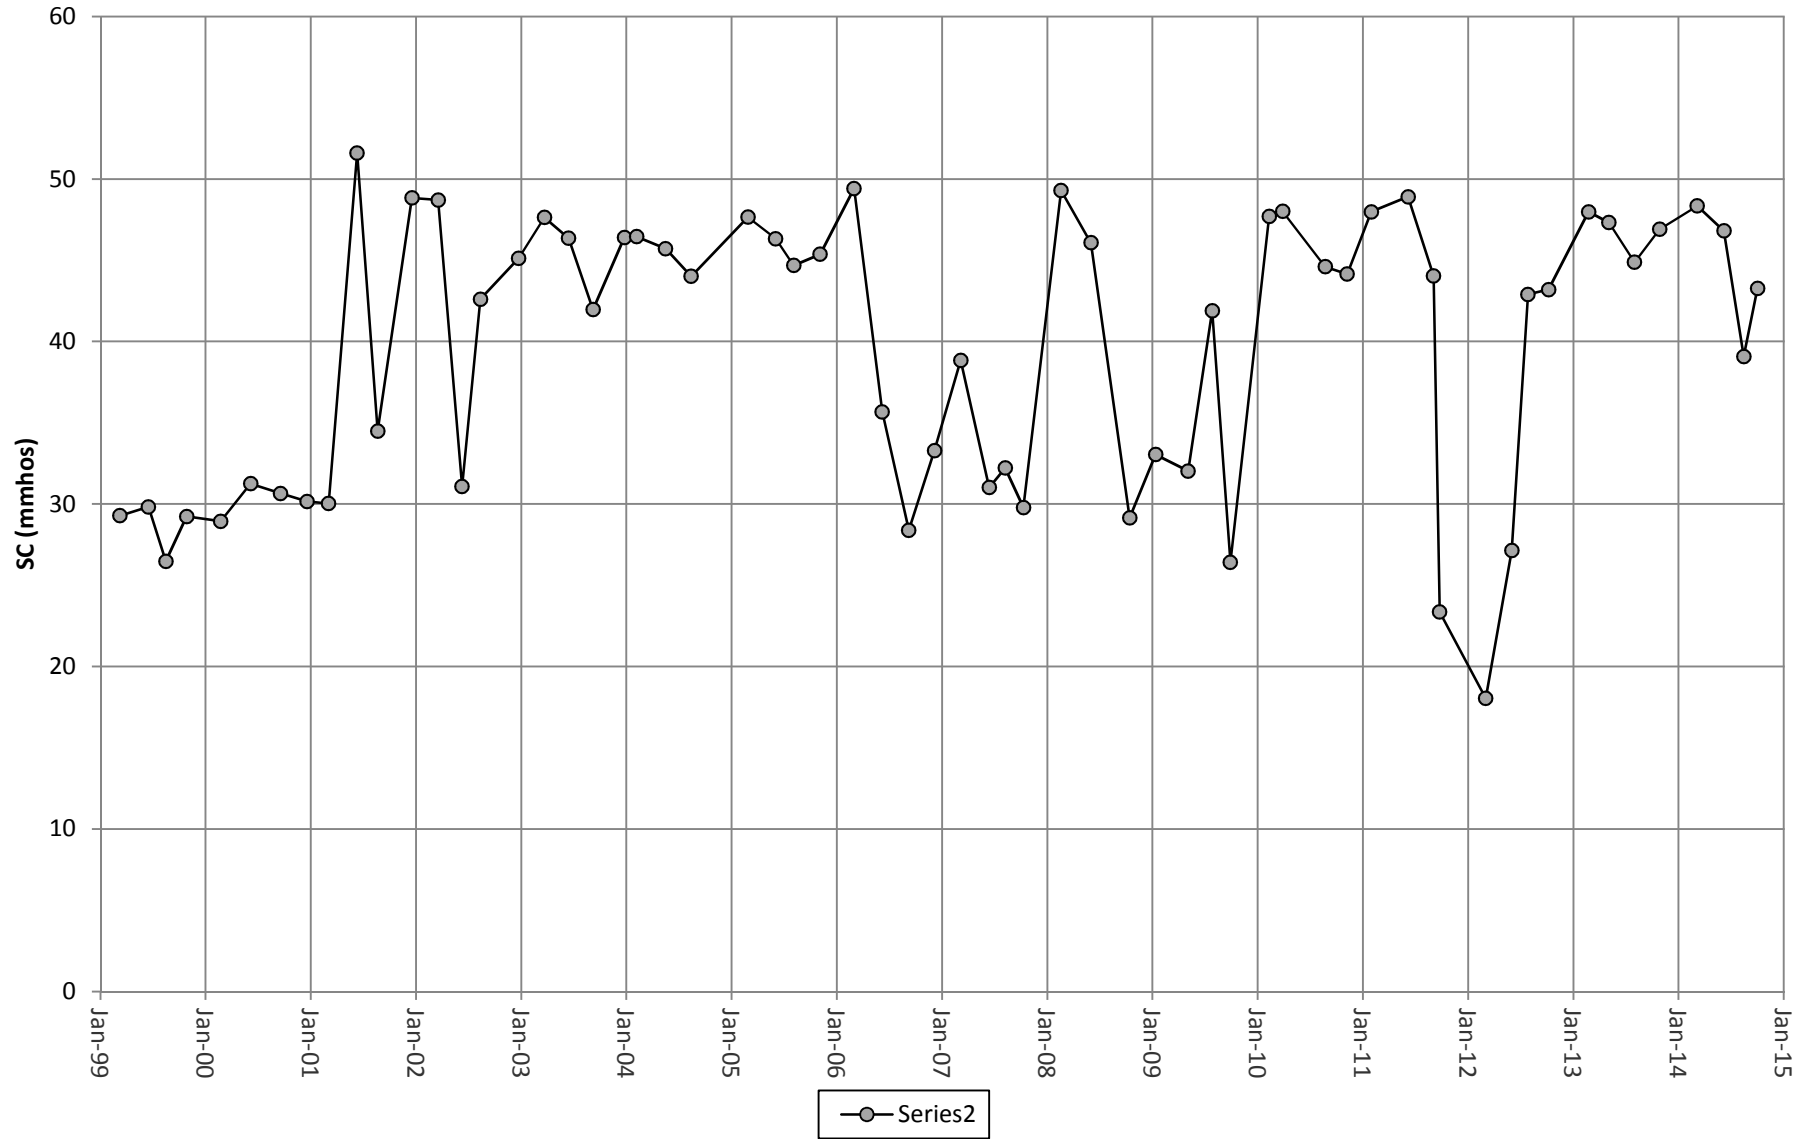
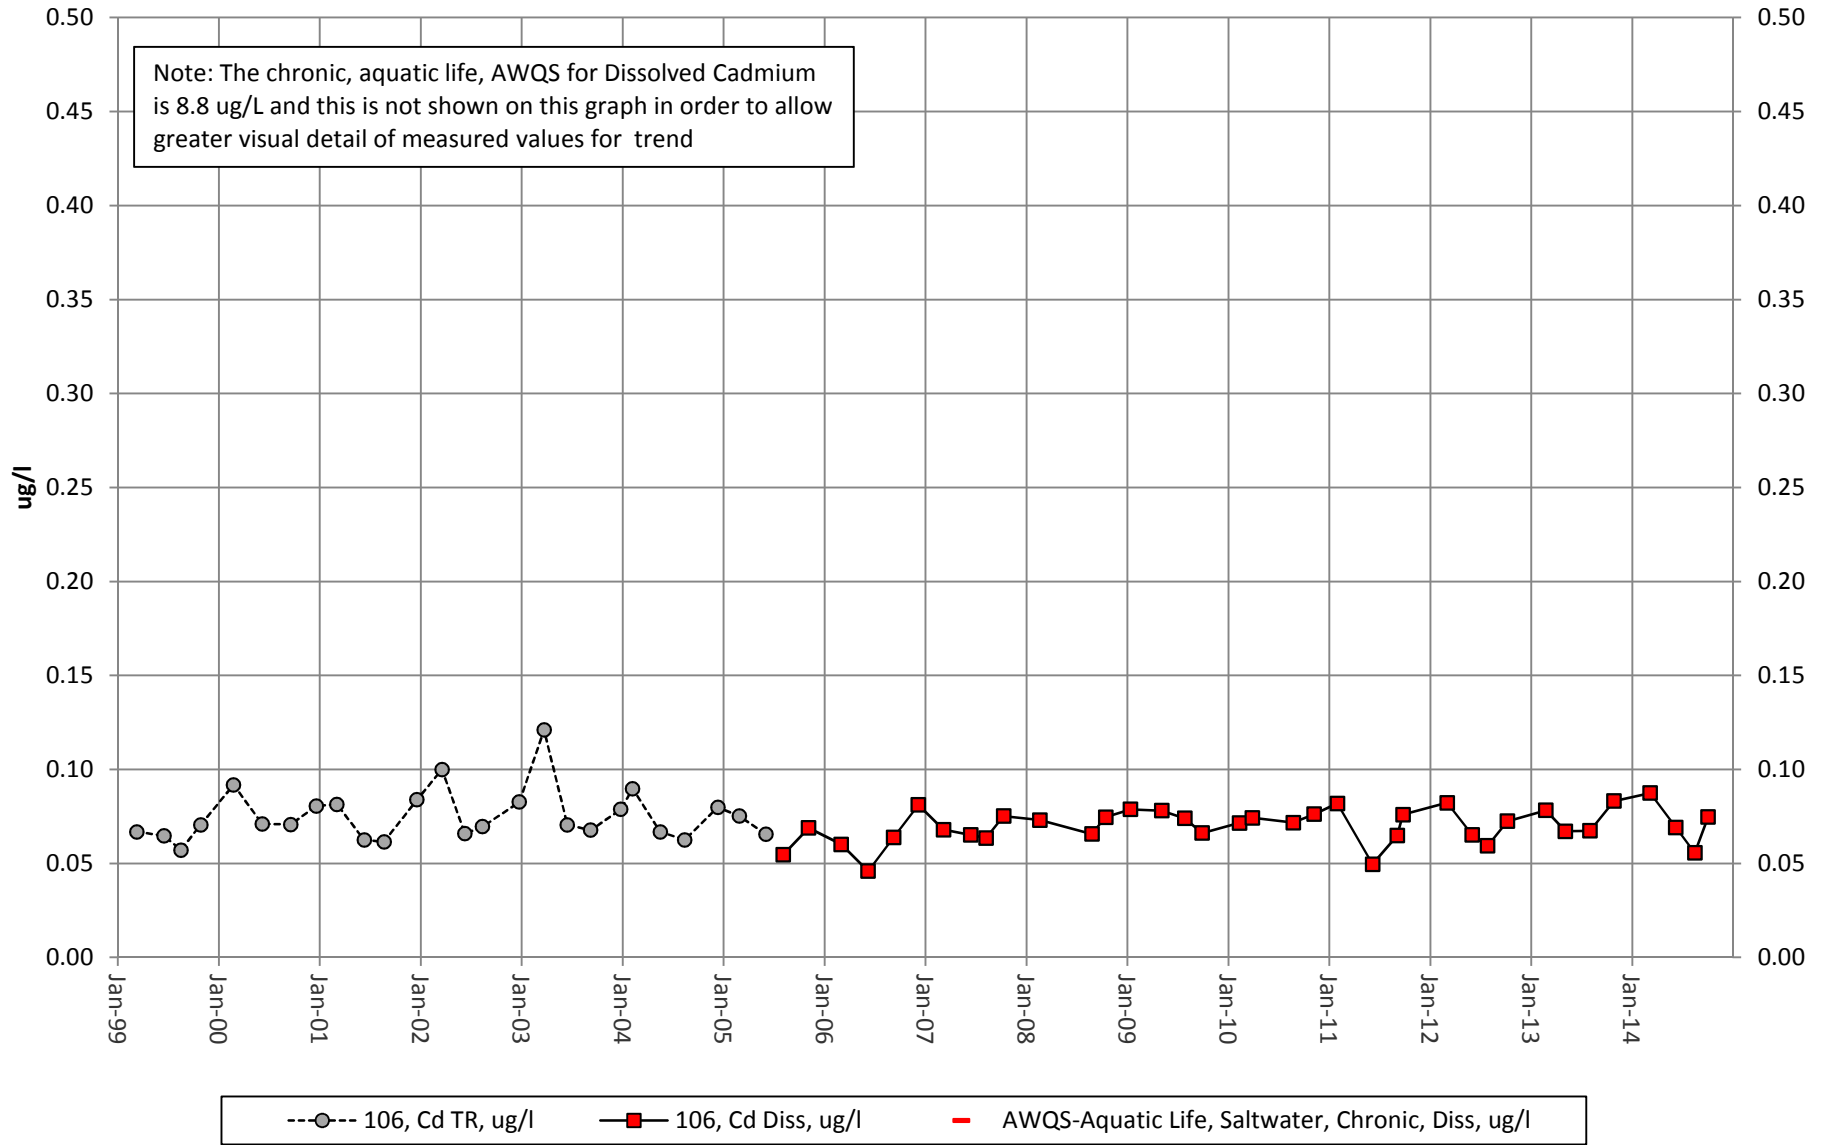
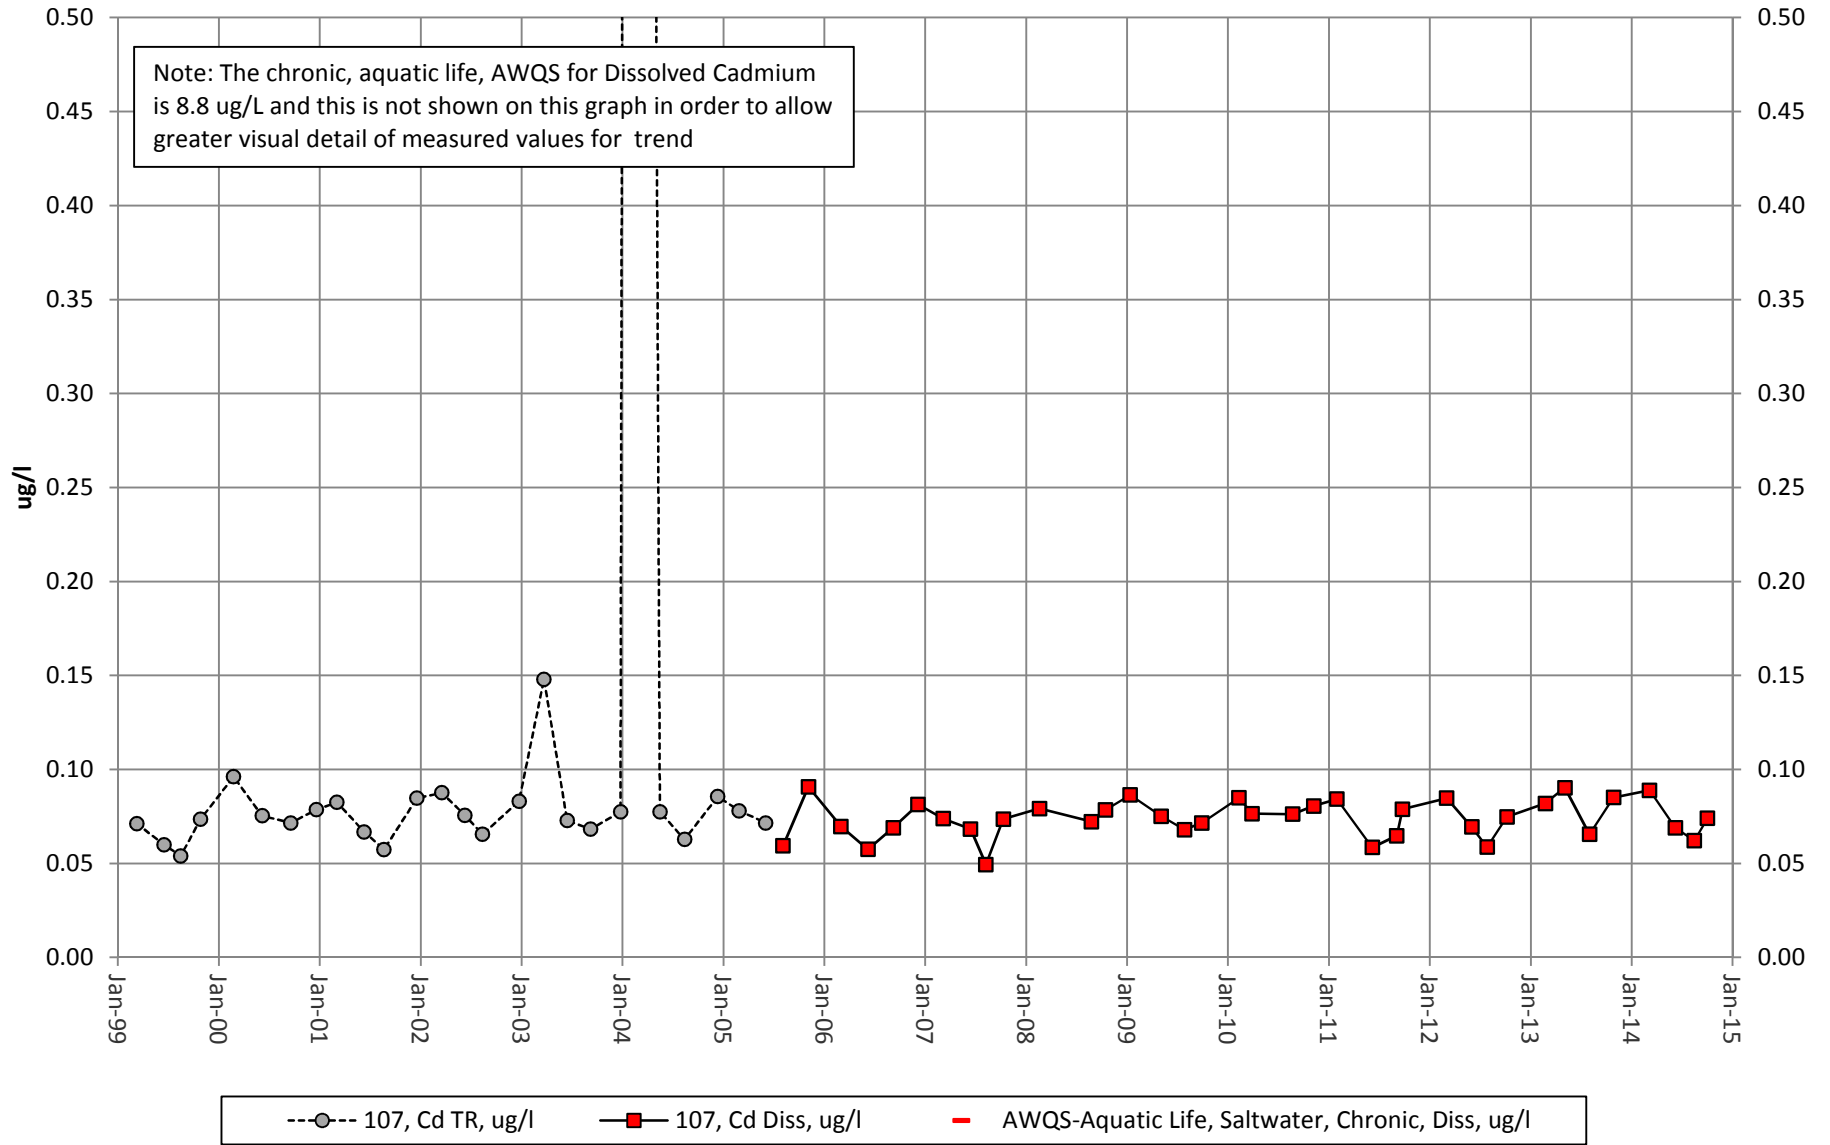
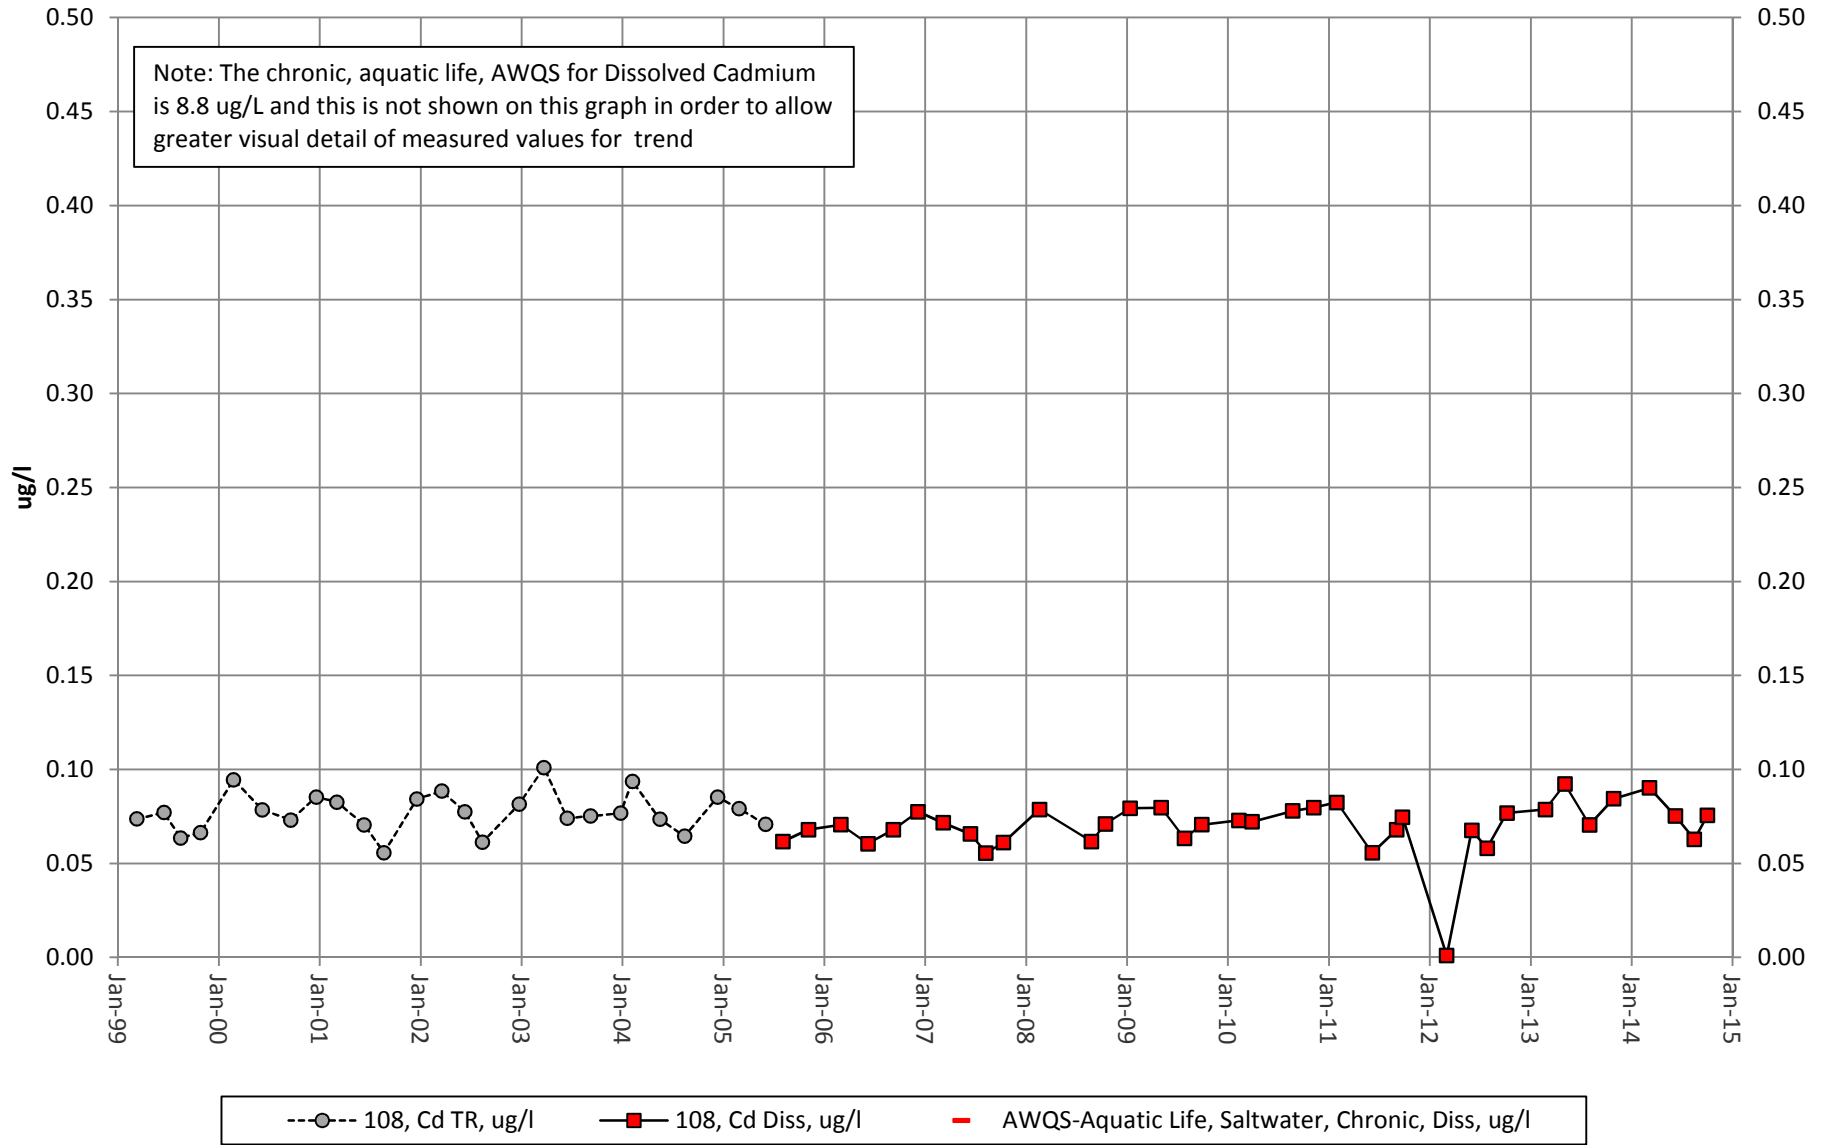
Figure 2-1a

Figures 2-1a, b, c through 2-7a, b, c show the time series plots of field pH, conductivity, cadmium, copper, lead, mercury and zinc for Stations 106 (2-1a through 2-7a), 107 (2-1b through 2-7b) and 108 (2-1c through 2-7c). The Alaska Water Quality Standards (AWQS) for marine aquatic life – chronic levels, are shown or noted on the graphs where applicable. The graphs show that the HGCMC results remain within or below these standards in all historical and 2014 samples.

Site 106 - Field pH

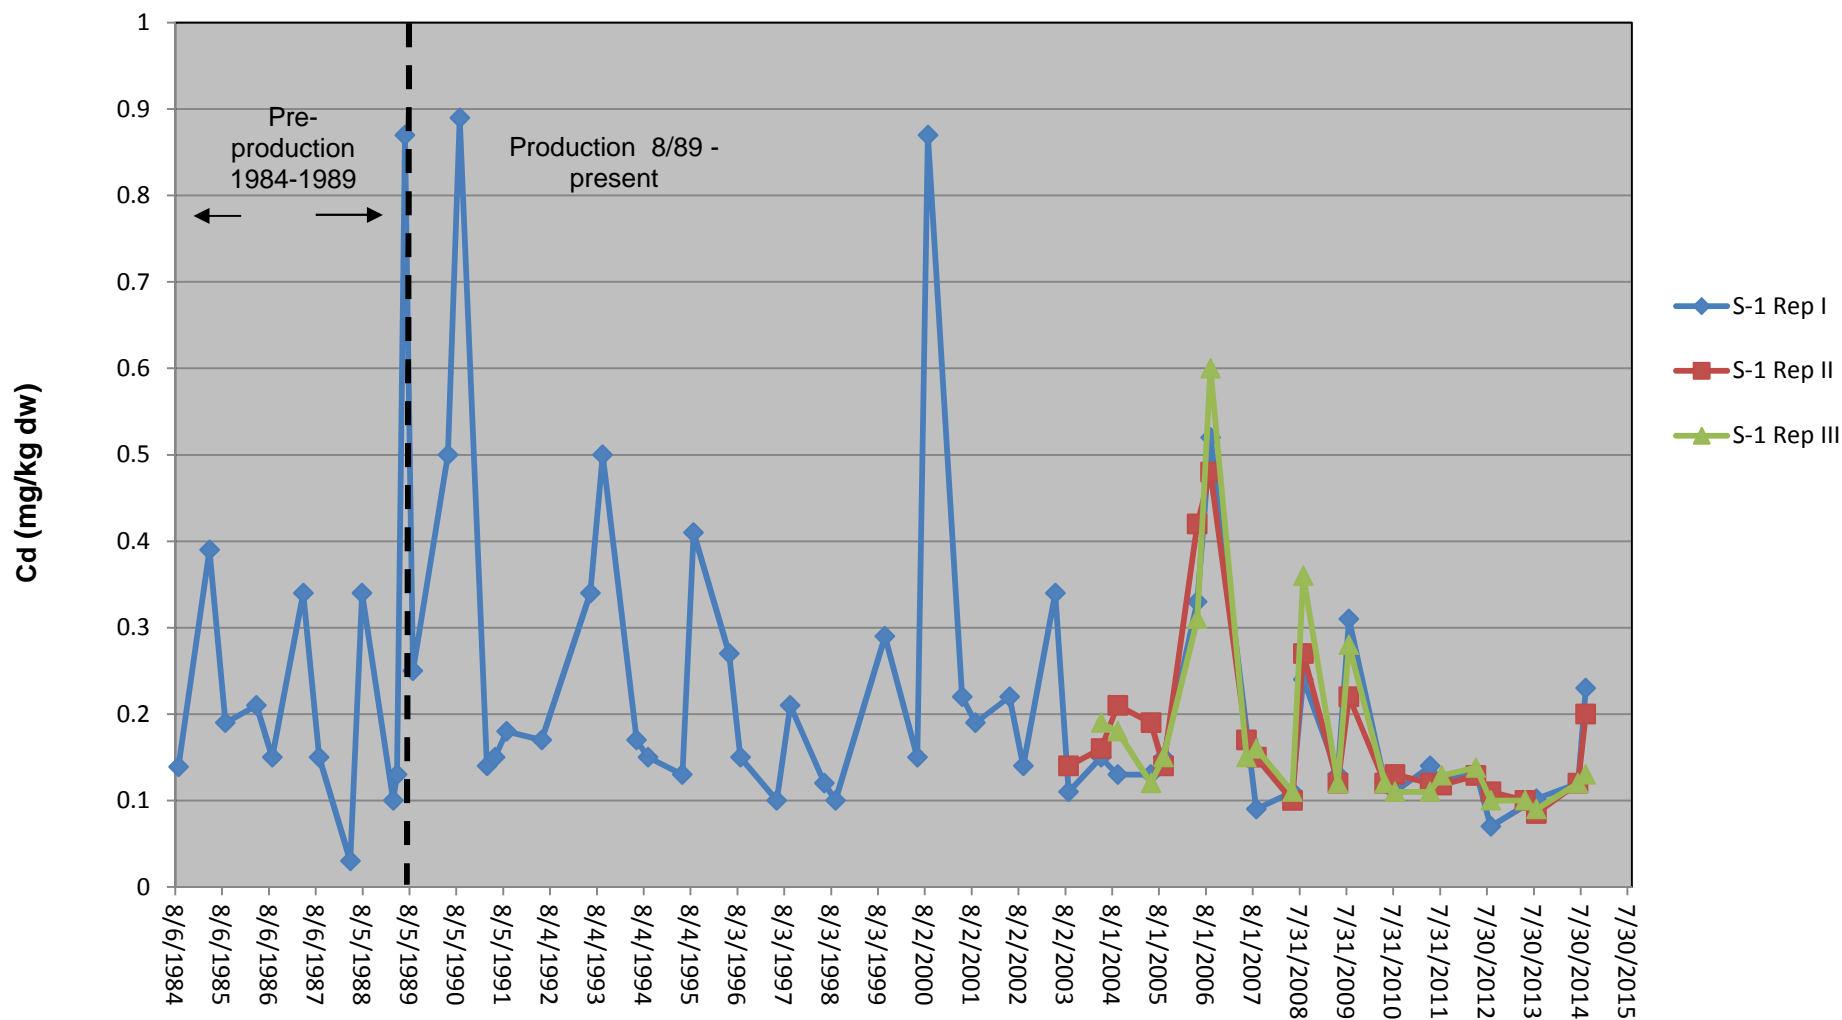
FIGURE 3-1

CADMIUM IN SEDIMENTS AT SITE S-1

Hawk Inlet sediment monitoring at S-1 and S-2 has been in place now for 30 years. When comparing S-1 which is located in the vicinity of the 002 outfall to S-2 a background site located over 1.5 miles to the south, it is evident that metal concentrations at the two sites exhibit similar concentration ranges. Furthermore, the yearly variability is similar between the two sites. Given the spatial distance but similar concentrations and the temporal similarity between the sites, the sediment metals concentrations at S-1 appear within the range of natural conditions.

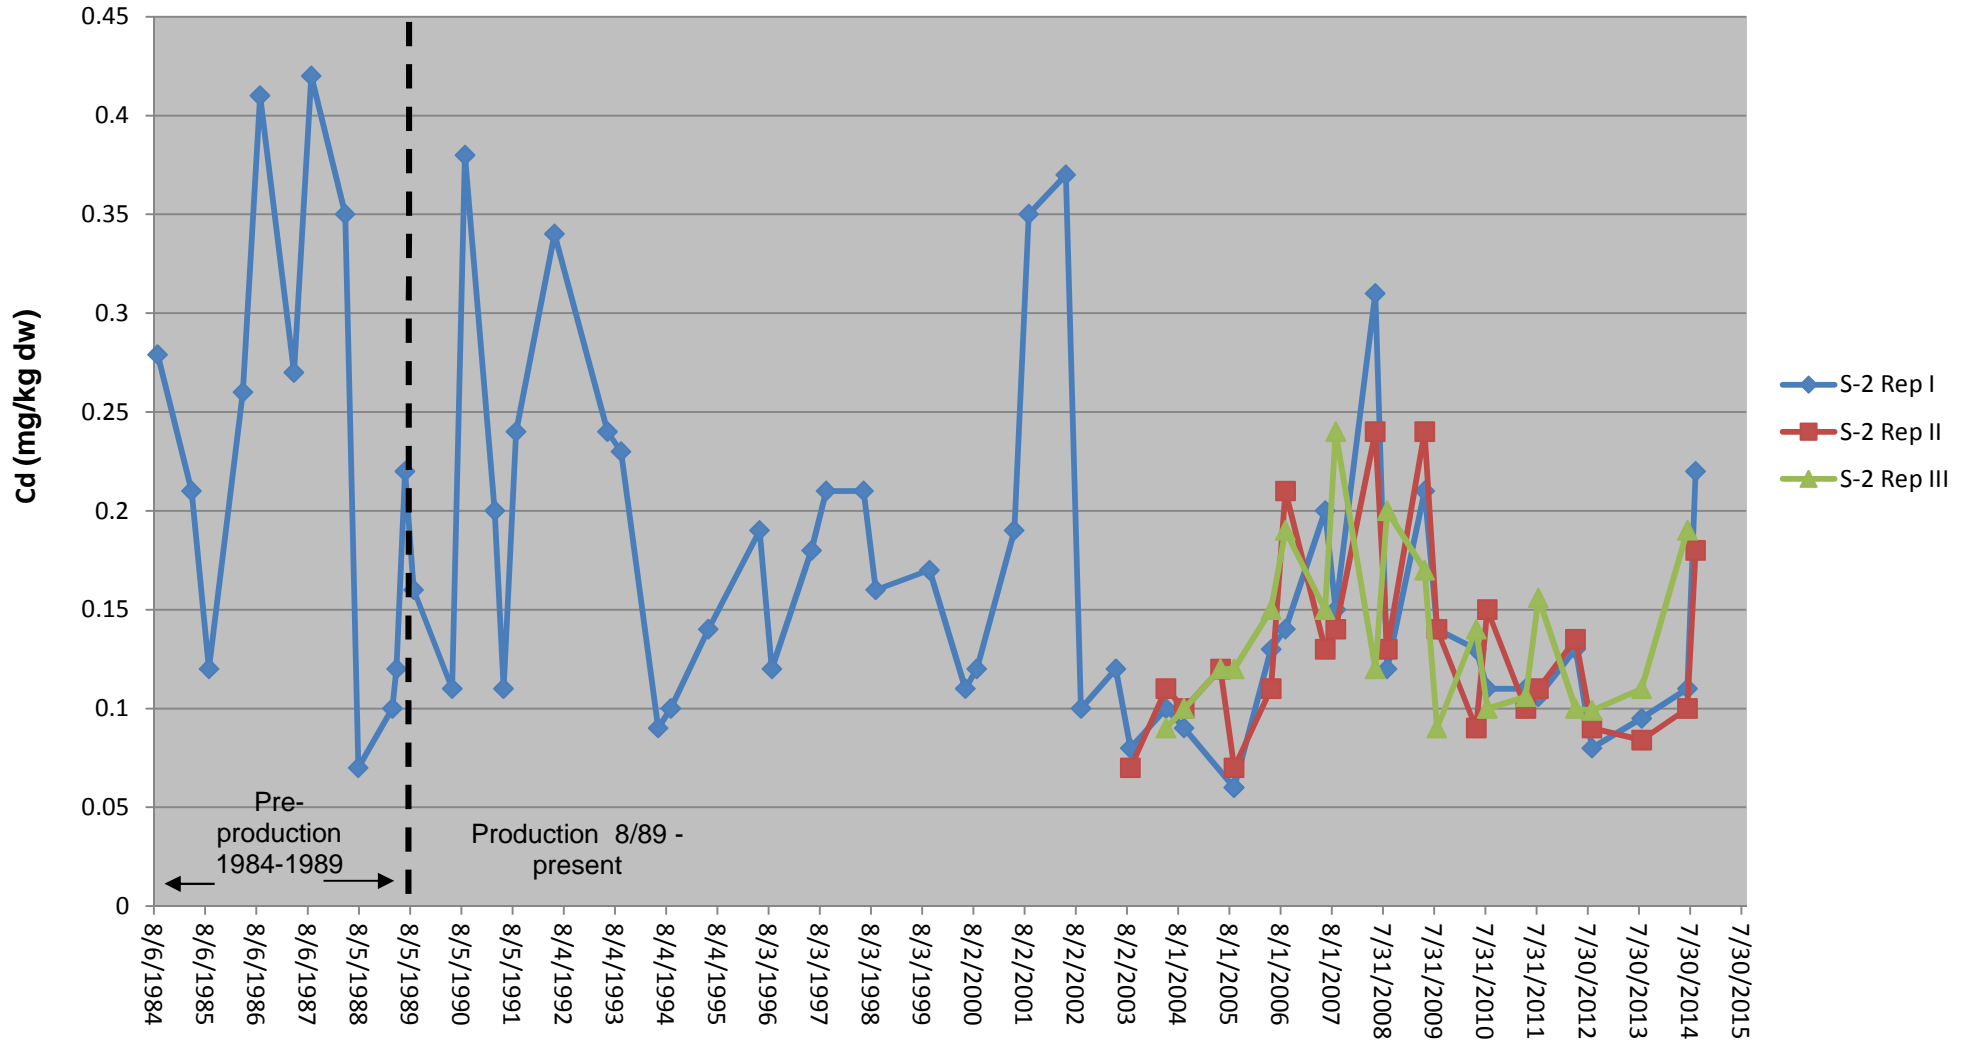
FIGURE 3-6

CADMIUM IN SEDIMENTS AT SITE S-2
