RE: Hawk Inlet Monitoring Program 2014 Annual Report (APDES Permit AK-004320-6)

**HAWK INLET MONITORING PROGRAM
2014 ANNUAL REPORT**

Hecla Greens Creek Mining Company

January 2015

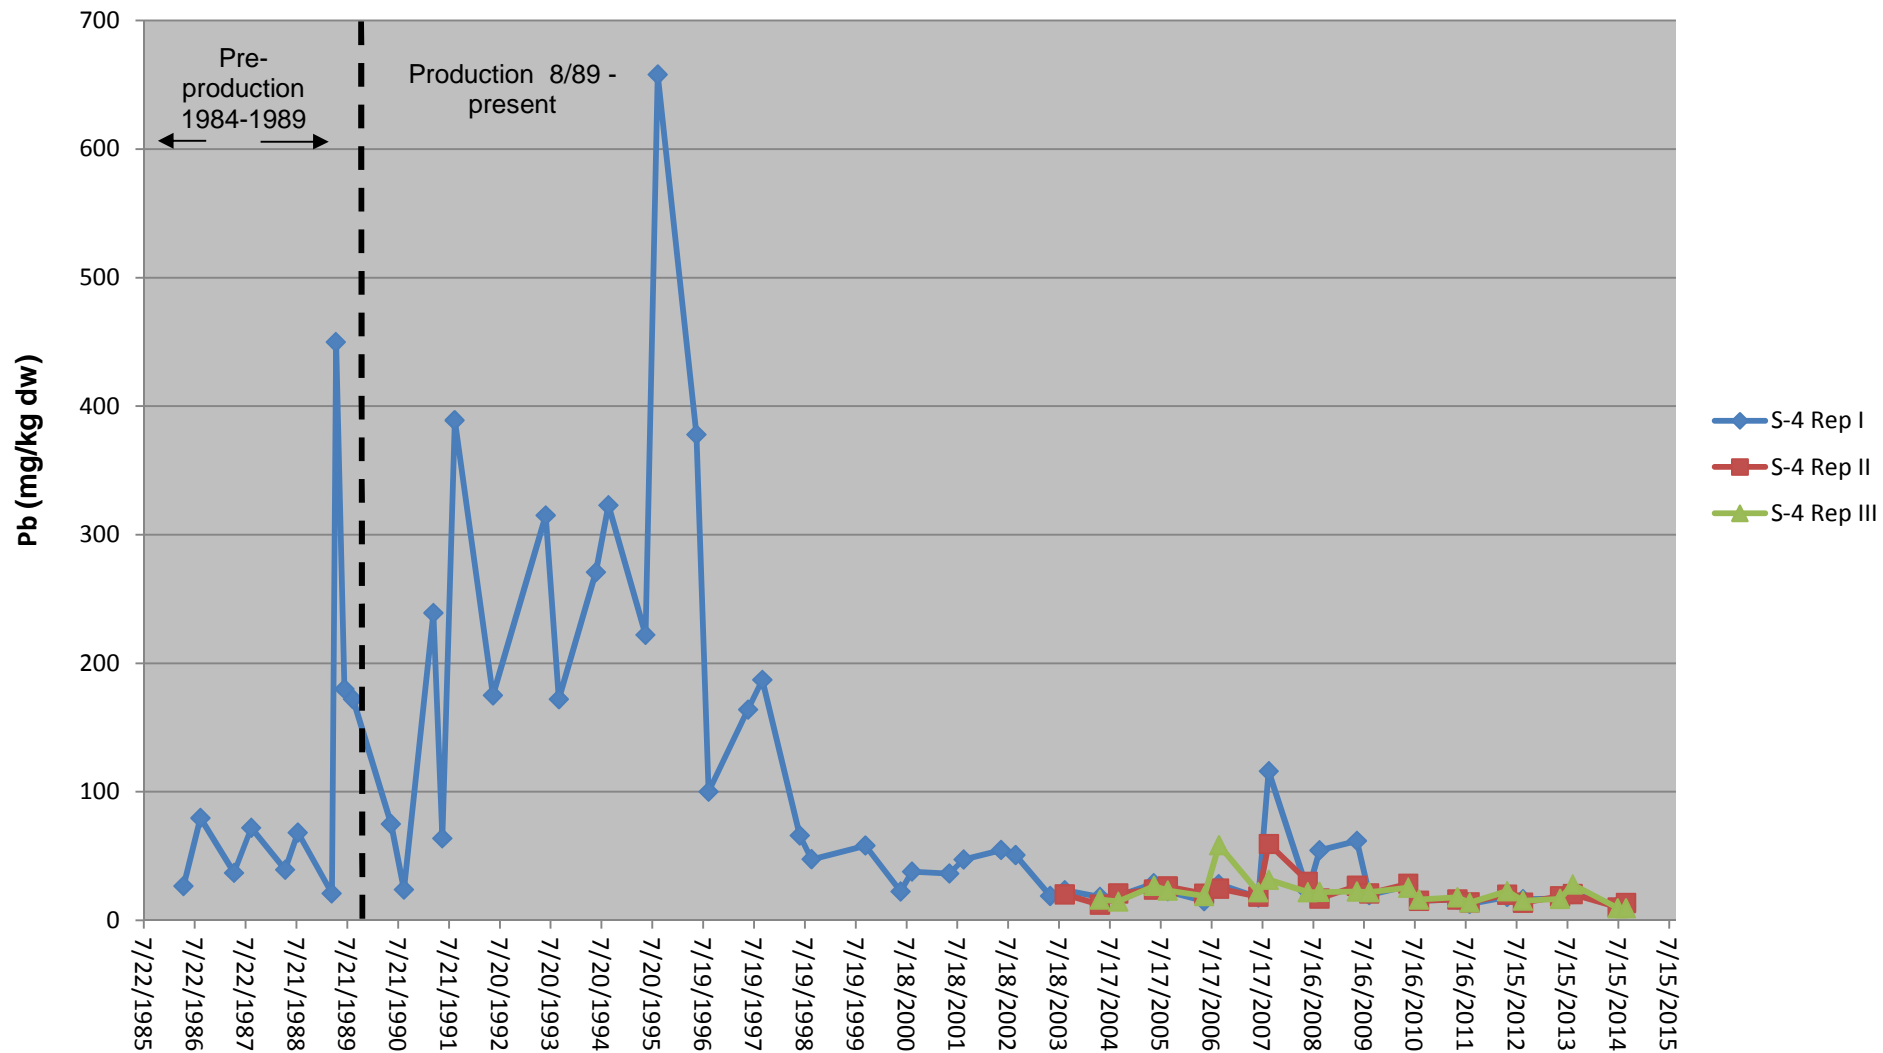
FIGURE 3-13

LEAD IN SEDIMENTS AT SITE S-4

The sensitivity of the sediment monitoring system is evident when metal concentrations at sites (S-4 and S-5 (N and S)) near the ship loader are examined. These sites are influenced from the original activities of the cannery, the burning down of the cannery in the 1970’s, and concentrate spillage associated with the shiploader spill in 1989. For example pre-production lead levels at S-4 averaged around 50 mg/kg about 8 times higher than at S-1. After the concentrate spill the lead levels average around 250 mg/kg at S-4. During re-commissioning (mid 1990s) sediments were dredged in the vicinity of the ship loader, after this the average lead level returned to pre-productions levels. Since the early 2000’s lead levels at S-4 have routinely been less than 30 mg/kg.

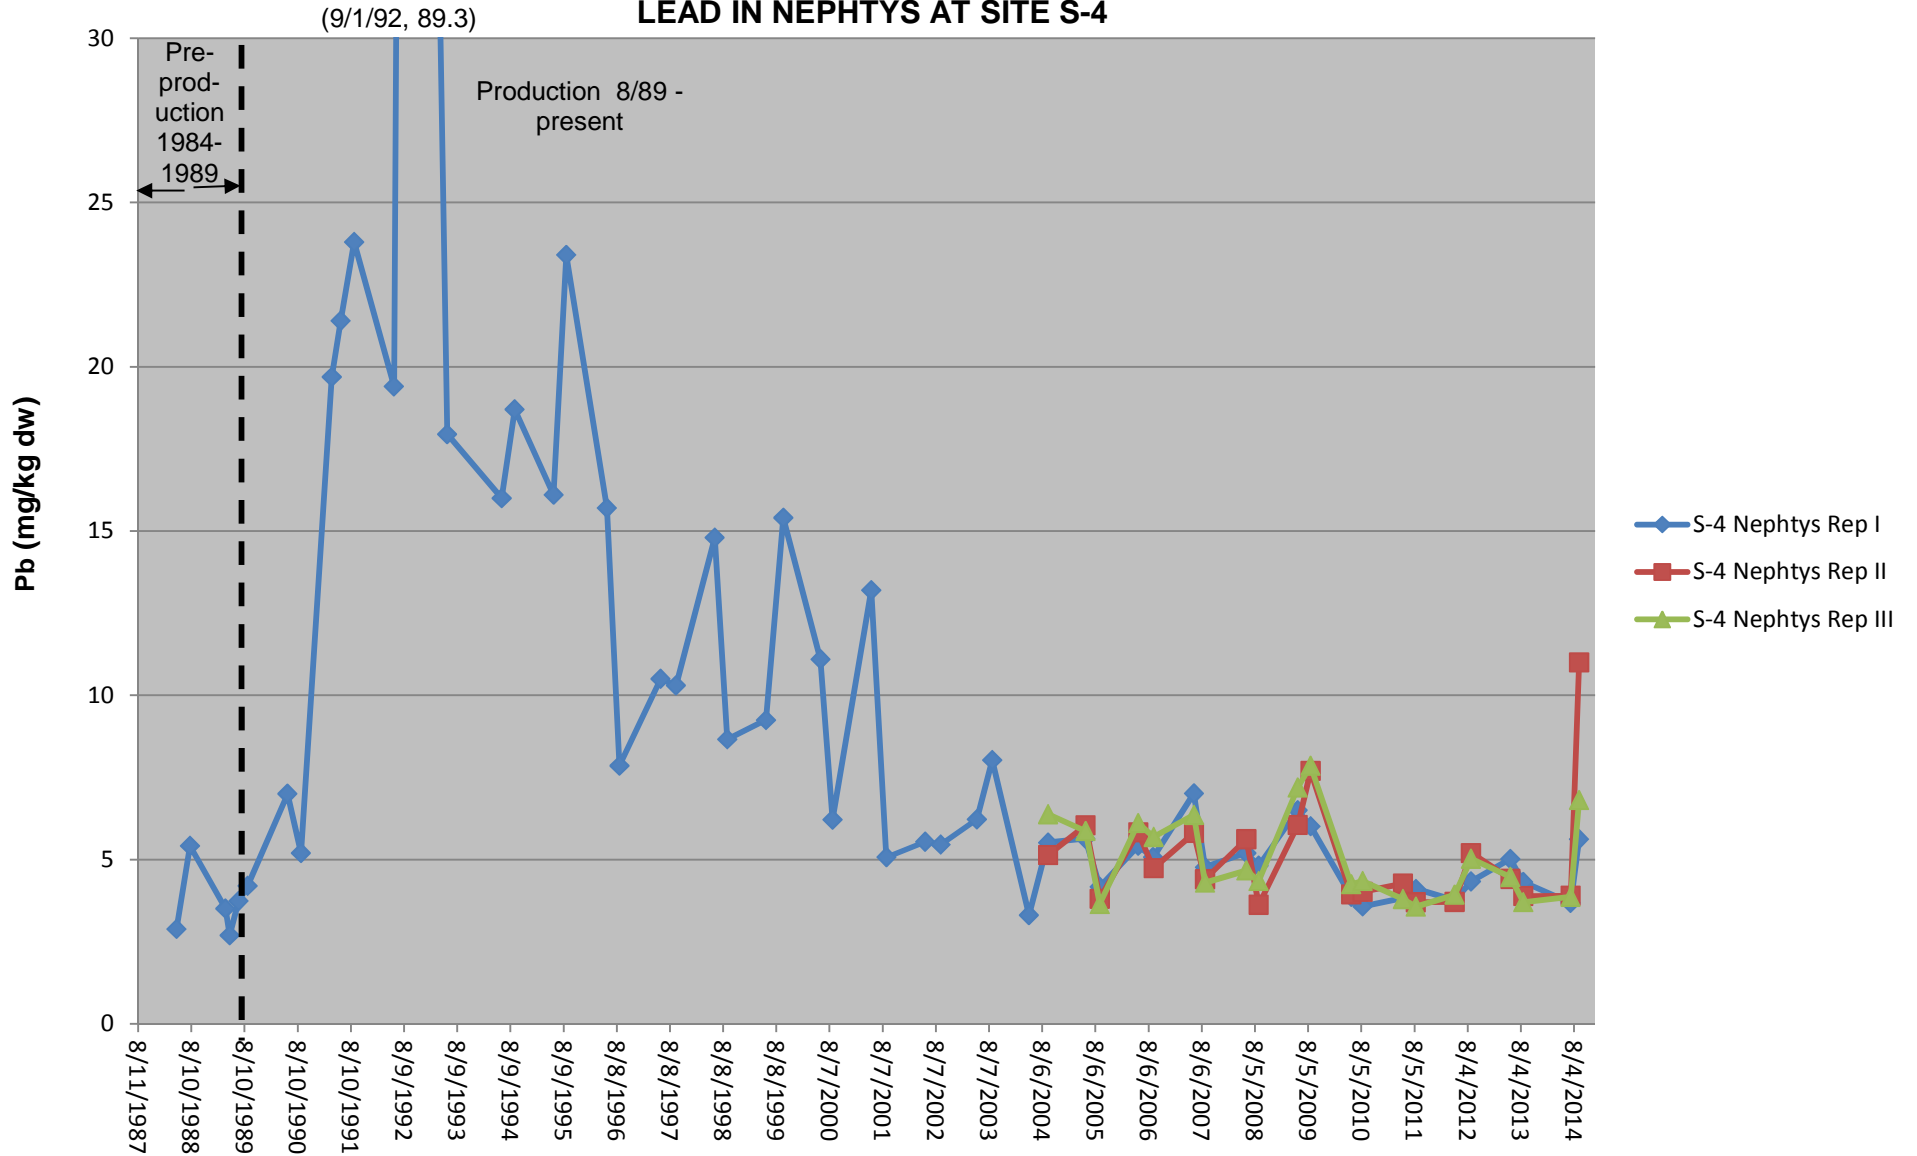
FIGURE 4-18

LEAD IN NEPHTYS AT SITE S-4

Lead levels from the tissue monitoring of *Nephtys* at site S-4 have a similar pattern as described for the sediment monitoring. Visually, it appears that there is a strong correlation between the two monitoring programs. This 'correlation' also exists when comparing lead in sediments to lead in *Nephtys* at site S-1. If the temporal variation in the sediment load at S-1 was a result of discharge from the 002 Outfall, the similar variation observed at S-2 would not be expected. This similarity in temporal variation and with spatial distances occurs with the other metals as well. HGCMC believes that the variation in concentration monitored in organisms near the 002 outfall is natural and that monitoring program is sufficient for detecting changes.
